SWG'S HISTORY/CASE STUDIES OF FRAC-OUT AND OTHER HORIZONTAL DIRECTIONAL DRILLING (HDD) INSTALLATION ISSUES

SWG Levee Safety Team
2020

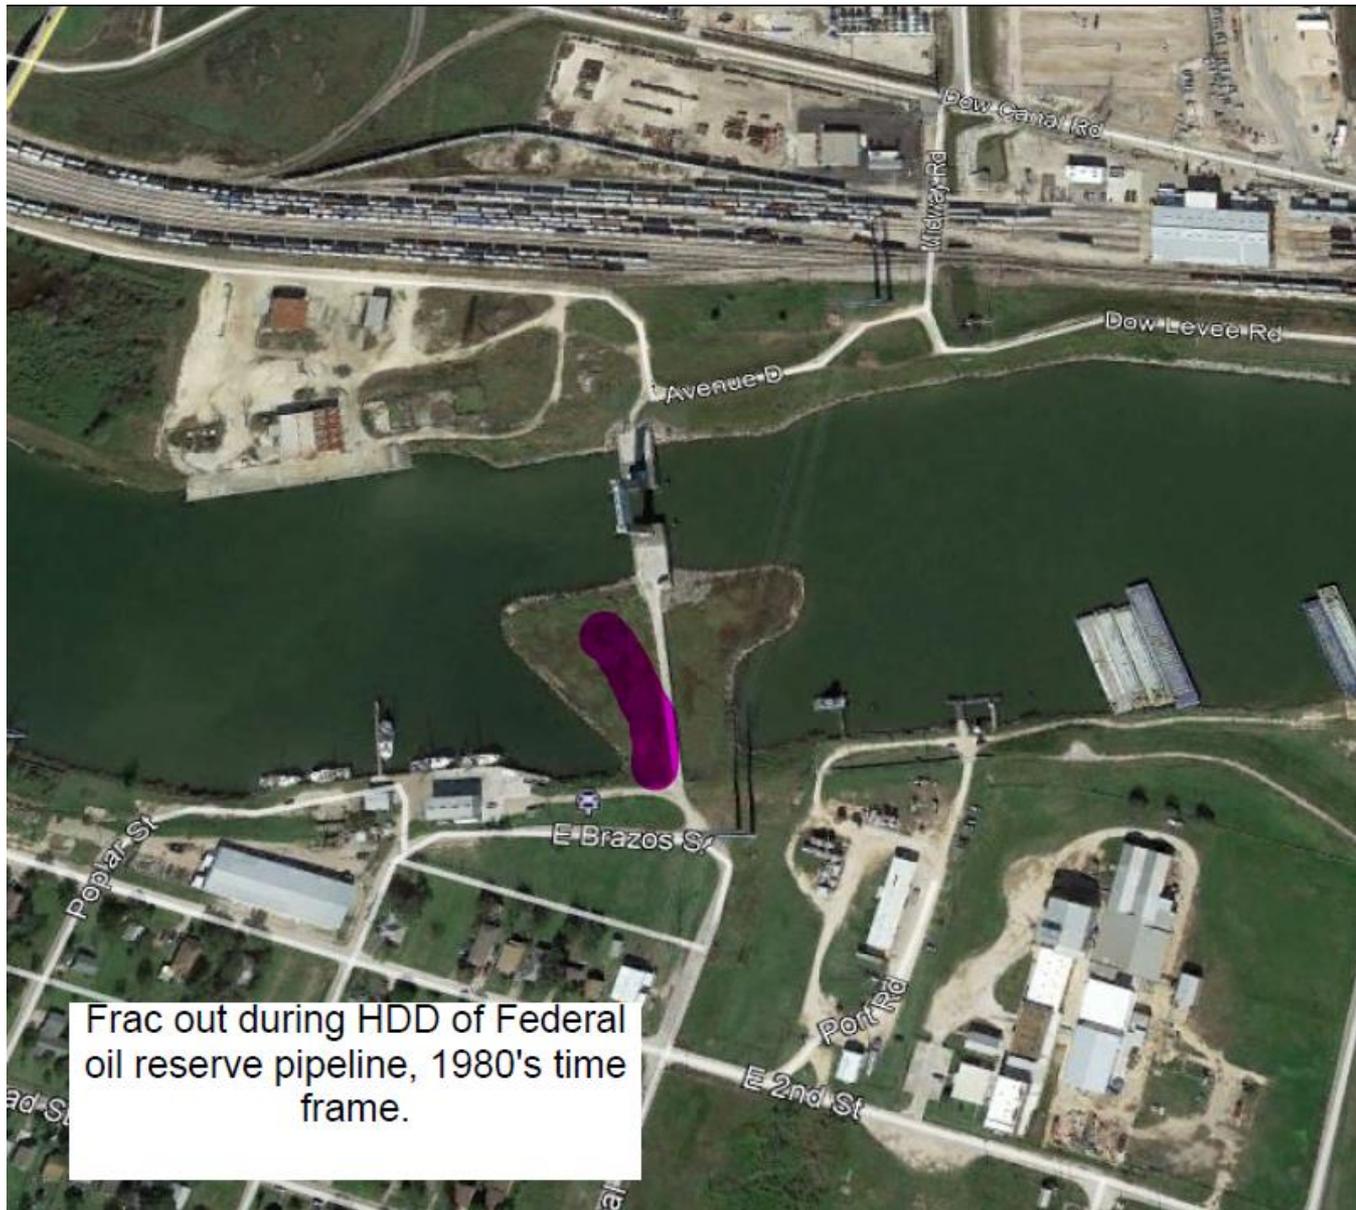
Hydrofracture in Freeport Levee system (1)

Frac out during HDD of Federal oil reserve pipeline, 1980's time frame.

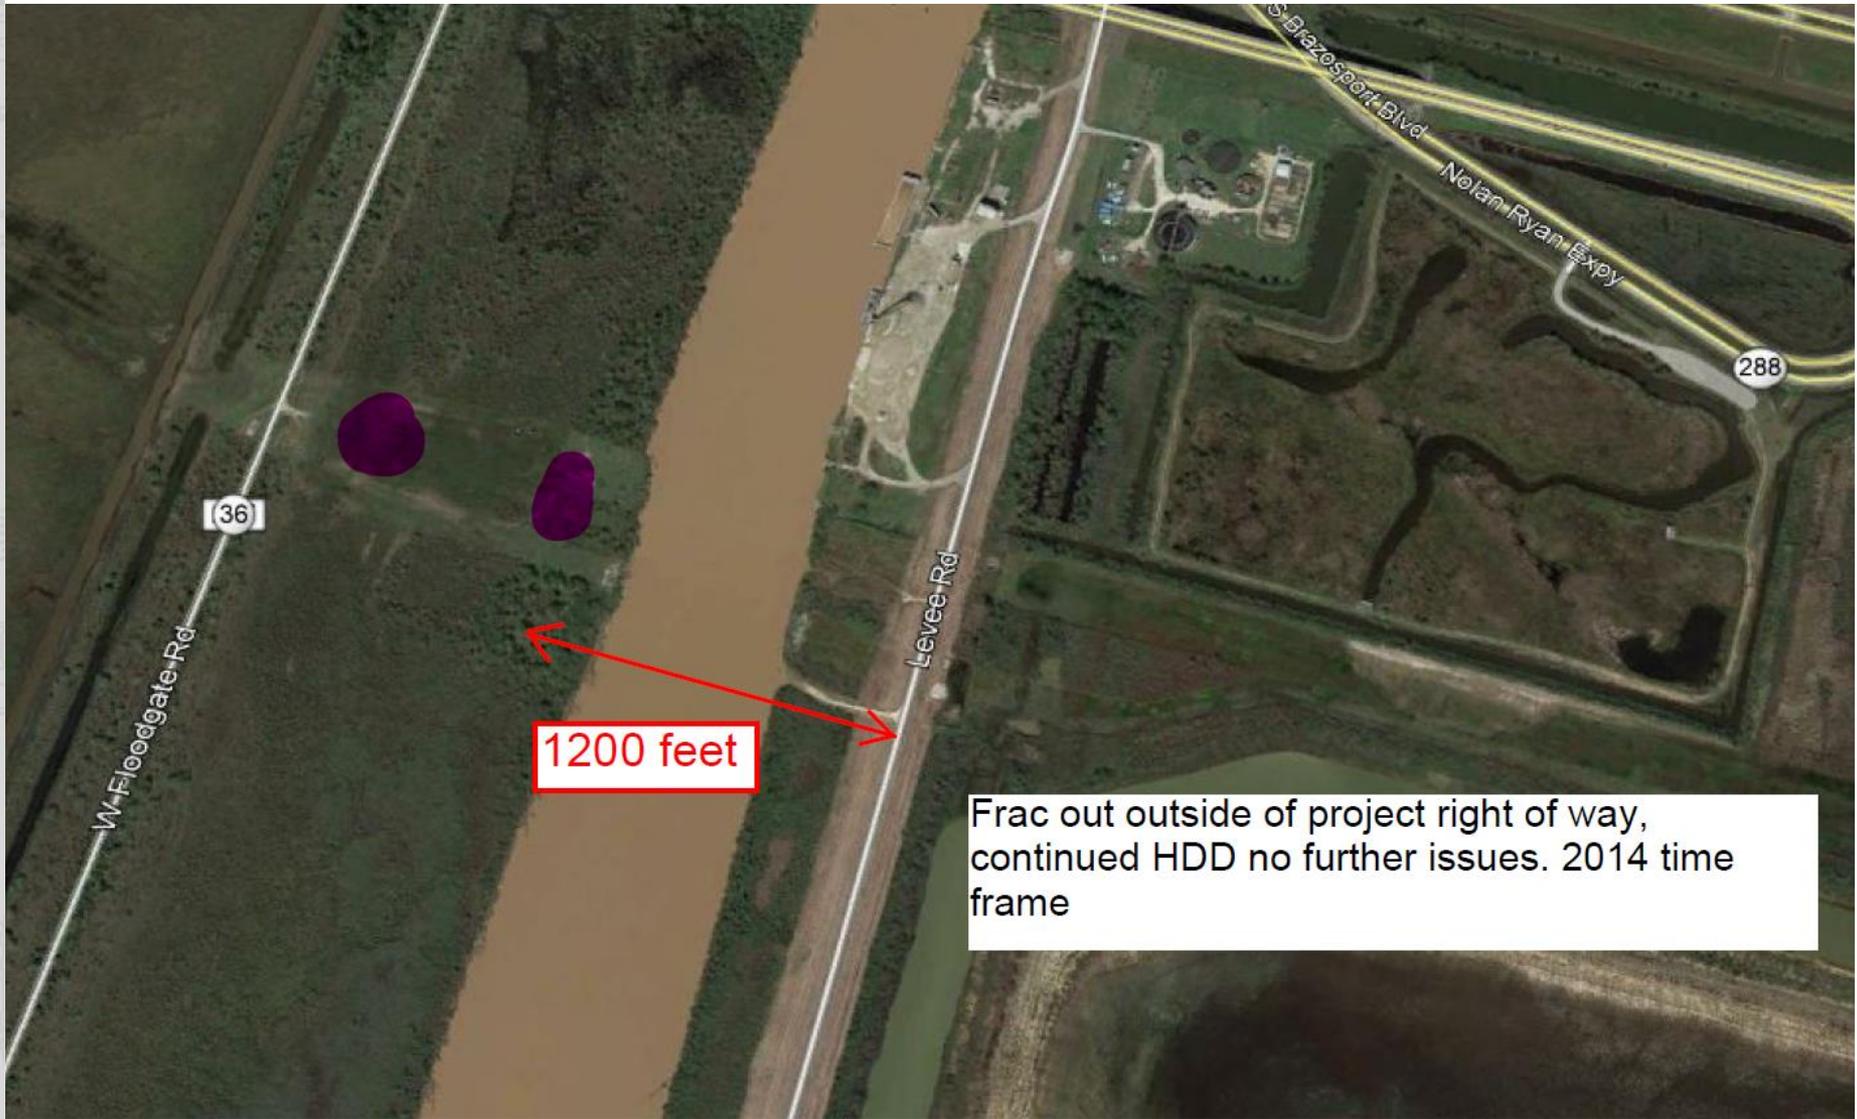
Hydrofracture in Freeport Levee system (3)

Frac out outside of project right of way, continued HDD no further issues. 2014 time frame

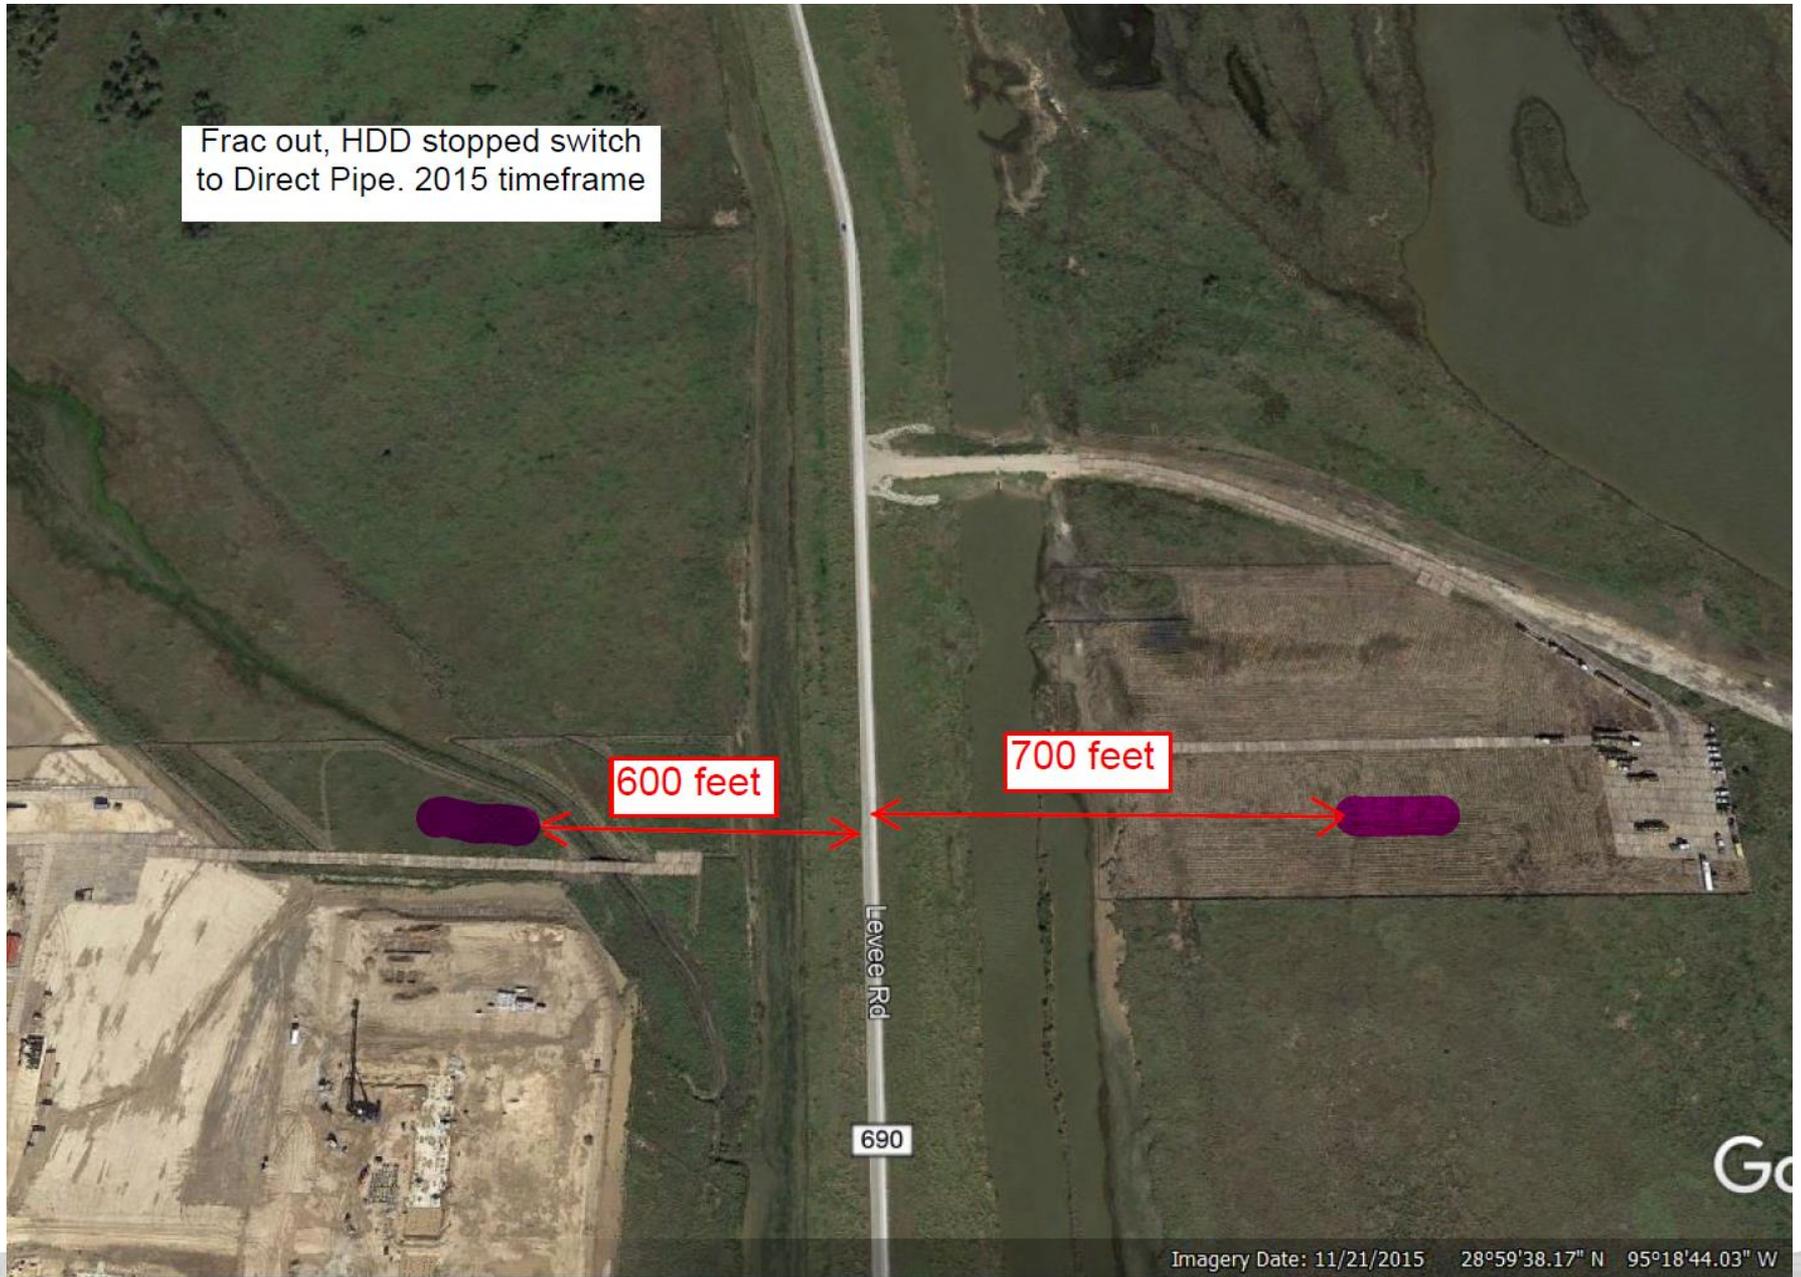
Hydrofracture in Freeport Levee system (4)

Frac out, HDD stopped switch to Direct Pipe. 2015 timeframe

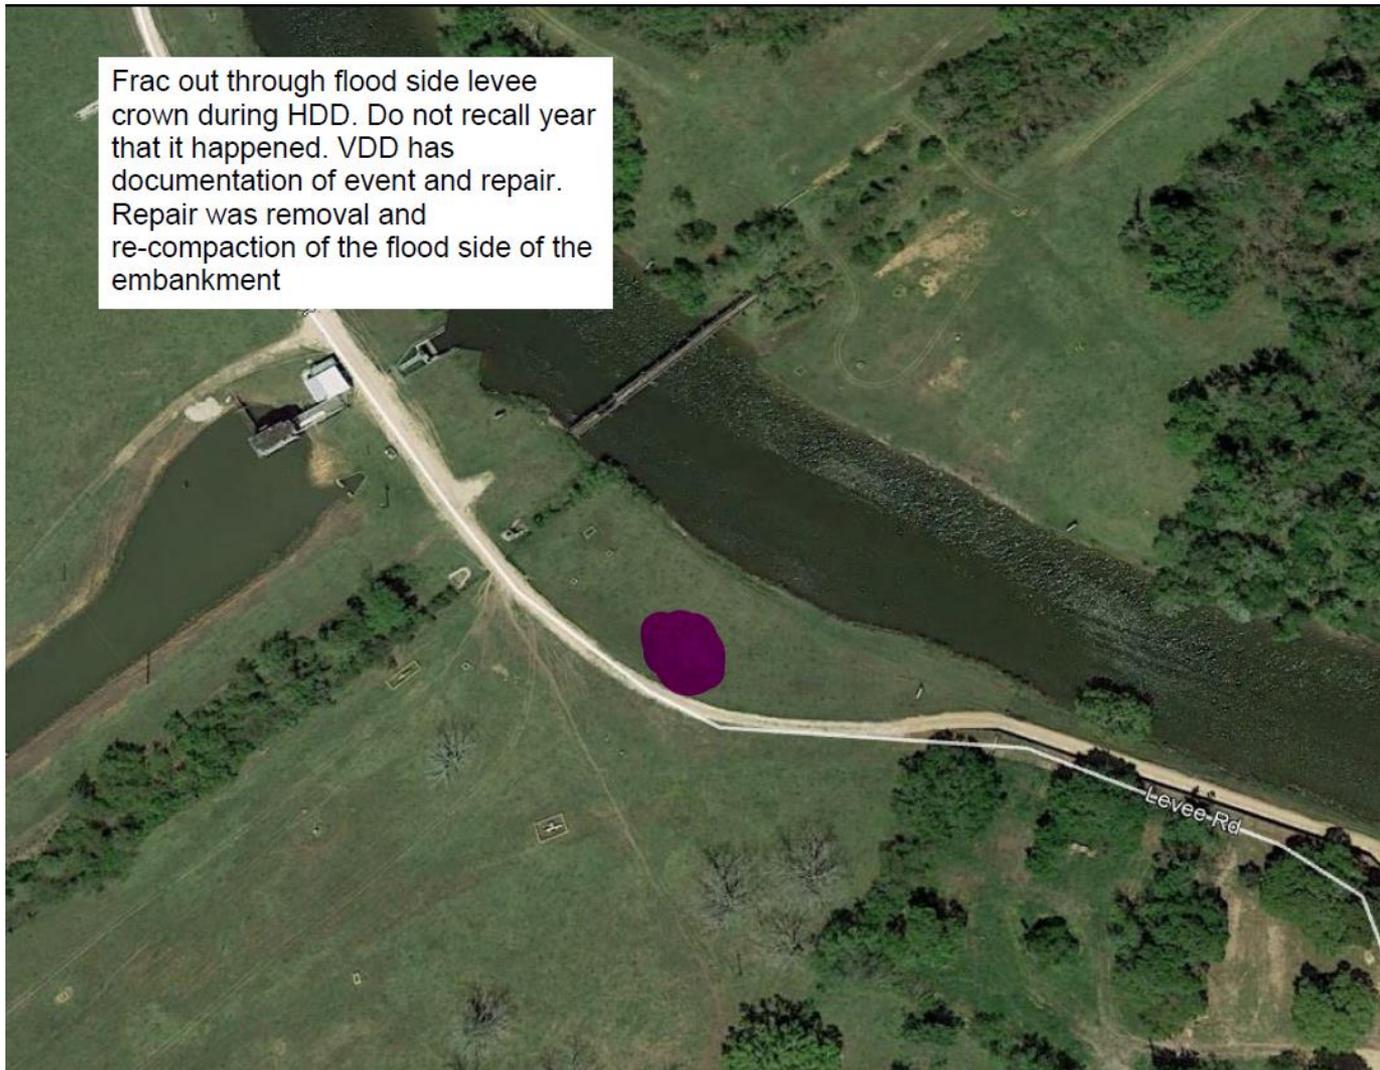
Hydrofracture in Freeport Levee system (7)

Frac out through flood side levee crown during HDD. Do not recall year that it happened. VDD has documentation of event and repair. Repair was removal and re-compaction of the flood side of the embankment

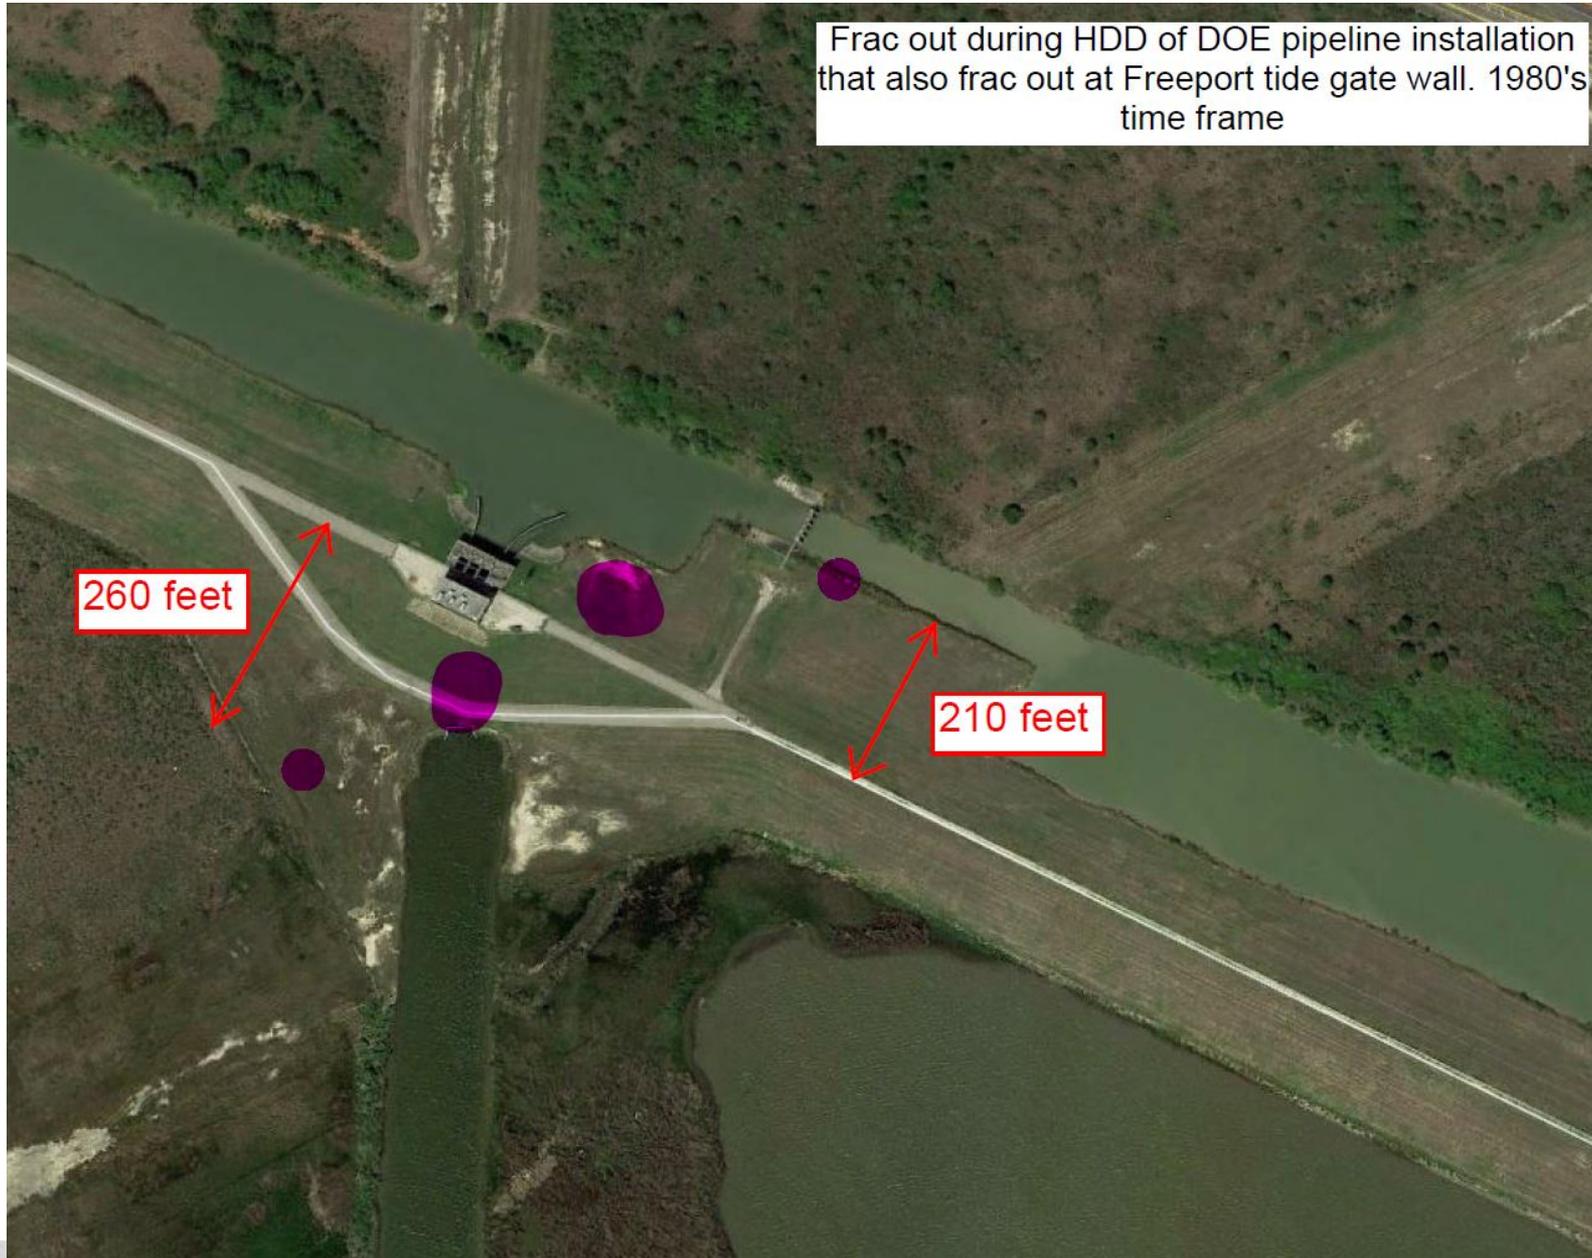
Hydrofracture in Texas City Levee system (8)

Frac out during HDD of DOE pipeline installation that also frac out at Freeport tide gate wall. 1980's time frame

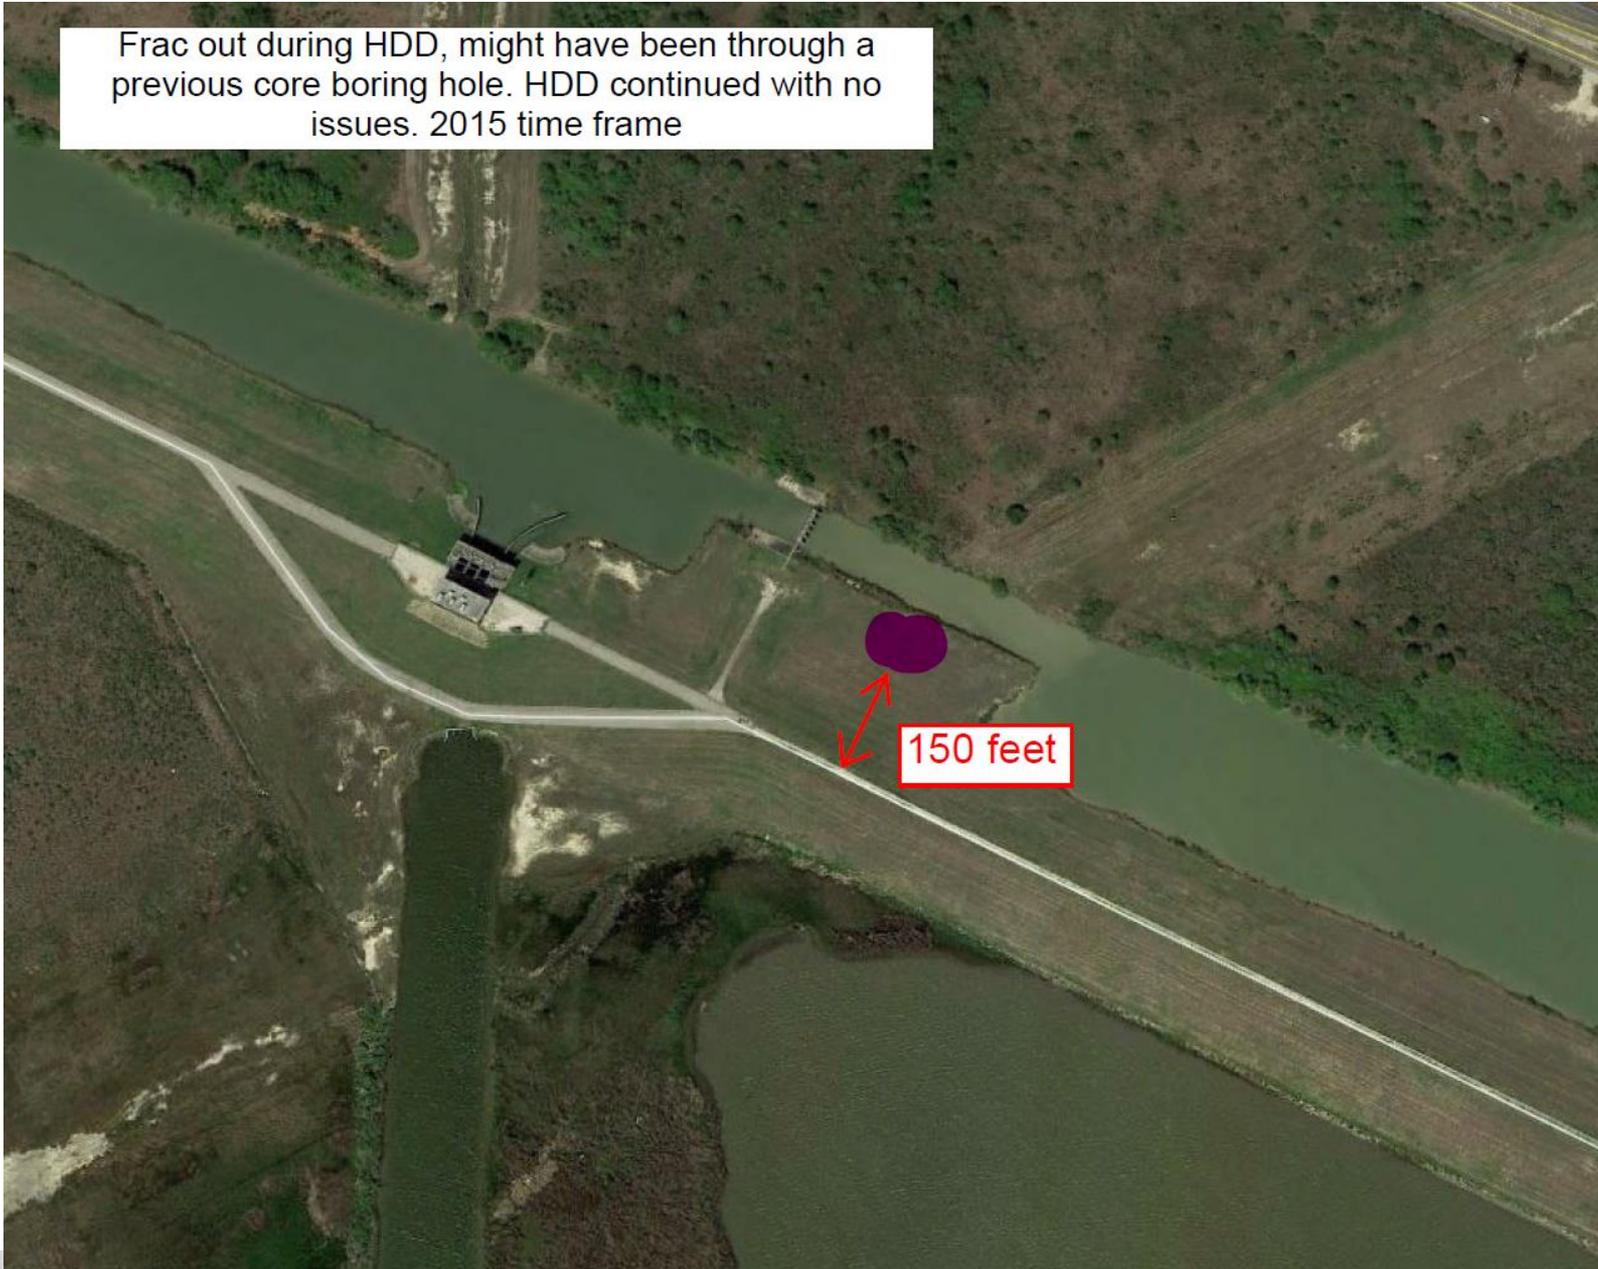
Hydrofracture in Texas City Levee system (9)

Frac out during HDD, might have been through a previous core boring hole. HDD continued with no issues. 2015 time frame

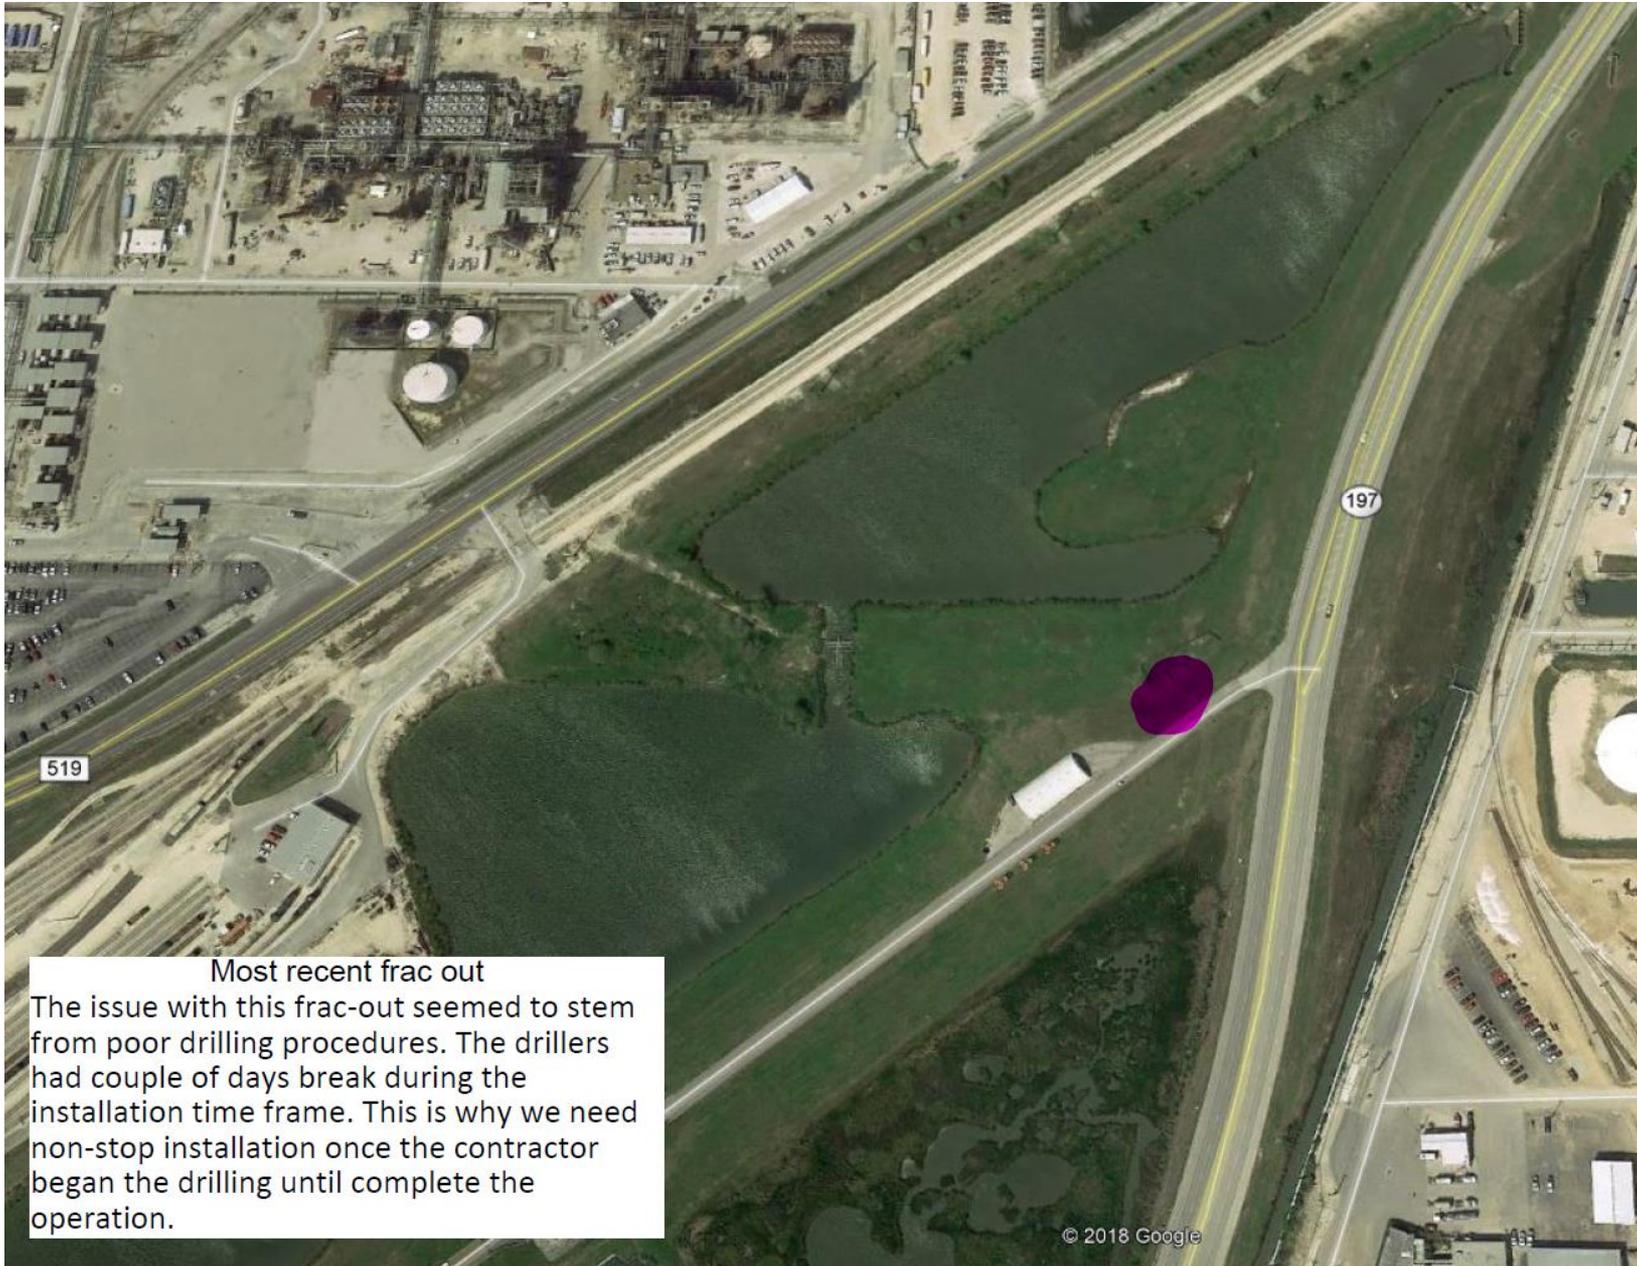
Hydrofracture in Texas City Levee system (10)

Most recent frac out

The issue with this frac-out seemed to stem from poor drilling procedures. The drillers had couple of days break during the installation time frame. This is why we need non-stop installation once the contractor began the drilling until complete the operation.

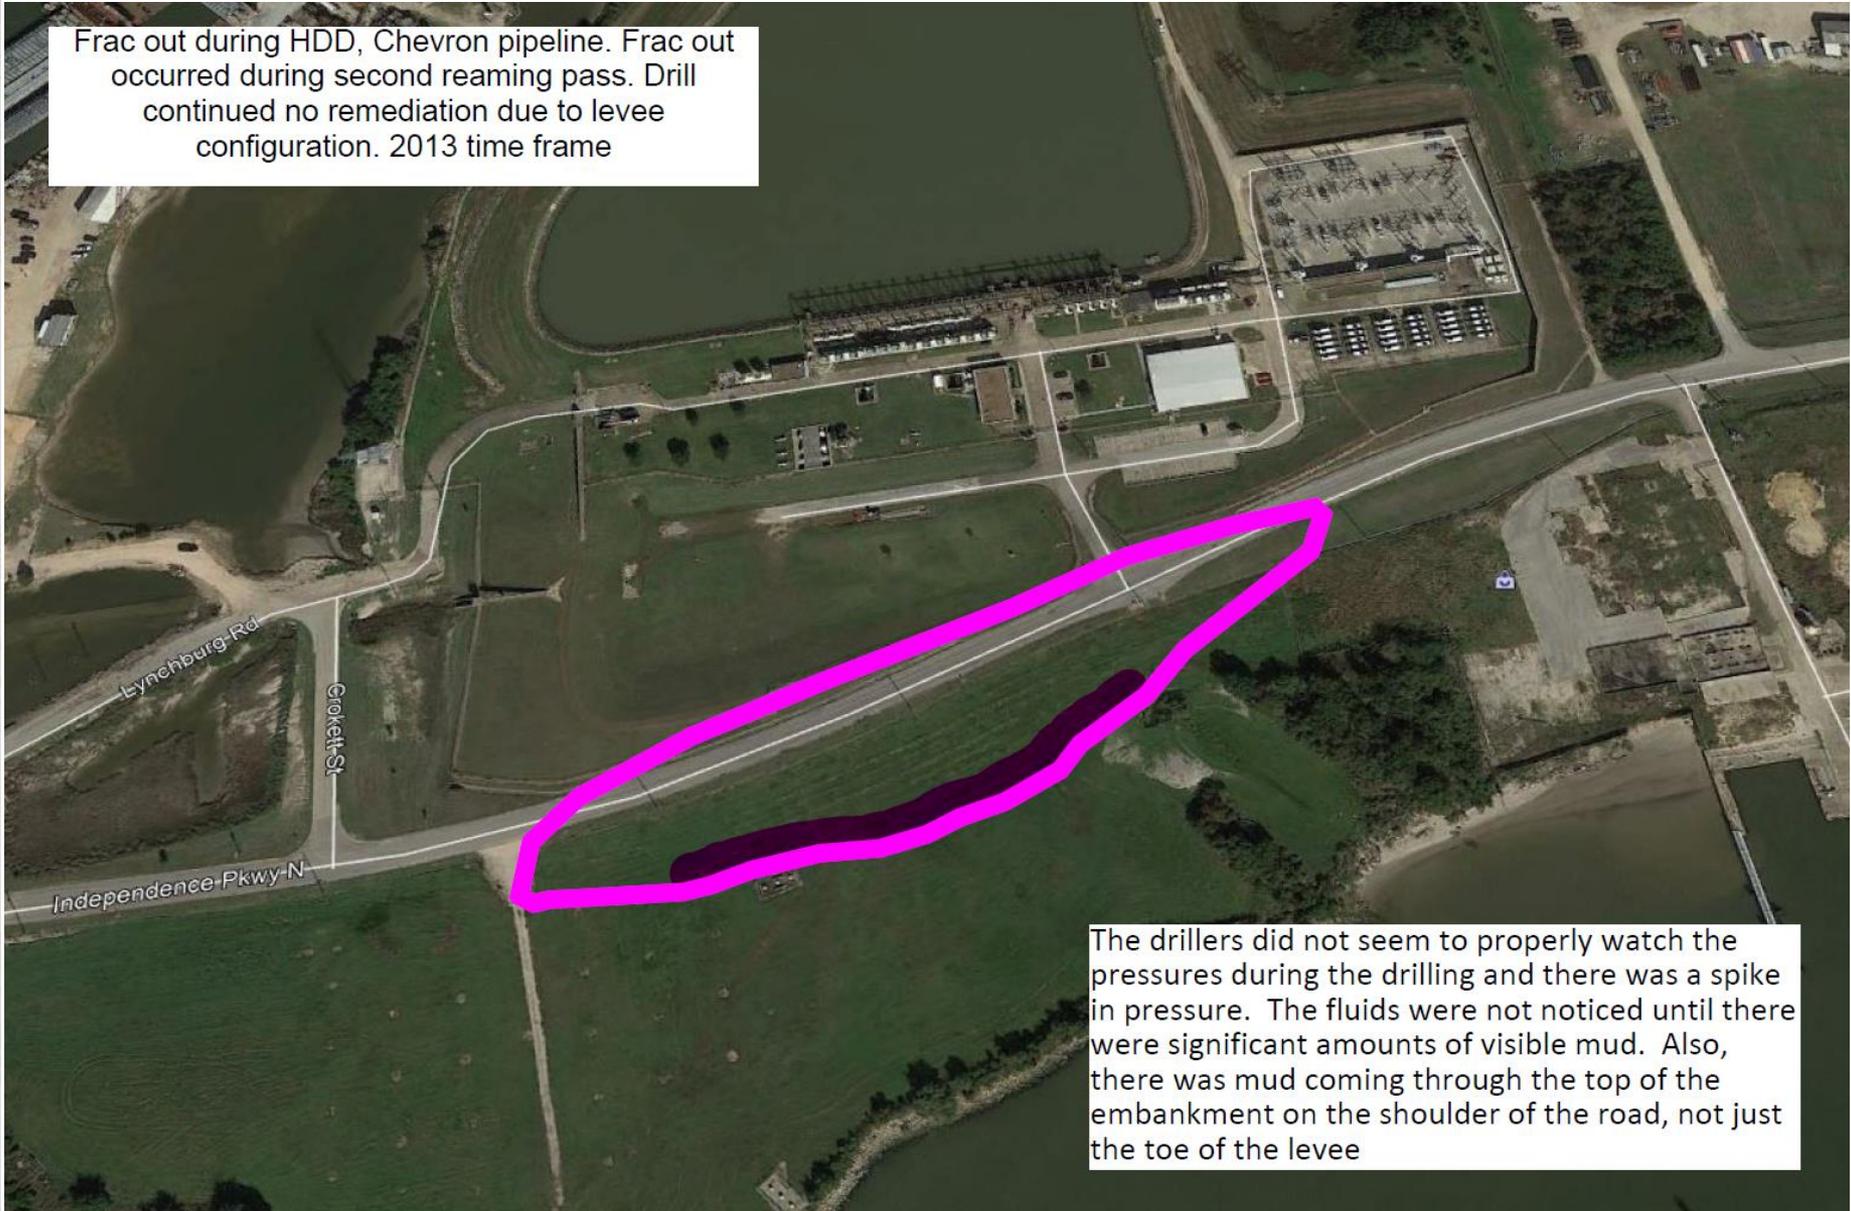
Hydrofracture in Lynchburg Levee system (11)

Frac out during HDD, Chevron pipeline. Frac out occurred during second reaming pass. Drill continued no remediation due to levee configuration. 2013 time frame

The drillers did not seem to properly watch the pressures during the drilling and there was a spike in pressure. The fluids were not noticed until there were significant amounts of visible mud. Also, there was mud coming through the top of the embankment on the shoulder of the road, not just the toe of the levee

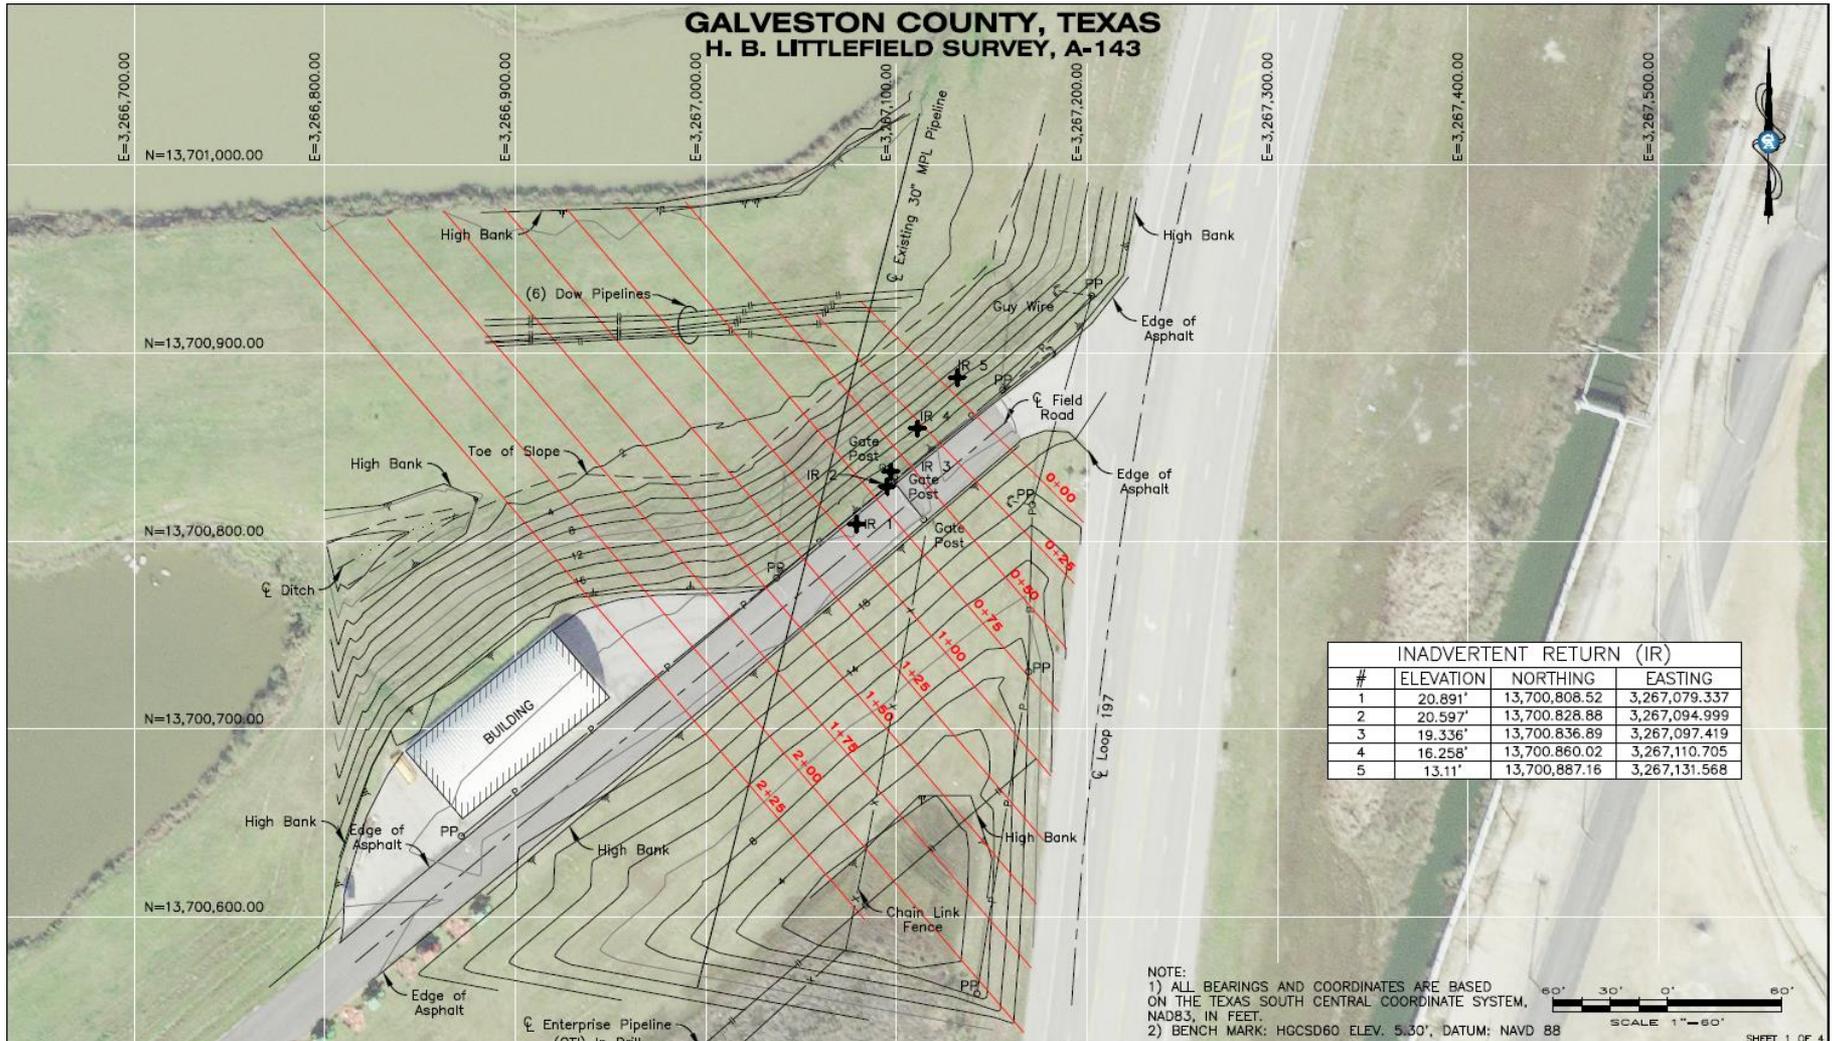
Photo for Locations of Hydrofractures

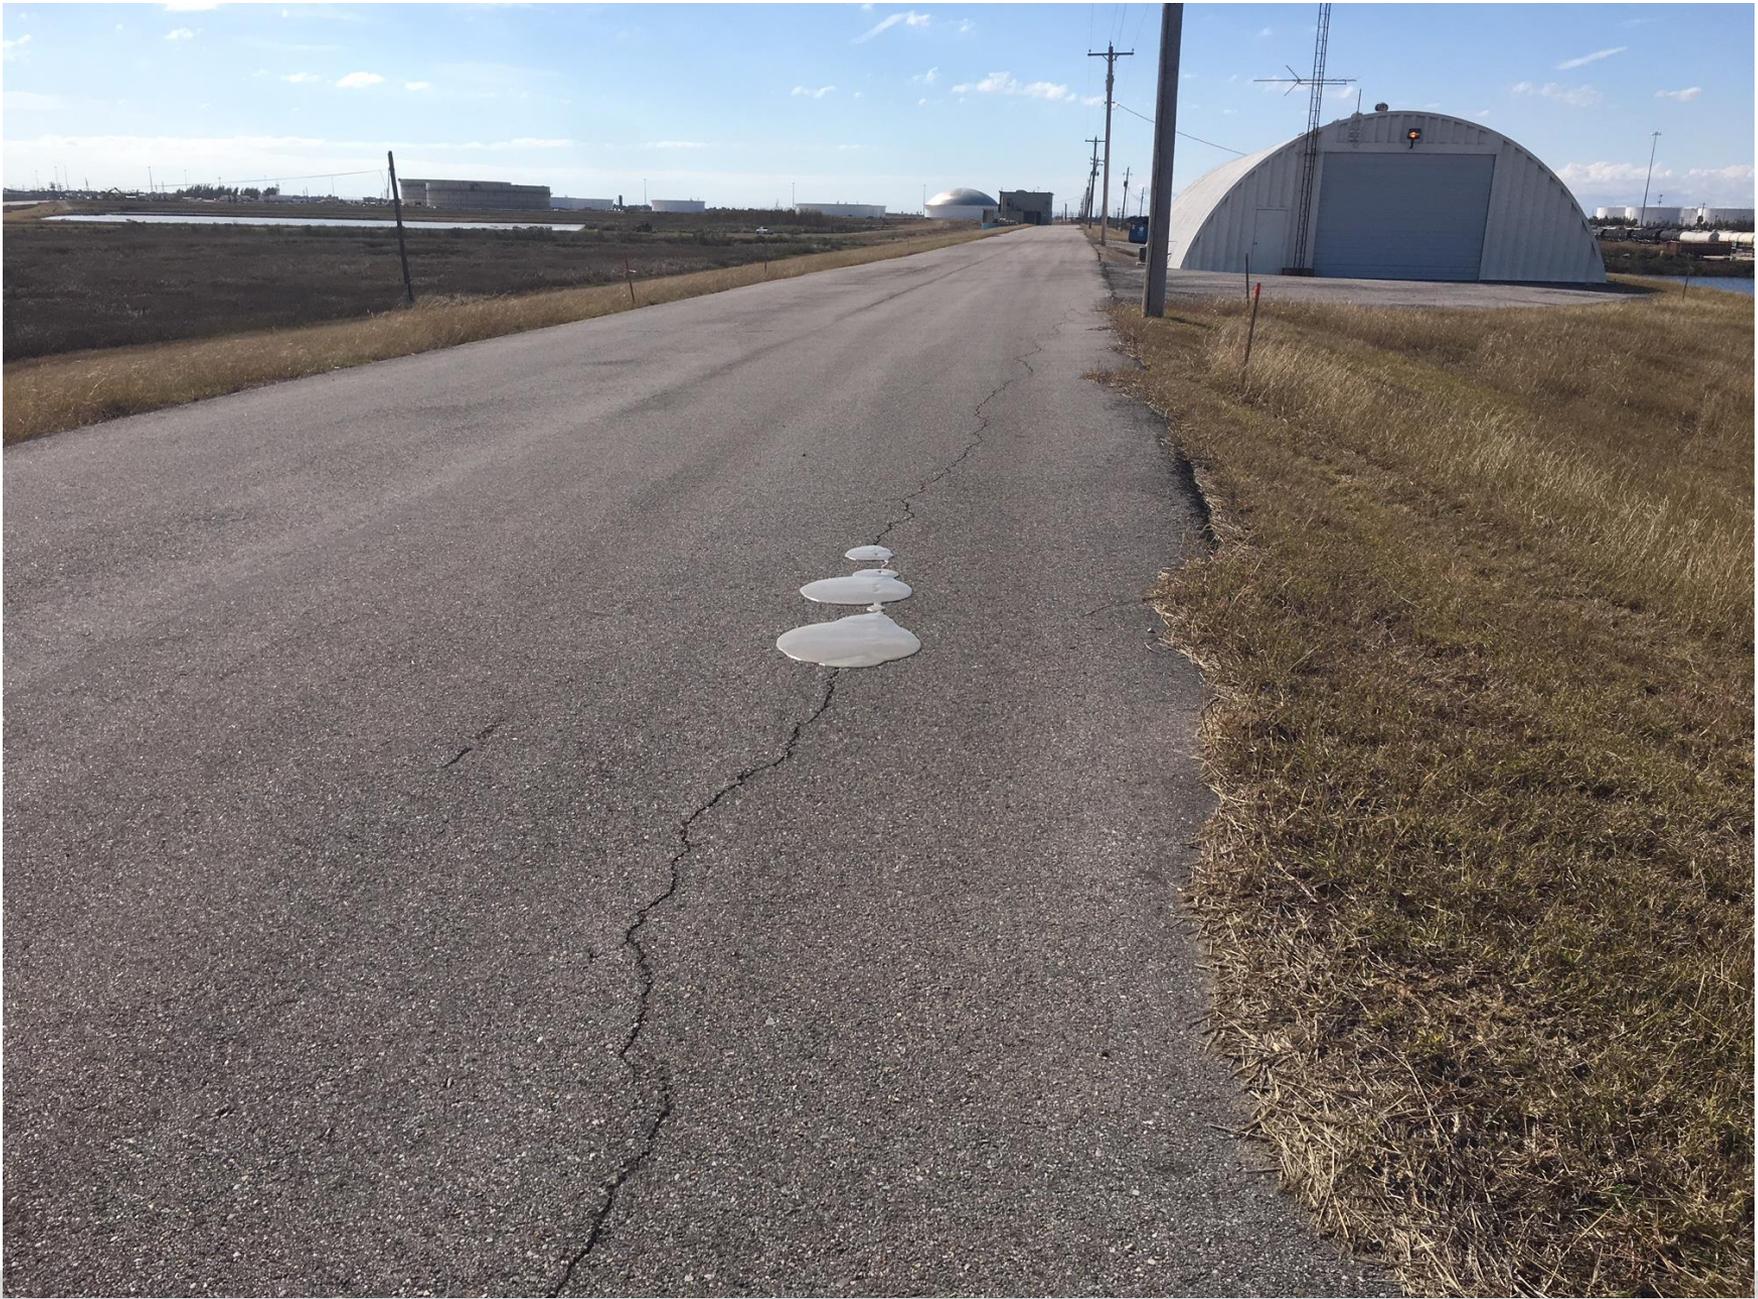
Photo for Locations of Hydrofractures
