# Shore & Beach

## LESSONS FROM HURRICANE IKE

# United States Army Corps of Engineers, Galveston District Operational experiences and response to Hurricane Ike

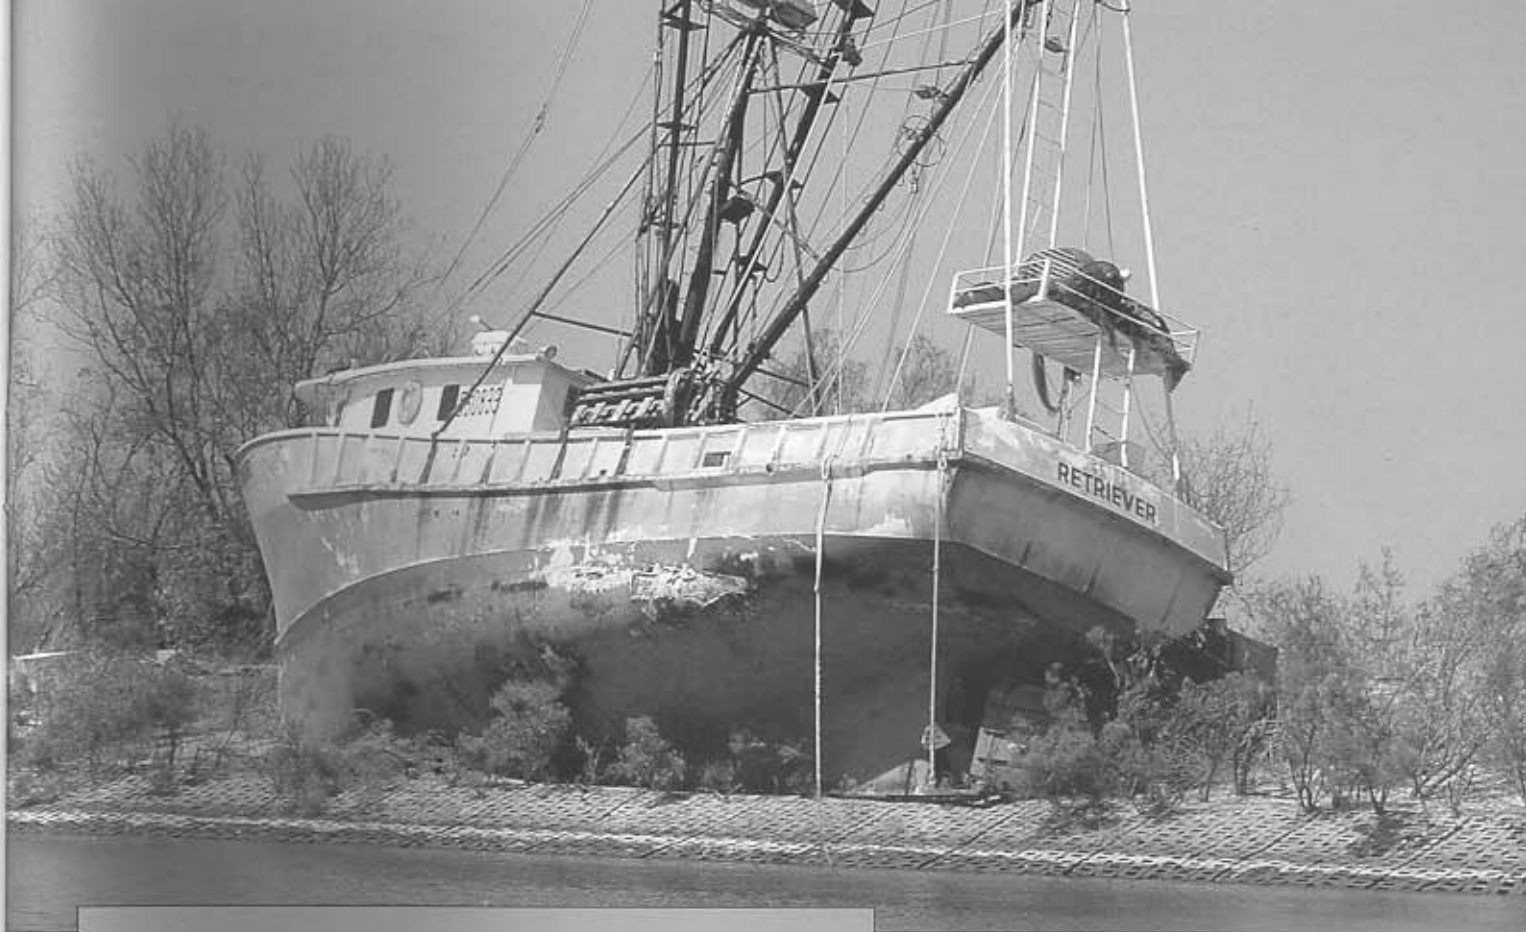
In some instances, placement areas within a dredging reach were destroyed or burdened with hurricane debris (Figures 4-6), requiring engineers to coordinate with the Texas General Land Office and the Texas Department of Transportation to find alternative locations to place dredged material. Each day that went by with waterways closed had a huge economic impact not only on the Texas coast, but also on the country as a whole because of the petrochemical industry and commodity shipping interests on this part of the coast (pers. comm., Johnny Rozsypal, Chief of Operations).

Figure 4 (above). Shrimp boat swept into dredge material placement area 39, located on the northern side of the Gulf Intracoastal Waterway (GIWW) and across from the Bolivar Peninsula.

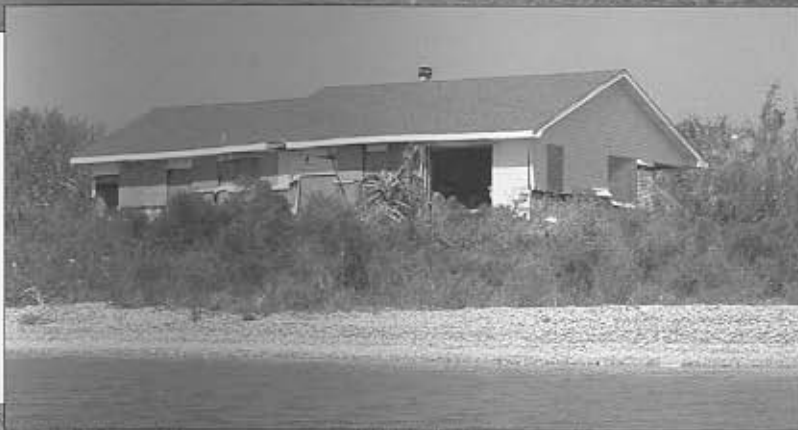
Figure 5 (left). House swept into dredge material placement area 38, located on the northern side of the GIWW and across from the Bolivar Peninsula.

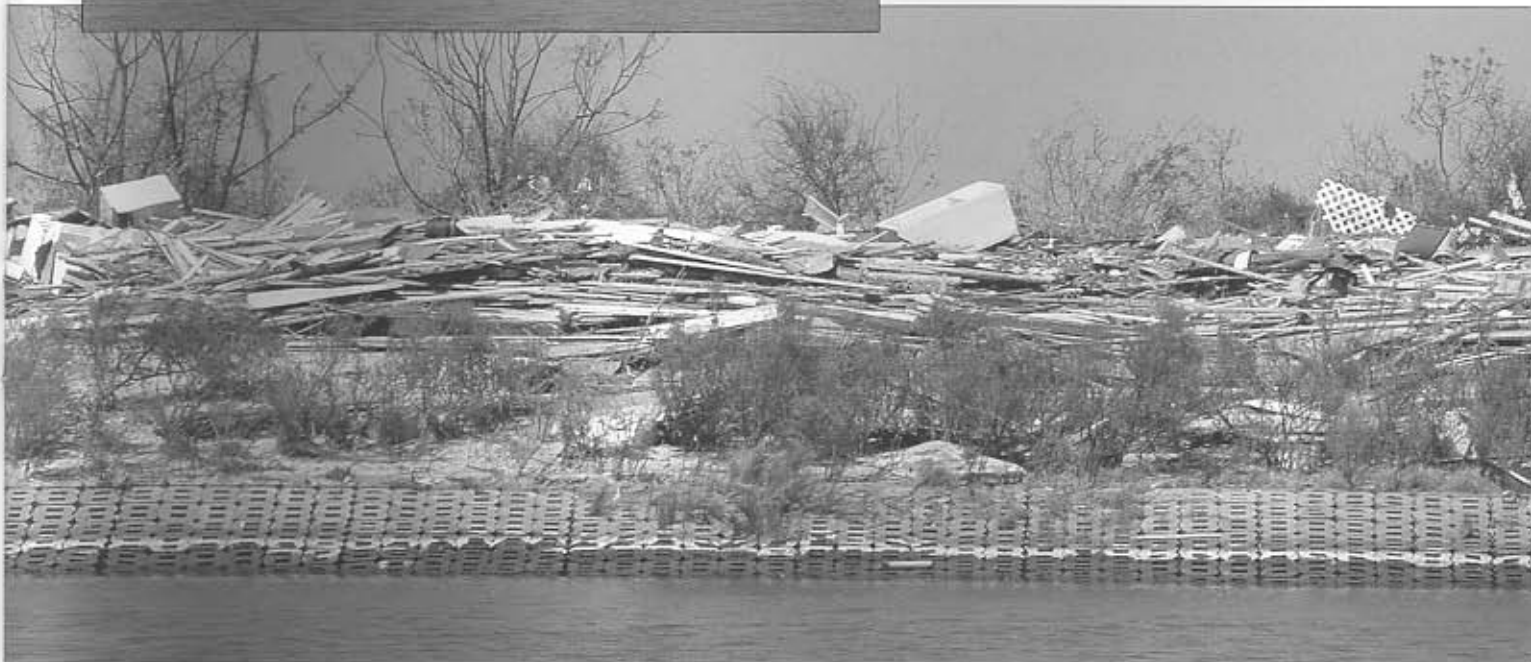
Figure 6 (below). Debris in dredge material placement area located on the northern side of the GIWW and across from the Bolivar Peninsula.

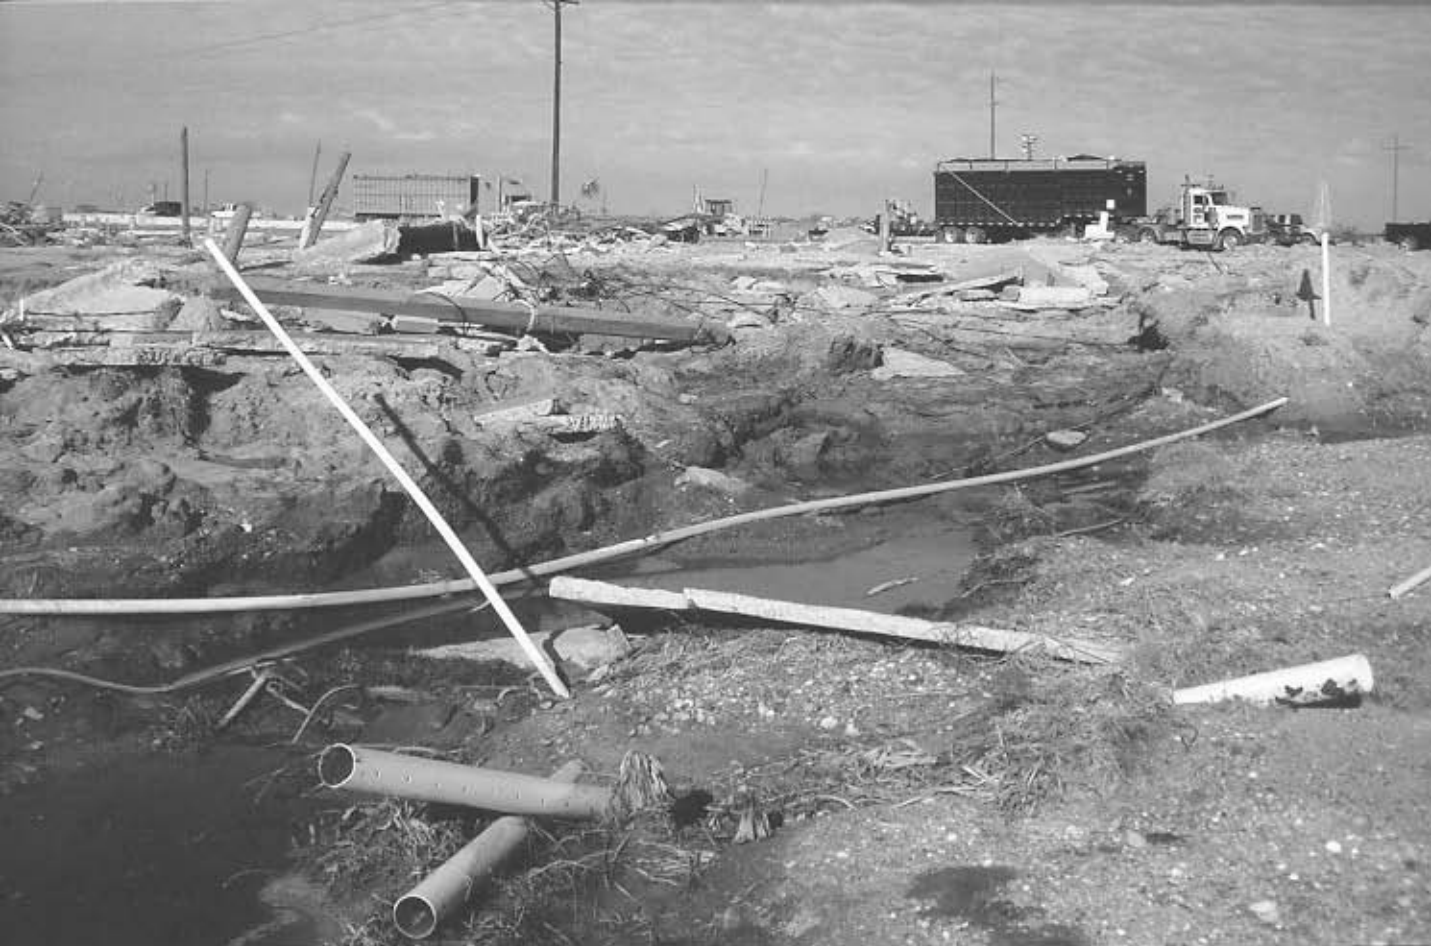
Figure 7 (above). Broken slabs, downed support pilings, and damaged residential infrastructure on the Bolivar Peninsula.

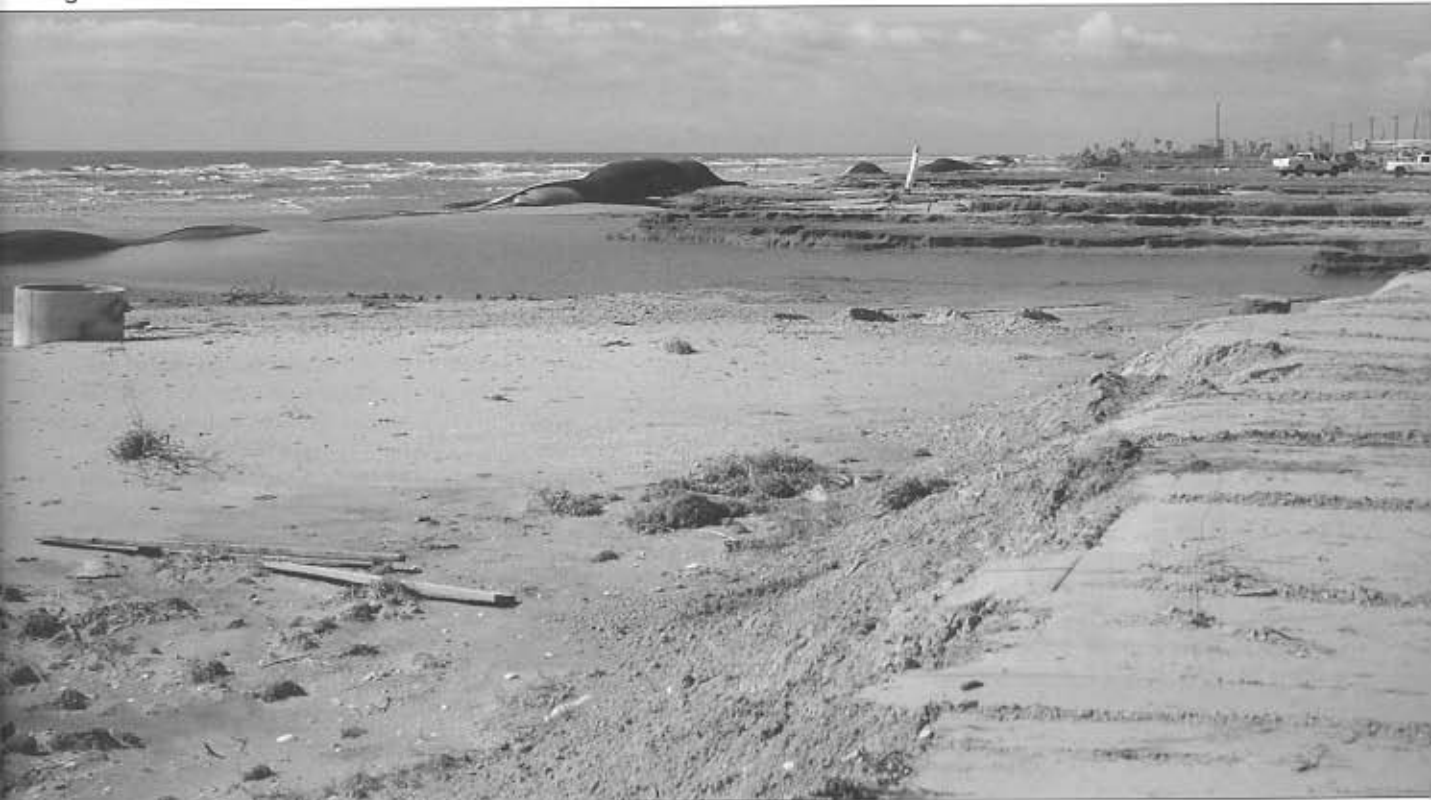
Figure 8 (below). Beach erosion on the Bolivar Peninsula. The sand in the right foreground of the photograph was placed after the storm. Note damaged geotextile tubes near the shore. The tubes were placed in the 1990s to simulate dune protection to beach front homes. The homes in this area were washed away by the 16-18 ft (4.8-5.5 m) storm surge.

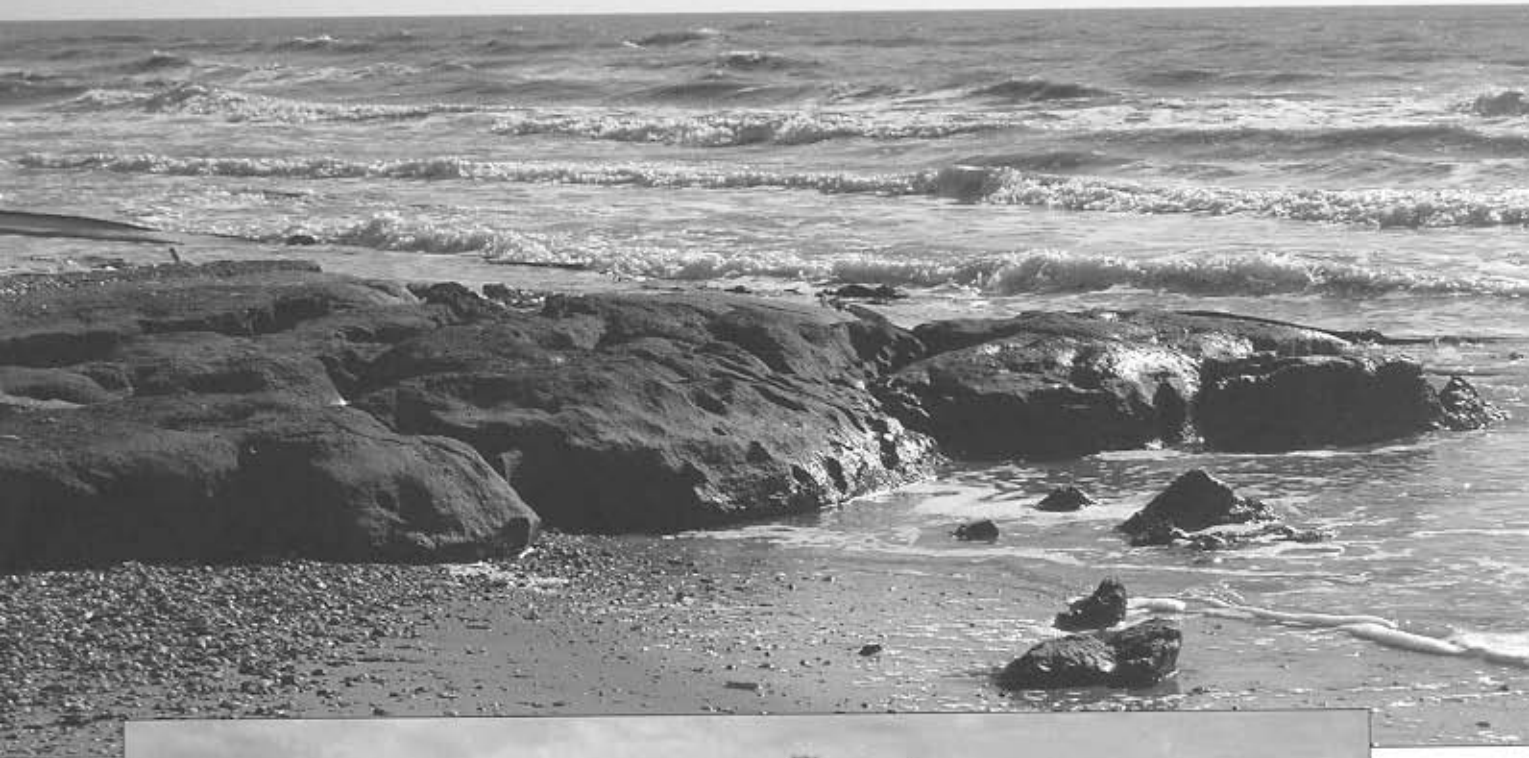
Figure 9 (top). Clay outcrop exposed on the beach front on the Bolivar Peninsula. The estimated 16-18 ft (4.8-5.5 m) storm surge and high waves severely eroded the beaches.

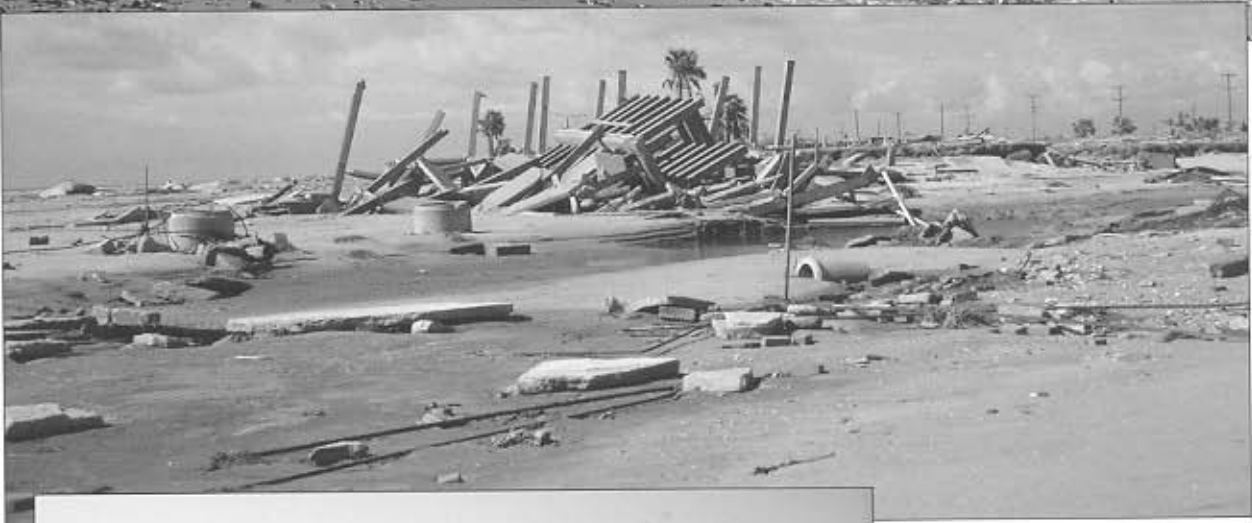
Figure 10 (above). Beach erosion and exposed septic tanks along with toppled pilings that once supported a house on the Bolivar Peninsula.

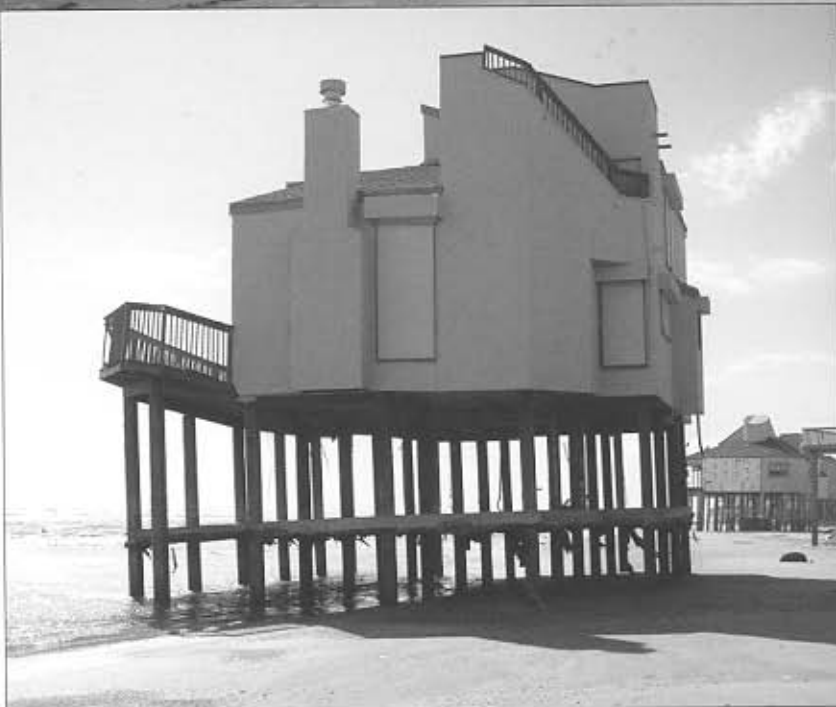
Figure 11 (left). Beachfront home on a Galveston beach west of the seawall. The foundation is now about 5 ft (1.5 m) above the beach, and the structure is currently in the surf zone.

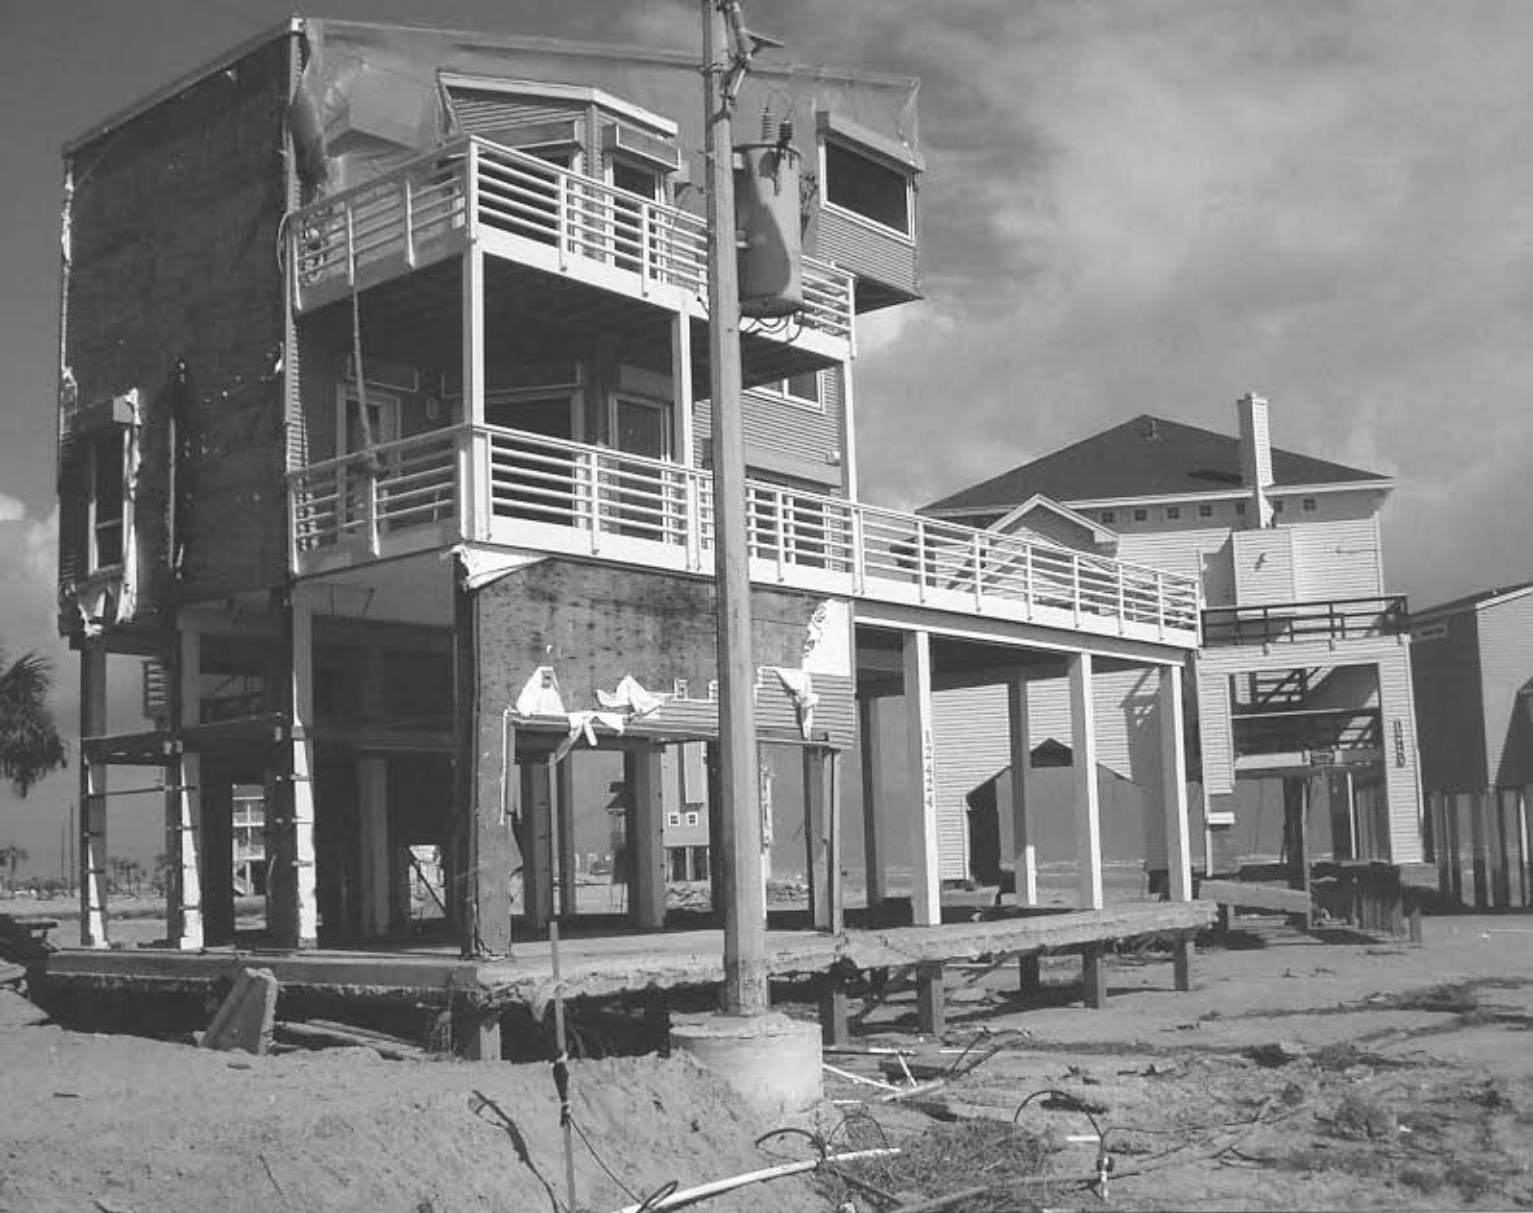
Figure 12 (above).  
Damage to houses  
along the beach west  
of Galveston seawall.  
After the storm, sand  
in left foreground  
of photograph was  
placed under an  
adjacent home.

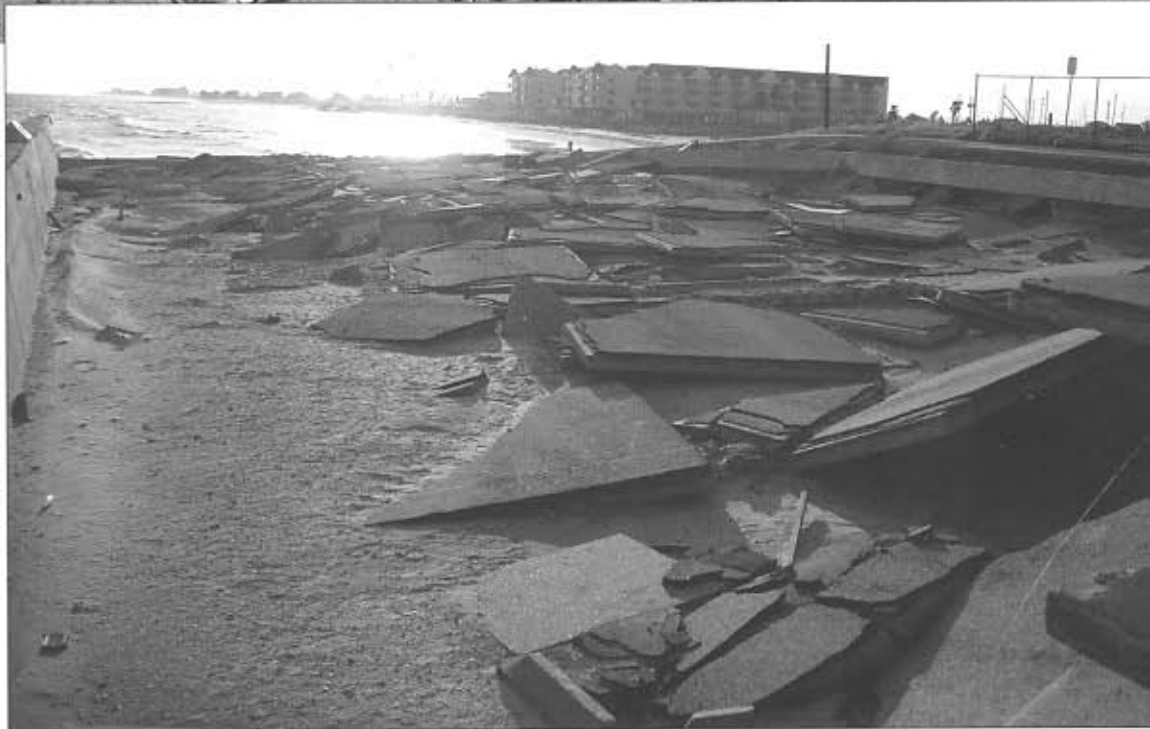
surge from the Gulf of Mexico. However, the massive waves and storm surge damaged several areas along the historic seawall. Hardest hit were the west end of the seawall, where the wall stood, but the sidewalks and road behind the wall collapsed from erosion (Figure 13). Rock groins extending gulfward from the wall, stairs, handrails, and down ramps were also damaged (Figure 14). In addition, several spots behind the face of the seawall collapsed, leaving sink holes and broken sidewalks.

Figure 13 (right).  
West end of Seawall  
Boulevard. Note that  
the wall is still intact  
(on left), the roadway  
and sidewalks  
collapsed due to  
erosion caused by  
storm surge.

The Galveston District has received Flood Control and Coastal Emergency (Public Law 84-99) funding for seawall rehabilitation. The entire seawall will be inspected by means of ground-penetrating radar. The repairs are scheduled to be completed by 1 July 2009 so the seawall will be fully repaired at the beginning of the next hurricane season.

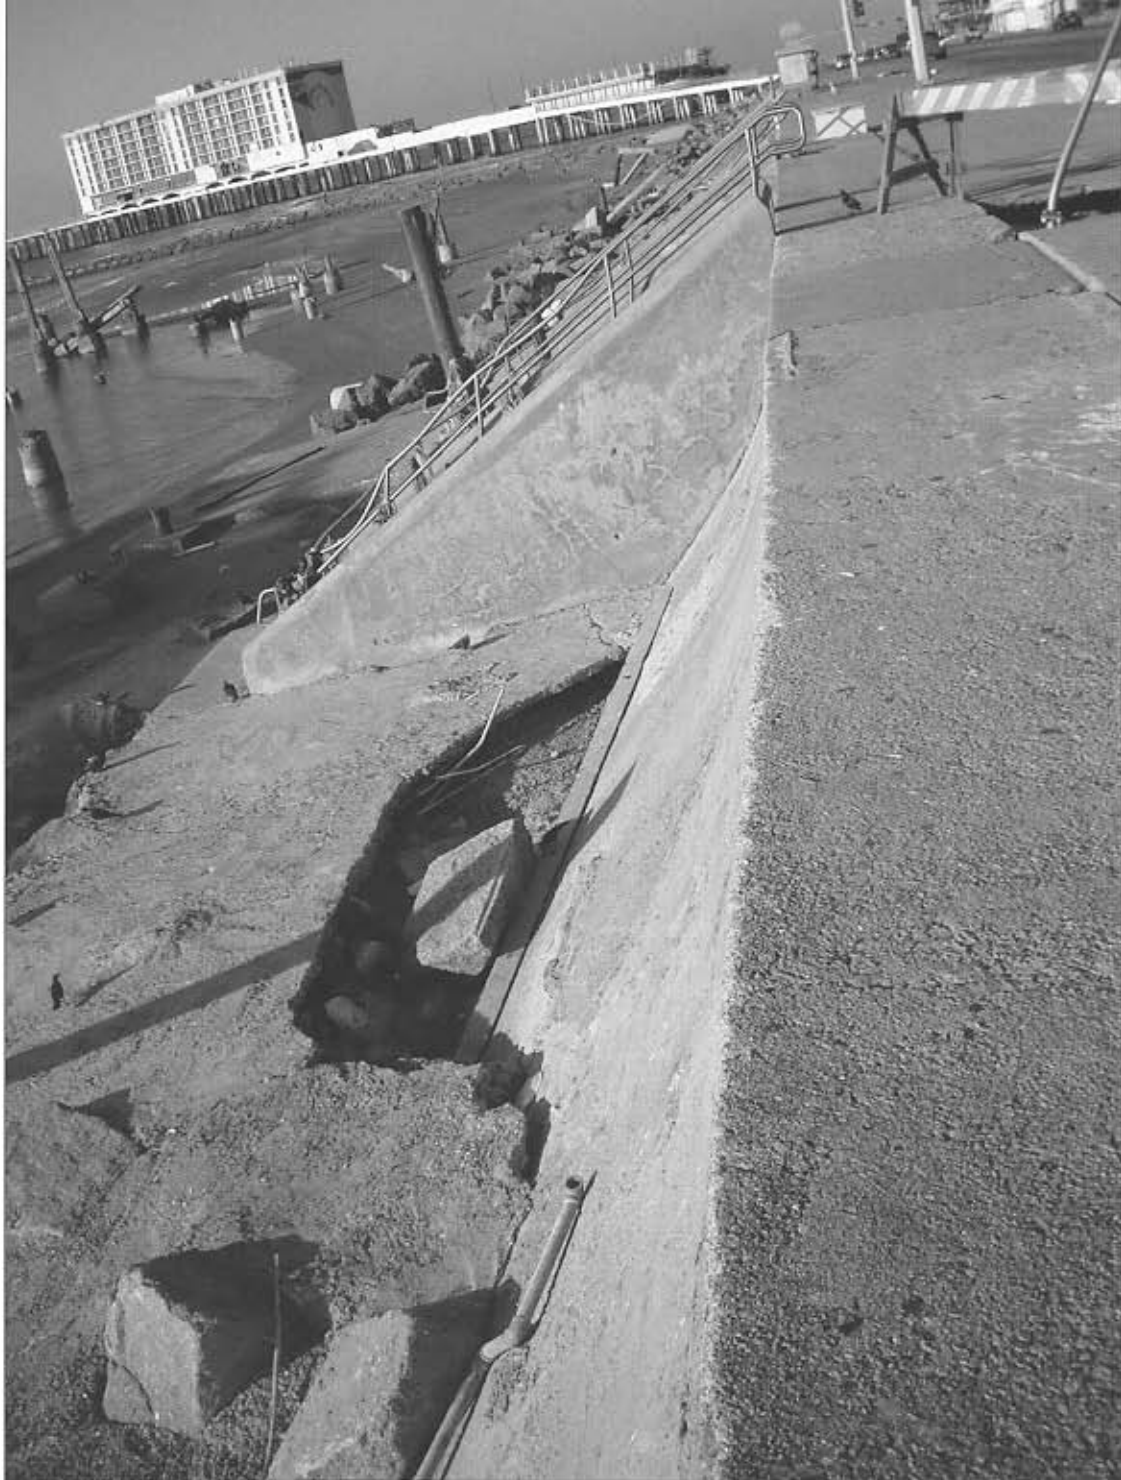
Figure 14 (left). Damage to Galveston's seawall; note the damage at the base of the wall, the stair rail and the sidewalk. The battered pilings in the foreground once supported a gift shop and a restaurant. Both were destroyed by the storm.

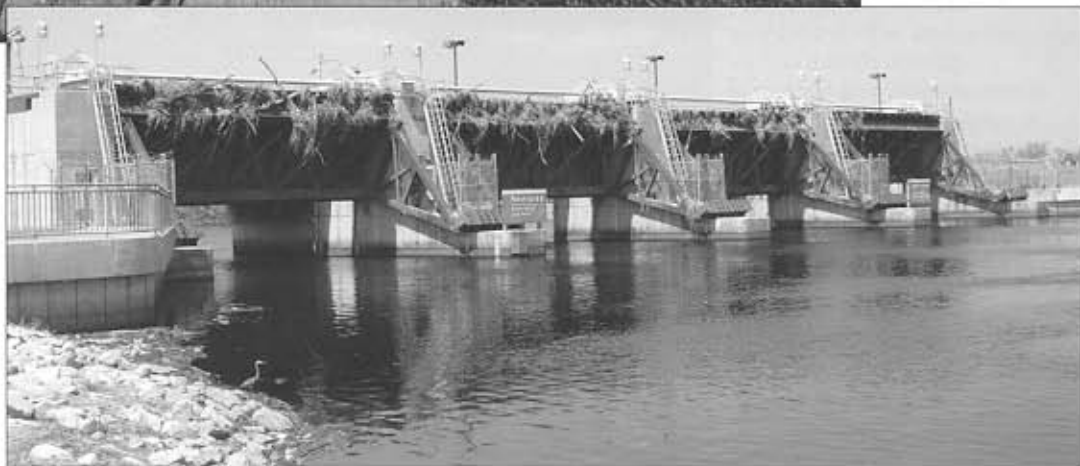
The Wallisville Lake Project, which serves as a salt water barrier on the Trinity River and protects freshwater intakes surrounding that of the city of Houston, sustained damage to the administrative buildings and other infrastructure including the dam, navigation lock and numerous recreational facilities from the 15.6-ft (4.8-m) storm surge. The surge carried with it 1,000 cubic yards (764 cubic meters) of debris, including an estimated 1,000 refrigerators, freezers and television sets; hazardous material containers including propane tanks; numerous 55 gallon (208 liter) drums; cans of paint; gas cans; tires, about 100 navigation buoys of various sizes; roofing materials; furniture; plastics; and organic debris, such as logs and marsh vegetation (Figure 15). Much of this debris came from the homes and businesses destroyed on the Bolivar Peninsula 20 miles (32 km) away. About the only structure that did not sustain extensive damage was the administration building. Due to the rapid response of the staff, the building was reoccupied on Monday, 15 September 2008, using generator power, just two days after Ike's landfall. Restoration and the removal of debris began within the next few days, and as of December 2008 still continued.

Figure 15 (right). Debris in dam at the Wallisville Lake Project.

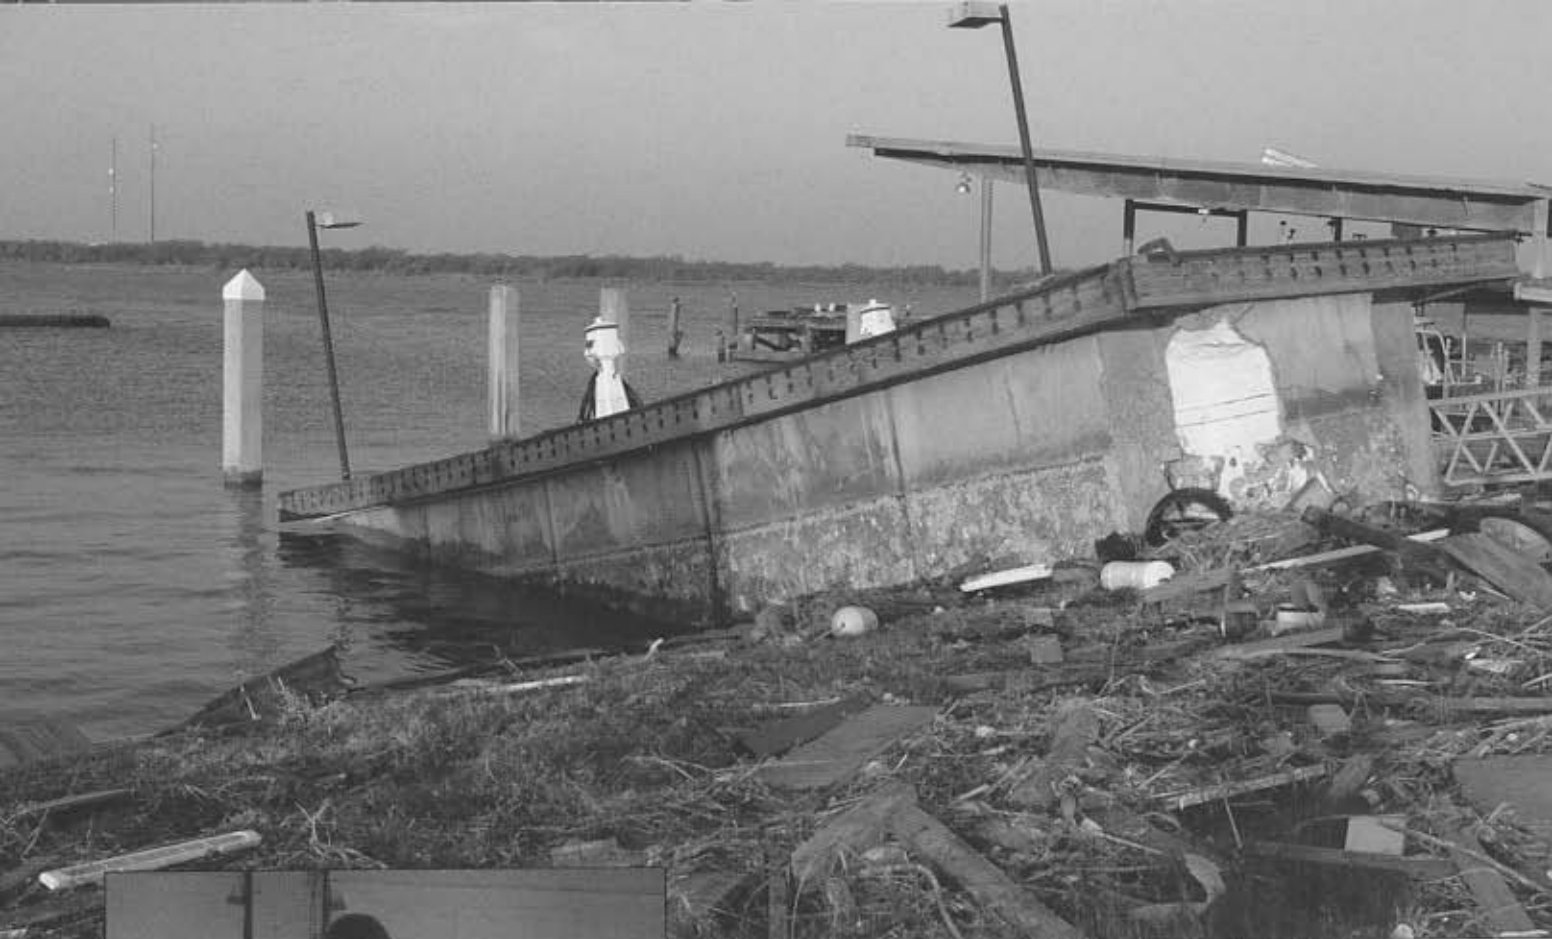
Figure 16 (above). Damage and debris at Galveston District Headquarters boat dock facility.

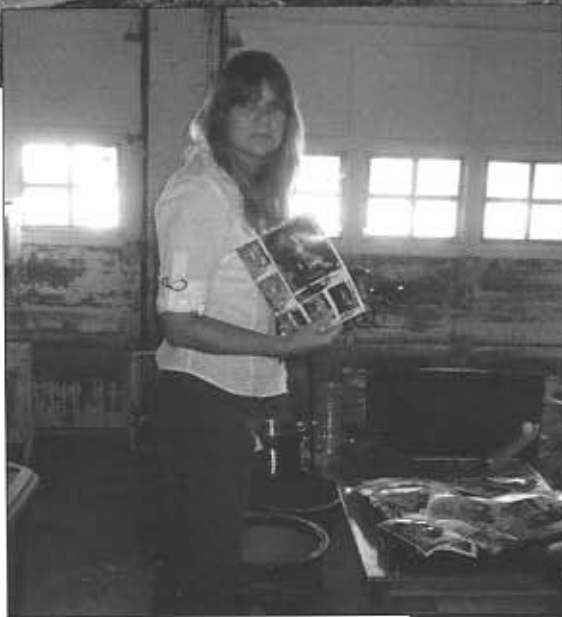
Figure 17 (left). Loretta Buddenhagen, a program analyst in the Programs Management Division, sorts through a few saved memories in the garage of her home. Four ft (1.2 m) of water inundated Buddenhagen's home and garage. Note the water line on the garage doors in the background.

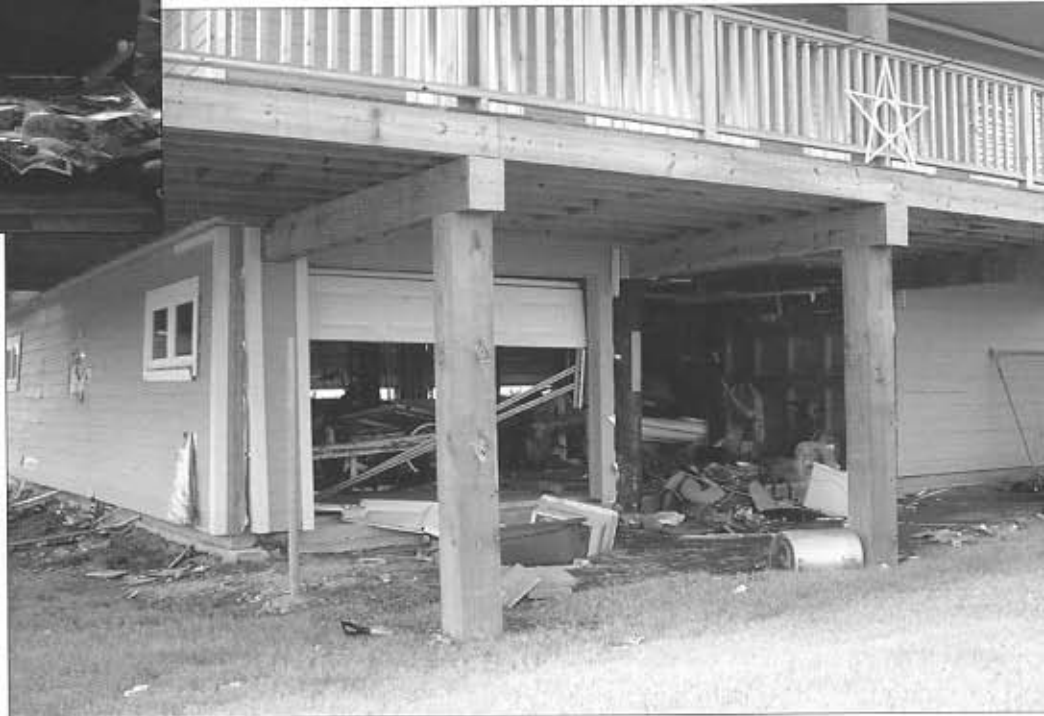
Figure 18 (right). Employee's elevated home with breakaway garage ripped out by Hurricane Ike. The house, in a neighborhood behind the protection of the seawall, is located on the water on the bay side of the Island. The water line almost reached the top of the window on the left side of the house.
