ATTACHMENT D-6  
HISTORIC RESOURCES SURVEY REPORT

NON-ARCHEOLOGICAL HISTORIC  
RESOURCES SURVEY REPORT  
Gulf Intracoastal Waterway, Brazos River  
Floodgates and Colorado River Locks  
Feasibility Study  
Brazoria and Matagorda Counties, Texas

NOVEMBER 2018

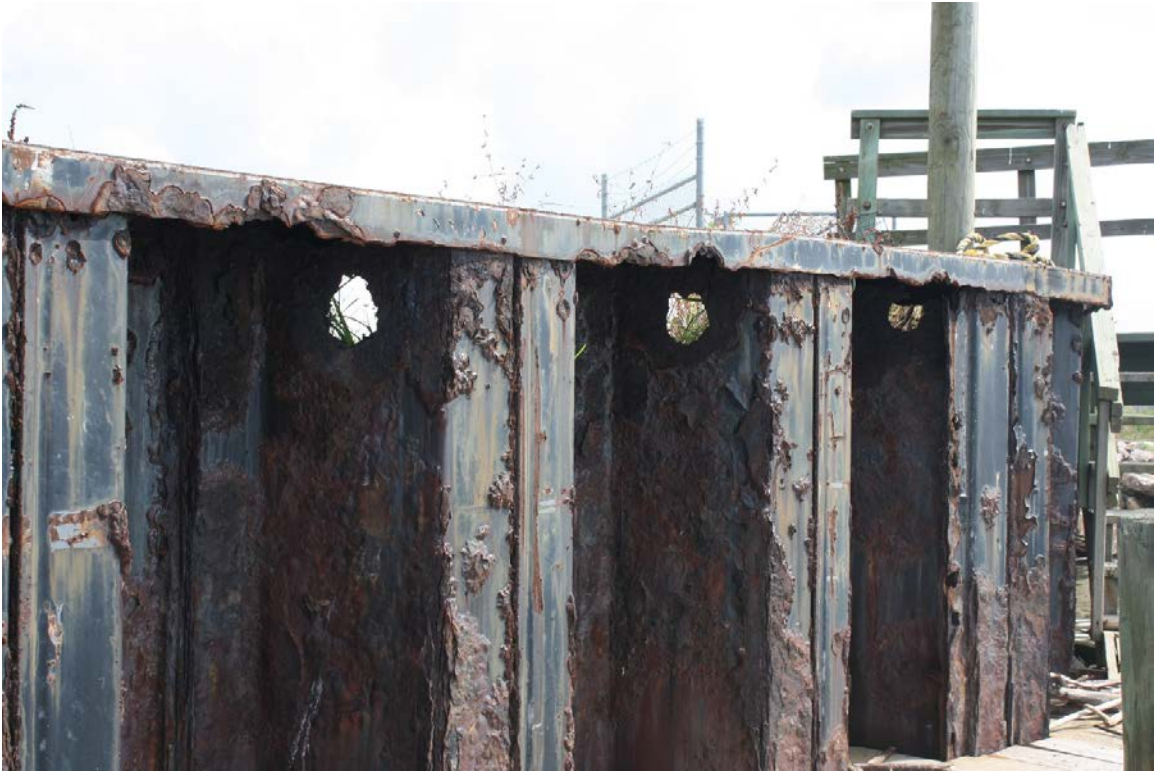
Resource No. 1A

Representative view of section loss, pack rust, and corrosion in steel section of guide wall, facing north

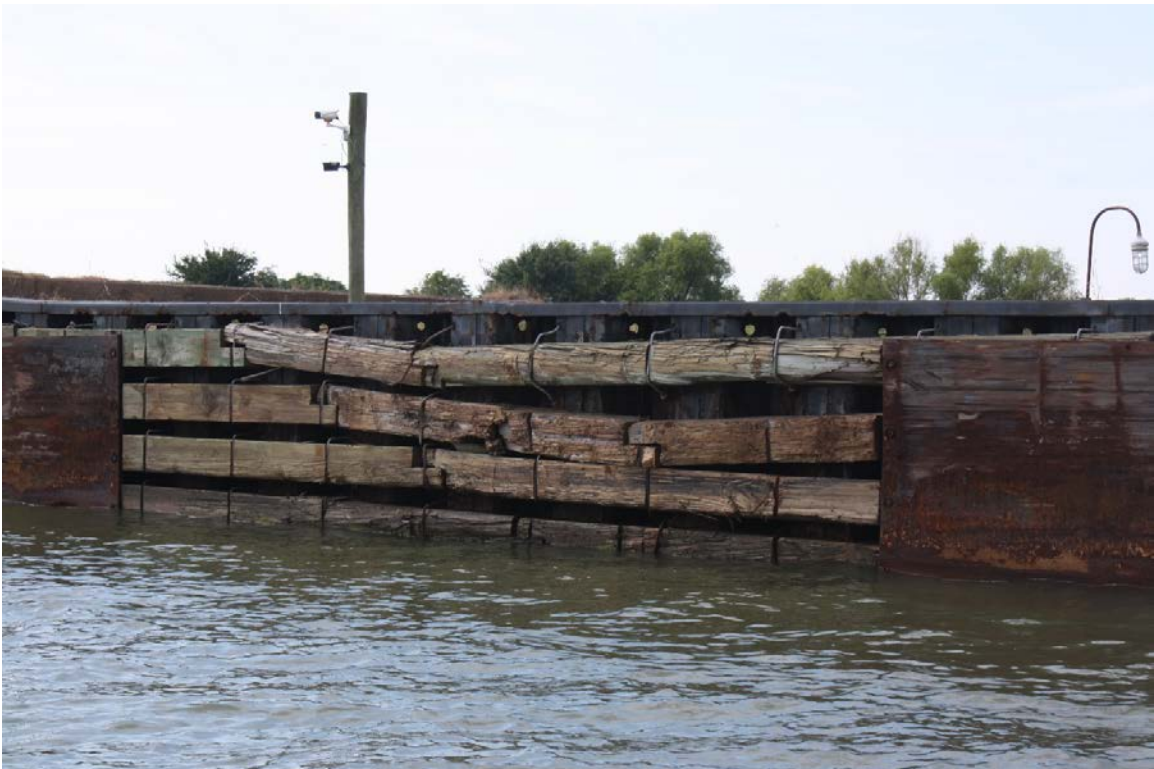
Representative view of damage to timber fenders, facing north

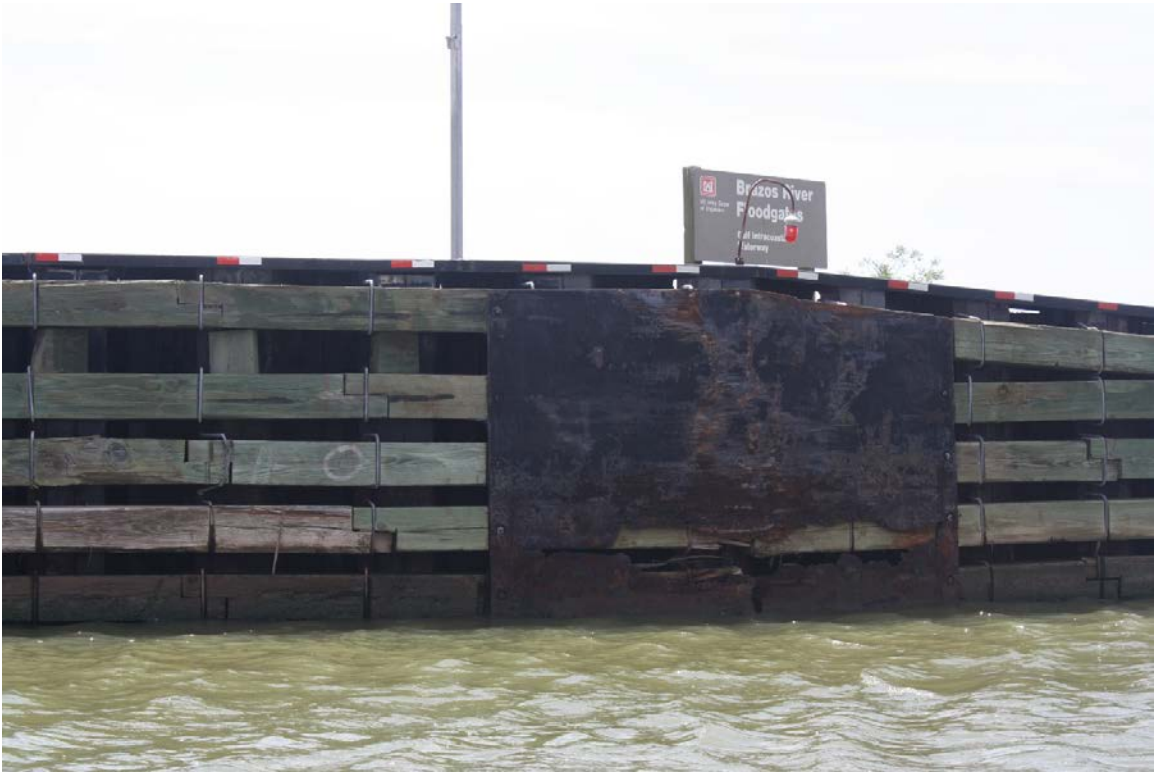
Resource No. 1B

Representative view of section loss and impact damage to steel sheets, facing east

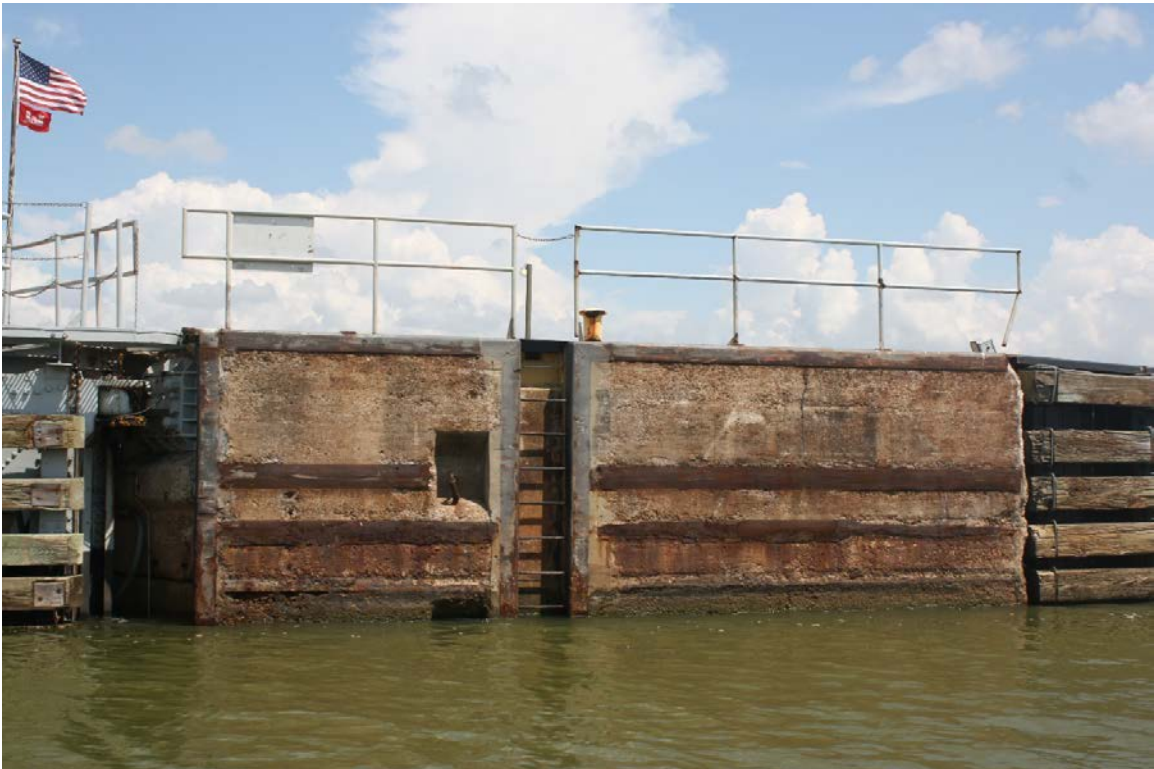
Representative view of cracked and spalling concrete, facing north

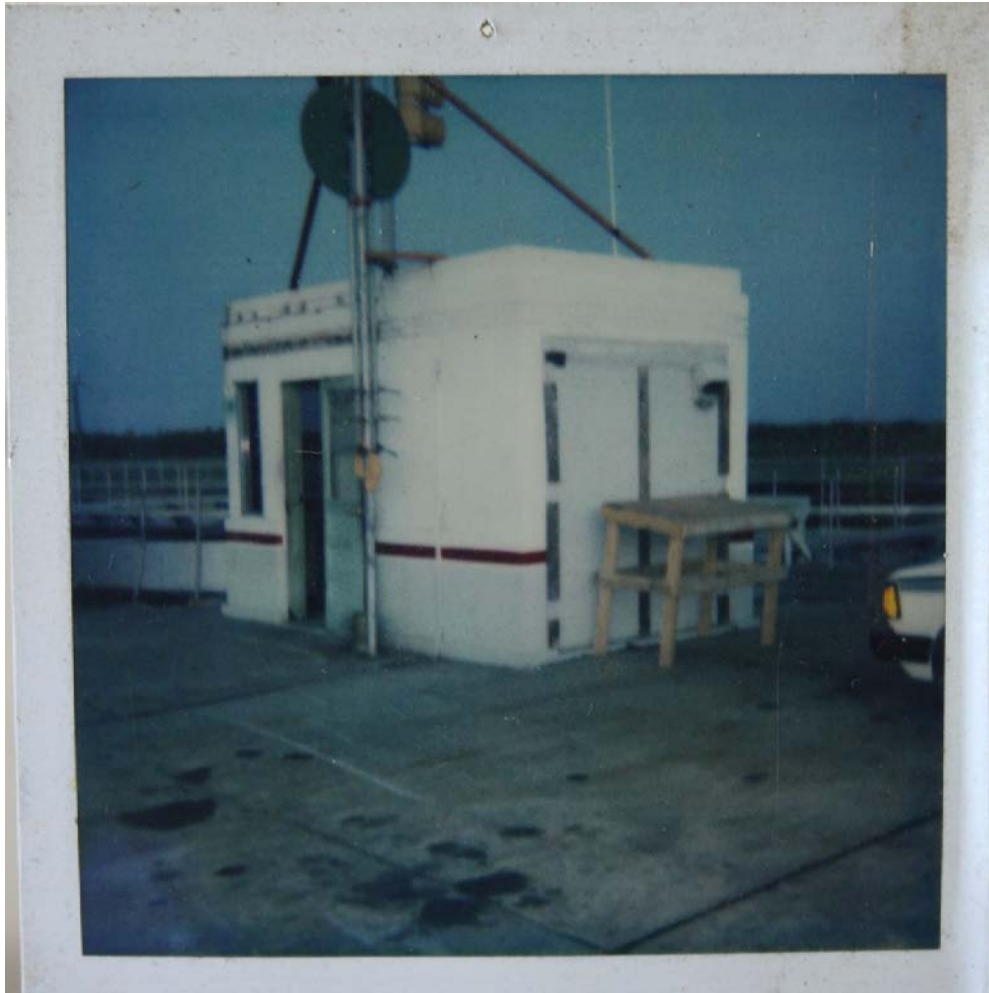
Resource No. 2

Photo dated to the 1970s showing the original size and Moderne detailing of the west control house. The multi-light windows have been replaced. Image courtesy USACE.

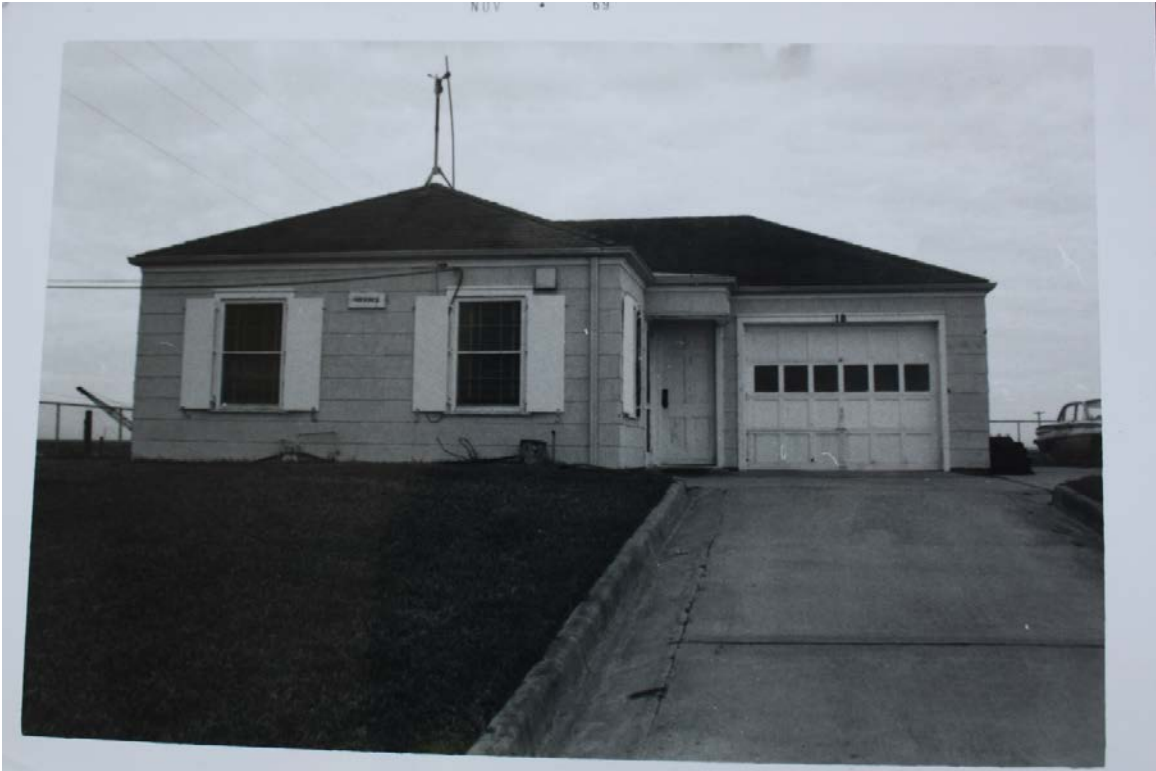
Resource No. 7

Photo dated 1969 showing front (south) elevation of office, facing northwest. Garage access door has since been infilled. Image courtesy of USACE.

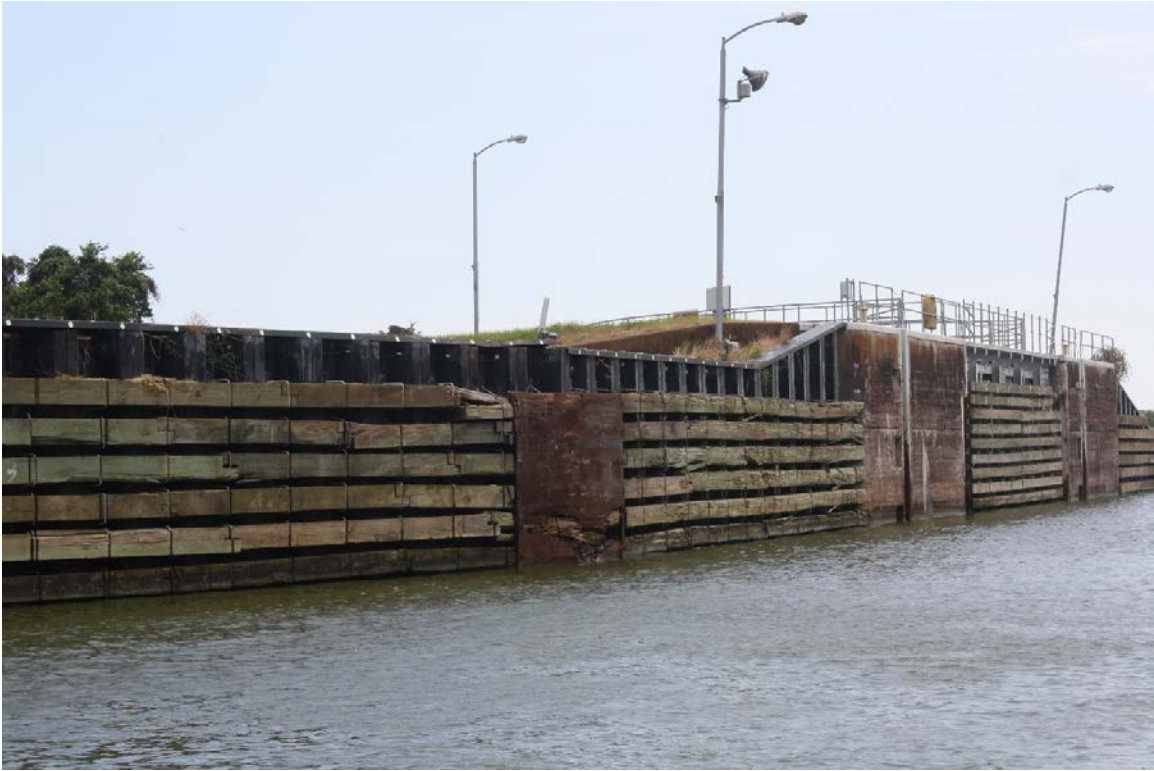
Resource No. 10A

Representative photo of damage to timber fenders and steel sheets, facing south

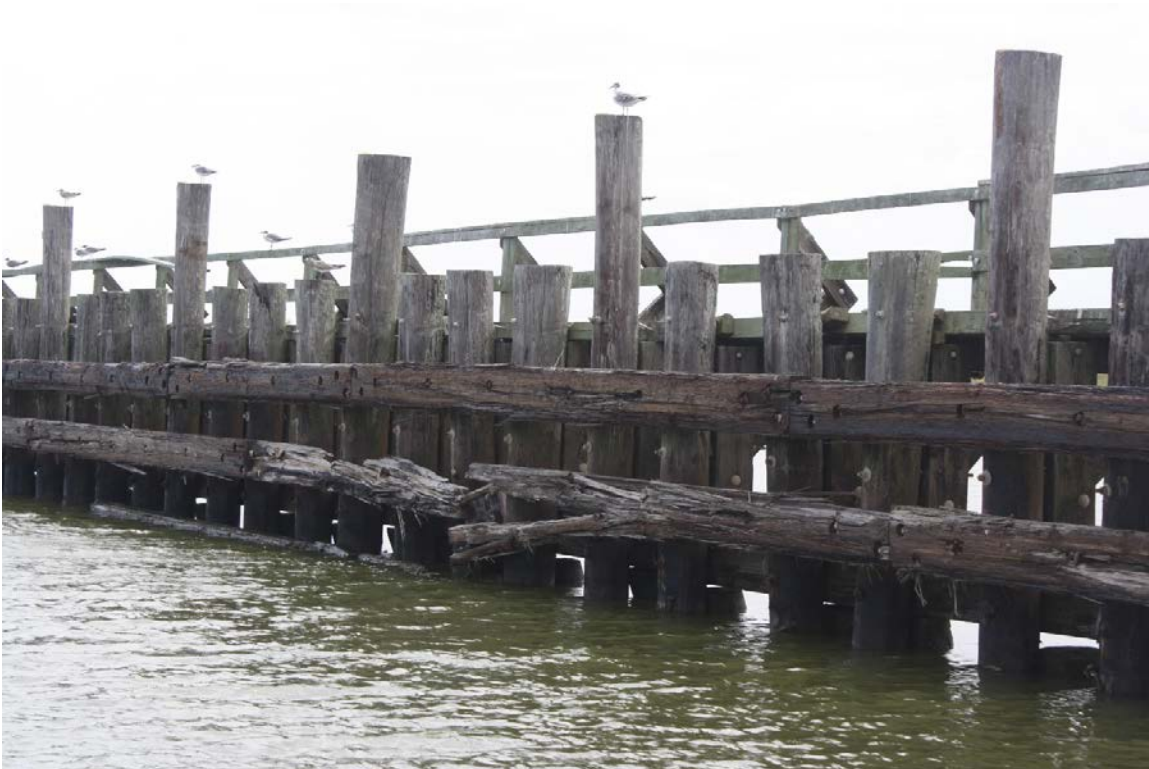
Representative photo showing damage to lock chamber timber guide wall, facing northwest

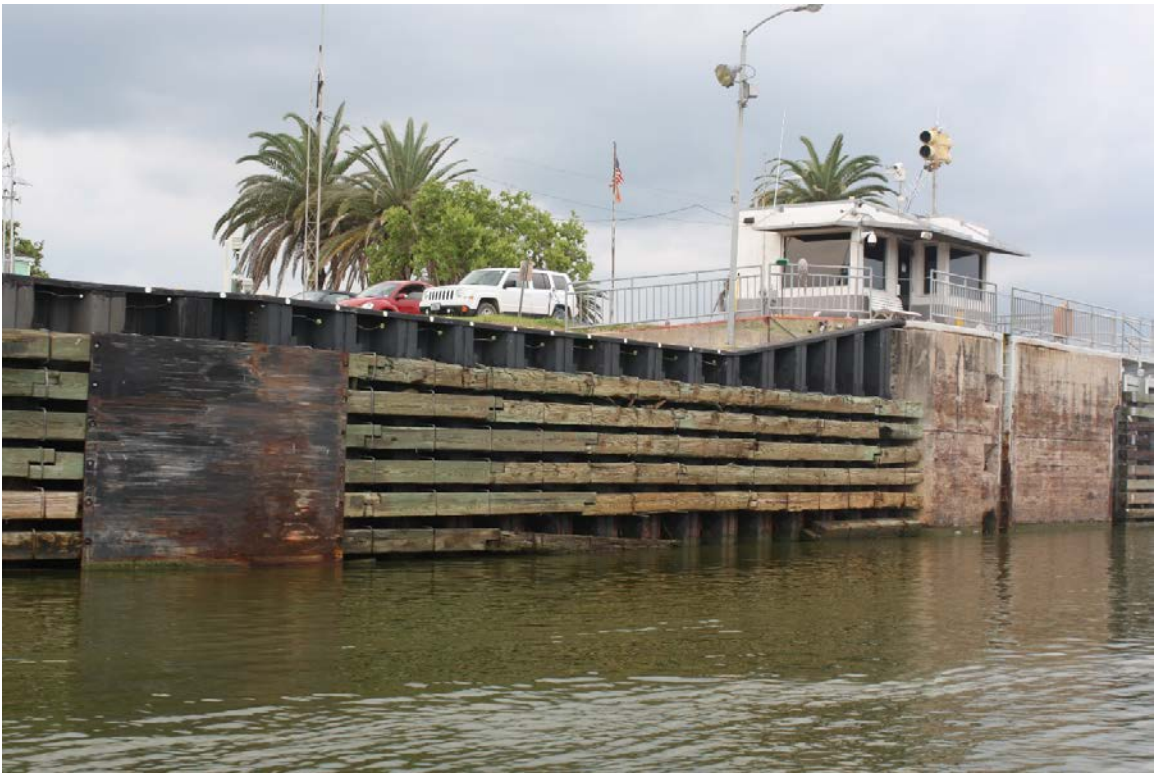
Representative view of damage to timber guide walls, facing west

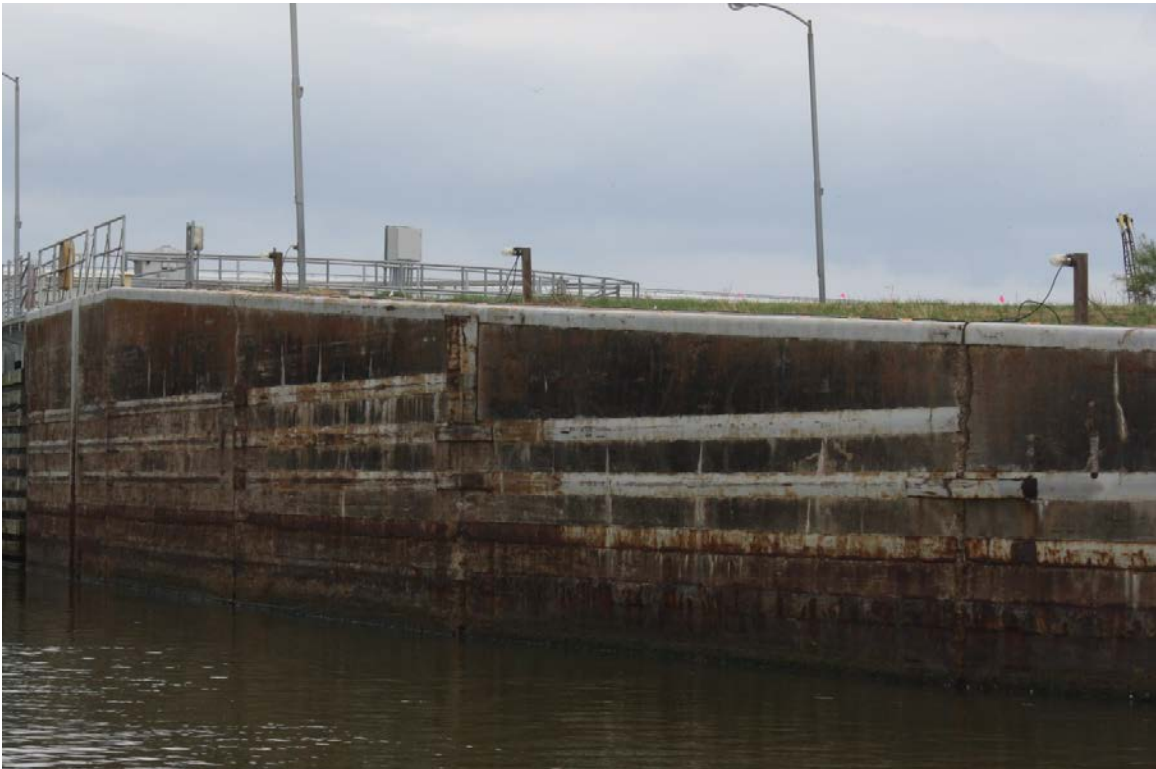
Representative view of cracking concrete and steel corrosion, facing east
