SUBMERGED AQUATIC VEGETATION SURVEY
(Original Survey Conducted by Hanson Inc. March 2018)

1.368± ACRE PARADISE FISHING PIER MARINE TRACT
13317 SOUTH PADRE ISLAND DRIVE
CORPUS CHRISTI, NUECES COUNTY, TEXAS

SWG-2003-01790

November 22, 2021

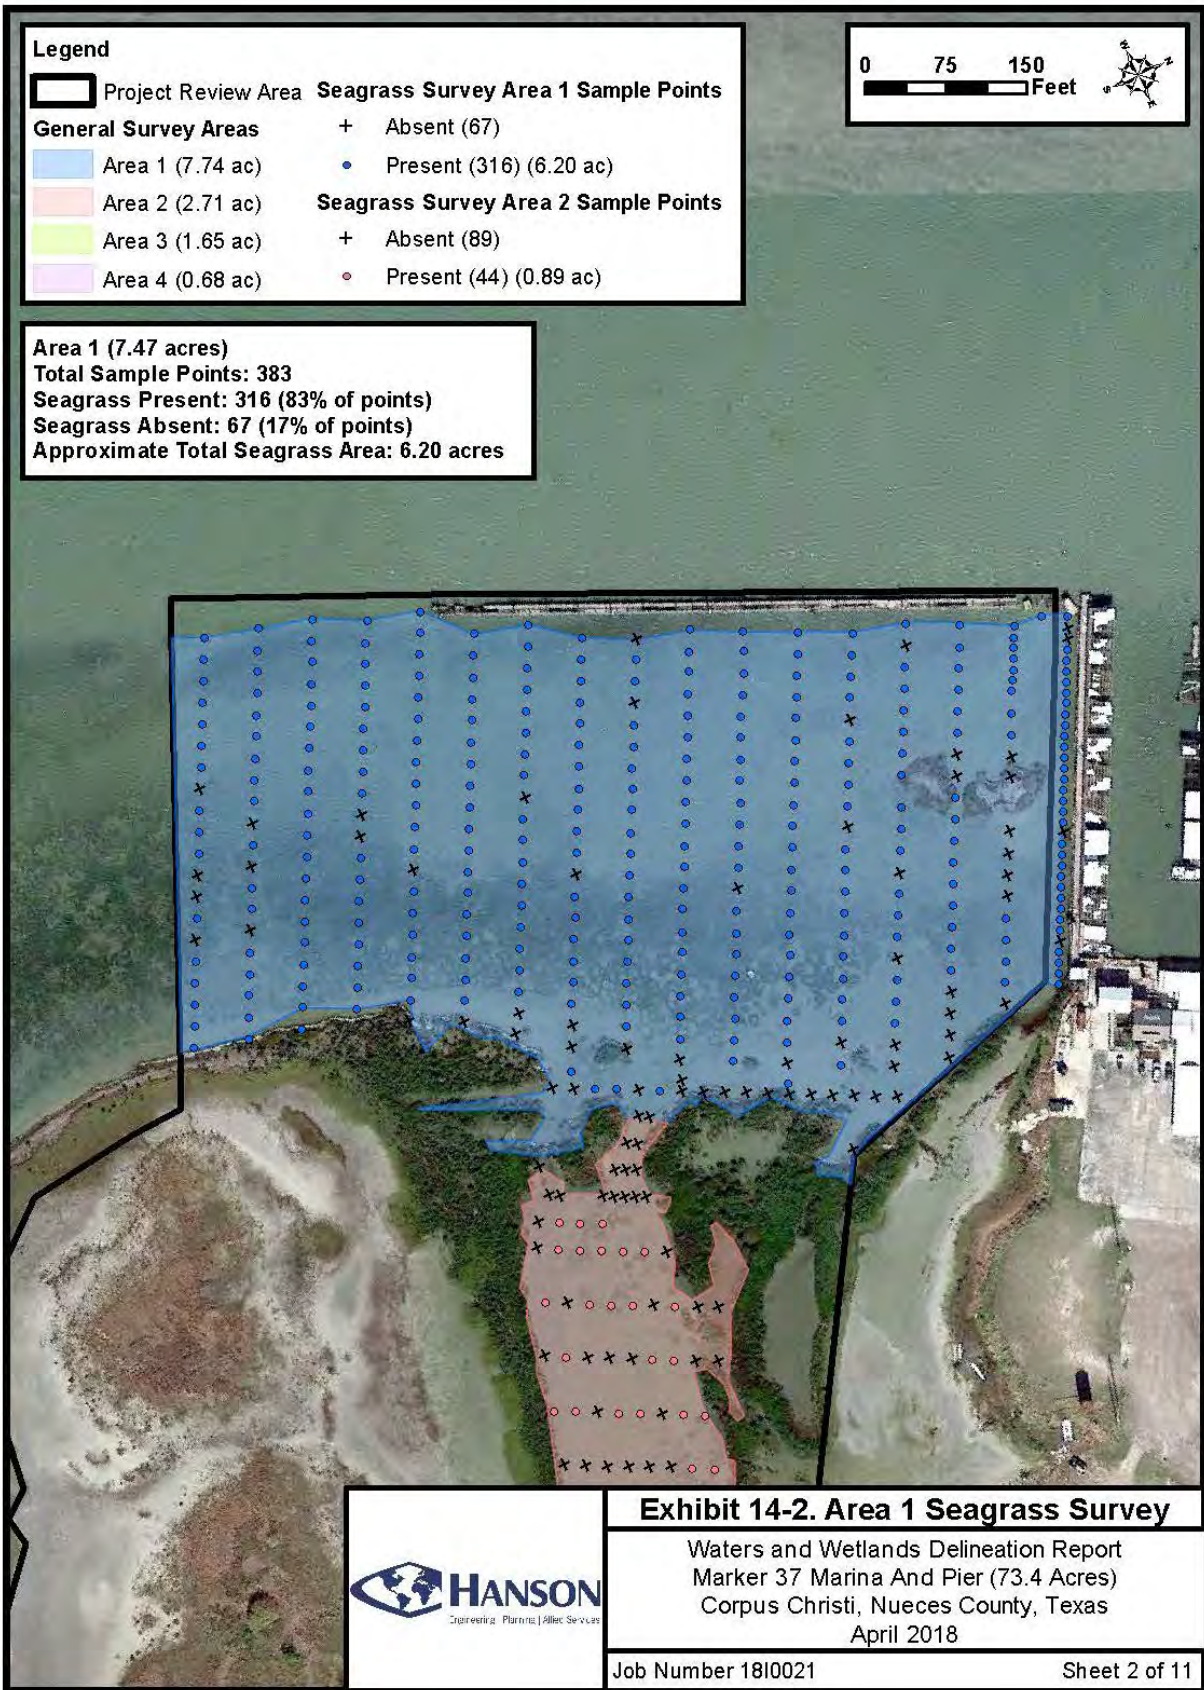
Appendix A
Original Hanson Seagrass
Survey Map
2018

Hanson's original survey, in March 2018, covered a total of 629 sample points within a 73.4 acres project area. However, when we look at only the 66 samples taken within the $1.368 \pm$ acre review area (Appendix B), there were a total of 61 locations present with seagrass and 5 locations absent. This tells us that 1.264 acres (92.4%) of seagrass meadows were present, while 0.104 acres (7.6%) were lacking in seagrass presence. At the time of the original survey, predominantly shoalgrass (*Halodule*

It is also worth noting that in Hanson's 2018 survey there were a total of five sample locations that were absent of seagrass. Of those five, two (1-2 and 1-3) are still absent of seagrass while three (4-24, 9-42, and 9-45) are now showing a presence of seagrass. In addition, Hanson only noted only observing shoalgrass (*Halodule wrightii*) and manatee grass (*Syringodium filiforme*), while CEI did note a small presence of peanut grass (*Halophilla engelmanni*) as well as a presence of drift algae and oyster shell hash throughout the project area.

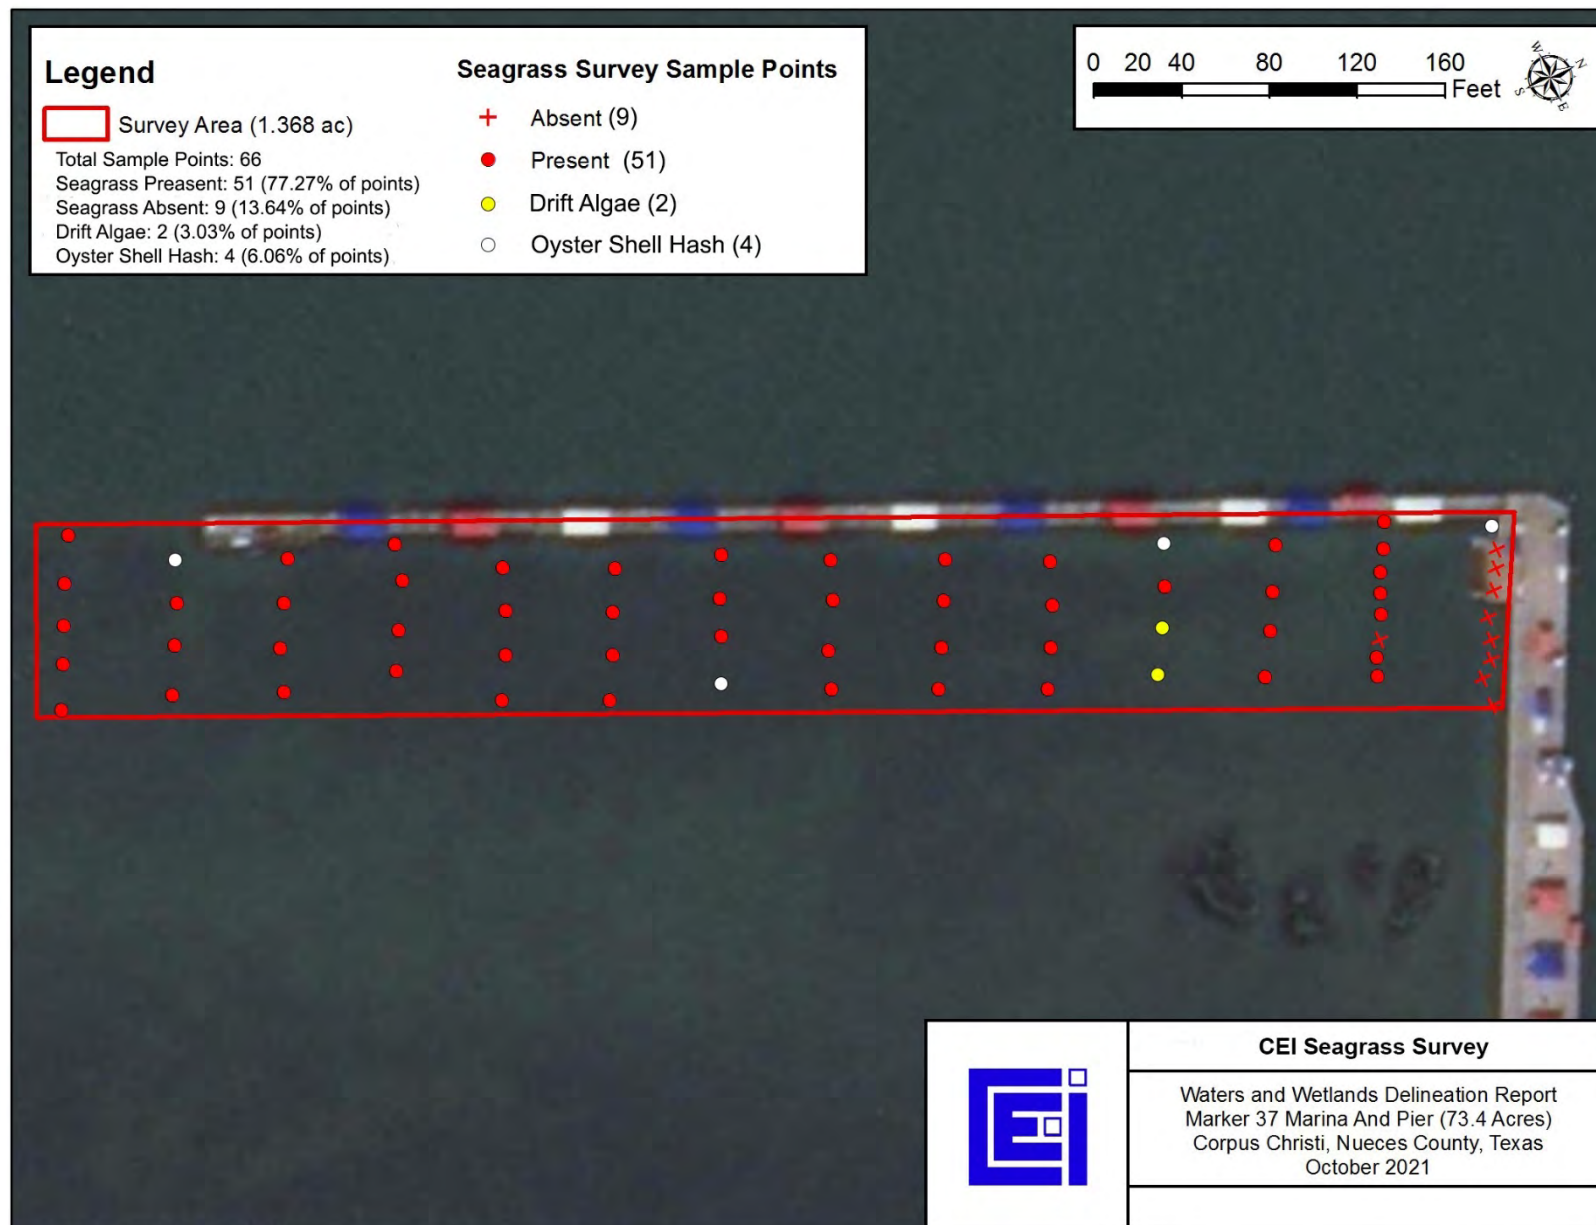
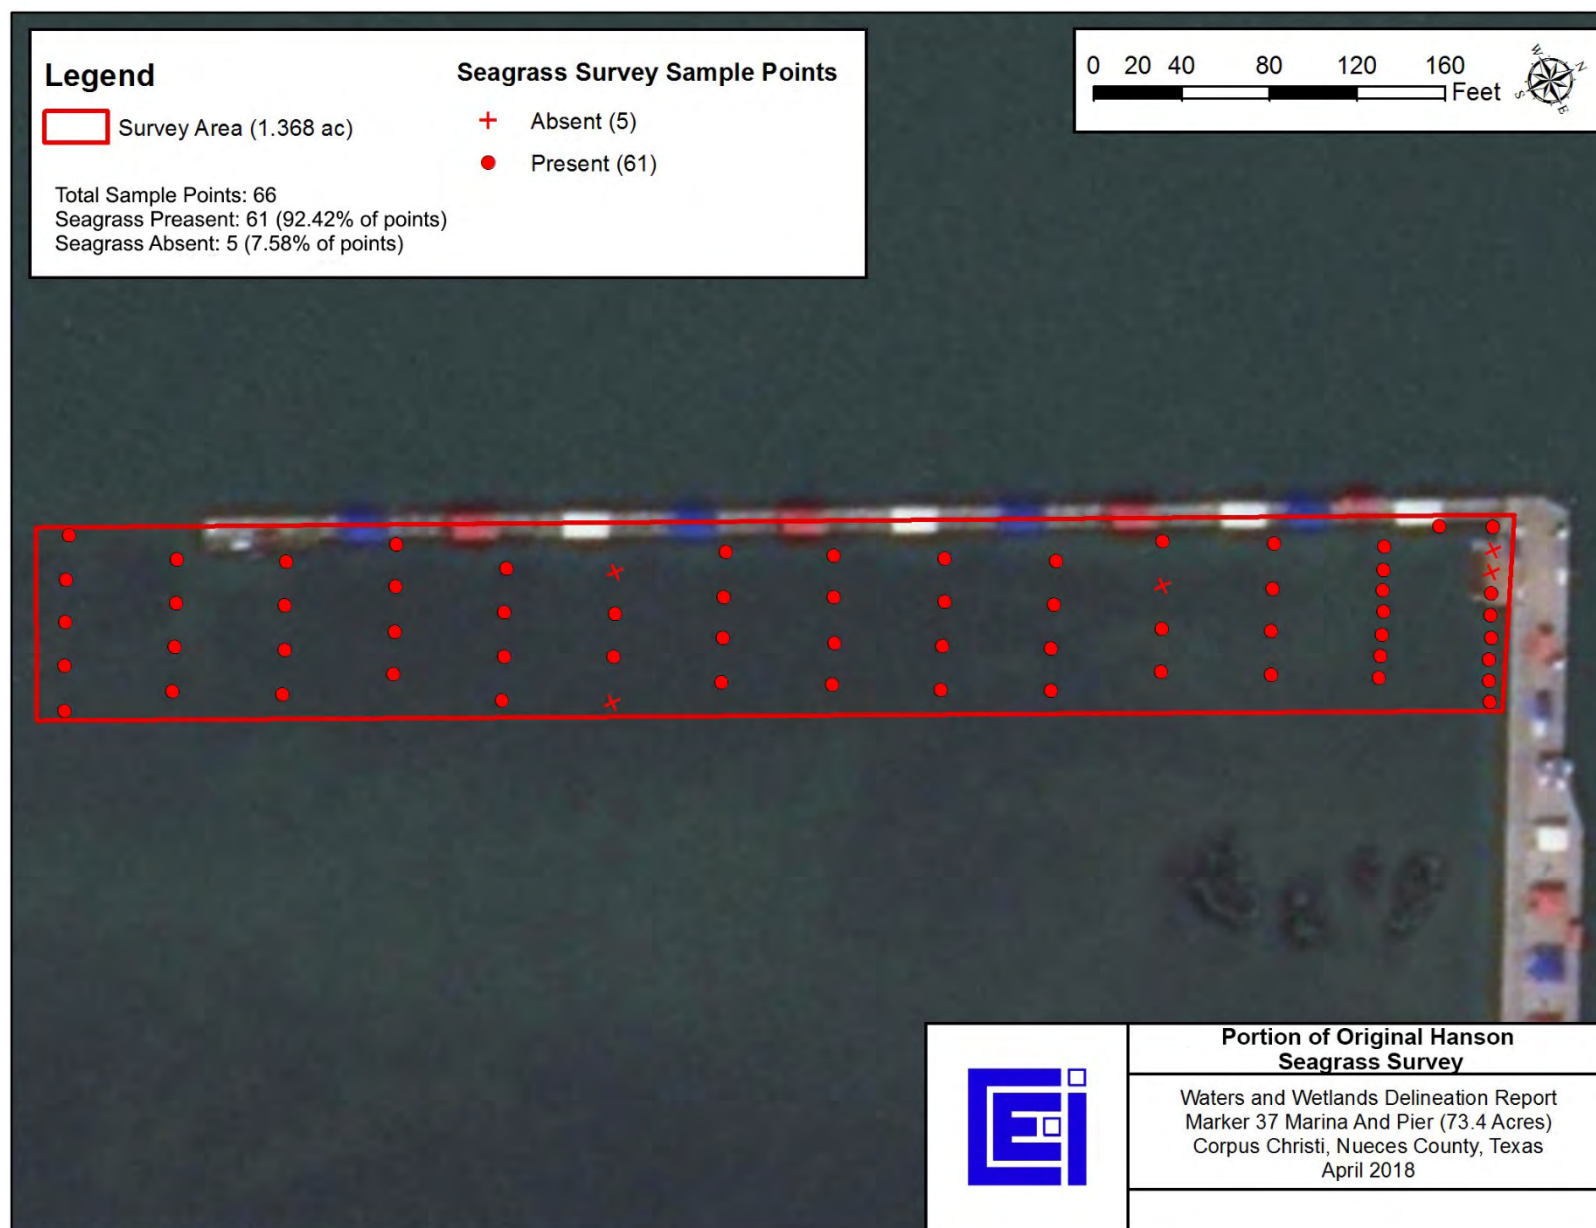
CEI – Hanson Survey Comparison Maps

CEI took a total of 66 sample points throughout the $1.368 \pm$ acre review area (Appendix C). Of that, there were 51 sample locations with seagrass present and 9 locations absent of seagrass. Interestingly, there were a total of 6 sample points that contained drift algae (2) and oyster shell hash (4) rather than seagrass. CEI found that seagrass meadows make up for 1.057 acres, or 77.27%, of the project review area, while 0.187 acres, or 13.64%, are lacking seagrass presence. Sample locations with drift algae and no seagrass make up for 0.041 acres or 3.03%, and oyster shell hash sample locations without seagrass make up for 0.083 acres, or 6.06%, instead of seagrass. See Table 1 for a detailed log of sample data.

In comparison, CEI's 2021 survey shows a 6.06% increase in the absence of seagrass, or 0.0829 acres loss in seagrass presence since Hanson's original survey in 2018. Most of the loss seems to be occurring along the northern corner of the pier running just southwest of and along the boardwalk, adjacent to the merge of the marina to the intercoastal waterway. Here there are an additional six locations (1-4 to 1-9) showing seagrass absence since 2018 and one location (1-1) where oyster shell hash has replaced the seagrass. There is one sample location (2-12) that is within 50-80ft southwest of the pier that was absent of seagrass and an additional four locations where seagrass was replaced by either drift algae (4-22 and 4-23) or oyster shell hash (4-25 and 8-38). In addition, there is one location (13-61) at the far end of the pier which contains oyster shell hash instead of seagrass.

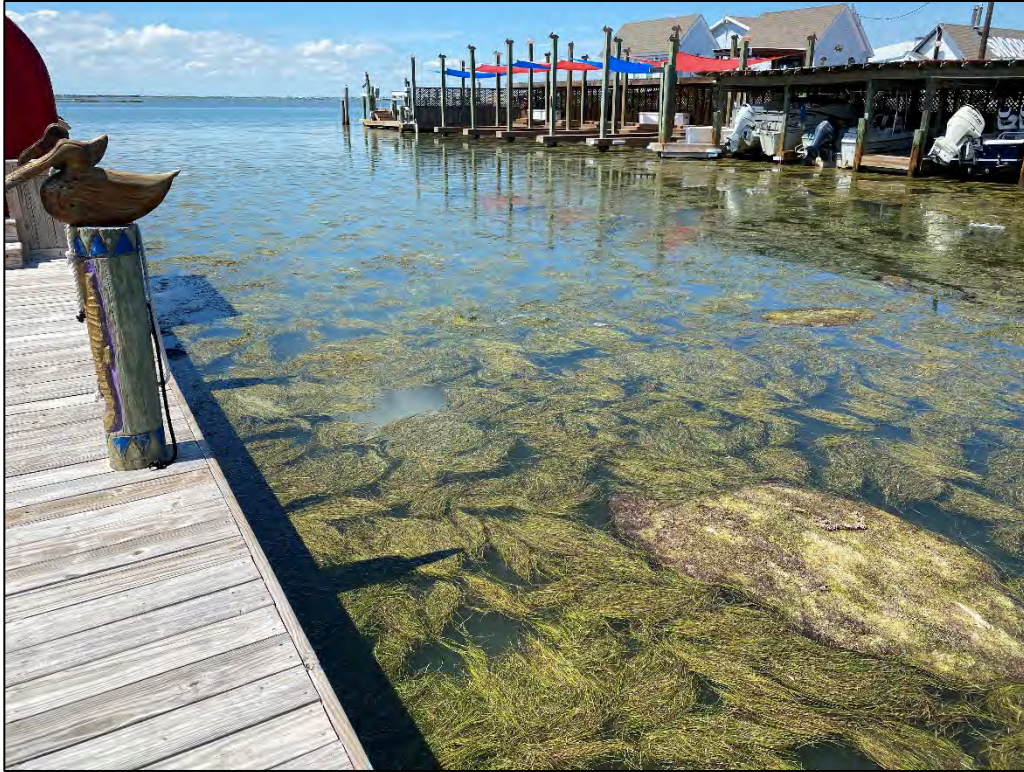
Figure 1. View of the Marker 37 Marina after Hurricane Nicholas passed through the Gulf of Mexico. Note the seagrass floating atop the surface due to being pulled up from hurricane turbulence, looking to the northwest (CEI: 9/15/2021).

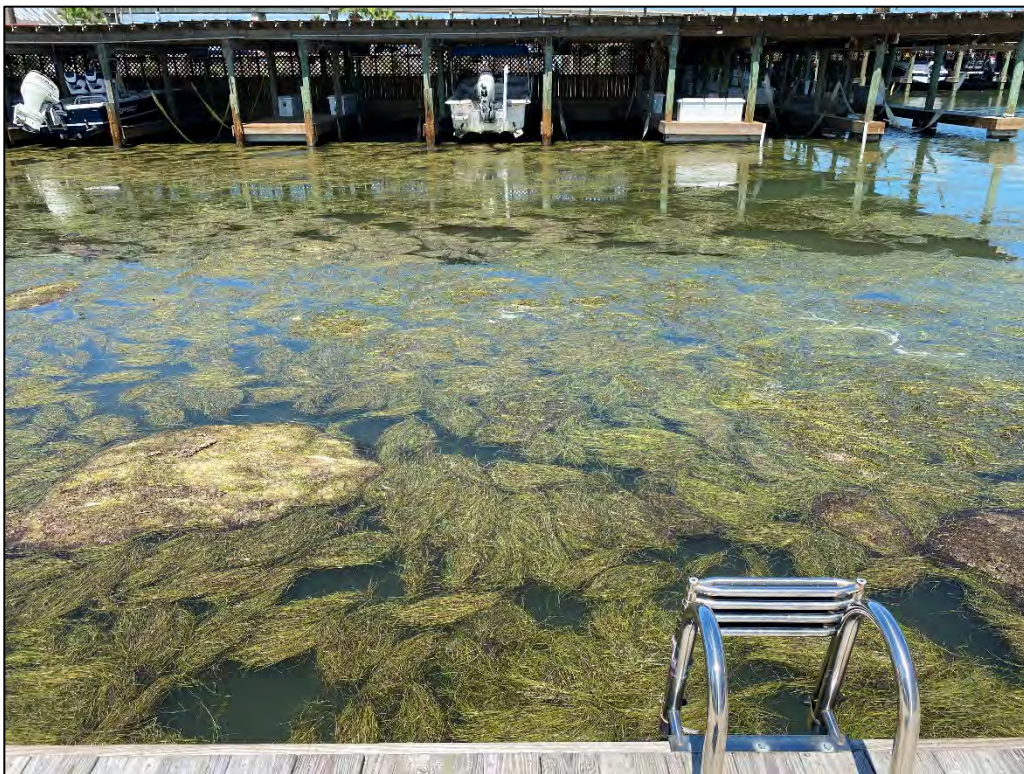
Figure 2. View of the Marker 37 Marina after Hurricane Nicholas passed through the Gulf of Mexico. Note the seagrass floating atop the surface due to being pulled up from hurricane turbulence, looking to the north (CEI: 9/15/2021).

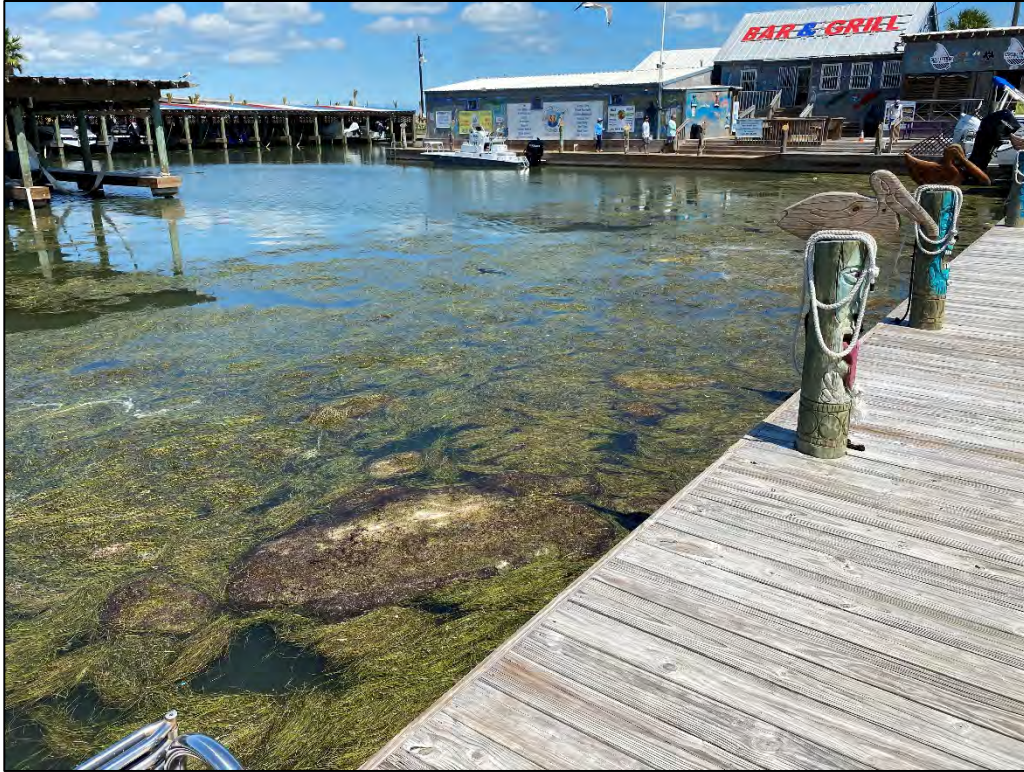
Figure 3. View of the Marker 37 Marina after Hurricane Nicholas passed through the Gulf of Mexico. Note the seagrass floating atop the surface due to being pulled up from hurricane turbulence, looking to the northeast (CEI: 9/15/2021).

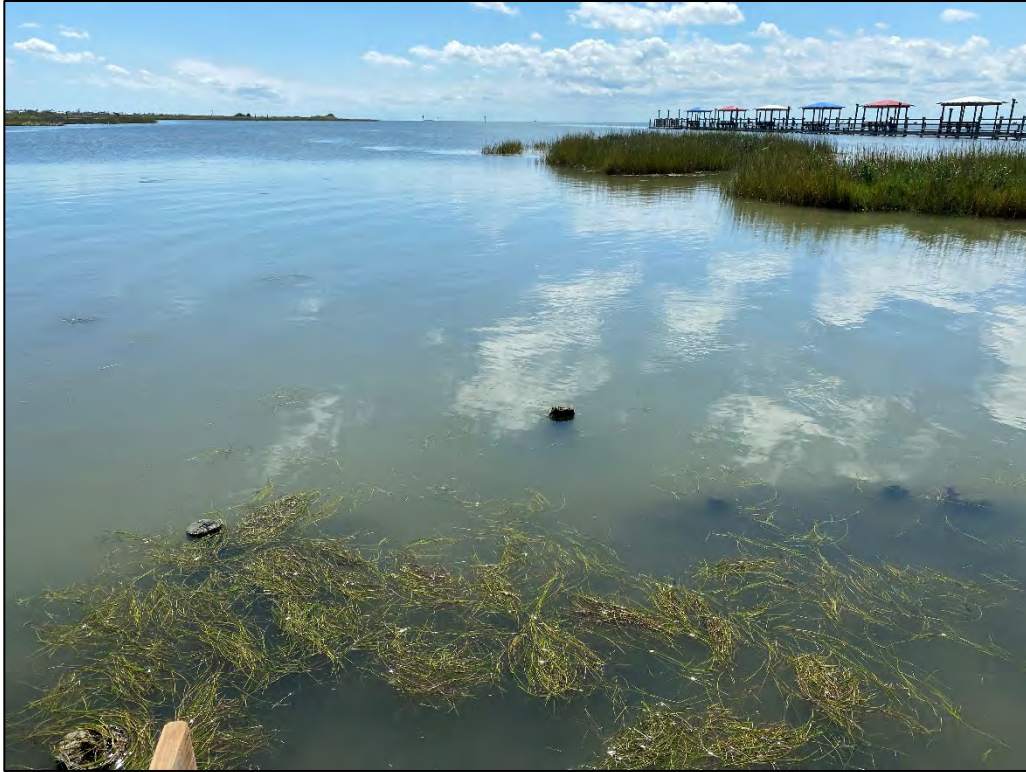
Figure 5. View of the Paradise Pier and project area from atop the Sunset Boardwalk, looking to the southwest. Note the seagrass floating at the surface, as well as oyster and seagrass beds subsurface (CEI: 9/15/2021).

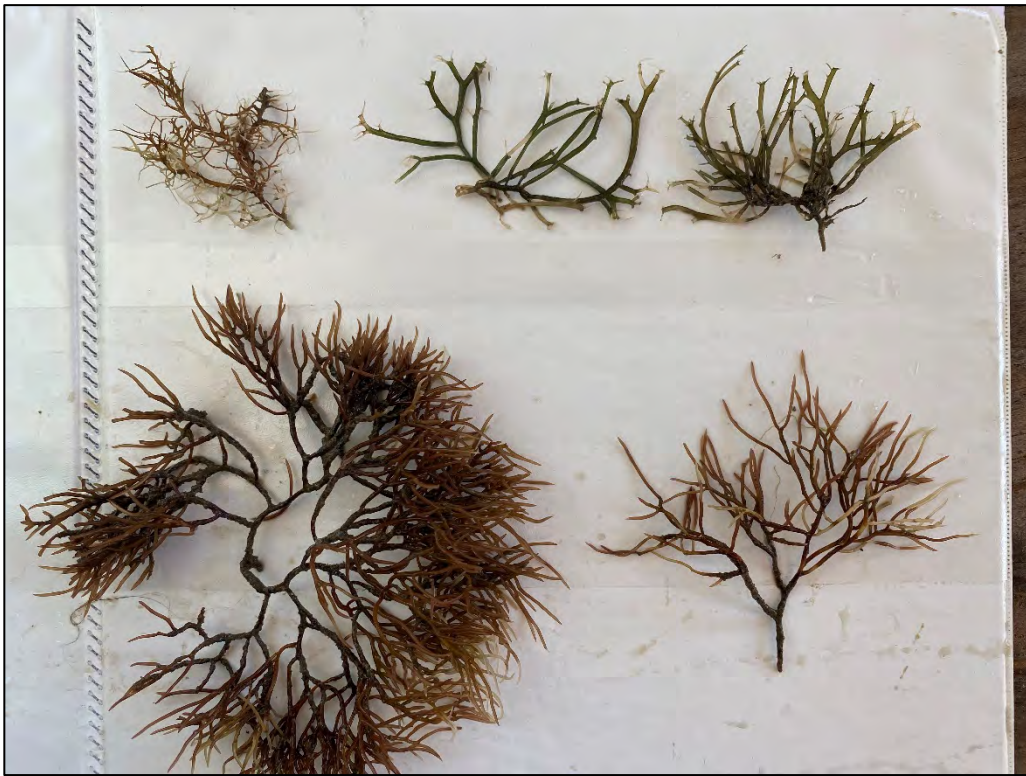
Figure 12. Representative sample of various species of drift algae found within the project area (CEI: 9/15/2021).

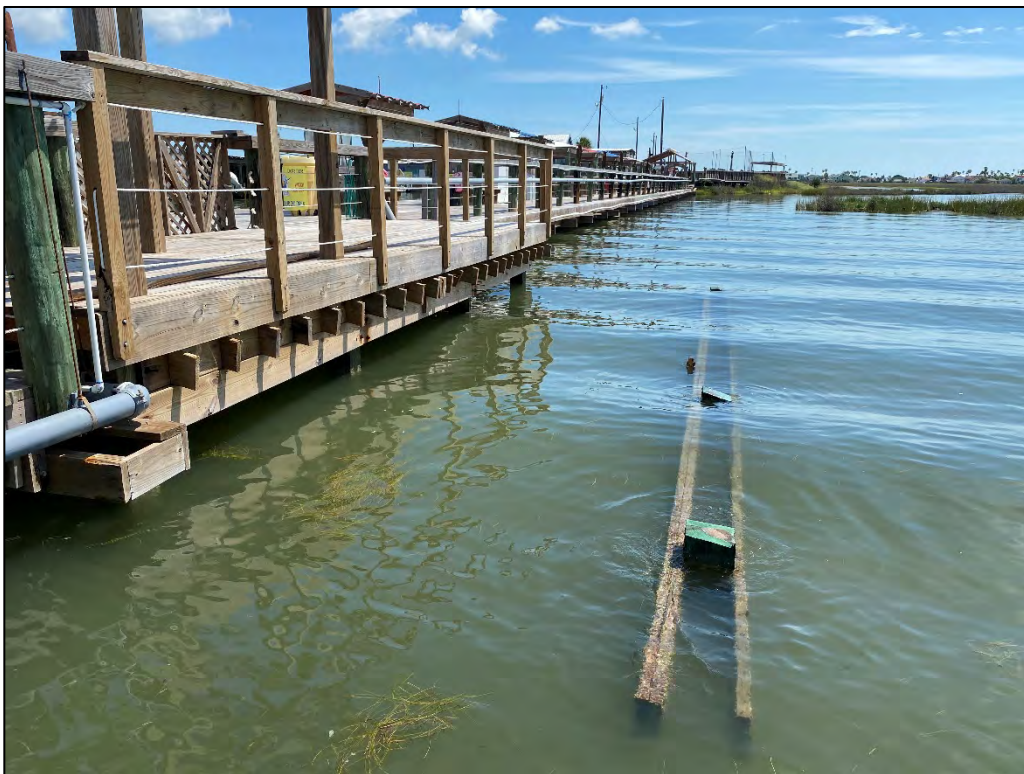
Only two sample locations were absent of seagrass in both surveys and they both lie next to on another atop the old jet ski launch. There were three locations that were absent of seagrass in 2018 are now showing presence of seagrass. A total of seven sample locations are absent of seagrass: six along the corner of the boardwalk extending southeast and one approximately 80 ft south from the corner of the pier and boardwalk. There was a total of six sample locations where either drift algae (two) or oyster shell hash (four) had replaced the seagrass.

Figure 20. View of the area where the previously installed jet ski launch was located, looking to the southeast (CEI: 9/16/2021).

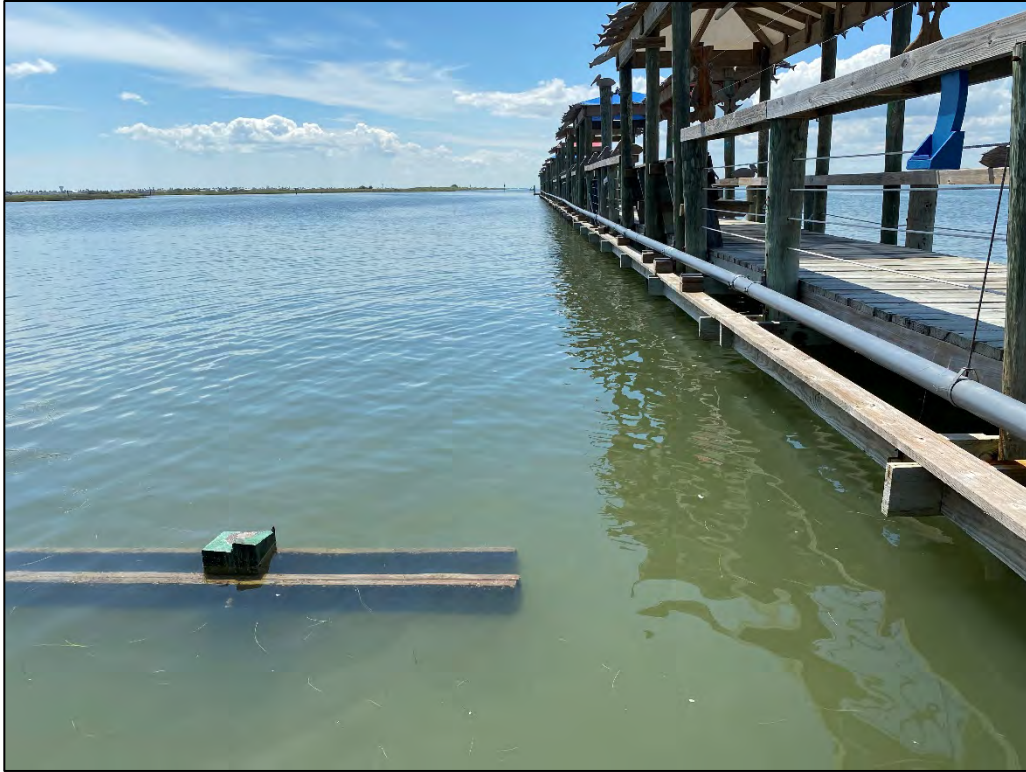
Figure 21. Another view of the area where the previously installed jet ski launch was located, looking to the southwest (CEI: 9/16/2021).

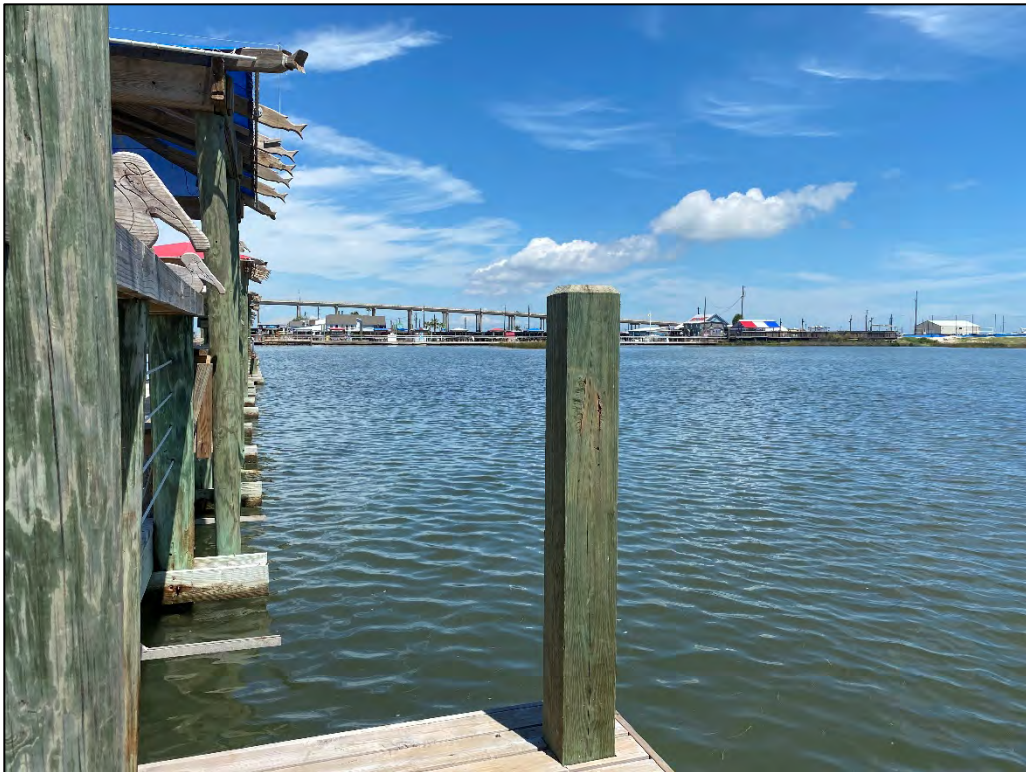
Figure 28. View of the project area from atop the kayak launch located at the end of Paradise Pier, looking to the northeast. Note the seagrass that is visible from the surface (CEI: 9/16/2021).
