## GRAND PARKWAY - SEGMENTS H&I-1 STREAM ASSESSMENT

# Stream Assessment Data Form for Level 1

U.S. Army Corps of Engineers Galveston District

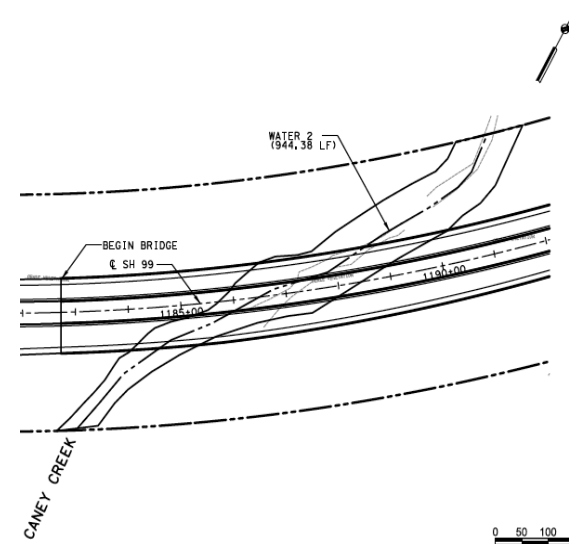
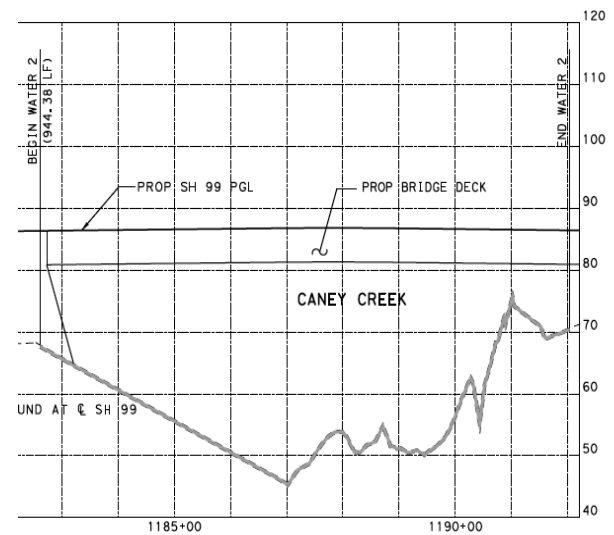
## Water 2 - Caney Creek

Pre-Project Condition					
Water 2	Visual Channel Condition Parameter	Riparian Buffers	Aquatic Use	Channel Alteration	Average
Transect 1	4	4	4	5	4.3
Transect 2	4	4	4	5	4.3
Transect 3	4	4	4	5	4.3
					4.3

Post-Project Condition					
Water 2	Visual Channel Condition Parameter	Riparian Buffers	Aquatic Use	Channel Alteration	Average
Transect 1	3	2	4	5	3.5
Transect 2	3	2	4	5	3.5
Transect 3	3	2	4	5	3.5
					3.5

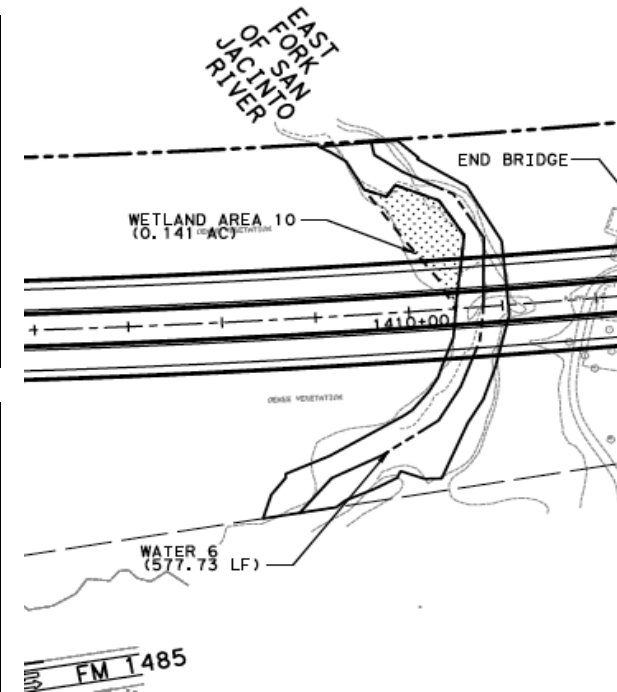
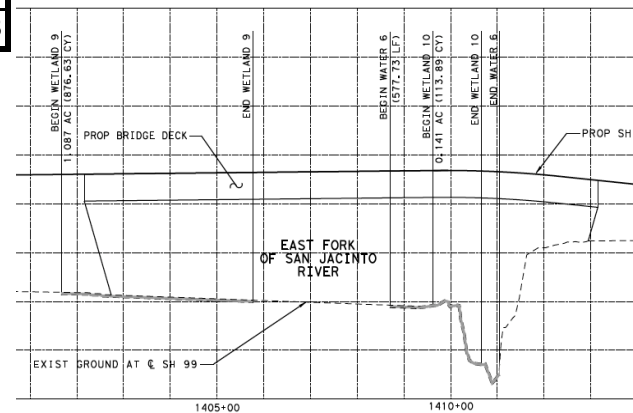
## Water 6 - East Fork San Jacinto

6	East Fork of San Jacinto River	578	4.0	3.3	0.7	2.0	809	Y	Would expect columns in the water to need basket cages around them (fill).
8	Luce Bayou	700	4.5	4.5	0.0	0.0	0	N	Will set the columns above OHW. Should be able to identify a set distance from the column to the stream. There would be basket cages, but they would not be within the water.
10	Cedar Bayou Tributary 1	404	1.8	1.8	0.0	0.0	0	N	This is an incised canal being entirely spanned.
11	Cedar Bayou Tributary 2	404	1.8	1.8	0.0	0.0	0	N	This is an incised canal being entirely spanned.
12	Cedar Bayou	449	2.9	2.9	0.0	0.0	0	N	This is an incised canal being entirely spanned.
13		426	2.0	2.0	0.0	0.0	0	N	This is an incised canal being entirely spanned.
14		137	1.8	1.8	0.0	0.0	0	N	This is an incised canal being entirely spanned.
15		120	1.9	1.0	0.9	2.0	216	N	1,390 linear feet within ROW, 120 linear feet of which will be impacted from culvert placement.

Pre-Project Condition					
Water 6	Visual Channel Condition Parameter	Riparian Buffers	Aquatic Use	Channel Alteration	Average
Transect 1	5	4.5	4	5	4.6
Transect 2	4	4.5	4	4	4.1
Transect 3	3	2.5	4	3	3.1
					4.0

Post-Project Condition					
Water 6	Visual Channel Condition Parameter	Riparian Buffers	Aquatic Use	Channel Alteration	Average
Transect 1	3	2	4	5	3.5
Transect 2	3	2	4	4	3.3
Transect 3	3	2	4	3	3.0
					3.3

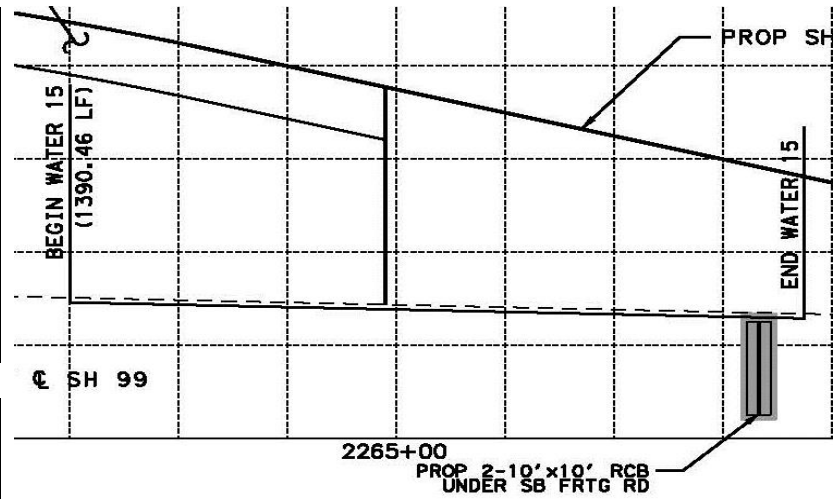
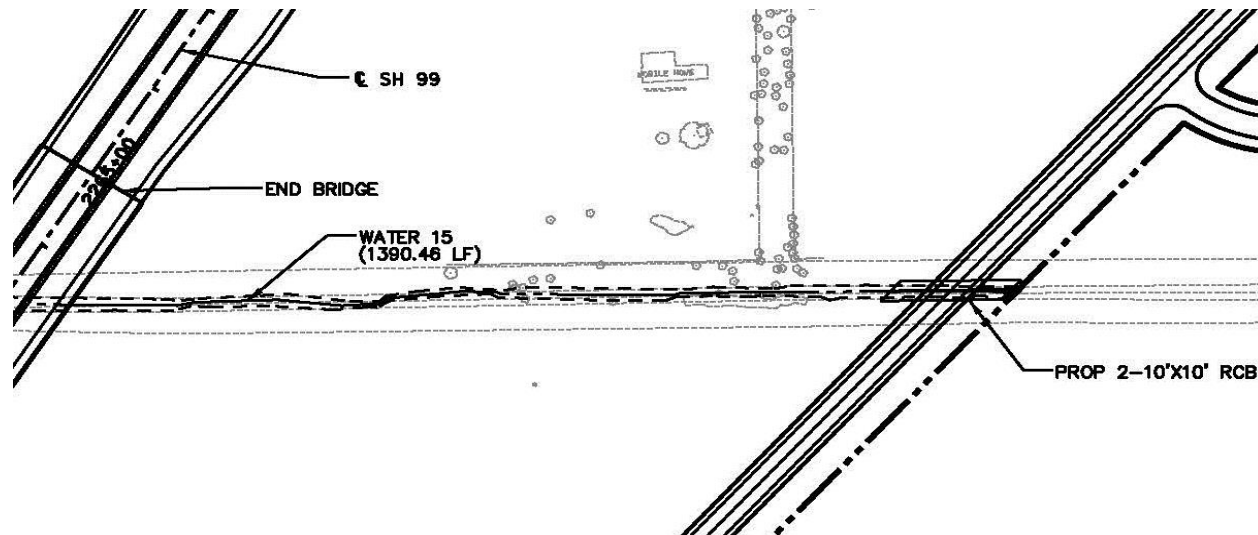
## Water 15

Pre-Project Condition				
Water 15	Visual Channel Condition Parameter	Riparian Buffers	Aquatic Use	Channel Alteration	Average
Transect 1	2	3	2	2	2.3
Transect 2	1	1	2	1	1.3
Transect 3	2	2	2	3	2.3
					1.9

Post-Project Condition				
Water 15	Visual Channel Condition Parameter	Riparian Buffers	Aquatic Use	Channel Alteration	Average
Transect 1	1	1	1	1	1.0
Transect 2	1	1	1	1	1.0
Transect 3	1	1	1	1	1.0
					1.0

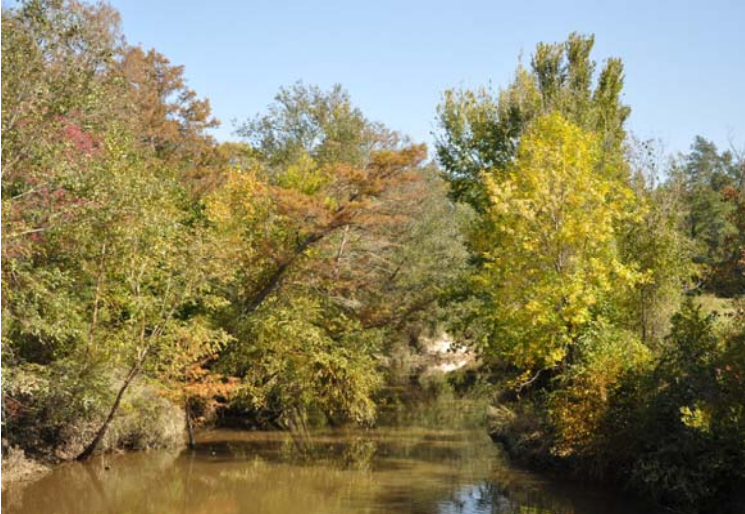
**Notes:** No noticeable channelization or alterations. Withdrawal structures were not observed.

Notes: A few areas of active erosion present, likely due to ATV use and small clearing on the east side. Channel appears natural and no riprap observed.

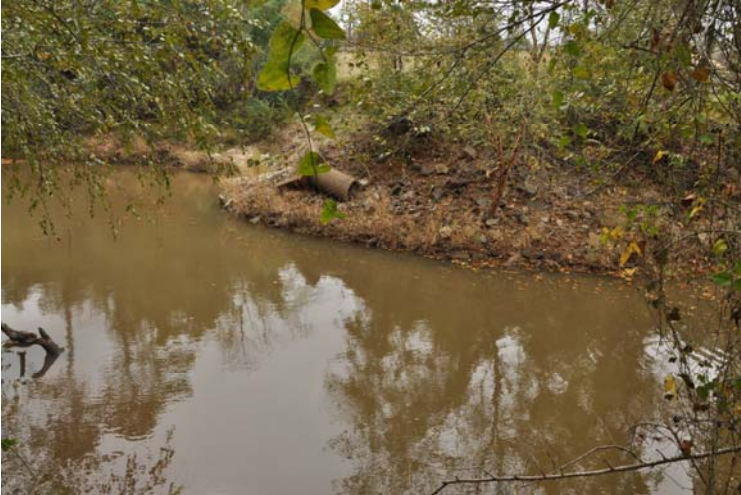
Notes: No alterization observed at this segment.

Notes: Some erosion and instability noted on left bank from turn in river. Bank is slightly undercut.
