SH 36 Stream Conditions Assessment and Evaluation Report – Level 1

Brazoria and Fort Bend Counties, Texas

2020

Ecosystem Planning and Restoration, LLC

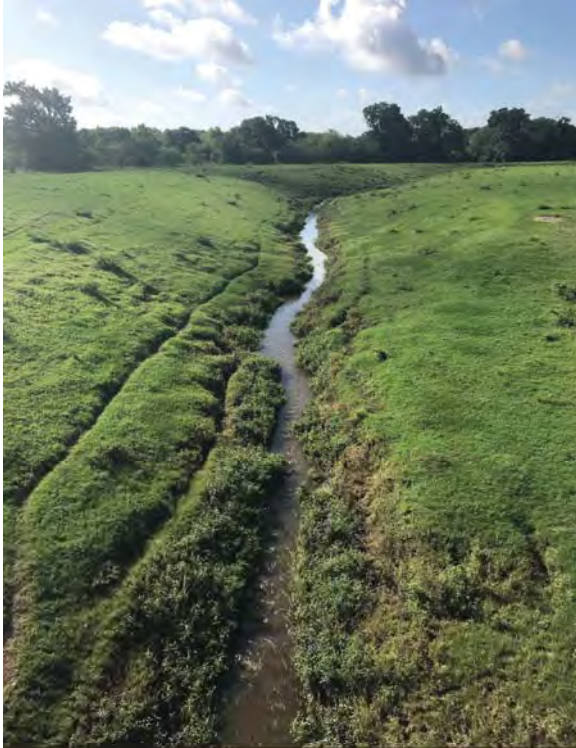
Notes: Bridge present and outside banks of stream. Cattle pressure present, degrading banks in portion via foot traffic. Does not appear to have access to floodplain.

REACH CONDITION INDEX and STREAM CONDITION UNITS FOR THIS REACH	
THE CONDITION INDEX (CI) >>	2.24

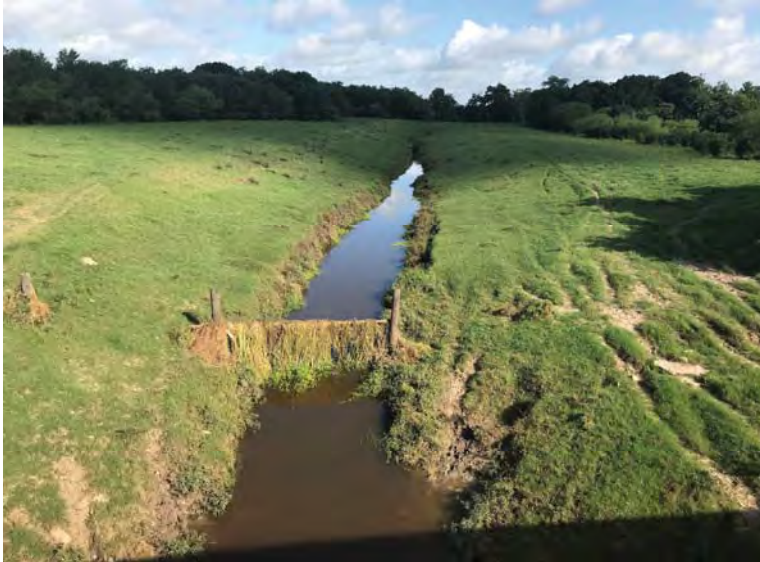
Notes: Projected condition similar to existing transect 2.

REACH CONDITION INDEX and STREAM CONDITION UNITS FOR THIS REACH	
THE CONDITION INDEX (CI) >>	2.24

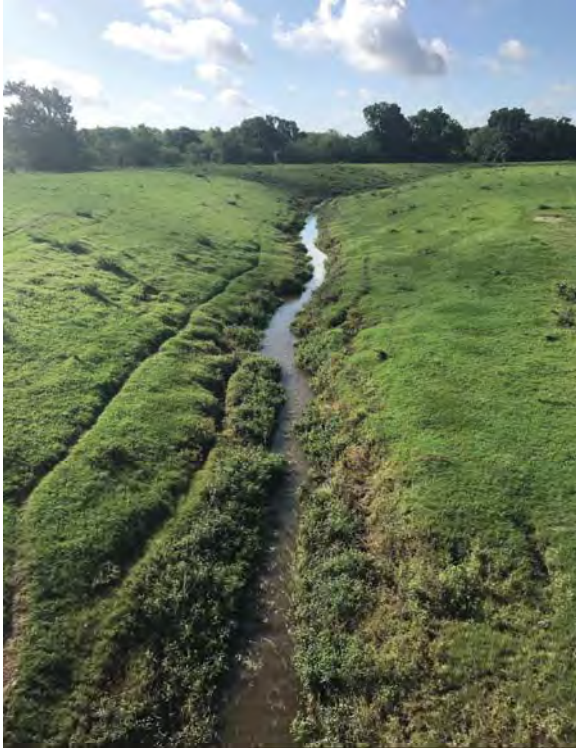
Notes: Rip rap present in areas, stream does not appear to be recovering. Projected impacts will are not anticipated to significantly change the condition or function of this portion of Water 2. This transect is withi nthe current crossing of SH 36.

REACH CONDITION INDEX and STREAM CONDITION UNITS FOR THIS REACH	
THE CONDITION INDEX (CI) >>	2.24

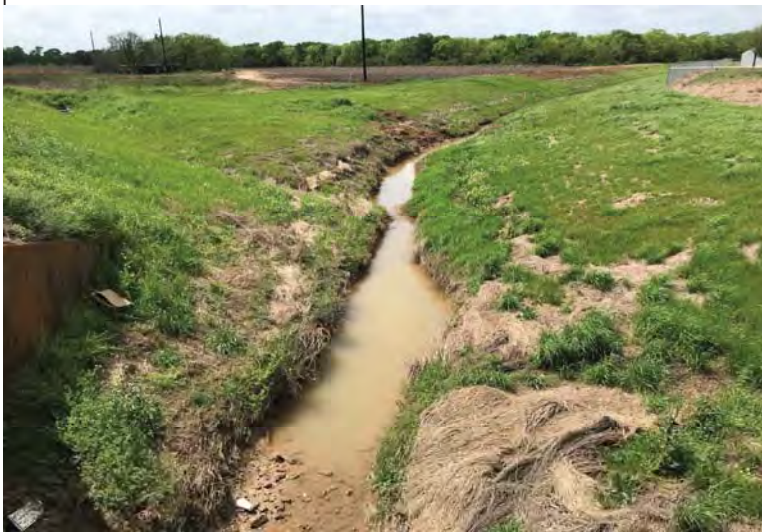
Notes: Channel is incised or has had its course widened. Erosional scars present. The stream does not have access to the active floodplain. Bulkheading or riprap is found along 25-50% of the Transect.

REACH CONDITION INDEX and STREAM CONDITION UNITS FOR THIS REACH	
THE CONDITION INDEX (CI) >>	2.08
