**RE: Summary of Stream Assessments
Permit Application SWG-2015-00145
Corrigan OSB, L.L.C.
CK Associates' Project No. 12356**

<p>Corrigan OSB, L.L.C. Corrigan, Texas</p>	
<p>Department of the Army Permitting</p>	
<p>Site Location Map</p>	
<p>Polk County</p>	
<p>CK ASSOCIATES Environmental Consultants</p>	<p>Drawn: CAL/AM10.4</p>
	<p>Checked: WLB</p>
	<p>Approved: TEW</p>
	<p>Date: 08/15/2016</p>
	<p>Dwg. No.: A12356-59</p>
<p>Figure 1</p>

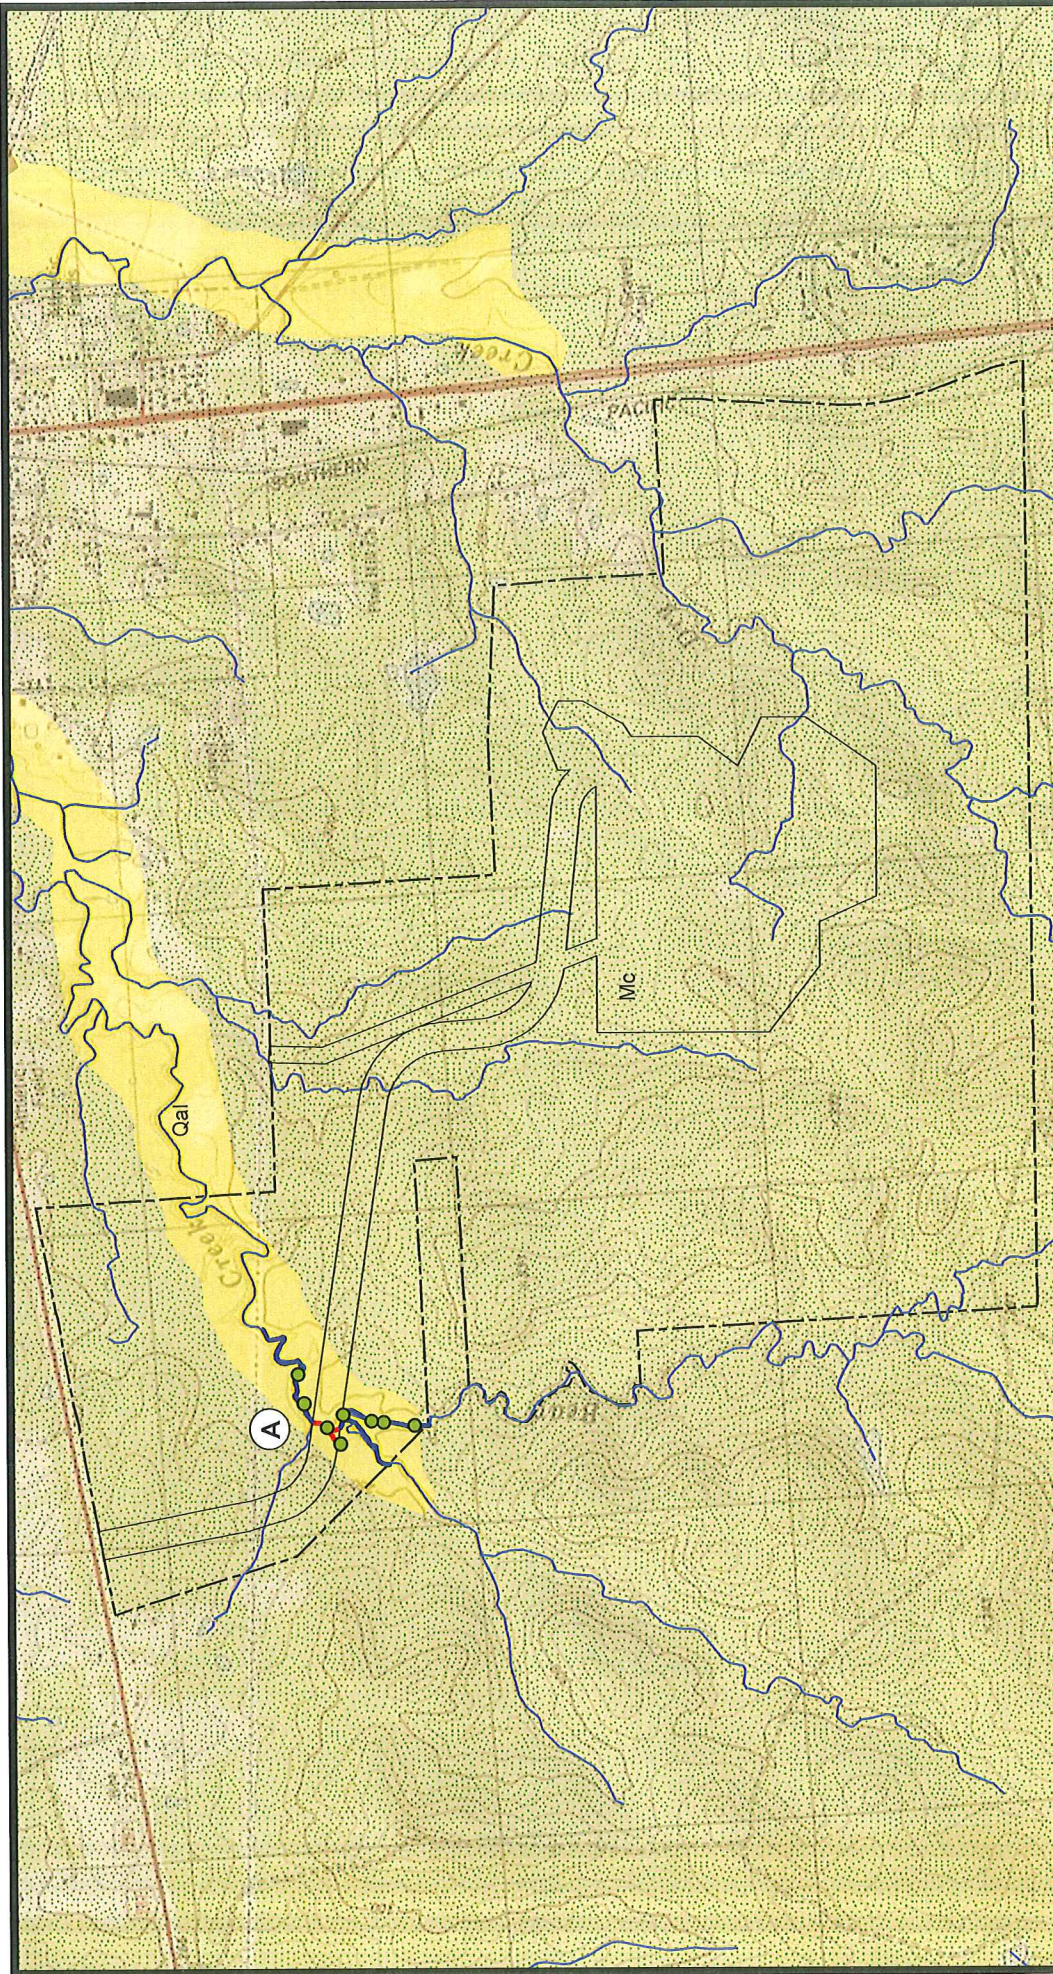
Figure 2

- 1) After review by Compliance, impacts to jurisdictional waters are associated with the construction of the plant access road and road crossing at Bear Creek (Figure 2). Other aquatic resources impacted within the project area were determined to be non-jurisdictional.
- 2) Impacts at the Bear Creek crossing have been reduced, the applicant has modified post construction plans to include replanting of native woody species along a portion of the area cleared during construction (Figure 3).
- 3) Assessment of an ephemeral tributary to Bear Creek that was rerouted and filled during road construction has been added (Figure 3).

Ordinary High Water Mark (OHWM) was determined utilizing field indicators outlined in Regulatory Guidance Letter Number 05-05. Leaf litter disturbance, sediment stained leaves and debris, and changes in soil character were used as indicators of OHWM along transects in areas with poorly defined bed and bank. OHWM determinations along several transects were confirmed by USACE during the site visit on June 10, 2016.

the intermittent section of Bear Creek was associated with bed and bank disturbance at the location of an historic low water crossing. It should be noted that the character of the Bear Creek changes along the three transects evaluated due to differences in topography and local geology. Transects 1 and 2 are located in an area with a steeper valley (colluvium) and have predominately limestone/mudstone beds. Stream bed along Transect 3 (alluvium) is predominately sand and gravel.

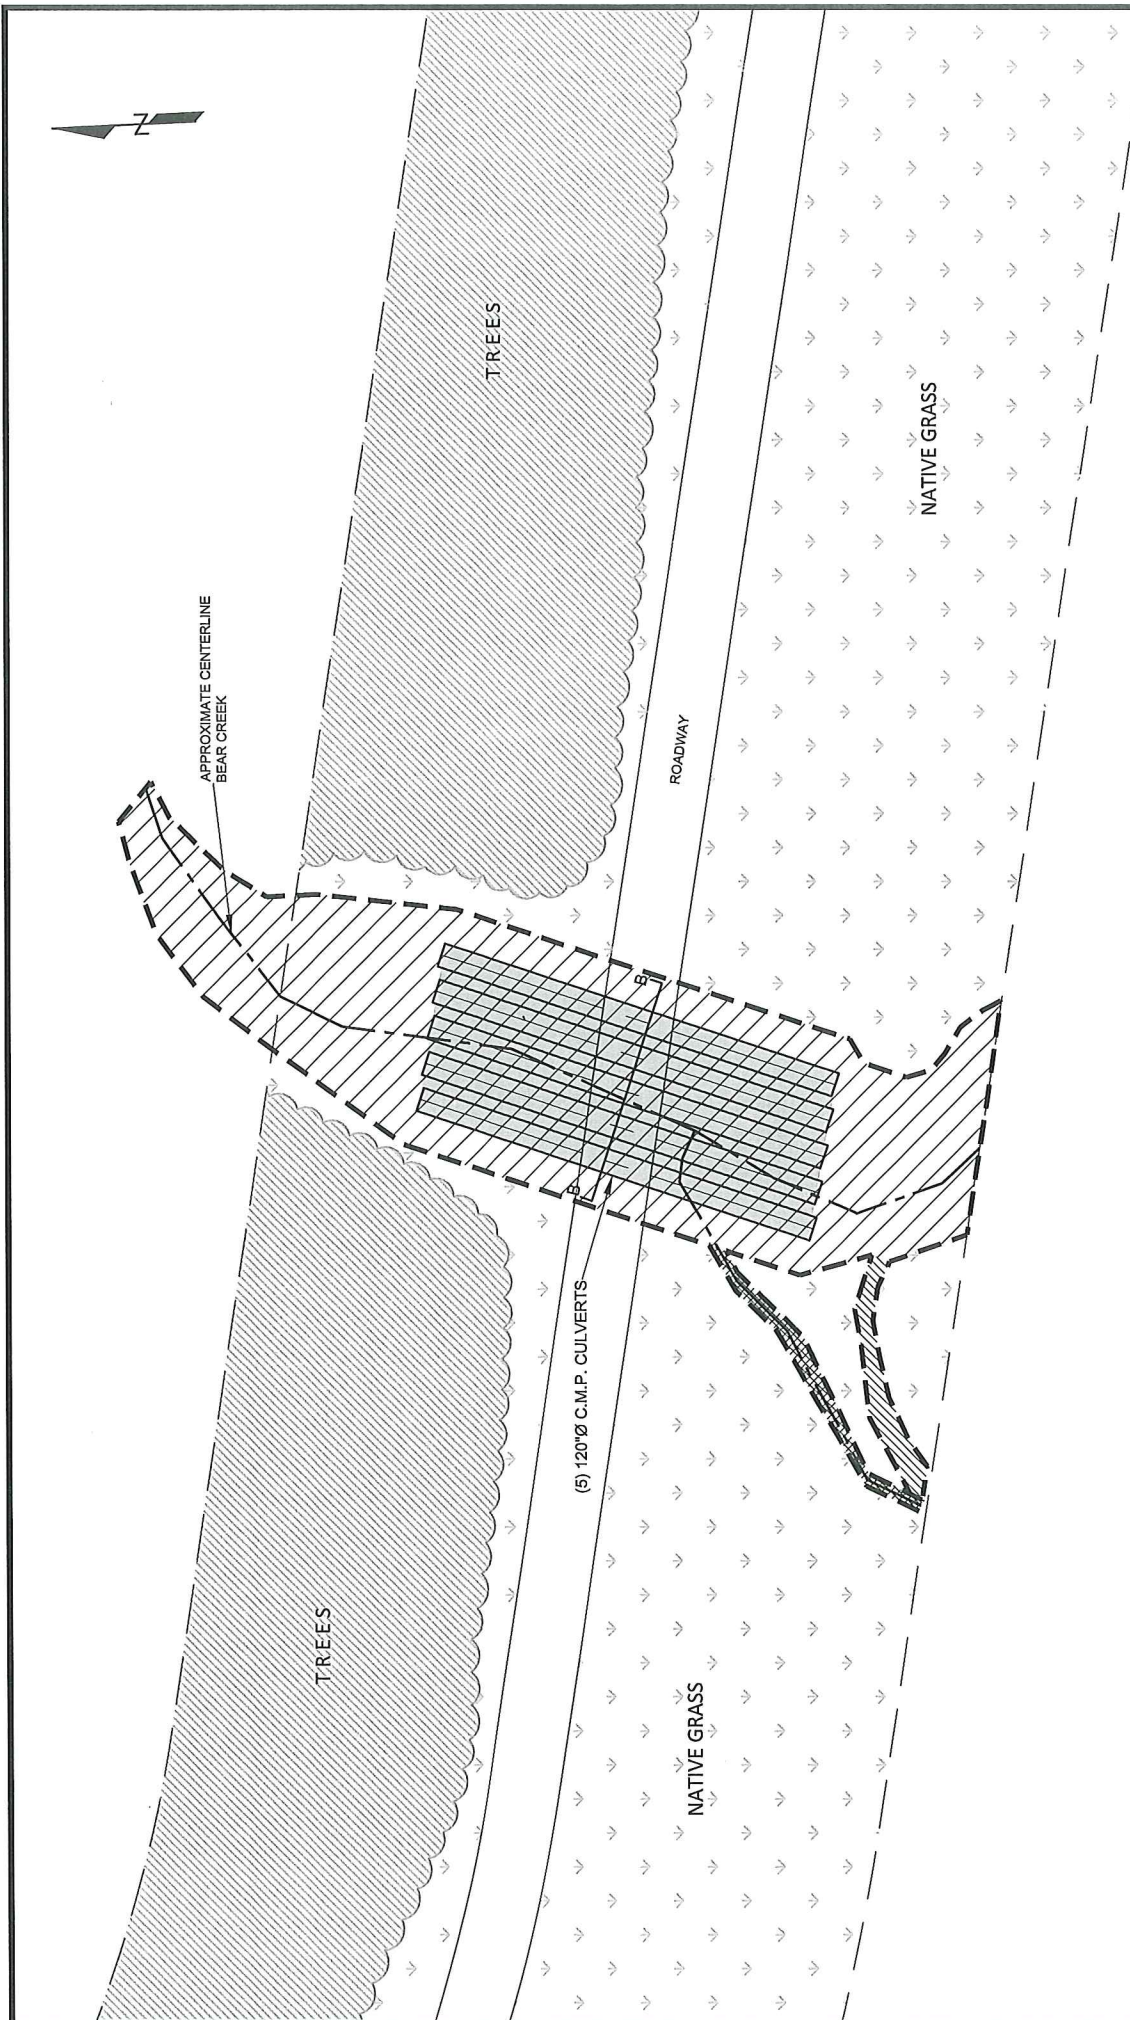
Figure 3

Construction of the entrance road to the OSB facility including a culverted crossing of has impacted two distinct jurisdictional waters: Bear Creek, an intermittent stream; and an unnamed ephemeral tributary to Bear Creek (Figures 2, 3). The impacts to the 430 linear feet of Bear Creek include: clearing/grading within the riparian zone, channel widening, installation of five (5) culverts measuring 10 feet in diameter and 174 feet in length, and installation of rip-rap for erosion control. Impacts to 180 linear feet of an unnamed ephemeral tributary include rerouting to join Bear Creek approximately 50 feet upstream of the former confluence and fill of the portion of the channel that was abandoned (Figure 3).

Limits of Impact determined from field GPS data prior to construction, recent aerial photos, and construction drawings provided by Johnson & Pace Inc.

In addition, a theoretical stream condition assessment was developed for Bear Creek at the crossing and this value was used to calculate the Reach Condition Index Delta and determine the appropriate Impact Factor. Cleared areas in the riparian zone will be replanted with native hardwoods to the maximum extent practical taking into account the requirement to not plant trees that could fall on the power line (Figure 3).
