USACE GALVESTON DISTRICT SUMMER 2017 STAKEHOLDER PARTNERING FORUM

BUFFALO BAYOU & TRIBUTARIES, HOUSTON, TEXAS ADDICKS AND BARKER RESERVOIRS DAM SAFETY MEGA PROJECT OVERVIEW

August 16, 2017

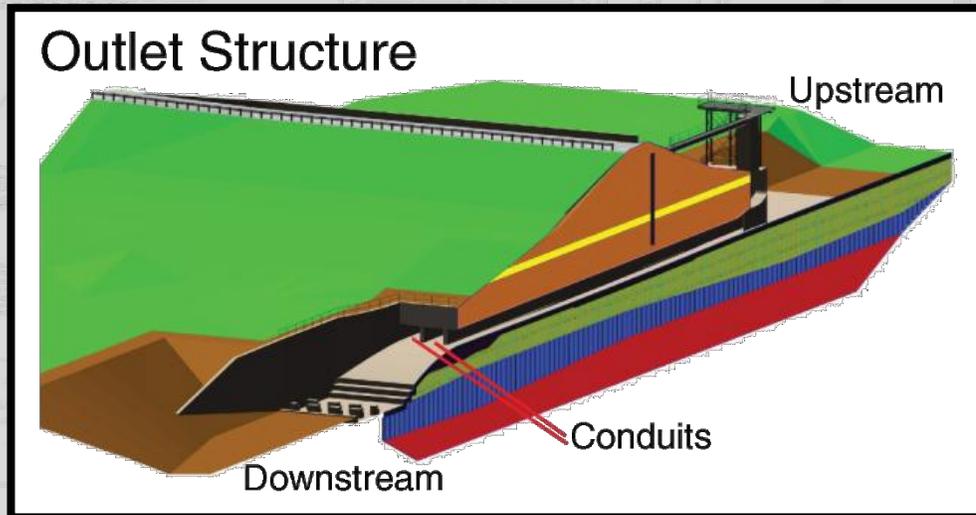
Seepage and Piping Beneath, Around, and Near the Conduits

Dam Safety Issues: High risk associated with seepage and piping beneath, around, and near the outlet works structure conduits and risks associated with auxiliary spillway flows and flows around the ends of the dams

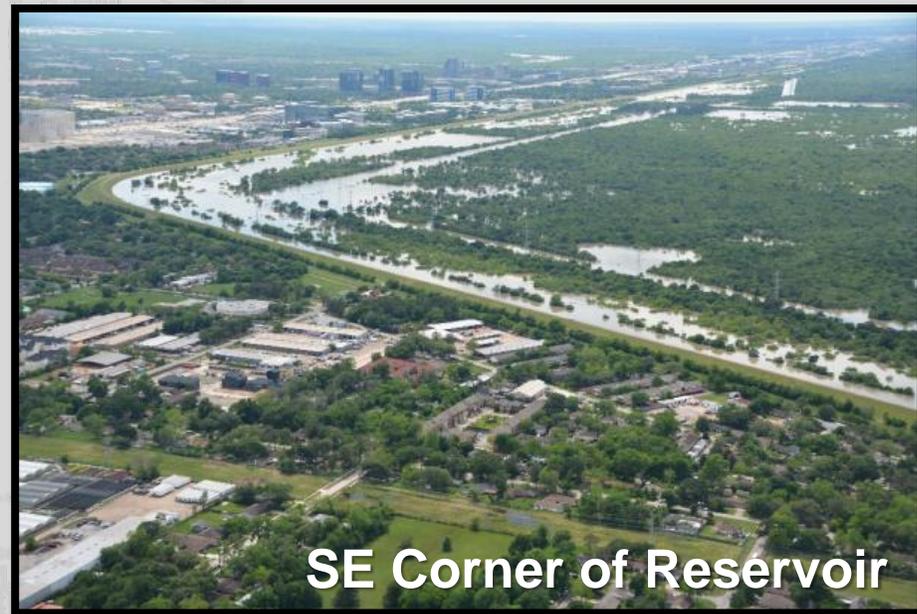
Addicks Dam Record Pools

Addicks Dam Record High Pool

Elevation: 102.6 feet
Acre Feet: 123,067
Datum: NAVD 1988
Date: April 23, 2016

Addicks Dam Previous Record High Pool

Elevation: 97.4 feet
Acre Feet: 65,264
Datum: NAVD 1988
Date: March 9, 1992

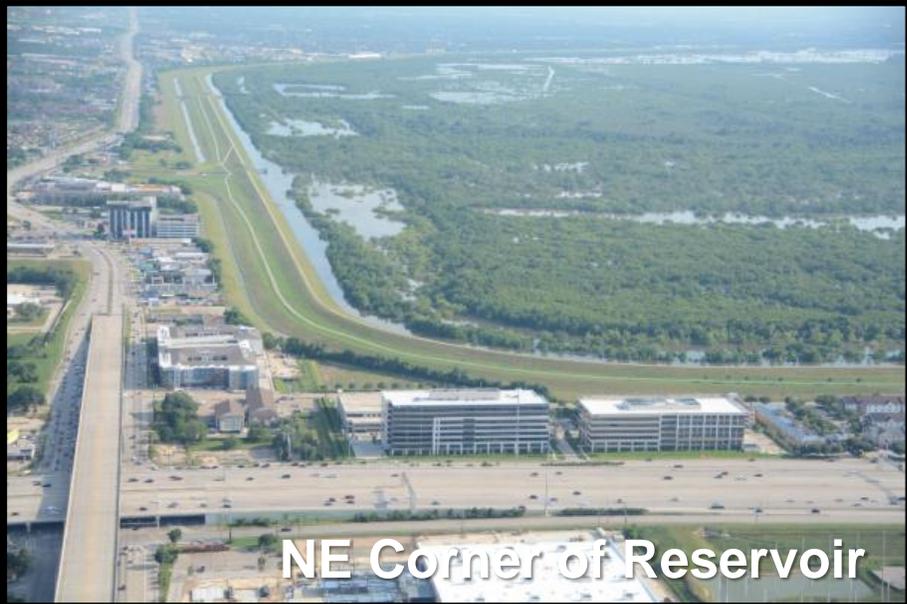
Barker Dam Record Pools

Barker Dam Record High Pool

Elevation: 95.2 feet
Acre Feet: 85,816
Datum: NAVD 1988
Date: April 23, 2016

Barker Dam Previous Record High Pool

Elevation: 93.6 feet
Acre Feet: 66,489
Datum: NAVD 1988
Date: March 6, 1992

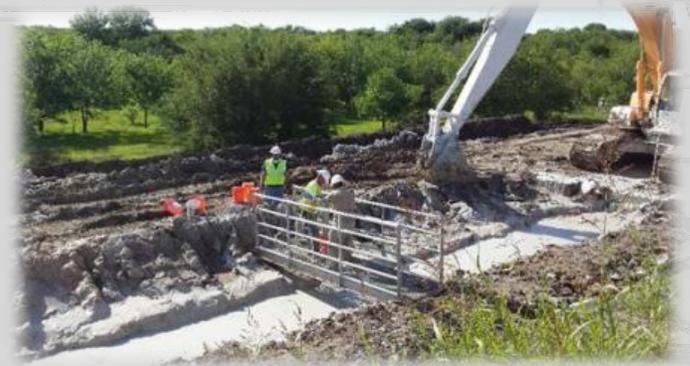
**CUT-OFF WALL
PERMEABILITY AND STRENGTH**

- Detailed reviews of slurry batching/placement CQC processes did not identify significant deficiencies
- Verification Drilling test results for compression and permeability did not match the results of the produced slurry sampling

- Notice of QA/QC deficiencies issued on 4 May 17 due to the verification drilling results
- Contractor evaluated alternative slurry mixes and performed trial batches

- 75/25% (Slag/Cement Ratio) Mix Approved by Government for use under new structure at Addicks Dam on 27 Jul 2017
- Contractor is of the opinion that SWG's approval of the 75/25 cut-off wall mix for Addicks Dam is a variance from the specifications and considers this as direction by the Government.
