WETLAND MITIGATION BANK PROSPECTUS

SEA BREEZE MITIGATION BANK
SWG-2016-00086
Chambers County, Texas

Prepared for Submittal to:
U.S. Army Corps of Engineers, Galveston District

February 24, 2017

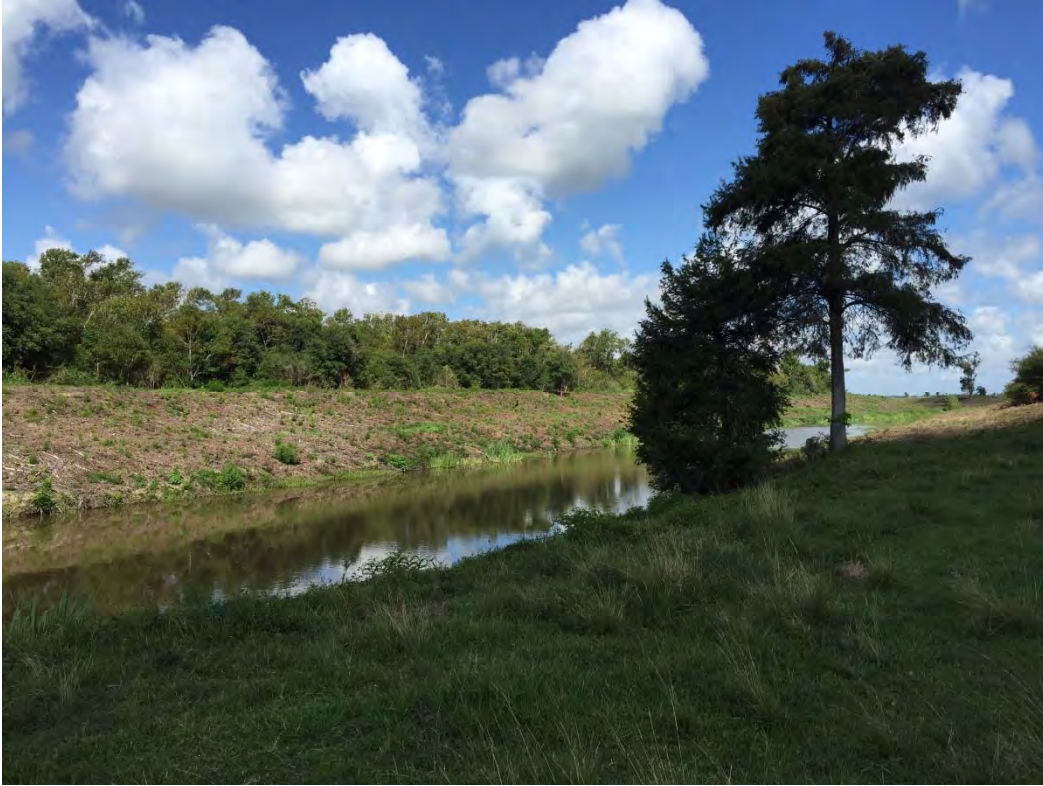
Photo 3. Offsite view of spoil bank “levee” on east tract taken from north bank facing upstream (September 2015).

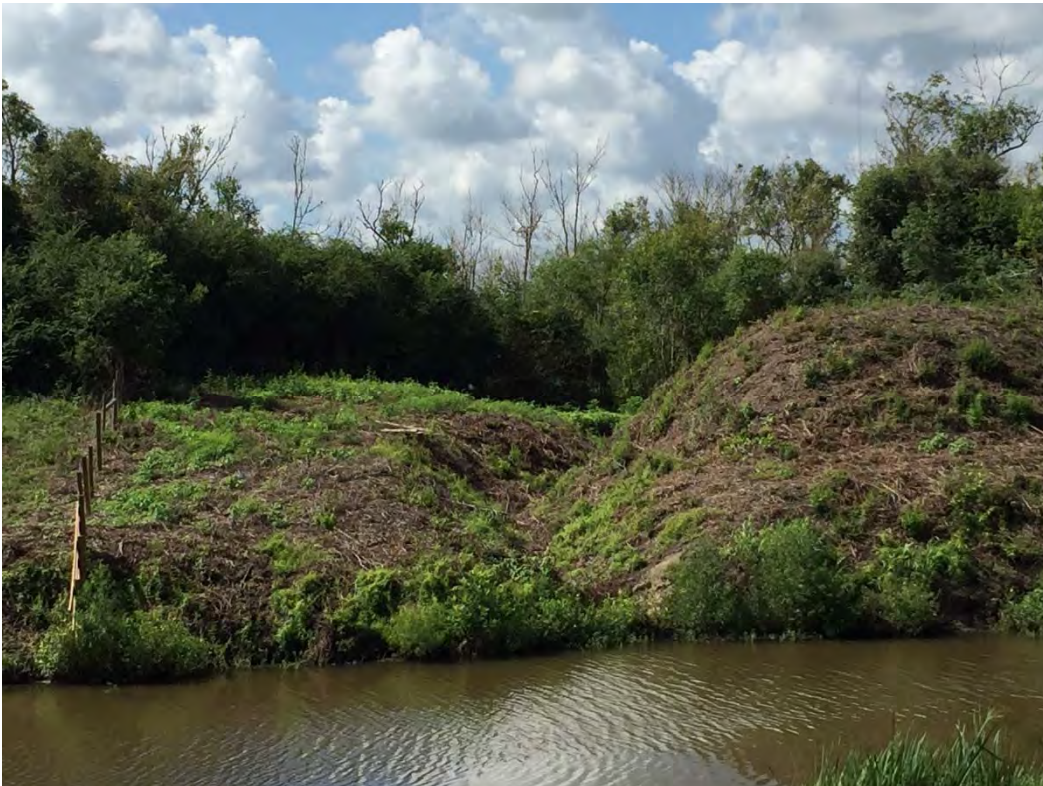
Photo 4. View from across Spindletop of current breach in levee on northeast corner of east tract (September 2015).

On the east tract, ponding duration would be improved by levelling the two narrow v-notch levee breaches that are eroding into the wetland (**Photo 4**). Flood frequency would be improved by largely degrading the levee to allow increased duration of flooding and increased volume of water to enter the site during a flood event. LiDAR data indicate that during a 1.76-year flood event, approximately 22 acres (51 percent) of the east tract would be inundated. Ponding would occur on over 33 percent of the east tract following the flood. Ponding would persist for over 14 consecutive days on over 28 percent (12 acres) of the east tract. Ponding values would be the same for precipitation as for flooding.

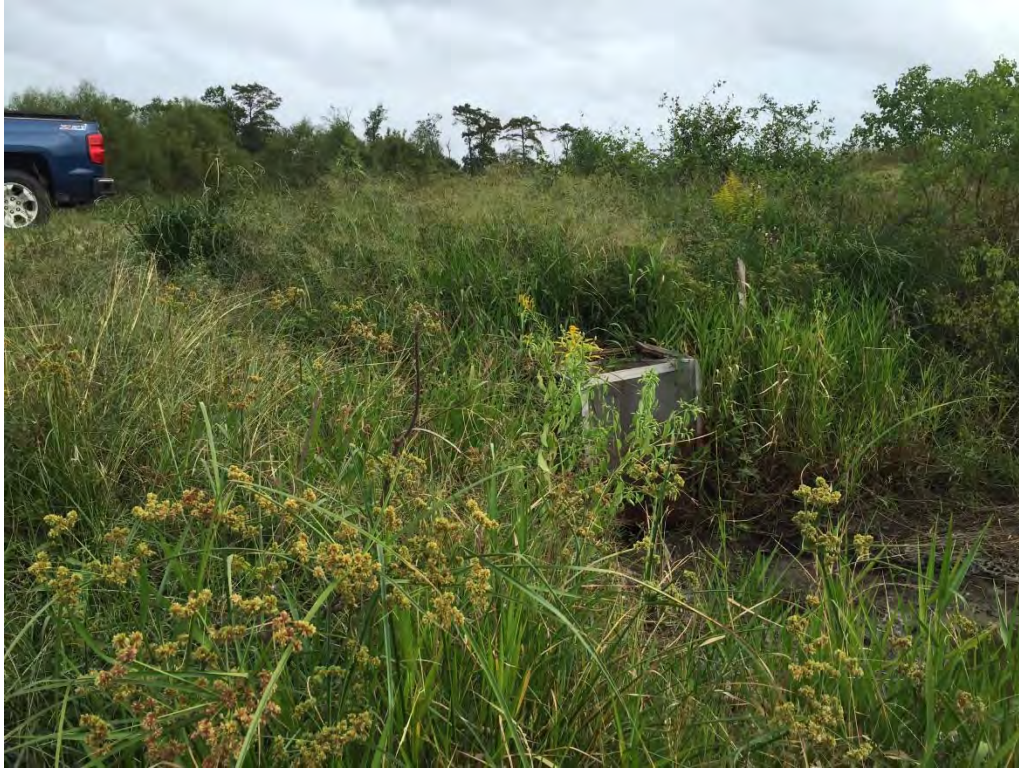
Photo 7. Water control structure in spoil bank levee along Spindletop Bayou in west tract (October 2015).

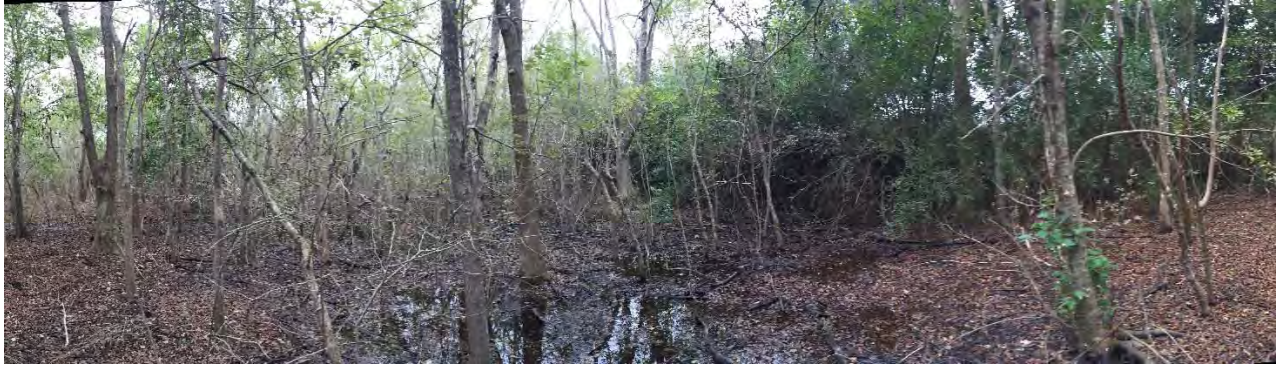
Photo 13. Panoramic view of forested wetland along edge of spoil bank showing ponding against spoil bank following rain event (November 2016).

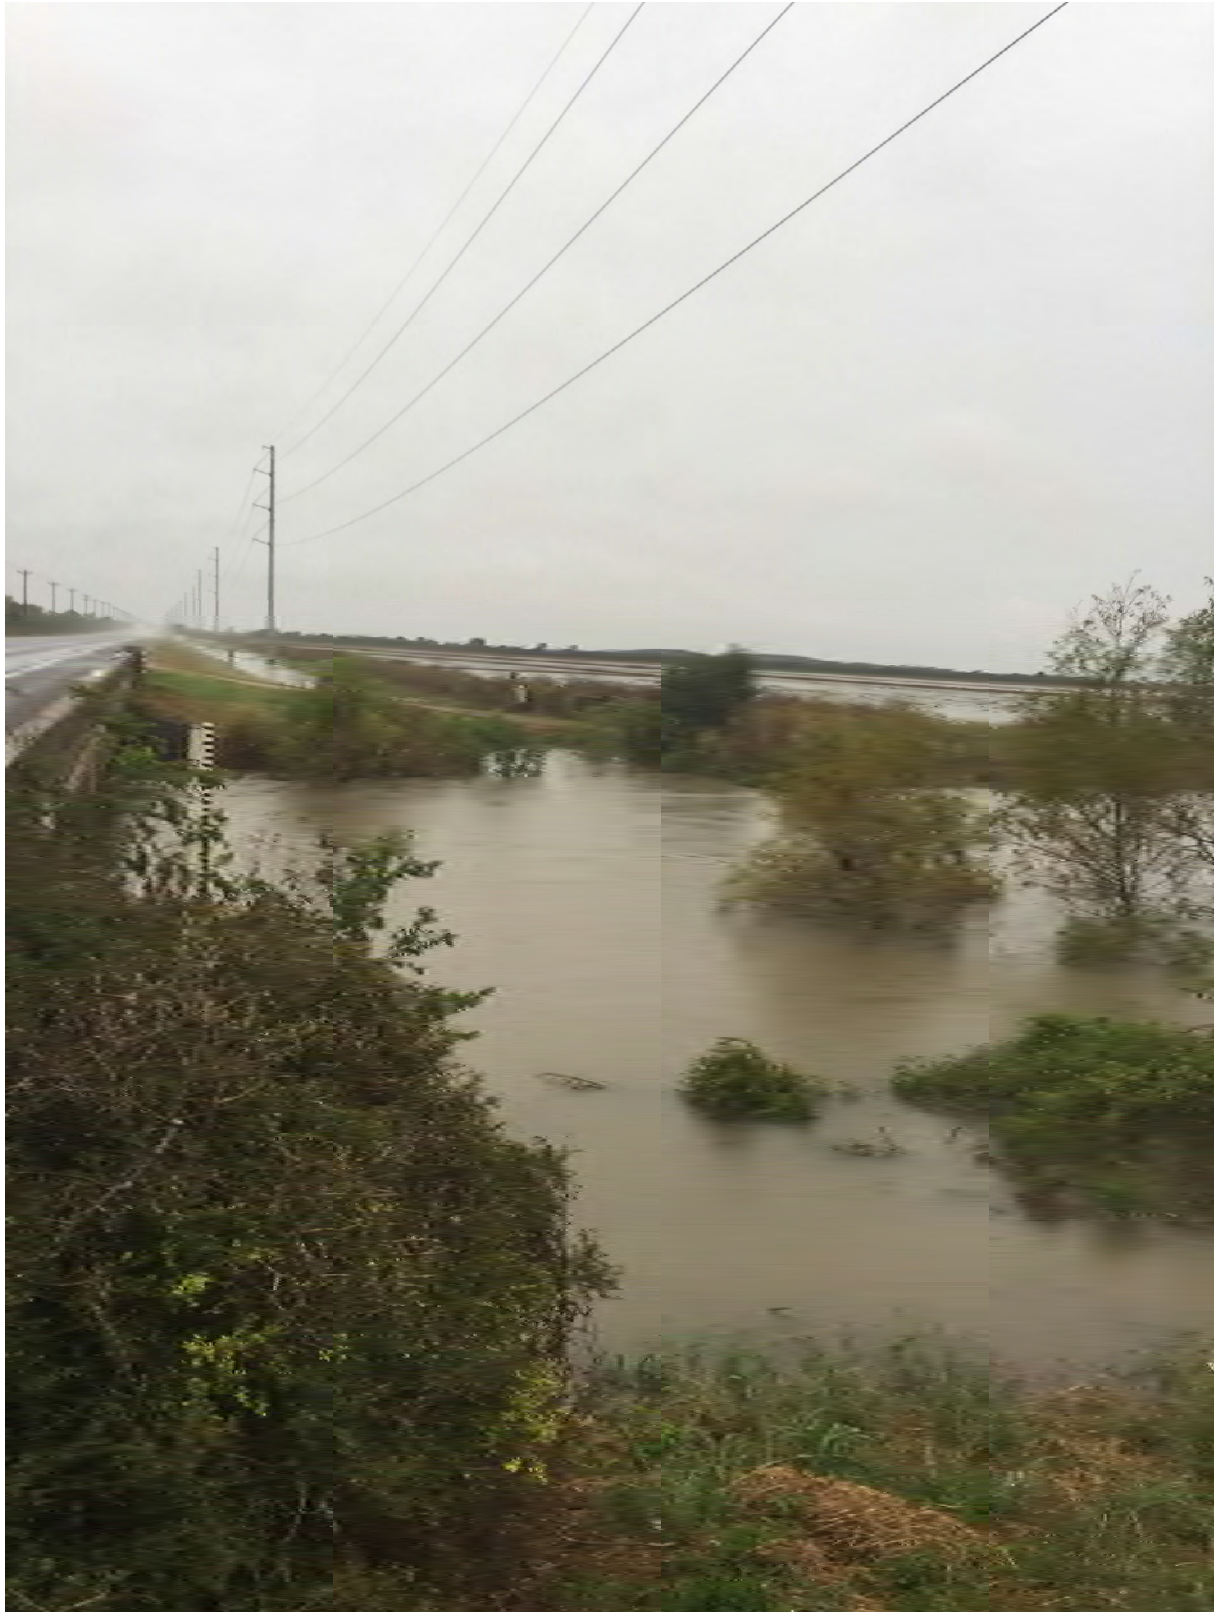
Photo 16. December 4, 2016 9:45 AM photo take from north side of bridge across Spindletop Bayou looking at northeast corner of west tract. The gage was at approximately 13.9 feet when this photograph was taken.

A rain and flood gauge operated by Jefferson County Drainage District #6 has been in continuous operation at the site since November 2002 (Jefferson County Drainage District No. 6, n.d.). A summary of the data can be found in Table 8. A photograph taken of the northeast corner of the west tract is available as **Photo 16**. This photo was taken on December 4, 2016 at 9:45 AM when the gage was at approximately 13.9 feet, after peaking at 14.0 feet (the 2.7 return interval event).
