WETLAND DELINEATION REPORT
SHIP DOCK 5 PROJECT
SWG-2016-00832
HARRIS COUNTY, TEXAS

November 2016

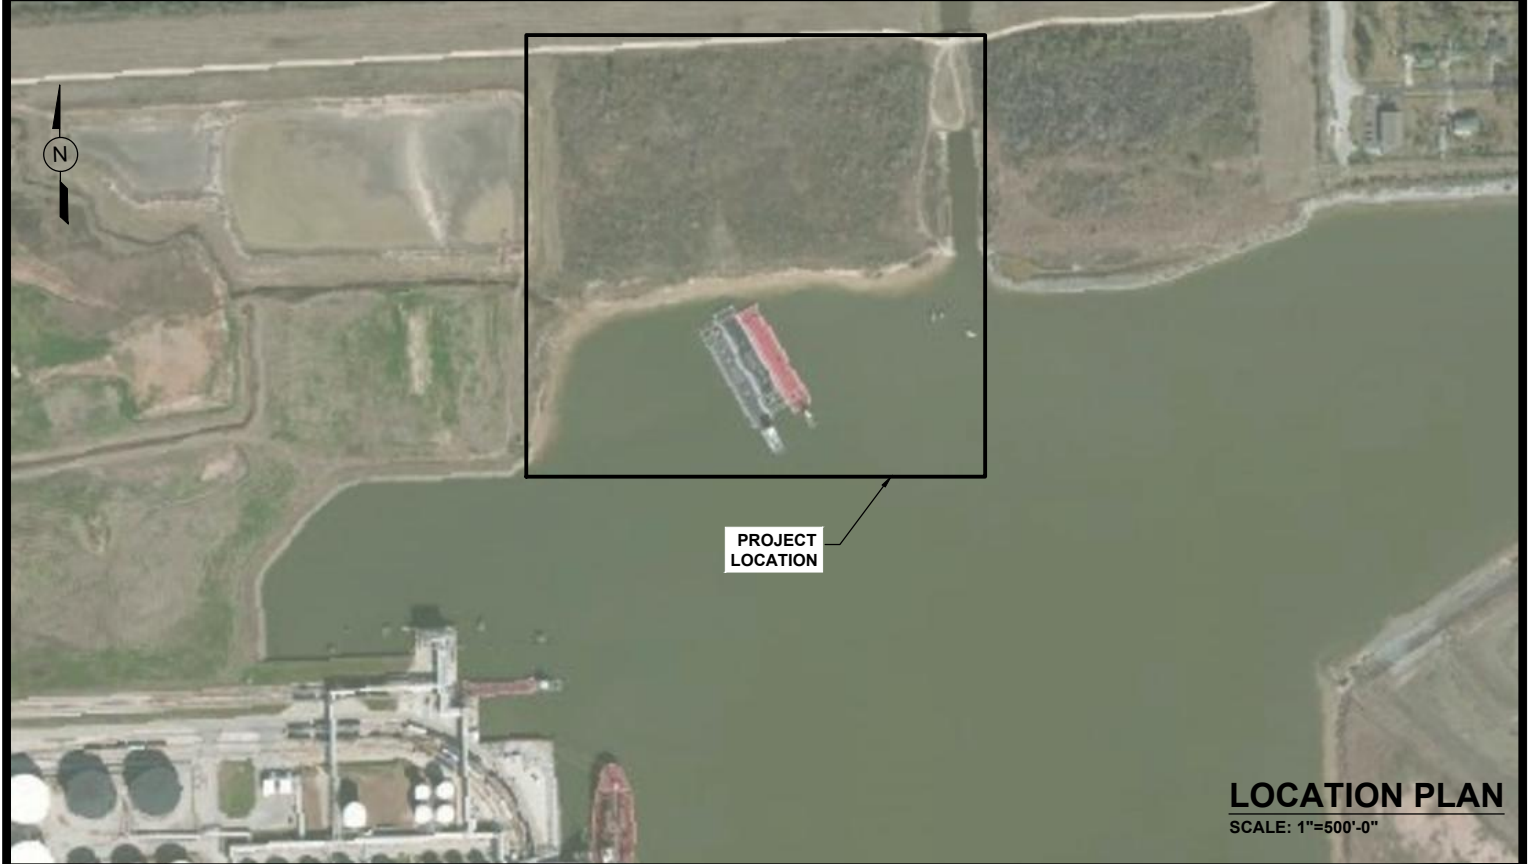
DESIGN BY:	MW
DRAWN BY:	JB
SCALE:	AS NOTED
DATE:	10/05/16
SHEET No:	FIGURE 1

PURPOSE:	PROPOSED SHIP DOCK 5
LOCATION:	LA PORTE, TX

This report presents the results of a wetland delineation conducted on behalf of LBC Houston, LP (LBC) for the proposed LBC Ship Dock 5 project, U.S. Army Corps of Engineers (USACE) Project No. SWG-2016-00832. The proposed project is located in La Porte, Texas approximately 0.72-mile east of the intersection of State Highway 146 and Shoreacres Boulevard and is positioned on the northwest shoreline of the Bayport Terminal. Lloyd Engineering, Inc. (LEI) conducted environmental investigations intermittently between the months of August and September within an approximate 19-acre survey area. The proposed project is positioned within the USACE Galveston District, and is located on the U.S. Geological Survey (USGS) League City, Texas, 7.5-minute series topographic quadrangle map (USGS, 1982). Refer to the vicinity map provided as Figure 1 in Appendix A for a depiction the project location.

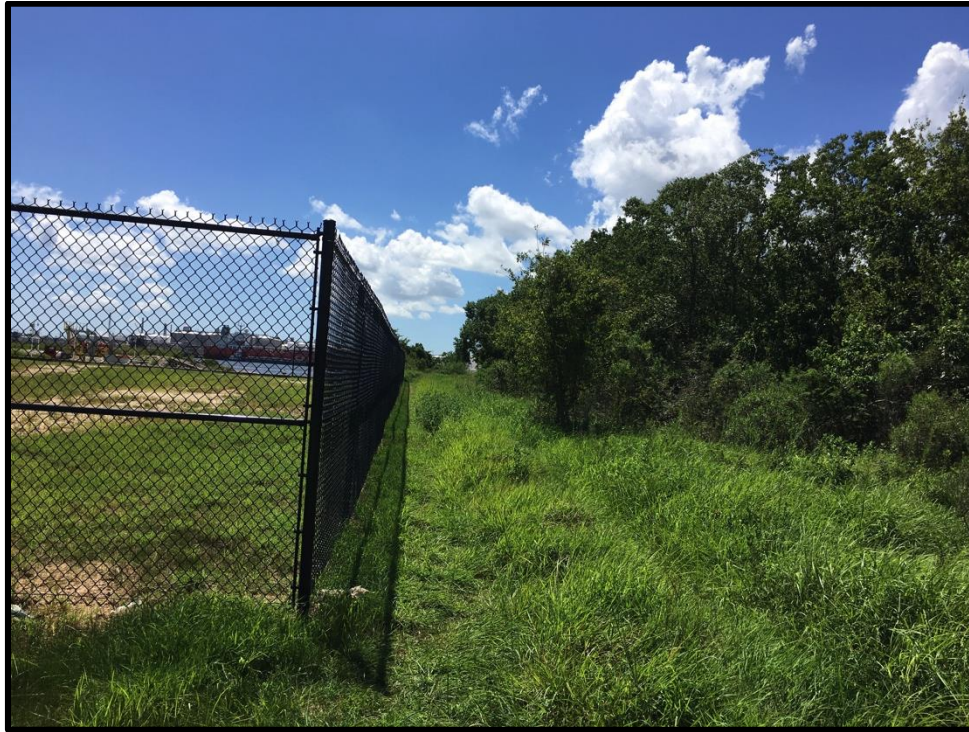
Photo 1: View of the northeast corner of the survey area at UDP WET 3, facing south.

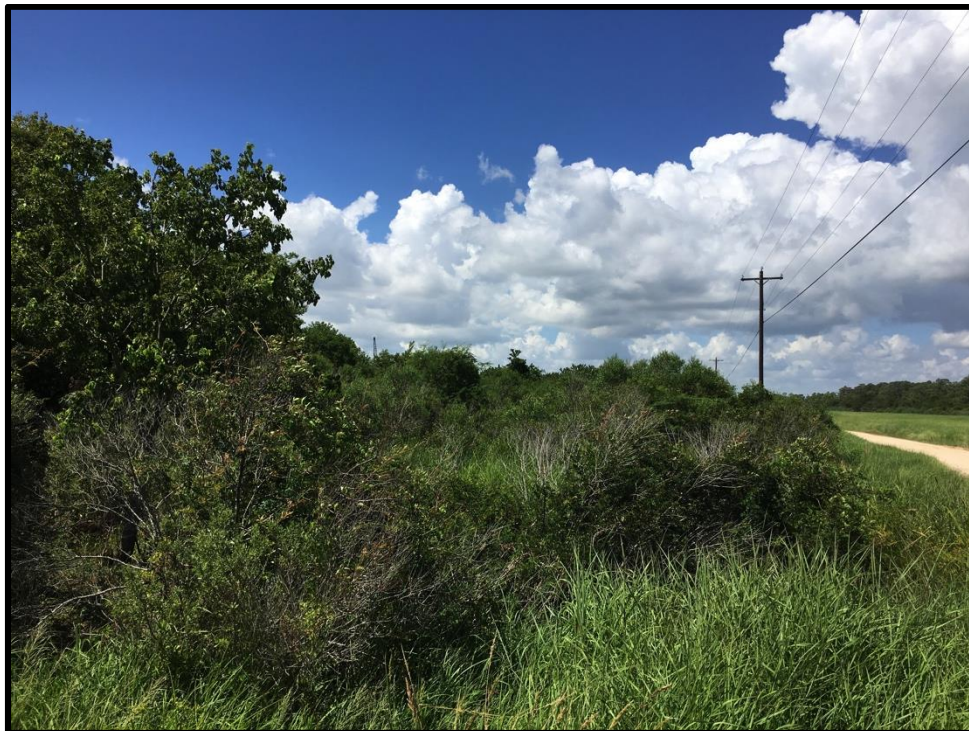
Photo 2: View of upland communities located within the survey area.

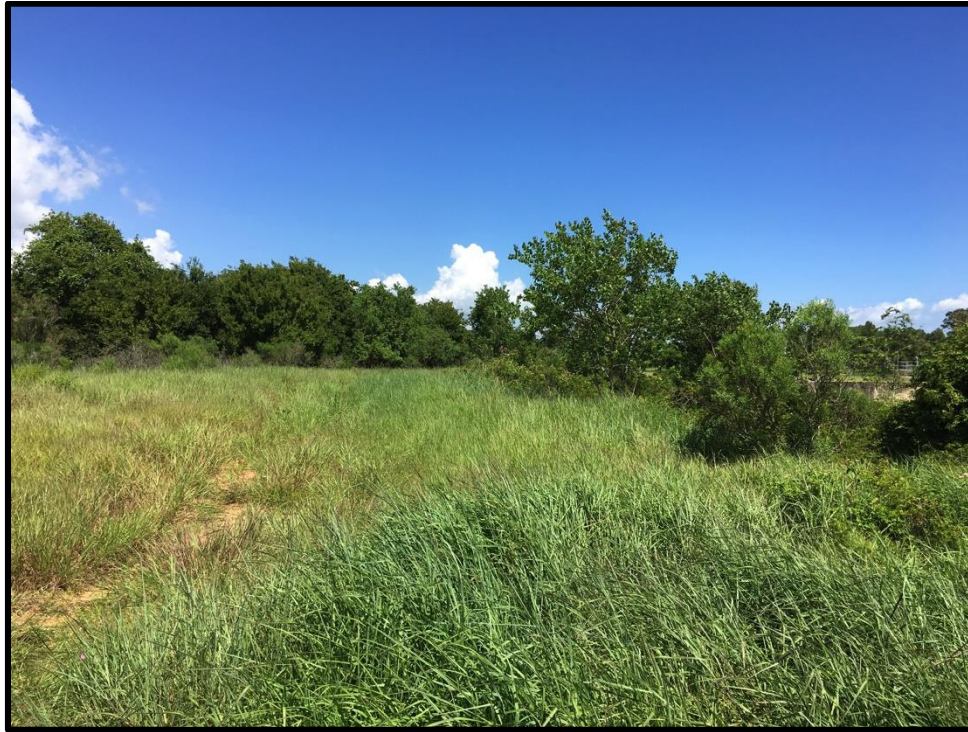
Areas described as upland grassland within the survey area typically consisted of herbaceous vegetative cover within a topographically elevated landscape. Common vegetation species observed in the upland pasture/grassland communities included annual ragweed (*Ambrosia artemisiifolia*, FACU), bermuda grass (*Cynodon dactylon*, FACU), annual sumpweed (*Iva annua*, FAC), beaked panicum (*Panicum anceps*, FAC), bahia grass (*Paspalum notatum*, FACU), Canada golden-rod (*Solidago canadensis*, FACU), and smut grass (*Sporobolus indicus*, FACU). Based on the technical criteria outlined in the Regional Supplement, the vegetation observed within this community is not representative of a hydrophytic plant community.

Photo 3: View of upland pasture vegetative communities at UDP WET 4, facing west.

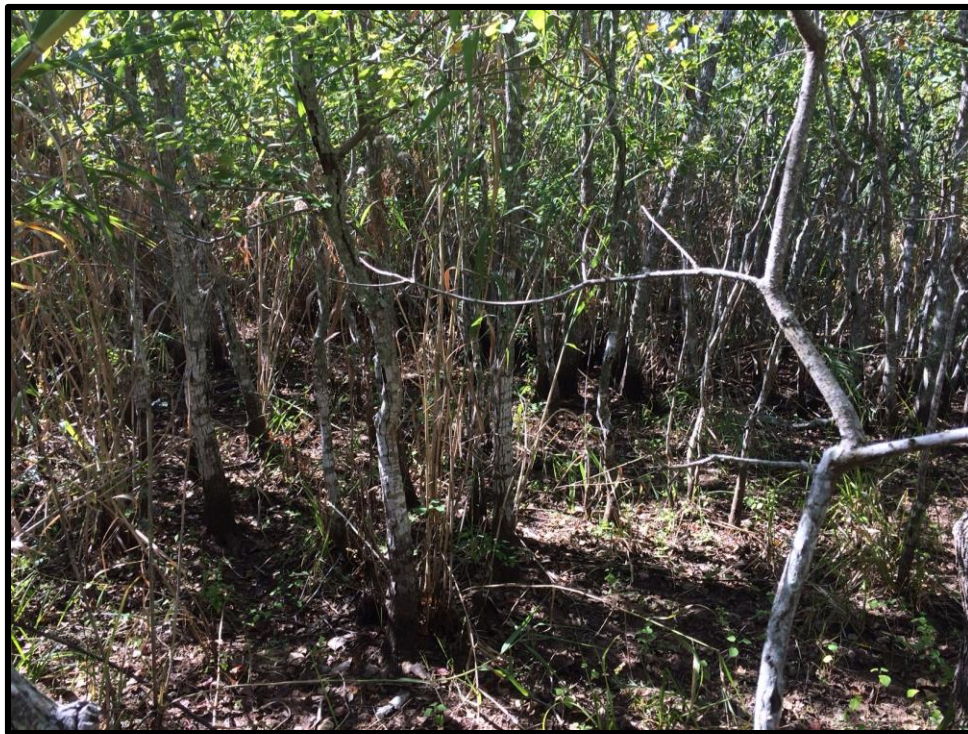
dbh and 20 feet or more in height (sapling) or 3 to 20 feet in height (shrub). Dominant species occurring within this wetland community consisted of Chinese tallow, swamp smartweed, jointed flatsedge, sand spike-rush, bushy goldentop, eastern baccharis (*Baccharis halimifolia*, FAC), wax myrtle (*Morella cerifera*, FAC), and black willow (*Salix nigra*, OBL). Based on the technical criteria outlined in the 1987 Manual and the Regional Supplement, the vegetation observed within this community is representative of a hydrophytic plant community.

Photo 4: View of WET 3, a PSS1 wetland located within the survey area, facing south.

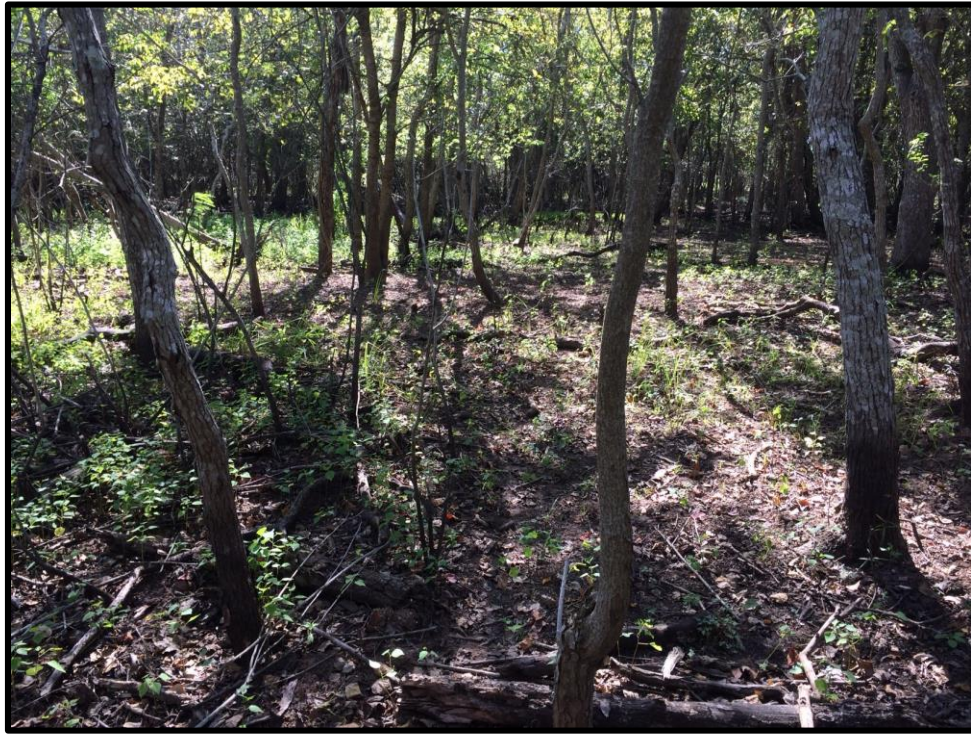
Forested wetlands are characterized by woody vegetation that is 20 feet tall or taller (Cowardin, et al., 1979). The currently used Regional Supplement defines the tree stratum as woody plants, excluding vines, greater than 20 feet in height and 3 inches or greater in dbh. Canopy species occurring within the tree stratum primarily consisted of monotypic stands of Chinese tallow with sugarberry (*Celtis laevigata*, FACW) interspersed throughout. Due to minimal sunlight penetrating the canopy, a low diversity of understory and minor canopy species were documented within forested wetlands. Understory and minor canopy species noted included eastern baccharis, wax myrtle, bushy goldentop, swamp smartweed, sand spike-rush, short-bristle horned beak sedge (*Rhynchospora corniculata*, OBL), and sturdy bulrush (*Bolboschoenus robustus*, OBL). Based on the technical criteria outlined in the 1987 Manual and the Regional Supplement, the vegetation observed within these communities is representative of a hydrophytic plant community.

Photo 5: View of WET 4, a PFO1 wetland located within the survey area, facing west.

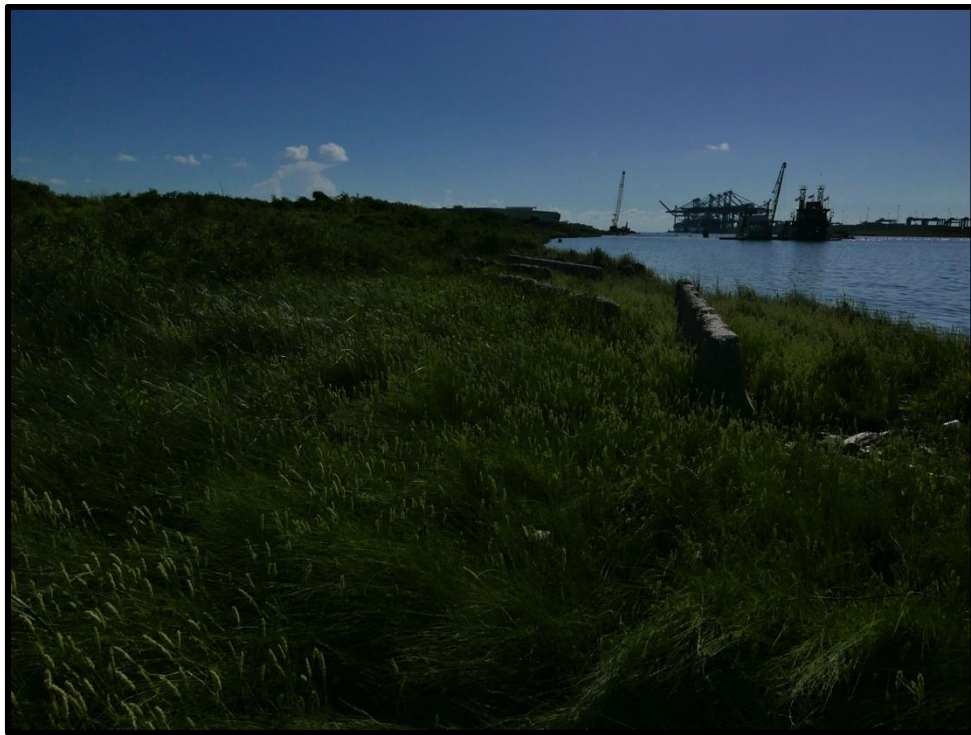
Photo 6: View of WET 8, an estuarine intertidal emergent wetland located within the survey area.

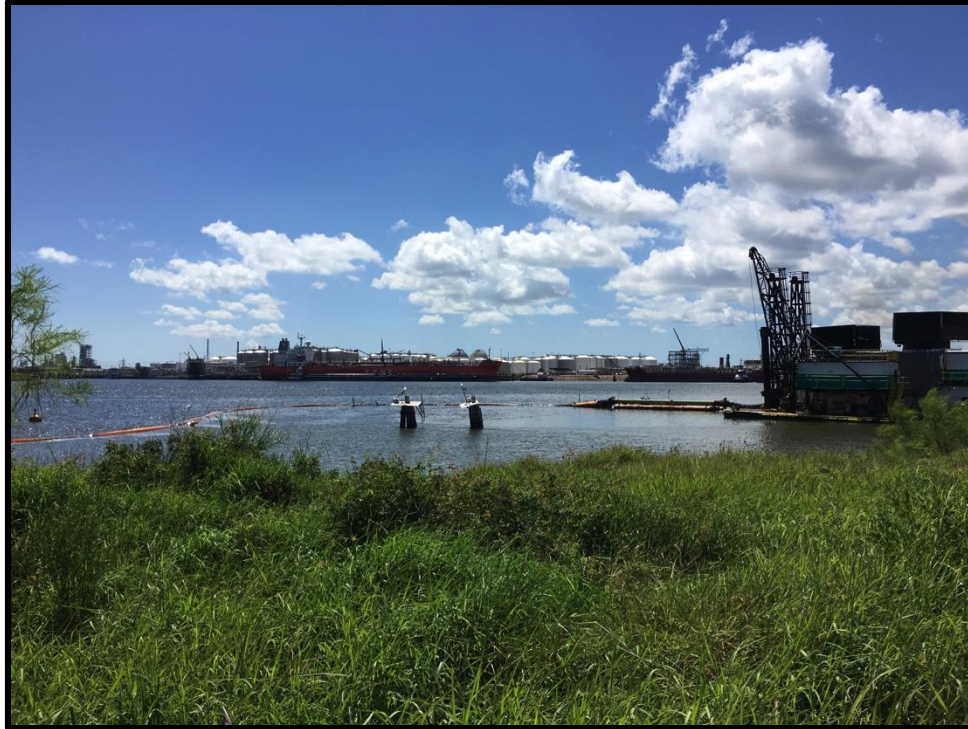
One perennial stream (CRK 1) was identified within the survey area of the proposed project. Portions of the survey area of the proposed project intersect the Bayport Ship Channel, a waterbody dredged for ship traffic connecting to the Houston Ship Channel. The Bayport Ship Channel is considered a TNW and subject to USACE jurisdiction under Section 10 of the RHA.

Photo 7: View of CRK 1, the Bayport Ship Channel, a perennial stream located within the survey area.
