# Hickory Cove Marsh Restoration And Living Shoreline

Bridge City, TX

WRDA 2016 Section 1122  
Beneficial Use of Dredged Material  
Appendix A: Engineering

U.S. Army Corps of Engineers  
Southwest Division  
Galveston District

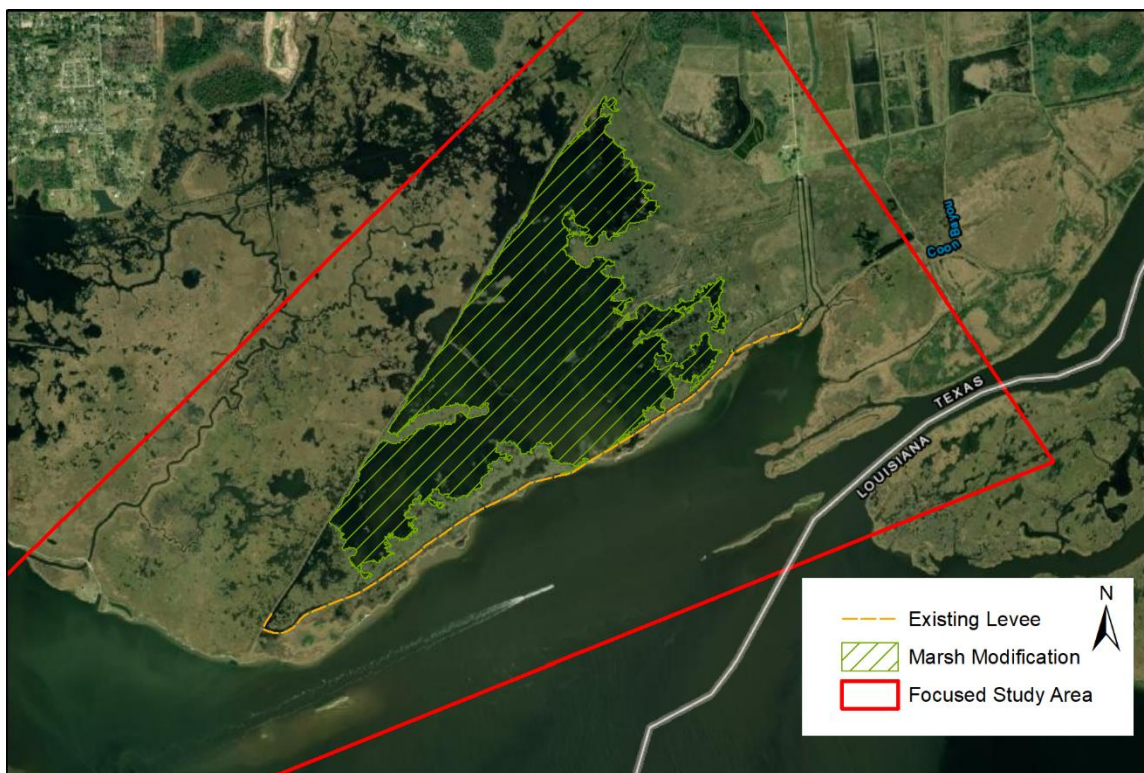
Figure 4. Hickory Cove Alternative 1

**Alternative 1:** This alternative focuses on restoring marsh to a target elevation for vegetation establishment utilizing dredged material. It will also restore an existing but breached privately owned containment dike (fig. 4).

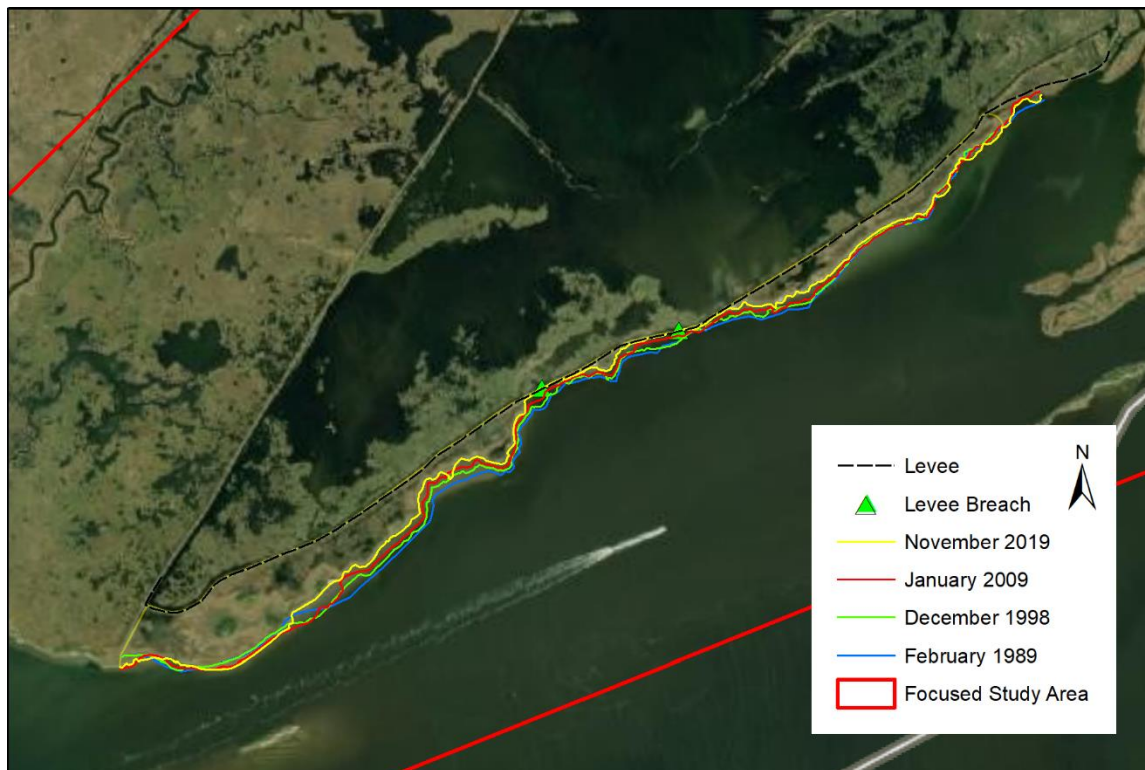
Figure 20. Shoreline Change from 1989 to 2019 at Hickory Cove based on Aerial Imagery

The shoreline of Hickory Cove Bay has eroded due to the wave climate exacerbated by navigation traffic and wind waves generated across Sabine Lake Estuary. While some isolated areas have accreted or remained generally intact, much of the shoreline has experienced significant loss. The General Marsh Model, a decision support tool developed by Ducks Unlimited (2013), identified Hickory Cove bay as a high and medium priority candidate for shoreline protection. Aerial imagery was utilized to demonstrate the shoreline change from 1989 to 2019, as shown in Figure 20. Consistent with the General Marsh Model results shown in Figure 21, the central exposed region of the shoreline has eroded significantly to the point that the containment levee surrounding the marsh has been breached in multiple locations.

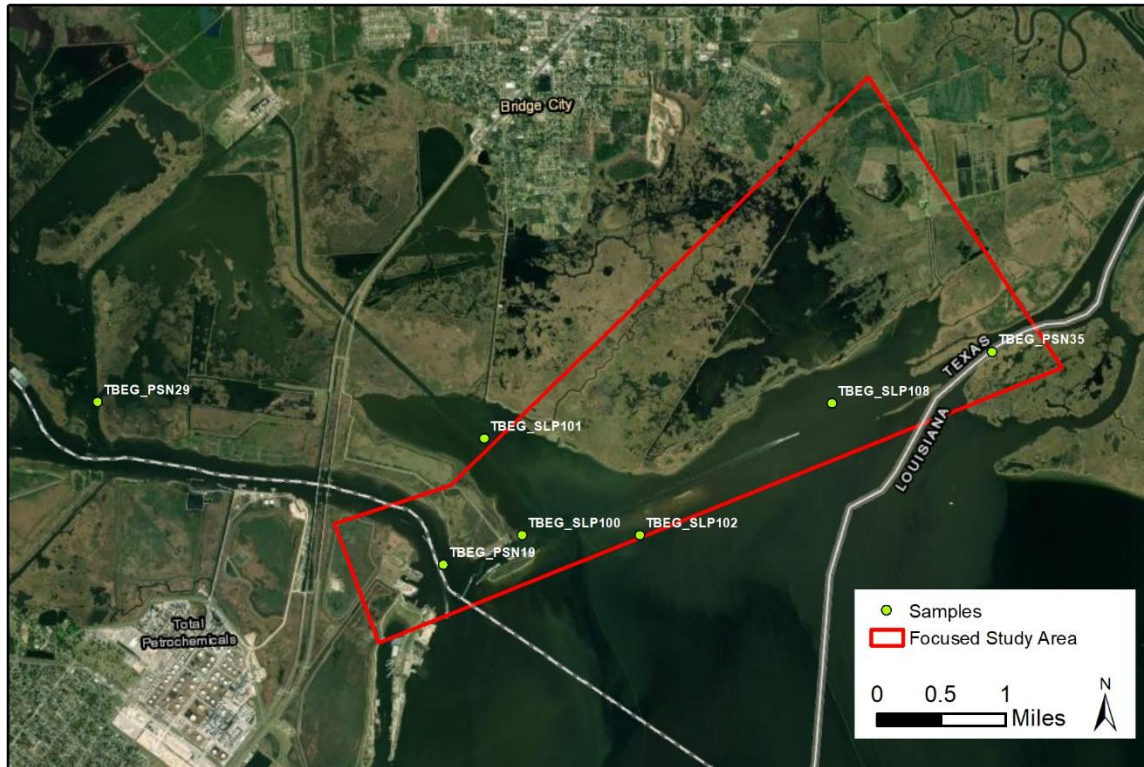
Figure 25. TxSed Samples in or near the study area (GLO, 2017)

Table 4. Sediment Sample Summary of Grab Samples in Figure 25
