## **Hazardous, Toxic and Radioactive Waste Review**

**Coastal Texas Protection and Restoration  
Feasibility Study**

**Hazardous, Toxic, and Radioactive Waste (HTRW) Assessment for the Coastal Texas  
Protection and Restoration Study**

# **DRAFT HAZARDOUS, TOXIC, AND RADIOACTIVE WASTE (HTRW) ASSESSMENT FOR THE COASTAL TEXAS PROTECTION AND RESTORATION STUDY**

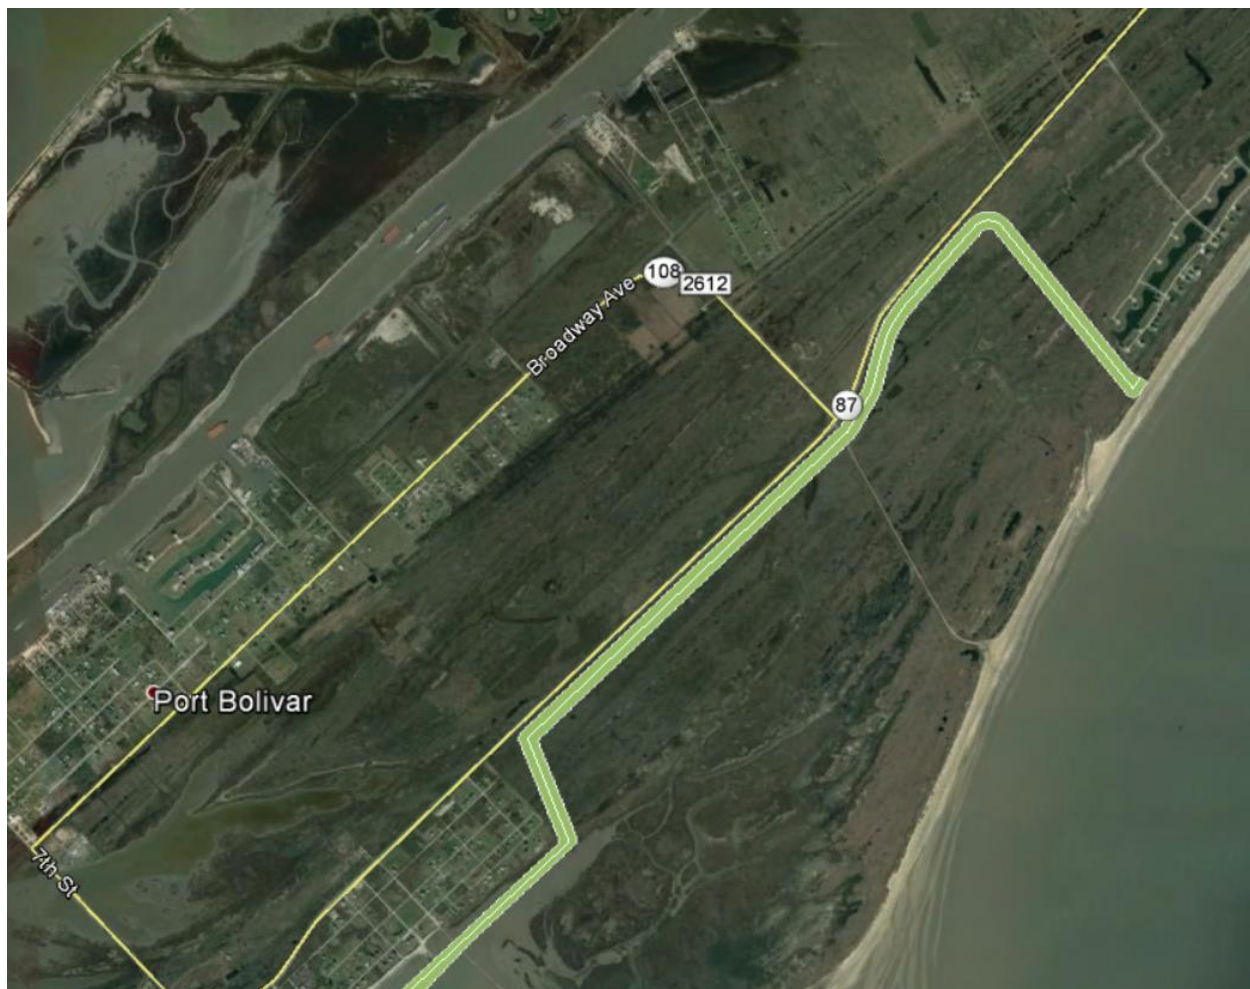
Figure 1: Current Areas of Disturbance (Marked in Green) within the Bolivar Tie-In Area

- **Bolivar Tie-In** is located on the western edge of the Bolivar Peninsula where Galveston Bay connects to the Gulf of Mexico. This study area of approximately 35,000 square feet is primarily undeveloped with recent residential development. The proposed land disturbance footprints can be seen in Figure 1.
- **Surfside B12** is located just east of Freeport where the Gulf Intracoastal Waterway (GIWW) connects to the Gulf of Mexico. While the disturbance areas within the 35,000 square feet study are mostly undeveloped areas, they run adjacent to industrial, commercial, and residential properties. The proposed land disturbance footprints can be seen in Figure 2.

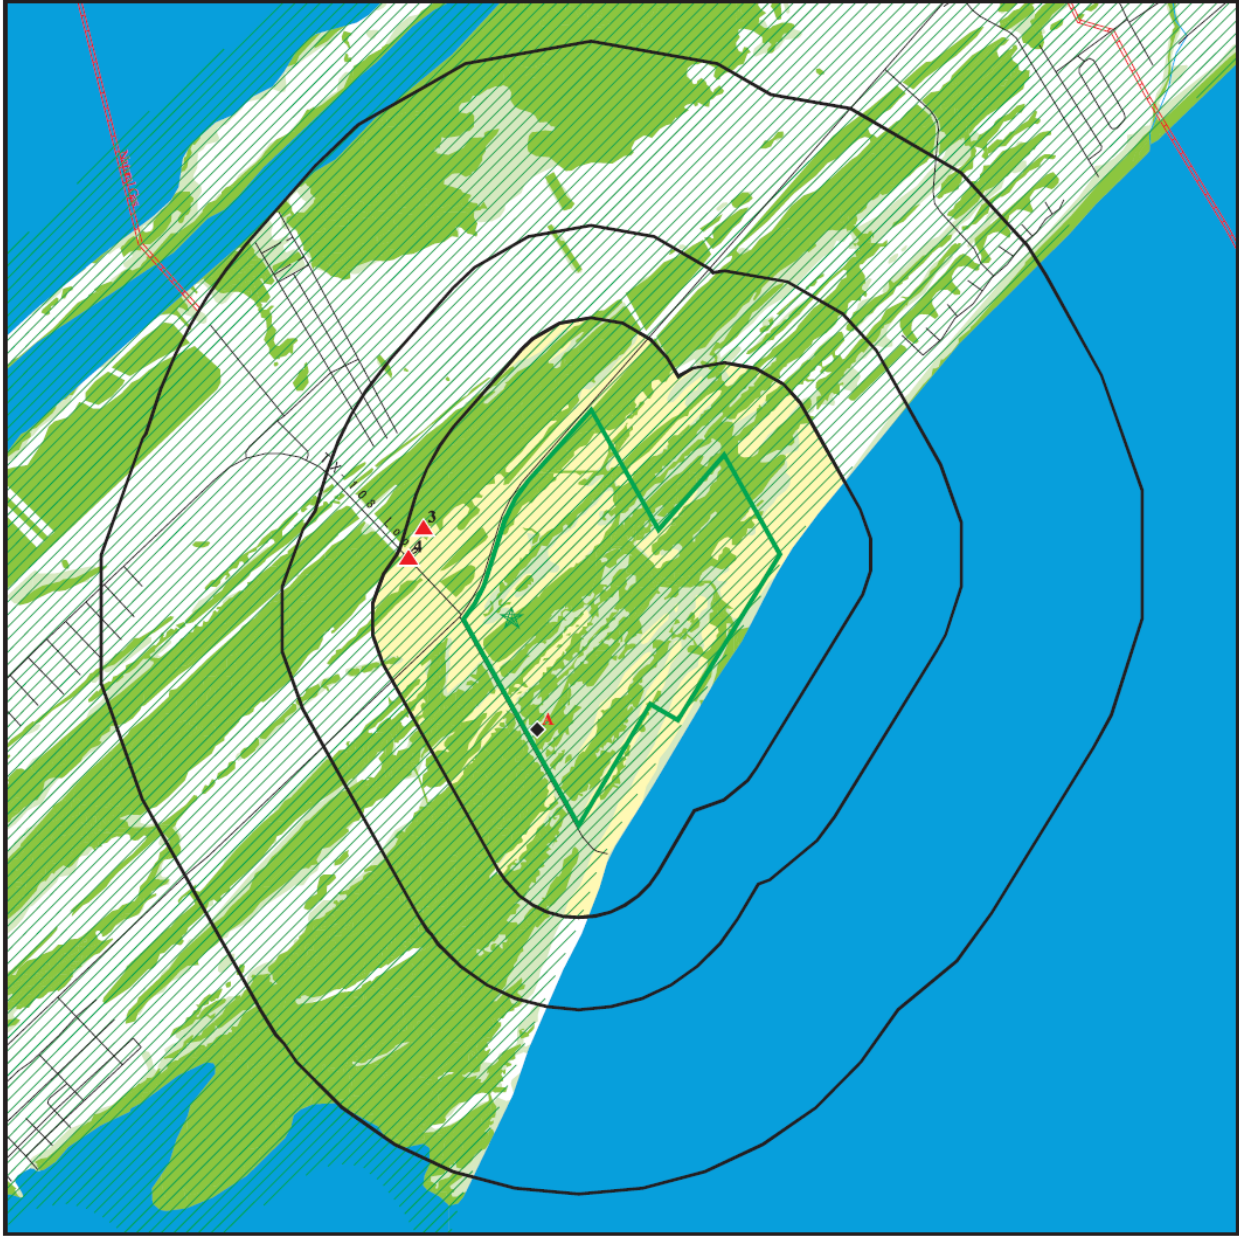
Figure 3: Bolivar Tie-In Table and Map of Potential Recognized Environmental Concerns

The potential RECs discovered in the vicinity of the Bolivar Tie-In project area are summarized in Figure 3. The full executive summary along with potential REC descriptions can be found in Appendix C. These identified REC are currently outside of the current project footprints and should not adversely affect the project unless disturbance areas change.

MAP ID	SITE NAME	ADDRESS	DATABASE ACRONYMS	RELATIVE ELEVATION	DIST (ft. & mi.)
A1	BOLIVAR DUMP	W OF OLD DUMP RD (RE	CLI	Lower	1 ft.
A2	BOLIVAR DUMP	W OF OLD DUMP ROAD (	CLI	Lower	1 ft.
3		INTERSECTION OF KING	VCP	Higher	1082, 0.205, NW
4		TX-108	VCP	Higher	1154, 0.219, WNW

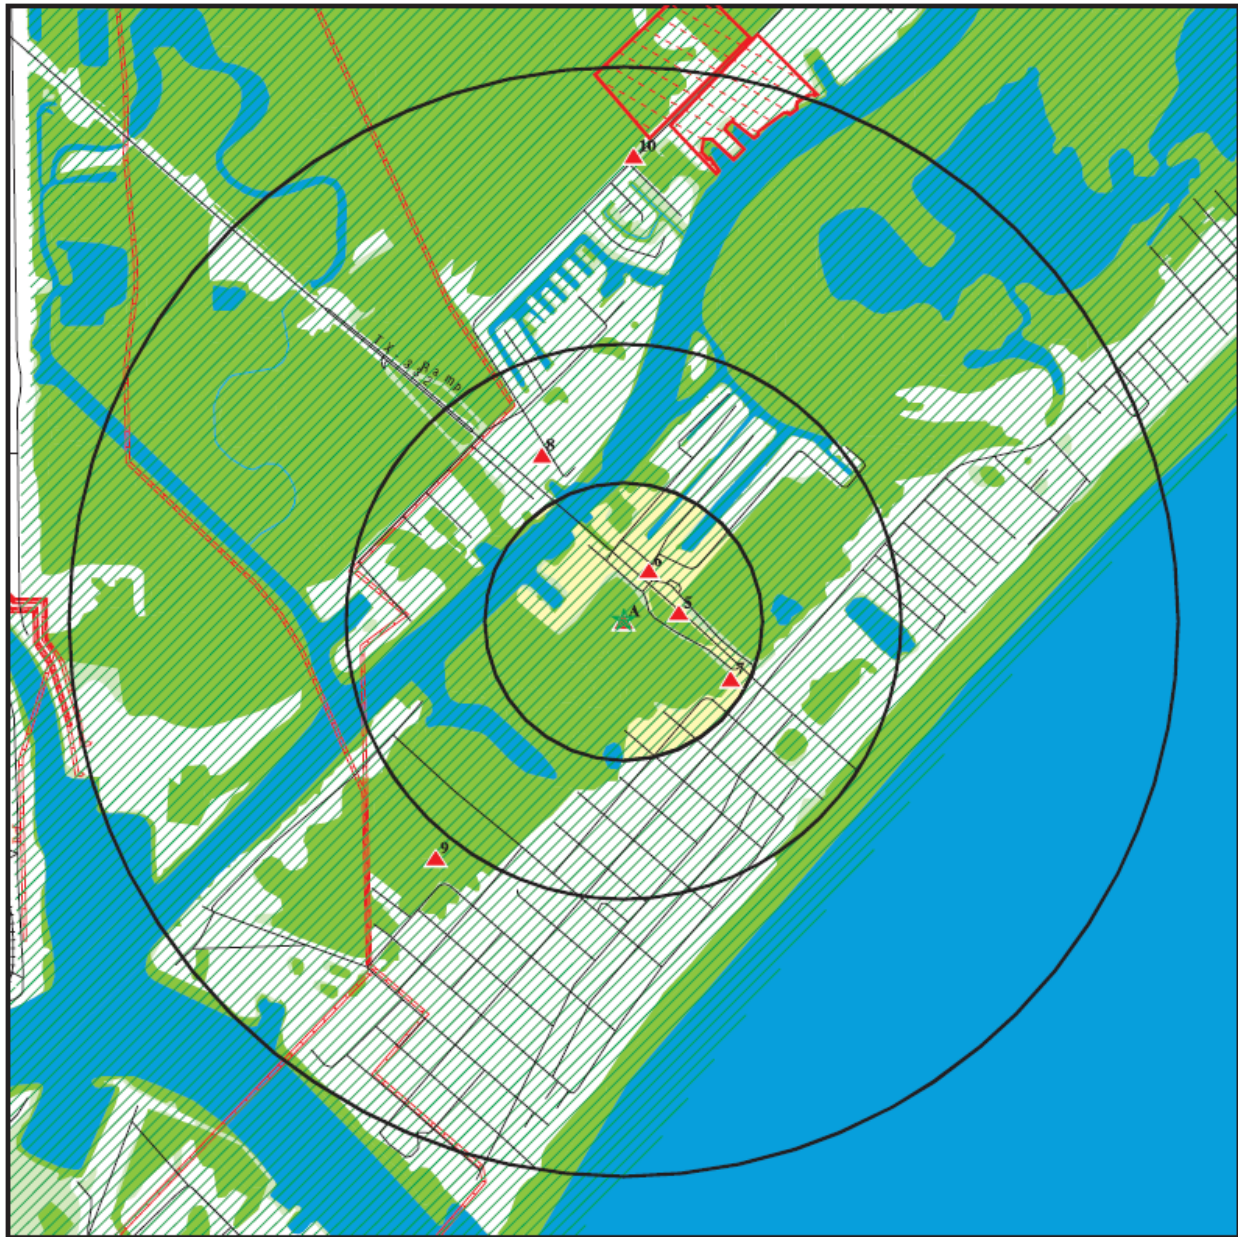
Figure 4: Surfside B-12 Table and Map of Potential Recognized Environmental Concerns

The potential RECs discovered in the vicinity of the Surfside B-12 project area are summarized in Figure 4. The full executive summary along with potential REC descriptions can be found in Appendix E. These identified REC are currently outside of the current project footprints and should not adversely affect the project unless disturbance areas change. The REC with the highest chance of impacting the project are from the National Priority List (NPL), also known as Superfund site, GULFCO MARINE MAINTENANCE. The project area is currently separated from the NPL site by the canal preventing aboveground direct contact. However, contaminated groundwater migration is possible.

MAP ID	SITE NAME	ADDRESS	DATABASE ACRONYMS	RELATIVE ELEVATION	DIST (ft. & mi.) DIRECTION
A1		827 GULF RD.	ERNS		TP
A2	SALESMAN-L607	827 GULF RD	CENTRAL REGISTRY		TP
A3	SURFSIDE INTEREST LL	827 GULF ROAD	TIER 2		TP
A4		827 GULF RD.	ERNS		TP
Reg	GULFCO MARINE MAINTENANCE	BRAZORIA COUNTY RD 7	NPL, SEMS, US ENG CONTROLS, US INST CONTROL, ROD,...	Same	4355, 0.825, NNE
5	GSI GULF STATES INC	611 E HWY 332 518 LO	EDR Hist Auto	Higher	532, 0.101, East
6	CONTAINER CARRIERS	HWY 332	UST	Higher	540, 0.102, NNE
7	SURFSIDE GROCERY	409 E HIGHWAY 332	UST	Higher	1158, 0.219, ESE
8	TESORO MARINE SERVICE	1018 TARPON LN	VCP, TIER 2, CENTRAL REGISTRY	Higher	1764, 0.334, NNW
9	GALVESTON ARMY AIRFIELD		FUDS	Higher	2874, 0.544, SW
10	HERCULES MARINE SERVICE	906 MARLIN AVE	SEMS-ARCHIVE, CORRACTS, RCRA NonGen / NLR	Higher	4431, 0.839, North
