# The Resacas

In the Vicinity of the City of Brownsville, Texas  
Interim Ecosystem Restoration Feasibility Study  
and Environmental Assessment

**FINAL February 2018**

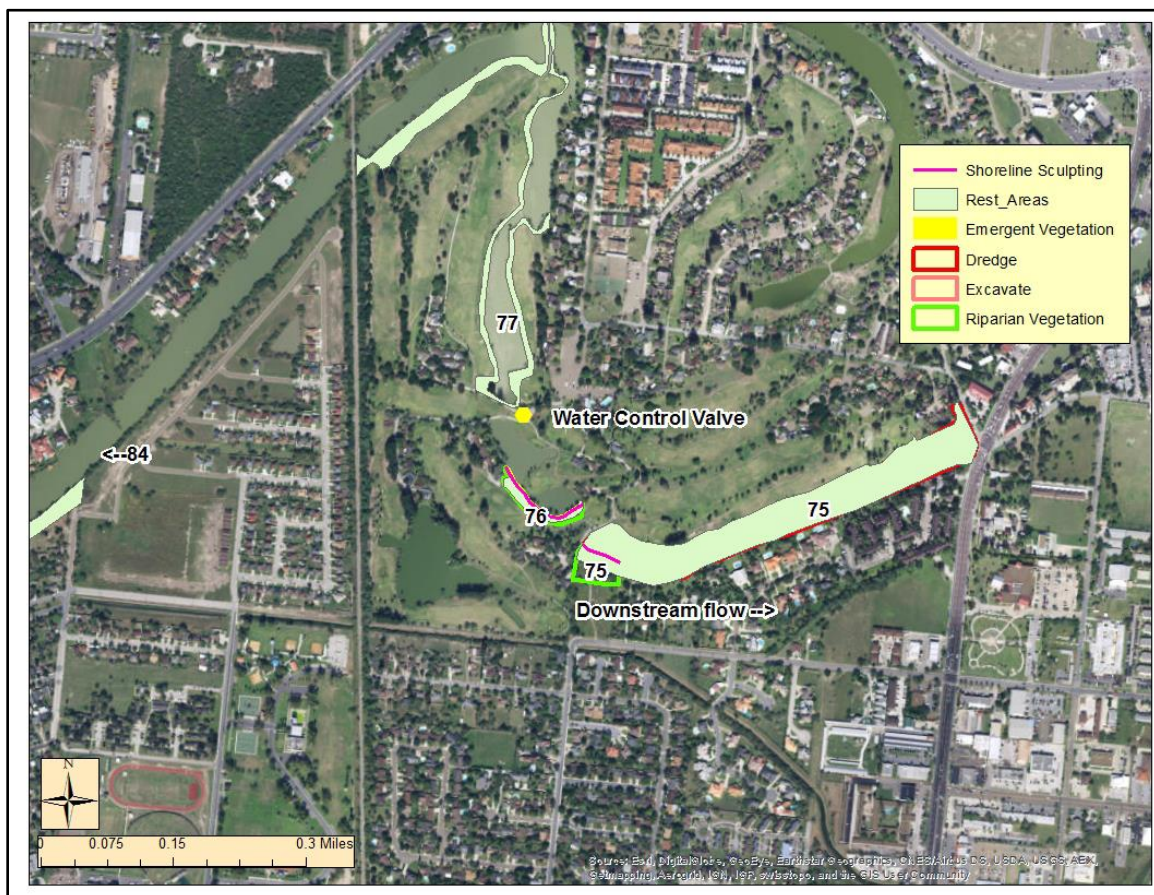
Figure A- 10: Example of water supply control for Resaca de la Guerra at the City of Brownsville Country Club.

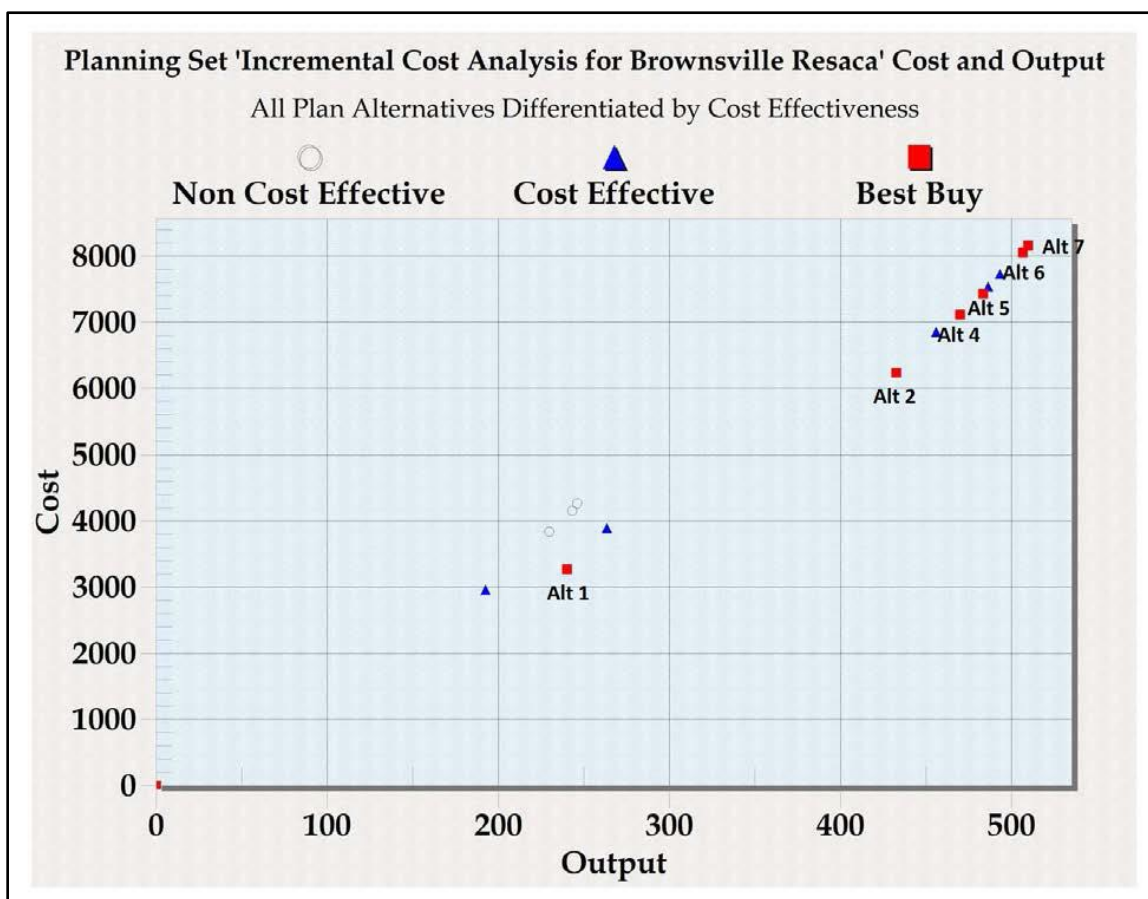
Figure A-11: CE/ICA Cost-effective and Best-buy Alternatives.

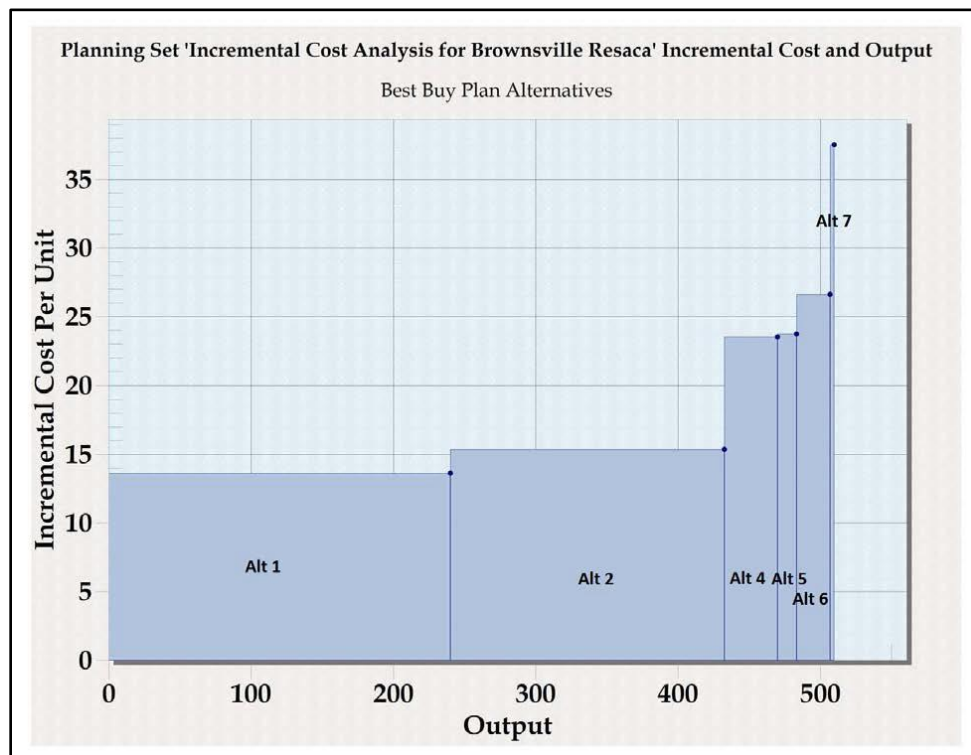
Figure A-12: Best Buy Array from CE/ICA.

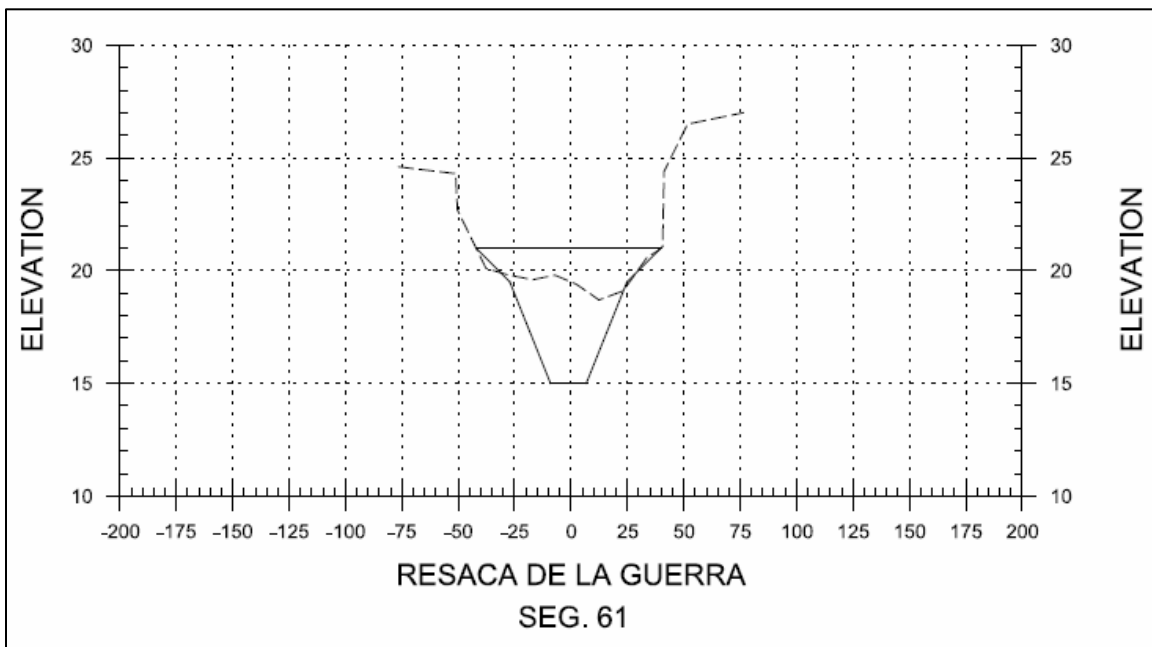
Figure E-1-2: Surveyed cross section of Segment 61

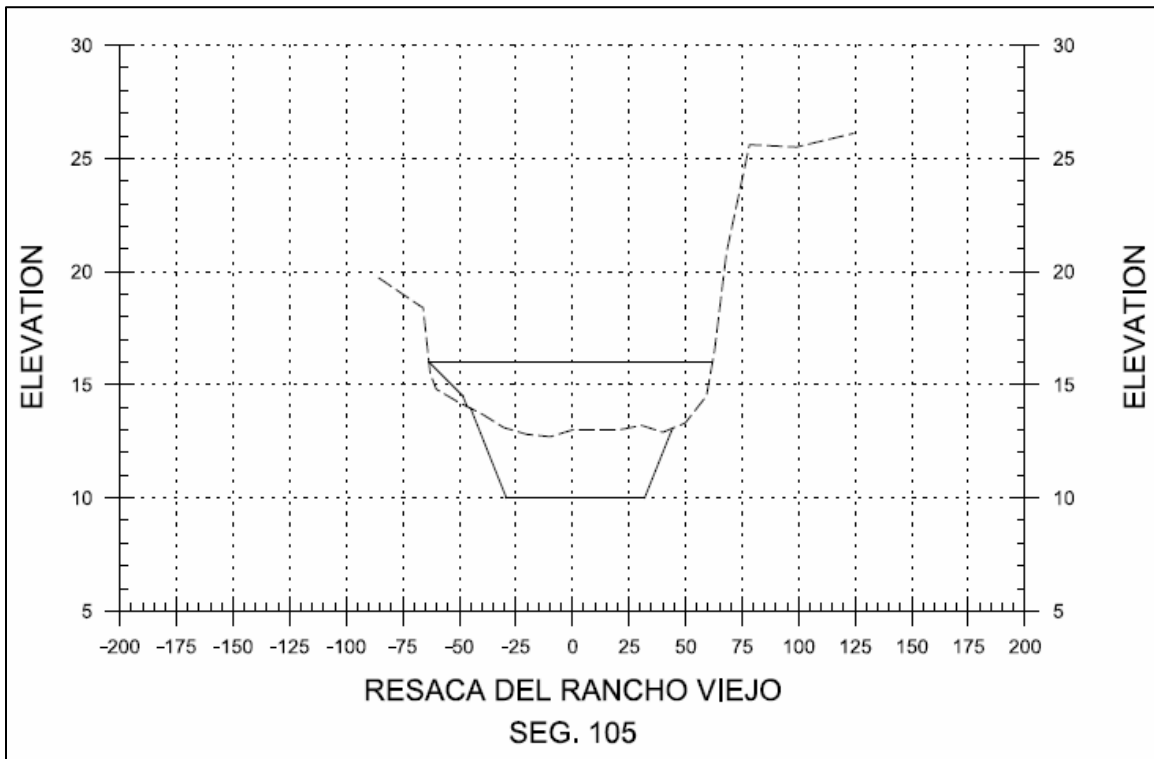
Figure E-1-4: Surveyed cross section of Segment 105
