**PERMITTEE RESPONSIBLE MITIGATION PLAN**

**THE CITY OF PORT ARANSAS OUTFALL PROJECT**

**NUECES COUNTY, TEXAS**

**DELTA LAND SERVICES, LLC**

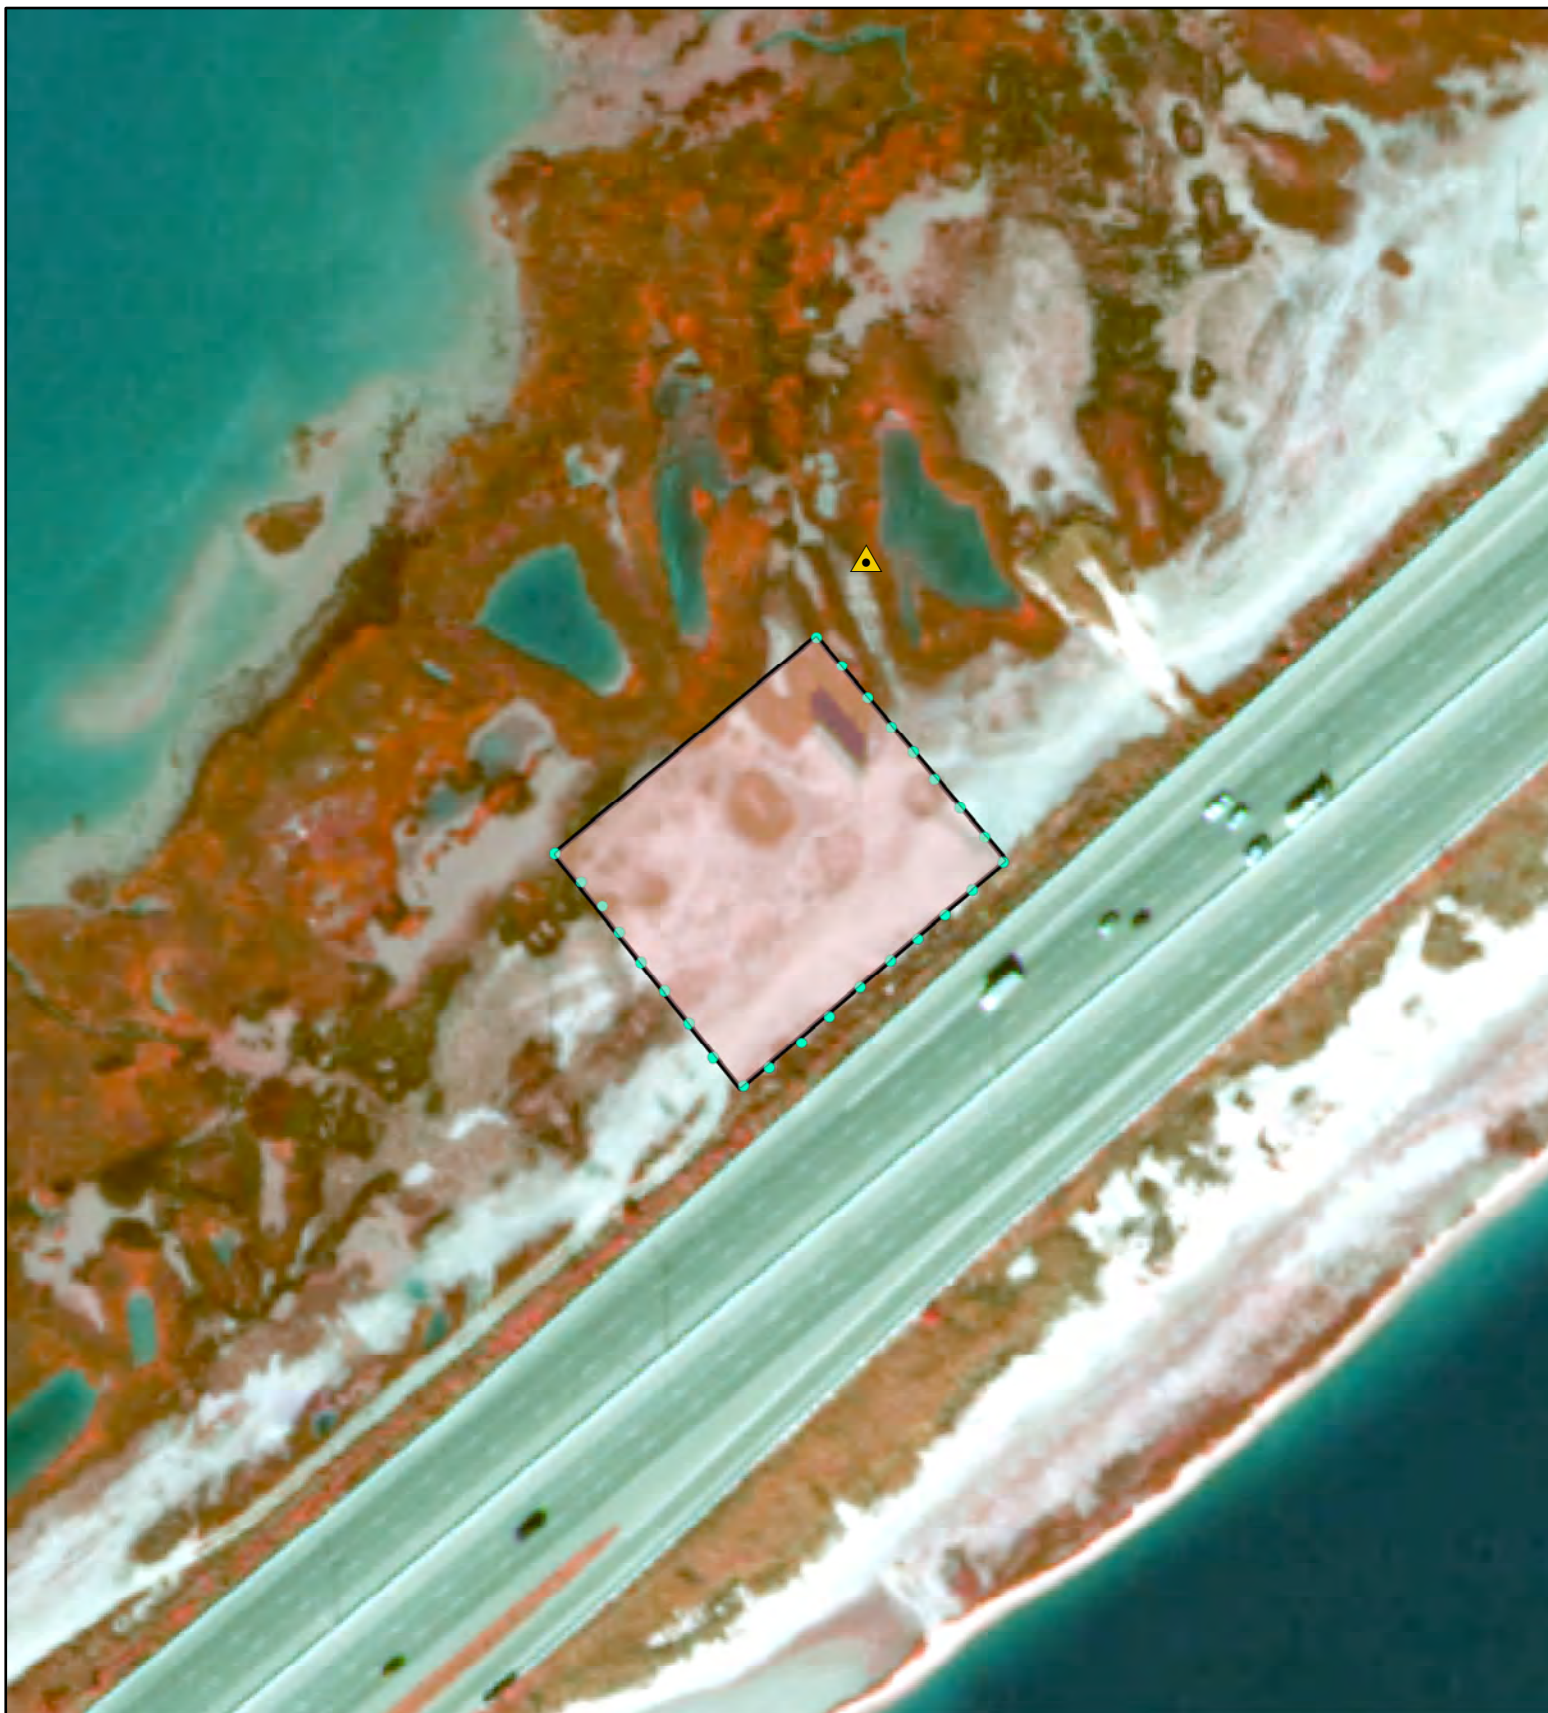
FIGURE 1

- Figure 1. Vicinity and Watershed Map
- Figure 2. Wetland Restoration Map
- Figure 3. USGS 7.5 Minute Quadrangle Map
- Figure 4. LIDAR Map
- Figure 5. Aquatic Resource Map
- Figure 6. National Wetland Inventory Map
- Figure 7. 2009 Aerial Photograph
- Figure 8. SSURGO Map

The City of Port Aransas (COPA), Texas (Permittee) presents this Permittee Responsible Mitigation Plan (PRMP) to compensate for the proposed wetland impacts associated with the construction of COPA Storm Water Outfall in South Corpus Christi Bay Watershed (Hydrologic Unit Code [HUC] 12110202<sup>1</sup> (**Appendix A, Figure 1**). The Permittee Responsible Mitigation Area (PRMA) is within the North Corpus Christi Bay Watershed (HUC 12110201). The wetland impact and mitigation areas are in the United States Army Corps of Engineers (USACE), Galveston District (CESWG). This PRMP is prepared in accordance with the Compensatory Mitigation for Losses of Aquatic Resources (33 CFR § 332.1<sup>2</sup>).

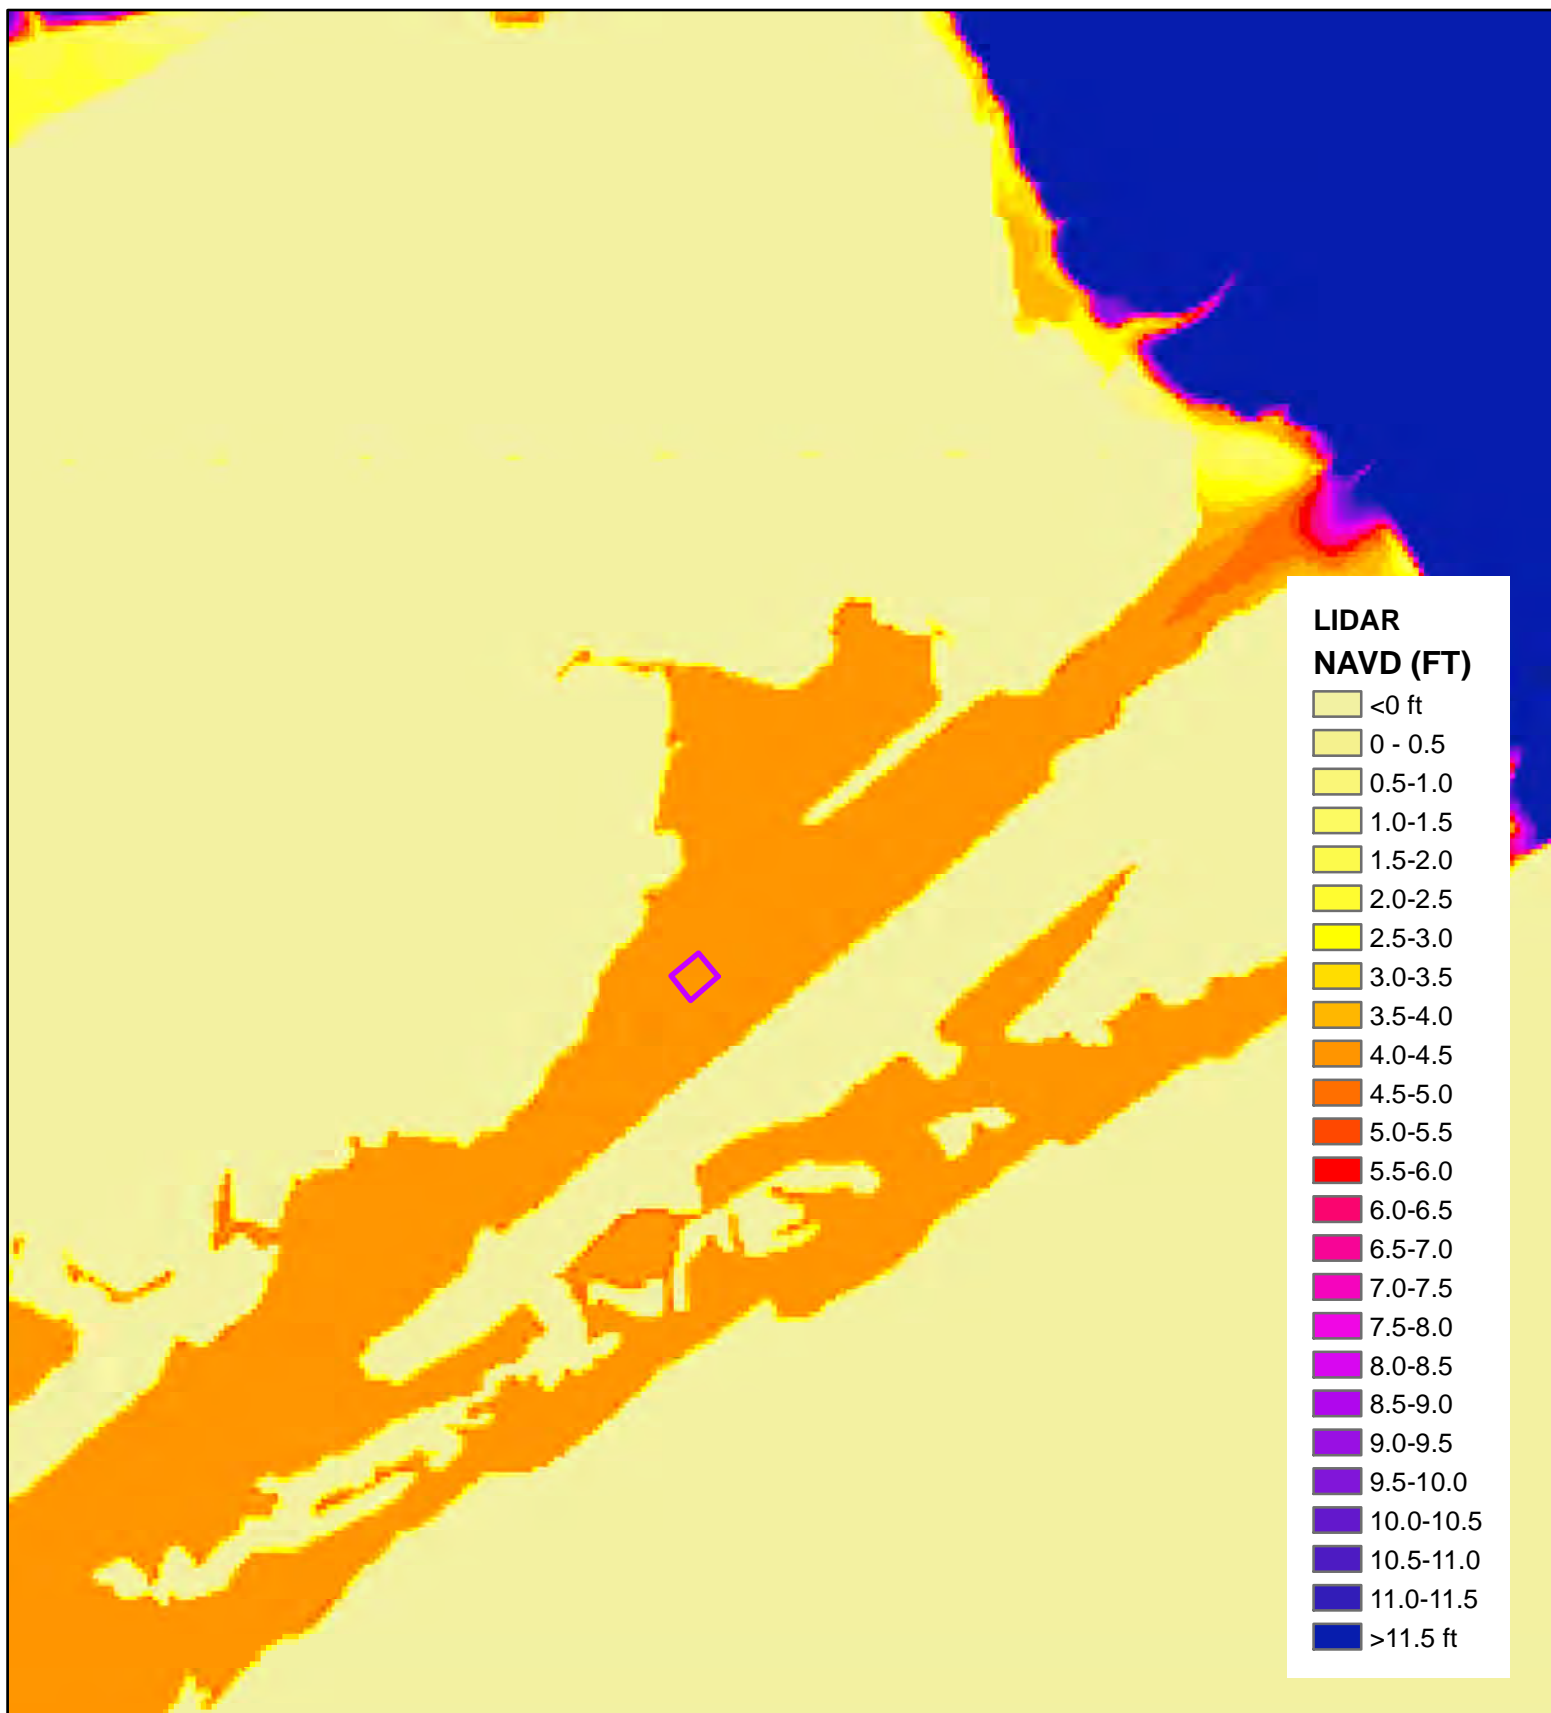
**FIGURE 4**

**Legend**  
 PRMA (1.0 ac)

The PRMA is mapped as less than or equal to 2.0-feet NAVD (**Appendix A, Figure 4**) and as Estuarine Intertidal Unconsolidated Shore (E2USP [USFWS 2023]; **Appendix A, Figure 5**). The PRMA is influenced by the tidal ebb and flood of the Nueces Bay tidal regime (**Appendix A, Figure 6**). The site exhibits wetland hydrology, hydric soils, and sparse hydrophytic vegetation. Hydrophytic cover is limited by off-road vehicle impacts (**Appendix A, Figure 7**).

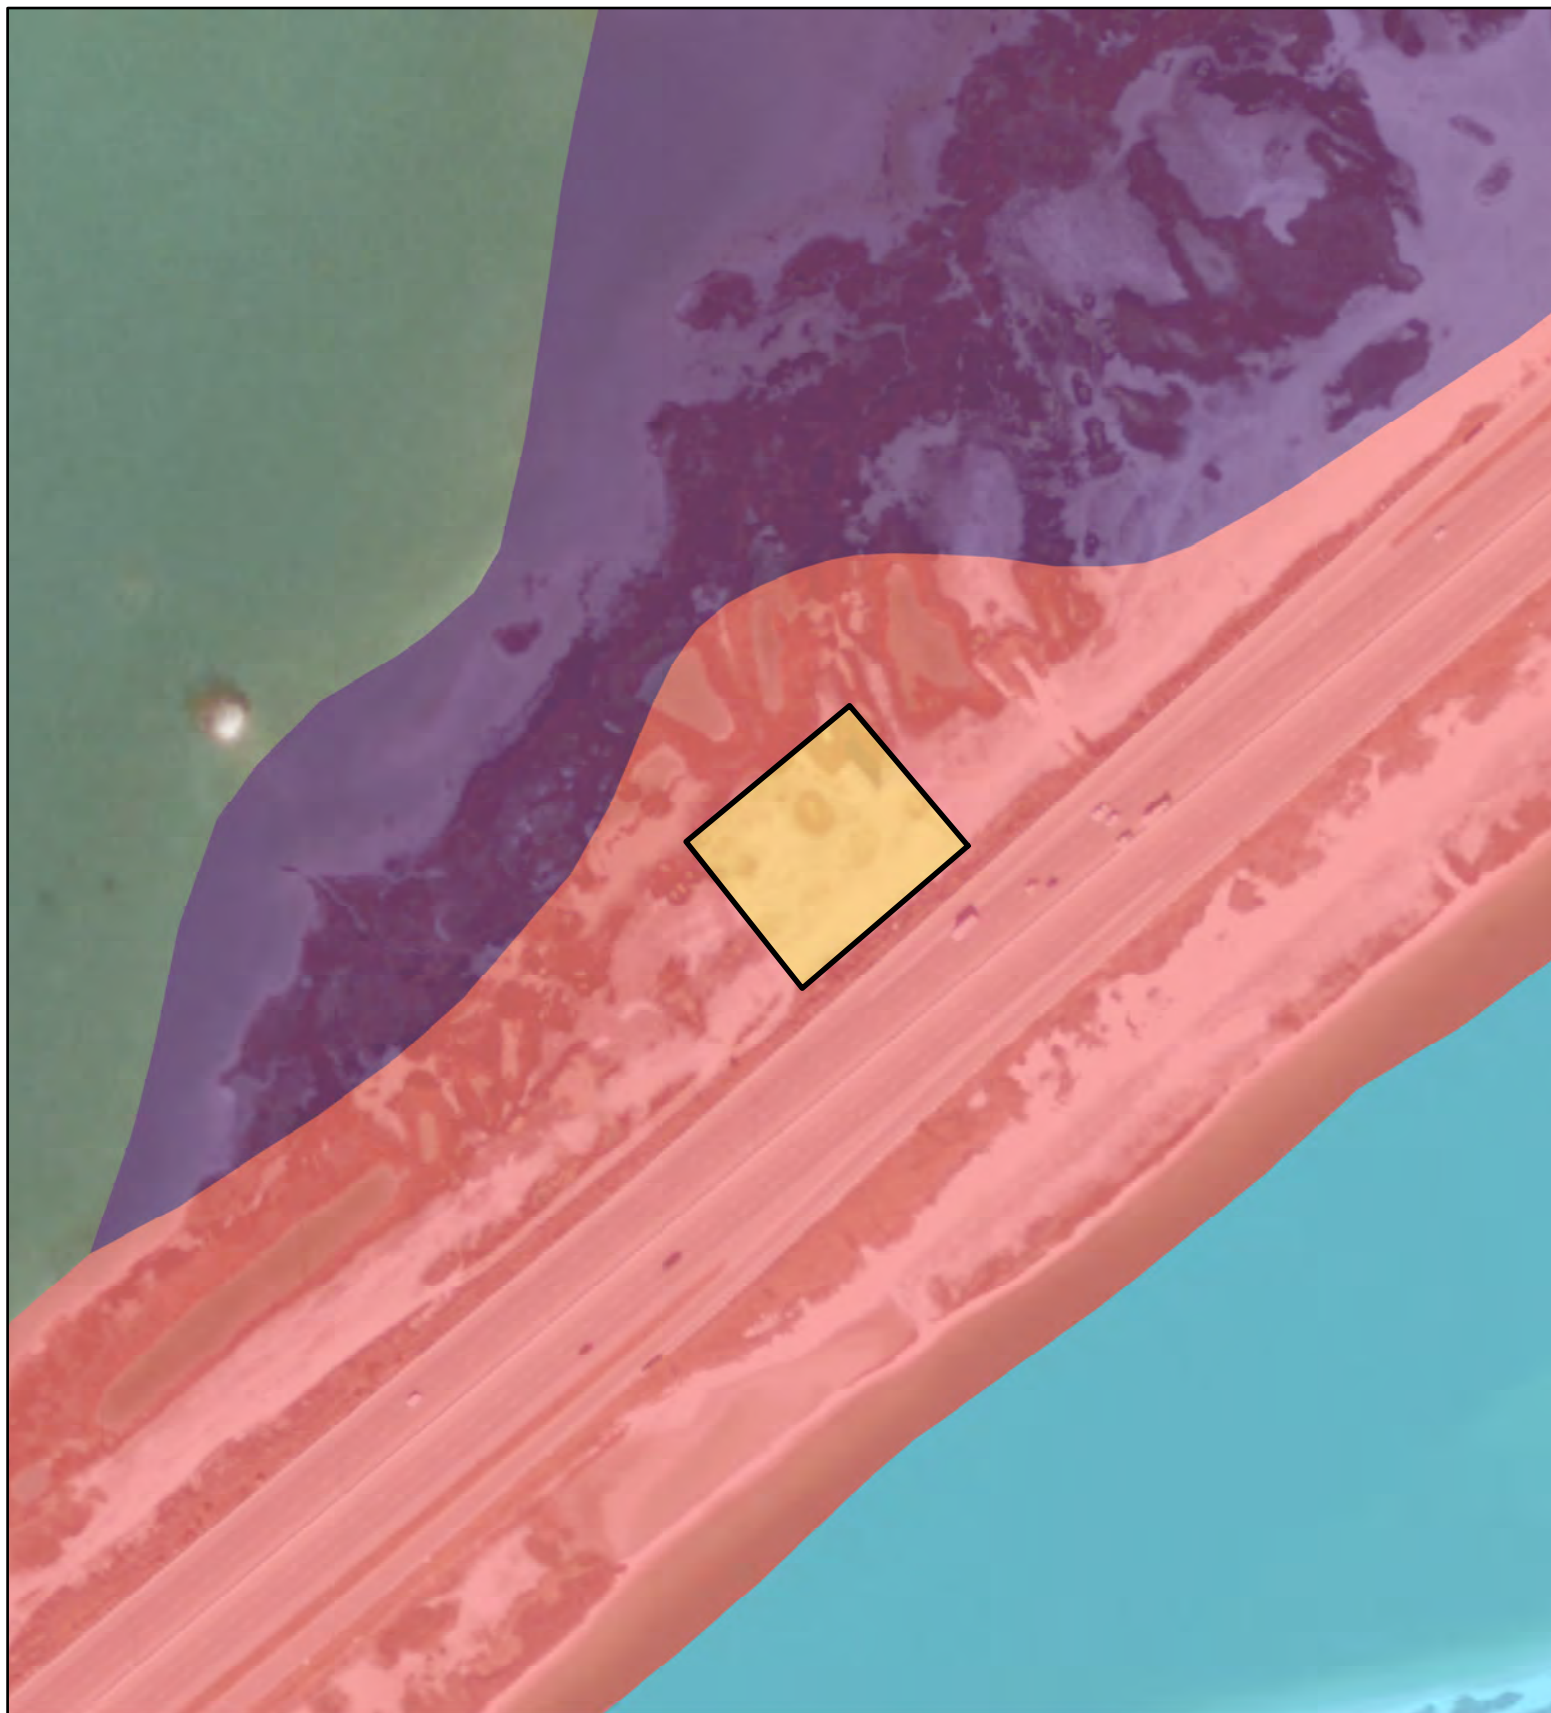
- PRMA (1.0 ac)
- Marsh Rehabilitation (1.0 ac)
- BT: Barrada-Tatton association
- Ds: Dianola soils
- W: Water

The PRMA is mapped with Dianola (Ds) soils, which are typical soils of tidal flat areas [NRCS 2020<sup>a</sup>, [Appendix A, Figure 8]]. Dianola has a 100% hydric rating, a 0-1% slope, and is frequently ponded.
