# CALL JUNCTION MITIGATION BANK

## FINAL PROSPECTUS

**SWG-2020-00693**  
**Call Junction Mitigation Bank**  
**Jasper County, Texas**

**Prepared For:**  
**US Army Corps of Engineers**  
**Galveston District**

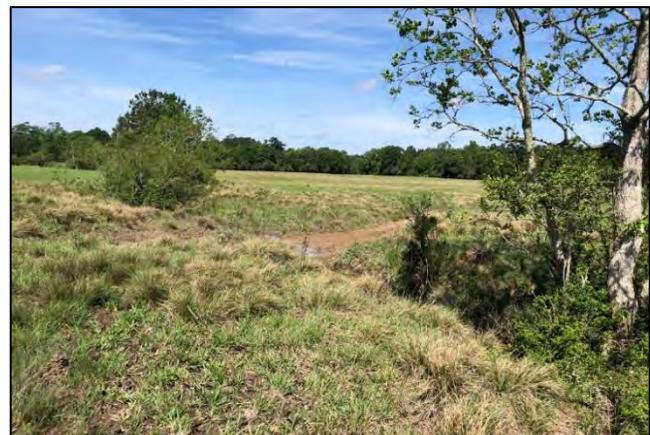
Image 1. Equipment and cattle crossing an unnamed tributary within the Bank Boundary, primarily vegetation consists of exotic invasive species such as Chinese tallow tree.

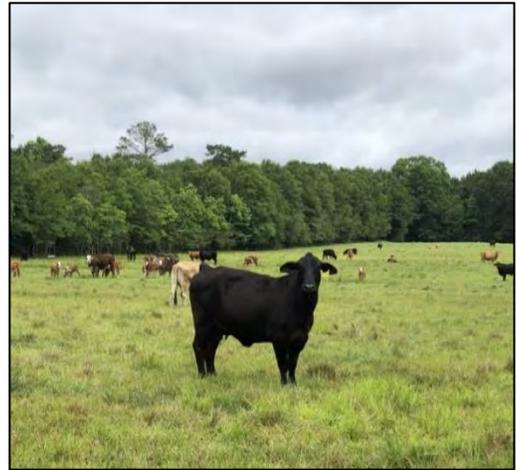
Image 2. Improved pasture grass with active cattle grazing in riparian buffer.

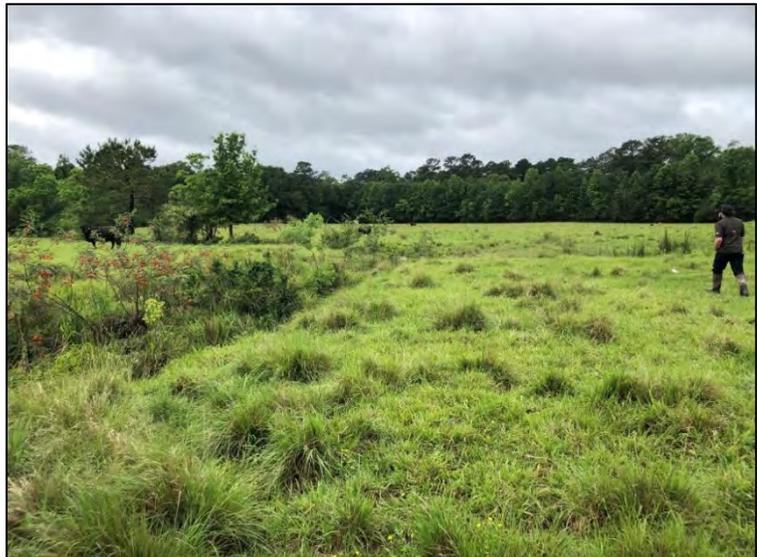
Image 4. The primary stream channel, UT 1, on the left with the confluence of UT 3 and small cattle pond to the right.
