RIVERINE FORESTED WETLAND
PERMITTEE RESPONSIBLE MITIGATION PLAN

FRACTIONATOR IX
CHAMBERS COUNTY, TEXAS

Prepared for
LONE STAR NGL MONT BELVIEU, LP

SEPTEMBER 25, 2019

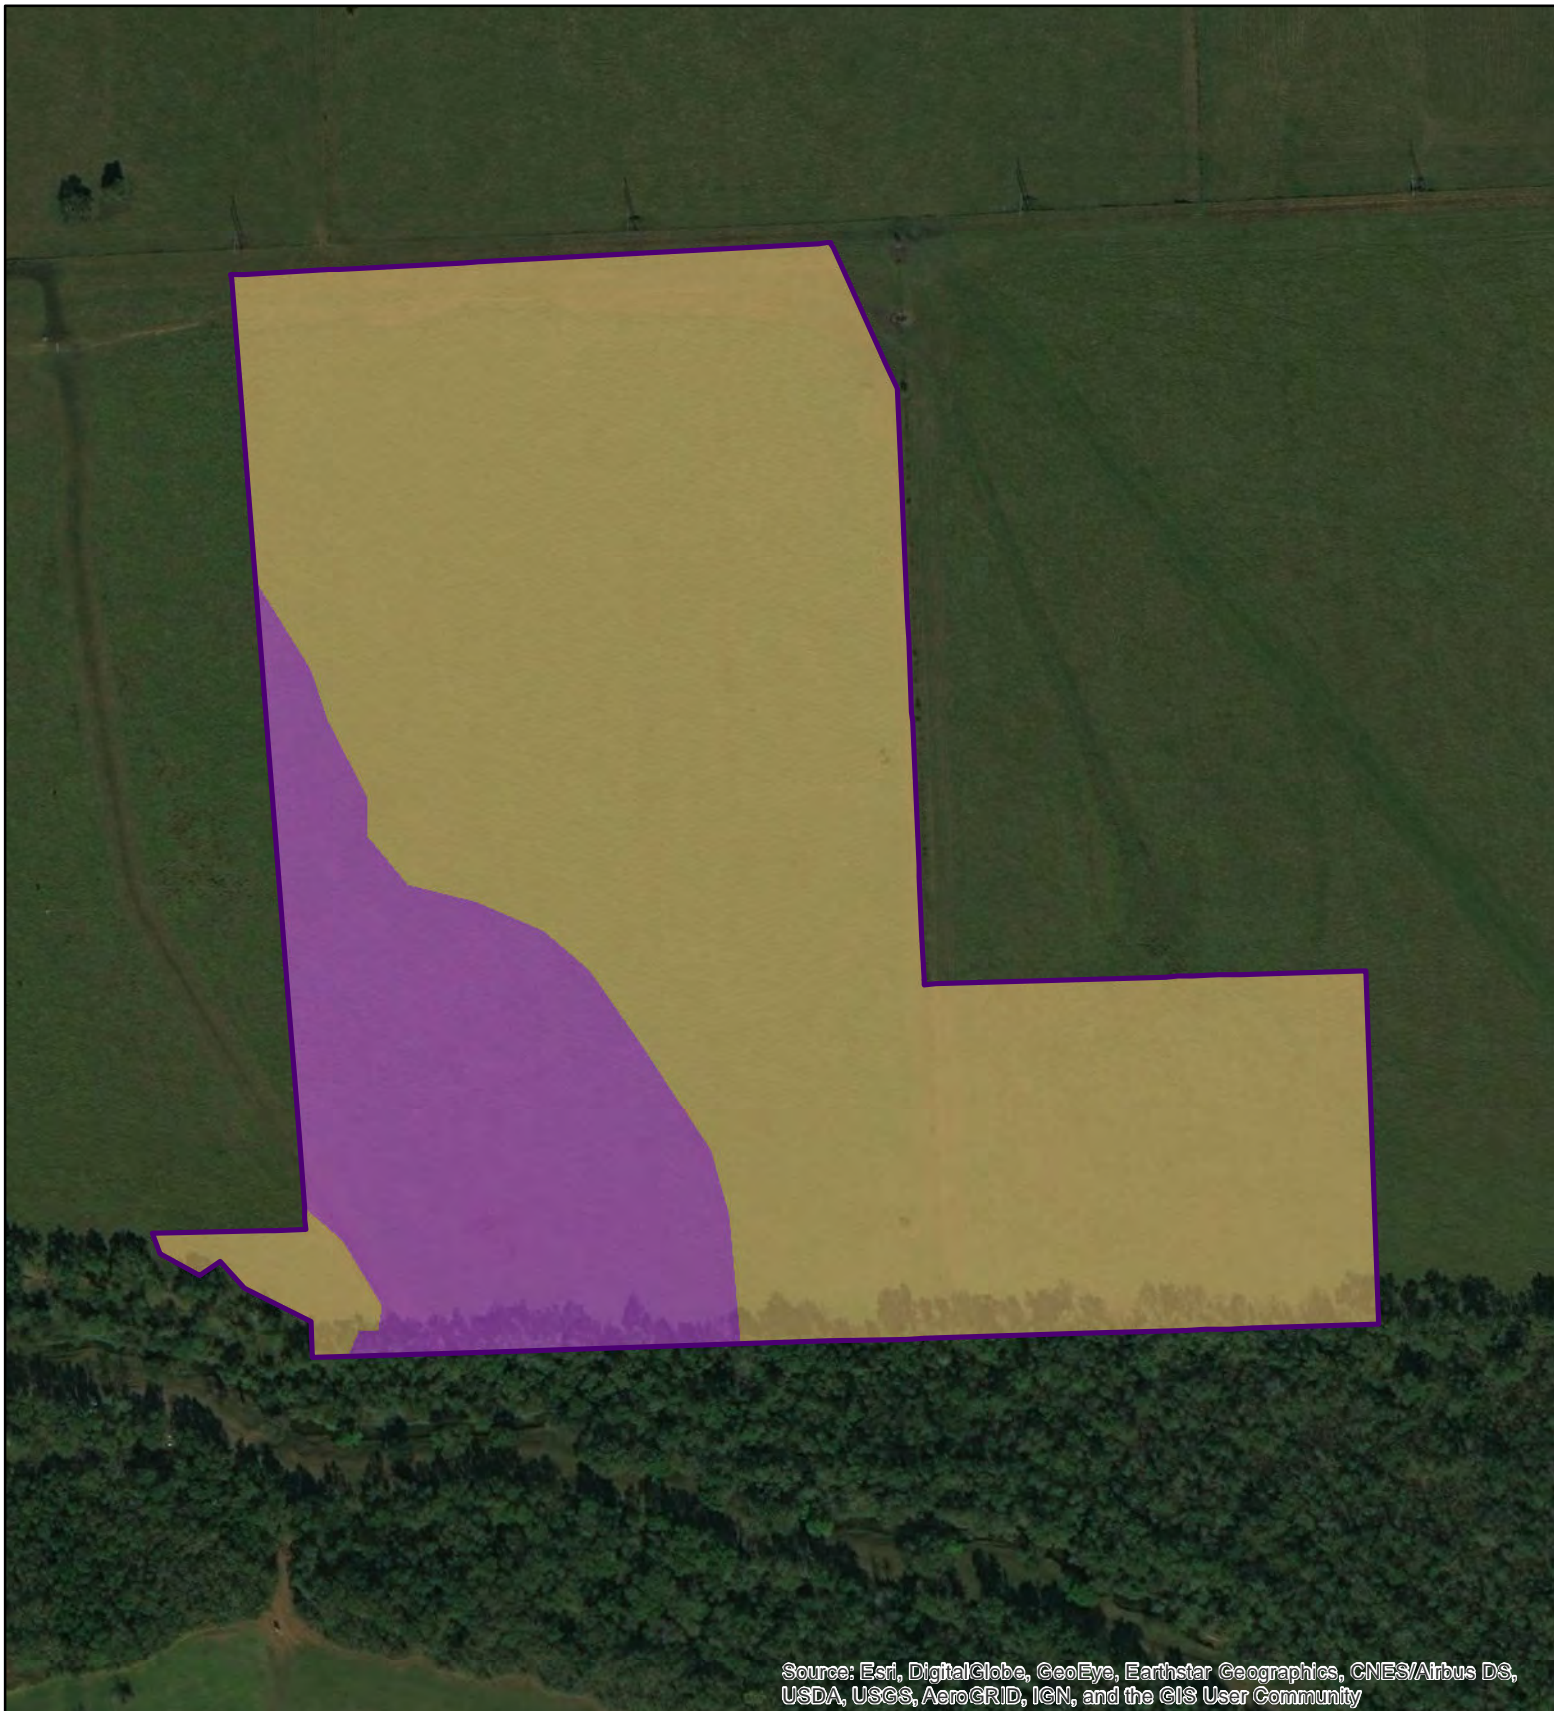
FIGURE 3

- PRM (38.7 ac)
- Re-establishment (30.5 ac)
- Rehabilitation (8.2 ac)

The goal of this PRMP is to restore¹ (rehabilitate²) 8.20 acres of PFO wetlands and re-establish³ 30.50 acres of PFO wetland located in the North Galveston Bay Watershed within the Northern Humid Gulf Coastal Prairies Level IV Ecoregion (Figure 3).

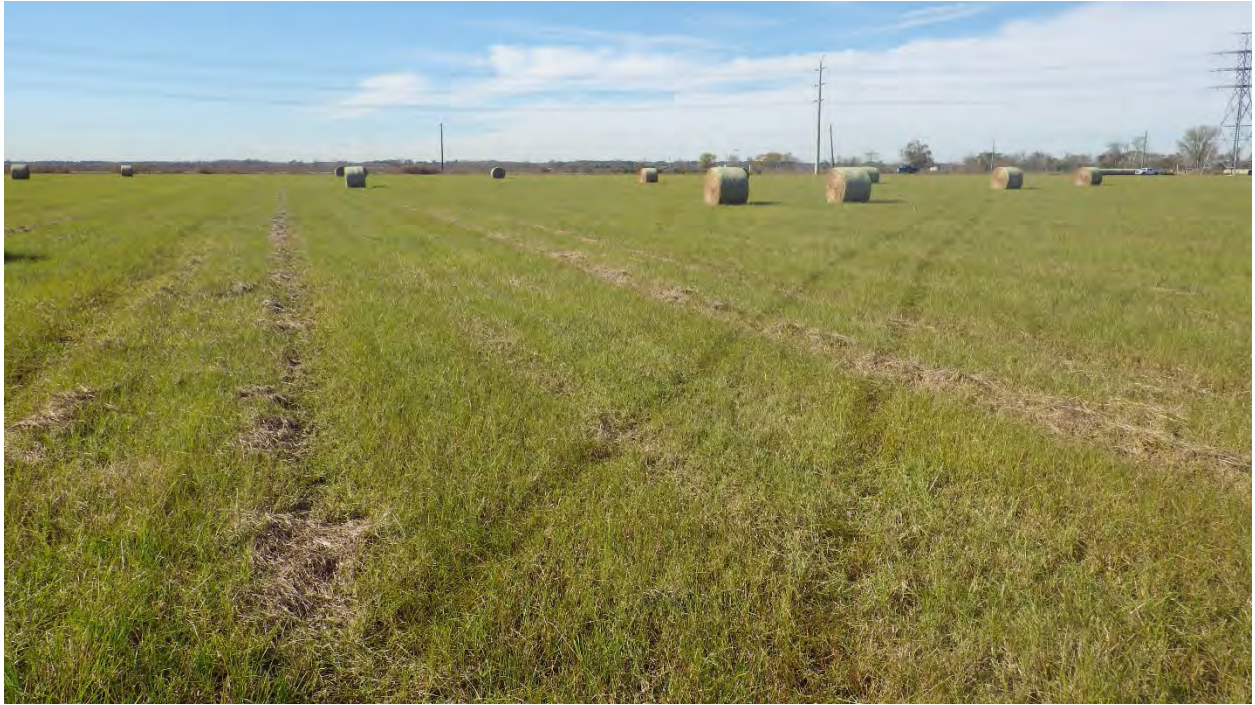
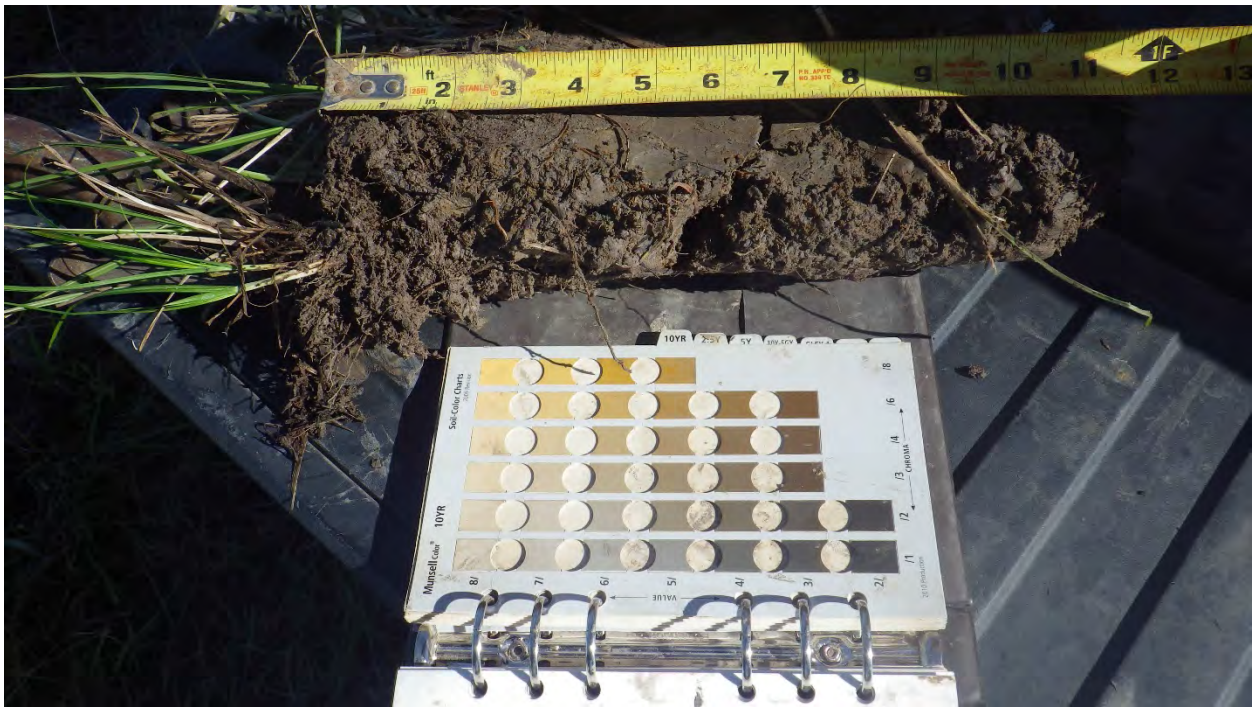
Mont Belvieu Tract DP 1

Remarks: (If observed, list morphological adaptations below).
 Photos:04-05. Hay pasture managed for Bahiagrass production.
