Final Mitigation Banking Instrument- Amendment I

*Tarkington Bayou Mitigation Bank
SWG-2015-00169*

Prepared by The Earth Partners, LP

4/10/2020

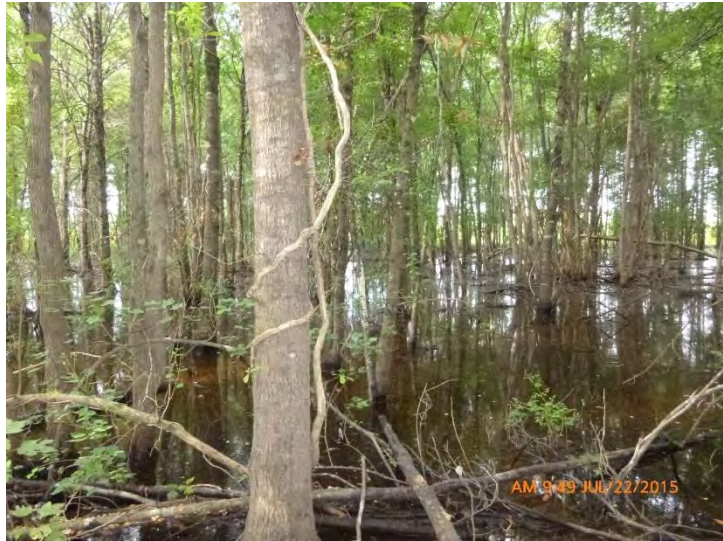
FIGURE 1: REPRESENTATIVE DEPRESSIONAL FORESTED WETLAND VEGETATION ON TBMB

The site consisted of three distinct habitat types that included depressional areas, flats, and riparian areas. The depressional areas were either forested or emergent wetlands periodically ponded throughout the year. Forested depressions within the Bank were typically represented by laurel oak (*Quercus laurifolia*), Drummond's maple (*Acer rubrum* var. *drummondii*), Chinese tallow (*Triadica sebifera*), sweetgum

(*Liquidambar styraciflua*), loblolly pine (*Pinus taeda*), common buttonbush (*Cephalanthus occidentalis*), and dwarf palmetto (*Sabal minor*). The “flat” communities were low-lying wetland areas of less than 1 percent slope and were dominated by laurel oak, loblolly pine, Drummond’s maple, Chinese tallow, and dwarf palmetto. The riparian and floodplain systems associated with Tarkington Bayou consisted of a mixture of large pine and hardwoods, including water oak (*Quercus nigra*), laurel oak, swamp chestnut oak (*Quercus michauxii*), cherrybark oak (*Quercus pagoda*), red maple (*Acer rubrum*), sweetgum, Chinese tallow, dwarf palmetto, and various understory species tolerant to moist environments (*Cephalanthus spp.*, *Vaccinium spp.*, *Viburnum spp.*, *Morella spp.*, etc.). Also within this area were pockets of bald cypress (*Taxodium distichum*) swamp. These swamps were in relatively good condition, ecologically, as the soils were too moist for commercial forestry.

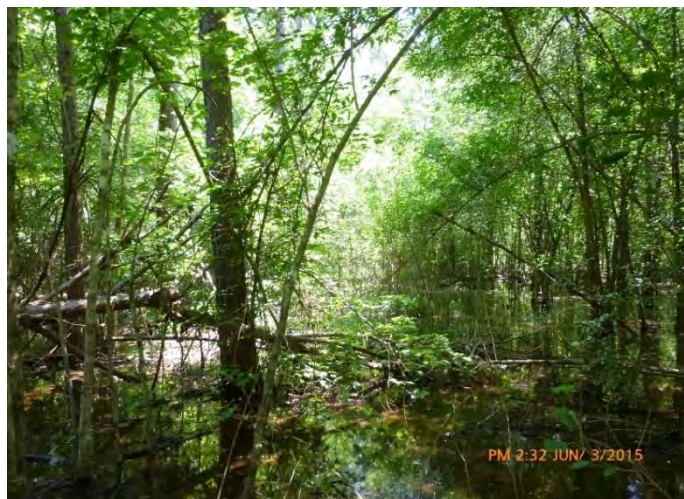
FIGURE 3: 25 YEAR-OLD PINE PLANTATION IN PRECIPITATION DRIVEN FLATS WETLAND

The “flat” communities at TBMB were low-lying forested and herbaceous wetland areas of less than 1 percent slope and were dominated by laurel oak, loblolly pine, Drummond’s maple, Chinese tallow, and dwarf palmetto. Historically, flats were usually ancient abandoned river terraces with alluvial soils and diverse topography. The mima mounds, hillocks of former point bars, and depressions of former channels created a diverse and heterogeneous landscape where water from precipitation ponds for extended periods during the growing season. Water on-site flowed slowly in a southeasterly direction from the “flat” communities, both as surface flows and as groundwater atop an argillic horizon, until it eventually entered Long Branch, a tributary to Luce Bayou. Representative soils for the flats were Waller loam depressional (Wc), Waller loam (Wa), and Kirbyville fine sandy loam (Kr) (Appendix E). Except for the herbaceous flats (WAA 7), most wetlands considered “flats” have been significantly impacted by silviculture activities. Various age classes of pine plantation are represented, and an area with raised beds and significantly altered hydrology (WAAs 11 and 13a) was within this area. Figure 3 is an example of a “flats” wetlands on-site.

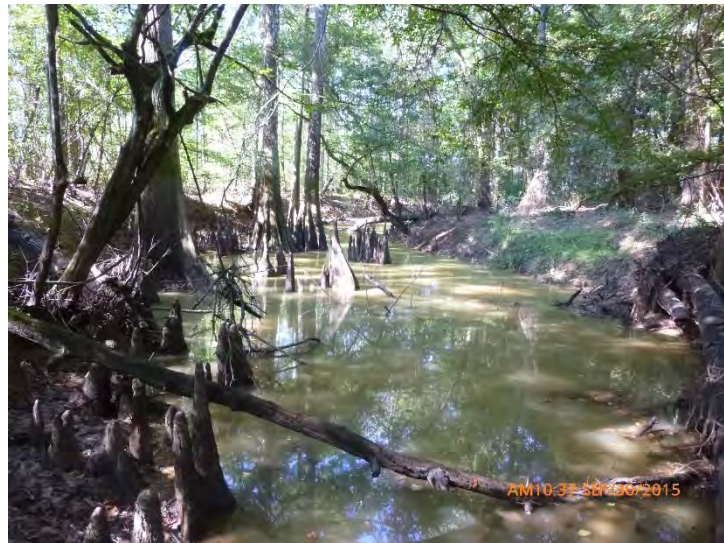
FIGURE 4: AN EXAMPLE PERENNIAL REACH OF STREAM-1 OR TARKINGTON BAYOU

A survey of the proposed bank included 30 separate streams with a defined OHWM for a total of 36,489 Lf of channel. Of these channels, 20,589 Lf were perennial streams, 11,833 Lf were intermittent streams, and 4,067 Lf were ephemeral channels. Generally, channels were C5 streams with sand dominated beds, but with definite gravel component. Soils became sandier toward Tarkington Bayou as older alluvial deposits gave way to the active floodplain and recently deposited alluvial sand. All streams possessed a forested buffer for 200 ft on either bank, with the exception of two pipeline rights-of-way, but some forests were under active timber management. These management practices and forest life histories were reflected in the scores for the riparian buffer assessment.

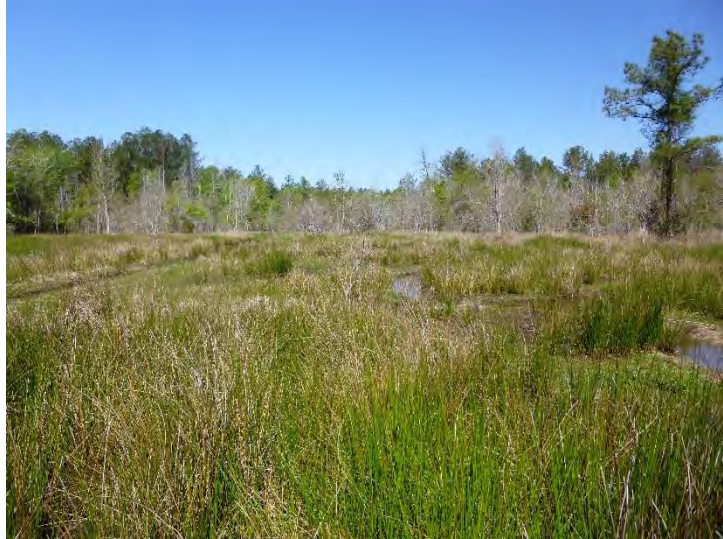
FIGURE 5: CONCEPTUAL REPRESENTATION OF HERBACEOUS WETLANDS AT BERM SPILLWAY

The established wetlands will range from forested wetlands with soils saturated in the top 12 in to herbaceous wetlands with water depths of approximately 2 ft at the spillway (Appendix J; Sheet: Ref. Proposed). Figure 5 shows the herbaceous “beaver pond” reference wetland located on Houston Conroe Mitigation Bank as a conceptual example of how these herbaceous wetlands at the spillway would develop. Plantings will be adjusted along a gradient perpendicular to the berm to account for soil moisture.

WAA 20 (56.9 Ac) is the area nearest to the berm, and areas dredged to create the berm that will become newly established herbaceous wetland. To prepare for construction of the berm, existing upland vegetation, consisting of various ages of pine plantations, will be cleared and/or grubbed to prepare for grading. During grading, some areas will be cut to 1-2 ft. below current grade, while others will be filled by 1-2 ft. as seen in Appendix J. All areas within WAA 20 will be set to an elevation of 118-119 ft. MSL (1-2 ft. of inundation at max pool). After grading, the area will be seeded with temporary stabilization seed as well as a permanent, native seed mix. Native herbaceous plugs and a variety of shrub species listed in Table 10 may also be planted to ensure proper vegetative establishment.
