**PALUSTRINE EMERGENT WETLAND  
AND PALUSTRINE SCRUB-SHRUB WETLAND  
PERMITTEE RESPONSIBLE MITIGATION PLAN  
SWG-2018-00613**

**INEOS Bayport Facility ESPN PROJECT  
Brazoria COUNTY, TEXAS**

PREPARED FOR  
**INEOS STYROLUTION AMERICA, LLC.**

**February 14, 2019**

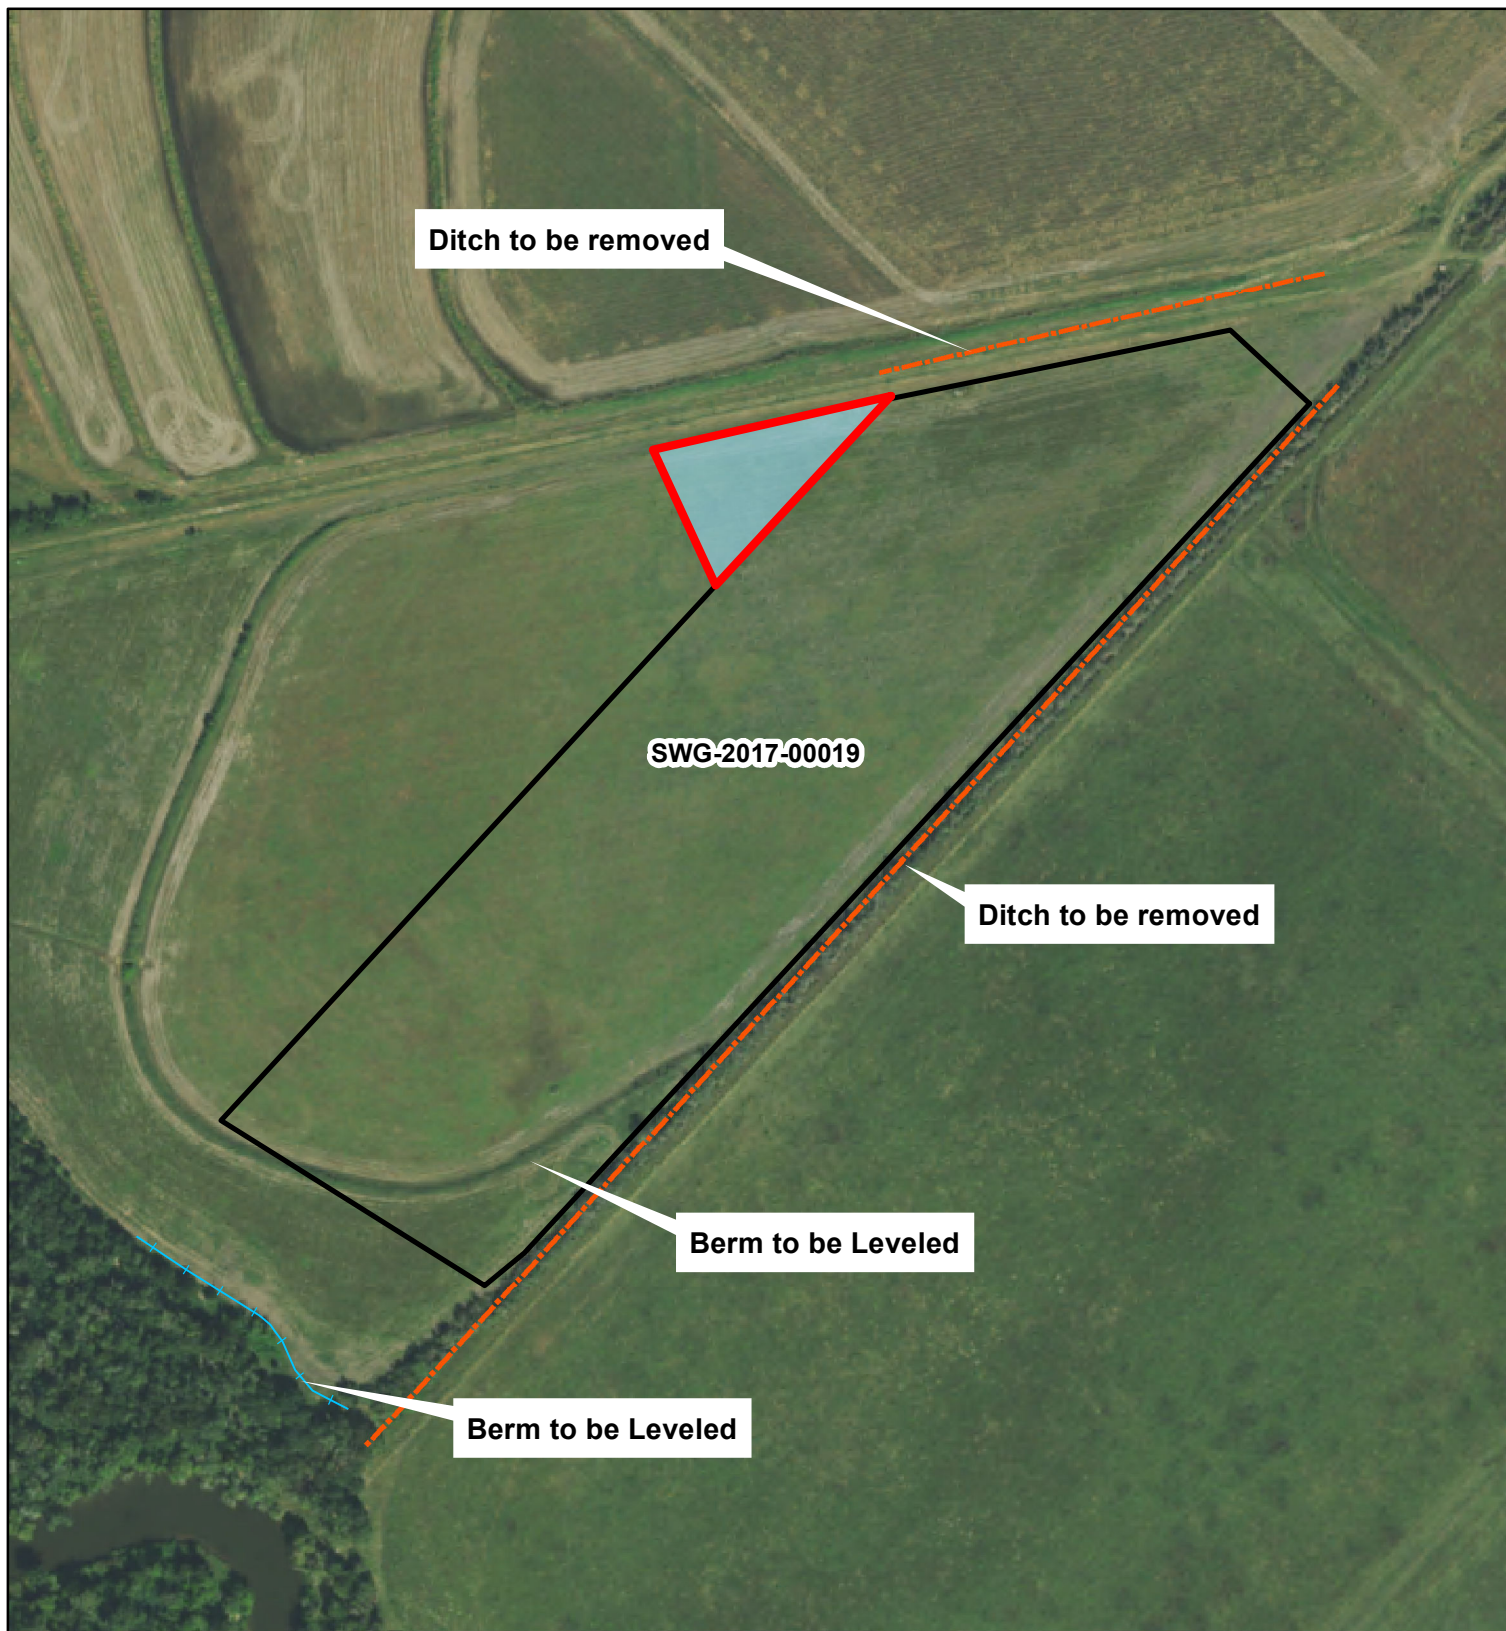
Figure 3. Mitigation Features Map

- Proposed PRMA (1.0 ac)
- PEM/PSS Rehabilitation
- (1.0 ac) Existing
- + SWG-2017-00019 Berm to be Levelled

The PRMA currently consists of fallow wet agricultural fields. Following the guidelines of the U.S. Army Corps of Engineers 1987 Wetland Delineation Manual (1987 Manual; USACE 1987) and U.S. Army Corps of Engineers Regional Supplement for the Atlantic and Gulf Coastal Plain (AGCP Regional Supplement; USACE 2010), wetland delineation data was collected from the entire 434-acre tract. The appropriate data sheets and jurisdictional determination (JD) are included in Attachment C. DLS received the JD from CESWG on March 1, 2018 (SWG-2016-00700). The JD stated the subject property contains 75.6 acres of waters of the United States, and an additional 264.3 acres of isolated wetlands. Additionally, the JD verified that Halls Bayou is a traditional navigable waterway (TNW). The PRMA is located in isolated Wetland 12. Wetland 12 is considered isolated based on separation from Halls Bayou and jurisdictional Wetland Mosaic 19; the isolated wetlands are separated by relic agricultural berms and drainage features (Attachment A, Figure 3).

In the current condition, the PRMA rehabilitation area has self-sustaining hydrology as indicated by the data collected from the wetland datapoints. A relic agricultural berm that crosses the southwestern portion of the 434-acre tract was removed to re-establish a hydrologic connection with Halls Bayou to a previously approved PRM (SWG-2017-00019) [Appendix A, Figure 3]. This PRMA is located immediately adjacent to the previous PRM; thus, the hydrologic connection was re-established during construction of SWG-2017-00019. Additionally, the ditch along the northern boundary of the PRMA will be filled, bladed, and leveled with *in-situ* material (Figure 3). Prior to the commencement of mitigation work, all agricultural activities will cease. Following the cessation of agriculture, the PRMA will be disked multiple times to 1) reduce surface compaction, 2) eliminate competition from pasture grasses, and 3) level small lateral drains/remnant berms. The soil surface will be subsoiled (i.e., ripped) to a depth of 14 to 16 inches using a straight shank Eco-Till™ ripper. Allen et al. (2000) suggests ripping of compacted soils will increase water infiltration. Ripped furrows will be spaced 10 feet apart. The straight shank minimizes surface soil disturbance as opposed to a parabolic shank, which may leave air pockets below the surface. The ripper will have an attachment immediately behind the shank, which will create a slightly elevated row of loose soil no greater than 6 inches above grade. Ripping will be conducted in the late summer-fall (i.e., August through October). Due to inherent problems of ripping and disking during wet periods on heavy clay soils, this work is planned during dry periods in the late summer and fall. The removal of the agricultural berms, drainage features will re-establish the jurisdictional connection to Halls Bayou and its adjacent wetlands.

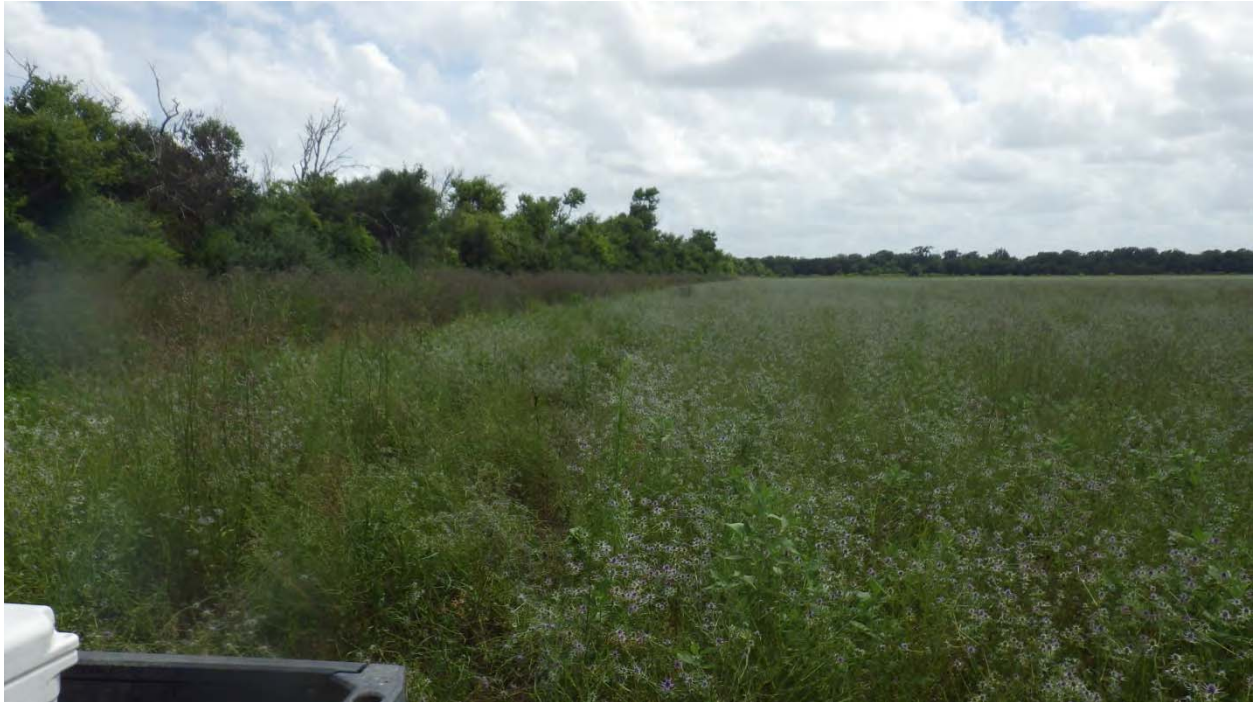
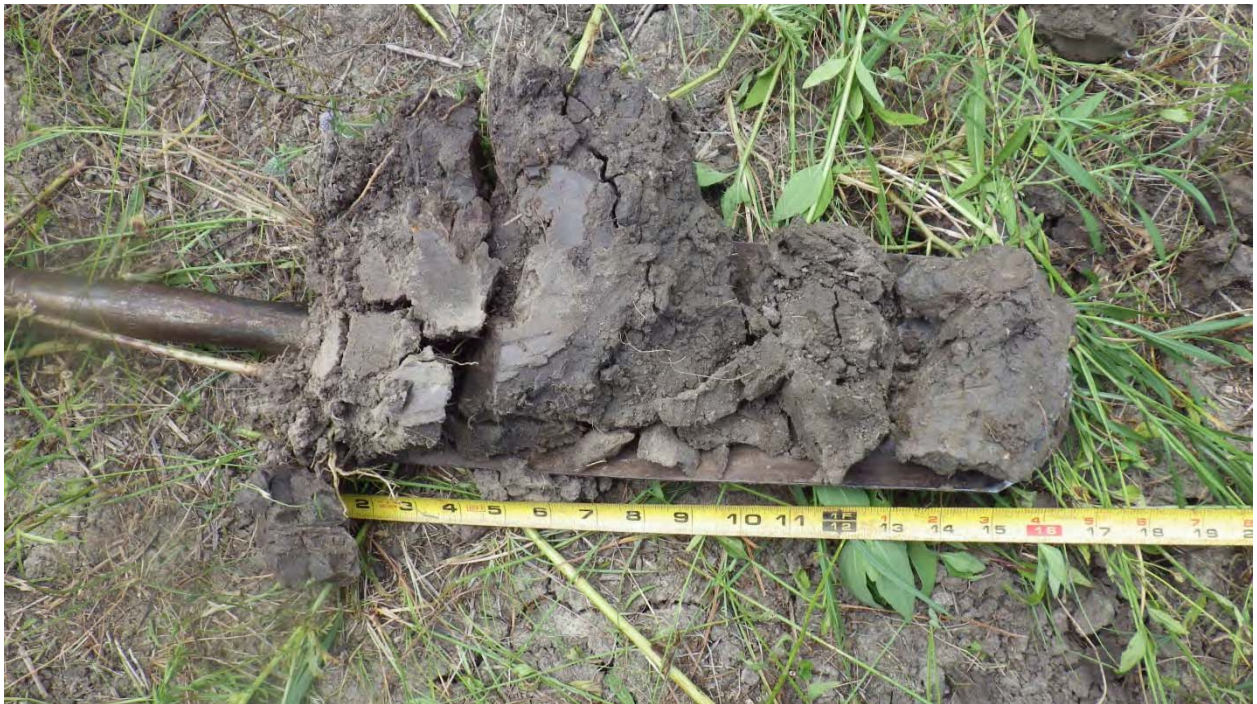
**DP 21**

Depth (inches)	Matrix		Redox Features					Texture	Remarks
	Color (moist)	%	Color (moist)	%	Type <sup>1</sup>	Loc <sup>2</sup>			
0-3	10YR	4/2	95%	10YR	3/6	5%	M	Clay	
3-16	10YR	4/1	80%	7.5YR	4/6	15%	M	Clay	
				7.5YR	5/8	5%	PL	Clay

**General View**

**Soil Profile**

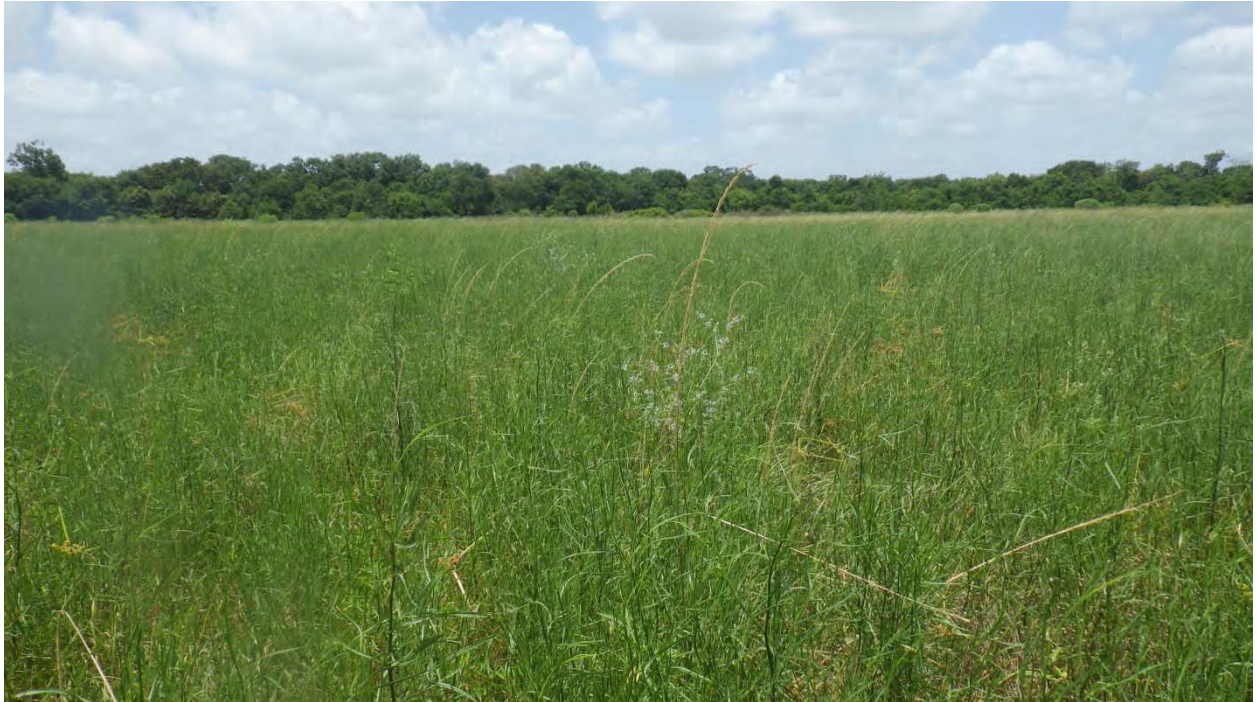
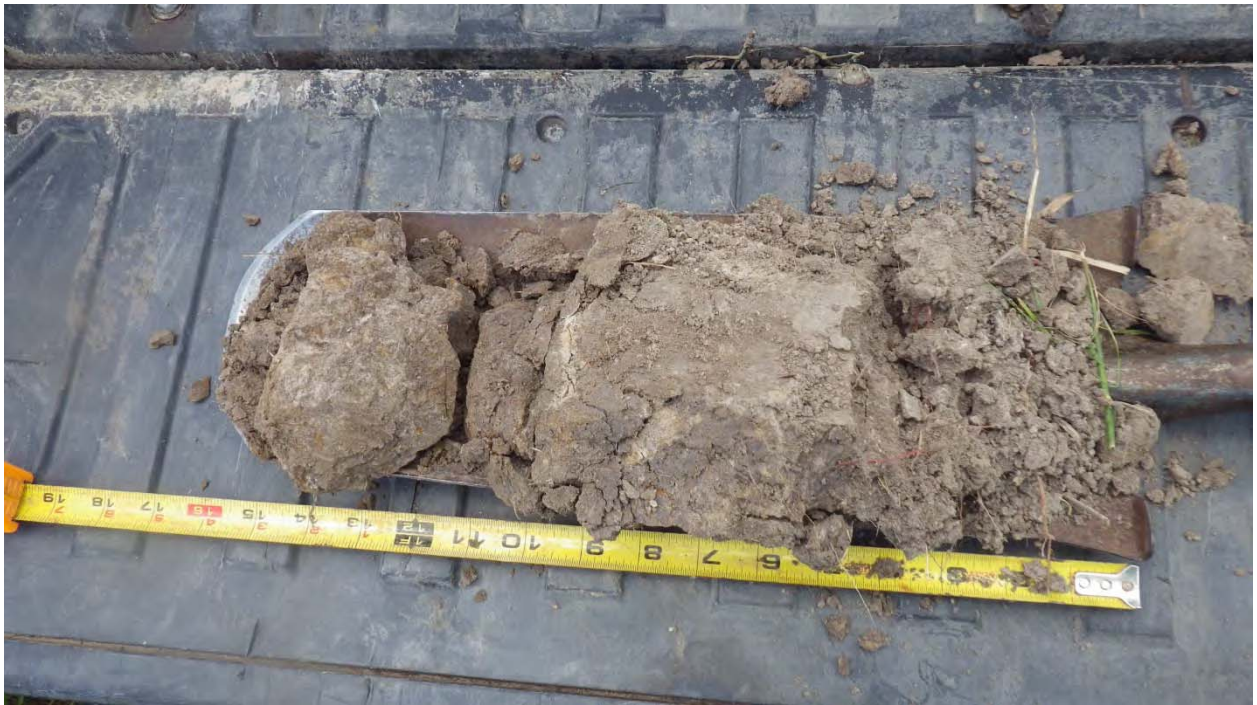
**DP 22**

**General View**

**Soil Profile**

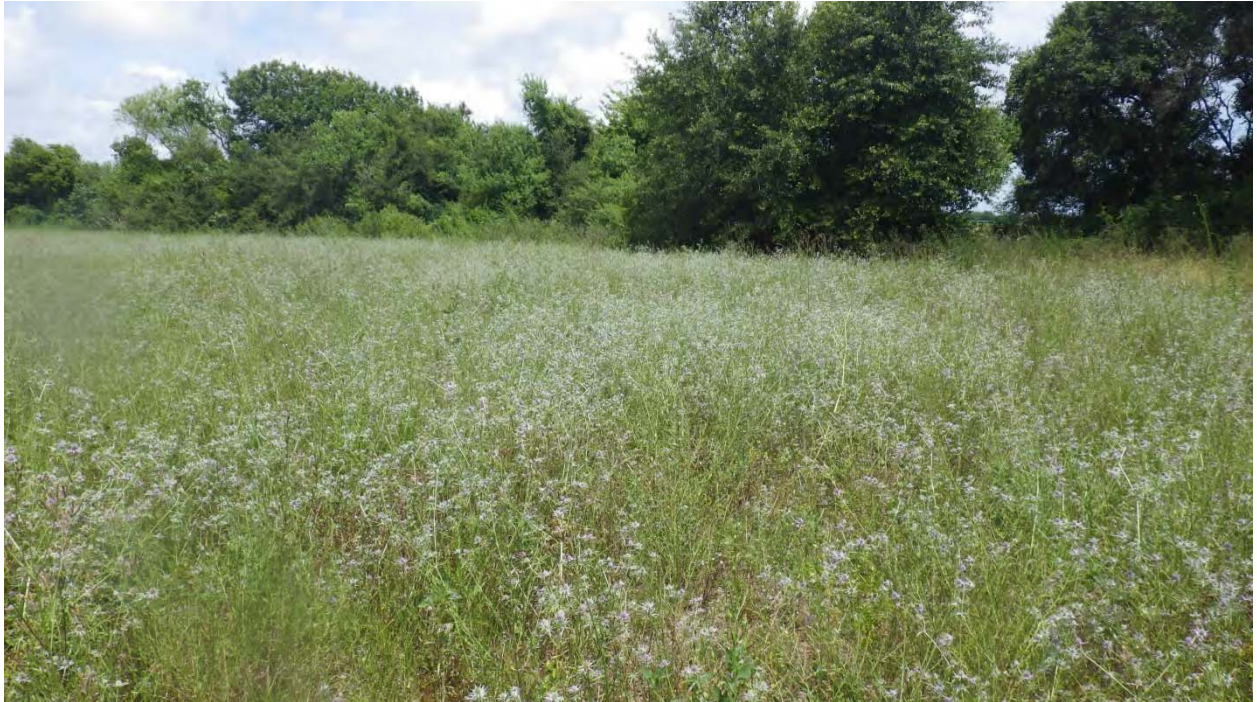
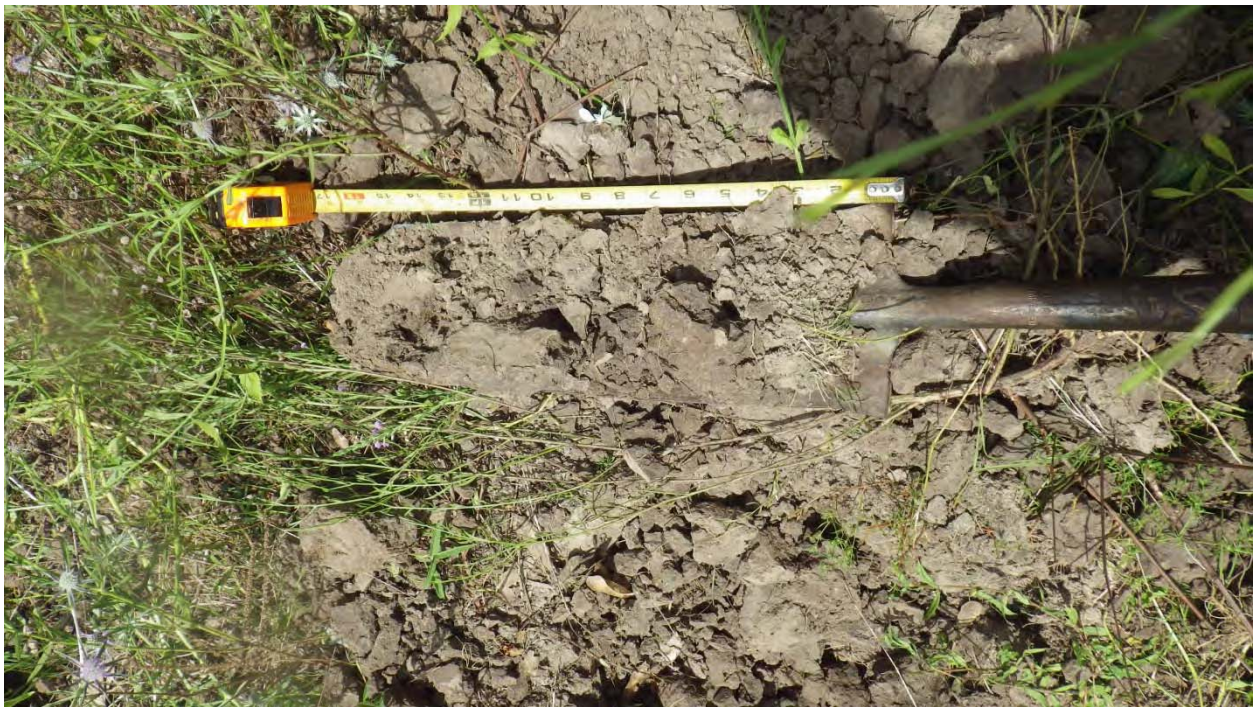
**DP 23**

Depth (inches)	Matrix			Redox Features				Texture	Remarks
	Color (moist)		%	Color (moist)		%	Type <sup>1</sup>		
0-4	10YR	4/1	95%	10YR	3/6	5%		Sandy Clay	
4-16	10YR	4/1	90%	10YR	3/6	10%		Clay

**General View**

**Soil Profile**
