Applicant Name: DKRS Driftwood Shores, LLC

## Boathouse #1 and #2

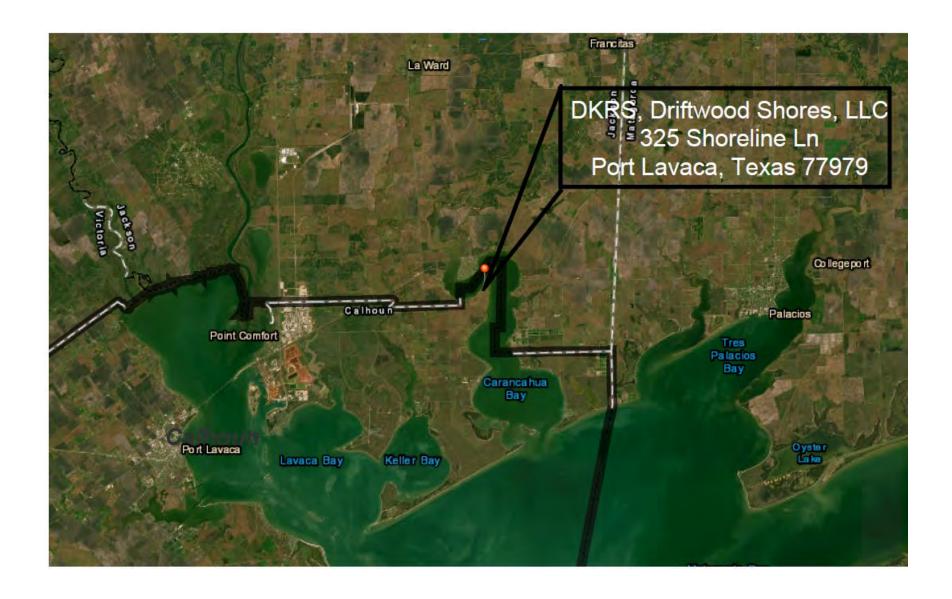
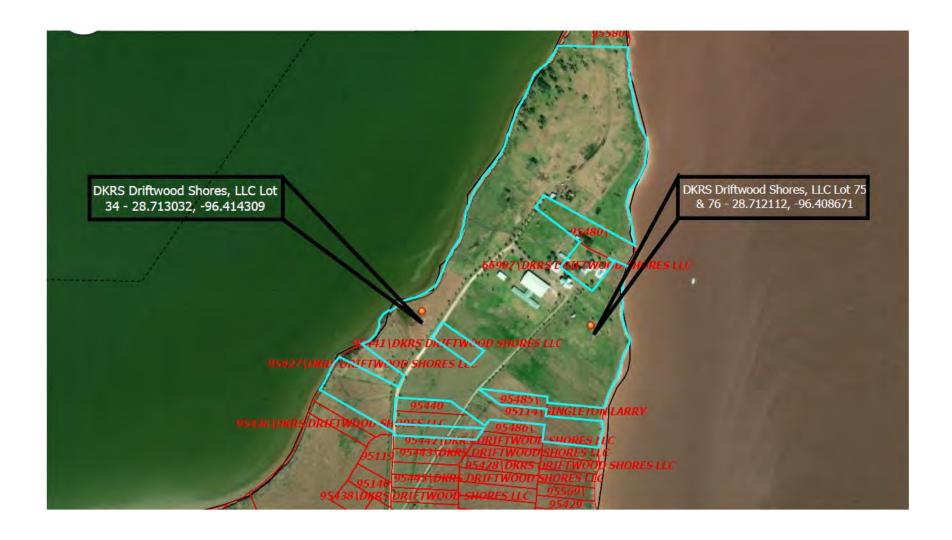
## Typical Cross-Section View of Rip Rap Lot 34 Proposed for Channel; Mechanically Dredge/Excavate. Area: 20'x20'x1.5' Area: 2-5'x20' Volume below Water Line: 2-5cy Volume Above Water Line: 2-17cy Volume Dredged/Excavated: 23cy Spoil Site: Uplands of lot 34 Proposed for Pond, Drain Pond and Mechanically Dredge/Excavate. Area: 18,601sf Current Bottom: 18" (MHW to Mudline) Proposed Bottom: 30"-36" (MHW to Mudline) Volume Dredged/Excavasted Quantitiy: 700cy Spoil Site: Uplands of lot 34 Existing Berm Approximately 18" in Height. 227.79 Proposed Rip Rap MEAN High Weter Proposed Bottom After Dredging 20 Required Information: 1, 227.79' Distance between Property Lines Depth of water at MEAN high water Distance between shoreline and front of proposed dredging at MEAN high 0' Cubic feet of fill placed along bank below the plane of WEAN high 4. None water Applicant Name: DKRS Driftwood Shores, LLC Drawing Scale: (Not To Scale)
