FORESTED AND HERBACEOUS/SHRUB WETLAND

PERMITTEE RESPONSIBLE MITIGATION PLAN

SWG-2019-00772

BURTON STATION PROJECT

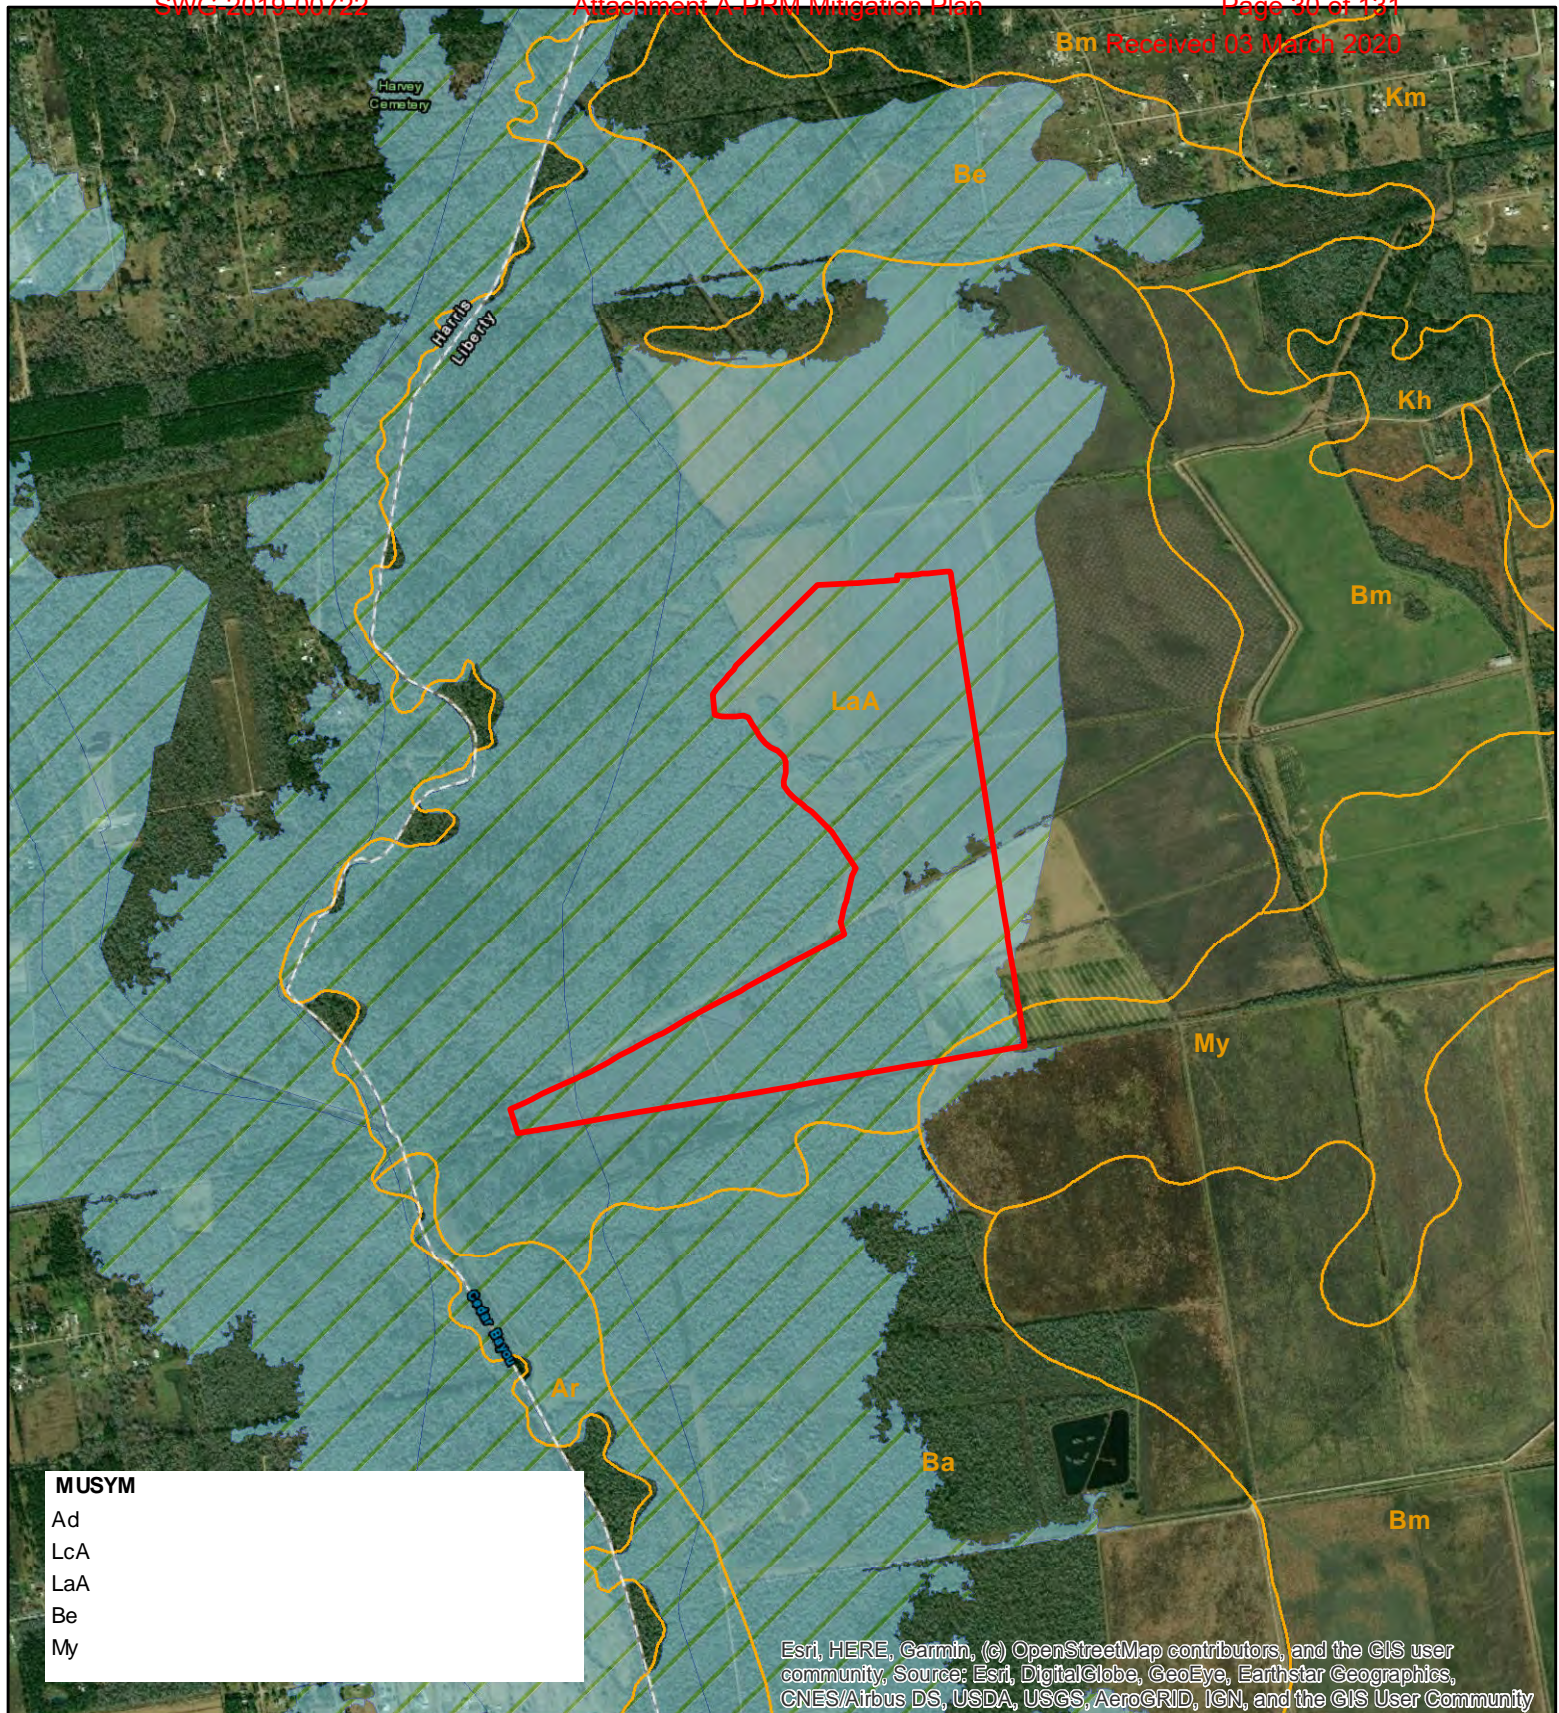
FIGURE 3

McCoy Ranch Mitigation Area
Lone Star NGL Mont Belvieu, LP
Burton Station Project
AERIAL MAP WITH SOIL
AND FLOODPLAIN
Liberty County, TX

The 288.6-acre PRMA is adjacent to Cedar Bayou in Liberty County, TX and is in the Bayou's 100-year floodplain (**Attachment A, Figure 3**). The PRMA is located approximately 6.6 miles northeast of Crosby, Texas within the North Galveston Bay Subbasin in the Northern Humid Gulf Coastal Plain Level IV Ecoregion within the Western Gulf Coast Plain Level III Ecoregion (Seaber et al. 1987, Griffith et al. 2007, EPA 2012). The approximate centerpoint of the PRMA is Latitude 29.923645° N and Longitude -94.980241° W (UTM 308845 E, 3311972 N).

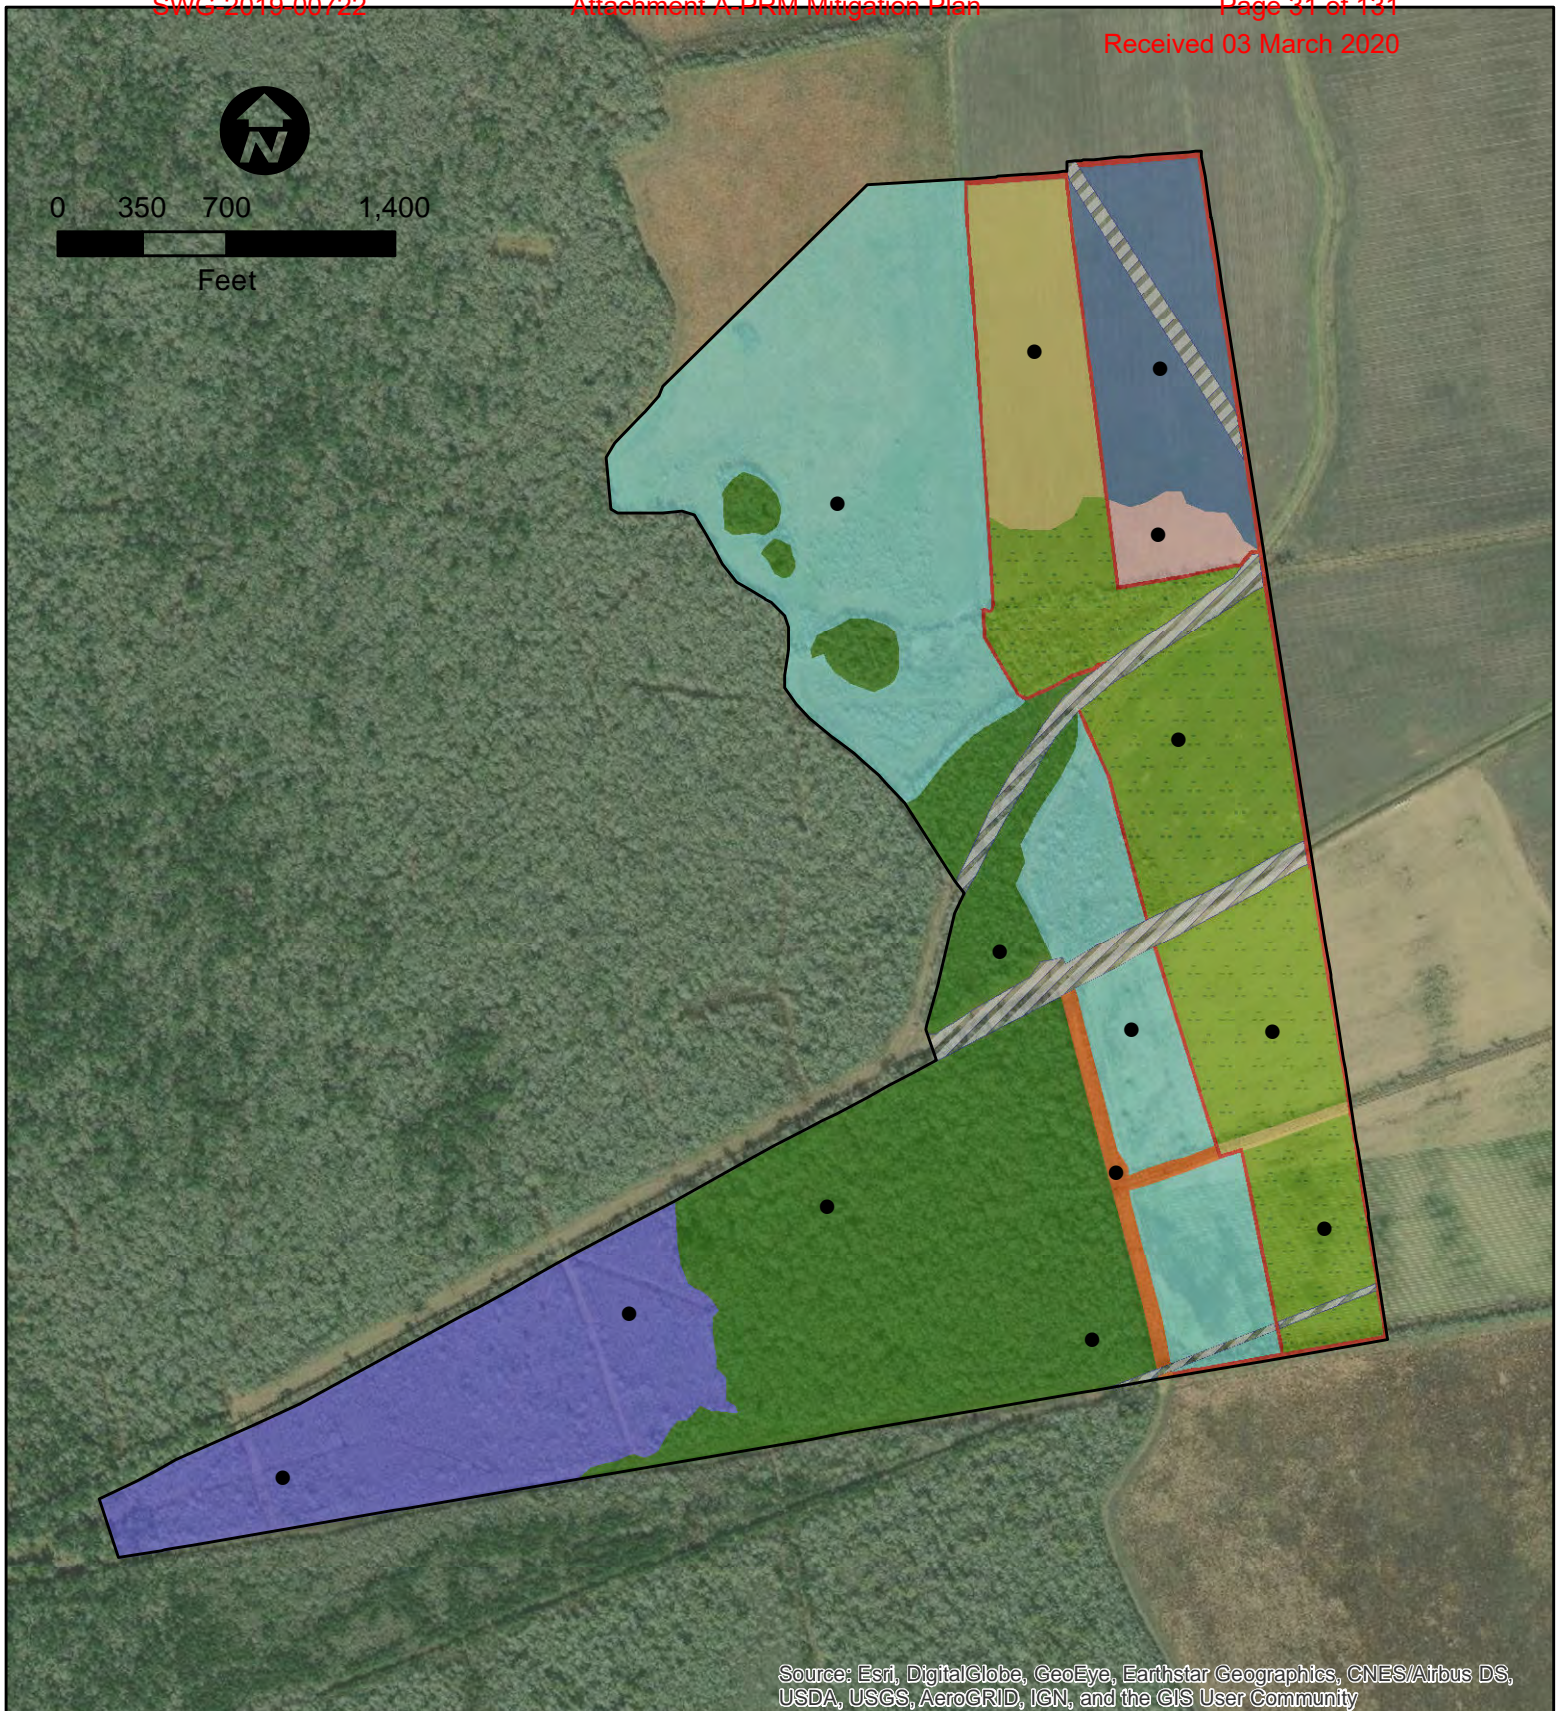
PRMA (288.6 ac)	PFO Preservation (70.6 ac)
Monitoring Plots	PFO Rehabilitation (75.6 ac)
PEM Re-establishment (16.6 ac)	PSS Re-establishment (15.0 ac)
PEM Rehabilitation (3.6 ac)	PSS Rehabilitation (49.1 ac)
PFO Re-establishment (3.0 ac)	Fire Break (6.3 ac)
PFO Enhancement (37.6 ac)	Non-Mitigation (11.2 ac)

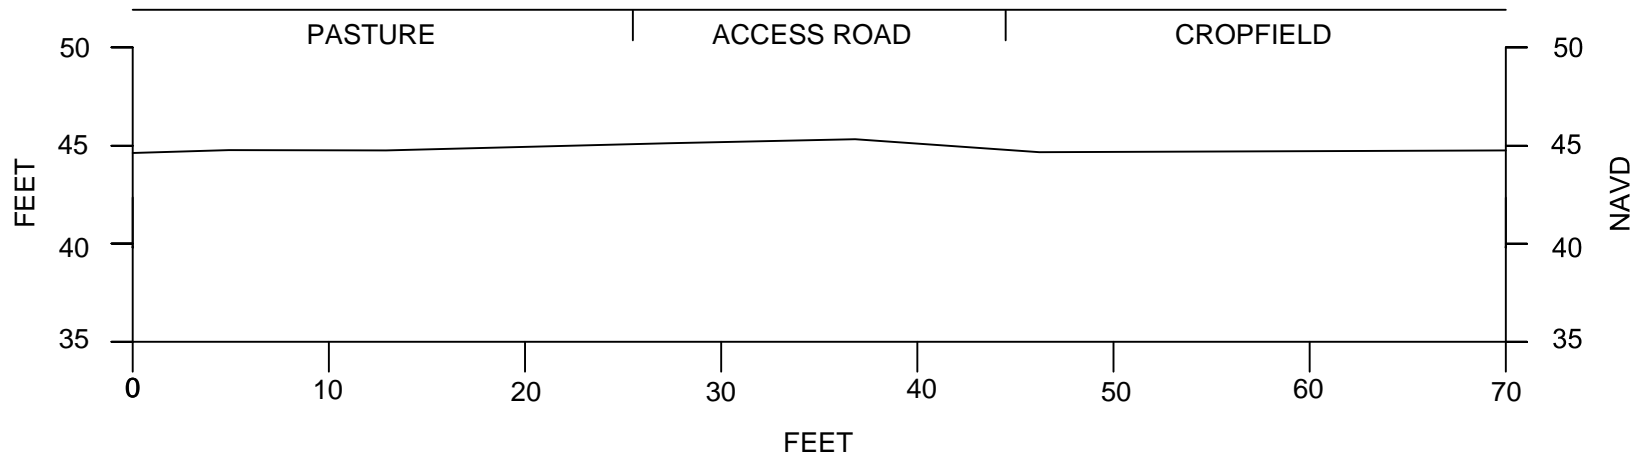
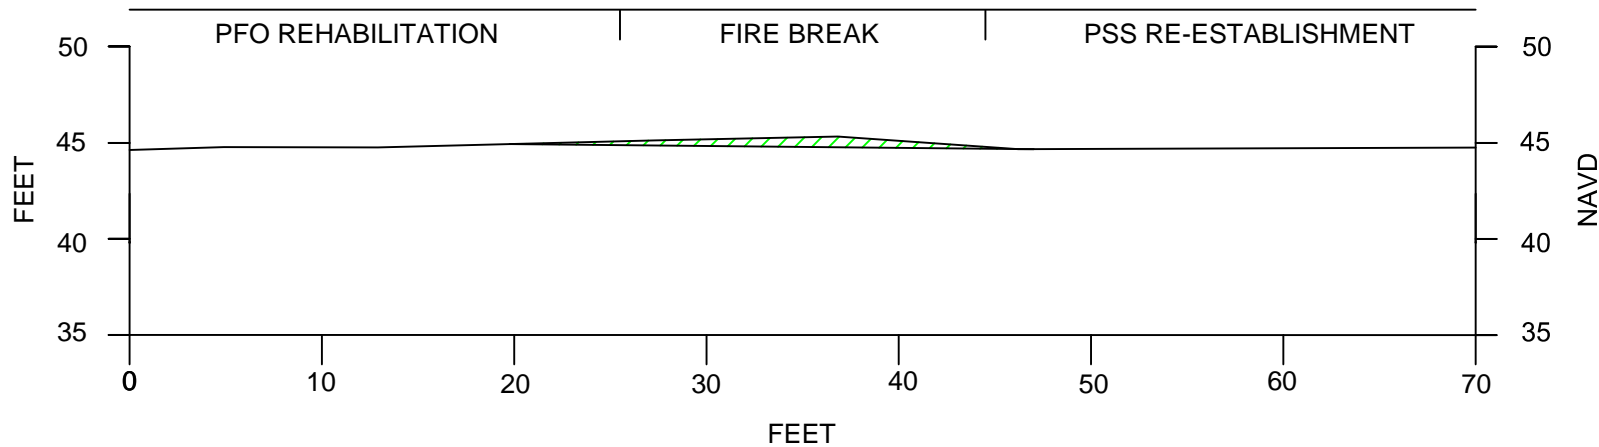
EXISTING CROSS-SECTION A

PROPOSED CROSS-SECTION A

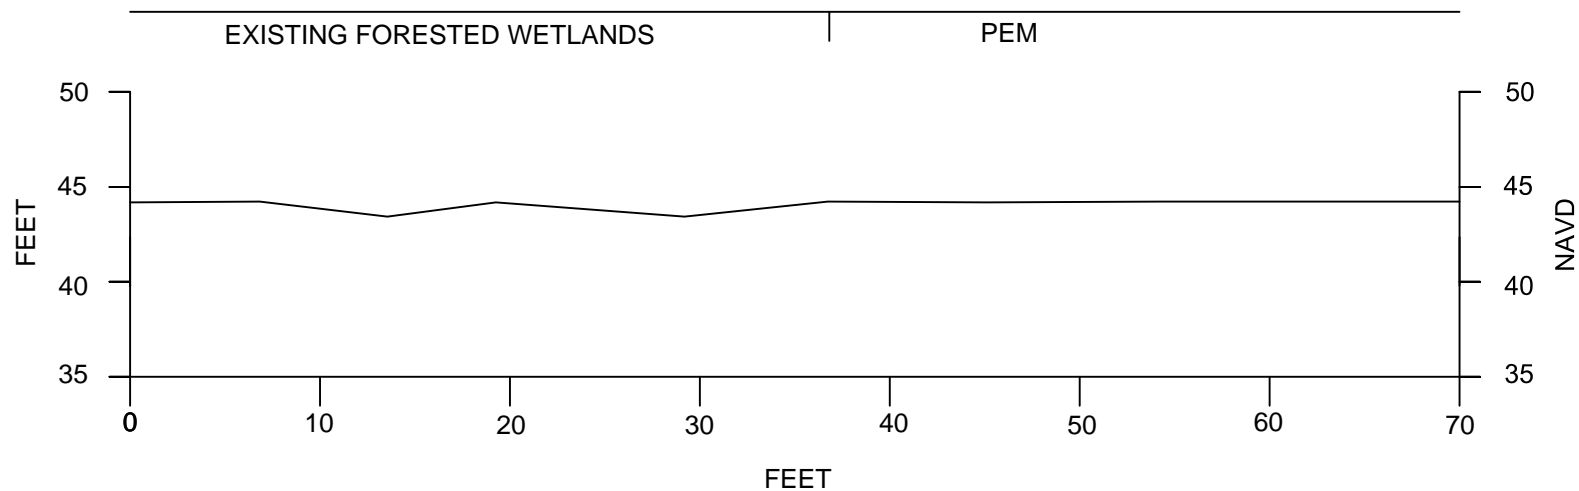
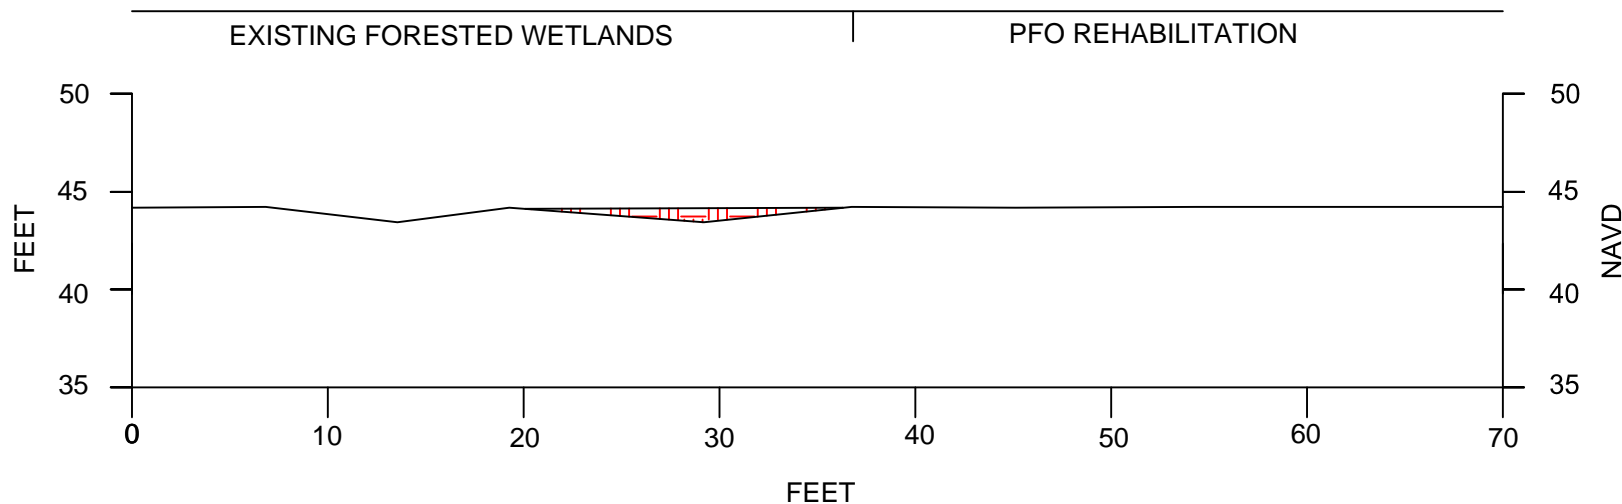
Proposed McCoy Ranch PRM	
EXISTING CONDITION AND PROPOSED CONDITION	
Cameron County, TX	
Created:	HJS/AutoCAD
Approved:	CB
Date:	10/11/19
Dwg. No.:	McCoyXSection.dwg
FIGURE 7B

EXISTING CROSS-SECTION B

PROPOSED CROSS-SECTION B

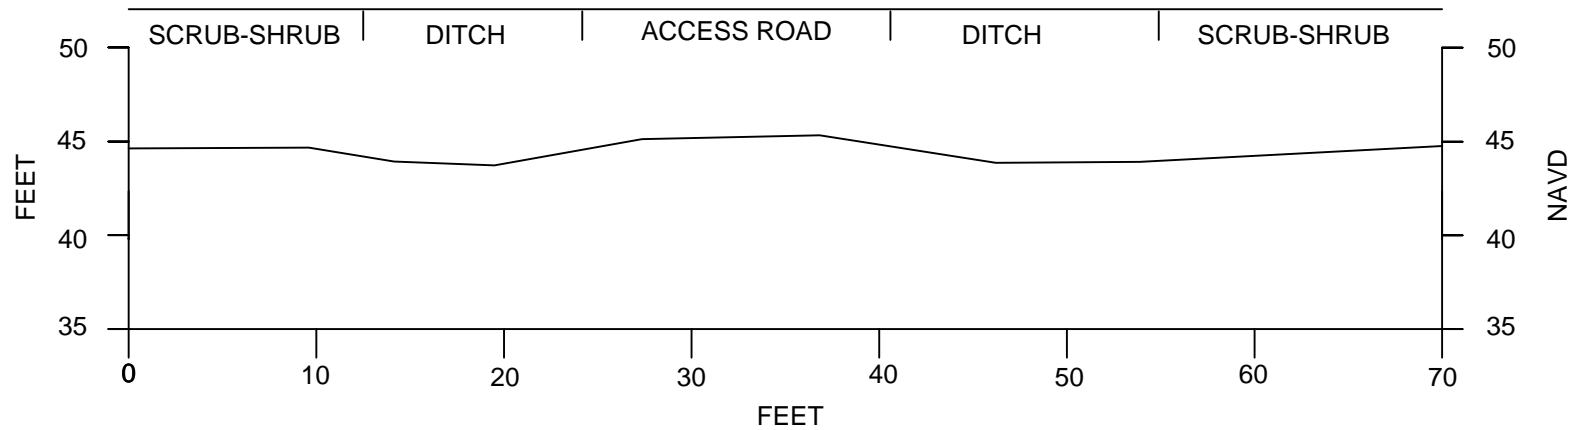
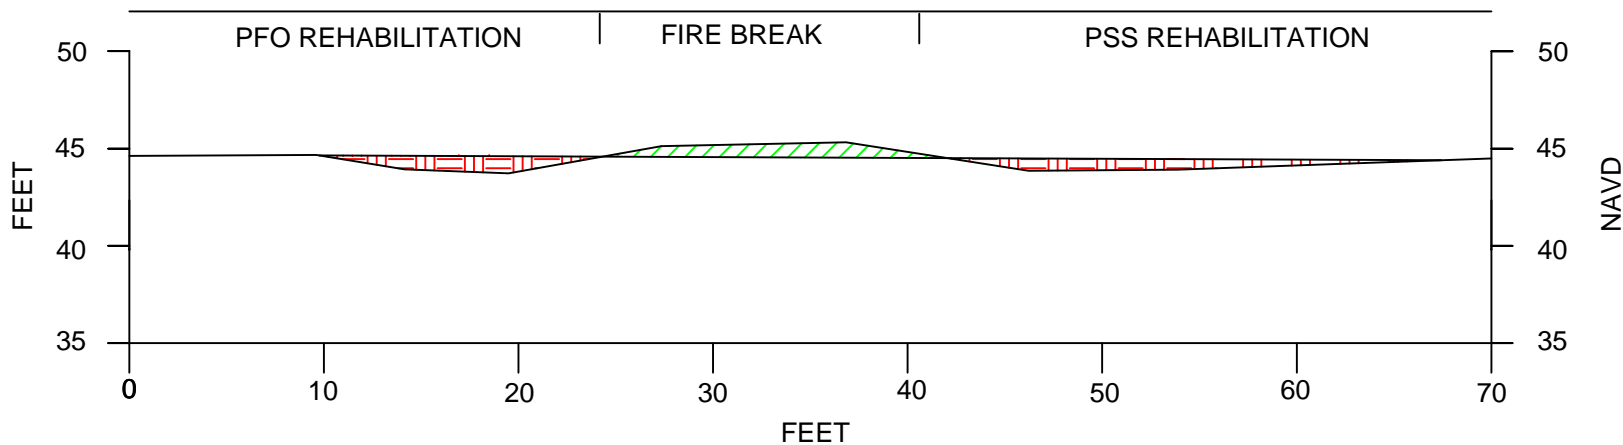
EXISTING CROSS-SECTION C

PROPOSED CROSS-SECTION C

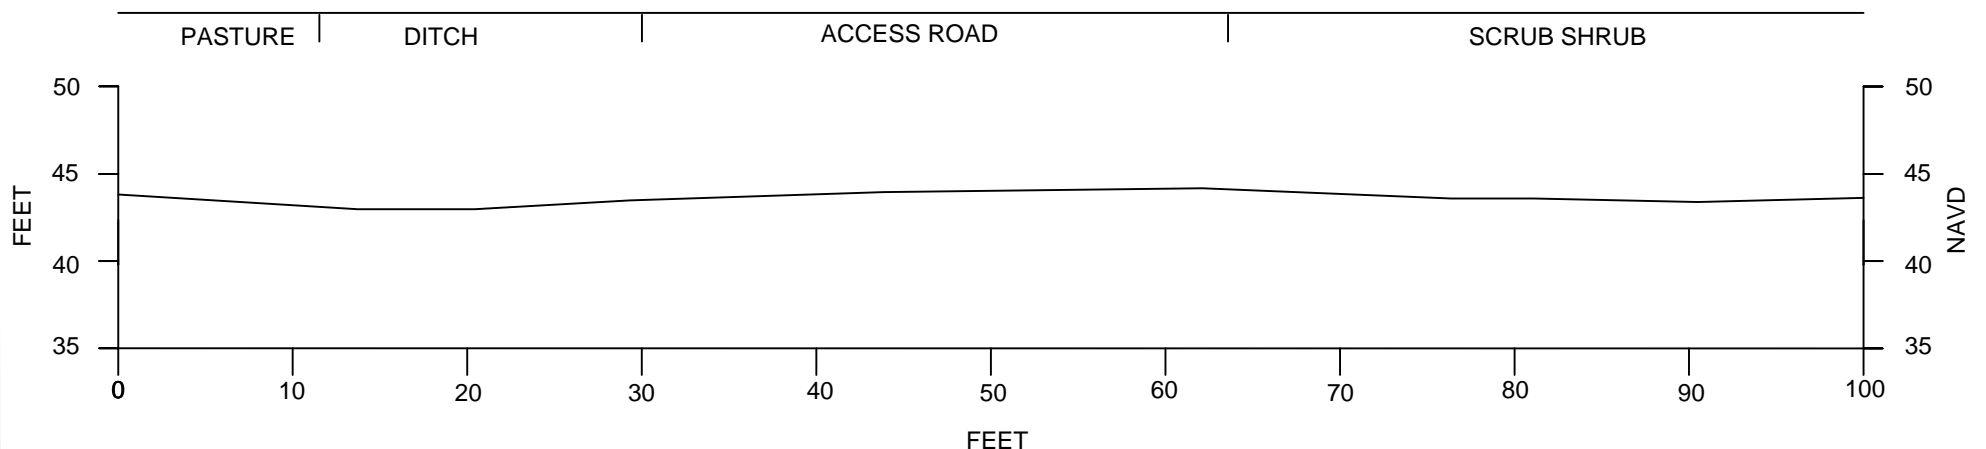
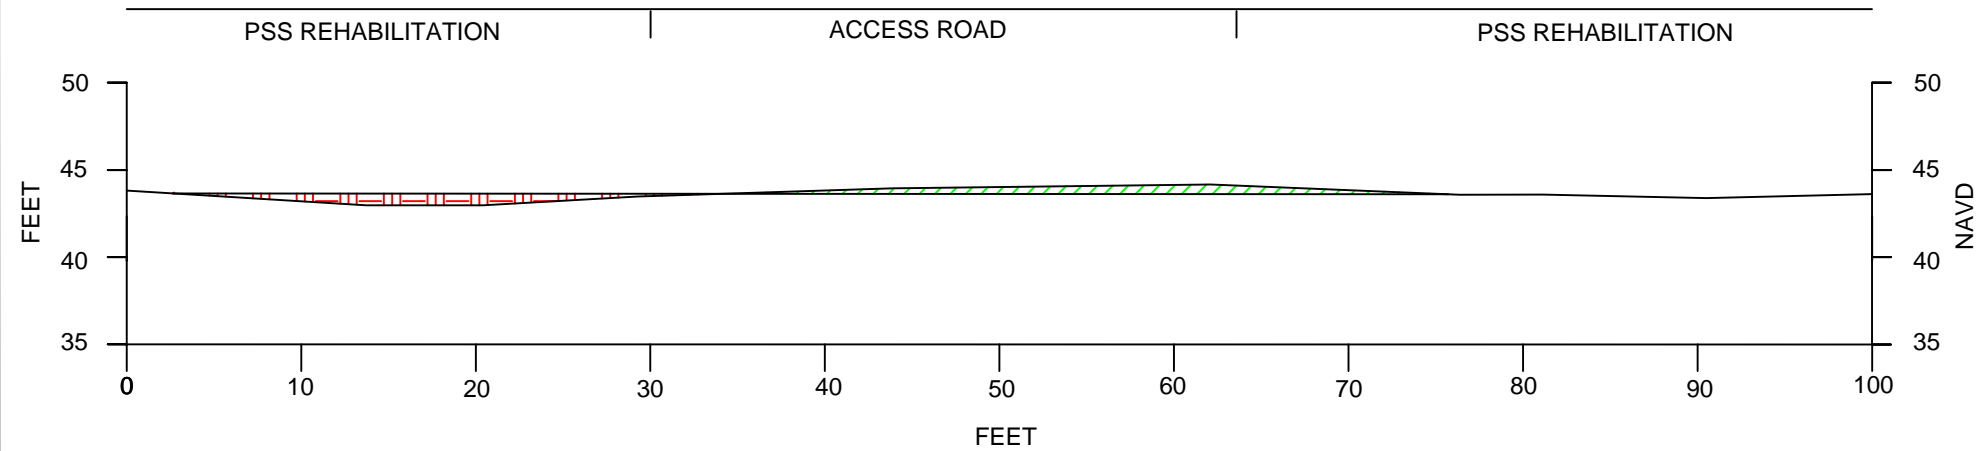
FIGURE 7D

EXISTING CROSS-SECTION D

PROPOSED CROSS-SECTION D

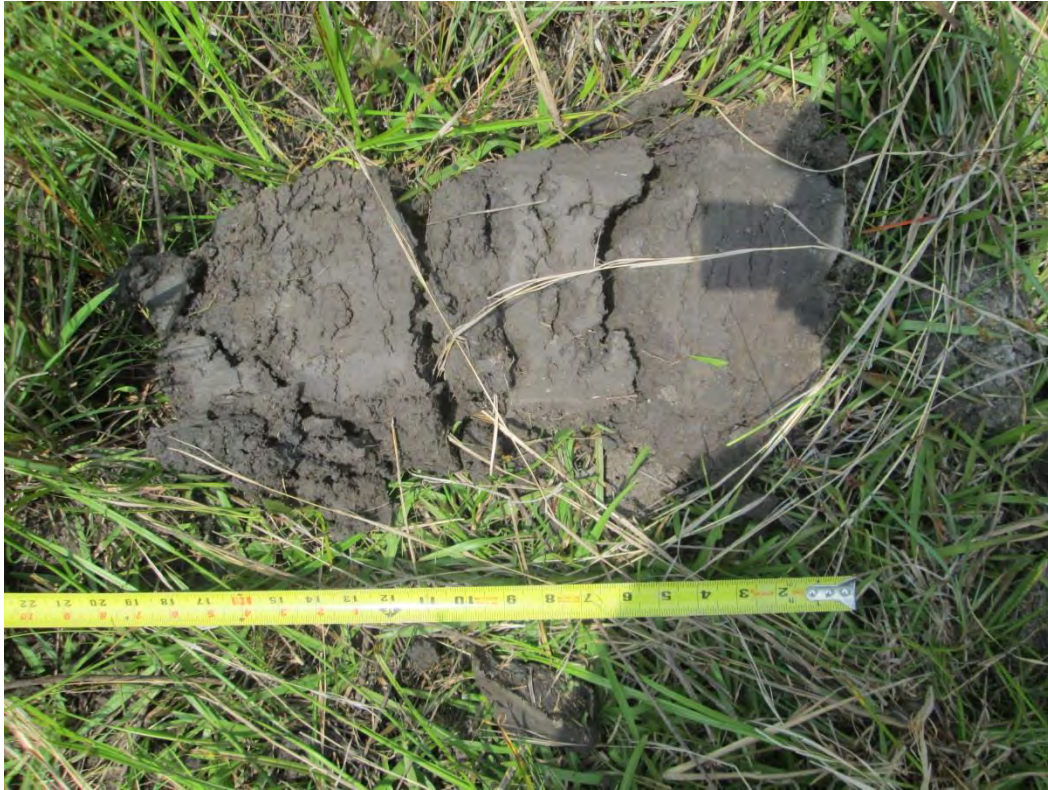
Photo 31: SP2-3 Soil Profile

Depth (inches)	Matrix		Redox Features				Texture	Remarks
	Color (moist)	%	Color (moist)	%	Type ¹	Loc ²		
0-5	10yr4/2	97	10yr5/8	3	C	M	Clay	
5-20	10yr3/2	95	10yr5/8	5	C	M	Clay

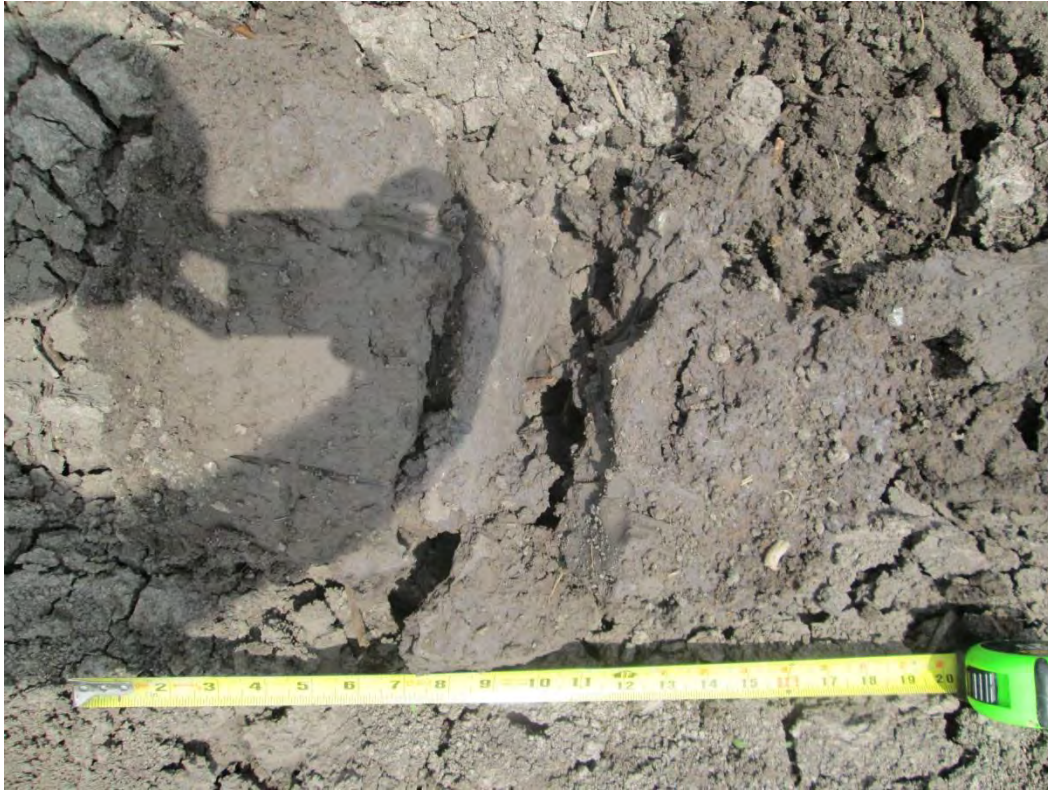
Photo 33: SP2-4 Soil Profile

Soils tilled down to approximately 6 inches.
