# FREEPORT LNG FLARE ACCESS ROAD PROJECT

# ATTACHMENT D Preliminary Compensatory Mitigation Plan

# Flare Access Road Project Preliminary Compensatory Mitigation Plan

August 2019

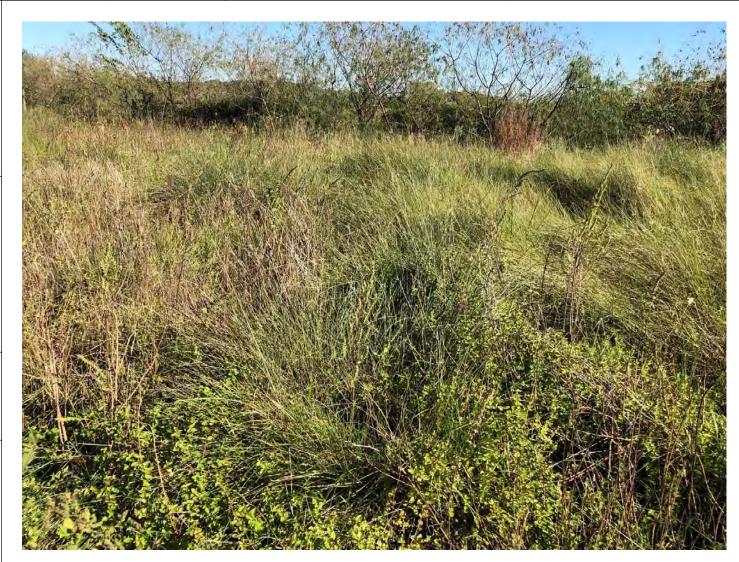
Area is consistent with upland conditions and vegetation dominated by herbaceous and scrub shrub species. Photo is taken facing north.

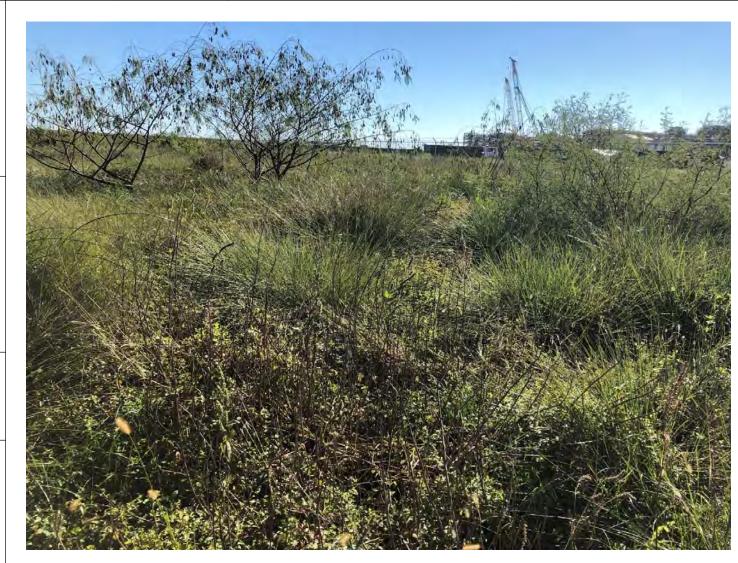
Area is consistent with upland conditions and vegetation dominated by herbaceous and scrub shrub species. Photo is taken facing east.

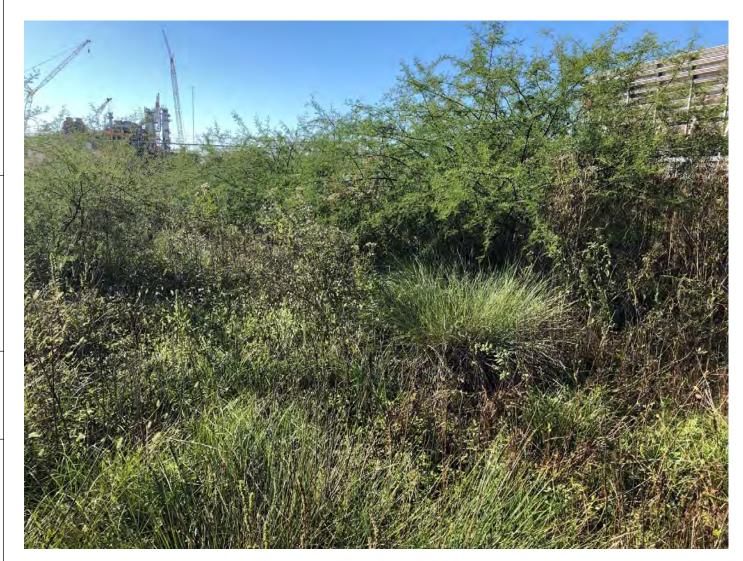
Area is consistent with upland conditions and vegetation dominated by herbaceous and scrub shrub species. Photo is taken facing south.

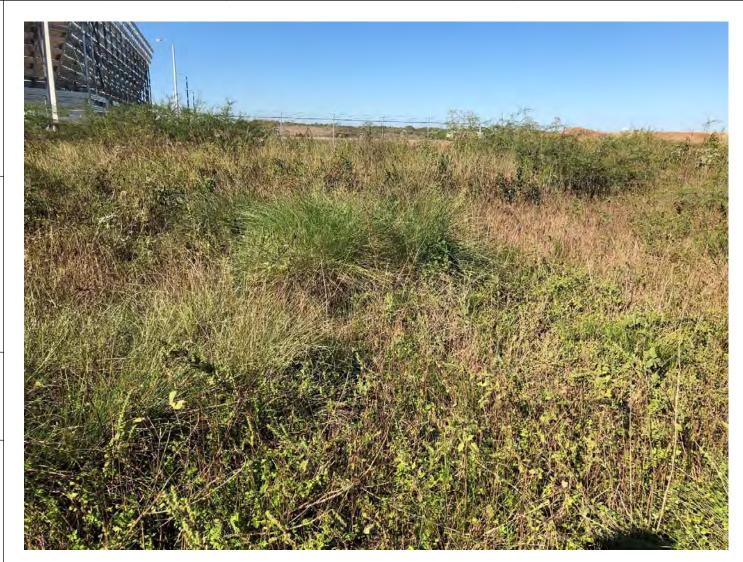
Area is consistent with upland conditions and vegetation dominated by herbaceous and scrub shrub species. Photo is taken facing west.

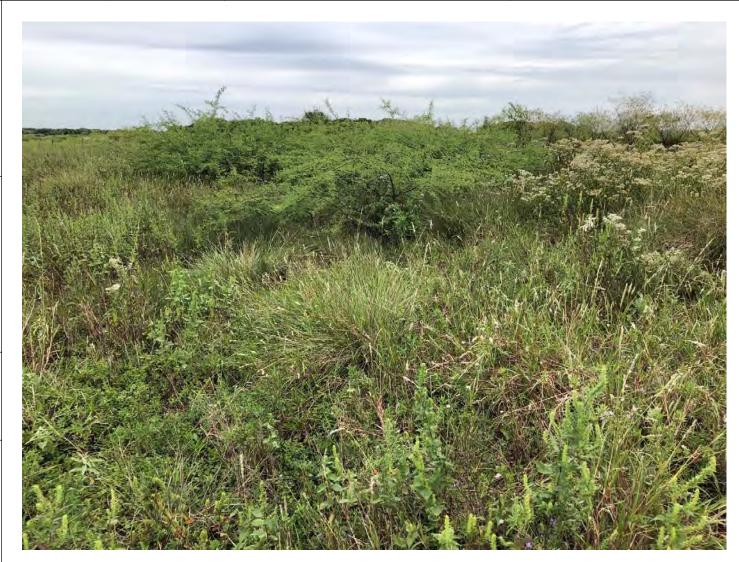
Area is consistent with wetland conditions and vegetation dominated by herbaceous and scrub shrub species. Photo is taken facing north.

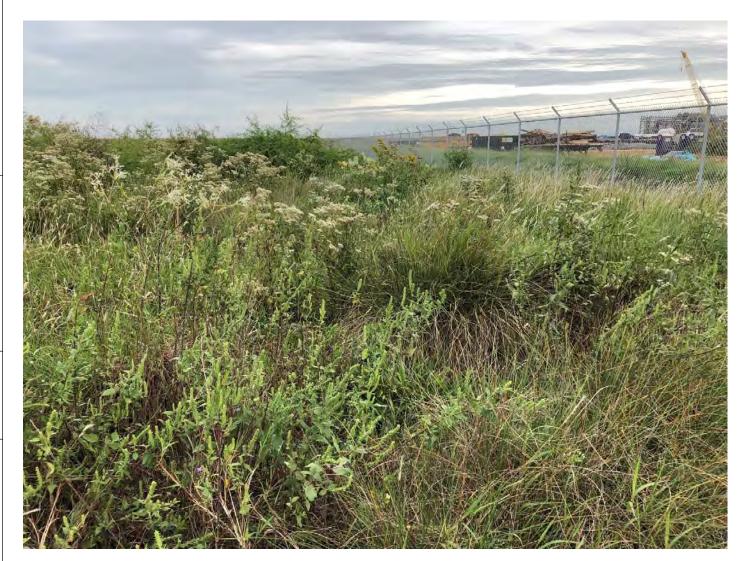
Area is consistent with wetland conditions and vegetation dominated by herbaceous and scrub shrub species. Photo is taken facing east.

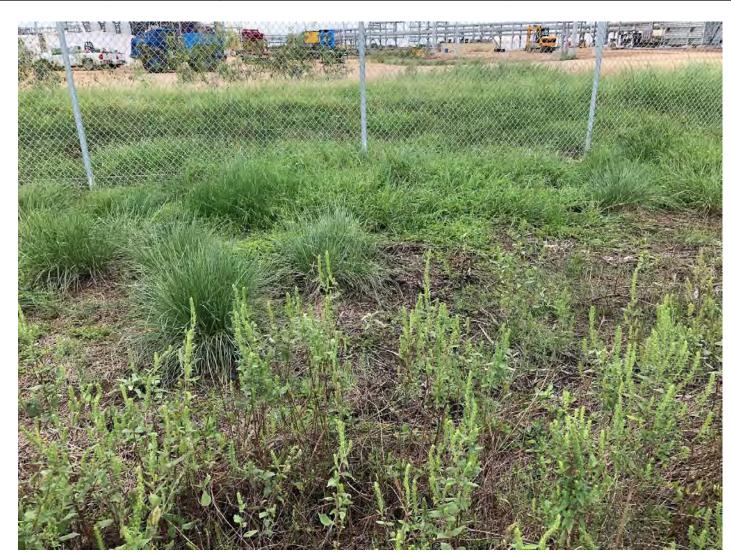
Area is consistent with wetland conditions and vegetation dominated by herbaceous and scrub shrub species. Photo is taken facing south.

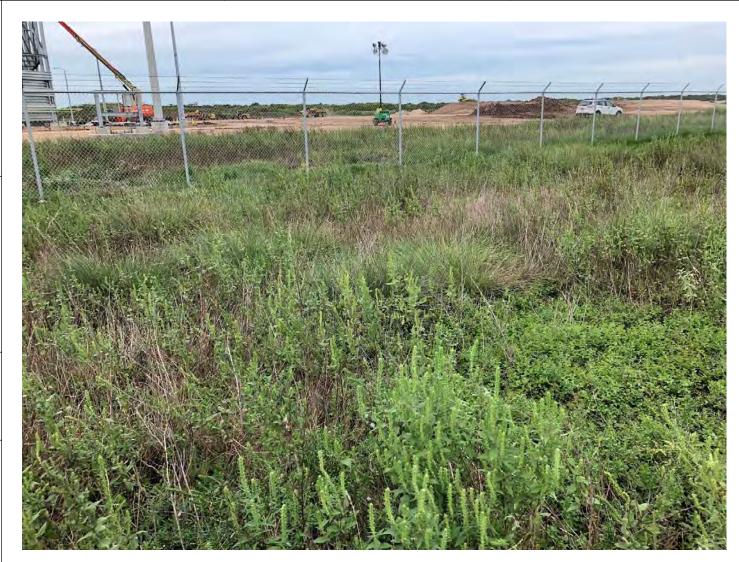
Area is consistent with wetland conditions and vegetation dominated by herbaceous and scrub shrub species. Photo is taken facing west.

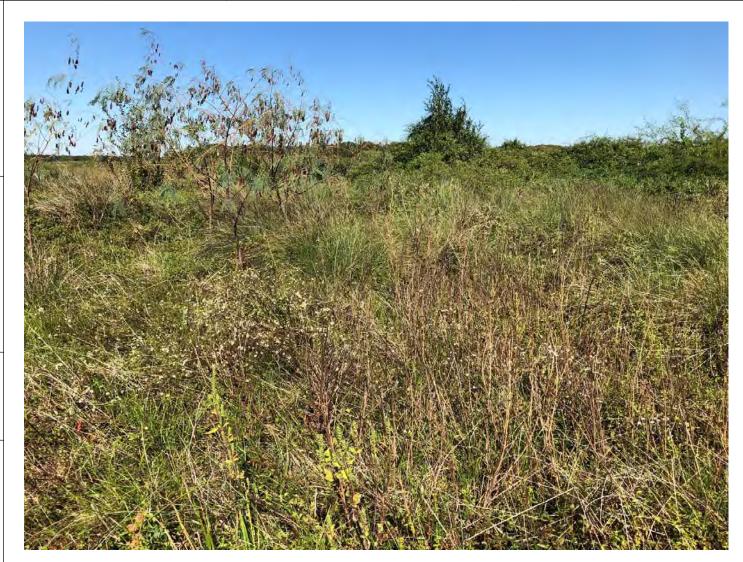
Area is consistent with wetland conditions and vegetation dominated by herbaceous and scrub shrub species. Photo is taken facing north.

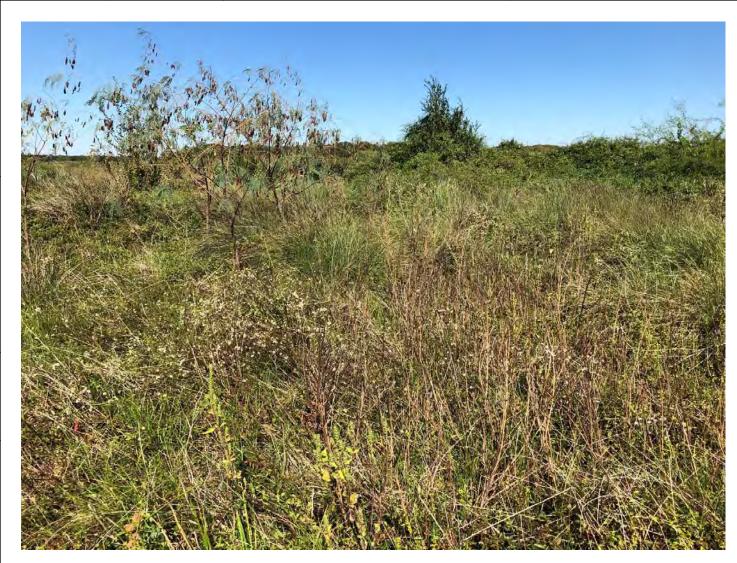
Area is consistent with wetland conditions and vegetation dominated by herbaceous and scrub shrub species. Photo is taken facing east.

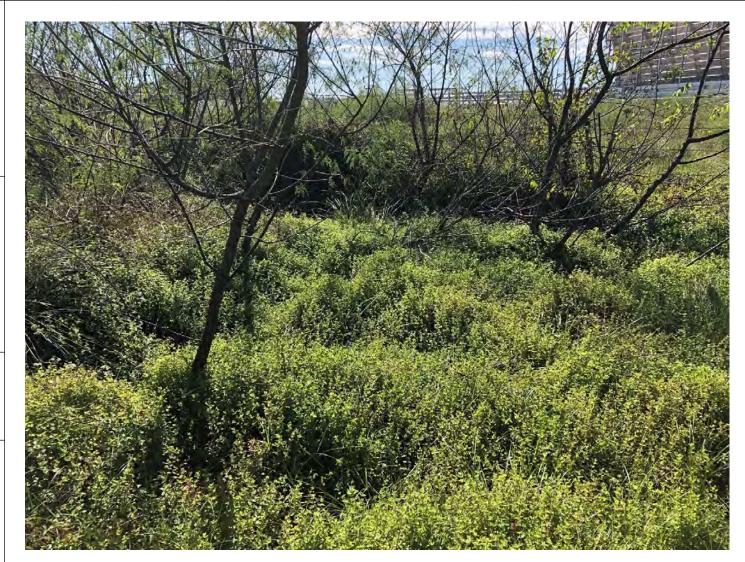
Area is consistent with wetland conditions and vegetation dominated by herbaceous and scrub shrub species. Photo is taken facing south.

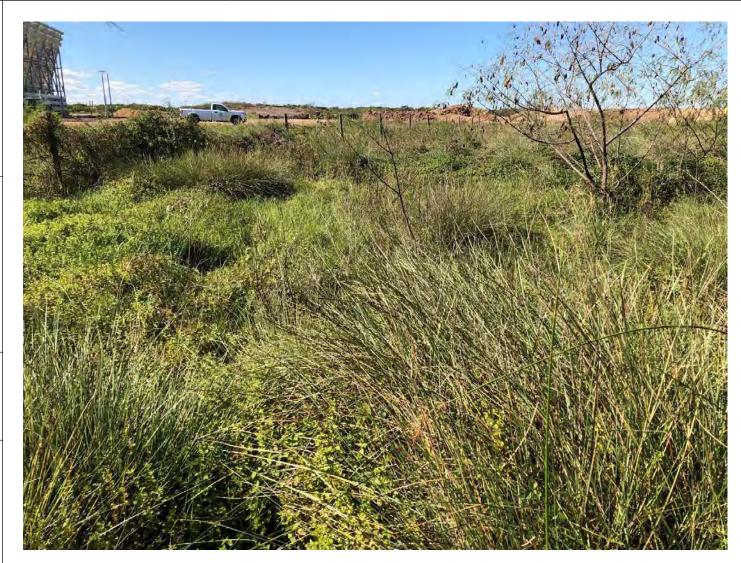
Area is consistent with wetland conditions and vegetation dominated by herbaceous and scrub shrub species. Photo is taken facing west.

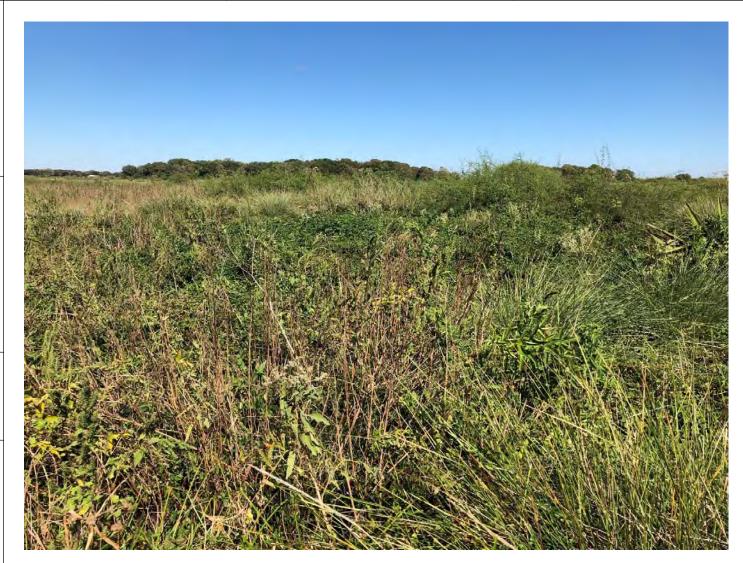
Area is consistent with wetland conditions and vegetation dominated by herbaceous and scrub shrub species. Photo is taken facing north.

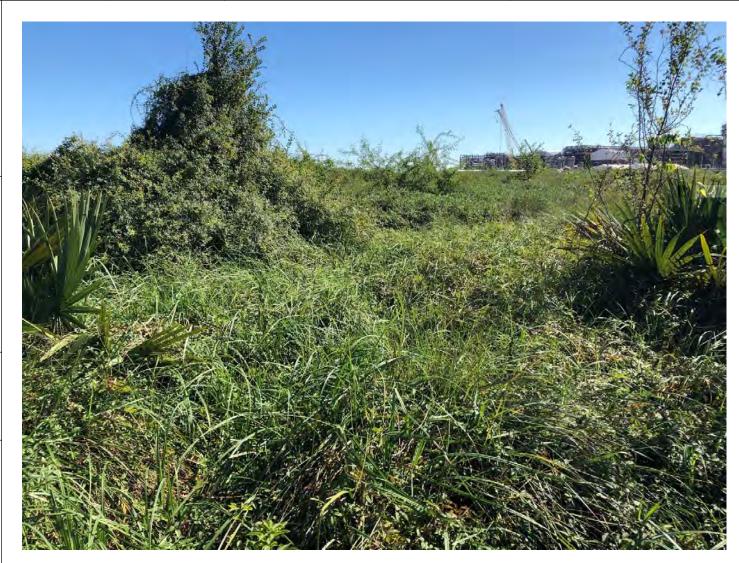
Area is consistent with wetland conditions and vegetation dominated by herbaceous and scrub shrub species. Photo is taken facing east.

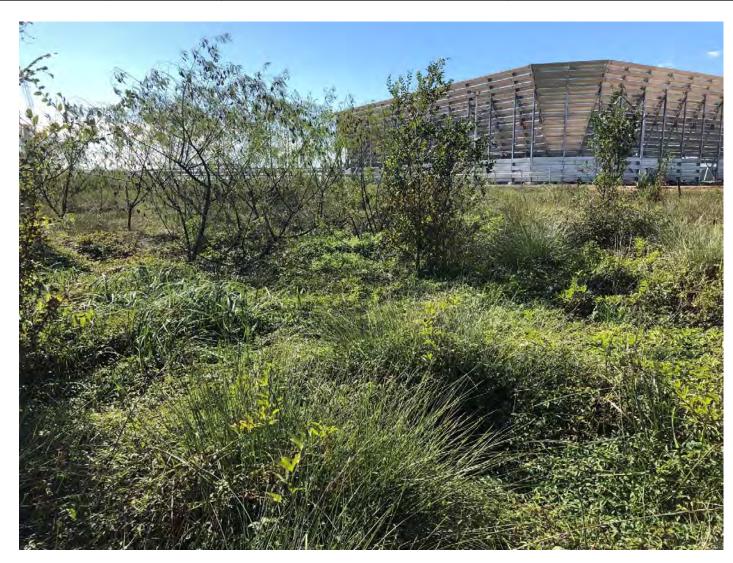
Area is consistent with wetland conditions and vegetation dominated by herbaceous and scrub shrub species. Photo is taken facing south.

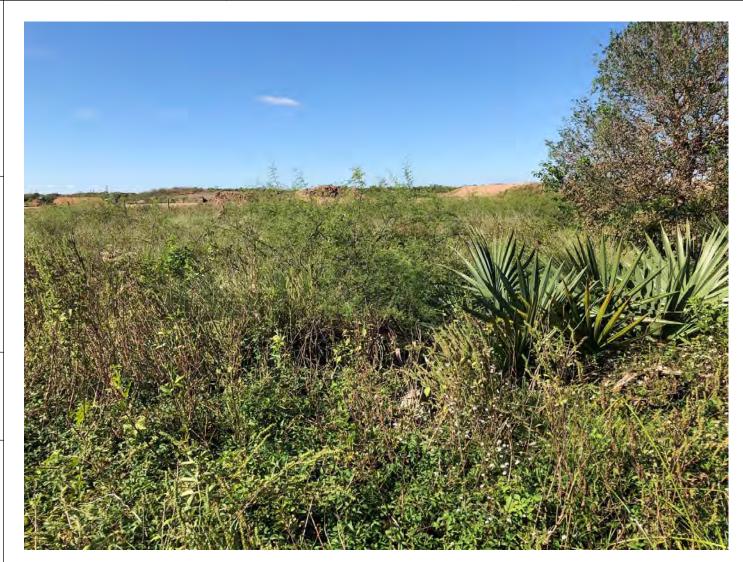
Area is consistent with wetland conditions and vegetation dominated by herbaceous and scrub shrub species with minimal trees in the area. Photo is taken facing west.
