BIG COW CREEK

MITIGATION BANK PROSPECTUS

SWG-2020-00374

Prepared by: Delta Land Services, LLC

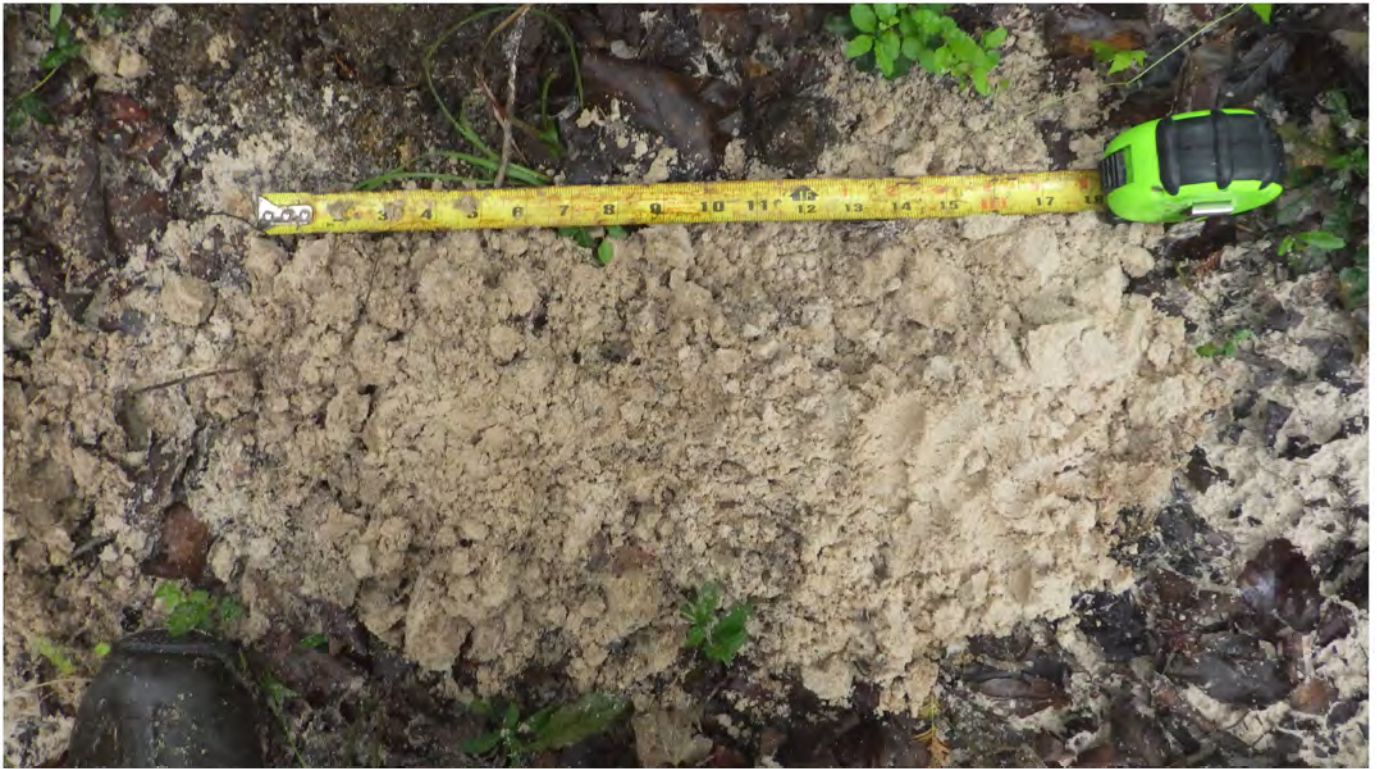
No positive indication of hydric soils was observed.

SP 1-1 Soil profile.

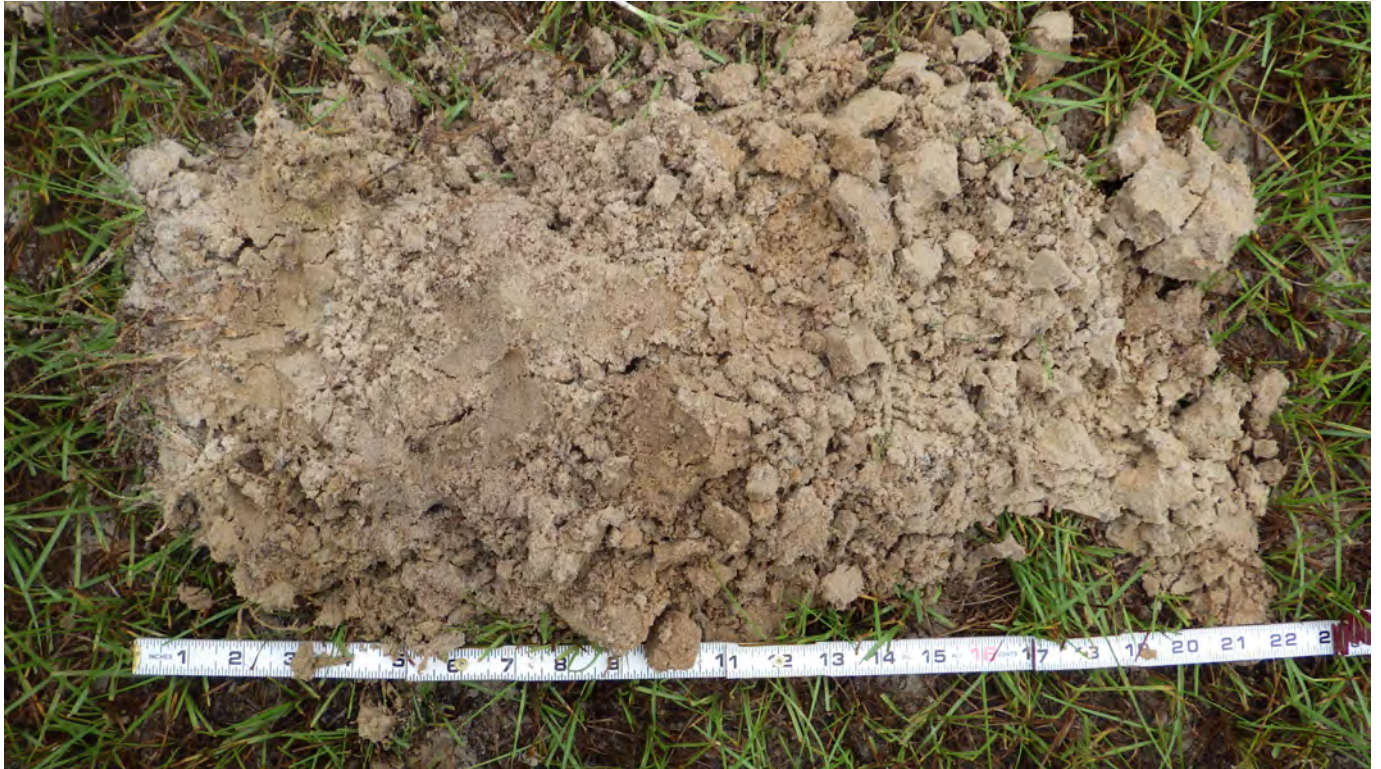
No positive indication of hydric soils was observed.

SP 1-2 Soil profile.

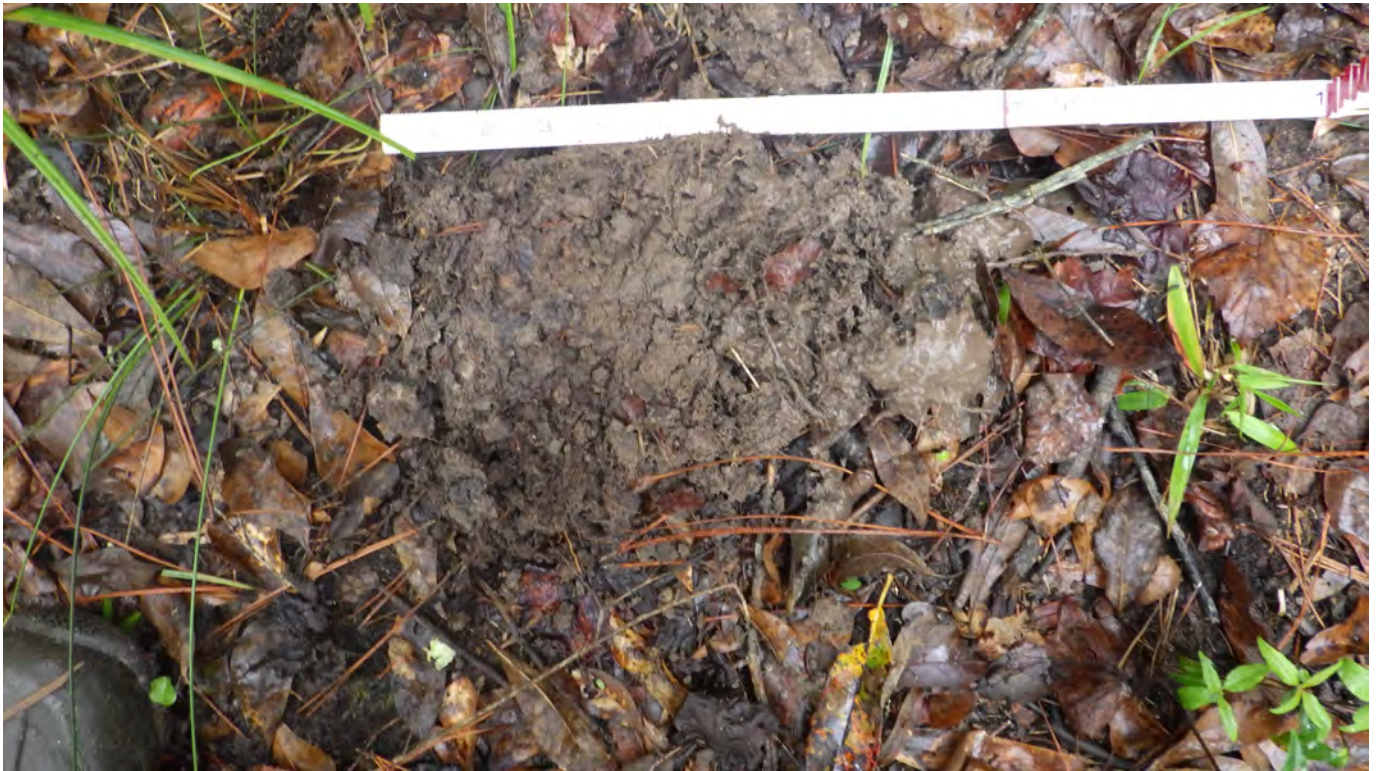
A positive indication of hydric soil was observed.

SP 1-3 Soil profile.

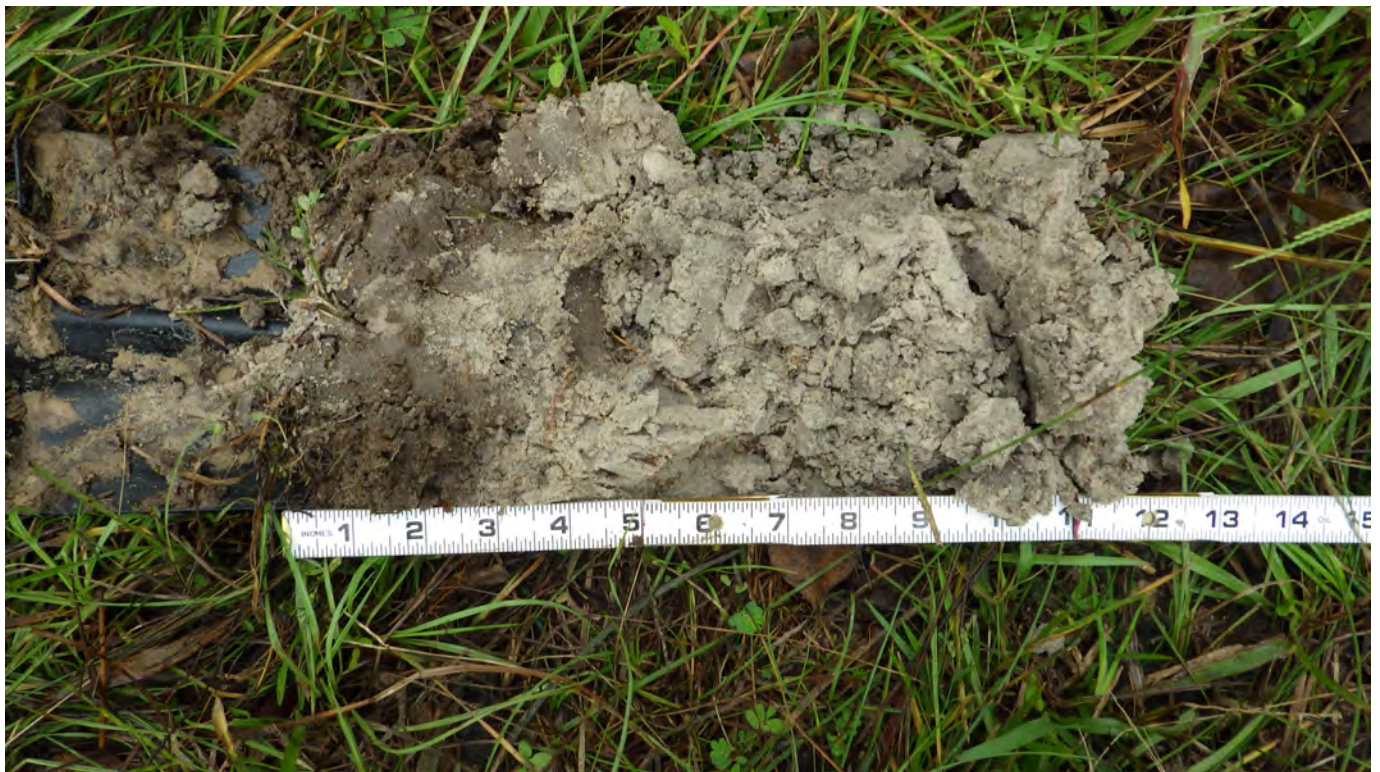
A positive indication of hydric soil was observed.

SP 1-4 Soil profile.
