**Updated Compensatory Mitigation Plan  
Grace Community Church  
Proposed Cathedral Lakes Pond and Mitigation Basins  
USACE File Number: SWG-2013-00680  
April 18, 2018**

**Updated Compensatory Mitigation Plan**

Proposed Cathedral Lakes Pond and Mitigation Basins ■ April 18, 2018  
 Spring, Montgomery County, Texas ■ Terracon Project No. 92127577

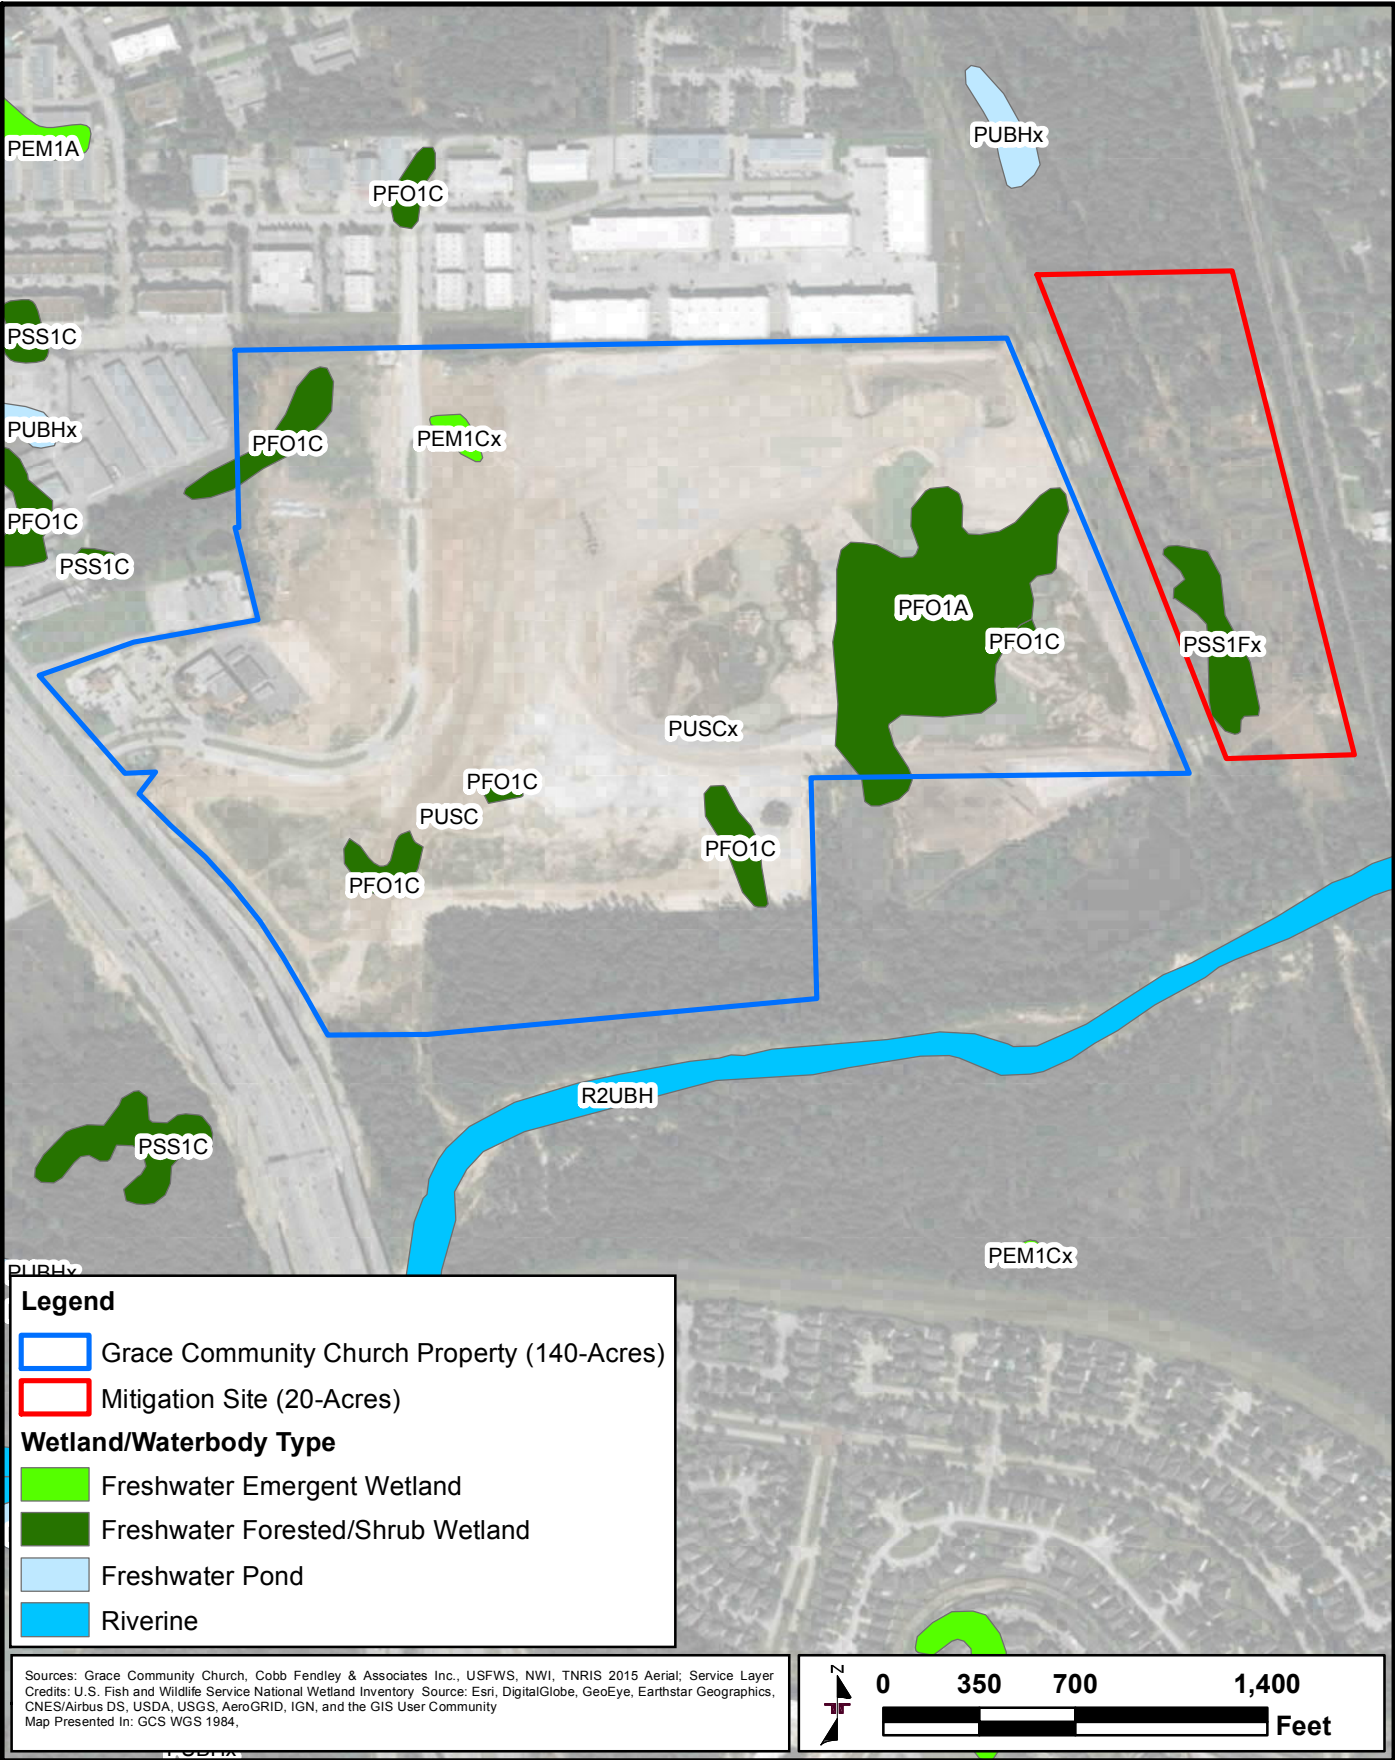
Exhibit
3.0

The U.S. Fish and Wildlife National Wetlands Inventory (NWI) Map does indicate the potential presence of wetlands within both the Grace Community Church property and the mitigation site. However, these features were not found to exist during the aforementioned site delineations. The *National Wetlands Inventory Map* can be seen in *Exhibit 3.0* in *Appendix A*.

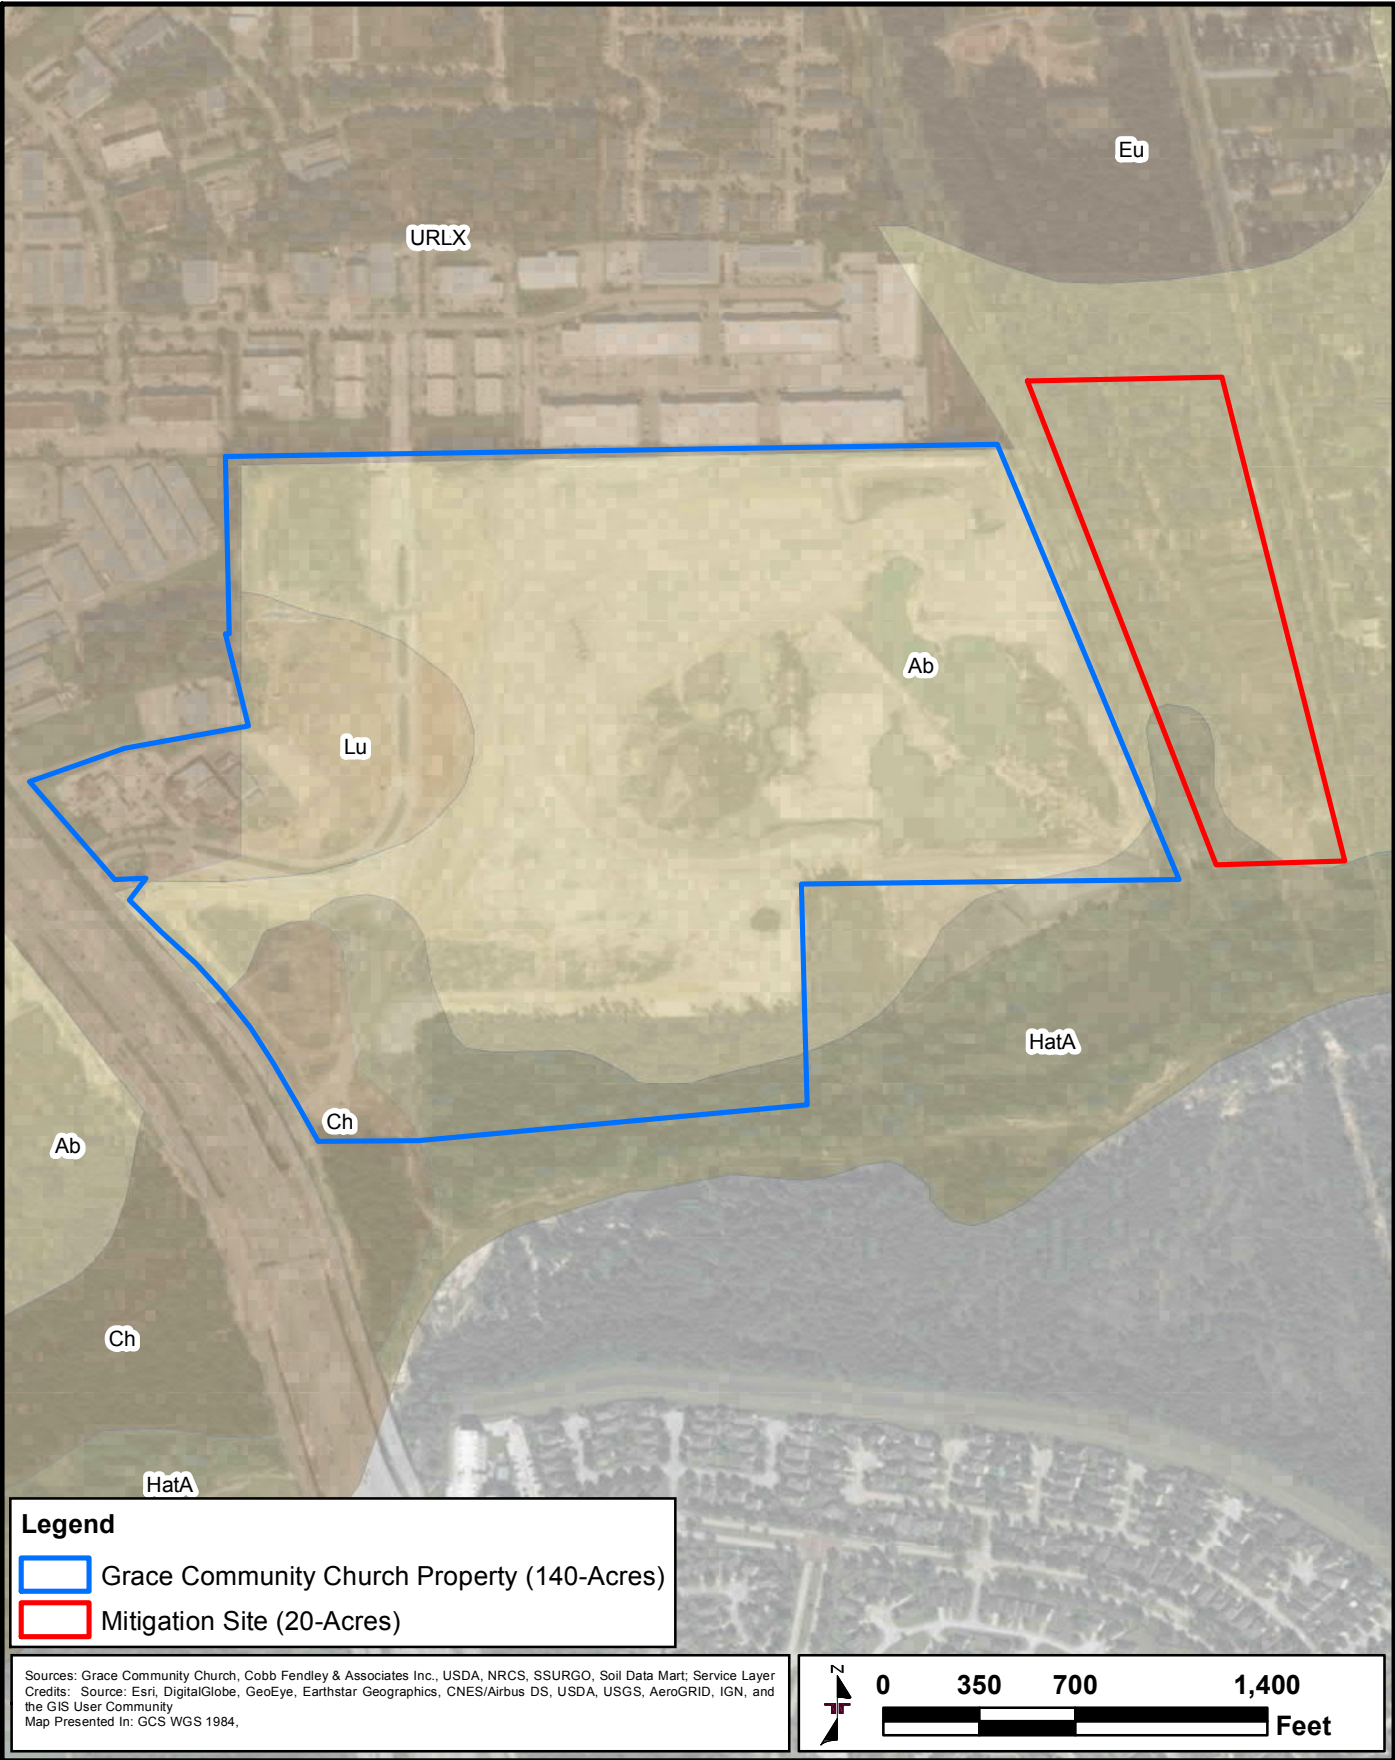
- Urban Land (URLX) – this map unit consists of impermeable surfaces associated with urban development.
- Landman fine sand (Ab) – this map unit consists of a moderately well drained natural drainage class and does not contain hydric components. This soil type can be found on stream terraces with convex slopes. The water table depth is present at about 48 to 72-inches, and there is no ponding and no flooding associated with the map unit.

- Alaga fine sand (Ch), 0-5% slopes – this map unit consists of a somewhat excessively drained natural drainage class and does not contain hydric components. This soil type can be found stream terraces with linear slopes. The water table is present at more than 80-inches and there is no frequency of ponding.

- Briley loamy fine sand (Lu), 1-3% slopes – this map unit consists of a well-drained natural drainage class and does contain hydric components. This soil type can be found on interfluvies with convex slopes. The water table depth is present at more than 80-inches and there is no ponding and no flooding associated with the map unit.

- Hatliff-Pluck-Kian complex, 0 to 1 percent slopes, frequently flooded (HatA) – this map unit consists of a well-drained drainage class and does not contain hydric components. This soil type can be found on flood plains with convex slopes. The water table depth is present at about 44 to 64-inches, and there is frequent flooding and no ponding associated with the map unit.

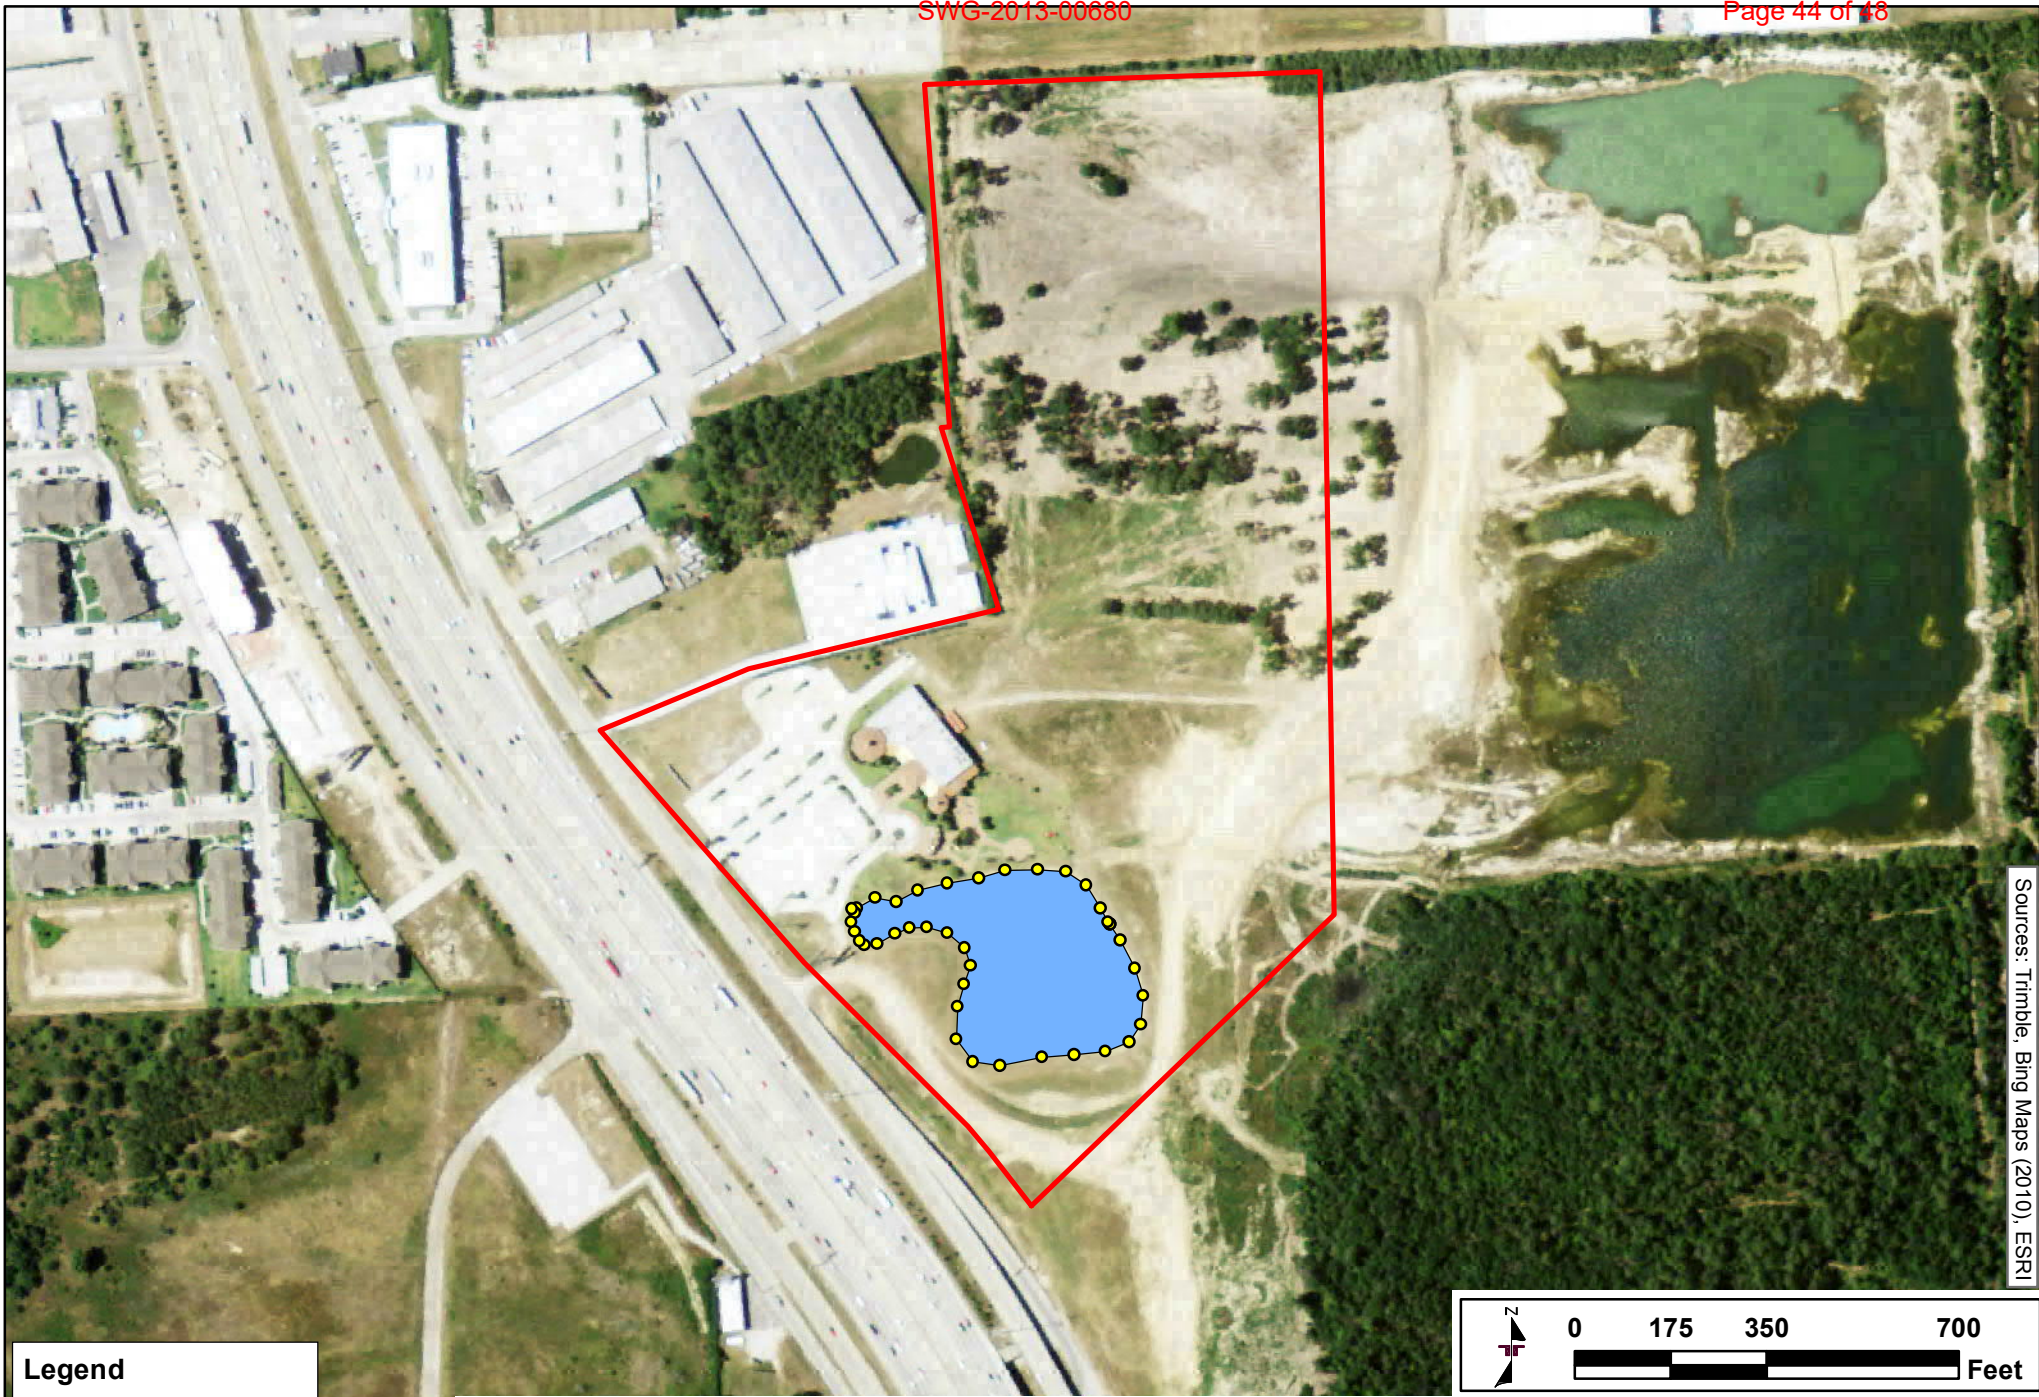
Terracon Project No. 92127577	October 2012 Delineated Features Map	Figure
CHECKED BY	GH		Updated Compensatory Mitigation Plan	7.0
SCALE	1 in: 350 ft		Grace Community Church	
DATE	10/11/2012		Spring, Montgomery County, Texas

Terracon first performed a preliminary WOUS delineation on a 36-acres portion of the now 140-acres Grace Community Church property in 2012. During the site visit, Terracon personnel observed one 2.63-acres water feature, identified as a freshwater landscaping pond, occurring on the project site. The report for this delineation, dated October 23, 2012, was submitted to the USACE. The site features for this delineation can be found on *Exhibit 7.0* in *Appendix A*.

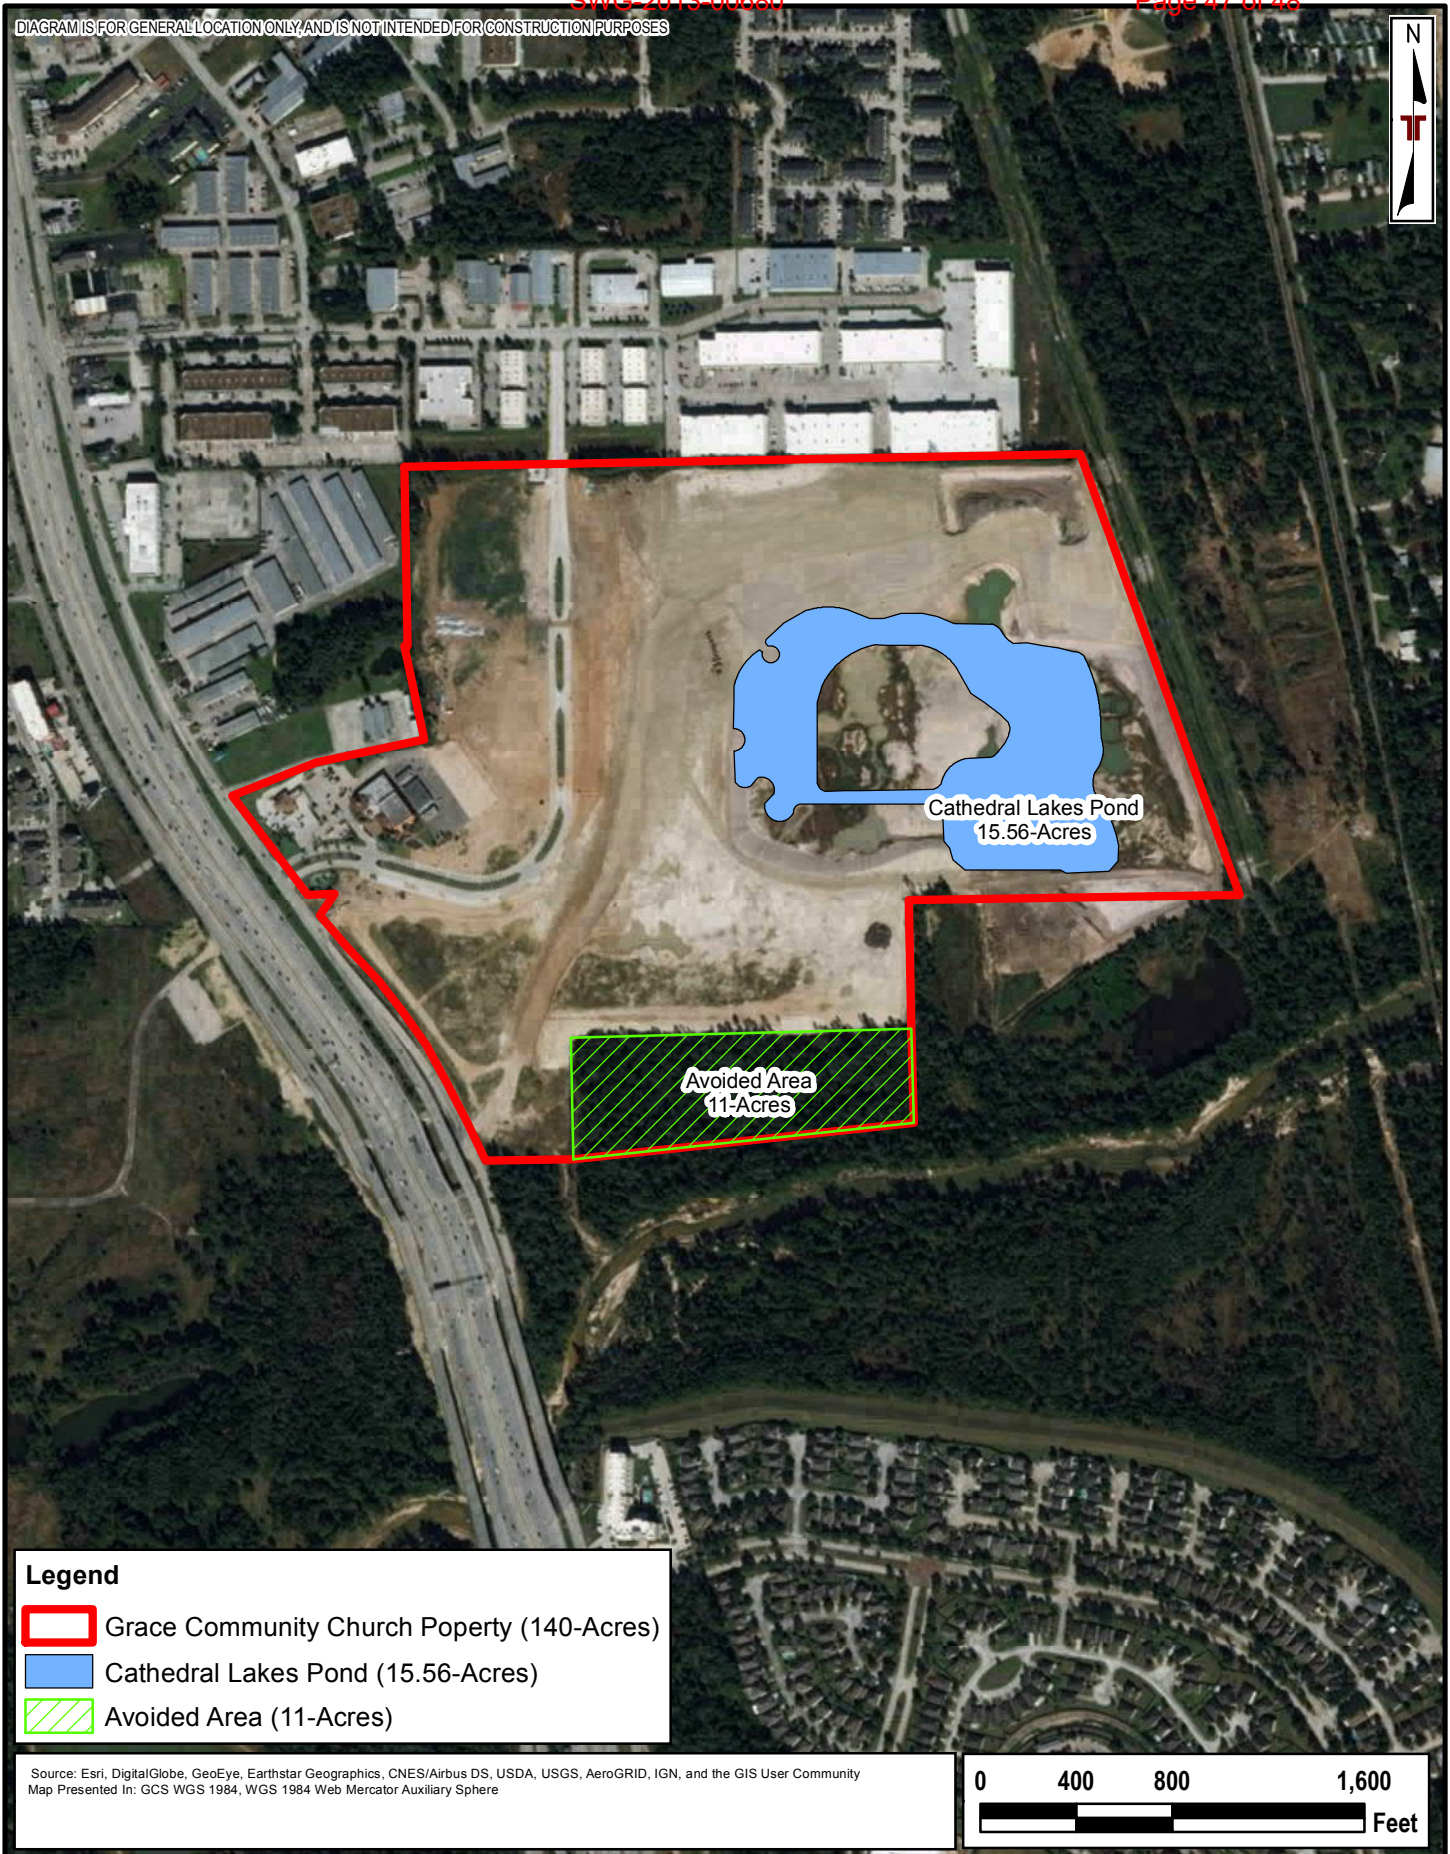
EXHIBIT
8.0

- Grace Community Church Property (140-Acres)
- Cathedral Lakes Pond (15.56-Acres)
- Avoided Area (11-Acres)

As discussed in the previously submitted mitigation plan, Grace Community Church has avoided an approximately 11-acres forested portion of their original property. This portion represents one of the last forested areas within the Grace Community Church property that was not cleared by sand mining operations. There is also approximately 3.44-acres of forested wetland within this avoided portion of the property. The avoided area and wetland can be seen in *Exhibit 7.1* and *Exhibit 8.0* in *Appendix A*.
