## Draft Permittee Responsible Mitigation Plan

### Project TIDE – SWG-2016-01025

Texas City, Galveston County, Texas

July 2017

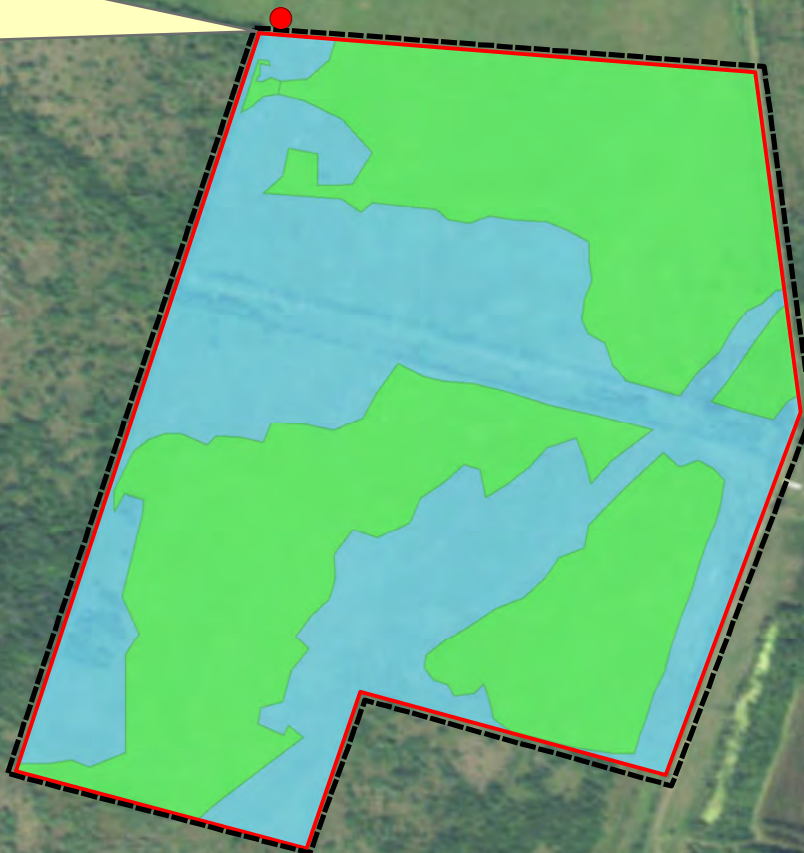
Existing cattle grazing will be prohibited within the proposed PRM project site. Additionally no vehicles will be allowed onsite.

This property will be placed under a deed restriction.

Ecological site restoration will be accomplished through cessation of all agricultural practices (e.g. livestock grazing) on the proposed PRM site. The livestock would be removed from the site allowing the vegetation communities to return to natural conditions. Research has shown that livestock significantly modify many aspects of soil structure and function, including soil porosity, chemistry, microbiology, nutrient cycles, productivity, and erosion rates<sup>17</sup>. Many studies have shown that grazing increases soil compaction, erosion, and short-term nutrient availability and reduces long-term soil nutrient and organic matter levels. Removing livestock from the proposed mitigation site, would remove the source of soil disturbance and soil compaction, allowing for the restoration of a natural nutrient cycle. Although prairie ecosystems evolved under grazing disturbance regimes; permanent, non-migratory livestock have adverse impacts on plant structure and biodiversity<sup>18</sup>. According to the U.S. Fish & Wildlife Service (FWS), the physical structure of plant communities is often changed by grazing and selective grazing can reduce the competitive vigor of plants. Trampling can also injure plants and reduce their reproductive capacities. In addition to restoring the chemical and physical aspects of the wetlands on the proposed PRM site, removing the livestock would increase plant biodiversity. The applicant does not propose to complete any site preparation, dirt work, or planting as a part of this work plan. Due to an existing community of wetland plant species onsite (described in Section 5.2), the applicant proposes to achieve restoration of plant biodiversity through native recruitment. Refer to Attachment 2 Figure 9 for an illustration of the mitigation work plan.

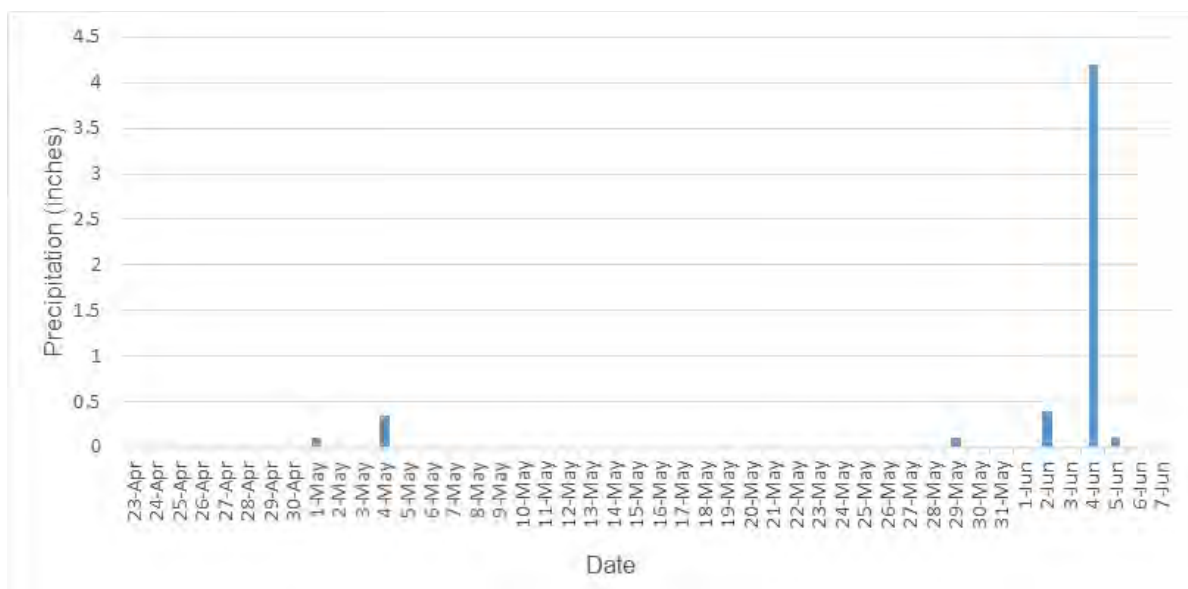
**Chart 5-1 Rainfall Trends for Bayou Vista, Galveston County, Texas**

These data show that there were six (6) precipitation events that totaled 5.24 inches of rain in the month prior to the last day of the site visit. A heavy rain event occurred on June 4, 2017 totaling 4.19 inches of rain.

A review of climatological data provided by NOAA obtained the following results for the Subject Site at the Bayou Vista 0.2 SE, TX US GHCND Station US1TXGV0006. The results, although not site-specific, represent rainfall trends for the region surrounding the site.

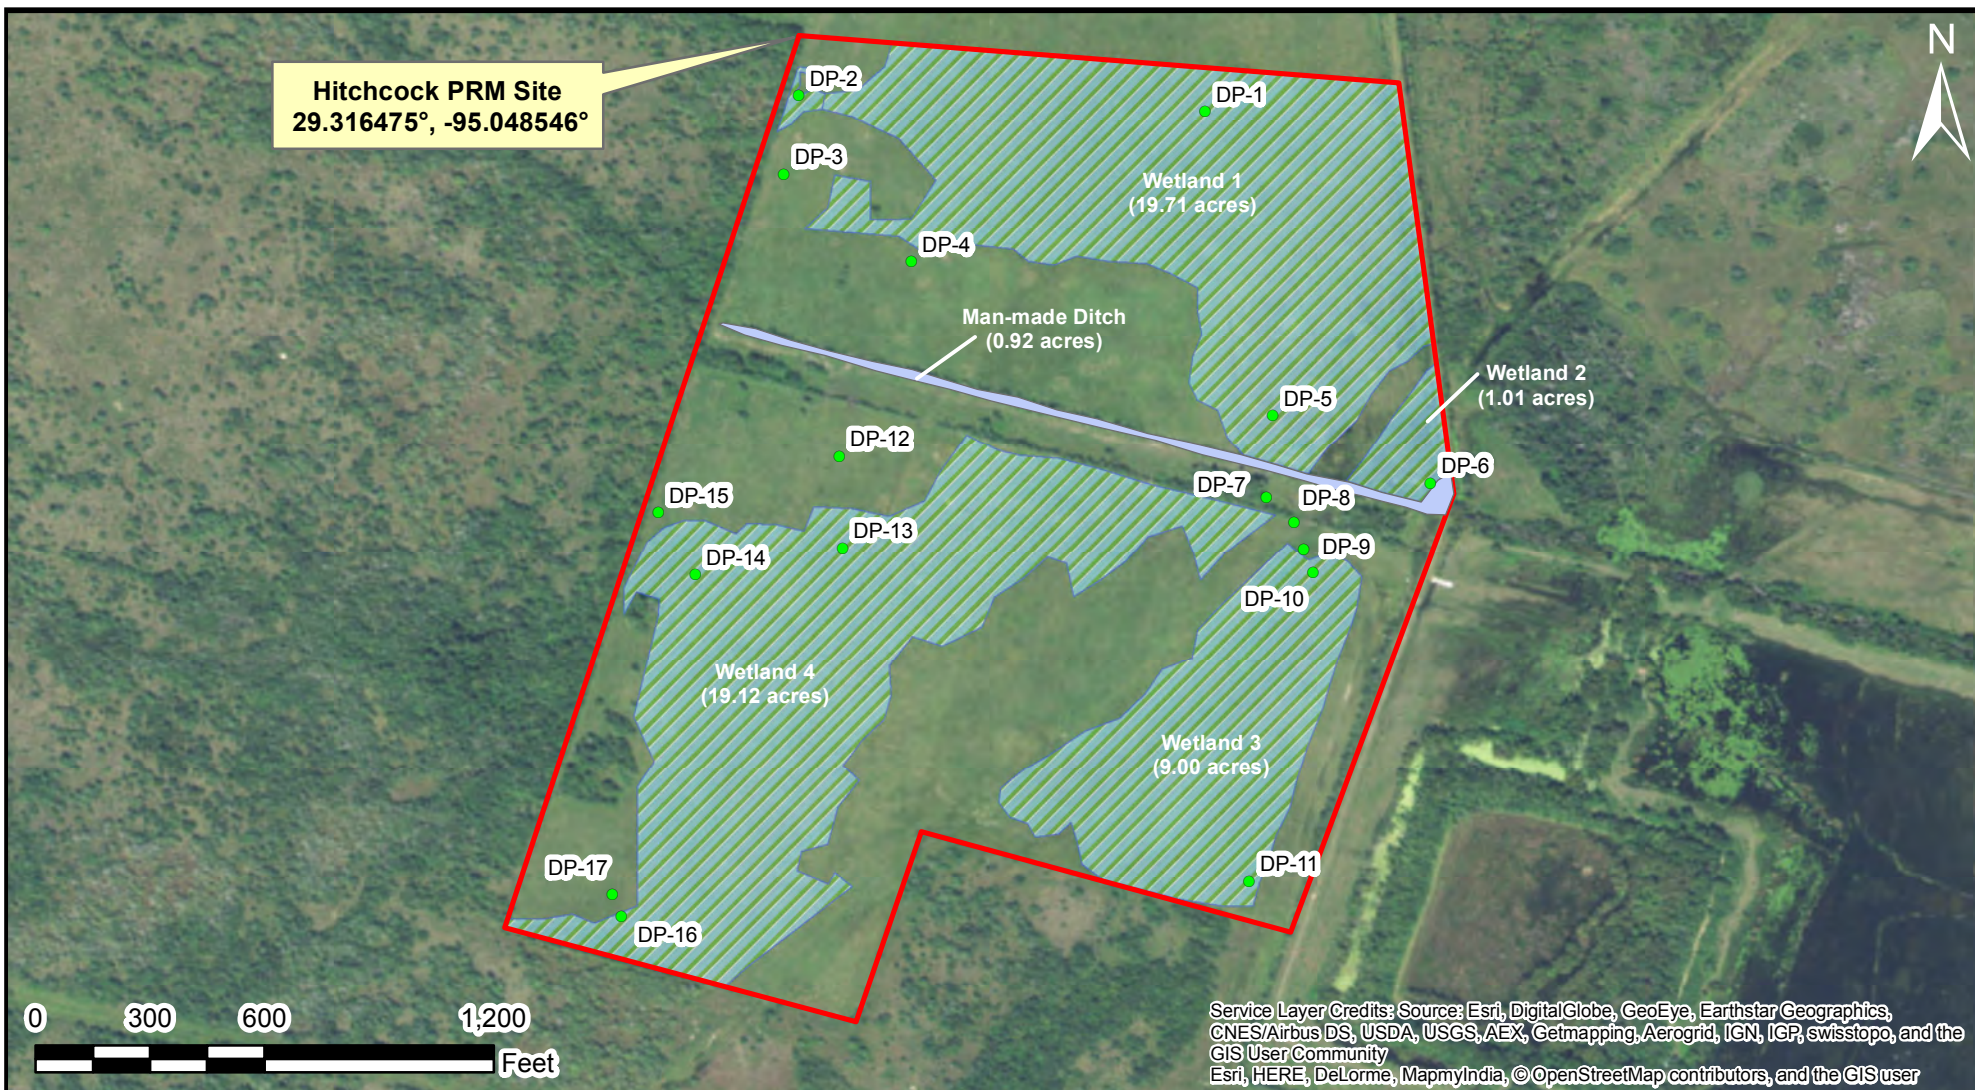
- Project Site (89.60 acres)
- Data Points
- PEM Wetlands (48.84 acres)
- Man-made Ditch (0.92 acres)

Spirit staff conducted a wetland and waterbody field survey on the project site with two (2) crew members. Field conditions varied between cloudy with light rain to sunny without rain. Approximately 48.84 acres of palustrine emergent (“PEM”) wetlands were observed within the project site. Refer to Table 5-3 below for details on each wetland feature delineated. Figure 7 illustrates the locations of the data points taken onsite and the wetland polygons delineated during the site visit.

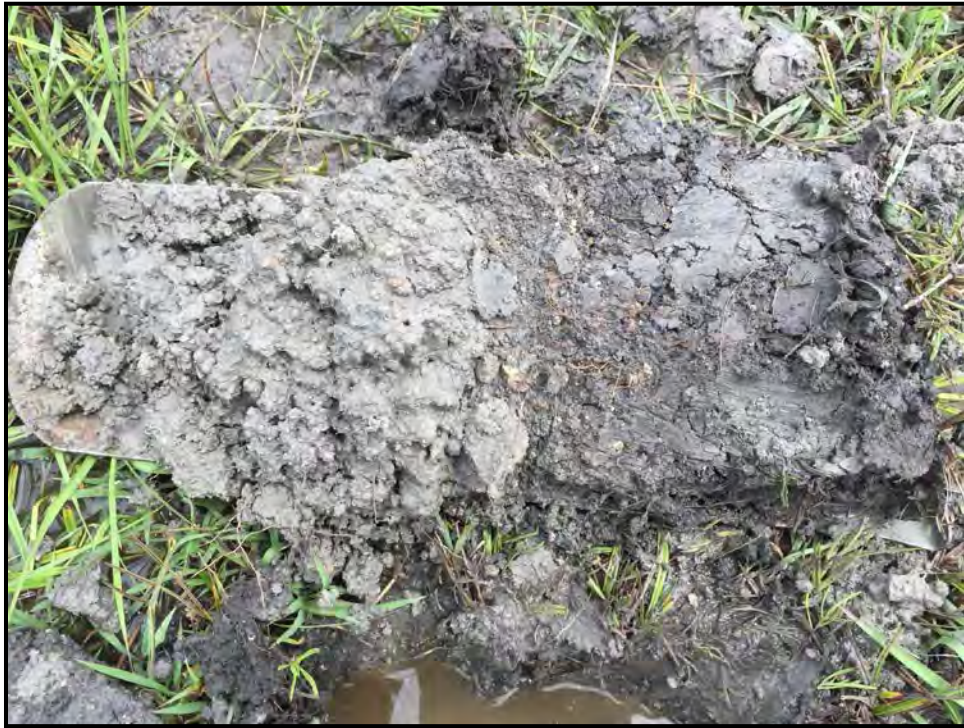
Photograph 1 – Typical wetland soils at DP-1

Subsurface soil profiles were obtained at each sample point throughout the site. Generally, the soil consisted of dark gray to black clay loam soils. Wetland soils observed exhibited 10YR 3/1, 3/2 or 4/1 matrices with redoximorphic features and were determined to meet the *Redox Dark Surface (F6)* or *Depleted Matrix (F3)* hydric soil indicators. *Hydrogen Sulfide (A4)* was encountered at “DP-5” and “DP-6.” Upland soils exhibited 10YR 2/1, 3/1, or 3/2 matrices without redoximorphic features.

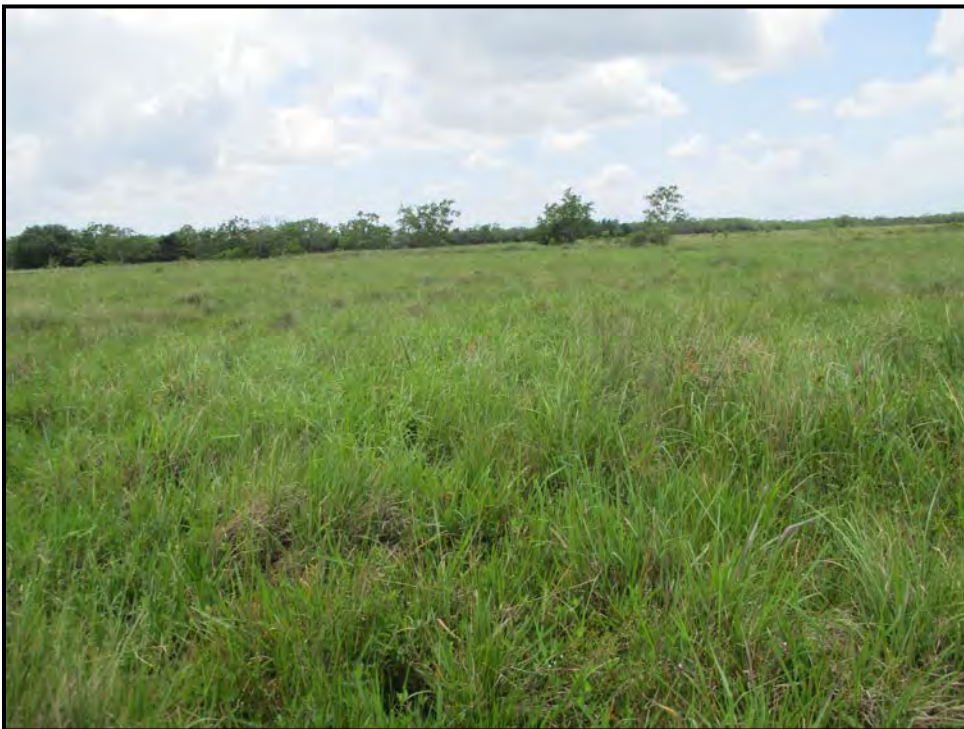
Photograph 2 – Typical vegetation at DP-1 in Wetland 1, facing northwest

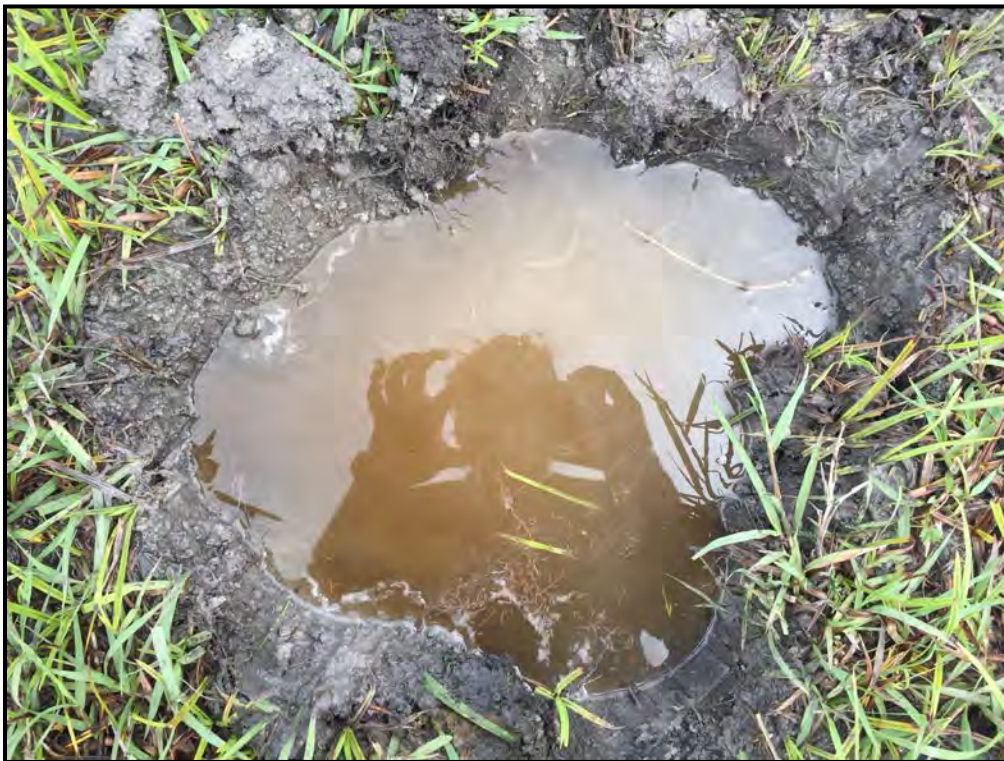
Photograph 4 – High water table and saturation at DP-1

Wetland hydrological indicators noted in the field included surface water, high water table, saturation, oxidized rhizospheres along living roots, hydrogen sulfide odor, and crawfish burrows. Nine (9) data points exhibited hydrology and were determined to be wetlands (“DP-1”, “DP-2”, “DP-5”, “DP-6”, “DP-10”, “DP-11”, “DP-13”, “DP-14”, and “DP-16”). Data points “DP-9” and “DP-12” exhibited secondary hydrological indicators; however, were not determined to be wetlands. Data points “DP-3”, “DP-4”, “DP-7”, “DP-8”, “DP-15”, and “DP-17” did not exhibit hydrological indicators and therefore were determined to be uplands.

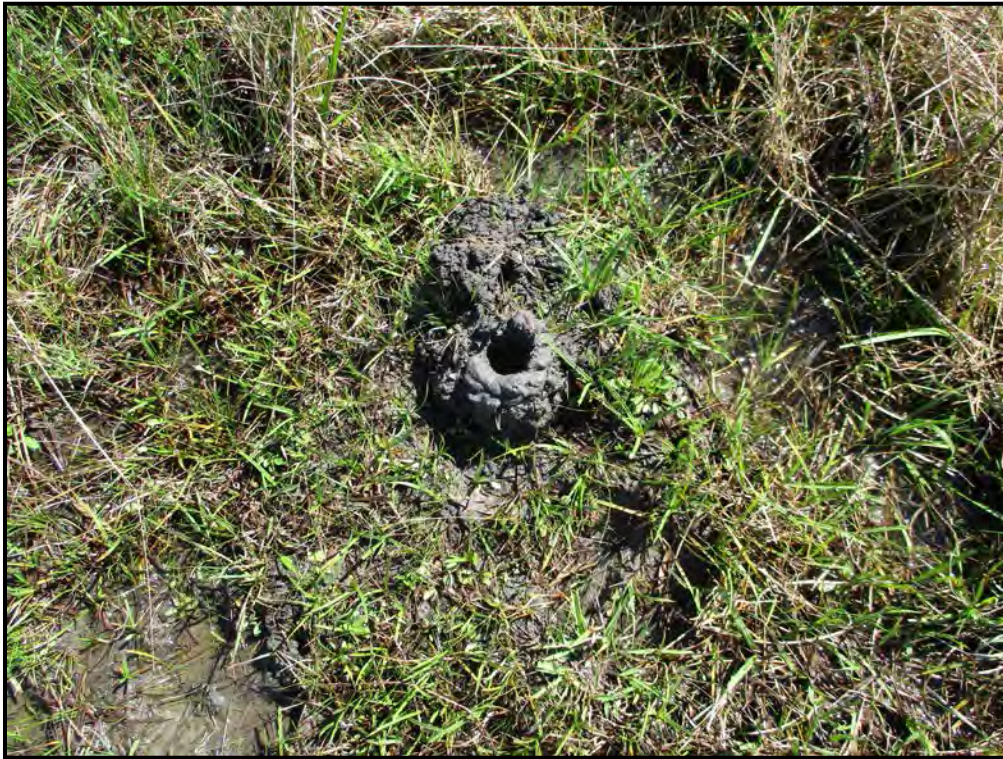
Photograph 5 – Secondary hydrological indicator – crawfish burrows seen throughout site

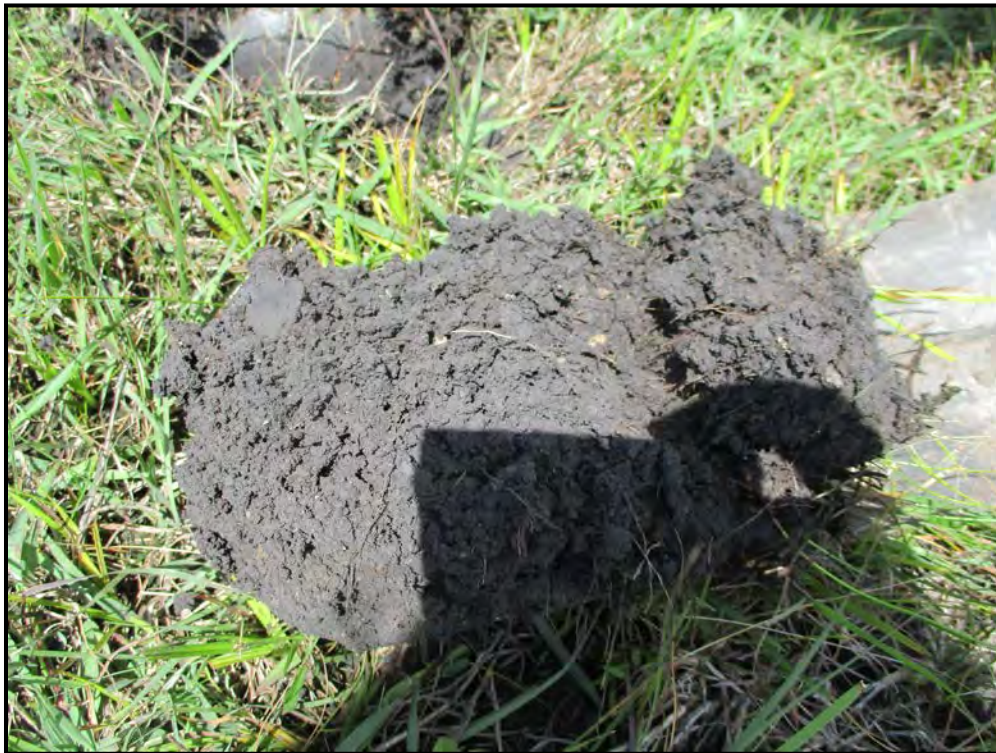
Photograph 6 – Typical upland soils at DP-8

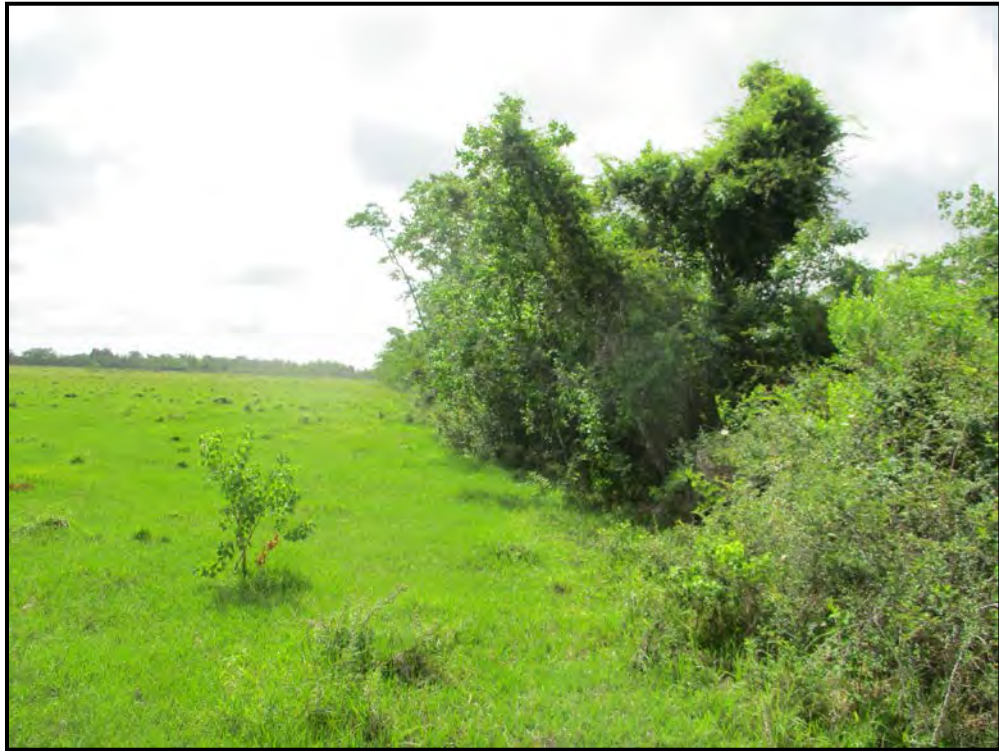
Photograph 7 – Typical upland vegetation at DP-8, facing west

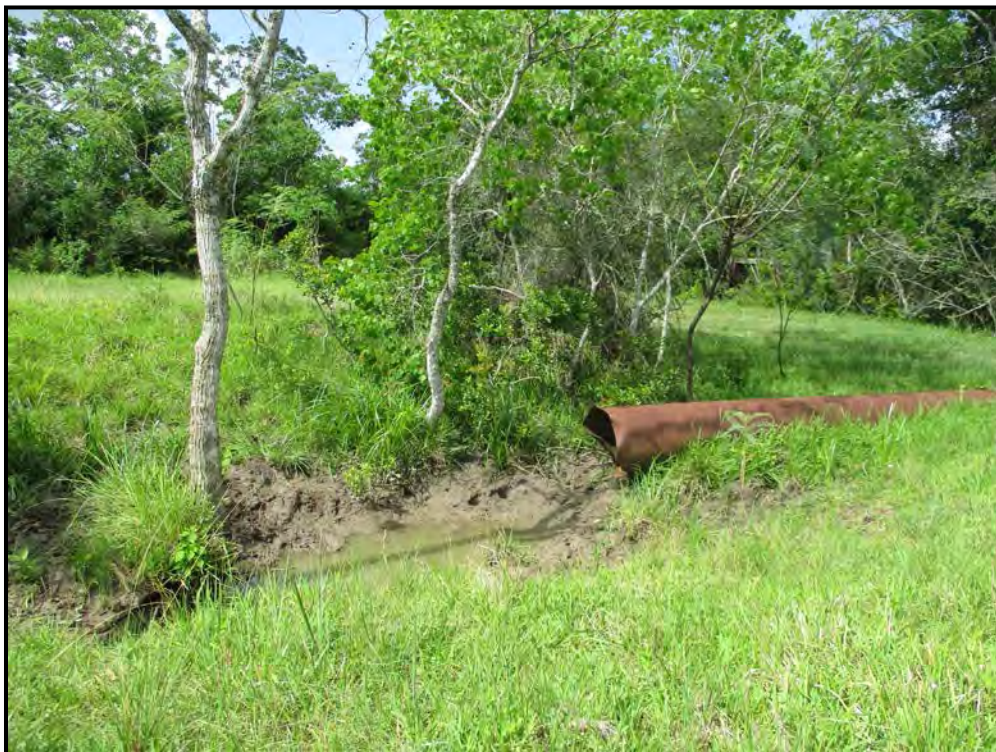
Photograph 8 – Culvert at western edge of man-made drainage ditch

One (1) waterbody totaling 0.92 acres was observed transecting the project site from west to east. The man-made drainage ditch flowed through a culvert on the western property boundary. The table below displays the characteristics of the man-made drainage ditch delineated onsite.

One (1) waterbody totaling 0.92 acres was observed transecting the project site from west to east. This man-made drainage ditch flowed through a culvert on the western property boundary. It does not appear that this ditch was excavated from a natural tributary; therefore, it is Spirit’s professional opinion this feature would not be considered a water of the U.S. according to USACE definitions.

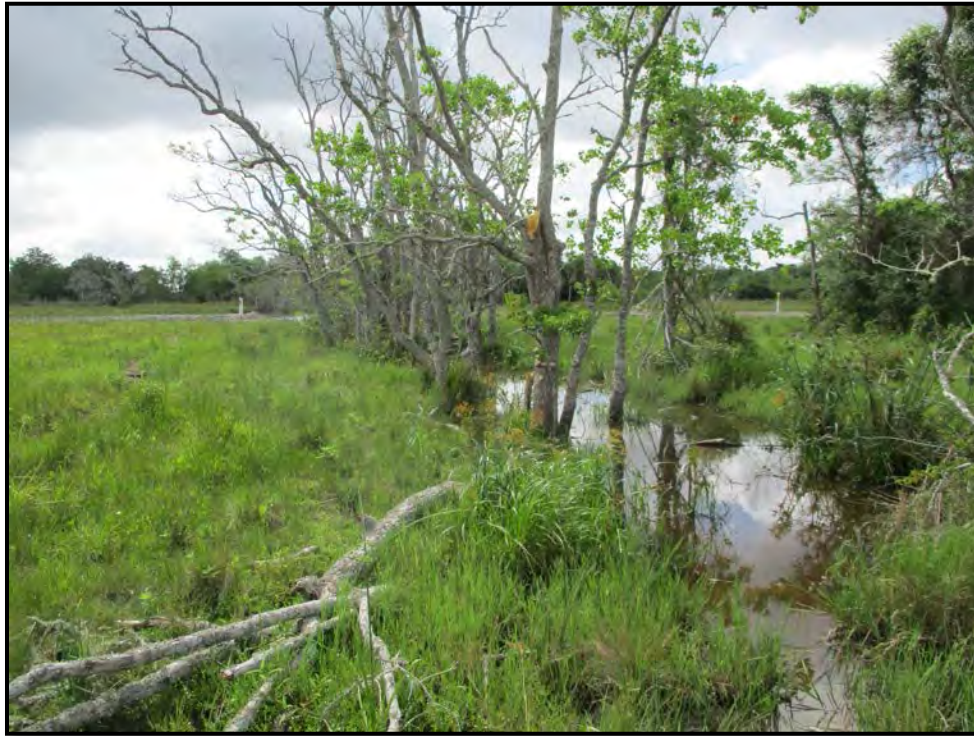
Photograph 9 – View of man-made drainage ditch, facing east

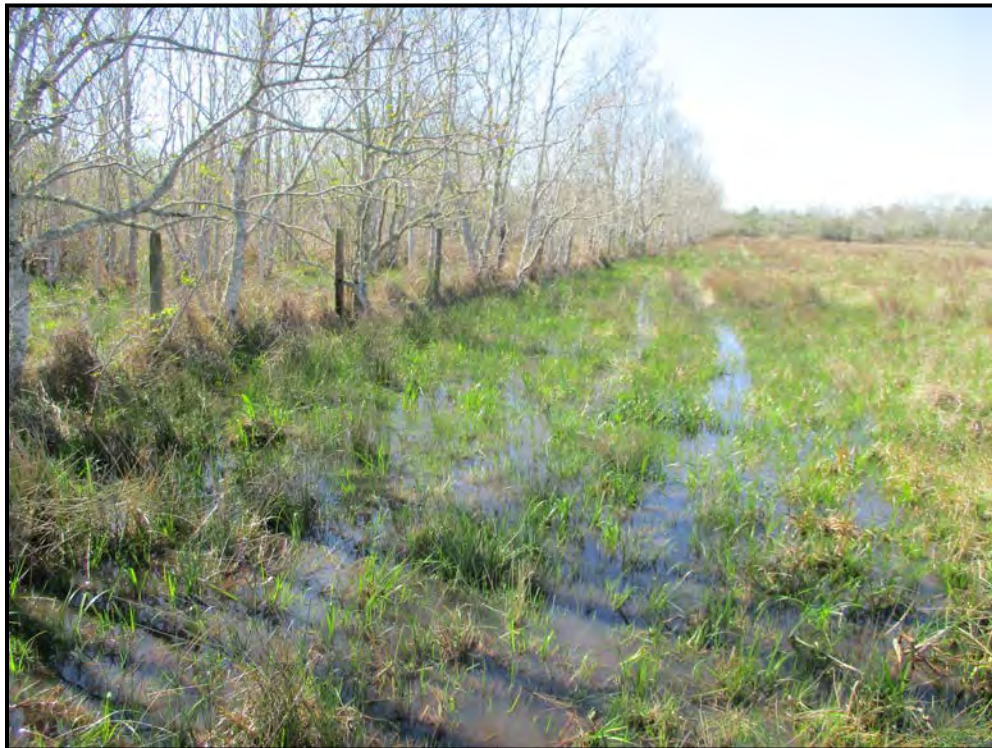
Photograph 12 – View of surface water in Wetland 4, facing west at southern border
