PROSPECTUS

BAYOU BEND MITIGATION BANK

MARCH 2018

SWCA Environmental Consultants

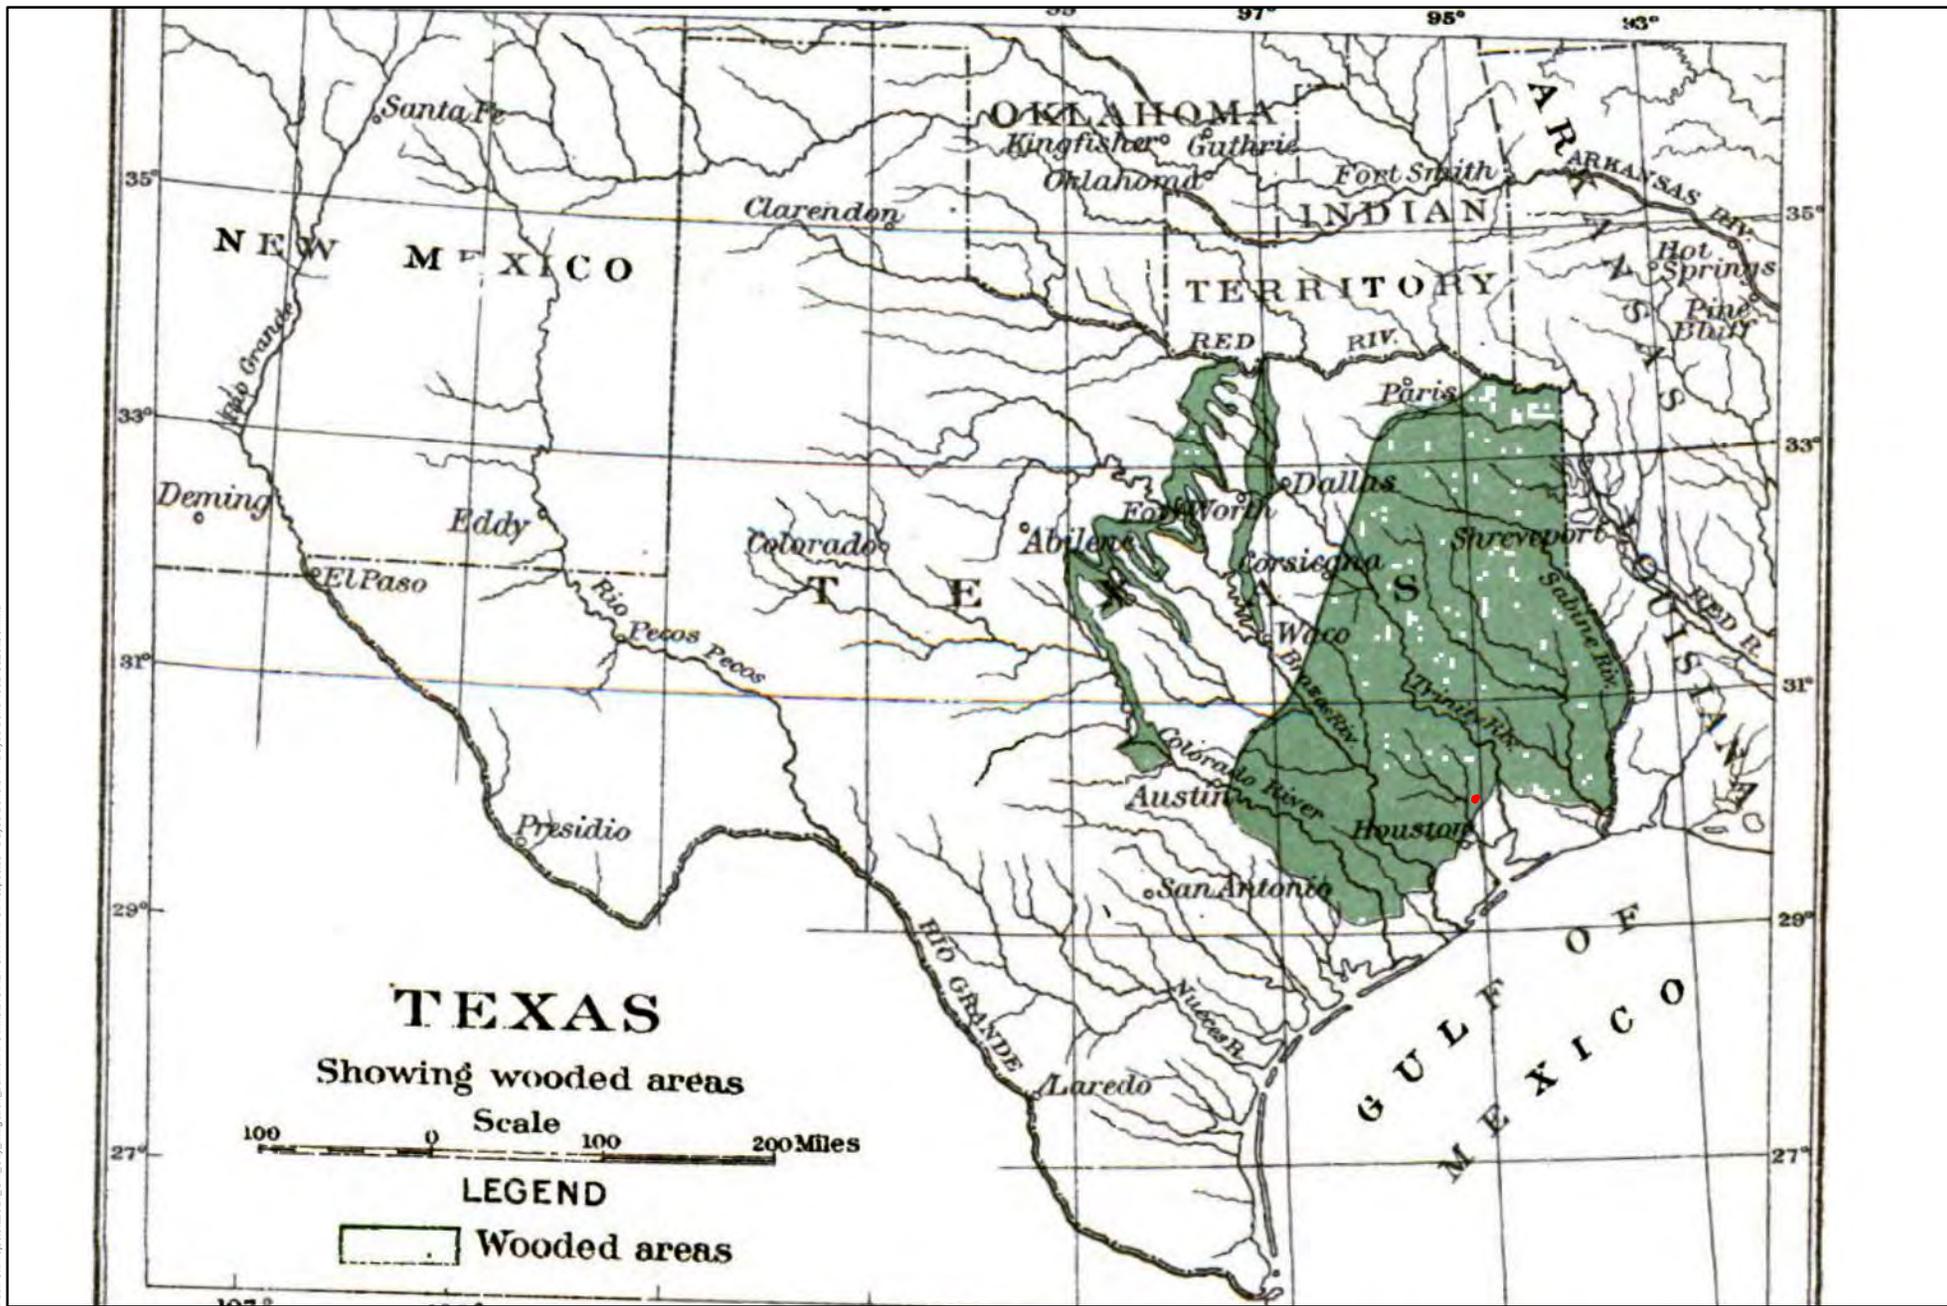
BAYOU BEND MITIGATION BANK
GAZETTEER OF TEXAS 1902 MAP
HARRIS AND LIBERTY COUNTIES, TEXAS

The historical wooded area shown in the 1902 Gazetteer of Texas (Exhibit 5 – Sheet 1) was quiet extensive, and likely comprised of mixed pine-hardwood forest interspersed with savanna or wet prairie areas, according to the two Level III ecoregions - South Central Plains and Western Gulf Coastal Plains described for this area (Griffith et al. 2007). The historical vegetation of the Northern Humid Gulf Coastal Prairies (Level IV) ecoregion was mostly grasslands with a few clusters of oaks, known as oak mottes or maritime woodlands. However the bank is located in close proximity to the border between the Northern Humid Gulf Coastal Prairies the Flatwoods (Level IV) ecoregions. Therefore the proposed bank likely contained a mix of pine-hardwoods stands and oak mottes able to support hydrophytic woody vegetation within the proposed bank site prior to its conversion to agricultural land use. Currently, BBMB consists mostly of rice, soybean, and hay production. The BBMB also contains three agricultural reservoirs in the northeast corner (Seaberg Reservoirs #1, #2 and #4) and approximately 101 acres of forest located around these reservoirs. Forested riparian zones are located along the waterbodies. Exhibit 6 includes a map sheet index followed by a map comprised of three sheets that depict the U.S. Fish and Wildlife Service's (USFWS) National Wetlands Inventory (NWI) wetlands, the Natural Resources Conservation Services' (NRCS) soils units, and delineated wetlands and waterbodies from a field delineation conducted by SWCA.

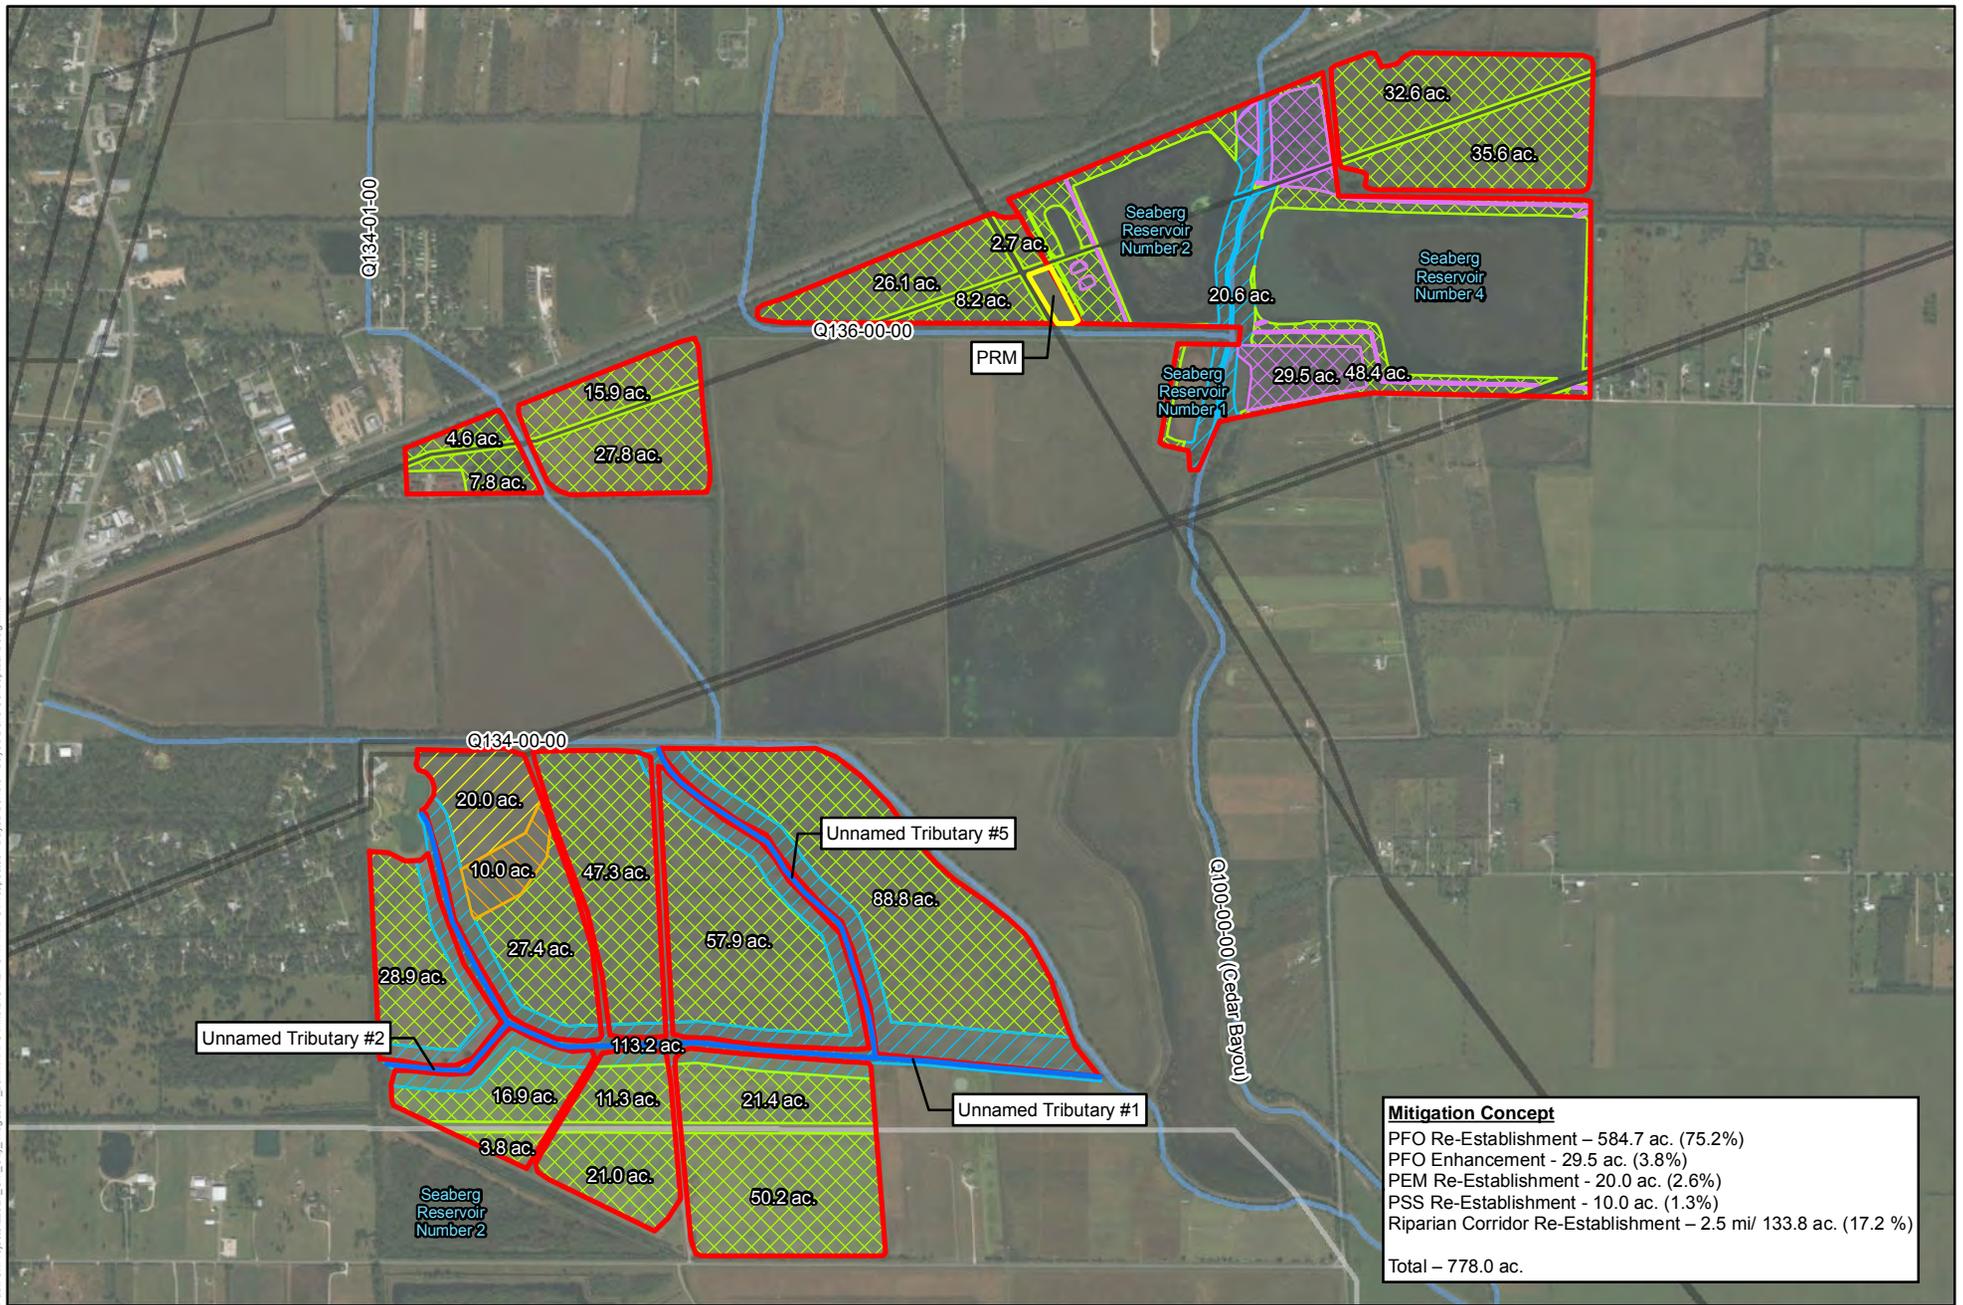
Mitigation Concept	
PFO Re-Establishment	- 584.7 ac. (75.2%)
PFO Enhancement	- 29.5 ac. (3.8%)
PEM Re-Establishment	- 20.0 ac. (2.6%)
PSS Re-Establishment	- 10.0 ac. (1.3%)
Riparian Corridor Re-Establishment	- 2.5 mi/ 133.8 ac. (17.2%)
Total	- 778.0 ac.

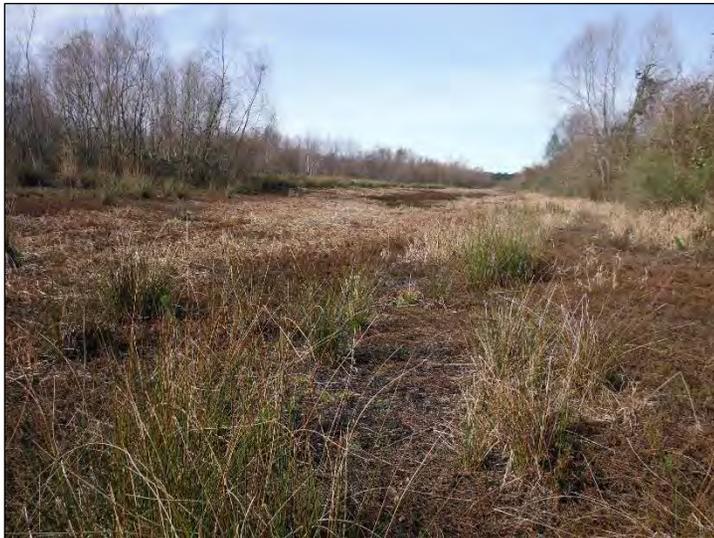
Figure 7. Palustrine emergent (PEM) wetland WETA001 as viewed from DPAT2001_PEM; view facing west.

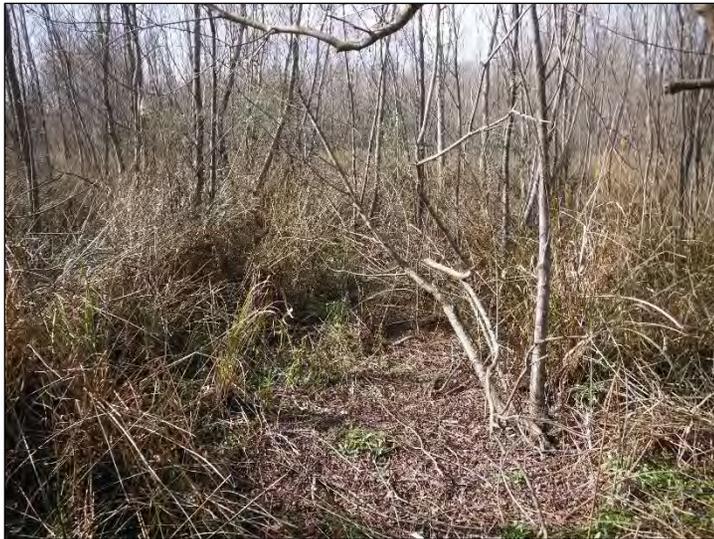
Figure 9. Palustrine forested (PFO) wetland WETA001 as viewed from DPA001_PFO; view facing west.

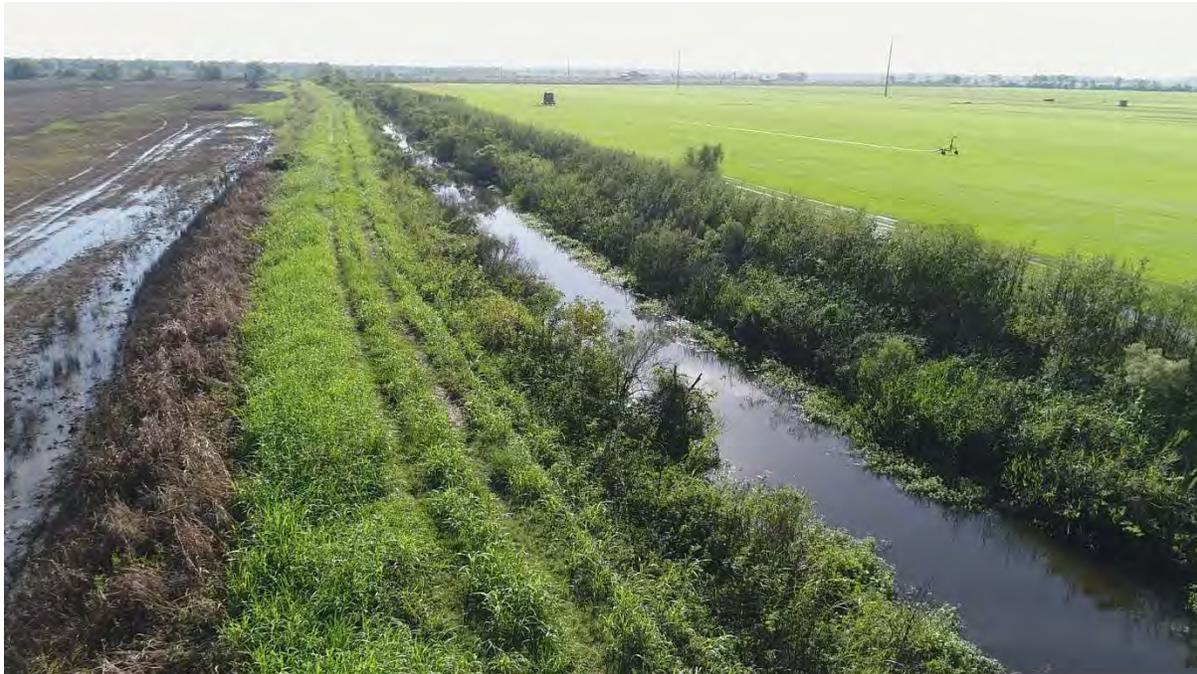
Figure 3. UT 1 – aerial view east and downstream.

UT 1 is a channelized drainage canal which begins at the northwestern portion of the project area and flows eastward for approximately 1.5 miles into another unnamed tributary to Cedar Bayou. The watershed for UT 1 is approximately 1004.01 acres (Figure 2). As seen in Figure 3, the land use of the area is primarily agriculture lands used for sod production and rice fields. The stream banks are lined with trees and shrubs with an access road levee on the left bank (view downstream).

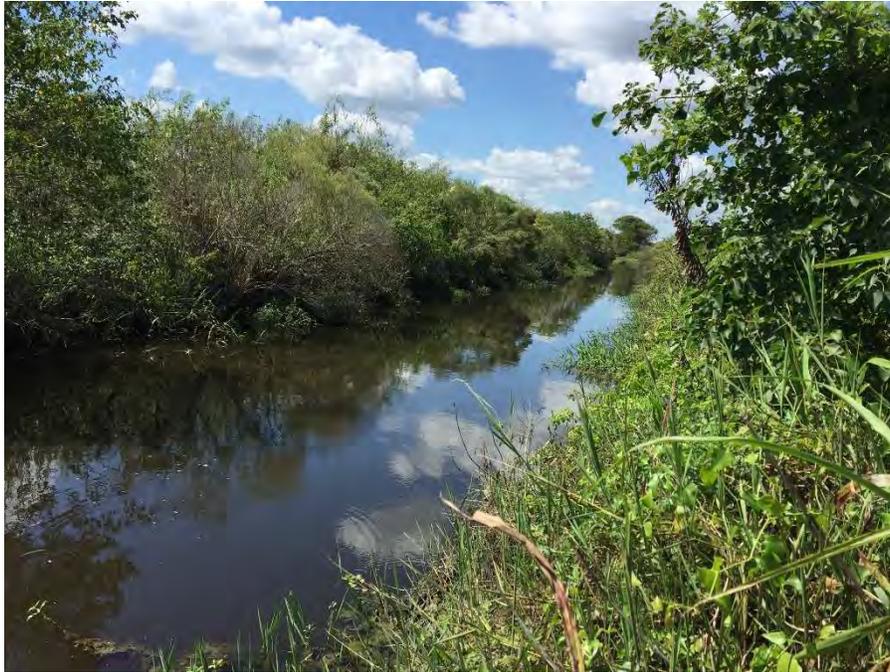
Figure 4. UT 1 – representative photograph of upstream section

Typical of drainage canals in the region, this channel was straightened and channelized to drain quickly downstream to prevent localized flooding. The stream banks were widened, deepened, and have no meander features. This negatively impacted the hydraulics of the stream and led to sedimentation problems. The beginning of UT 1 has a long pool feature due to its low slope. At certain areas the stream has a nearly level bed with a low slope of 0.006. This is characterized by stagnant water and low sediment carrying competency. Figure 4 provides a representative photograph of the upstream portion of UT 1. Downstream of the long pool feature, the channel continues as a straightened G type stream with very low sinuosity.

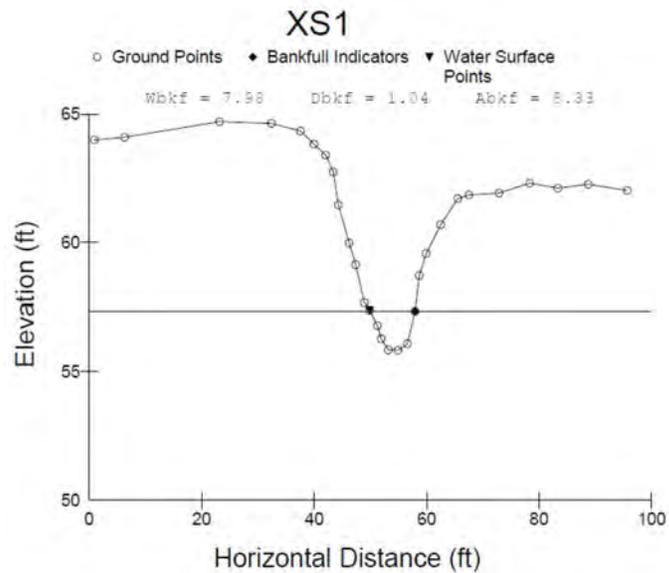
Figure 5 shows a surveyed cross section at the upstream portion of UT 1. Based on the cross section surveyed, the stream is entrenched with an ER of 1.2, and a WDR of 7.67. Bankfull indicators were difficult to be identified in the field due to the presence of a pool. The WDR is a departure from reference conditions and is considered to be impaired due to the ER, as the stream has limited access to its floodplain.

Figure 5. UT 1 – typical cross section (upstream section).

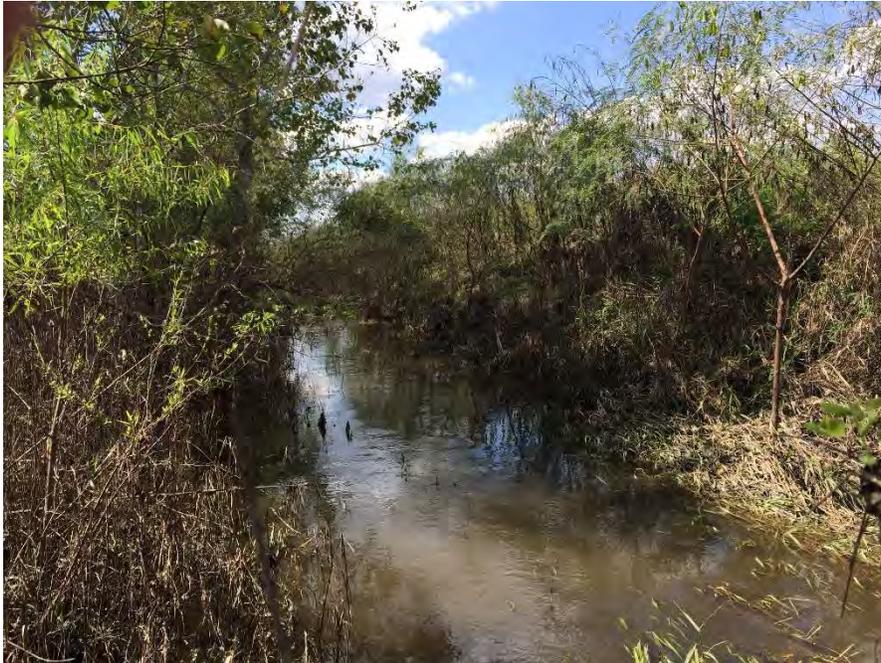
Figure 6. UT 1 – representative photograph of downstream section.

stream. Riparian vegetation is denser on the slope and there is undercutting of roots. The slope of the stream at this section remains low at 0.006. Figure 6 shows a representative photograph of the downstream portion of UT 1. Figure 7 shows a typical cross section with high banks on both the left and right sides of the stream. Based on the findings, UT 1 is a good candidate for restoration and SWCA recommends the full re-establishment of the dimension, pattern, and profile of the stream to reference conditions. The location of UT 1 in the headwaters of Cedar Bayou highlights the importance of restoring the stream to healthier reference conditions as the benefits such as flood abatement, improved sediment flow regime, and improved stream and riparian habitat will propagate downstream as well.

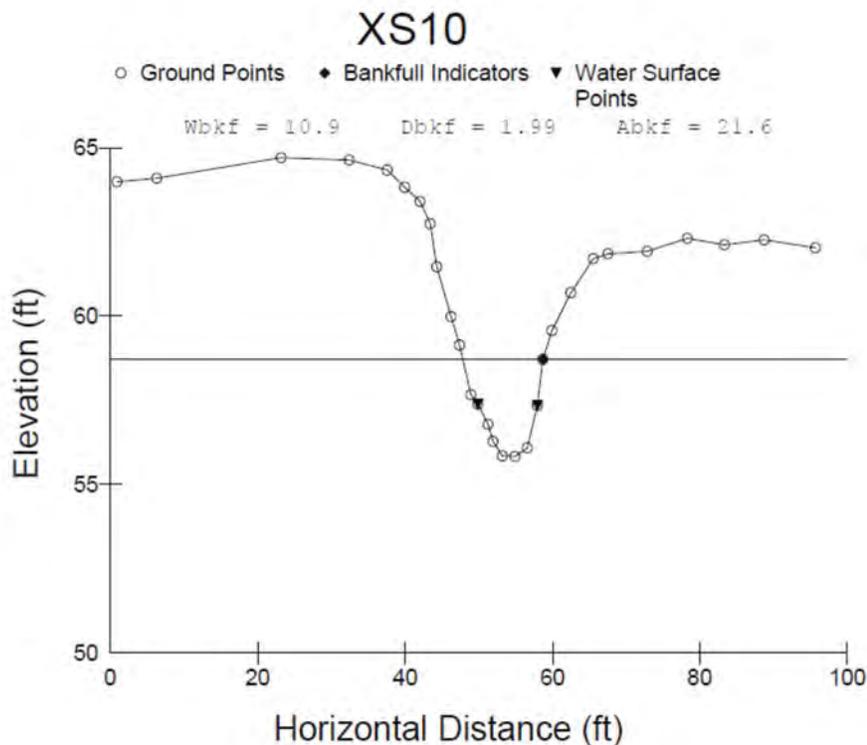
Figure 7. UT 1 – typical cross section (downstream section).

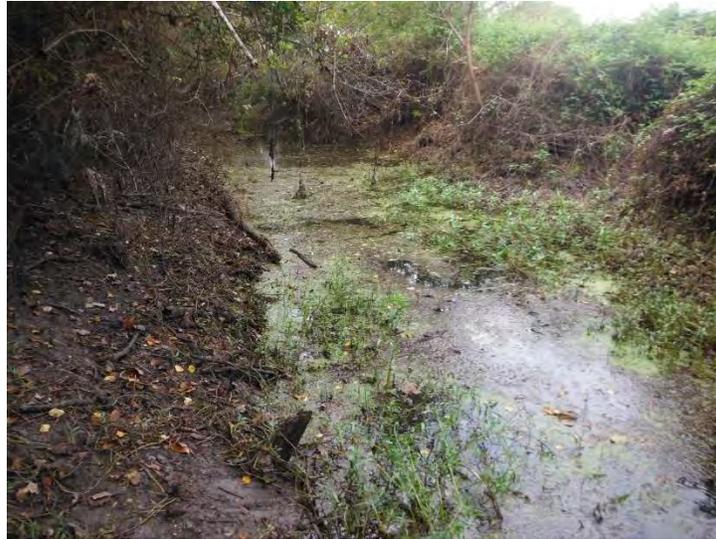
Figure 8. UT 2 – view upstream and west.

Typical of drainage canals in the region, this channel was straightened and channelized to drain quickly downstream to prevent localized flooding. The stream banks were widened, deepened, and have no meander features. This negatively impacted the hydraulics of the stream and led to sedimentation problems. At certain areas the stream has a nearly level bed with the slope at a very low 0.0002. This is characterized by stagnant water and low sediment carrying competency. Figure 8 shows vegetation growing in the channel which indicates high sediment deposition.

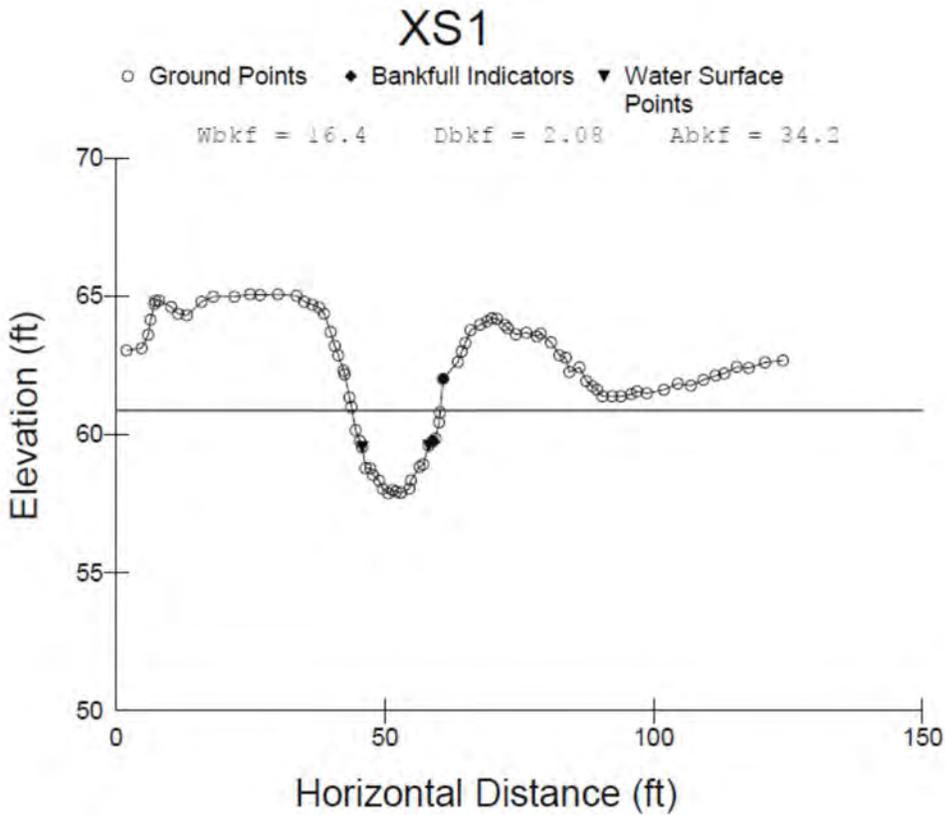
Figure 9 shows a typical cross section of UT 2. Based on the cross section surveyed, the stream is moderately entrenched with an ER of 1.5, and a WDR of 7.88. Bankfull indicators were difficult to identify in the field due to the incision of the stream with no access to a bankfull floodplain. The stream is considered impaired due to its WDR departure from reference conditions, low sinuosity, erosion, sedimentation problems, and lack of connection to the floodplain. Based on the findings, UT 2 is a good candidate for restoration and SWCA recommends the full re-establishment of the dimension, pattern, and profile of the stream to reference conditions.

Figure 9. UT 2 – typical cross section.

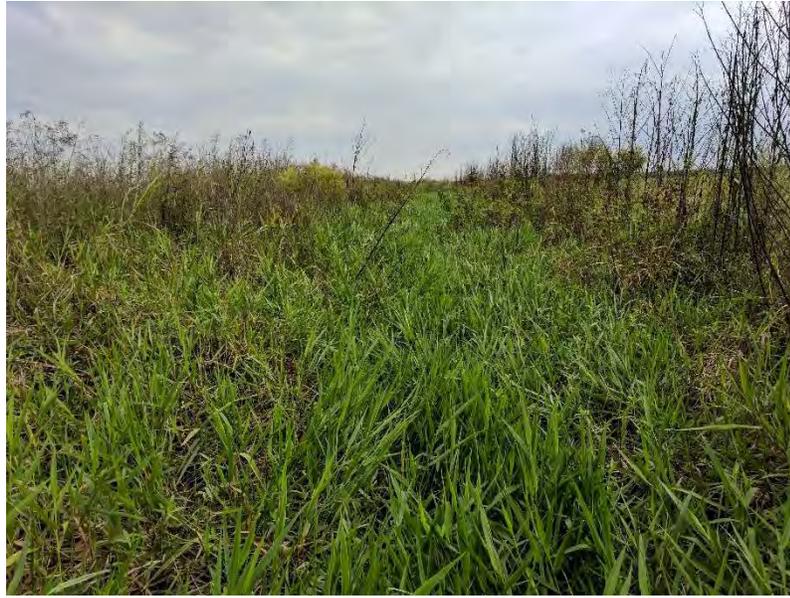
Figure 10. UT 3 – view upstream and north.

UT 3 was straightened and channelized to drain quickly downstream to prevent localized flooding. The stream banks were widened, deepened, and have no meander features. This negatively impacted the hydraulics of the stream and led to sedimentation problems. At certain areas the stream has a nearly level bed with the slope at 0.006. This is characterized by stagnant water and low sediment carrying competency. Figure 10 shows vegetation growing in the channel which indicates high sediment deposition.

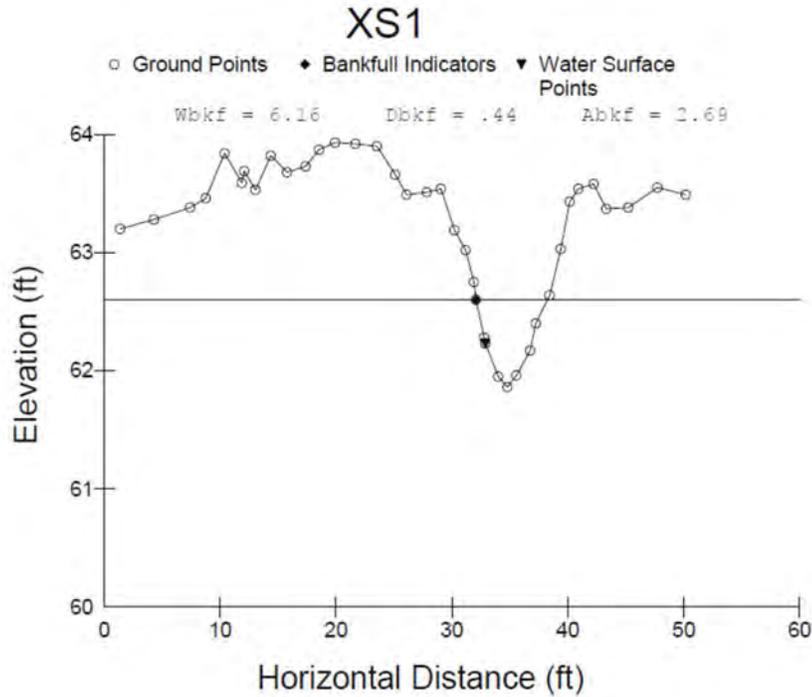
Figure 11 shows a typical cross section of UT 3. Based on the cross section surveyed, the stream is moderately entrenched with an ER of 1.5, and a WDR of 14. Bankfull indicators were difficult to identify in the field due to the incision of the stream with no access to a bankfull floodplain. The stream is considered impaired due to its WDR departure from reference conditions, low sinuosity, erosion, sedimentation problems, and lack of connection to the floodplain. Based on the findings, UT 3 is a good candidate for restoration and SWCA recommends the full re-establishment of the dimension, pattern, and profile of the stream to reference conditions.

Figure 11. UT 3 – typical cross section.

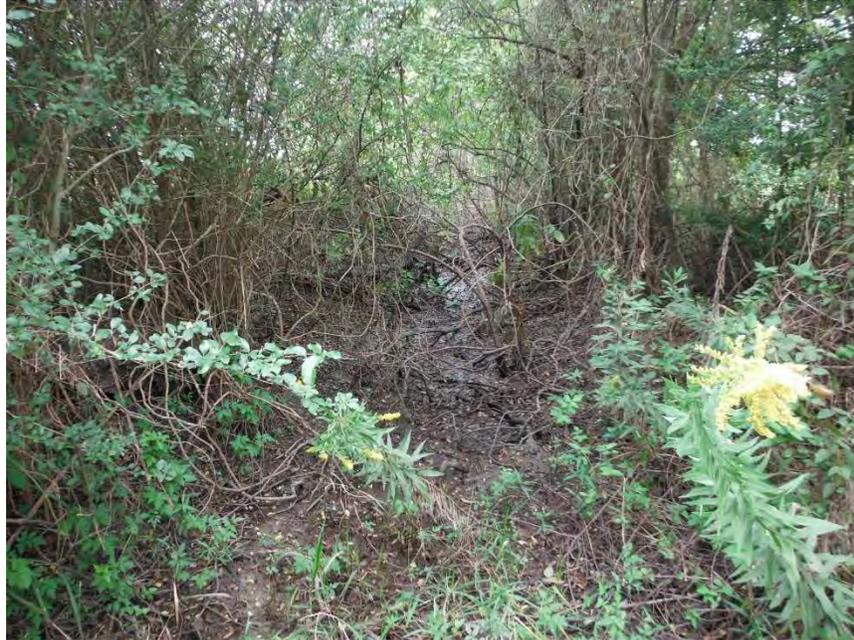
Figure 12. UT 4 – view downstream and northeast.

UT 4 was straightened and channelized to drain quickly downstream to prevent localized flooding. The stream banks were widened, deepened, and have no meander features. This negatively impacted the hydraulics of the stream and led to sedimentation problems. At certain areas the stream has a nearly level bed with the slope at 0.017. This is characterized by stagnant water and low sediment carrying competency. Figure 12 shows vegetation growing in the channel which indicates high sediment deposition.

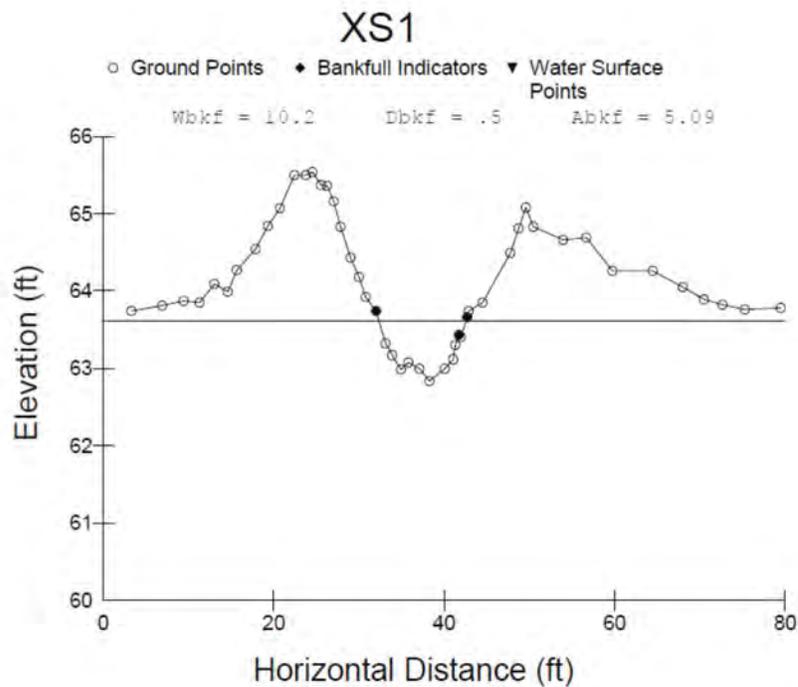
Figure 13 shows a typical cross section of UT 4. Based on the cross section surveyed, the stream is moderately entrenched with an ER of 1.7, and a WDR of 2. Bankfull indicators were difficult to identify in the field due to the incision of the stream with no access to a bankfull floodplain. The stream is considered impaired due to its WDR departure from reference conditions, low sinuosity, erosion, and sedimentation problems, and lack of connection to the floodplain. Based on the findings, UT 4 is a good candidate for restoration and SWCA recommends the full re-establishment of the dimension, pattern, and profile of the stream to reference conditions.

Figure 13. UT 4 – typical cross section.

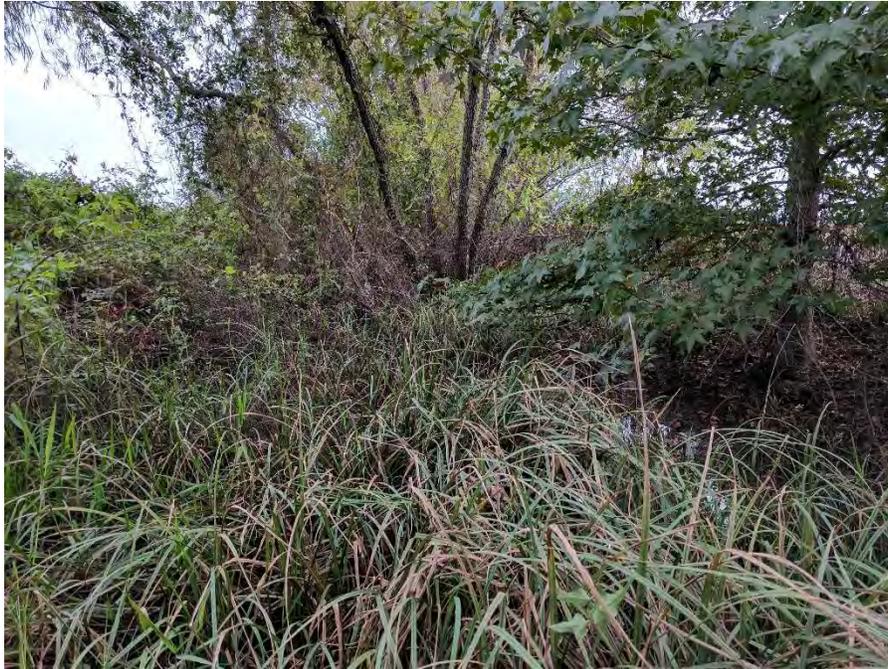
Figure 14. UT 5 – view upstream to culvert crossing of County Road 686.

UT 5 was straightened and channelized to drain quickly downstream to prevent localized flooding. The stream banks were widened, deepened, and have no meander features. This negatively impacted the hydraulics of the stream and led to sedimentation problems. At certain areas the stream has a nearly level bed with the slope at 0.006. This is characterized by stagnant water and low sediment carrying competency. Figure 14 shows vegetation growing in the channel which indicates high sediment deposition.

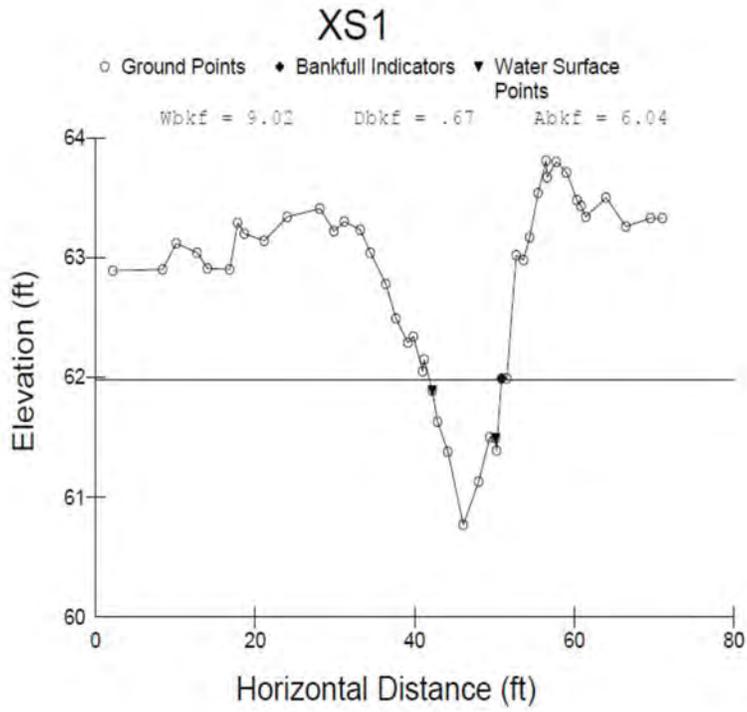
Figure 15 shows a typical cross section of UT 5. Based on the cross section surveyed, the stream is slightly entrenched with an ER of 2.3, and a WDR of 13.5. Bankfull indicators were difficult to identify in the field due to the incision of the stream with no access to a bankfull floodplain. The stream is considered impaired due to its WDR departure from reference conditions, low sinuosity, erosion, sedimentation problems, and lack of connection to the floodplain. Based on the findings, UT 5 is a good candidate for restoration and SWCA recommends the full re-establishment of the dimension, pattern, and profile of the stream to reference conditions.

Figure 15. UT 5 – typical cross section.
