PERMITTEE-RESPONSIBLE MITIGATION PLAN
SWG-2016-00832
SHIP DOCK 5 PROJECT
HARRIS COUNTY, TEXAS

LBC Houston, LP
11666 Port Road
Seabrook, Texas 77586

Lloyd Engineering, Inc.
6565 West Loop Street, Suite 708
Bellaire, Texas 77401

November 2016

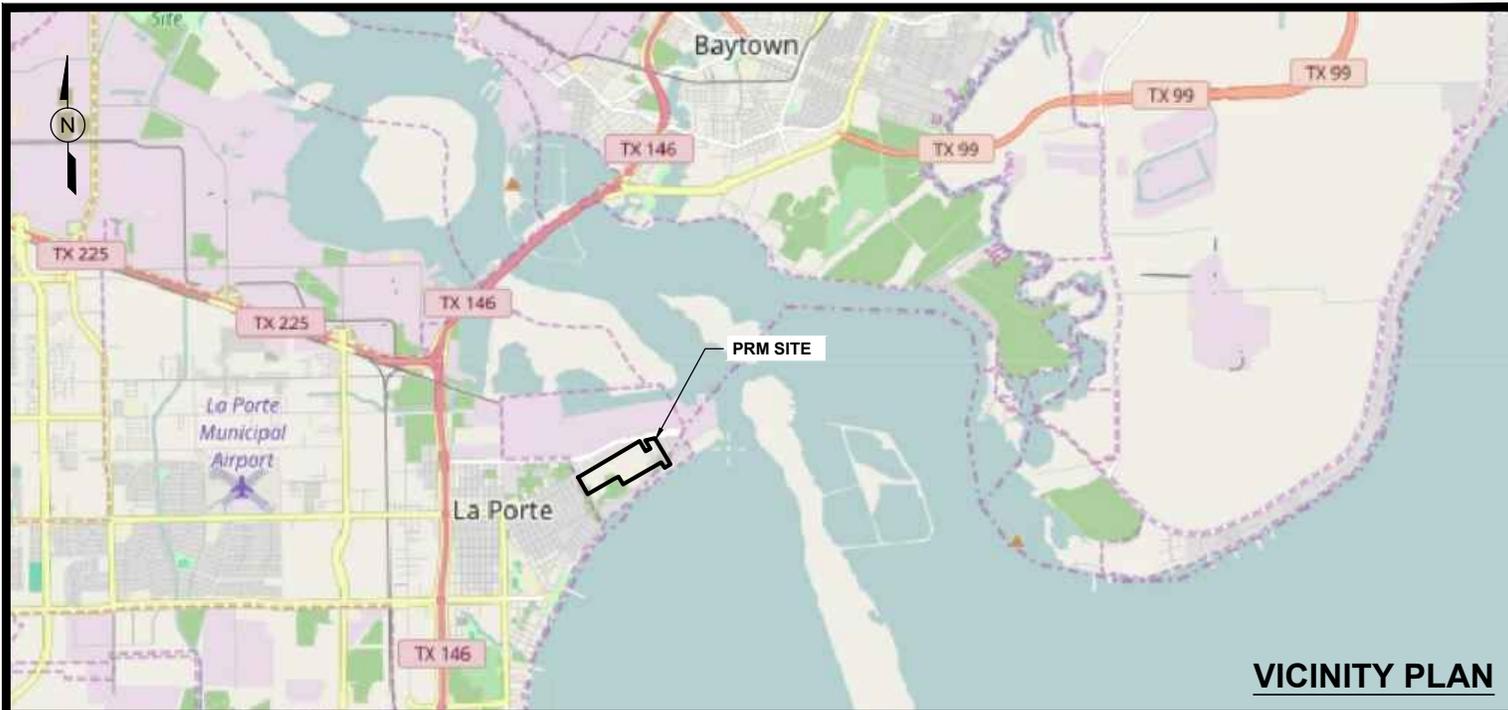
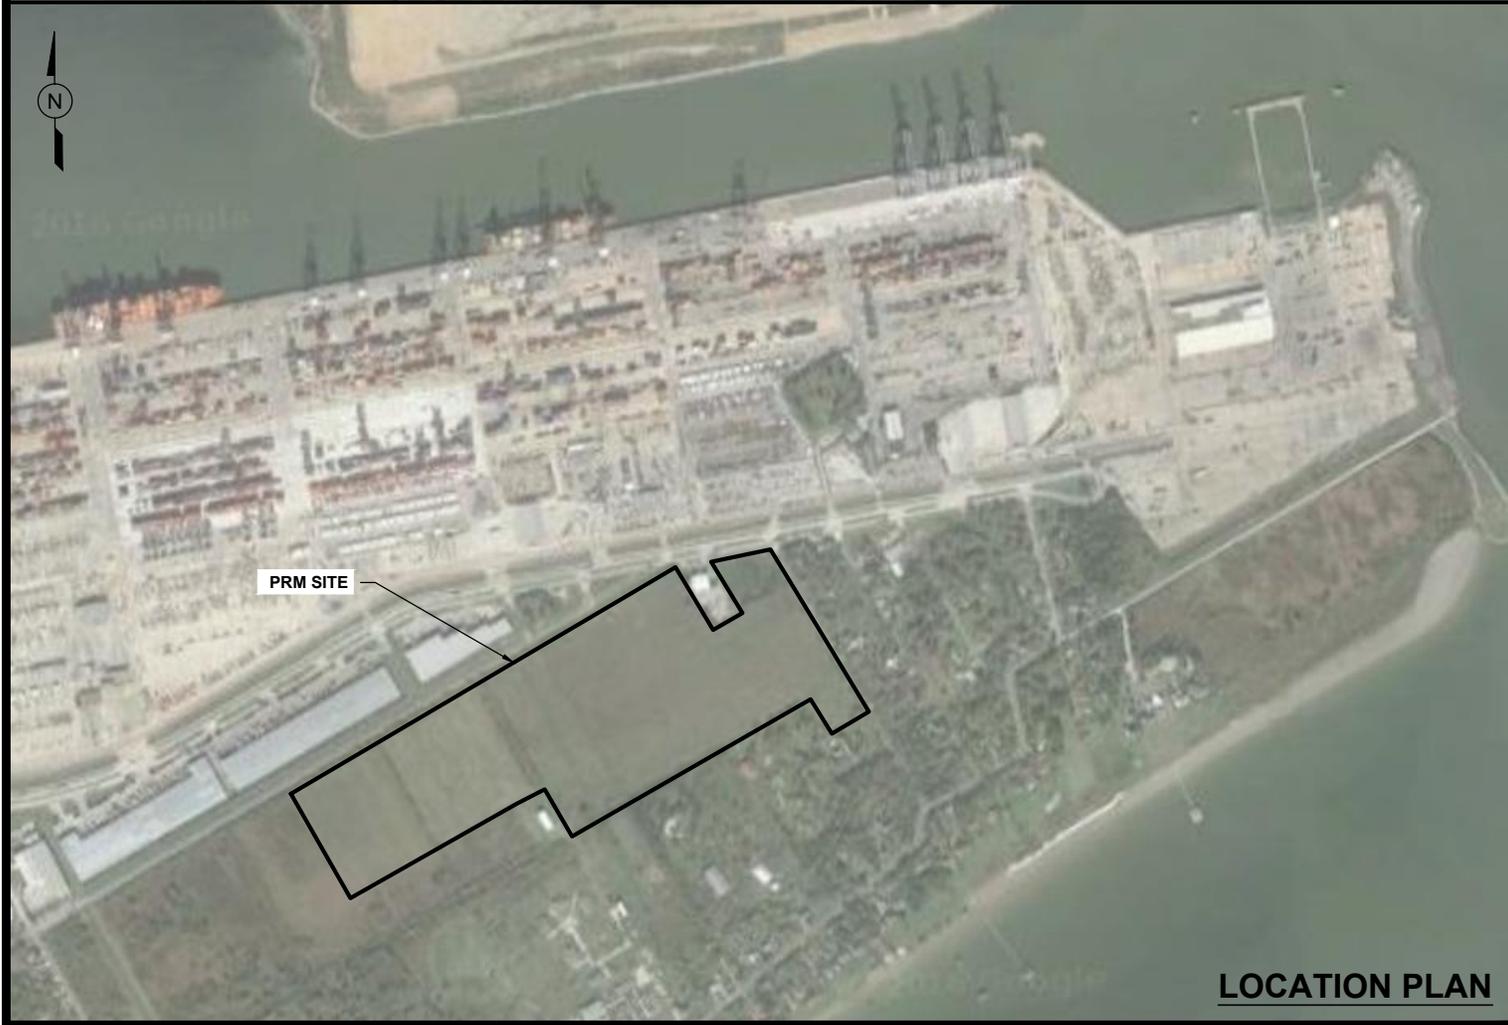
DESIGN BY:	POP
DRAWN BY:	JV
SCALE:	N. T.S.
DATE:	11/29/16
SHEET No:	FIGURE 1

PURPOSE:	PROPOSED SHIP DOCK 5 PRM SITE
LOCATION:	MORGAN'S POINT, TX

The proposed mitigation site is located approximately 4 miles northeast of the project site and is similarly situated within the Northern Humid Gulf Coastal Prairies (34a) Level IV Ecoregion. Refer to Appendix A, Figure 1 for a depiction of the location of the proposed mitigation site.

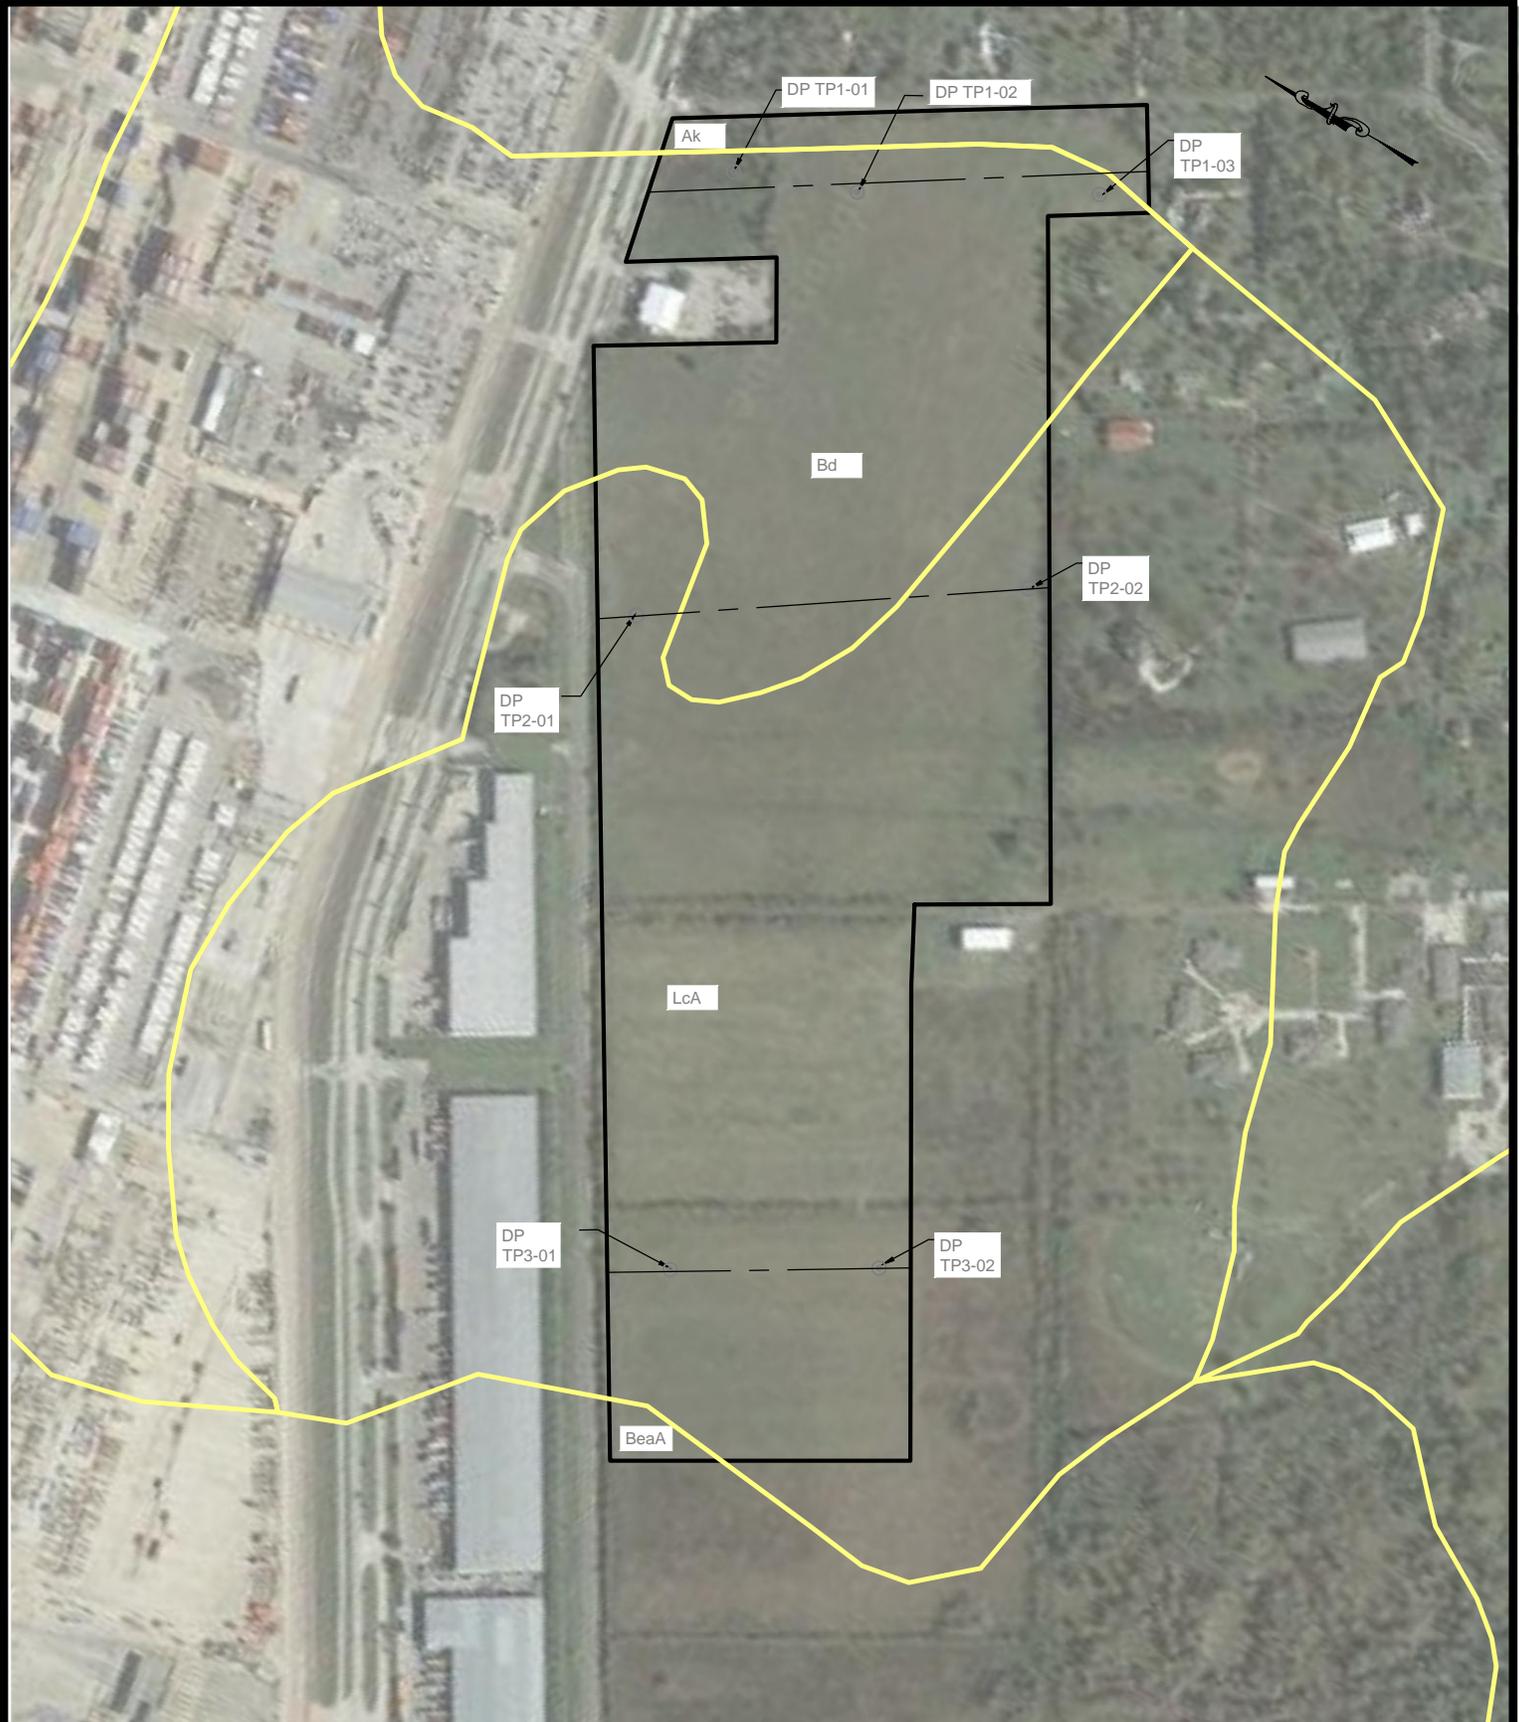
DESIGN BY:	POP
DRAWN BY:	JV
SCALE:	1"=400'
DATE:	11/21/16
SHEET No:	FIGURE 4

PURPOSE:	PROPOSED SHIP DOCK 5 PRM SITE
LOCATION:	MORGAN'S POINT, TX

LEI conducted formal wetland delineation in accordance with USACE recommendations for sites larger than 5 acres in size within the entirety of the proposed mitigation site for the purpose of documenting any potential WOUS located within the mitigation site. As a result of this investigation, potential WOUS, including wetlands were identified. Refer to Appendix C for the results of a formal wetland delineation conducted within proposed mitigation site.

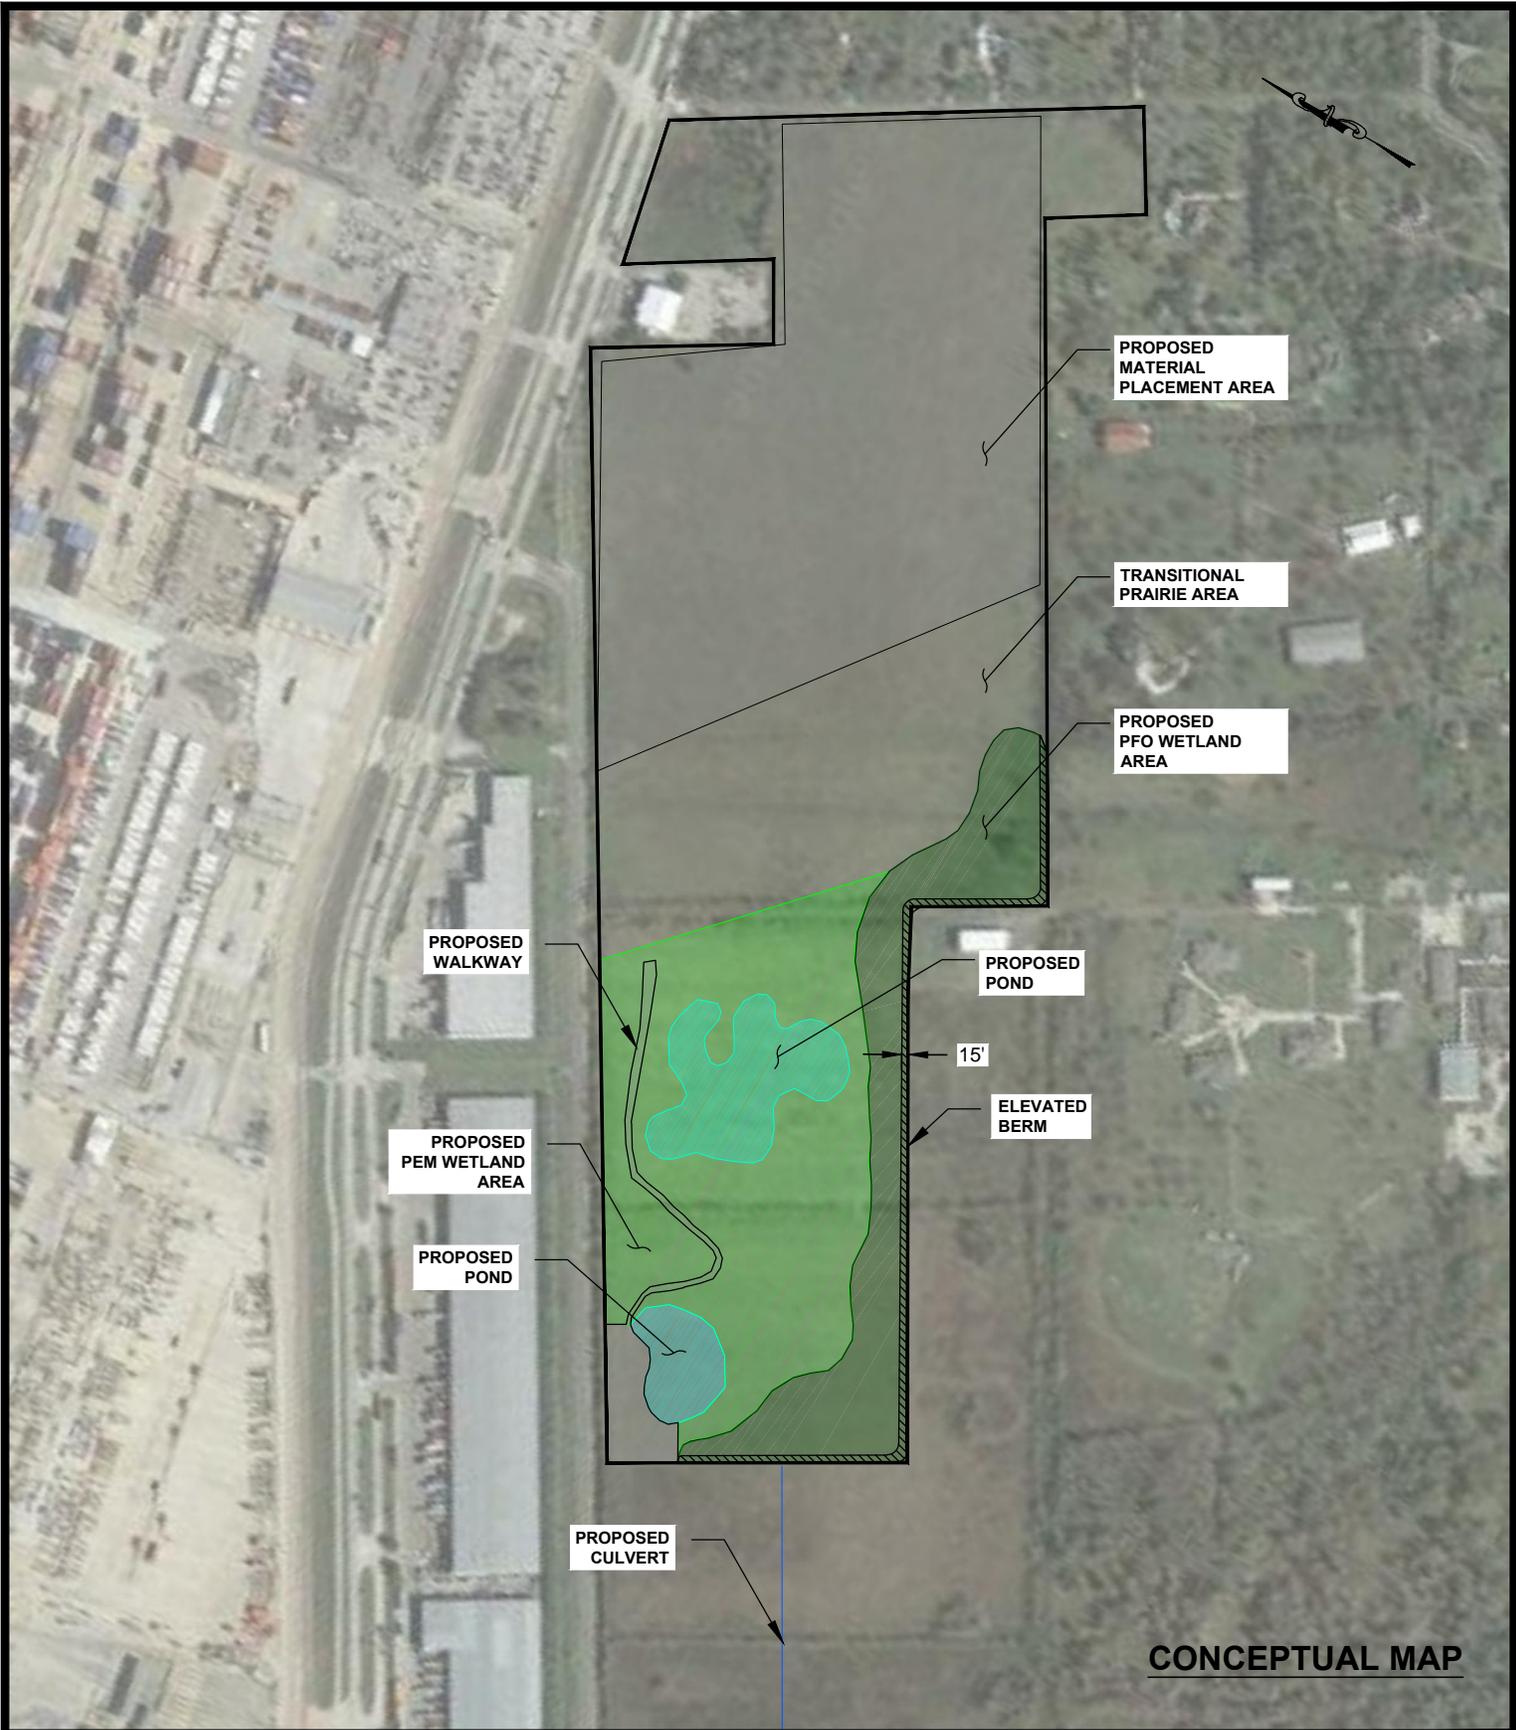
CONCEPTUAL MAP

PURPOSE:	PROPOSED SHIP DOCK 5 PRM SITE
LOCATION:	MORGAN'S POINT, TX

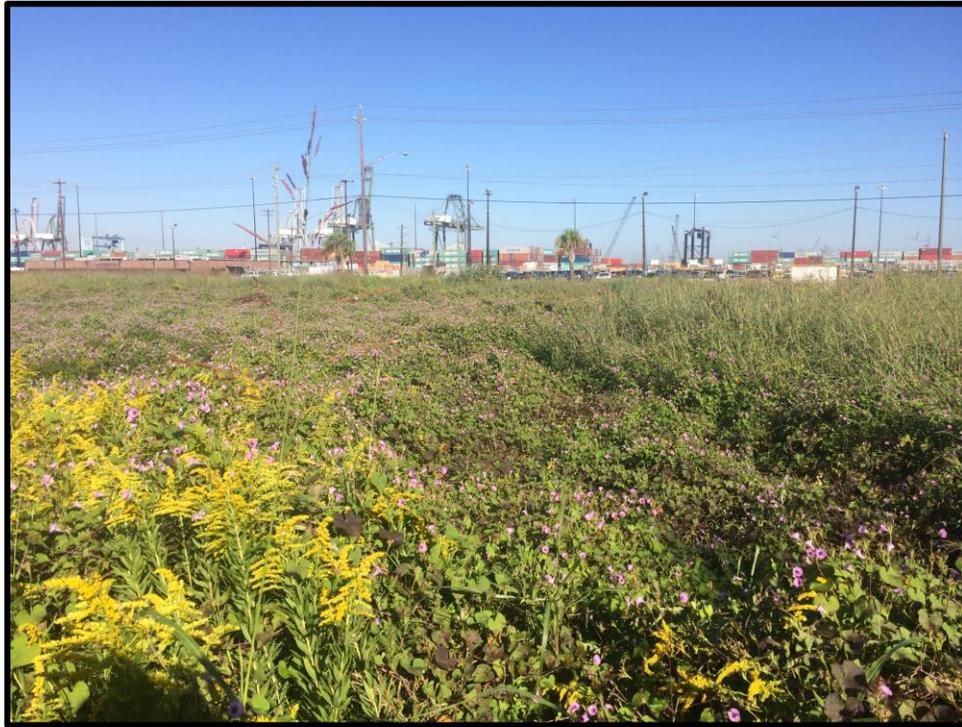
Photo 1: View upland grassland communities located in the northeast corner of the project area. View at DP T1-01, facing north.

During the field investigations, one vegetation community, upland grassland, was identified within the proposed project area. The wetland vegetation community types are based on the Cowardin, et al. (1979) classification system. Refer to Attachment B for representative photographs of the vegetation communities observed within the proposed project areas.

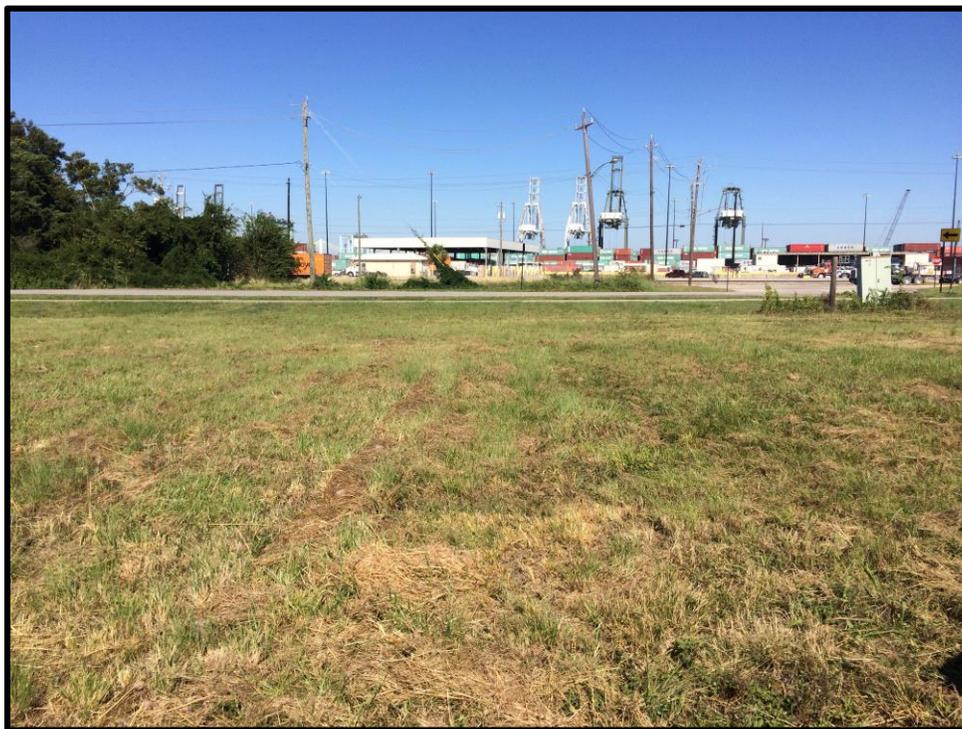
Photo 2: View upland grassland communities located in the project area. View at DP T2-02, facing north.

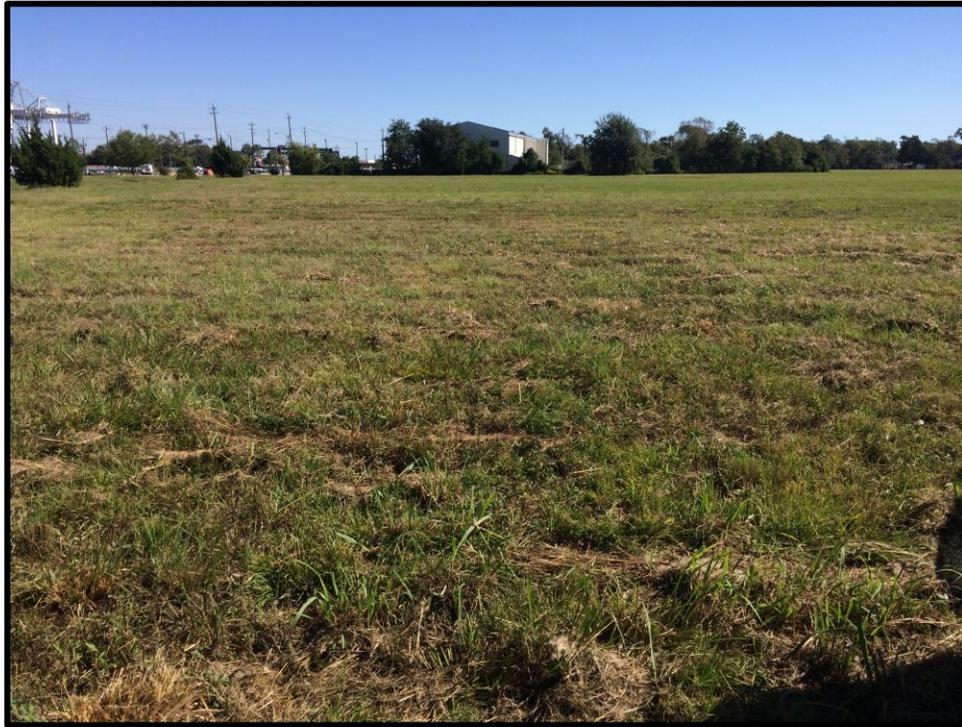
Photo 3: View upland grassland communities located in the project area. View at DP T2-02, facing east.

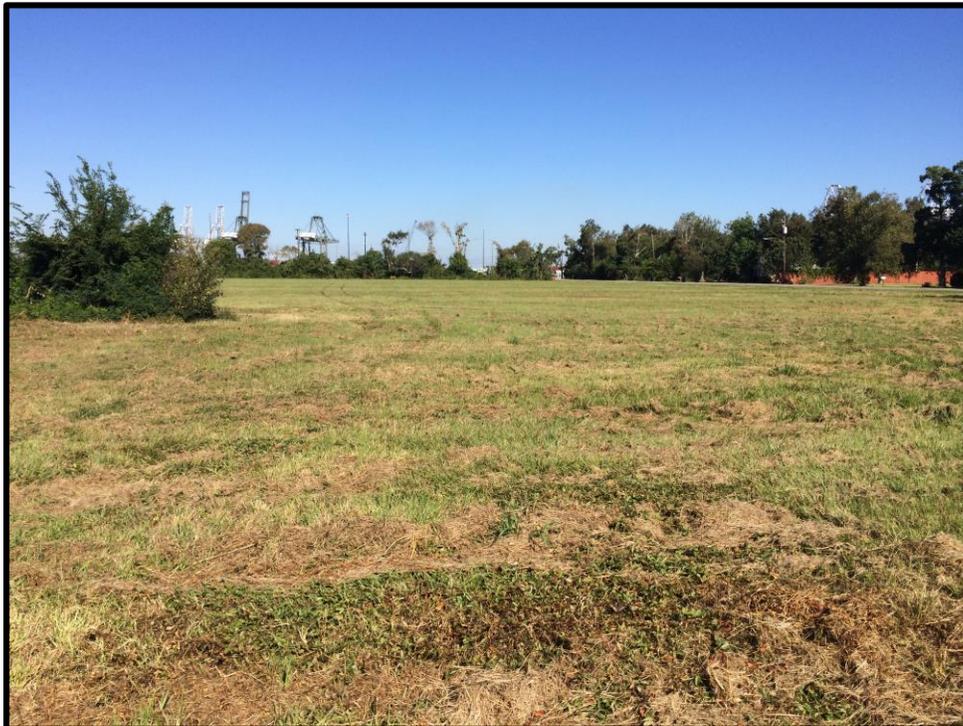
Photo 4: View upland grassland communities located in the southeast corner of the project area. View at DP T1-03, facing north.
