**FINAL OYSTER REEF MITIGATION PLAN
FOR THE
PROPOSED MAT PLACEMENT ON THE 24-INCH
FLORIDA GAS TRANSMISSION PIPELINE**

Located in
Galveston Bay, Chambers & Galveston County, Texas

BW Project No: 2658.01
November 2020

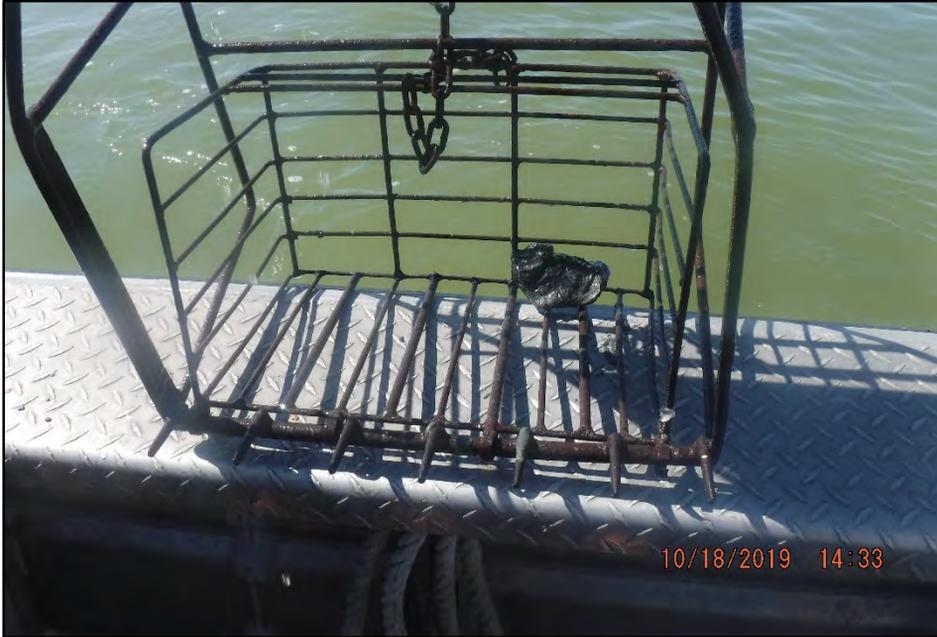
Photo 1: Dredge Tow #01 – pre-rinse.

When analyzed by individual dredge tow, live oyster size class only occurred at Tows 04, 05, 06, and 08 (Figure 3). Two of the seven remaining dredge tows (Tows 01 and 07) contained only one dead box oyster and broken shell, while the last five tows (02, 03, 09, 10 and 11) contained no live or dead oysters at all. Associated reef organisms were also found in some dredge tow samples, including barnacles (*Balanus* sp.), serpulid worms (*Hydroides dianthus*), and hooked mussels (*Ischadium recurvum*). Oyster dredge tow data sheets are provided in Appendix C and photographs of each individual tow are in Appendix B.

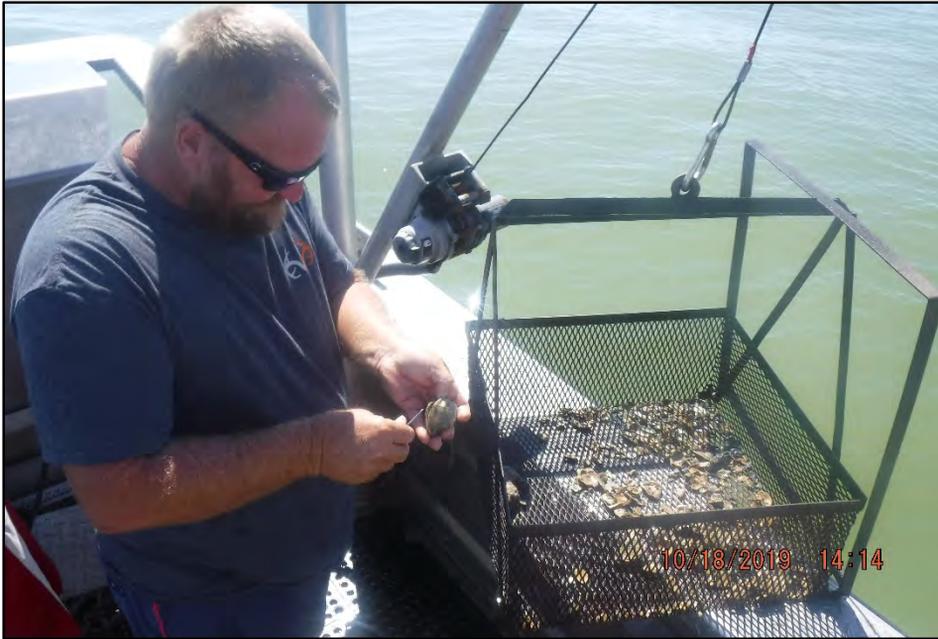
Photo 28: Diver Quadrat #04 – BIO-WEST biologists measuring and classifying individual oysters.

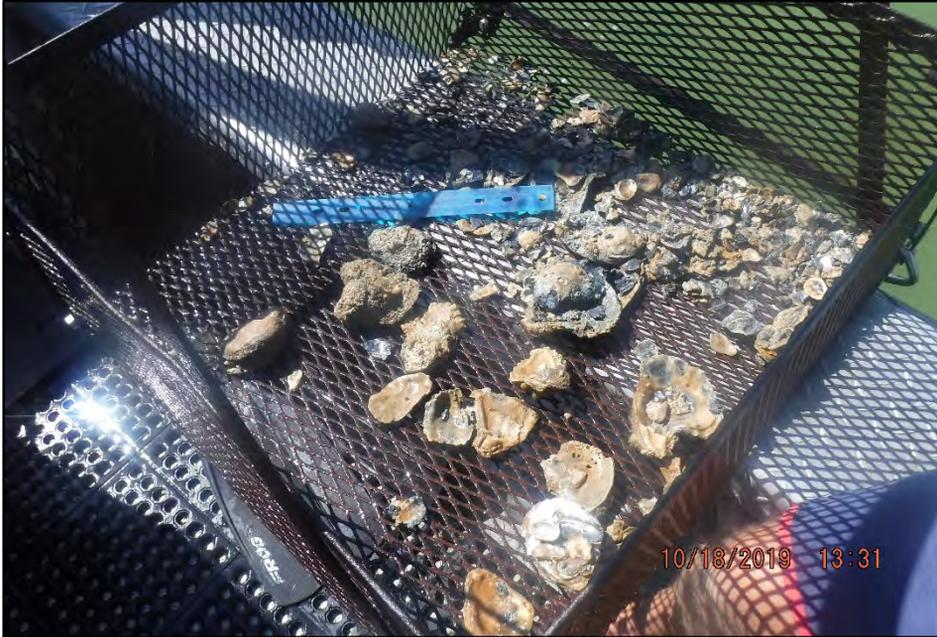
Photo 30: Diver Quadrat #05 – post-rinse illustrating the shell hash bottom type that was consistent throughout the project corridor.

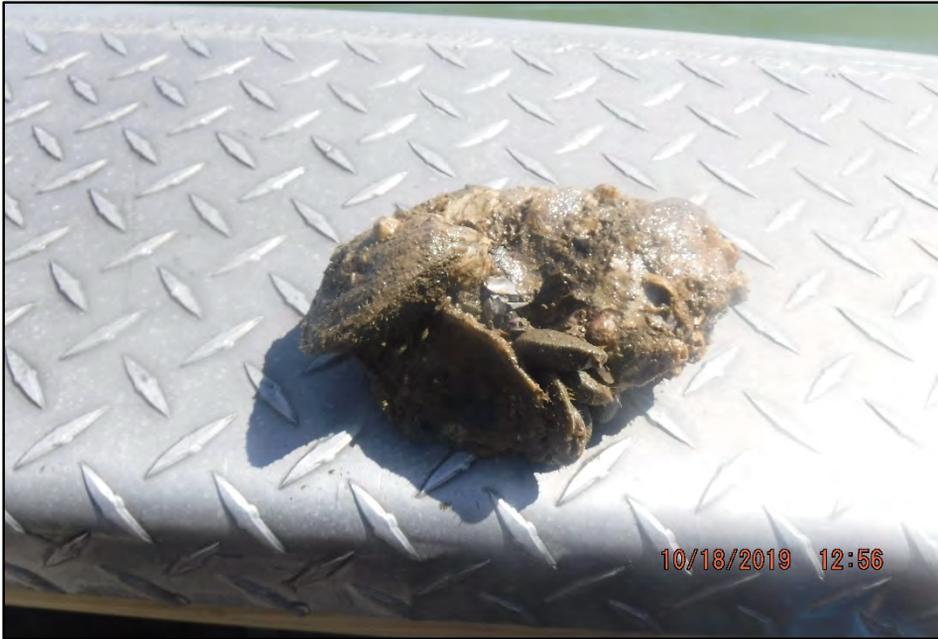
Photo 32: Diver Quadrat #06 – post-rinse illustrating a typical live oyster cluster observed during diver quadrat sampling.

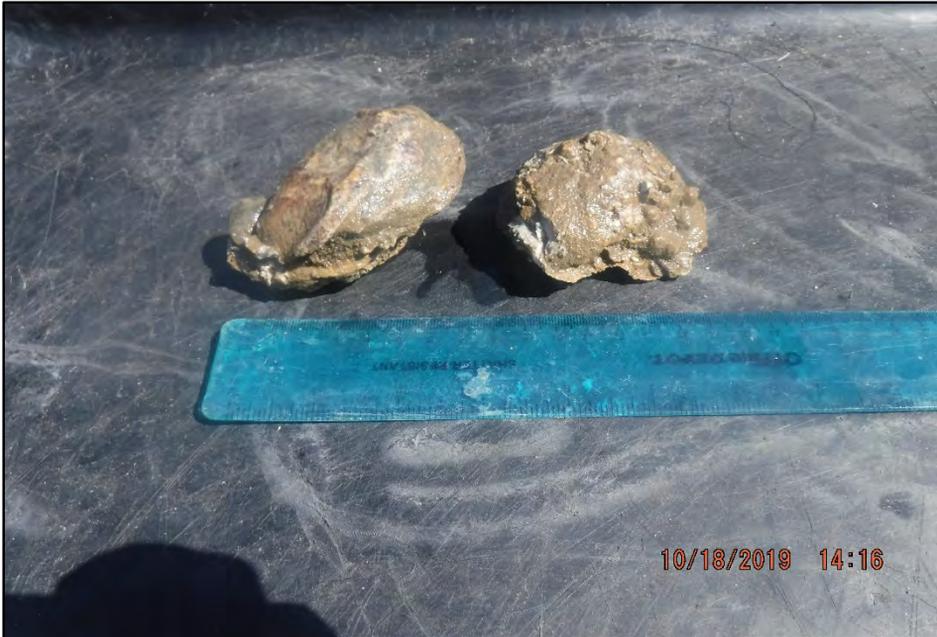
Photo 34: Diver Quadrat #07 – post-rinse illustrating typical single live oysters observed throughout the project corridor. Individuals such as these were the dominate form of living oyster.
