## 1 MITIGATION SITE OVERVIEW

The proposed PRM site for the Metro Park Square Project consists of approximately 28.80 Ac, 17.72 Ac of which is proposed wetland establishment, located within a 3,500-acre tract owned by HCMB LLC, and managed by The Earth Partners LP. The site is located within the same parent tract as the approved Houston-Conroe Mitigation Bank (HCMB) (SWG-2013-00141), and the pending Tarkington Bayou Mitigation Bank (TBMB) (SWG-2015-00169) (Appendix A - Exhibit 2). The PRM site is located directly adjacent to HCMB and is partially within the floodplain of streams restored at HCMB.

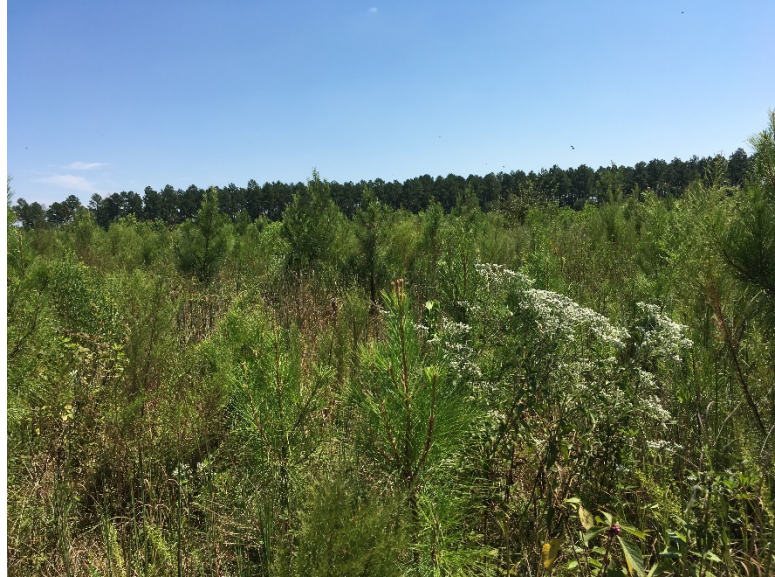
Figure 1 – Typical view of vegetation across the site.

The habitat across the PRM site is characterized as juvenile pine plantation. The area was clear-cut and replanted in pine approximately 3 years ago. Most of the species within the site were facultative wetland (FAC) so hydrophytic vegetation was present. No tree strata was present and the shrub layer was dominated by loblolly pine (*Pinus taeda*) and Chinese tallow. Other inclusions in the shrub layer included water oak (*Quercus nigra*), sweetgum (*Liquidambar styraciflua*), American beautyberry (*Callicarpa americana*), and others. The herbaceous layer was dominated by broomsedge

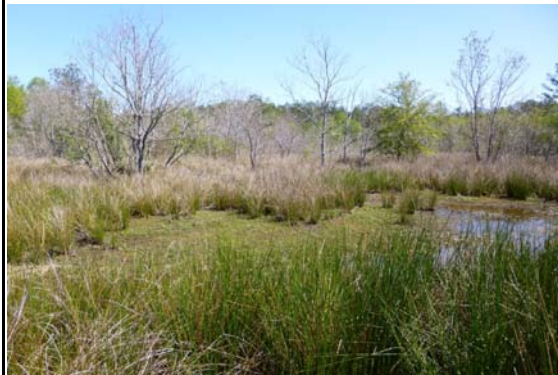
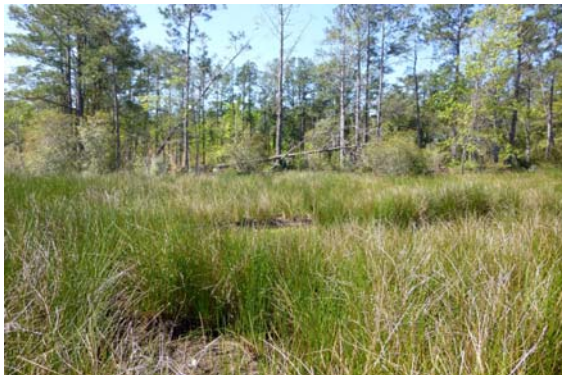
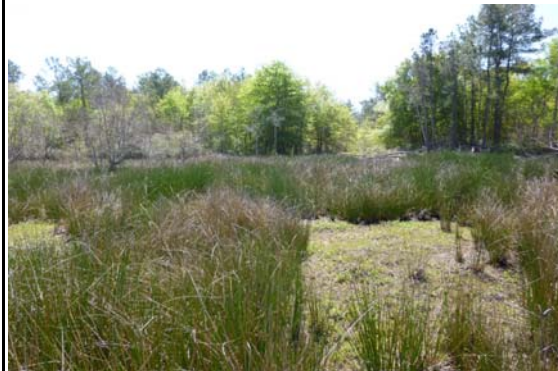
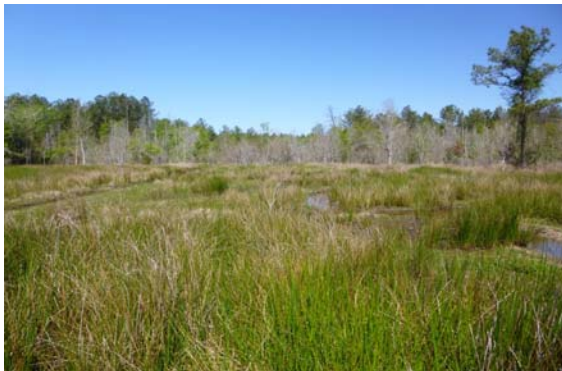
Herbaceous wetland associated with natural impoundment on HCMB. Area was dominated by common rush (*Juncus effusus*) and maidencane (*Panicum hemitomom*).

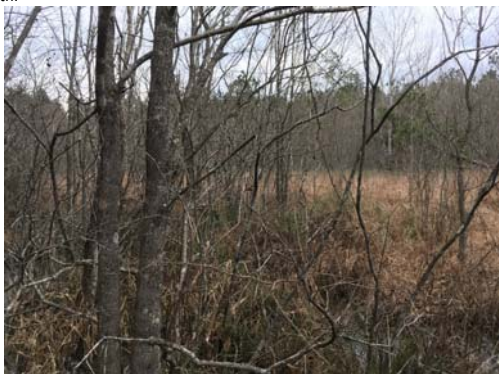
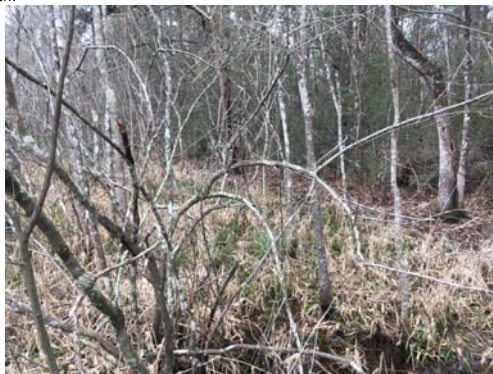
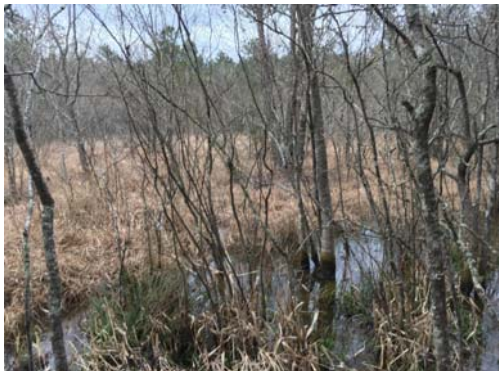
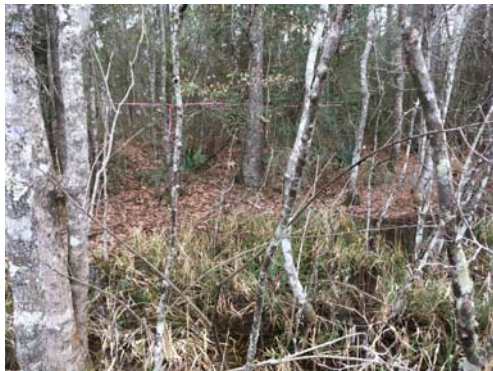
## WAA 2 - Scrub/Shrub Wetland

Scrub-shrub wetland adjacent to herbaceous wetland near HCMB. Area was dominated by common buttonbush (*Cephalanthus occidentalis*), American snobell (*Styrax americanus*), and green ash (*Fraxinus pennsylvanica*).

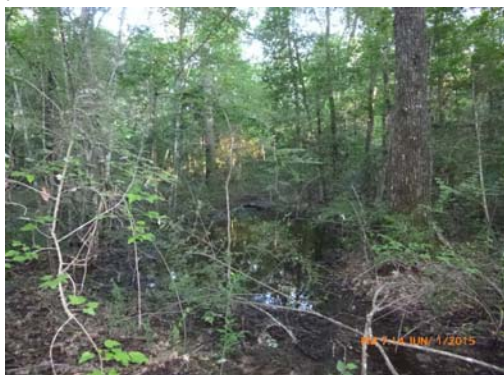
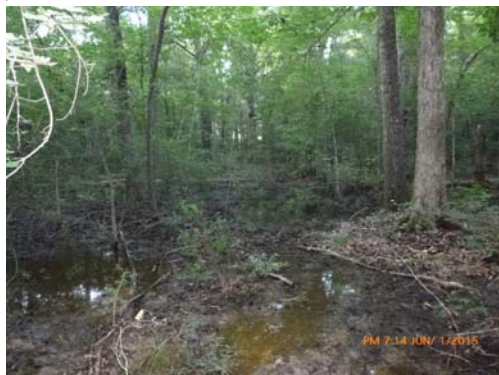
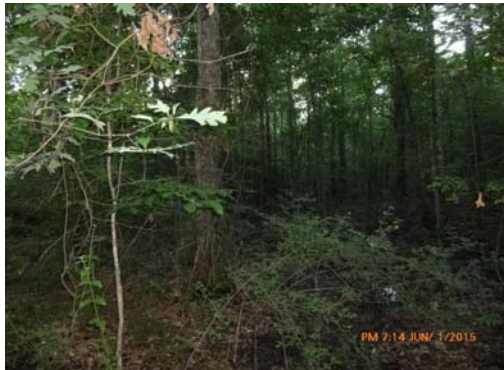
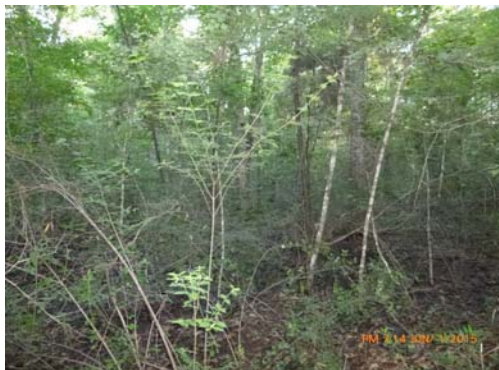
## WAA 3 - Forested Wetland

Mixed hardwood/pine forested wetland in unharvested portion of parent tract. Area contained cherrybark oak (*Quercus pagoda*), water oak (*Quercus nigra*), willow oak (*Quercus phellos*), swamp chestnut oak (*Quercus michauxii*), white oak (*Quercus alba*), sweetgum (*Liquidambar styraciflua*), American holly (*Ilex opaca*), and red maple (*Acer rubrum*).
