RG-NTD-000-REG-PLN-00004
Issued for Information
Revision 1

Compensatory Wetland Mitigation Plan

Rio Grande LNG, LLC
Rio Bravo Pipeline Company, LLC
Permit Number SWG-2015-00114

September 11, 2019

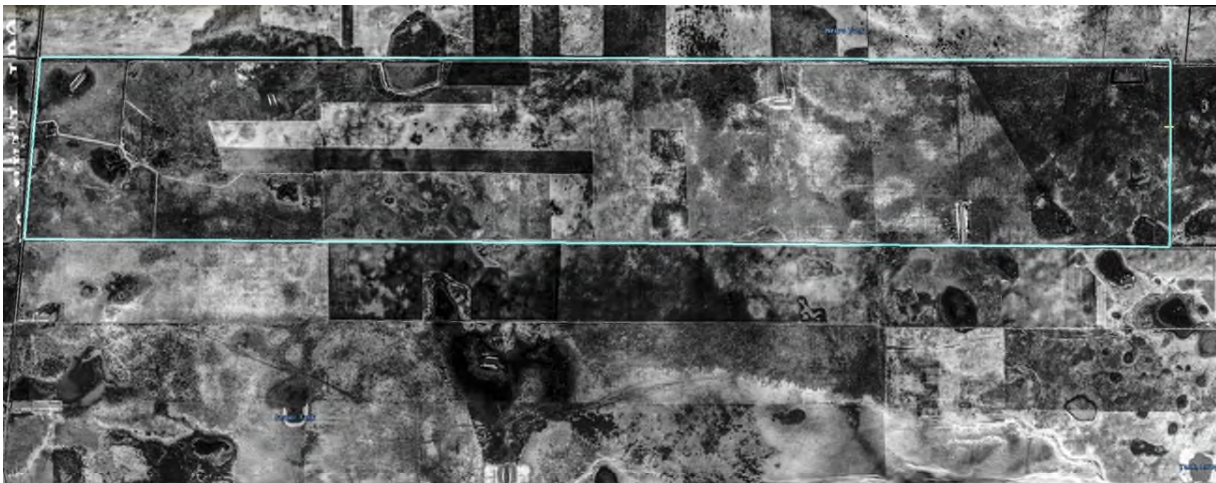
1962 Aerial of the Miradores Mitigation Site

2005-2010: Ponding is apparent at a dugout area located along the drainage canal in the northern portion of the property. One remnant depression area in the northeastern corner of the property also appears to contain water. The aquaculture farm located to the west of the site no longer appears to be active in the 2010 aerial image. No additional modifications to the project property or adjacent properties were apparent between 2005 and 2010.

2012-2016: Aerial photos from 2015 and 2017 indicate this time period did not include any improvements on the site, but all site developments and agricultural operations continued.

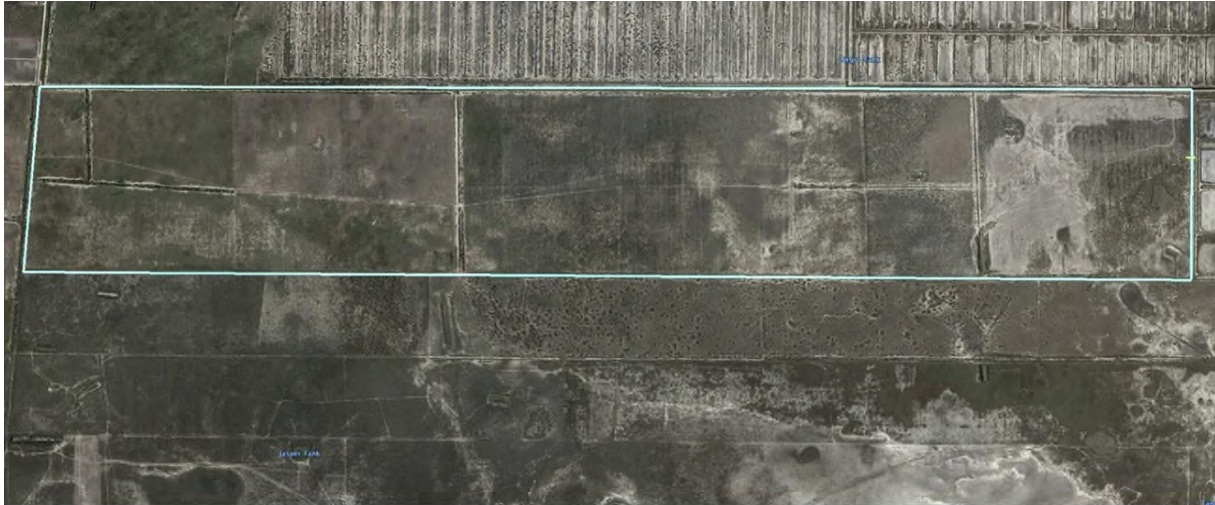
2017 Aerial Photo of the Miradores Mitigation Site

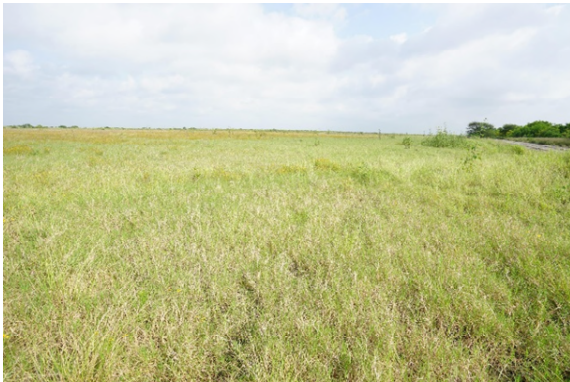
Photo of MMS Non-Wetland Pasture Habitat

Non-Wetland – Pasture: Habitat classified as South Texas: Disturbed Grassland (Ecological Mapping Systems of Texas ID 9187) by NatureServe in the Anthropogenic category and is called CRP/Other Improved Grassland by the Ecological Mapping Systems of Texas ID 9327. These grasslands exhibit heavy grazing and are managed exotic pastures. The dominant grasses include bermudagrass (*Cynodon dactylon*), buffelgrass (*Pennisetum ciliare*), Kleberg bluestem (*Dichanthium annulatum*), and guineagrass (*Urochloa maximum*). Shrub species include mesquite, huisache (*Acacia farnesiana*), and lotebush (*Ziziphus obtusifolia*).

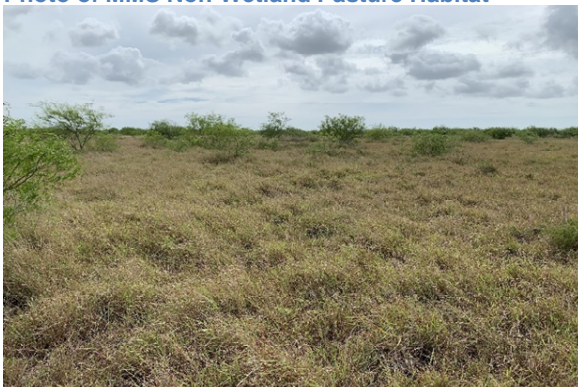
Photo of Site Invasive Mesquite Habitat

Non-Wetland Native Invasive Mesquite: This habitat is Native Invasive Mesquite Shrubland (9106) and Native Invasive Mesquite Woodland (9114). The native invasive mesquite woodland consists of honey mesquite dominated canopy. The native invasive mesquite shrubland can have huisache (*Acacia farnesiana*) mixed within and typically has understories of introduced grasses like buffelgrass (*Pennisetum ciliare*) or in more saline areas native invasive sea ox-eye daisy (*Borrchia frutescens*).

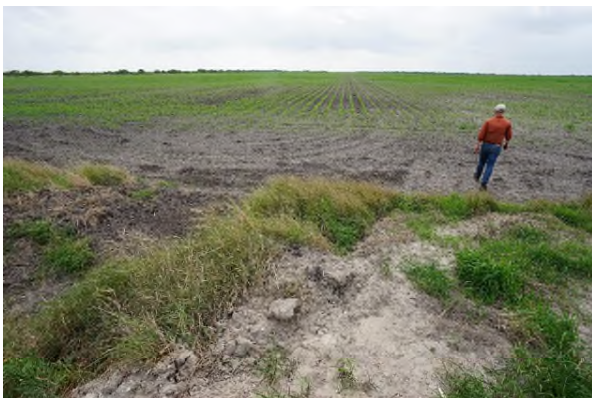
Photo of Blow Out in Existing West Main Ditch After Large Rainfall Event

Ditch Breaches: Land managers have observed water entering the MMS through breaches in the levee that parallels the main ditch on the western side of the property during larger storm events. Based off a regional regression analysis of the contributing watershed coupled with a 1-D hydraulic analysis, it is estimated that the 5-year peak flow rate would be enough to enter through these breaches (National Streamflow Statistics Software/NRCS Cross Section Analyzer). In addition, it has also been observed by the landowners that water from the Arroyo Colorado can backwater into the site, entering through these same levee breaches.

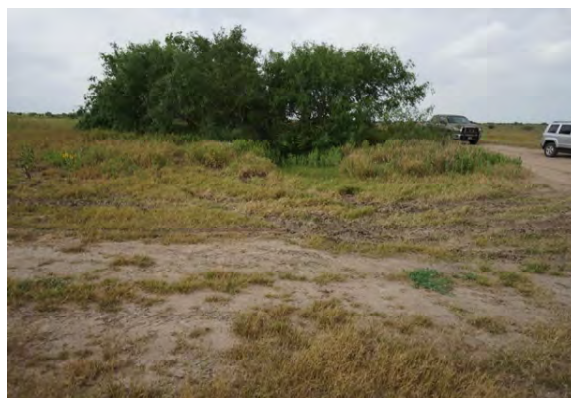
Photo of Middle South Drain on Site that Efficiently Drains Rainwater from Site

The landowners stated that if the drainage infrastructure was removed from the site that the soils and topography on the site would be saturated or inundated for periods of time sufficient to support facultative wet and obligate wetland species/plant communities.

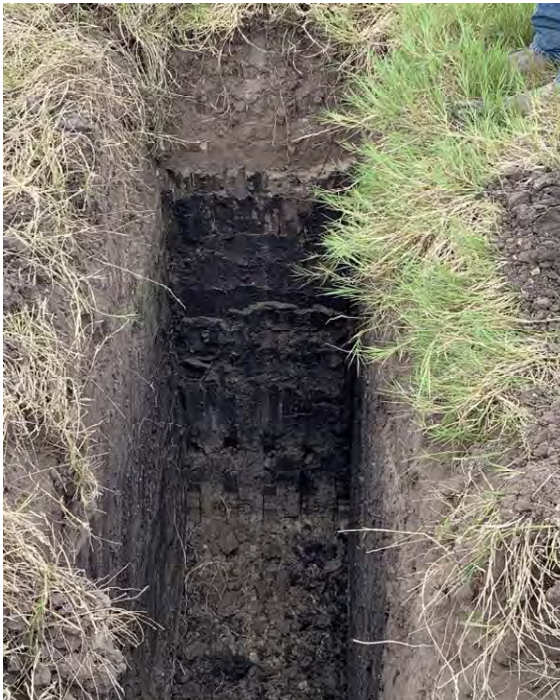
Photo of soil profile at historic PEM

The NRCS Soils Data for the project area indicates that the site is primarily composed of Willamar fine sandy loam with a smaller fraction of Tiocano clay and Sejita silty clay loam present in isolated areas. See Table 4 below and Figures 14 and 15 for more information. Reference samples taken throughout the site showed hydric soil indicators. In July 2019 soil pits were excavated in areas throughout the site where we have designed the PEM wetland restoration. A majority of these soil pits presented clay loam soils within 12 inches of the soil surface. In areas where historic PEM wetlands have existed, then were subsequently drained for agriculture, during the July 2019 field work hydric soil conditions were observed at the estimated level of these historic PEM wetland areas. These areas were established by creating berms around them to capture rainwater, which also helped guide the PEM wetland restoration design. The picture below on the left shows a profile of one of these historic PEM wetland areas. See Appendix B for more information and pictures of the soil sampling areas.

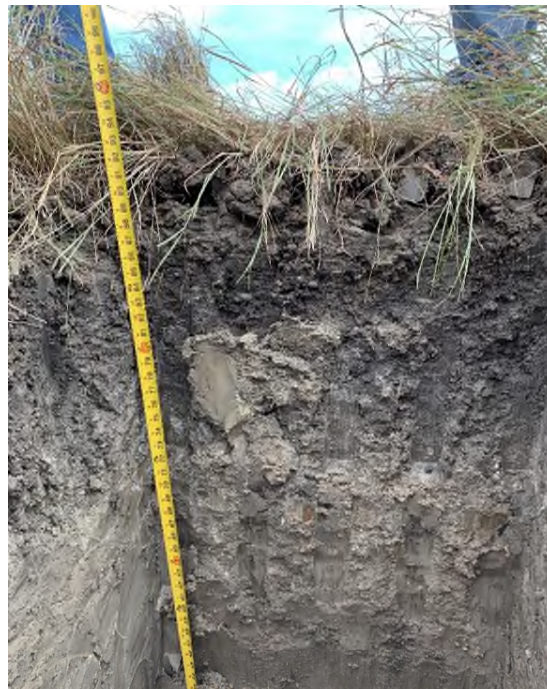
Photo of one of the proposed PEM creation sites

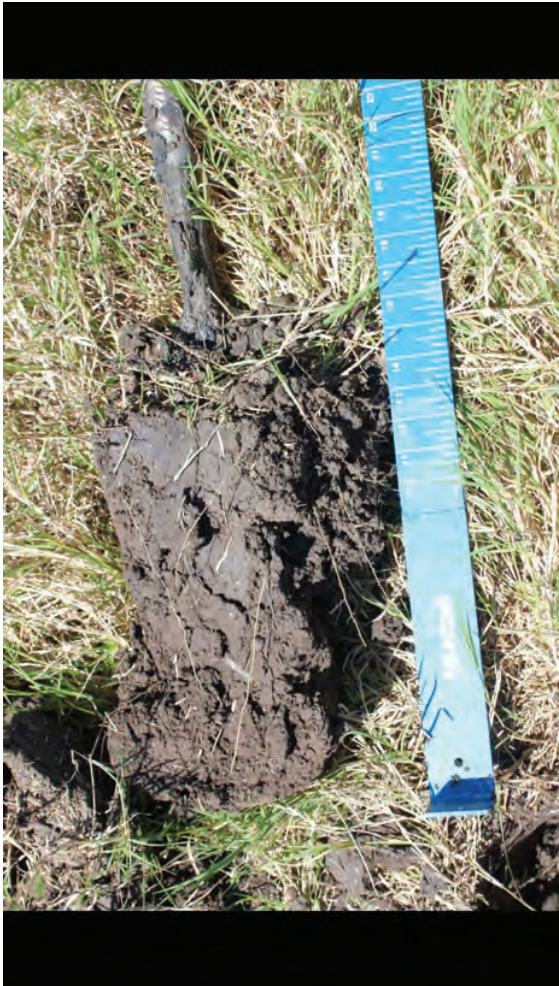
Site B Soil Profile

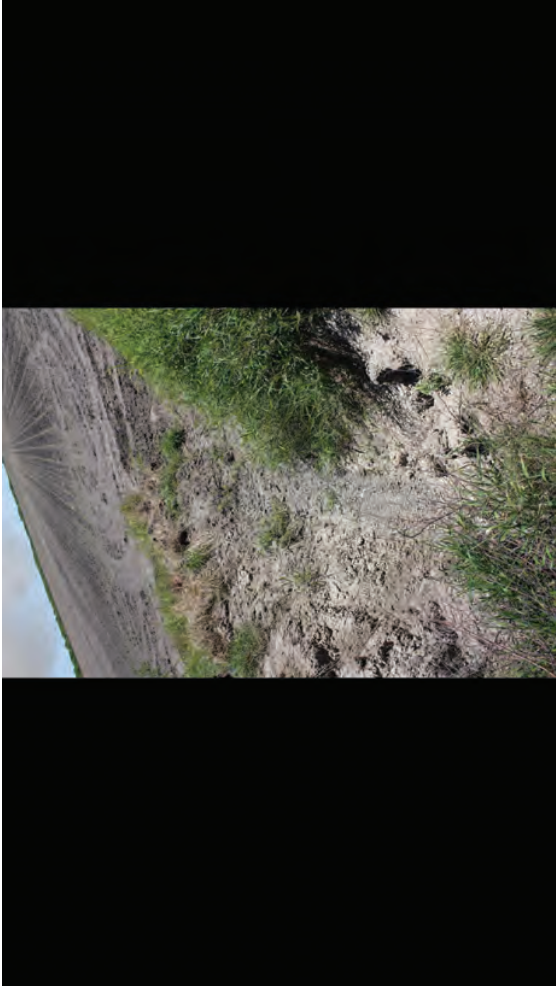
Site C Looking East Into Fields From Blown Out Levee That
Drains fields in Large Rain Events

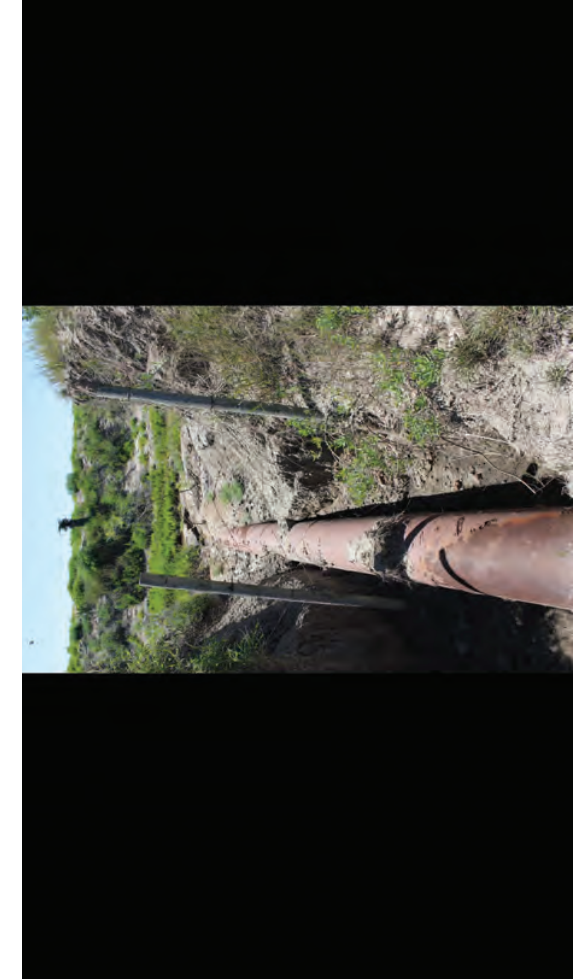
Site G Looking East Through Blown Out Levee Draining Fields

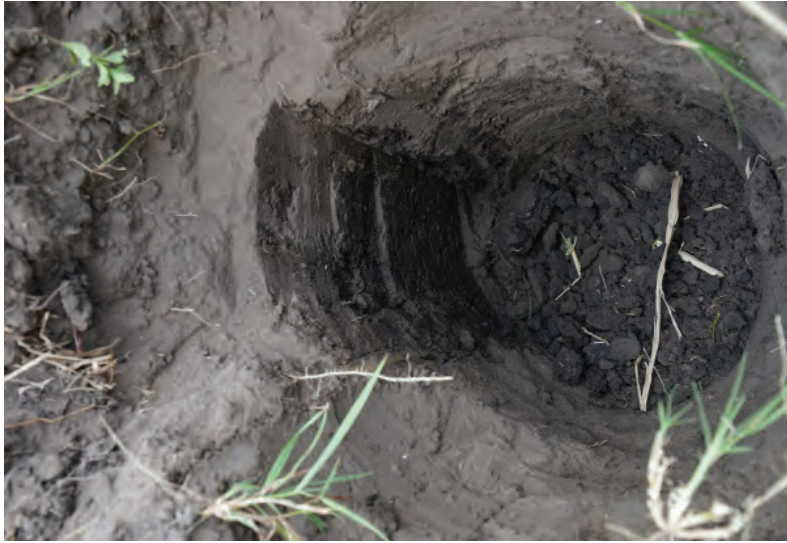
A Majority of Initial Sampling Points Had Tight Clay Loam Soils Within 12” of Soil Surface

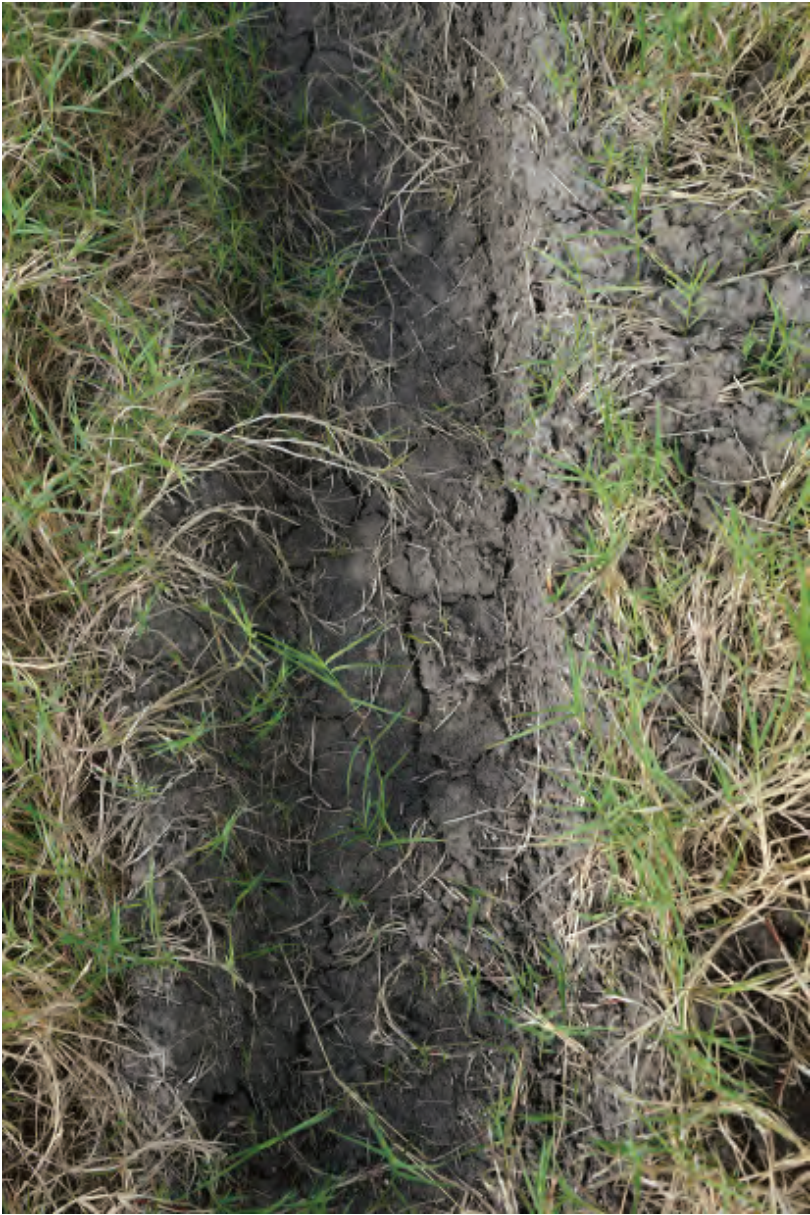
Tire Ruts With Demonstrating High Clay Content in Soils
