PCCA – Corpus Christi Ship Channel Deepening Project
Upland Determination Form Plot Locations
PA4 Survey Area Photographs

**Aquatic Survey Overview Map
SS1 & PA4 Survey Areas & Aquatic Survey Transects
Corpus Christi Ship Channel Deepening Project
(SWG-2019-00067)**

Port of Corpus Christi Authority
Corpus Christi Ship Channel Deepening Project

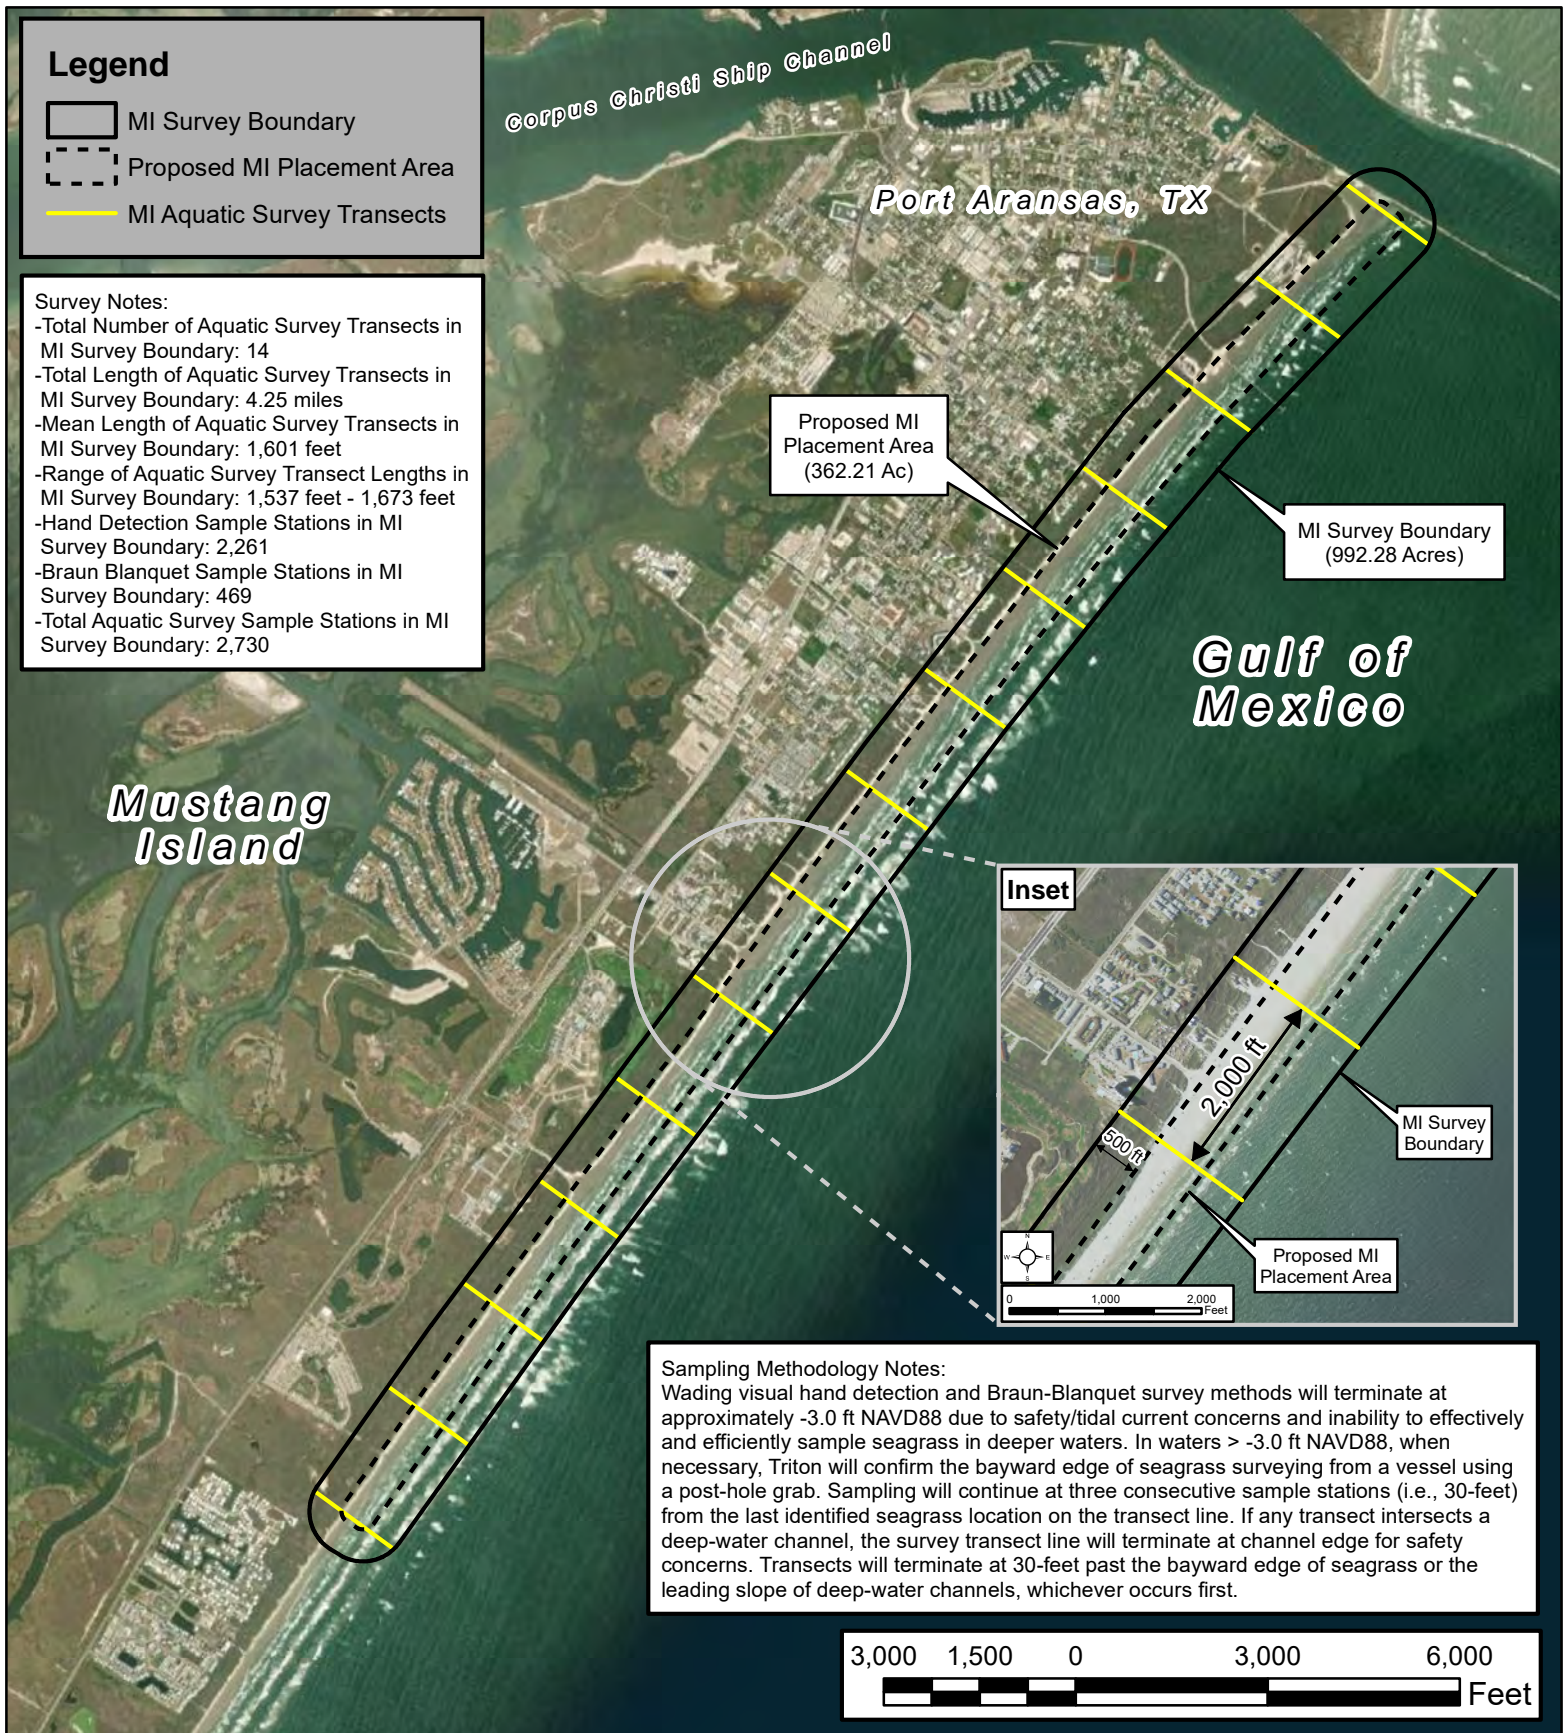
- Total Number of Aquatic Survey Transects in MI Survey Boundary: 14
- Total Length of Aquatic Survey Transects in MI Survey Boundary: 4.25 miles
- Mean Length of Aquatic Survey Transects in MI Survey Boundary: 1,601 feet
- Range of Aquatic Survey Transect Lengths in MI Survey Boundary: 1,537 feet - 1,673 feet
- Hand Detection Sample Stations in MI Survey Boundary: 2,261
- Braun Blanquet Sample Stations in MI Survey Boundary: 469
- Total Aquatic Survey Sample Stations in MI Survey Boundary: 2,730

Sampling Methodology Notes:
 Wading visual hand detection and Braun-Blanquet survey methods will terminate at approximately -3.0 ft NAVD88 due to safety/tidal current concerns and inability to effectively and efficiently sample seagrass in deeper waters. In waters > -3.0 ft NAVD88, when necessary, Triton will confirm the bayward edge of seagrass surveying from a vessel using a post-hole grab. Sampling will continue at three consecutive sample stations (i.e., 30-feet) from the last identified seagrass location on the transect line. If any transect intersects a deep-water channel, the survey transect line will terminate at channel edge for safety concerns. Transects will terminate at 30-feet past the bayward edge of seagrass or the leading slope of deep-water channels, whichever occurs first.

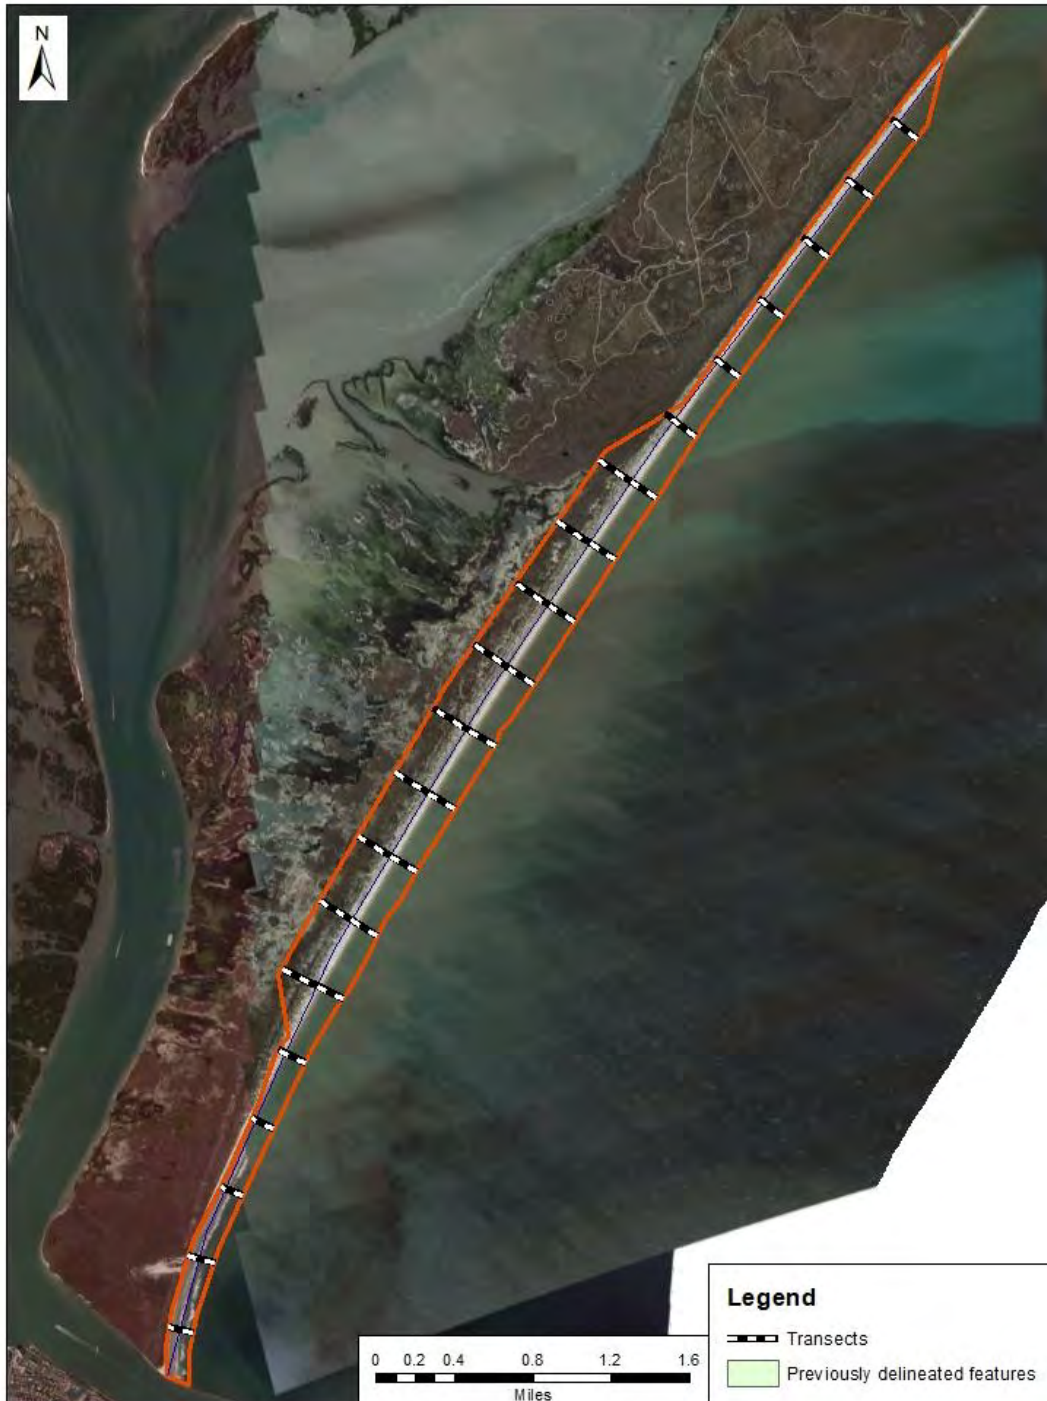
PA4 will be fully delineated within the orange boundary. Proposed transects are shown in dashed lines. Previously delineated wetlands are shown in green, and previous data points are shown in red and blue.

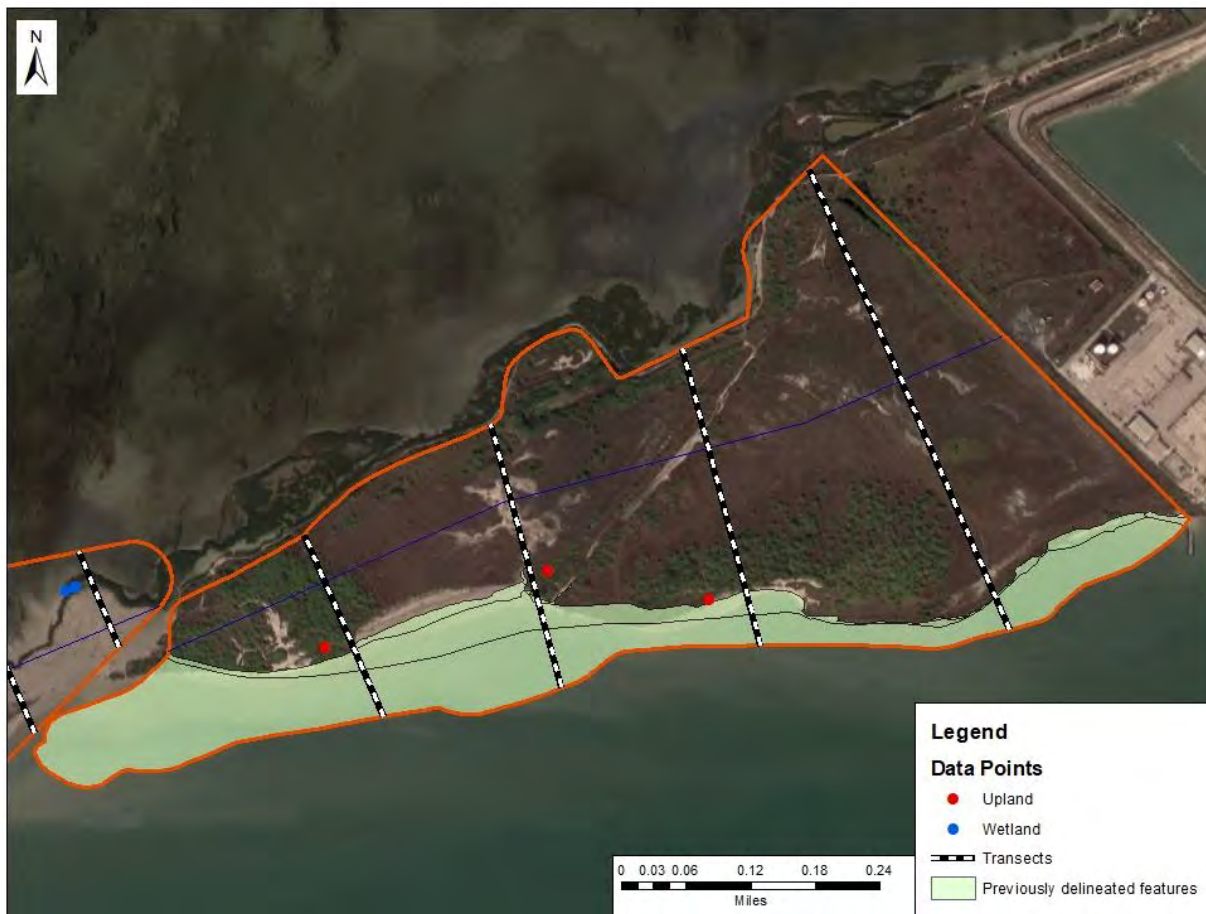
HI-E has been delineated within the orange boundary. Proposed transects are shown in dashed lines. Previously delineated wetlands are shown in green, and previous data points are shown in red and blue.

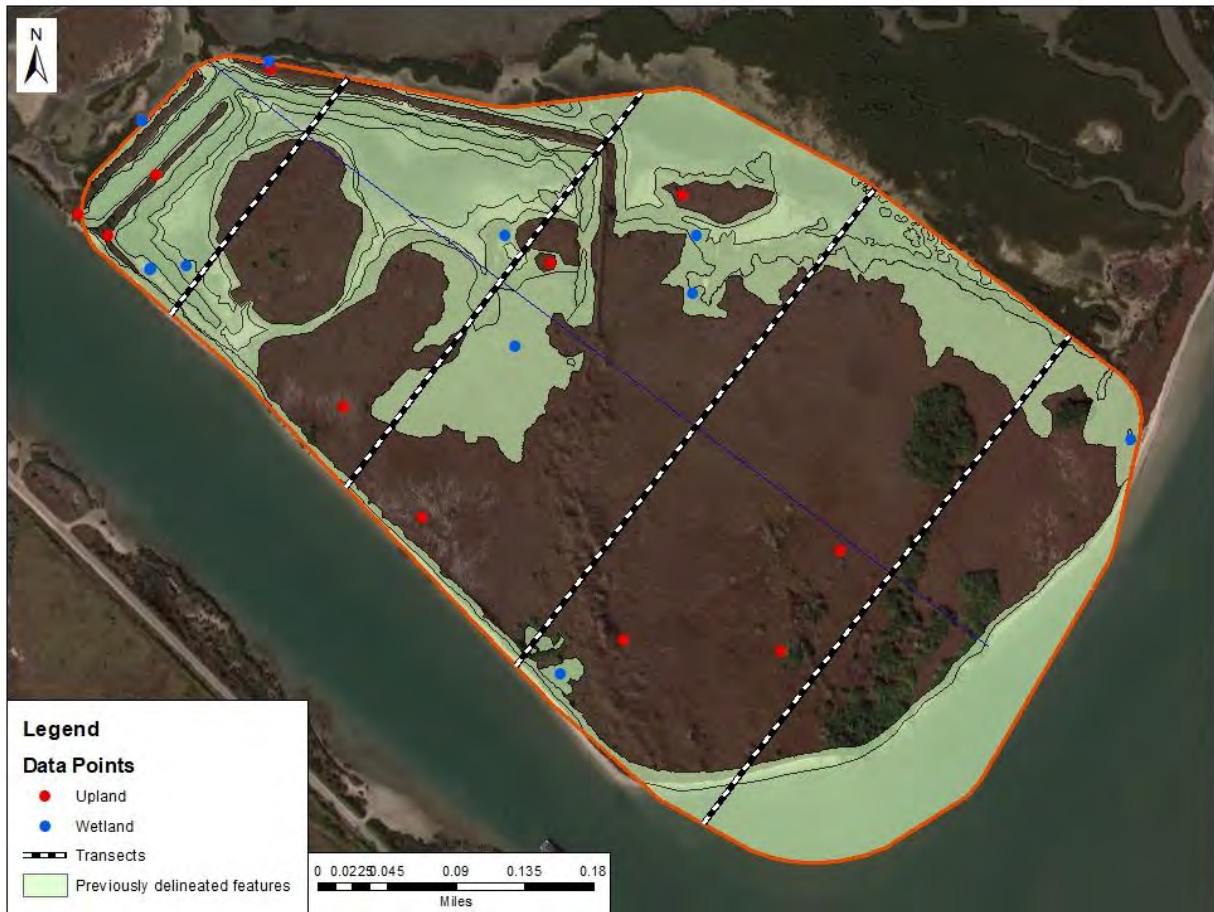
SS1 has been delineated within the orange boundary. Proposed transects are shown in dashed lines. Previously delineated wetlands are shown in green, and previous data points are shown in red and blue.
