Preliminary Hydrology and Hydraulics Report

DCC Harris Reservoir Expansion EIS

2018-0568.0-TX

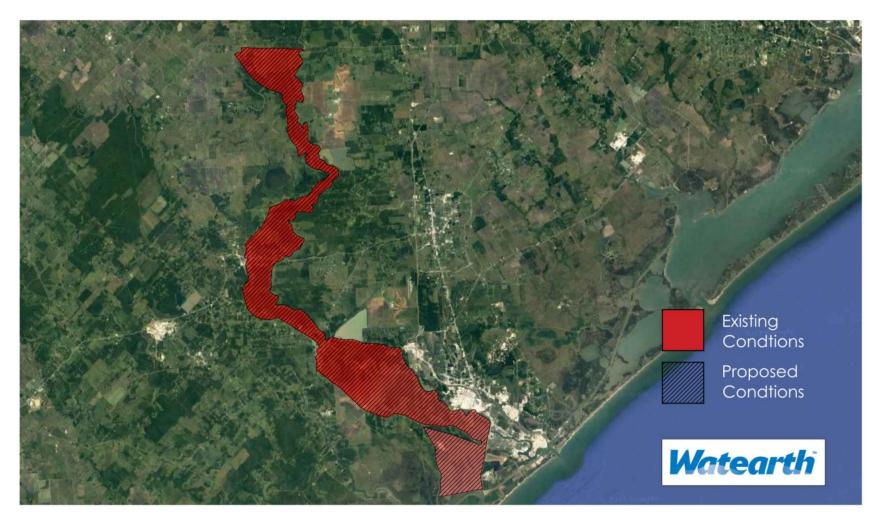
Figure 72: Maximum flood inundation results of both existing and proposed conditions over the 10.5-year simulation period.
