US Army Corps of Engineers
Galveston District

DEFICIENCY CORRECTION EVALUATION REPORT AND FINDING OF NO SIGNIFICANT IMPACT WITH ENVIRONMENTAL ASSESSMENT

Houston Ship Channel Project Deficiency Report (Flare at the Intersection of the Houston Ship Channel and Bayport Ship Channel) Houston-Galveston Navigation Channels, Texas

11 September 2015

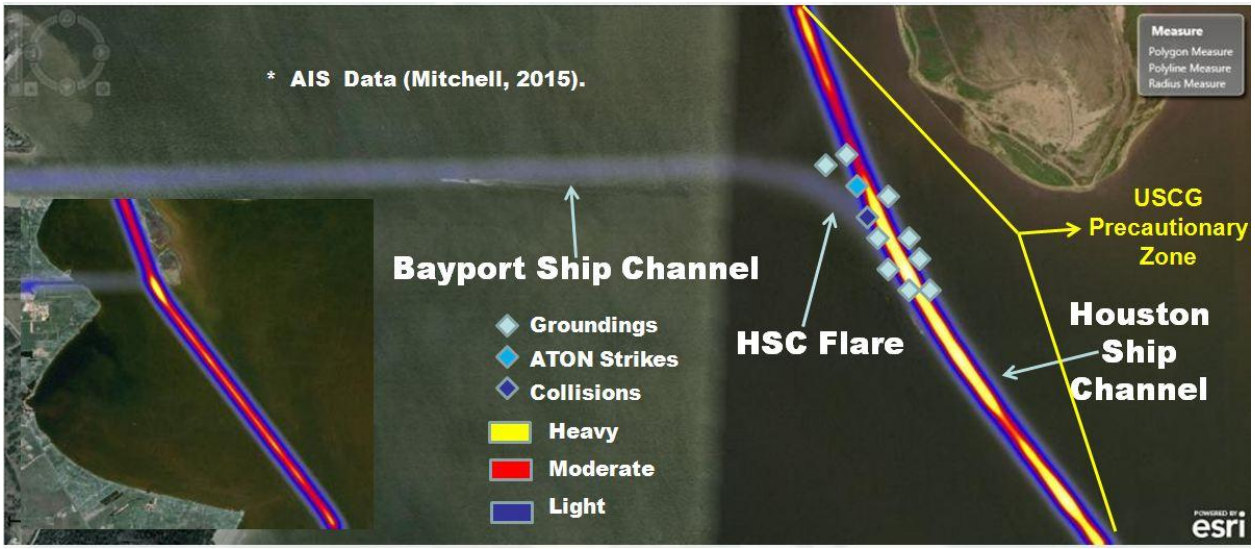
Figure 3-2: Figure of AIS Data Highlighting Known Groundings and Collisions

In summary, the navigation safety problems identified at the intersection are:

- The navigability of turning from HSC onto the BSC with design vessels is hampered by an undersized turning radius compared to recommendations in EM 1110-2-1613.
