ATTACHMENT D-6  
HISTORIC RESOURCES SURVEY REPORT

NON-ARCHEOLOGICAL HISTORIC  
RESOURCES SURVEY REPORT  
Gulf Intracoastal Waterway, Brazos River  
Floodgates and Colorado River Locks  
Feasibility Study  
Brazoria and Matagorda Counties, Texas

NOVEMBER 2018

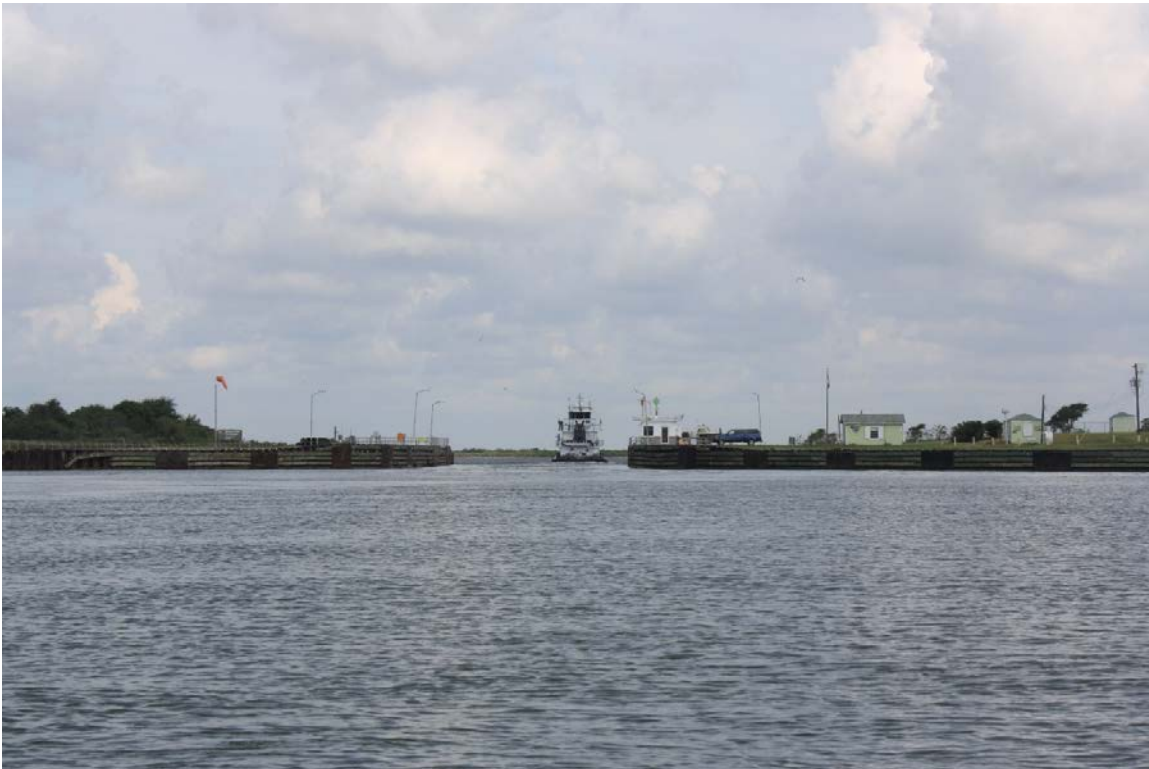
Resource No. 1A

Resource No: 1A  
Latitude/Longitude: 28.896362/ -95.388490  
Address: Brazos River West Floodgate, Brazoria County, Texas  
Function: Infrastructure/Floodgates  
Construction Date: 1943  
Comments: The Brazos River West Floodgate was constructed in 1943 and is located west of the Brazos River along the GIWW. The steel, concrete, and timber floodgate measures 750 feet long and 75 feet wide. Each of the two approximately 45-foot-long sector gates displays steel construction with timber protective fenders. Walkways extend across the top of each gate, allowing access to the gate and ability to walk to the south sector gate. The gates themselves show very few alterations aside from replacement timber fenders. The floodgate guide walls exhibit replacement timber fenders. Steel sheet piles and sheet protective fenders have corrosion, pitting, and section loss. Concrete elements of the floodgate show extensive cracking, spalling, and exposed rebar.

Overall view of west Brazos River floodgate, facing northwest

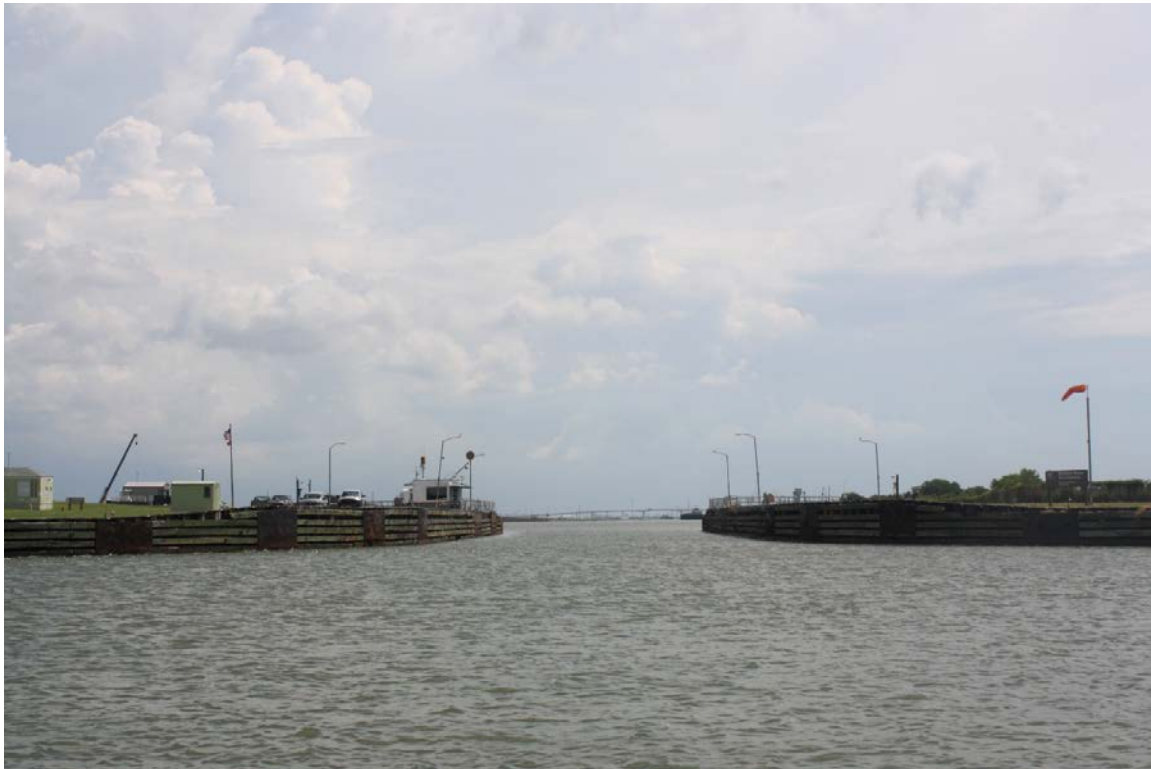
Resource No. 1B

Comments: The Brazos River East Floodgate was constructed in 1943 and is located east of the Brazos River along the GIWW. The steel, concrete, and timber floodgate measures 750 feet long and 75 feet wide. Each of the two approximately 45-foot-long sector gates displays steel construction with timber protective fenders. Walkways extend across the top of each gate, allowing access to the gate and ability to walk to the south sector gate. The gates themselves show very few alterations aside from replacement timber fenders. The floodgate guide walls exhibit replacement timber fenders. Steel sheet piles and sheet protective fenders have corrosion, pitting, and section loss. Concrete elements of the floodgate show extensive cracking, spalling, and exposed rebar.

Overall view of east Brazos River floodgate, facing northwest

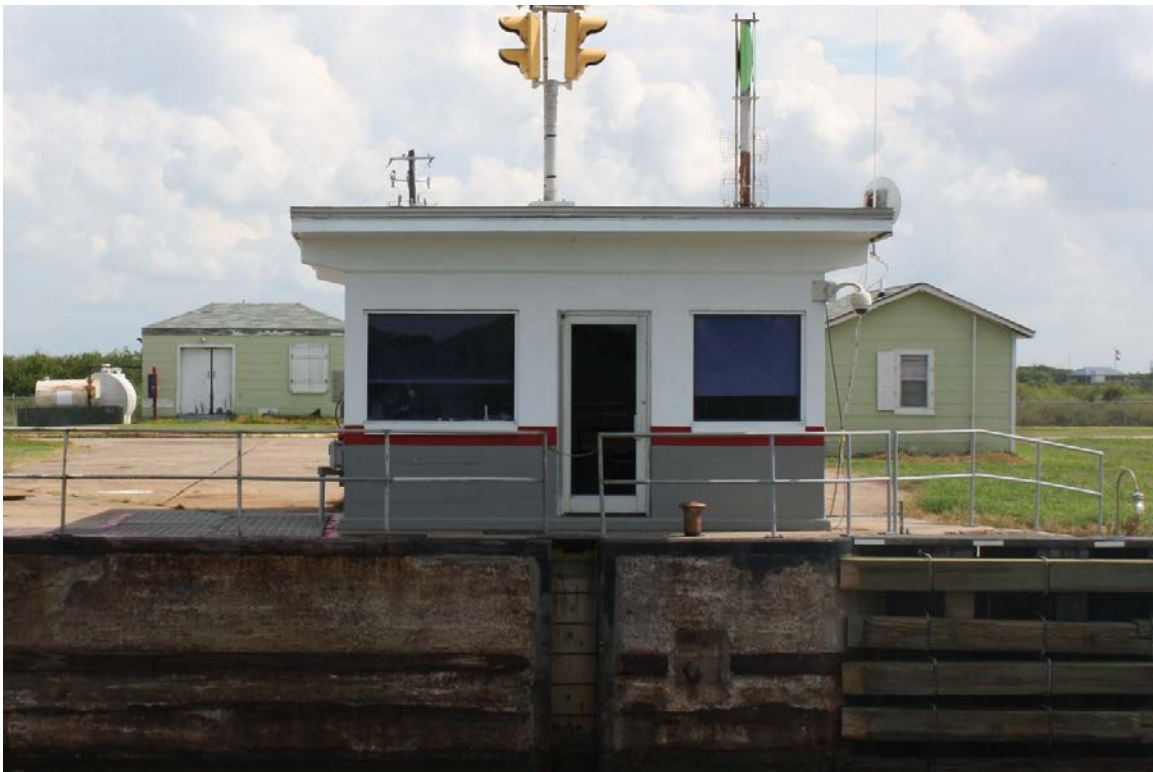
Resource No. 2

Resource No.: 2  
Latitude/Longitude: 28.896441/ -95.388111  
Address: Brazos River West Floodgate, Brazoria County, Texas  
Function: Infrastructure/Control house  
Construction Date: 1943  
Comments: The concrete block control house is located on the north guide wall adjacent to the north sector gate. The small flat roof building exhibits large non-historic-age picture windows on the east, south, and west elevations and entrance doors on the south and east elevations. Alterations include non-historic-age windows, doors, and a new flat roof with overhanging eaves. Originally the control house exhibited Moderne detailing with horizontal banding near the roofline and multi-light windows that wrapped around the building. The control house was also enlarged in the 1970s, nearly doubling its original size.  
NRHP Eligibility: Not eligible

View of Brazos River west floodgate control house, facing north

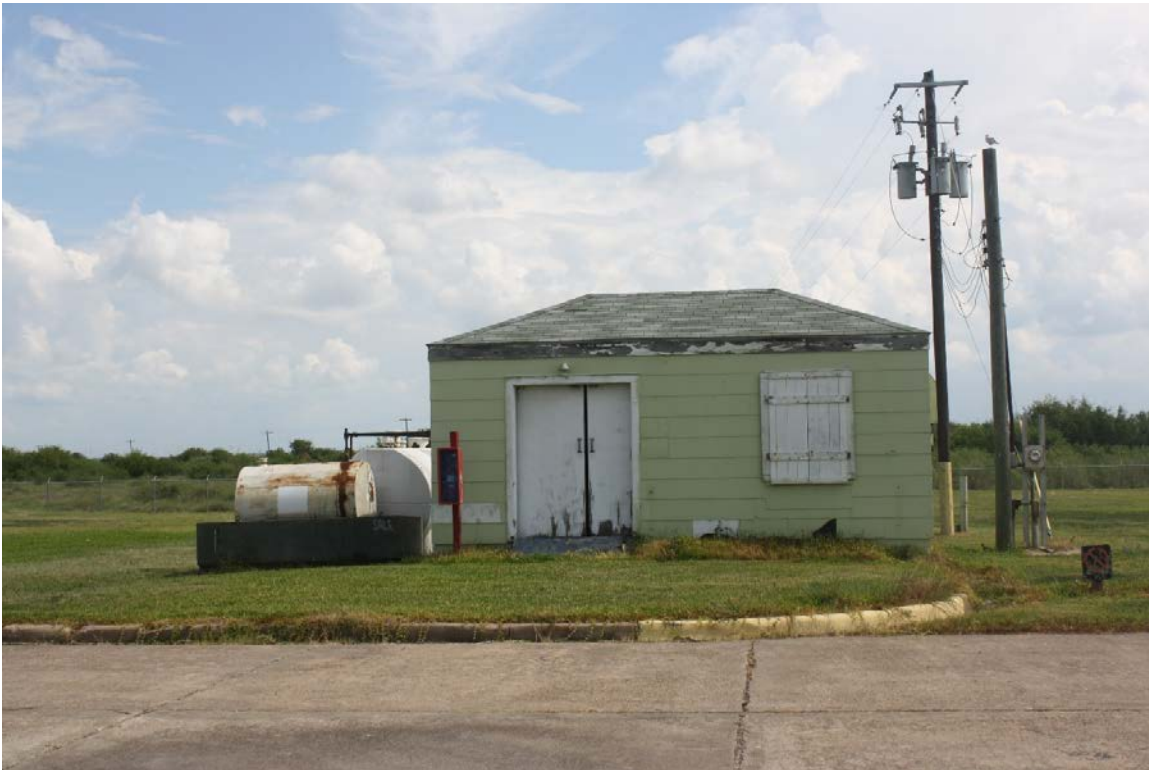
Resource No. 4

Resource No: 4  
Latitude/Longitude: 28.896828/ -95.387964  
Address: Brazos River East Floodgate, Brazoria County, Texas  
Function: Infrastructure/Power house  
Construction Date: 1943  
Comments: This hipped-roof building is the original power building for the floodgates. Situated north of the control house, the building exhibits horizontal siding, a large opening on the south elevation, and shuttered windows. Alterations include some replacement siding. There is also some missing siding and deteriorating sliding entrance doors.  
NRHP Eligibility: Not eligible  
Survey Date: August 2017

View of south elevation, facing northeast

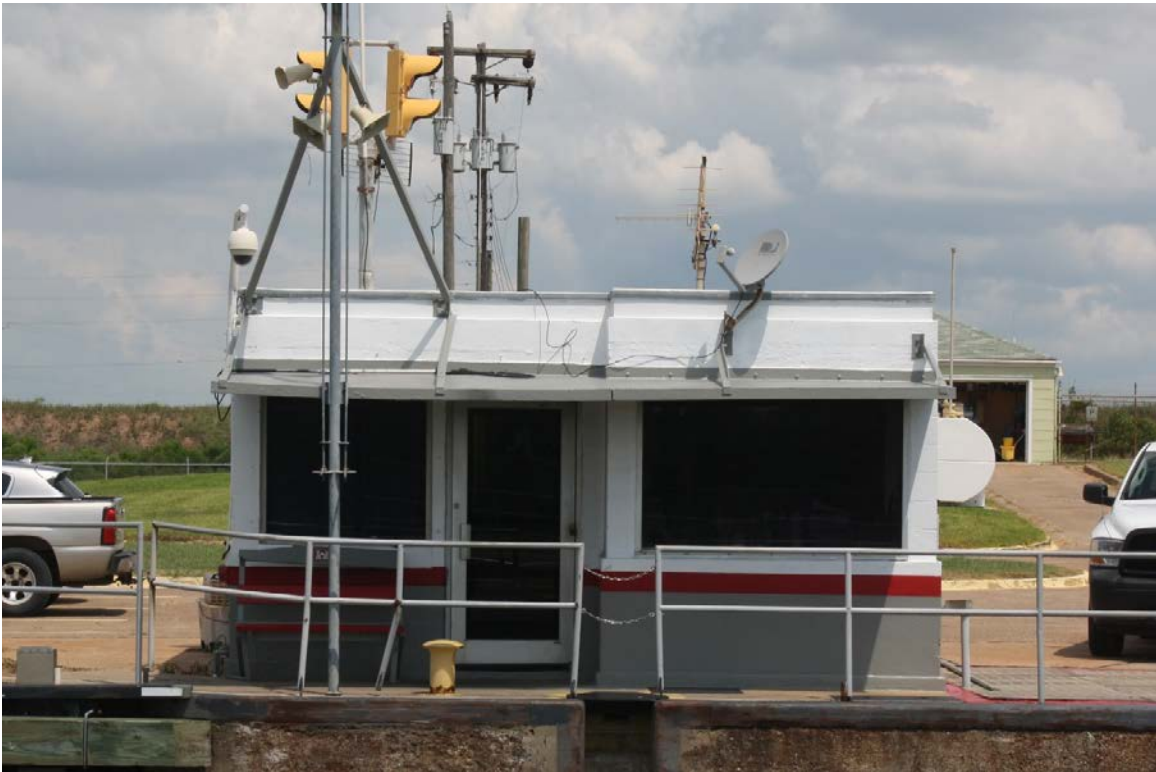
Resource No. 5

Resource No.: 5  
Latitude/Longitude: 28.897147/ -95.381801  
Address: Brazos River East Floodgate, Brazoria County, Texas  
Function: Infrastructure/Control house  
Construction Date: 1943  
Comments: The concrete-block control house is located on the north guide wall adjacent to the north sector gate. The small flat roof building exhibits large non-historic-age picture windows on the south and west elevations and entrance doors on the south and east elevations. The Moderne horizontal banding near the roofline is faintly visible. Alterations include non-historic-age windows and doors, as well as infilled windows and door on the north elevation.  
NRHP Eligibility: Not eligible

View of south elevation, facing northwest

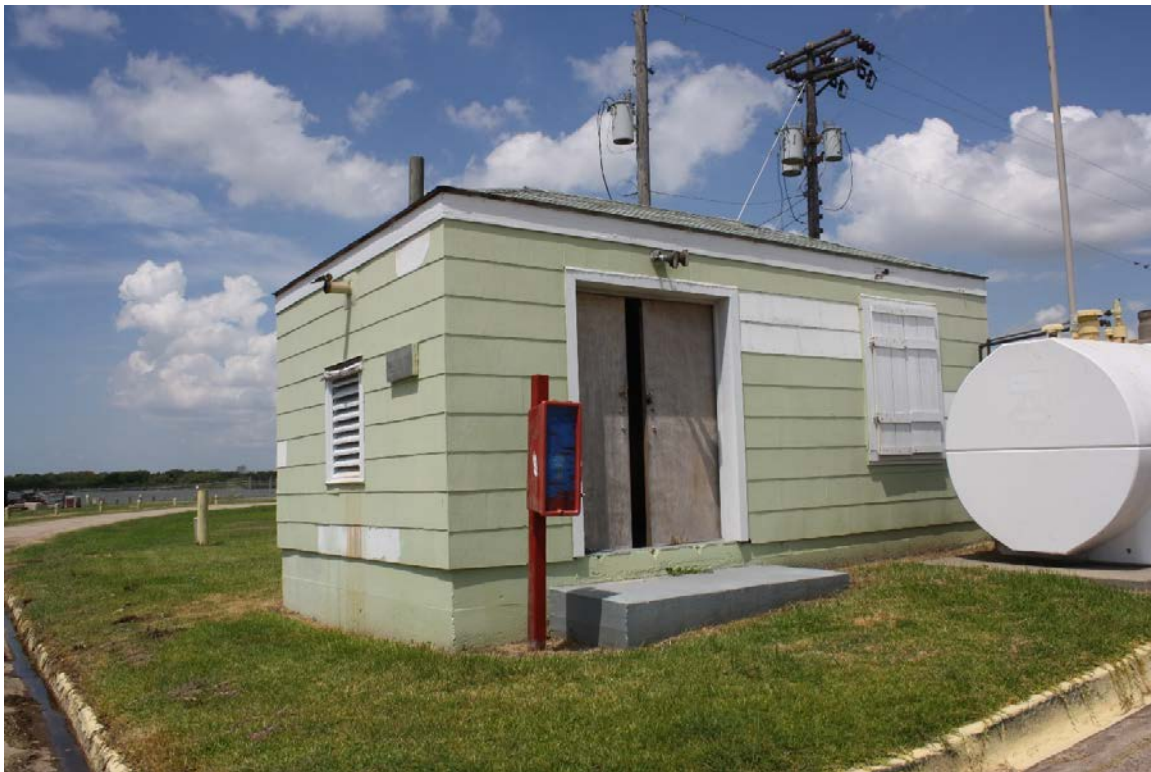
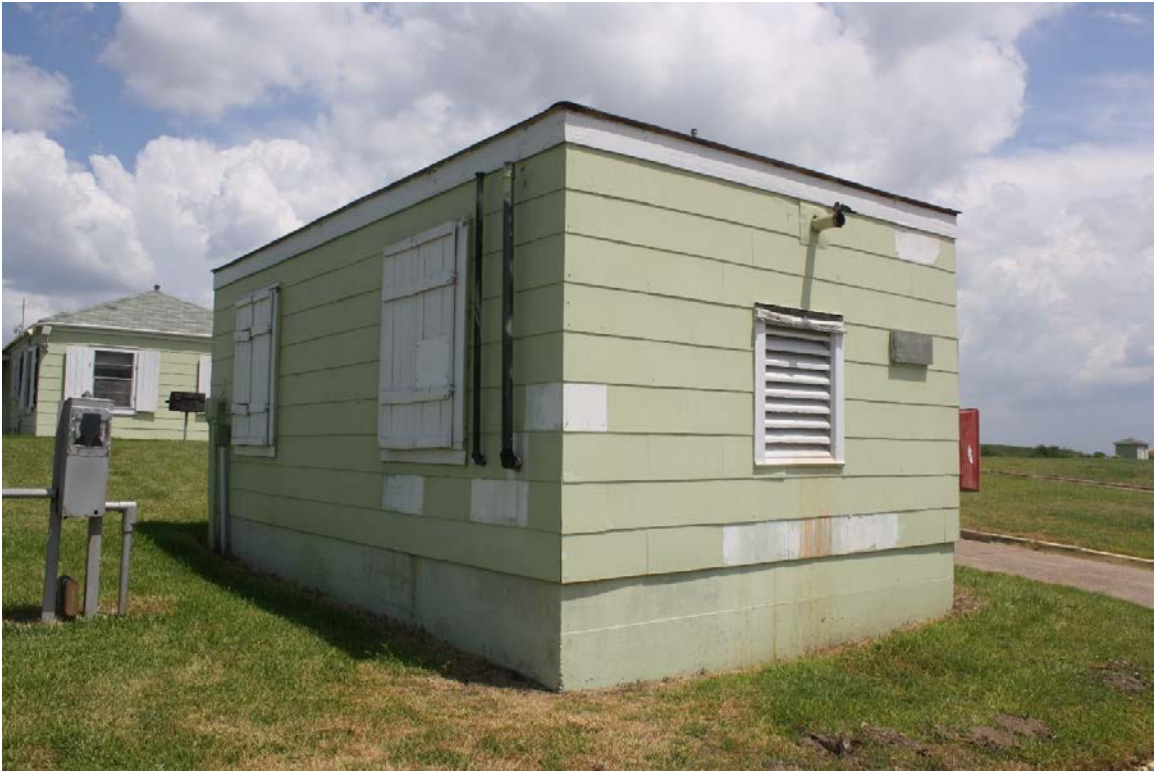
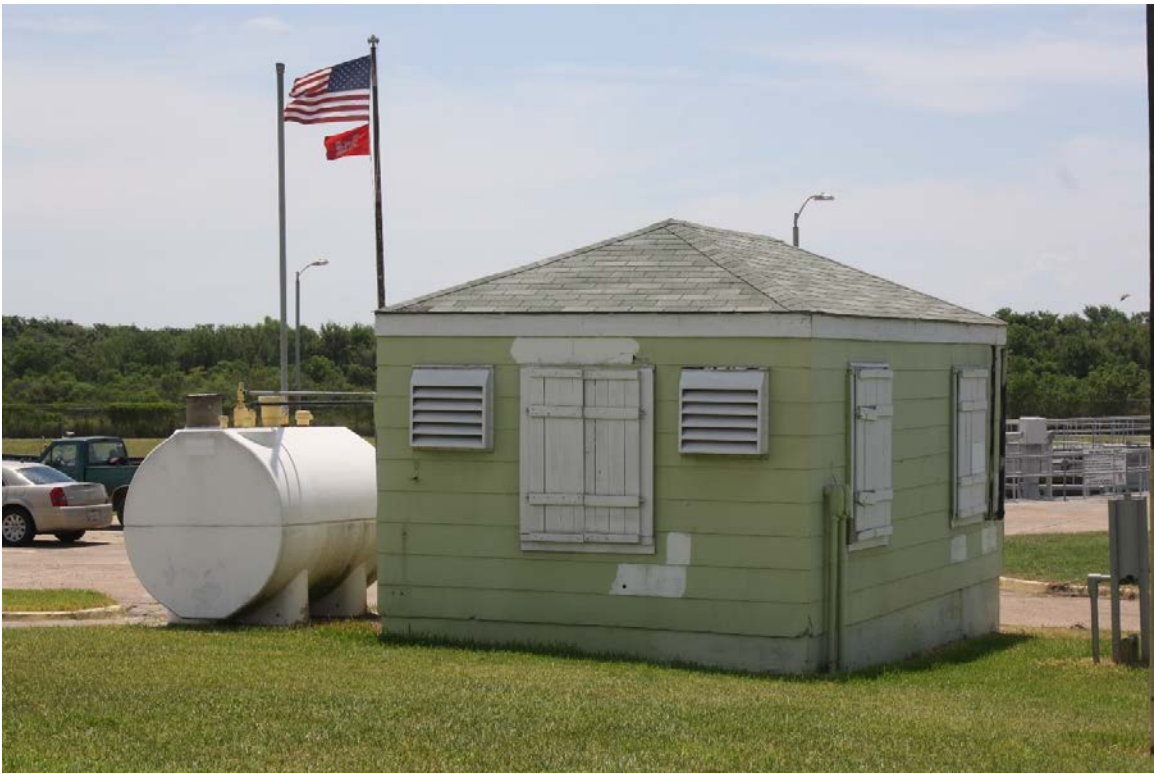
Resource No. 6

Resource No.: 6  
Latitude/Longitude: 28.897464/ -95.381982  
Address: Brazos River East Floodgate, Brazoria County, Texas  
Function: Infrastructure/Power house  
Construction Date: 1943  
Comments: This hipped-roof building is the original power building for the floodgates. Situated north of the control house, the building exhibits horizontal siding, a large opening on the east elevation, and shuttered windows. Alterations include some replacement siding and replacement shutters. There is also some missing siding and deteriorating sliding entrance doors.  
NRHP Eligibility: Not eligible  
Survey Date: August 2017

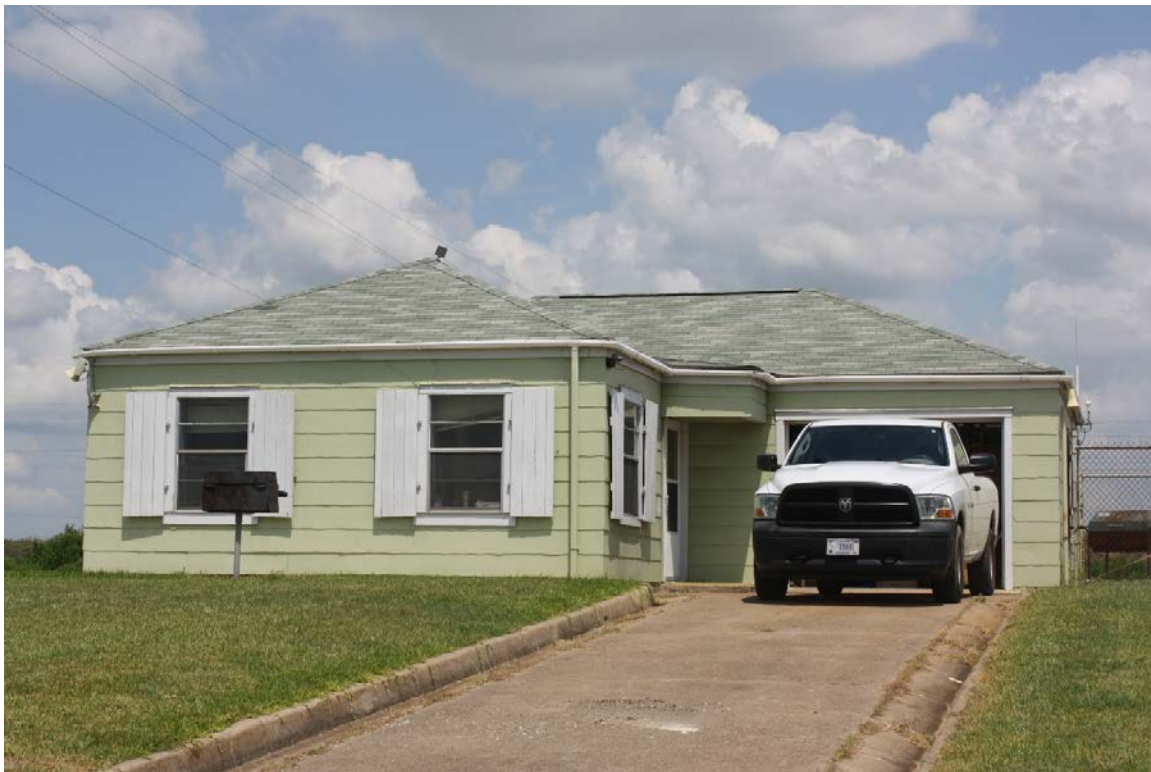
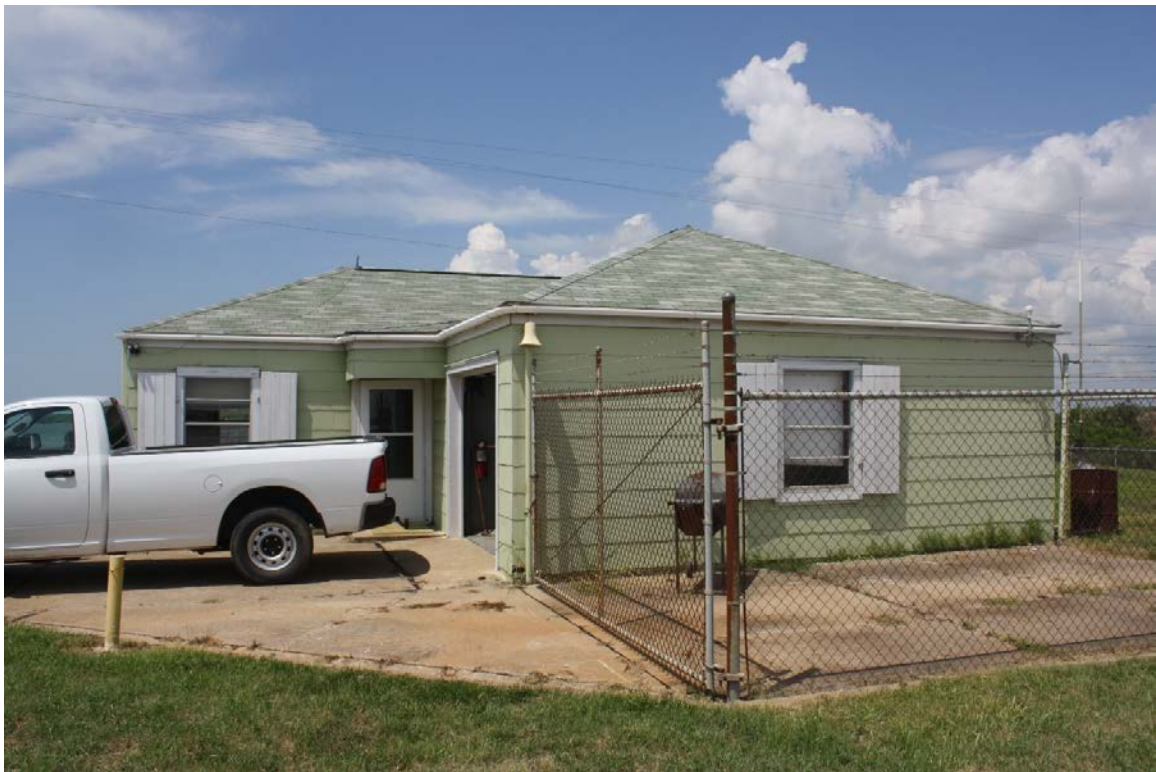
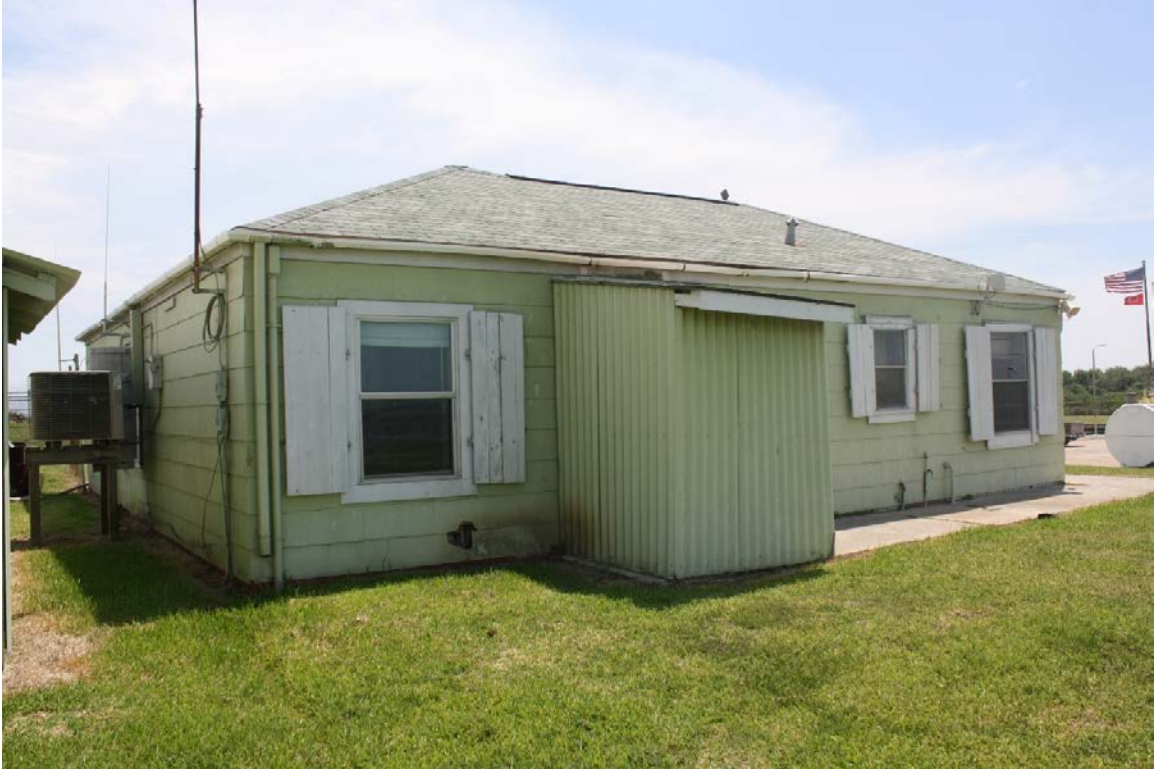
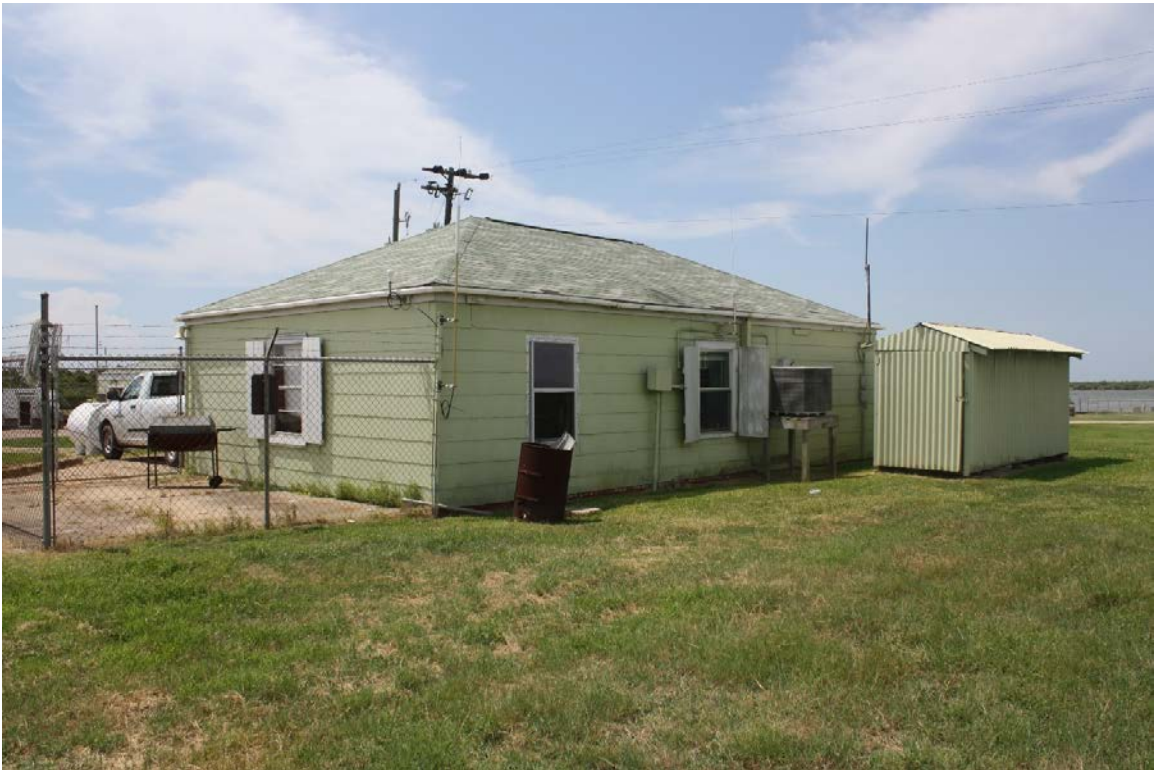
Resource No. 7

Resource No.: 7  
Latitude/Longitude: 28.897681/ -95.382116  
Address: Brazos River East Floodgate, Brazoria County, Texas  
Function: Infrastructure/Office  
Construction Date: 1943  
Comments: This hipped-roof L-plan building is the office and warehouse for the floodgates. The original plans of the site showed this building as an office and warehouse. Situated just north of the power house (Resource No. 6), the building has horizontal siding, two-over-two windows with shutters, and an integrated garage. Alterations include a small, partially enclosed porch on the west elevation and replacement windows on the north elevation. The original door accessing the garage has also been infilled.  
NRHP Eligibility: Not eligible  
Survey Date: August 2017

View of west elevation with porch addition, facing east

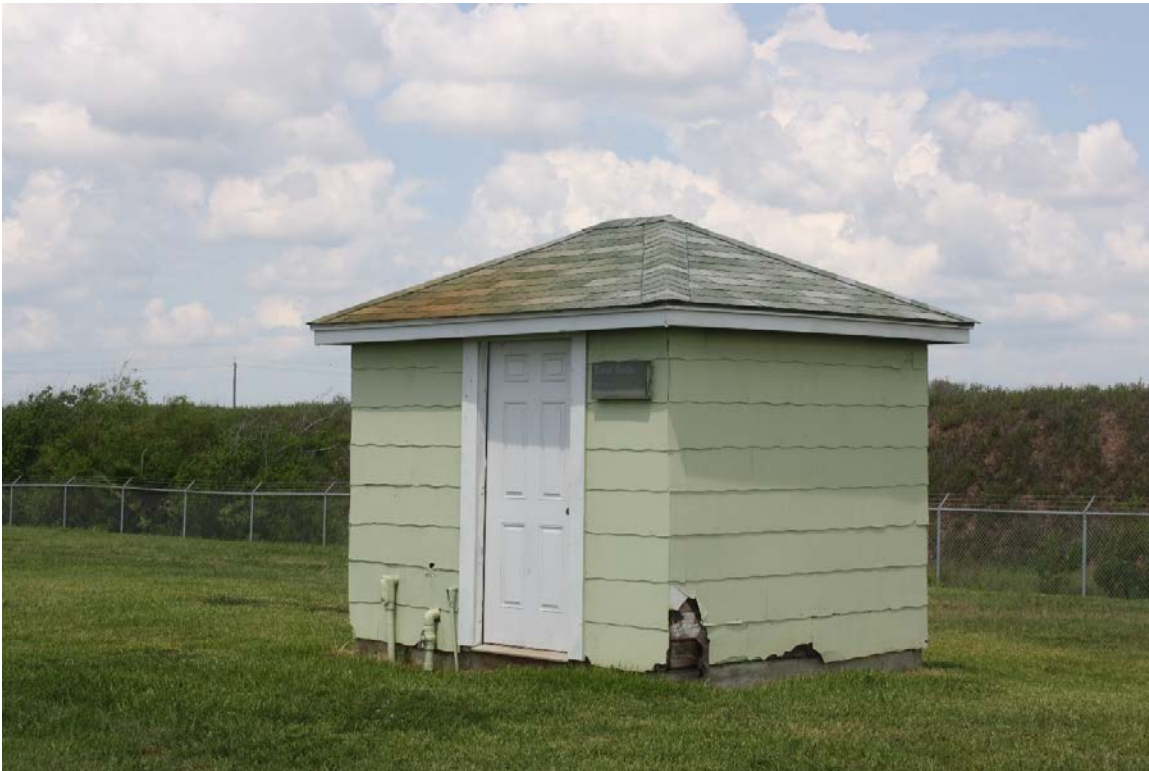
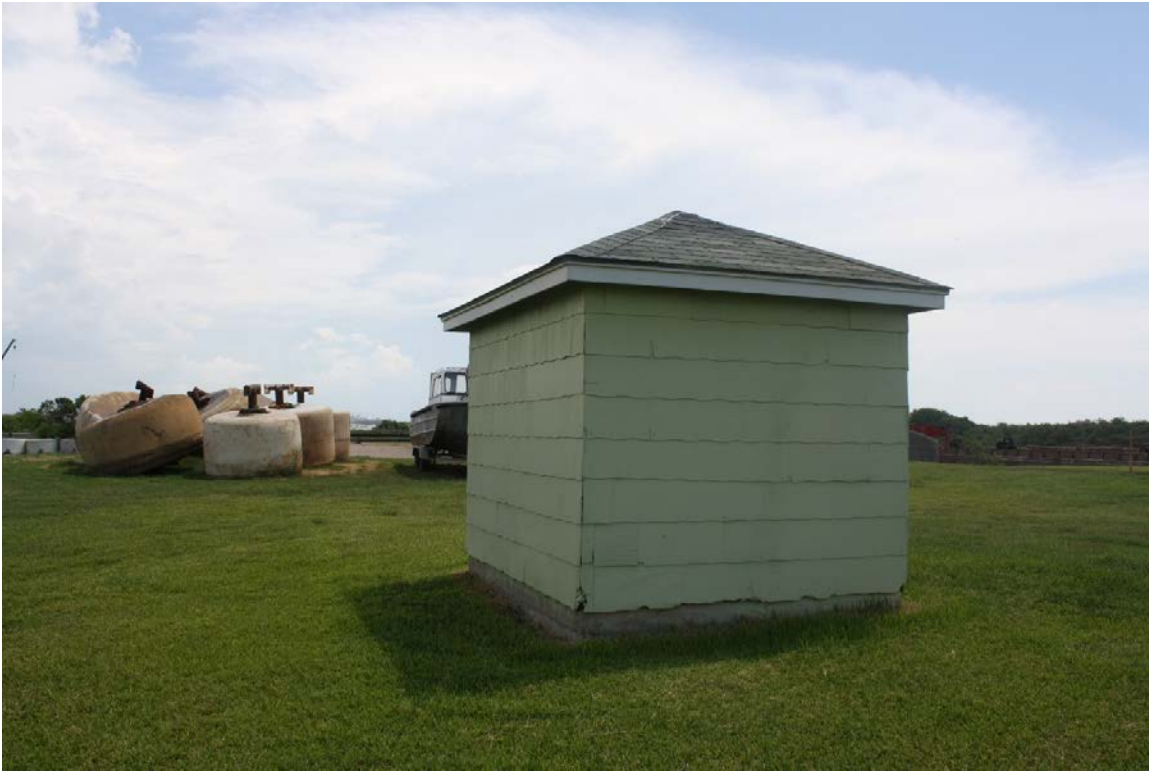
Resource No. 8

Resource No.: 8  
Latitude/Longitude: 28.898387/ -95.381340  
Address: Brazos River East Floodgate, Brazoria County, Texas  
Function: Infrastructure/Support building  
Construction Date: 1943  
Comments: This small hipped-roof building was originally a well pumphouse for the no-longer extant four residences. Situated approximately 200 feet from the boat house (Resource No. 9), the building has horizontal siding and an entrance door on the south elevation. The building exhibits some deteriorating and missing siding.  
NRHP Eligibility: Not eligible  
Survey Date: August 2017

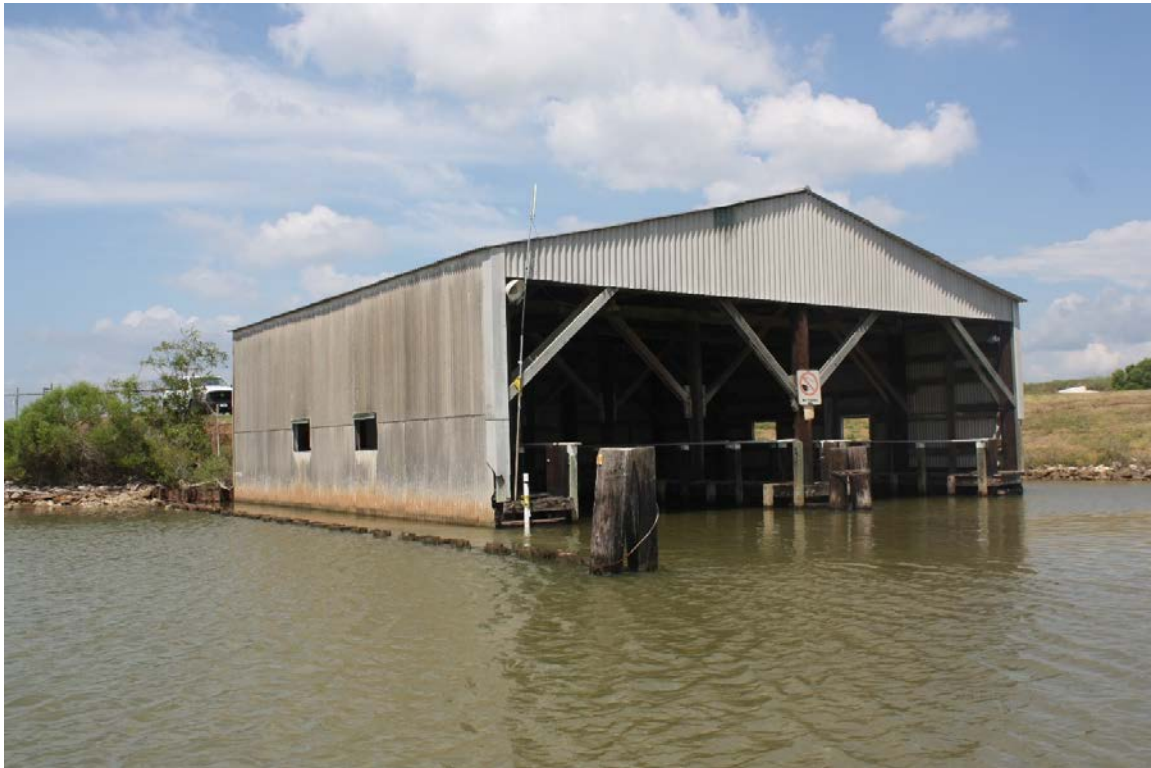
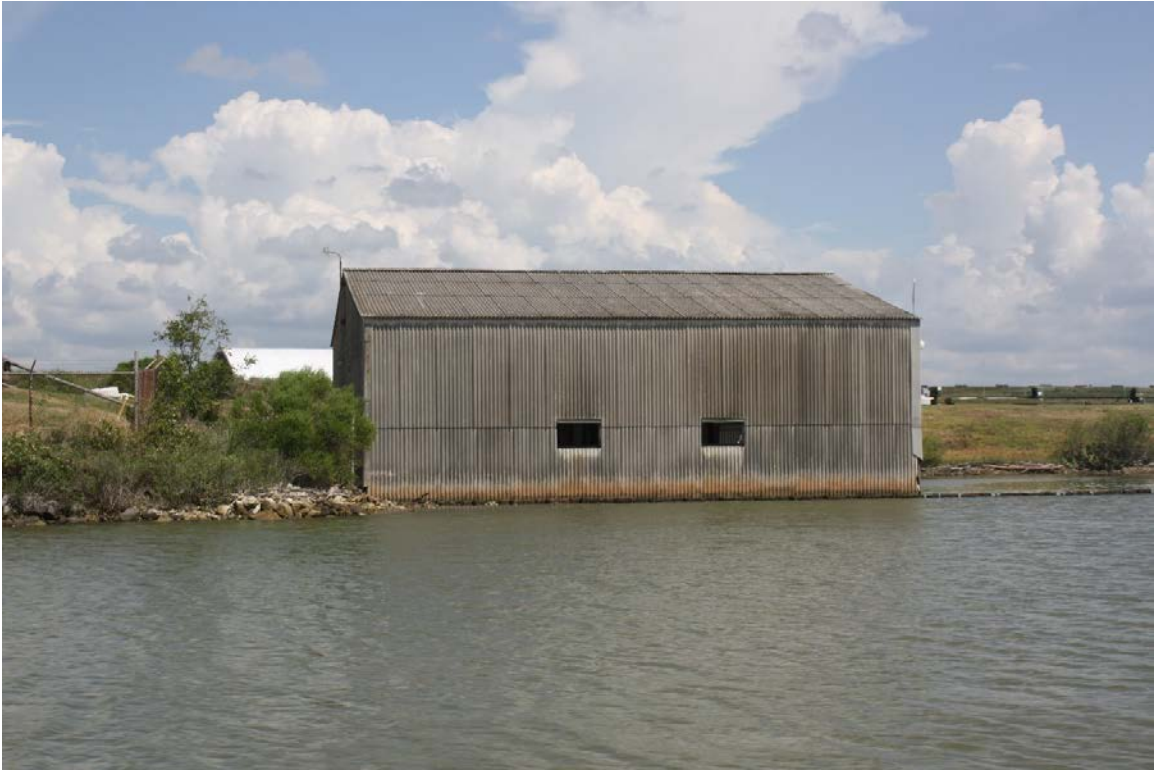
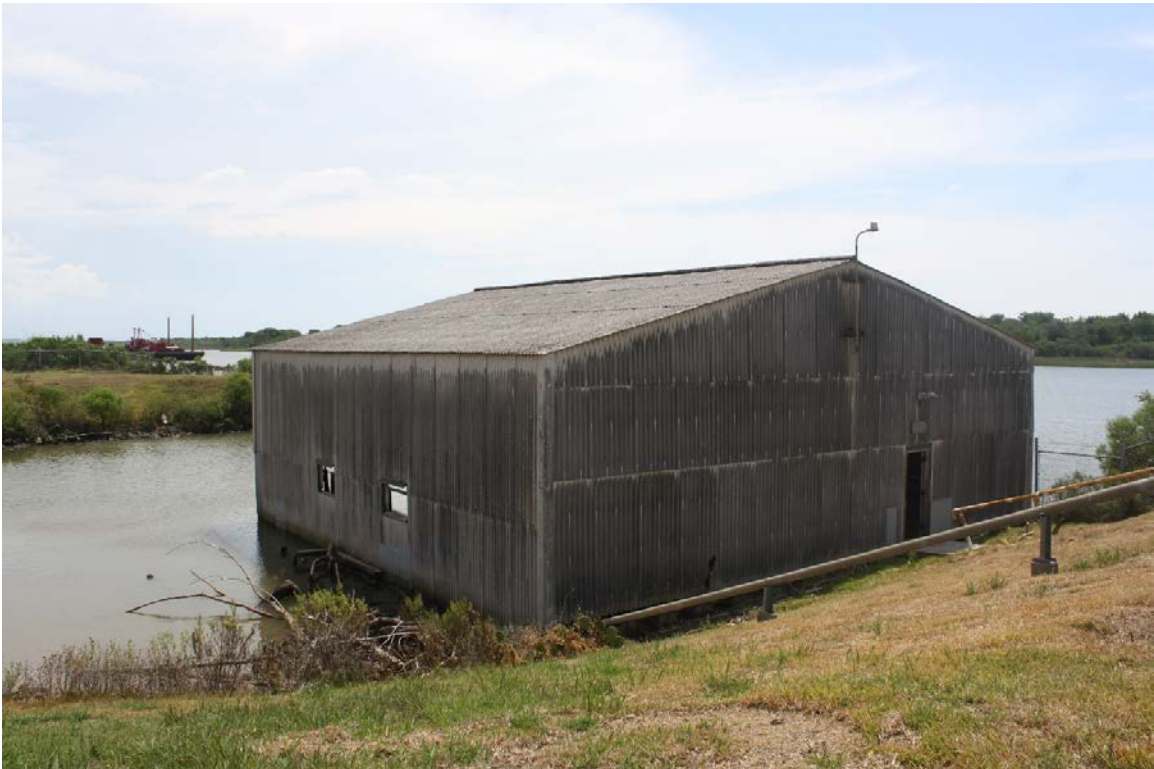
Resource No. 9

Resource No.: 9  
Latitude/Longitude: 28.898402/ -95.380459  
Address: Brazos River East Floodgate, Brazoria County, Texas  
Function: Infrastructure/Boat house  
Construction Date: ca. 1970  
Comments: This gable roof building is the boat house for the east floodgates. Constructed ca. 1970, it replaced a previously smaller boat house. The corrugated metal building is open on the east elevation and is situated in the far eastern portion of the east floodgate area. The inside of the boat house includes two boat bays, docks, and no-longer operable boat lift machinery.  
NRHP Eligibility: Not eligible  
Survey Date: August 2017

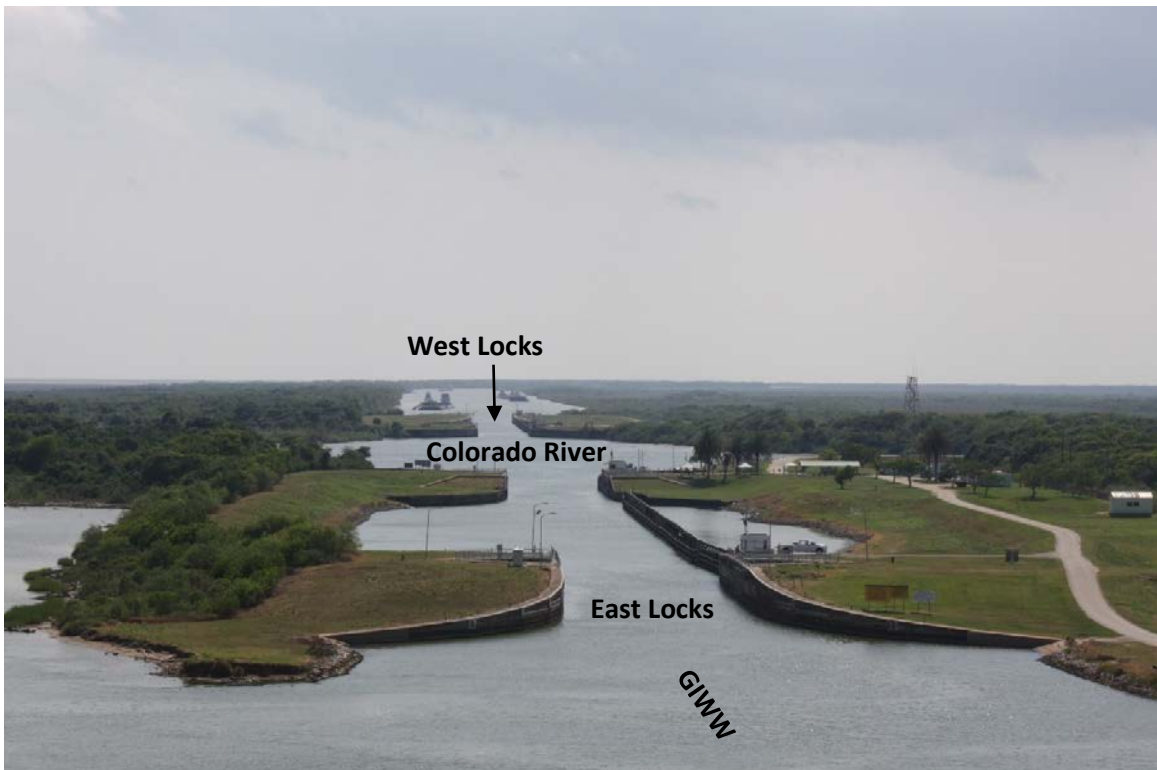
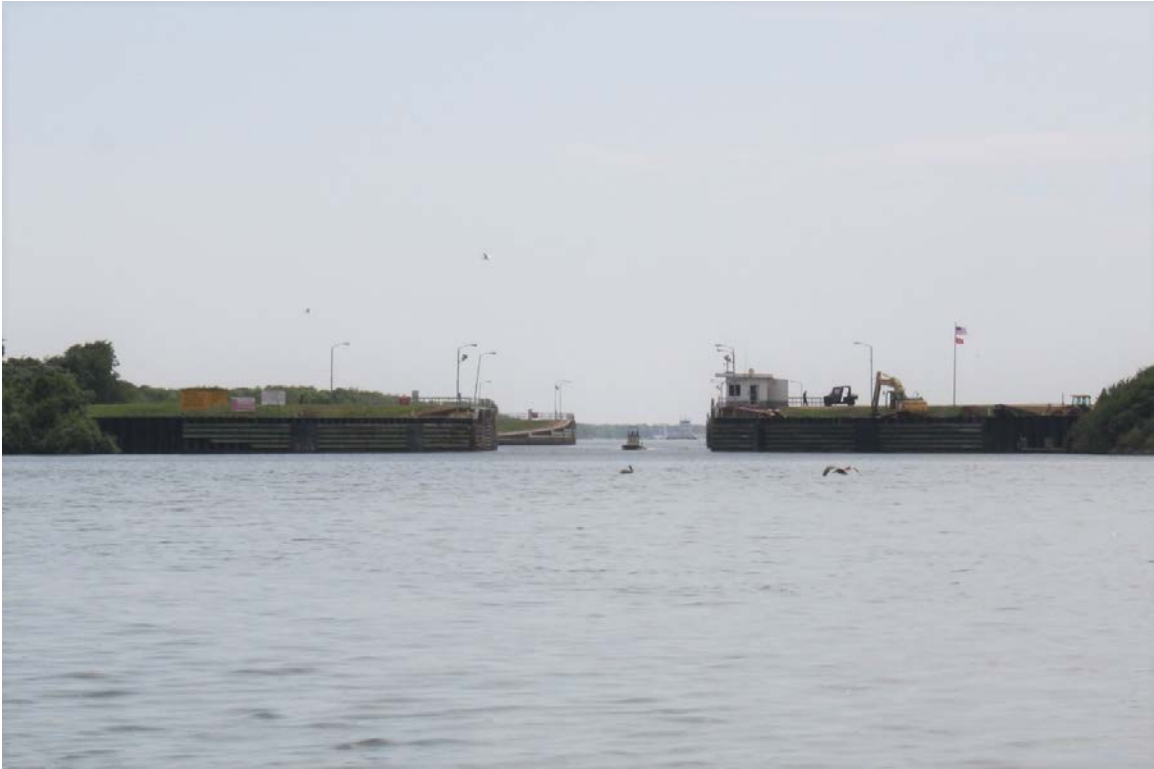
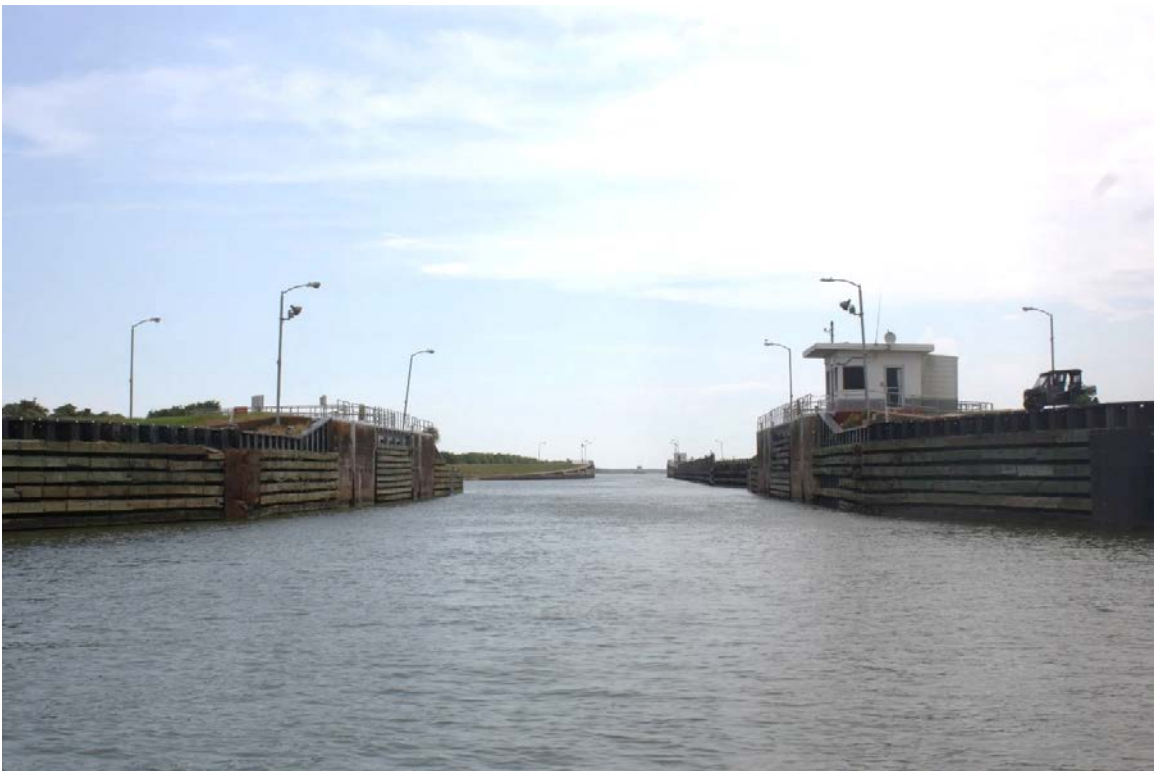
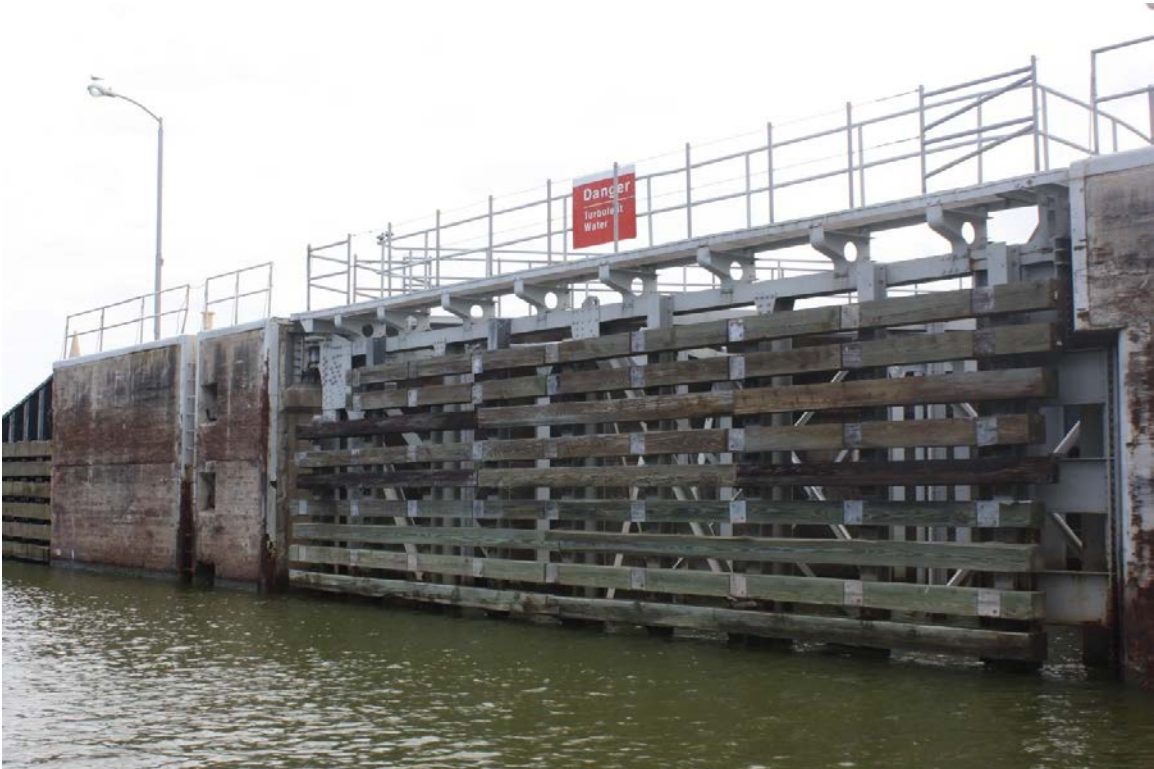
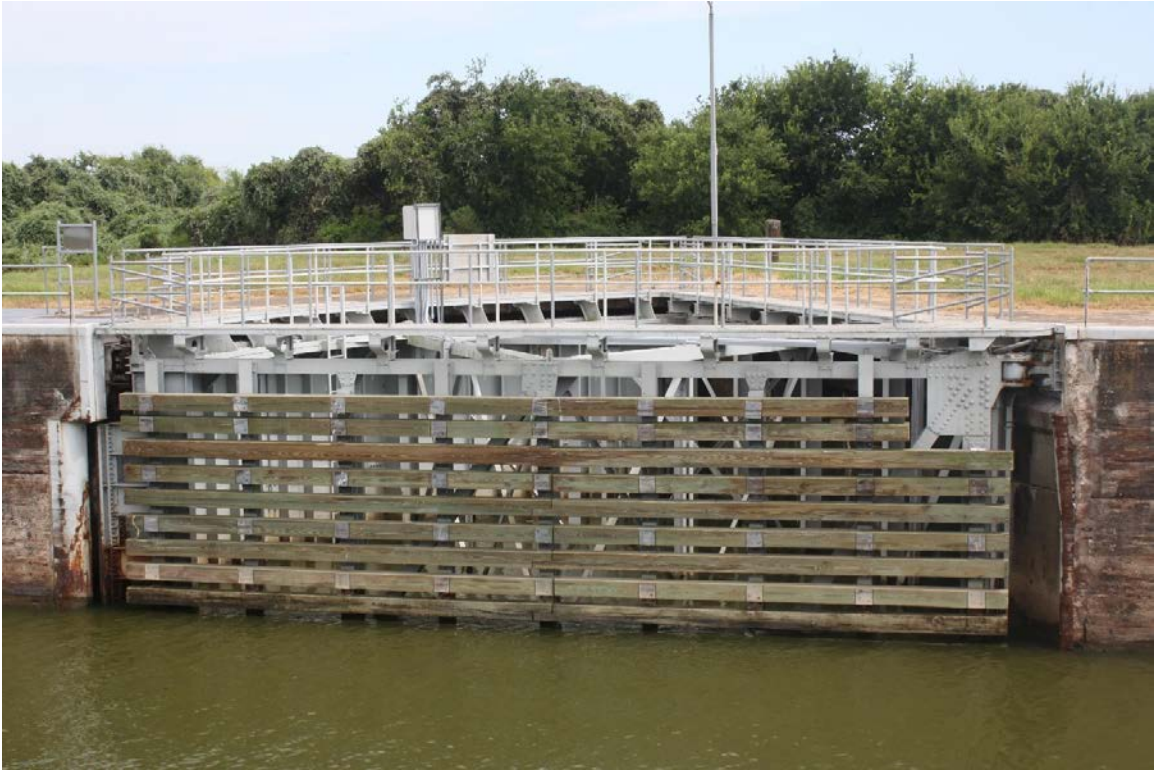
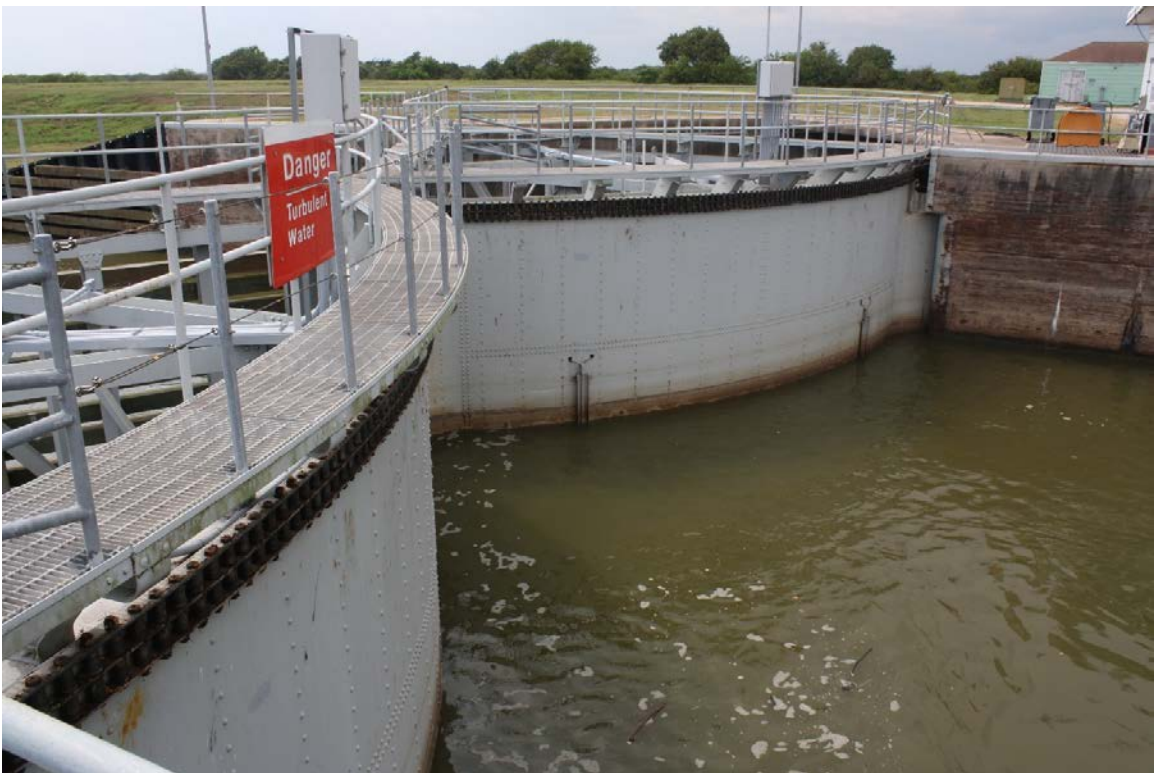
Resource No. 10A

Property No.	Latitude/Longitude	Function	Date(s)	Integrity/ Comments	NRHP Eligibility	Figure No.
10A	28.679311/ -95.981781	Transportation (water-related)/ River locks	1944/1951	The west lock gates themselves show very few alterations aside from replacement timber fenders. The lock guidewalls exhibit replacement timber fenders and impact damage. Steel sheet piles and sheet protective fenders have corrosion, pitting, and section loss. Concrete elements of the lock show extensive cracking, spalling, and exposed rebar.	Not eligible	3
10B	28.684215/ -95.971145	Transportation (water-related)/ River locks	1944/1951	The east lock gates themselves show very few alterations aside from replacement timber fenders. The lock guidewalls exhibit replacement timber fenders and impact damage. Steel sheet piles and sheet protective fenders have corrosion, pitting, and section loss. Concrete elements of the lock show extensive cracking, spalling, and exposed rebar.	Not eligible	3
