ATTACHMENT D-6  
HISTORIC RESOURCES SURVEY REPORT

NON-ARCHEOLOGICAL HISTORIC  
RESOURCES SURVEY REPORT  
Gulf Intracoastal Waterway, Brazos River  
Floodgates and Colorado River Locks  
Feasibility Study  
Brazoria and Matagorda Counties, Texas

NOVEMBER 2018

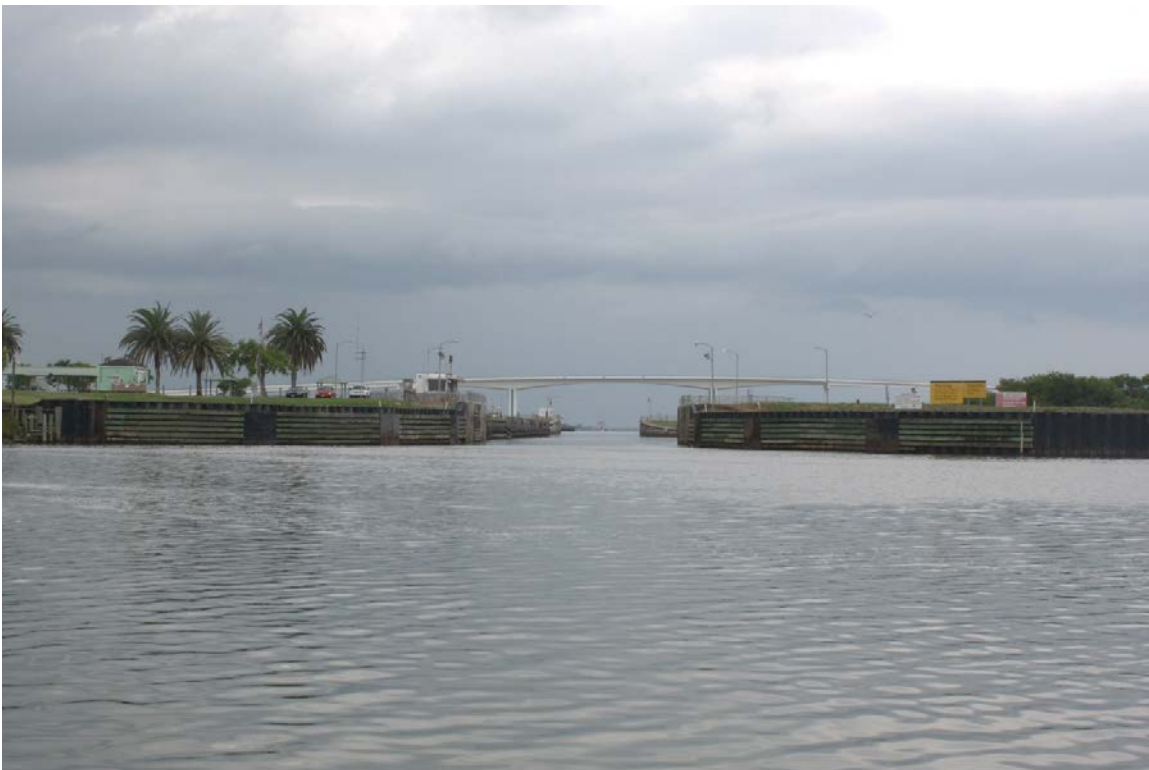
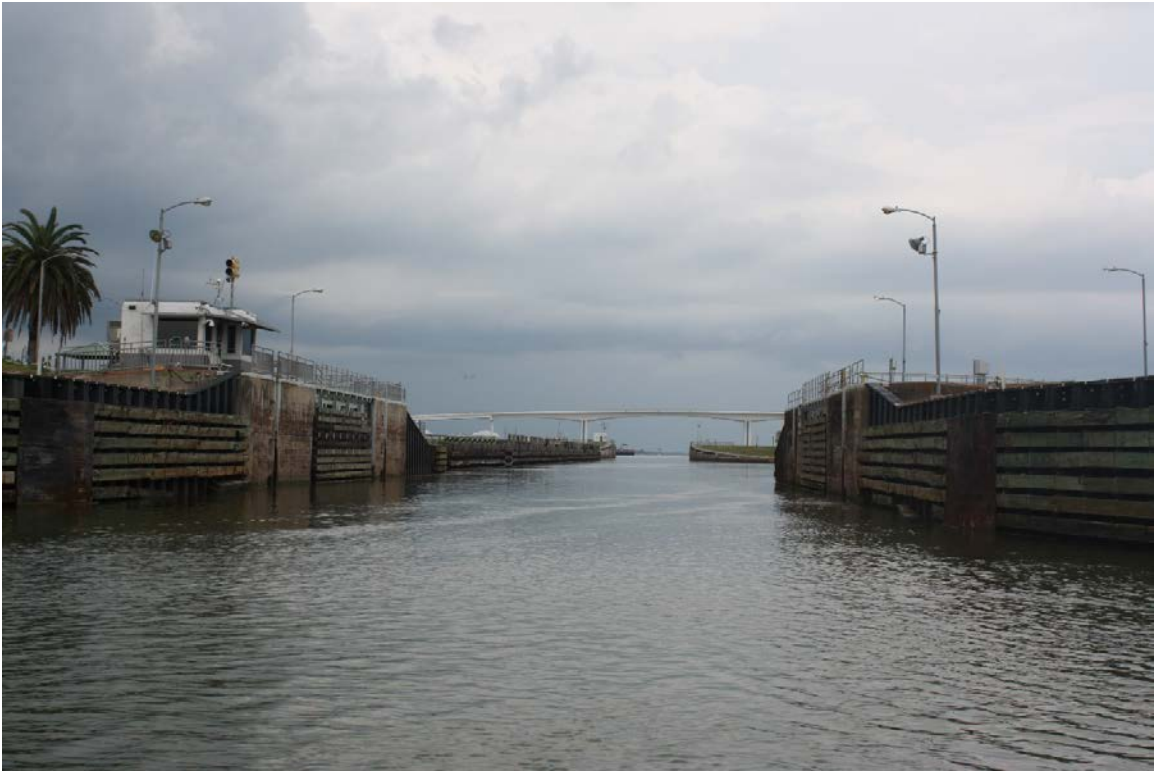
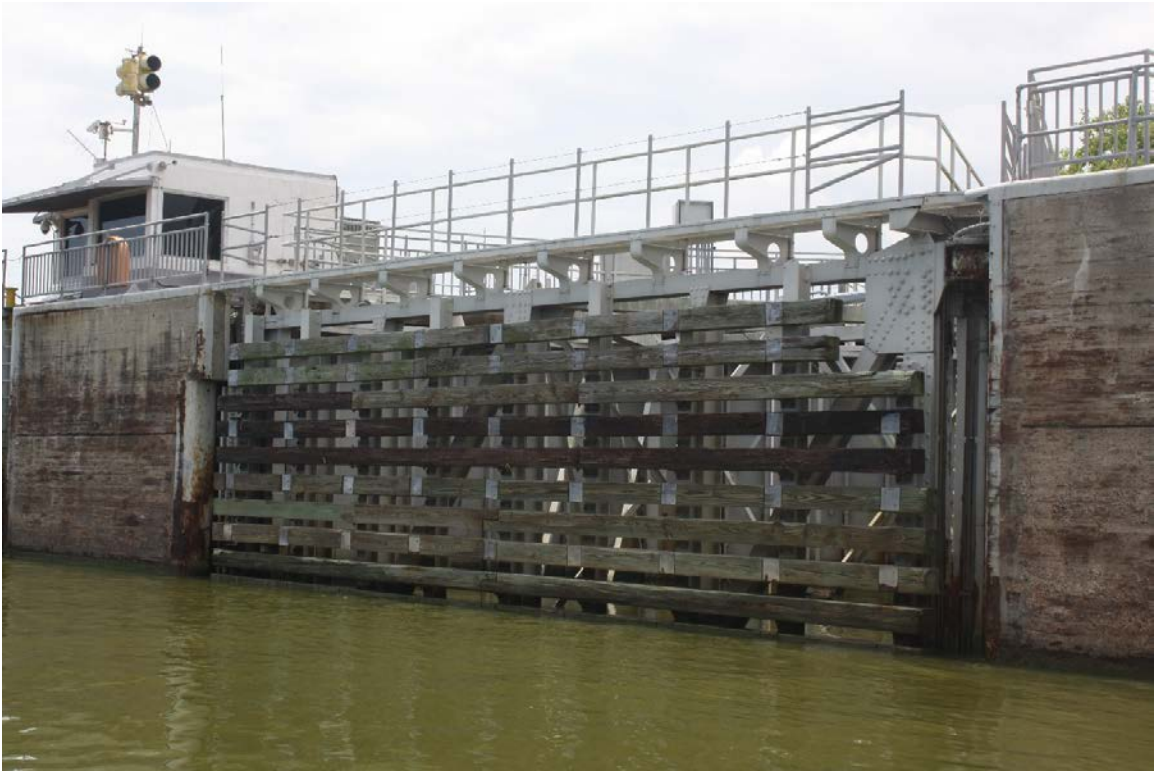
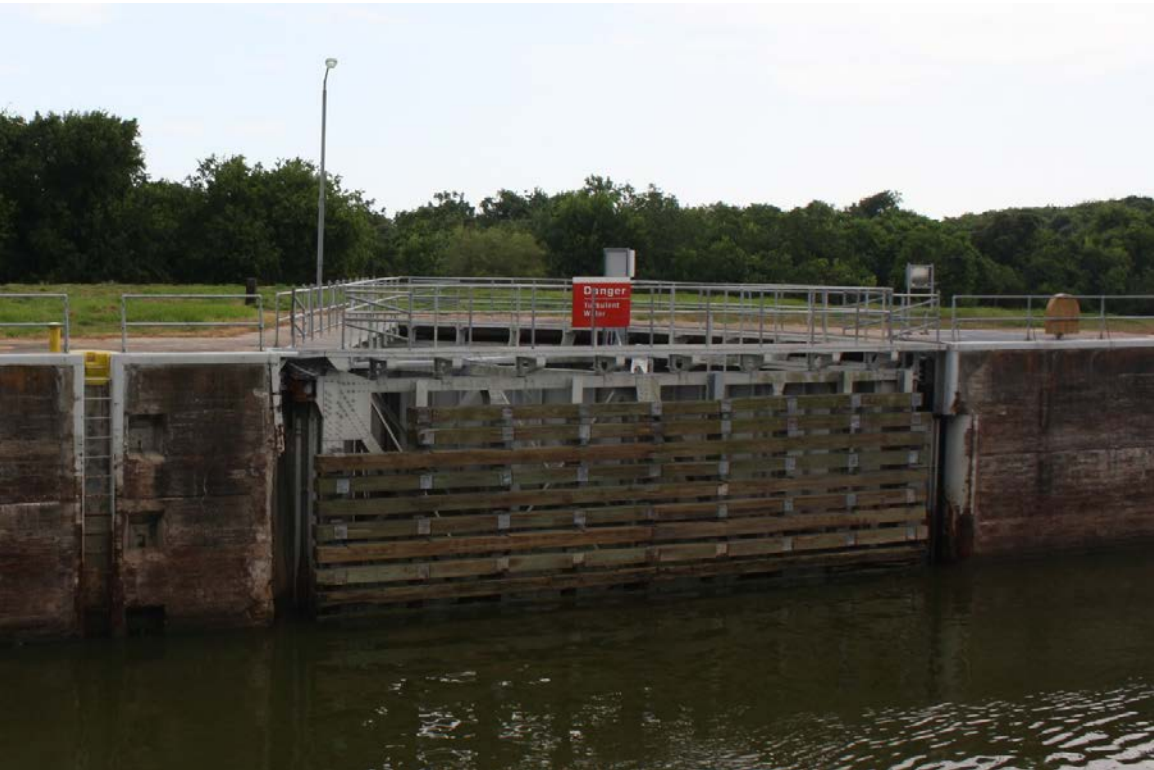
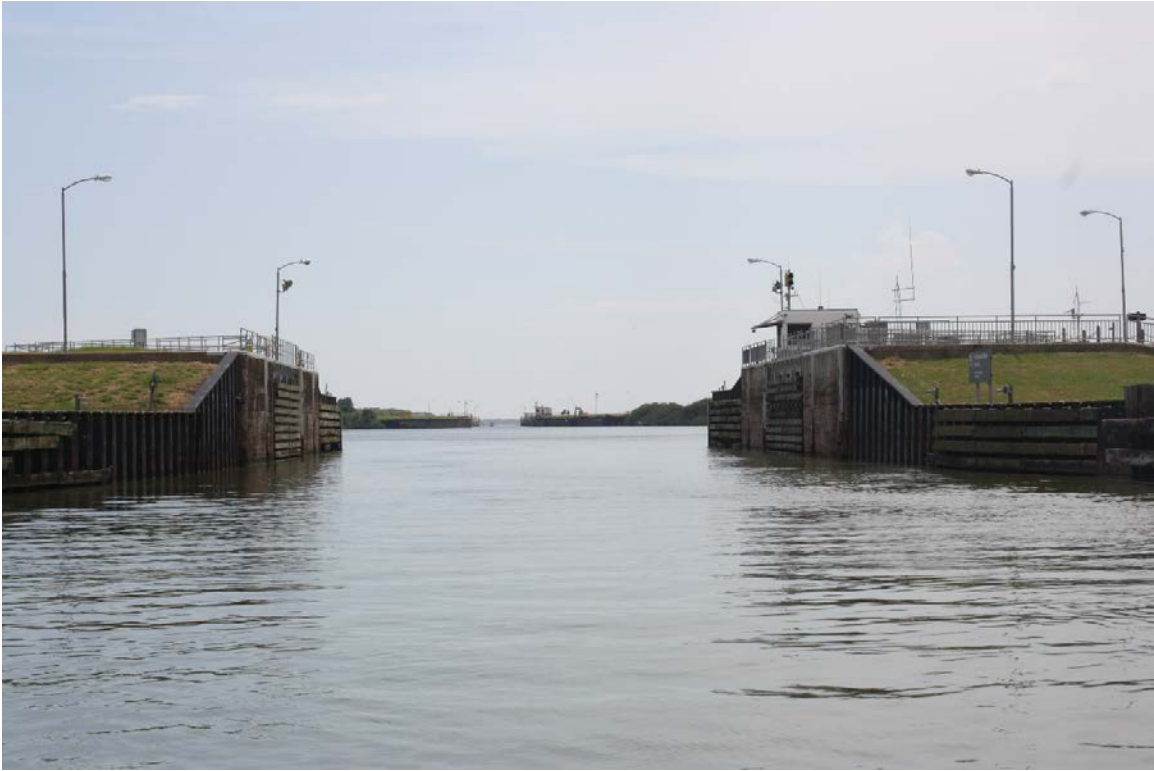
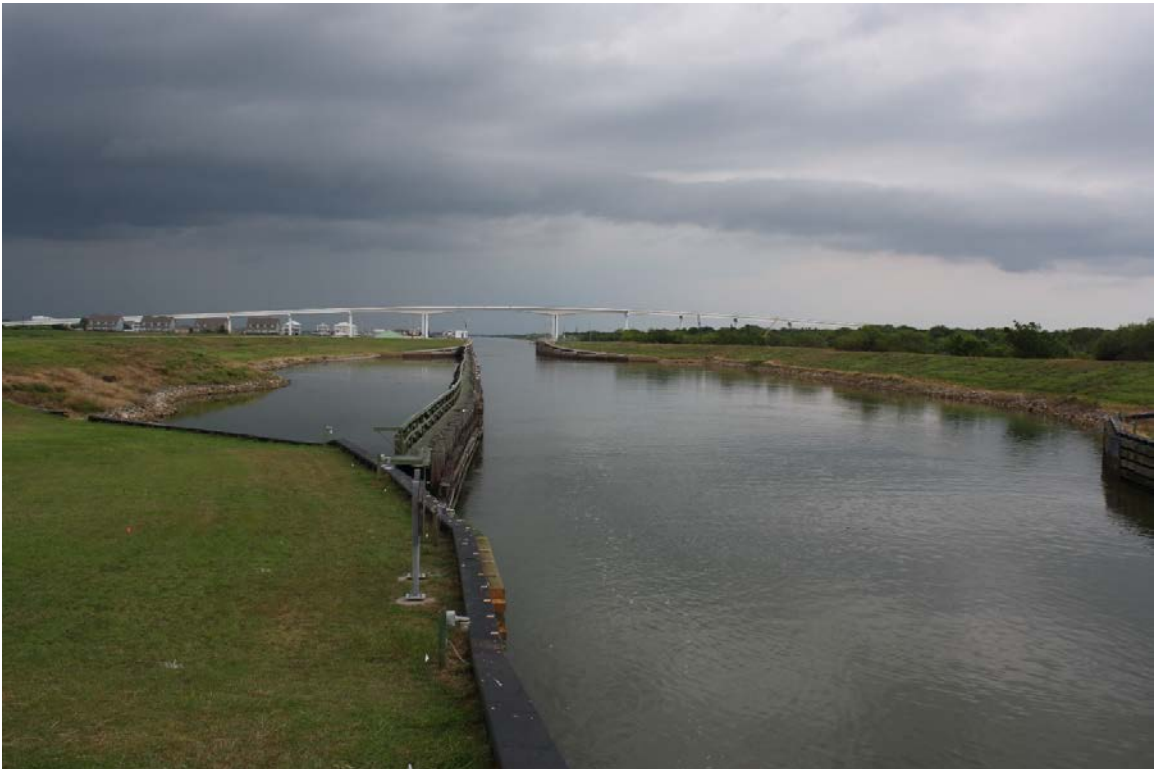
Resource No. 10B

Comments: The Colorado River East Lock is located east of the Colorado River along the GIWW. The lock consists of two sets of gates (four gates total) separated by a lock chamber. The set of gates closest to the Colorado River date to 1944 when the gates operated as floodgates. The adjacent lock chamber and gates to the east date to 1951 when the Colorado River floodgates were converted to locks. All four steel, concrete, and timber gates measure 1,200 feet long and 75 feet wide. Each of the four approximately 45-foot-long sector gates has steel construction with timber protective fenders. Walkways extend across the top of each gate, allowing access to the gate and ability to walk to the south sector gate. The gates themselves show very few alterations aside from replacement timber fenders. The lock gate guide walls exhibit replacement timber fenders and impact damage. Steel sheet piles and sheet protective fenders have corrosion, pitting, and section loss. Concrete elements of the locks show extensive cracking, spalling, and exposed rebar.

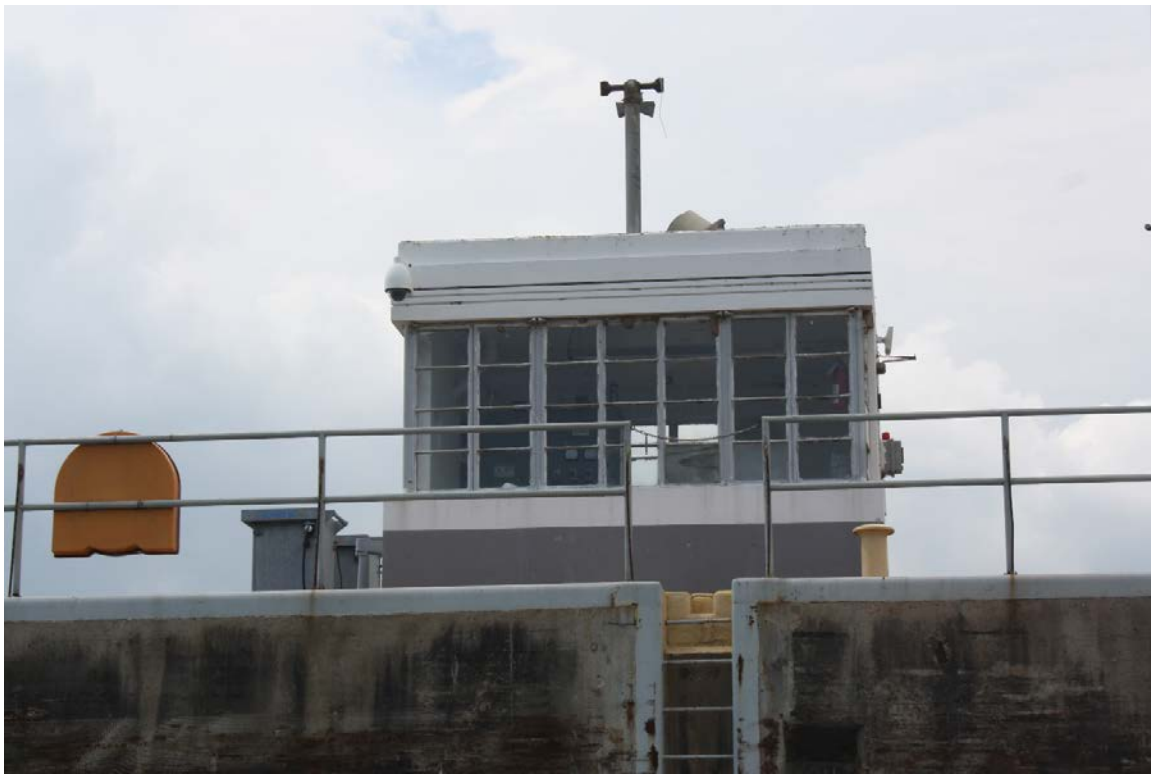
Resource No. 11

Resource No.: 11  
Latitude/Longitude: 28.678783/ -95.983302  
Address: Colorado River West Lock, Matagorda County, Texas  
Function: Infrastructure/Control house  
Construction Date: 1951  
Comments: The concrete block control house is located on the north guide wall adjacent to the 1951 north lock gate. The small flat roof building exhibits Moderne architectural detailing with a smooth stucco surface, flat roof, horizontal banding near the roofline, and multi-light single-pane windows that wrap around the building. Alterations include several window lights that are currently boarded.  
NRHP Eligibility: Not eligible

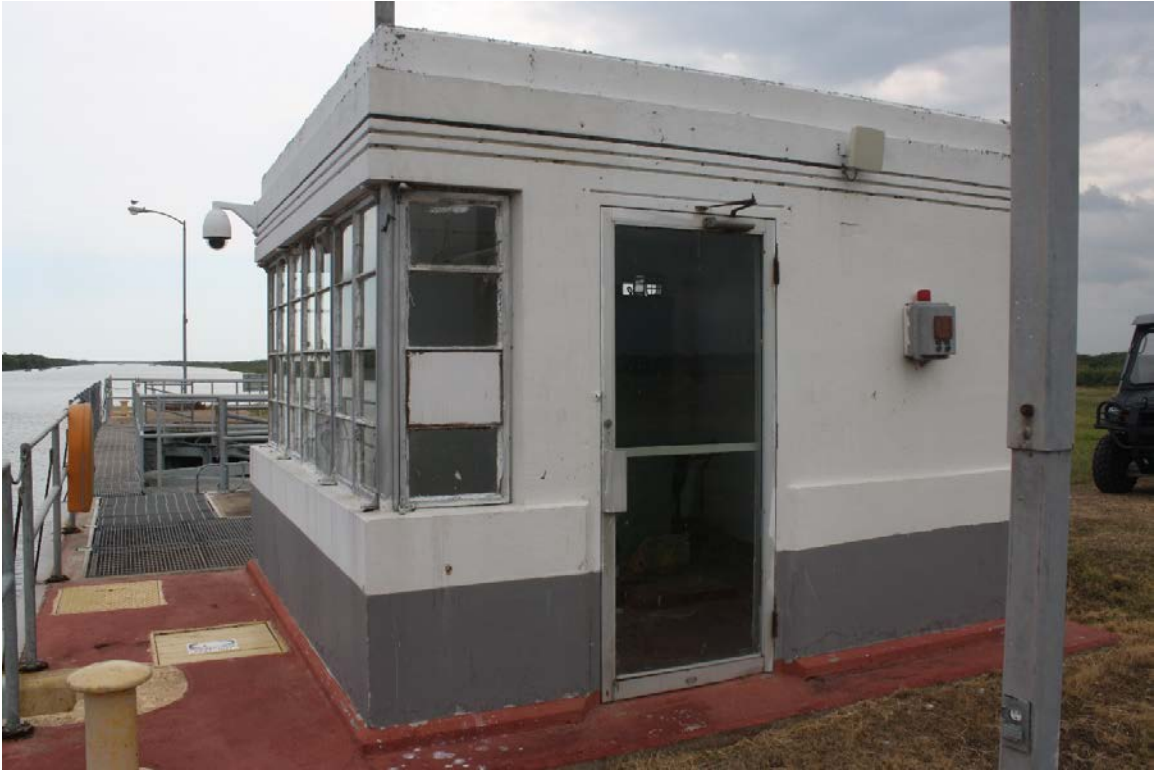
View of east elevation, facing west

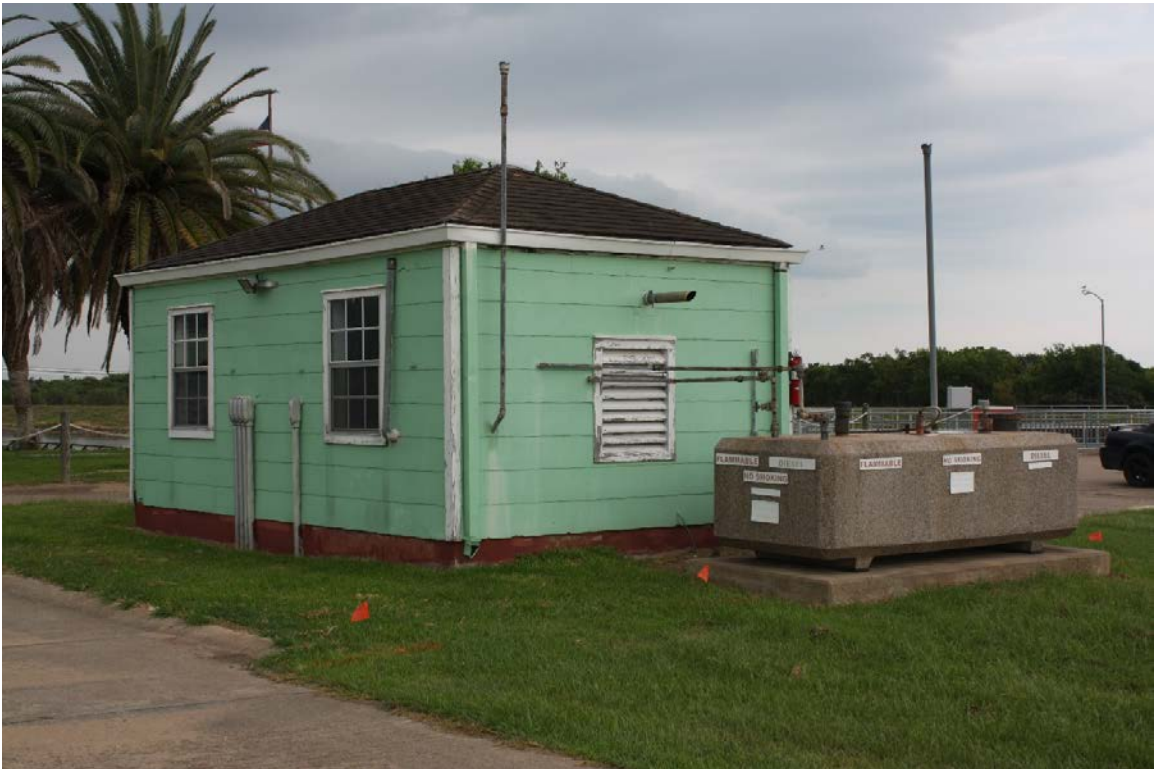
Oblique view, facing east

Resource No: 16  
Latitude/Longitude: 28.684088/ -95.973533  
Address: Colorado River East Lock, Matagorda County, Texas  
Function: Infrastructure/Office  
Construction Date: 1944  
Comments: This hipped-roof L-plan building is the original office building for the east lock. Situated on the north side of the internal access road, the building has horizontal siding, an entrance door with metal a large opening on the south elevation, and a garage door on the east elevation. Alterations include some replacement doors and the integrated garage has been converted to office space.  
NRHP Eligibility: Not eligible  
Survey Date: August 2017

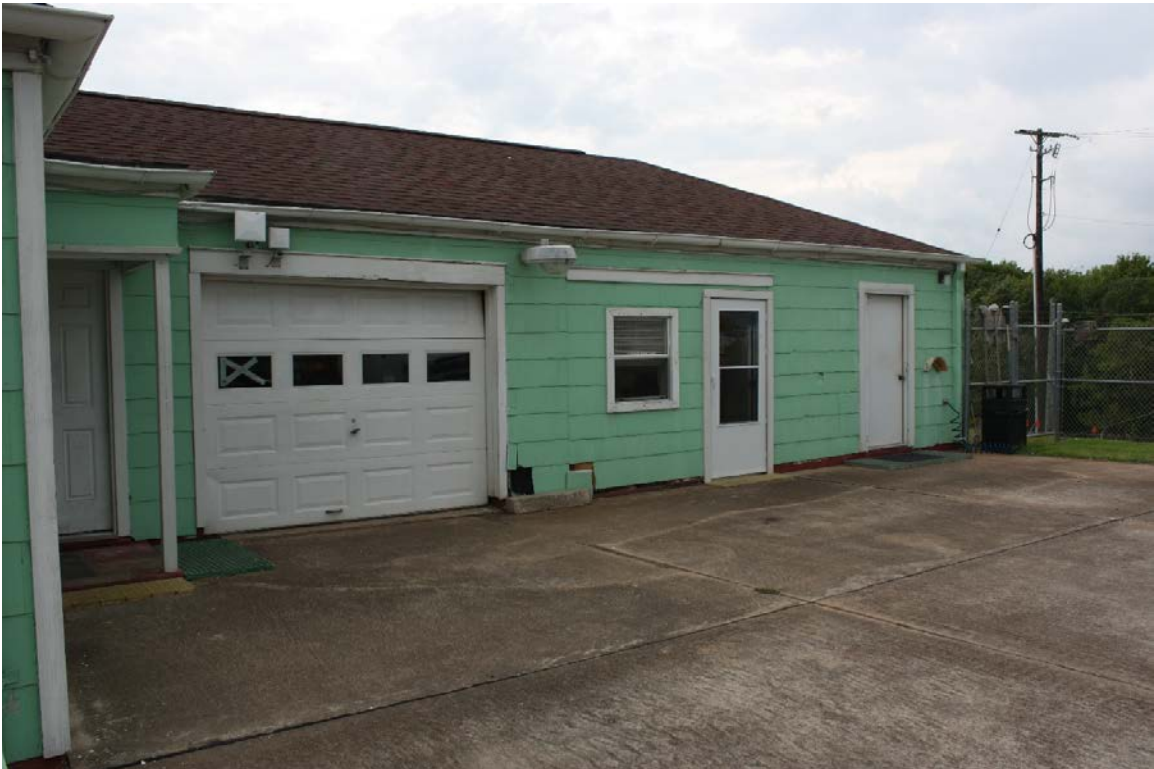
Resource No. 16

14	28.683692/ -95.973452	Transportation (water-related)/ Control house	1944	Alterations include a small non-historic-age rear addition, non-historic-age windows, doors, and a new flat roof with overhanging eaves. Originally the control house exhibited Moderne detailing with horizontal banding near the roofline and multi-light windows. The control house was also enlarged in the 1970s, nearly doubling its original size.	Not eligible	3
15	34.187013/ -101.250040	Transportation (water-related)/ Power house	1944	Alterations include one replacement windows and replacement doors.	Not eligible	3
16	28.684088/ -95.973533	Transportation (water-related)/ Office	1944	Alterations include some replacement doors and the integrated garage has been converted to office space.	Not eligible	3

View showing converted garage space, facing west

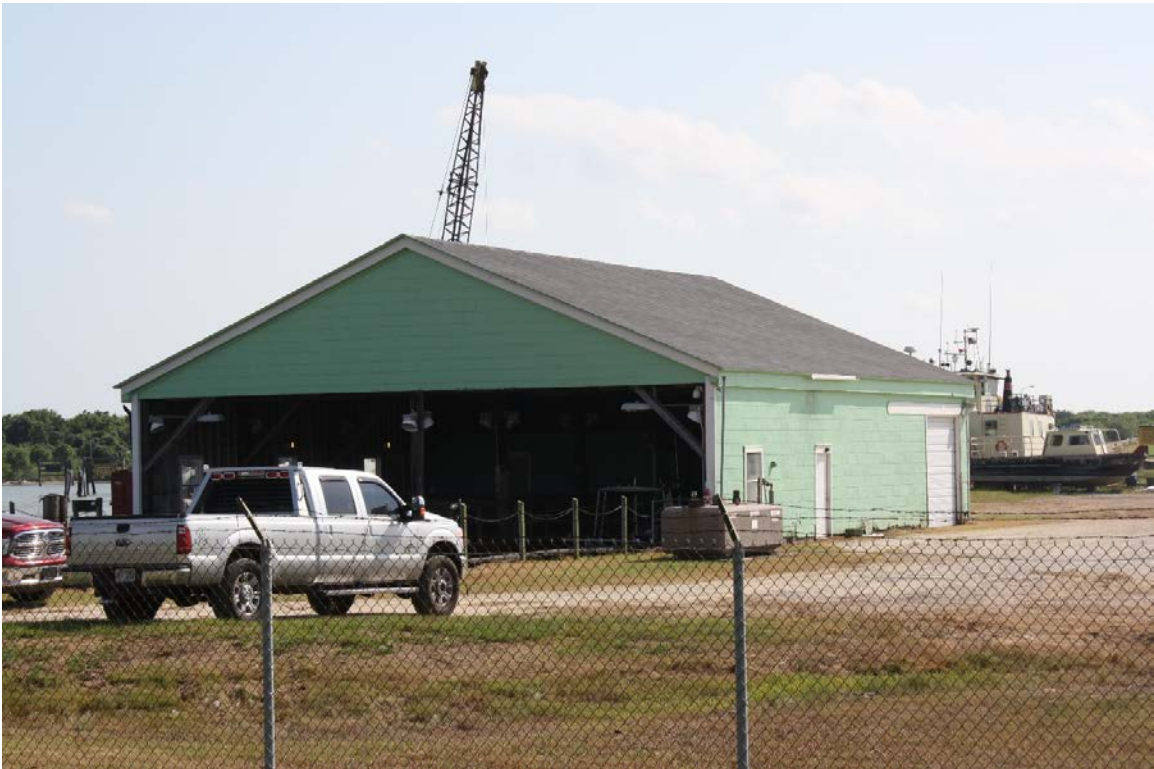
Resource No: 19  
Latitude/Longitude: 28.686564/ -95.967613  
Address: Colorado River East Lock, Matagorda County, Texas  
Function: Infrastructure/Boat house  
Construction Date: ca. 1965  
Comments: This gable roof building is the boat house for the east locks. Constructed ca. 1965, the building has horizontal siding, one-over-one windows, an entrance door on the south elevation, and a large overhead door on the north elevation. The boat house is situated in the far eastern portion of the east lock area and includes two boat slips and docks. The boat house was almost completely reconstructed after a fire.  
NRHP Eligibility: Not eligible  
Survey Date: August 2017

View of boat house, facing west
