## GRAND PARKWAY - SEGMENTS H&I-1 STREAM ASSESSMENT

# Stream Assessment Data Form for Level 1

U.S. Army Corps of Engineers Galveston District

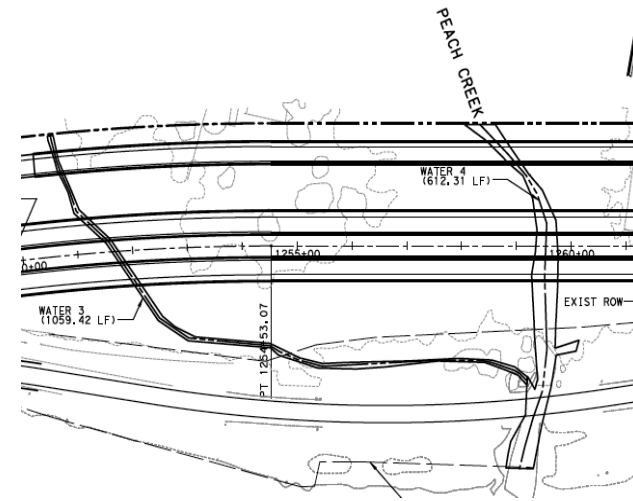
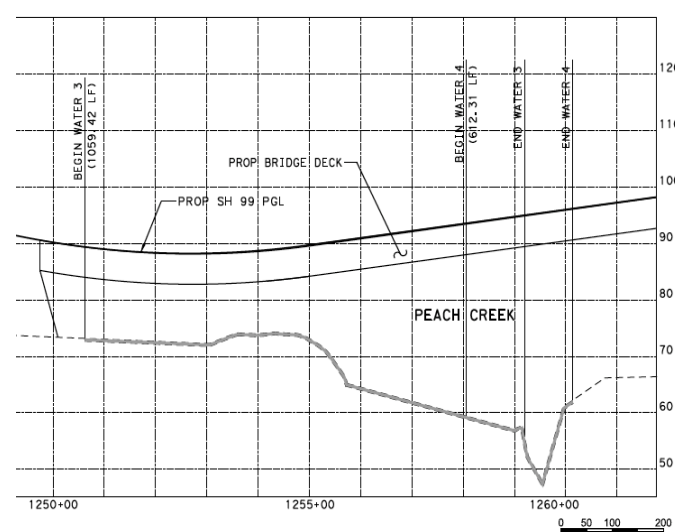
### Water 3 - Peach Creek Tributary

Notes: Riprap found along at least 50% of the transect. Erosional scars present.

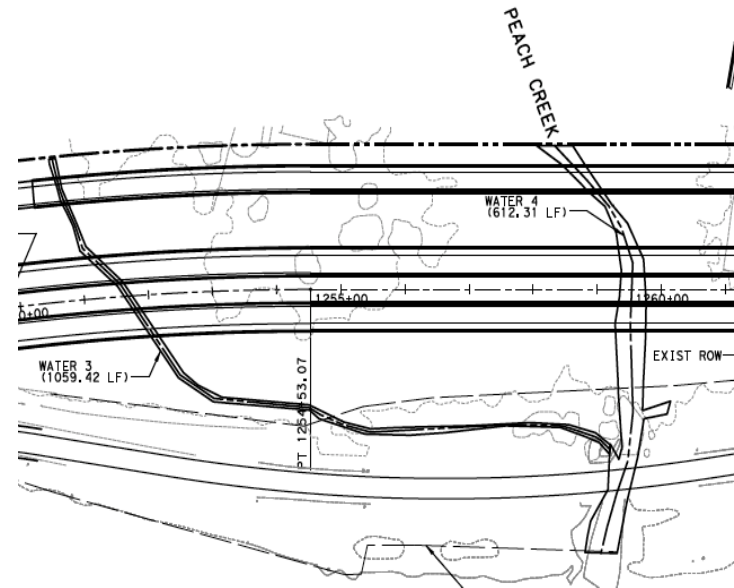
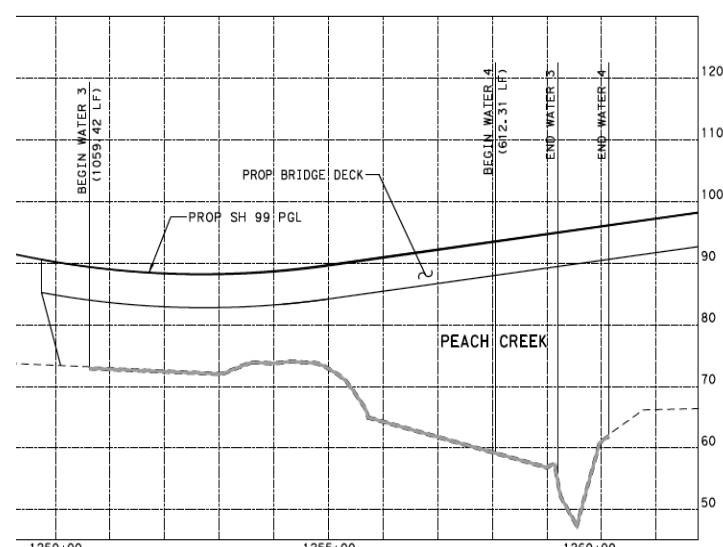
## Water 4 - Peach Creek

Notes: A few areas of active erosion present, likely due to ATV use and small clearing on the east side. Channel appears natural and no riprap observed.

Notes: Riprap present near bridge and just north. No withdrawal observed. Stream appears mostly stable although erosion is present at the bridge.

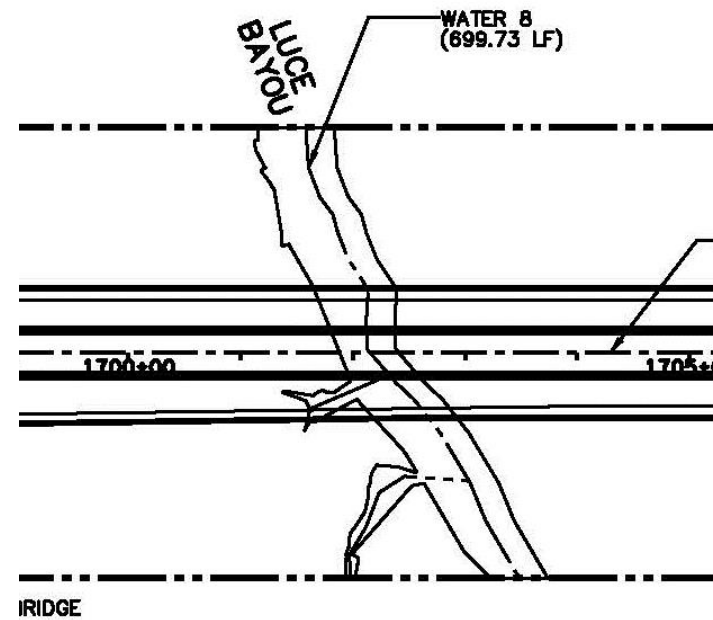
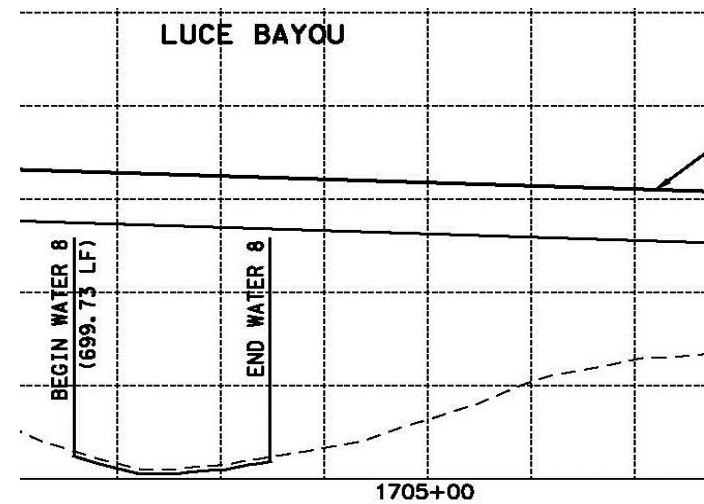
## Water 8 - Luce Bayou

6	East Fork of San Jacinto River	578	4.0	3.3	0.7	2.0	809	Y	Would expect columns in the water to need basket cages around them (fill).
8	Luce Bayou	700	4.5	4.5	0.0	0.0	0	N	Will set the columns above OHW. Should be able to identify a set distance from the column to the stream. There would be basket cages, but they would not be within the water.
10	Cedar Bayou Tributary 1	404	1.8	1.8	0.0	0.0	0	N	This is an incised canal being entirely spanned.
11	Cedar Bayou Tributary 2	404	1.8	1.8	0.0	0.0	0	N	This is an incised canal being entirely spanned.
12	Cedar Bayou	449	2.9	2.9	0.0	0.0	0	N	This is an incised canal being entirely spanned.
13		426	2.0	2.0	0.0	0.0	0	N	This is an incised canal being entirely spanned.
14		137	1.8	1.8	0.0	0.0	0	N	This is an incised canal being entirely spanned.
15		120	1.9	1.0	0.9	2.0	216	N	1,390 linear feet within ROW, 120 linear feet of which will be impacted from culvert placement.

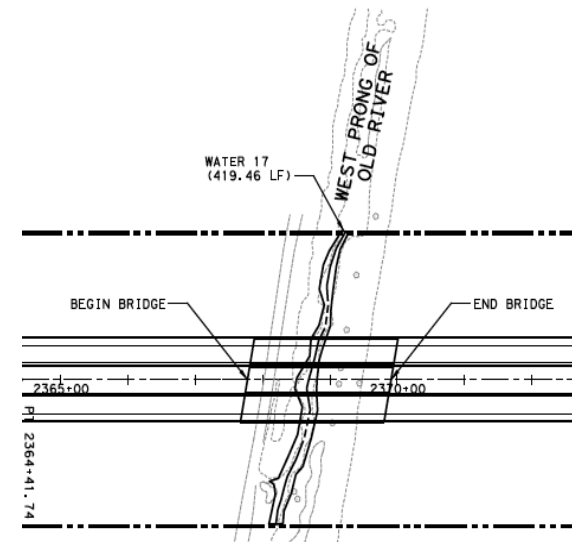
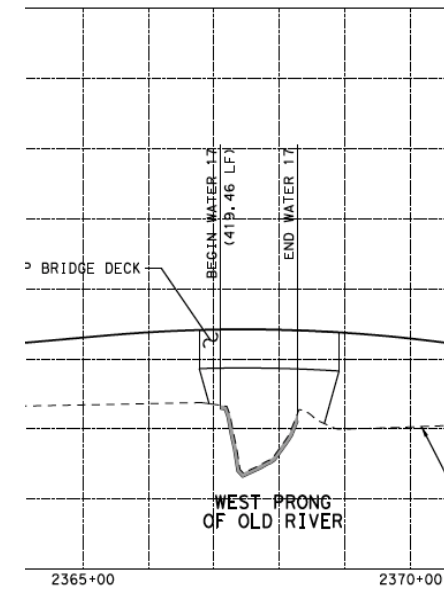
17	West Prong of Old River	419	1.5	1.5	0.0	0.0	0	N	This is an incised canal being entirely spanned.
18		404	3.6	3.6	0.0	0.0	0	N	This is an incised canal being entirely spanned.
