**SABINE PASS TO GALVESTON BAY, TEXAS**  
**MEASURES 6-1.1, 6-1.2, 6-2, 6-3, 6-4.1, 6-4.2, 6-5.1, 6-5.2, 6-5.3, 6-6.1, 6-6.2**  
**INFORMATION SHEET**

**DESCRIPTION OF MEASURES**

**Measure 6-1.1 GIWW Breakwater at Old River Cove, Orange County.**

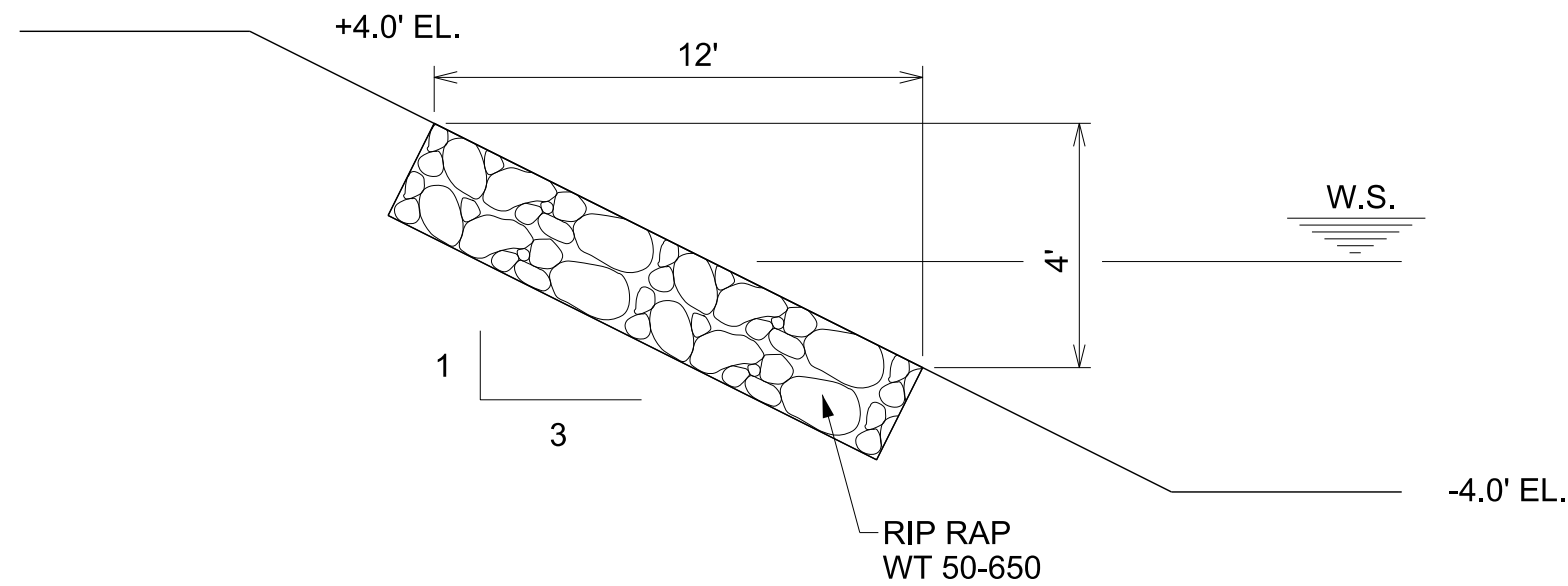
# Typical Section S-14: Levee Armor

- Measures:  
6-5.2  
6-5.3  
6-6.2

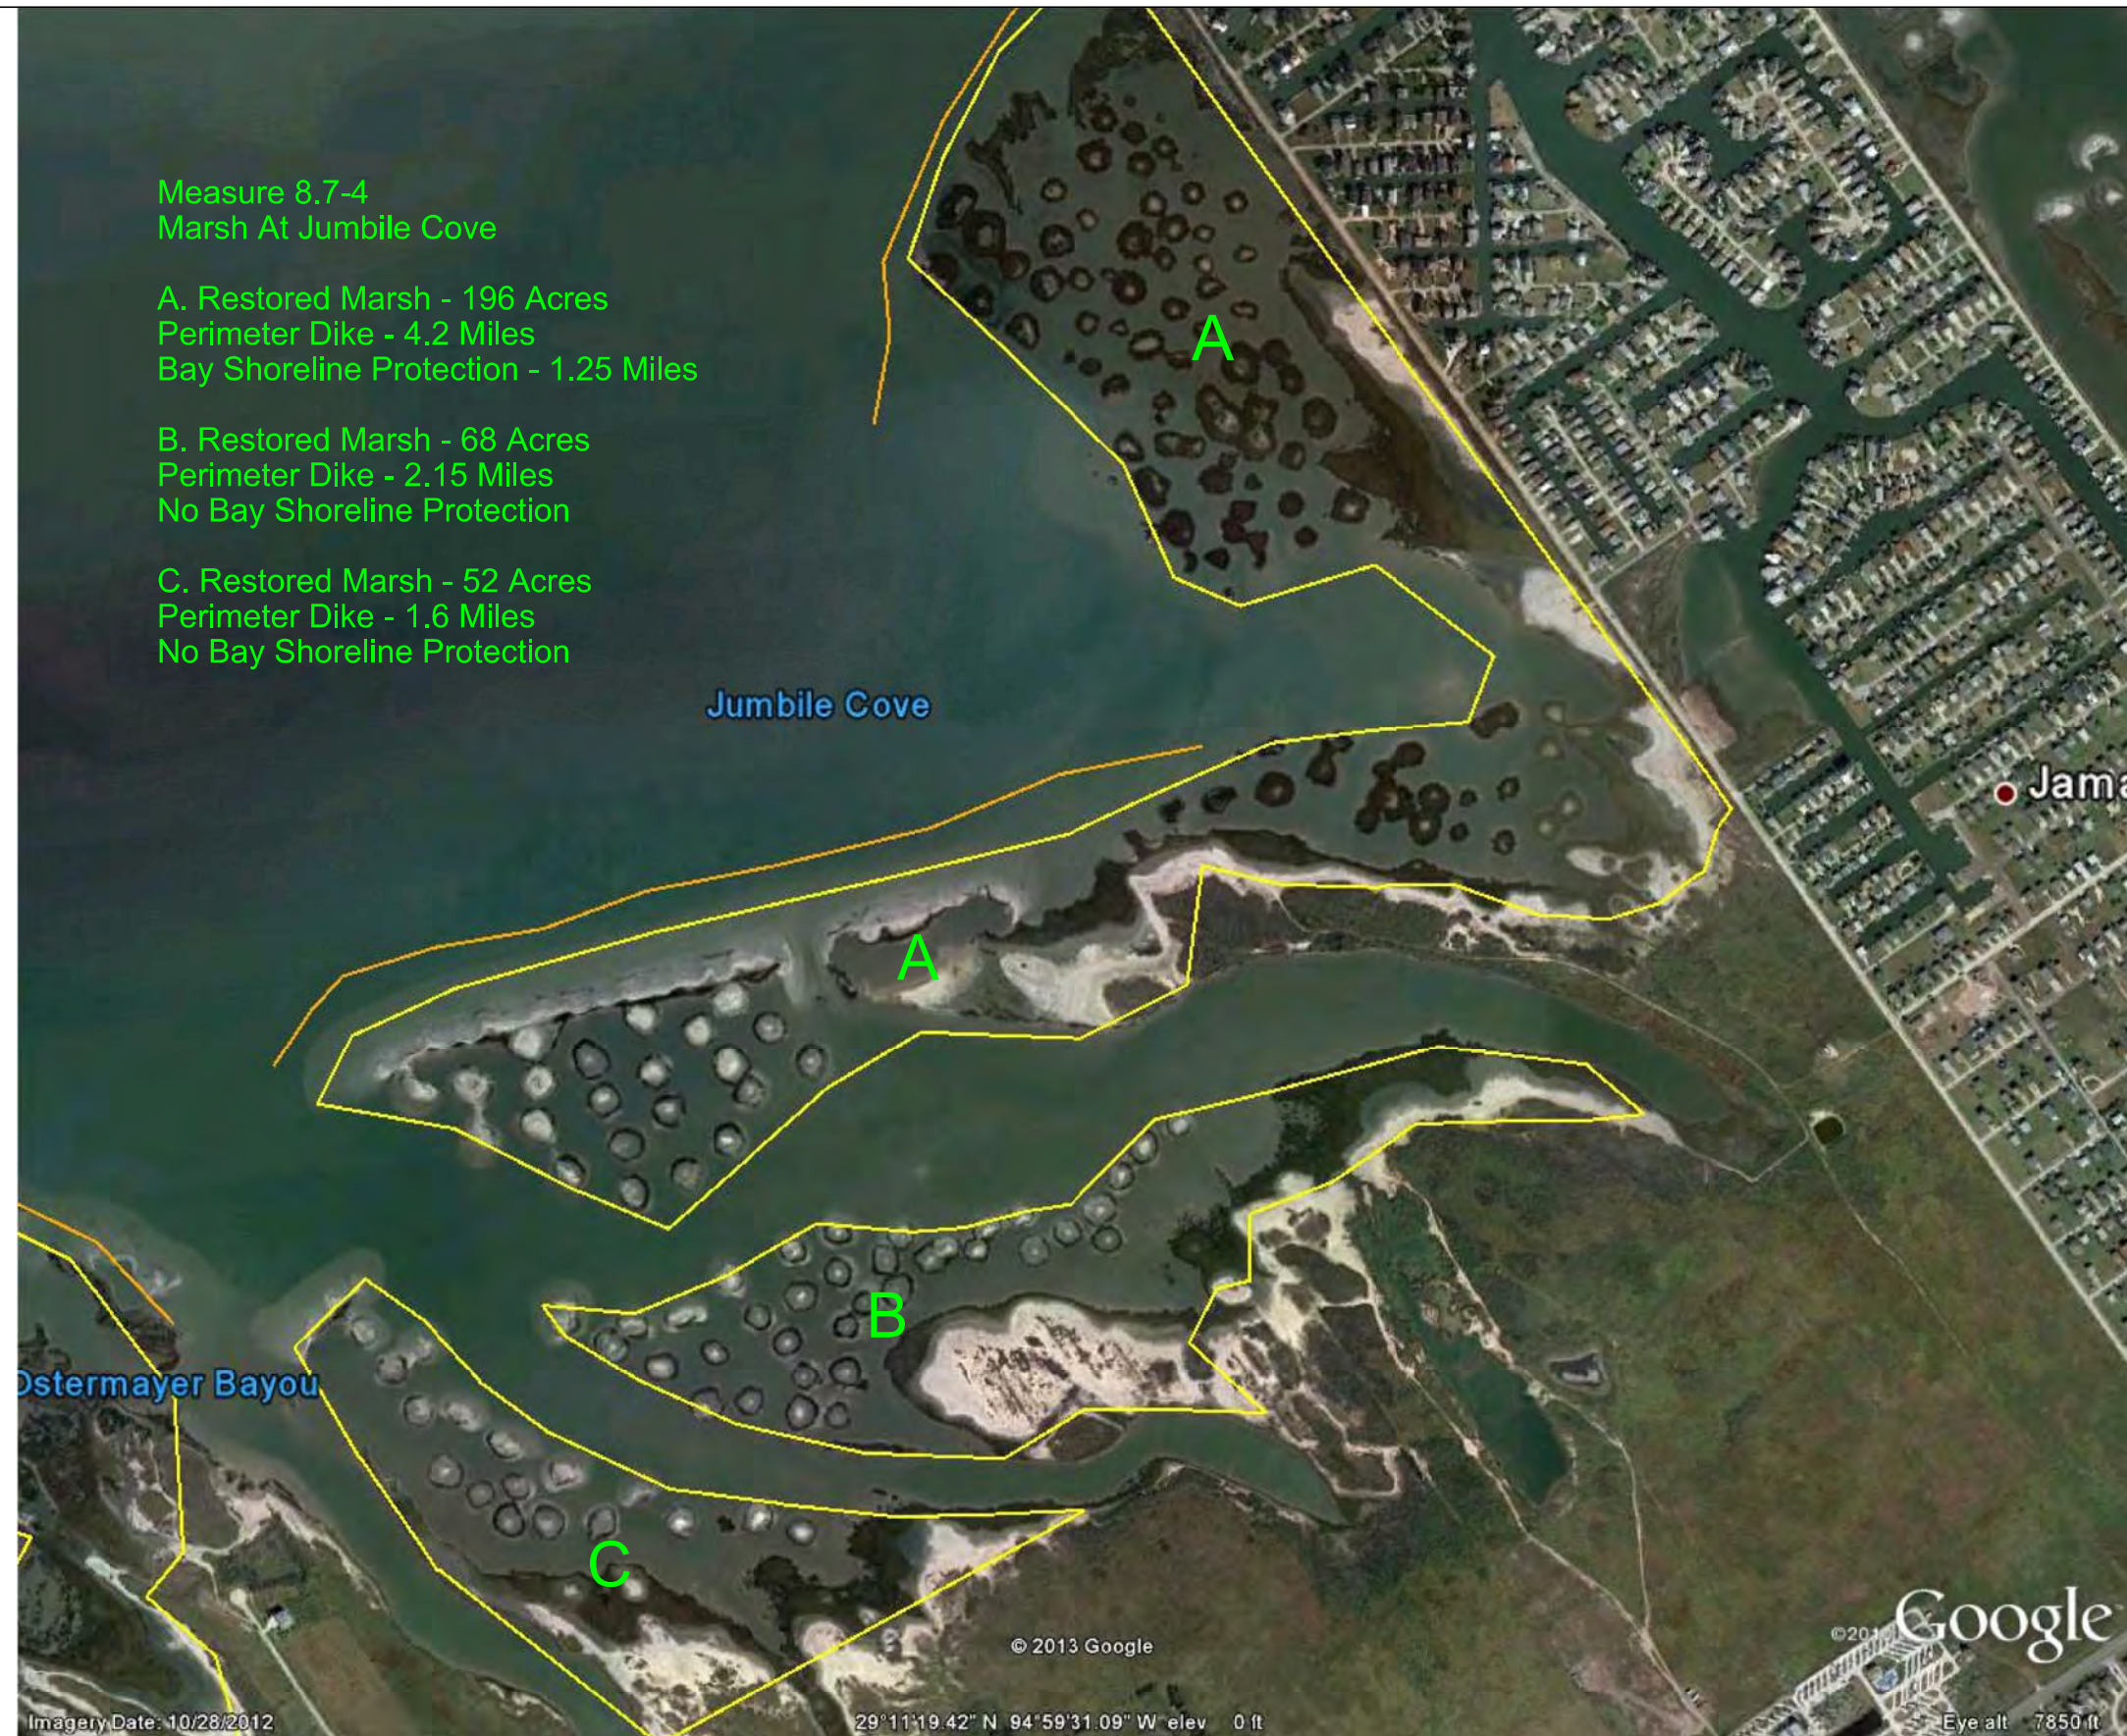
Measure 8-7.4: Marsh Restoration, Jumbile Cove, Galveston County

- Measure 8-7-4  
Marsh At Jumbile Cove
- A. Restored Marsh - 196 Acres  
Perimeter Dike - 4.2 Miles  
Bay Shoreline Protection - 1.25 Miles
  - B. Restored Marsh - 68 Acres  
Perimeter Dike - 2.15 Miles  
No Bay Shoreline Protection
  - C. Restored Marsh - 52 Acres  
Perimeter Dike - 1.6 Miles  
No Bay Shoreline Protection

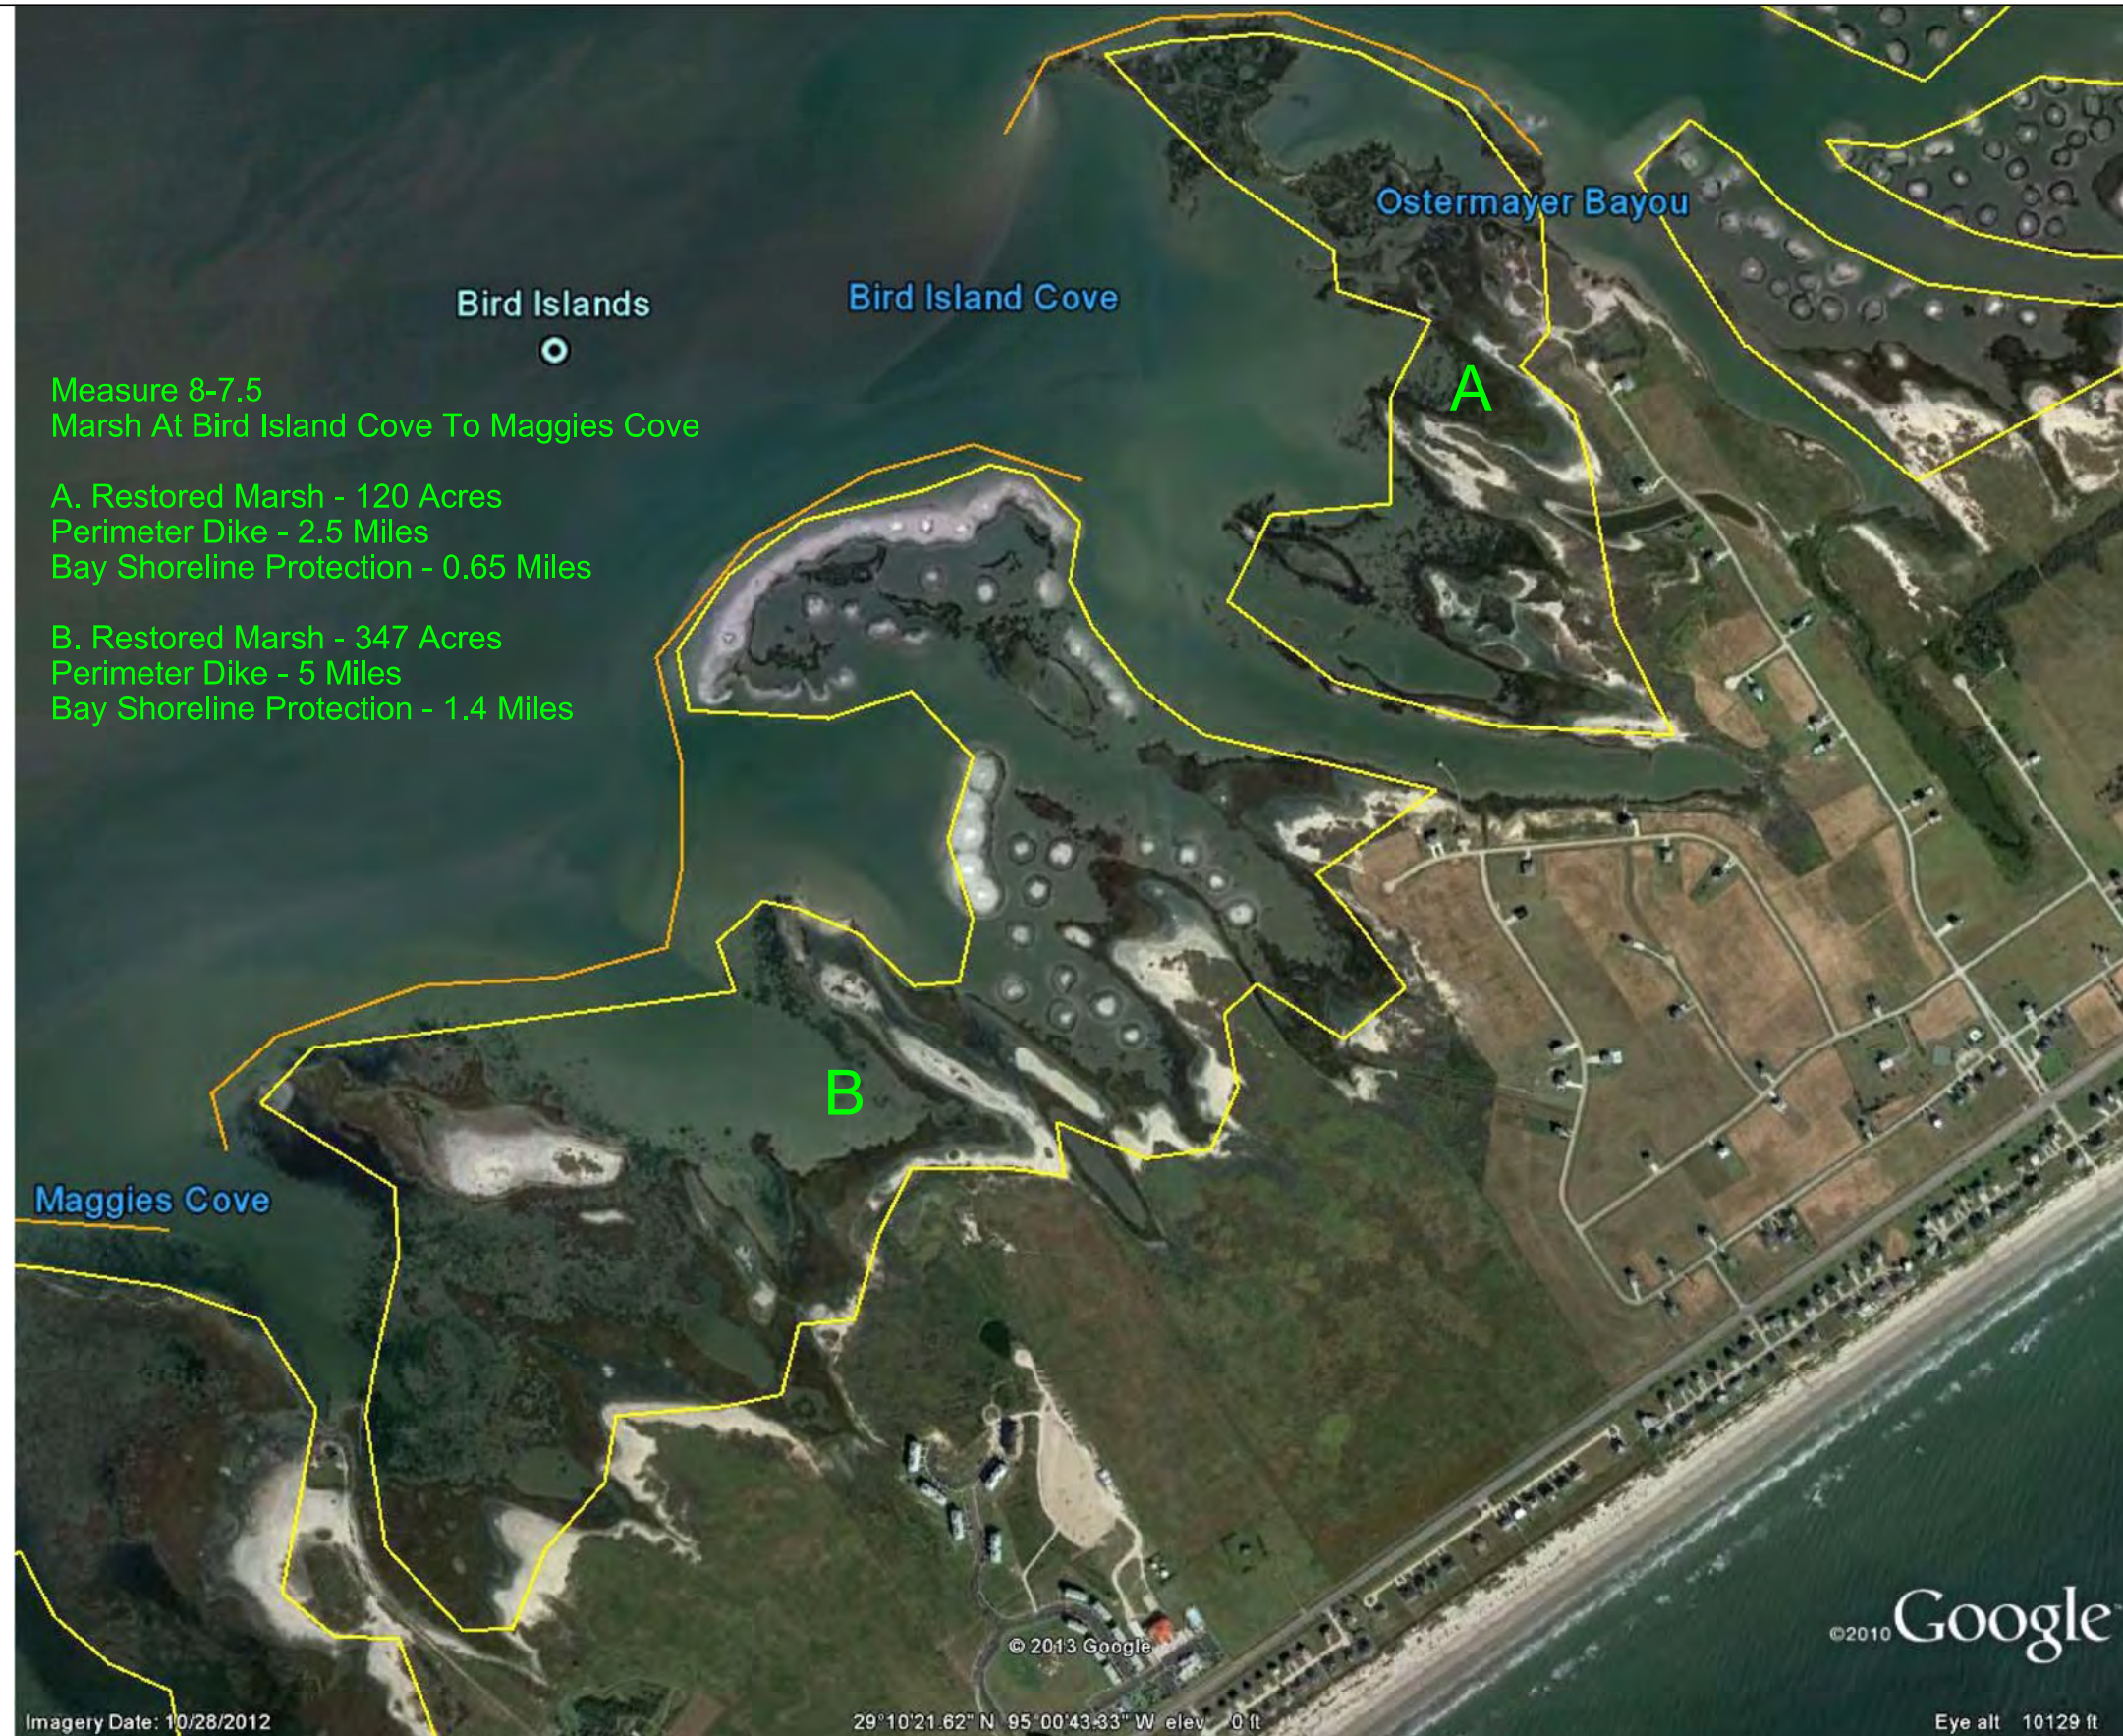
Measure 8-7.5: Marsh Restoration, Bird Island to Maggies Cove, Galveston County

Measure 8-7.5  
Marsh At Bird Island Cove To Maggies Cove

A. Restored Marsh - 120 Acres  
Perimeter Dike - 2.5 Miles  
Bay Shoreline Protection - 0.65 Miles

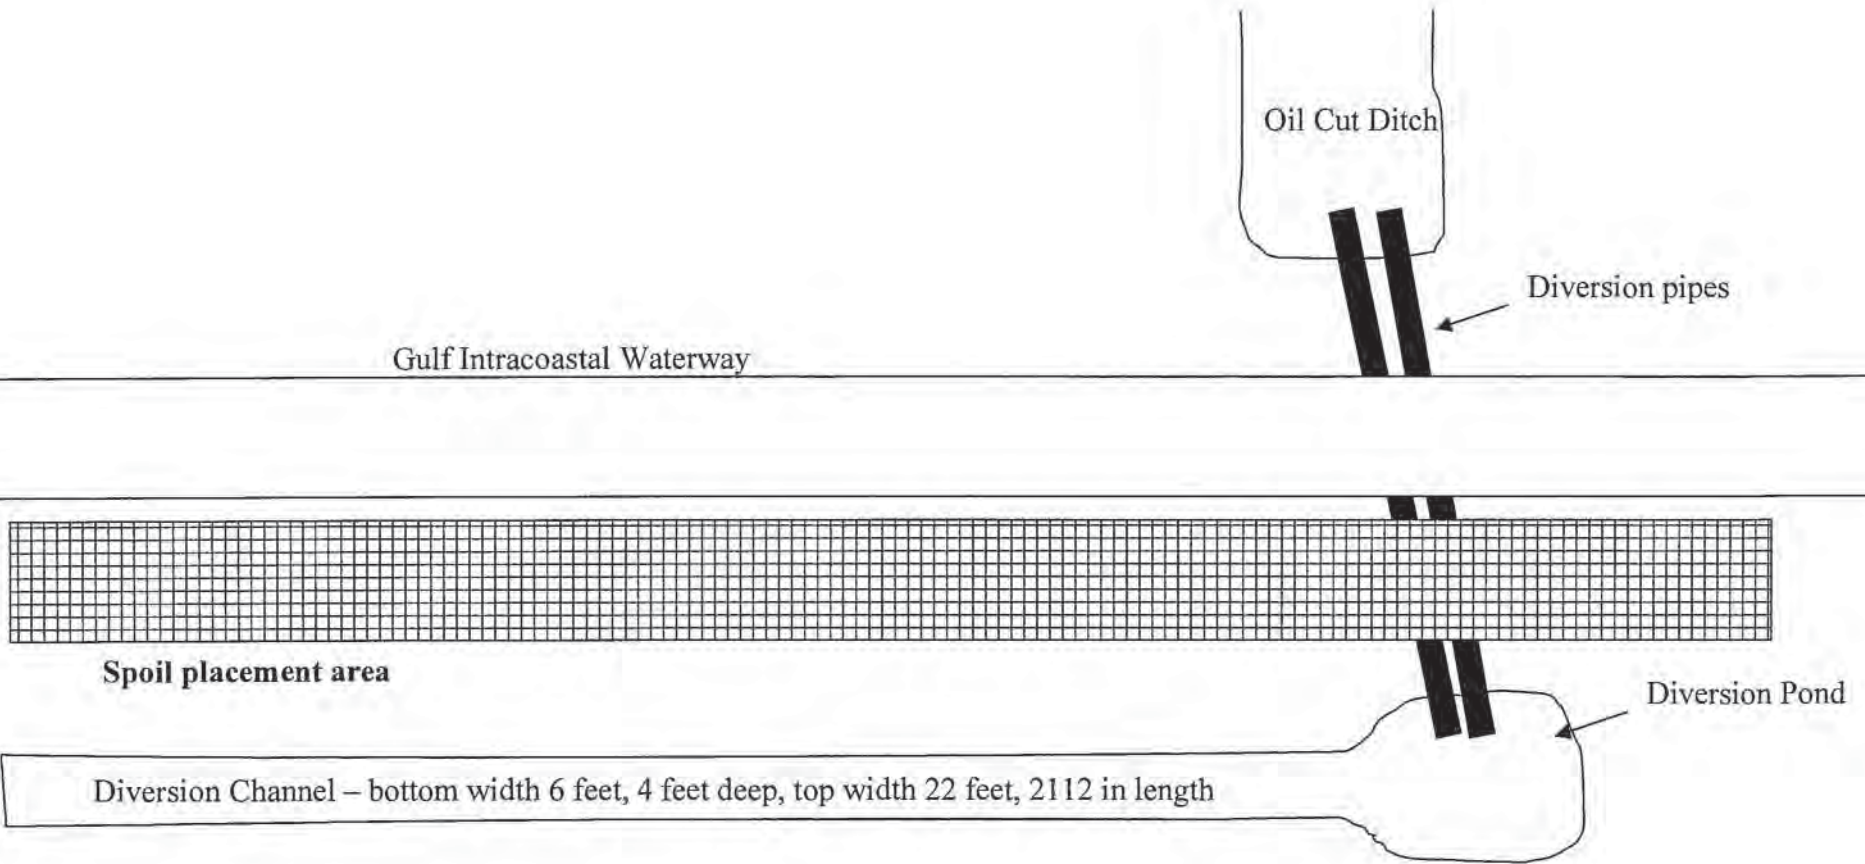
# Aerial View of Siphon and Diversion Channel

Diversion Channel's spoil material will be place on the existing shoreline to increase GIWW elevation to stop salt water intrusion. Diversion channel will create 4646 cubic yards of material from the ditch will be placed on the existing shoreline berm. Pond will be 30 feet diameter with a depth of 8 feet. Spoil material to be placed on GIWW shoreline berm. Pond will create 267 cubic yards of material from the pond site which will be placed on the existing shoreline berm.
