# **Galveston Ring Barrier Overtopping Memorandum**

Coastal Texas Protection and Restoration Study

February 19, 2020

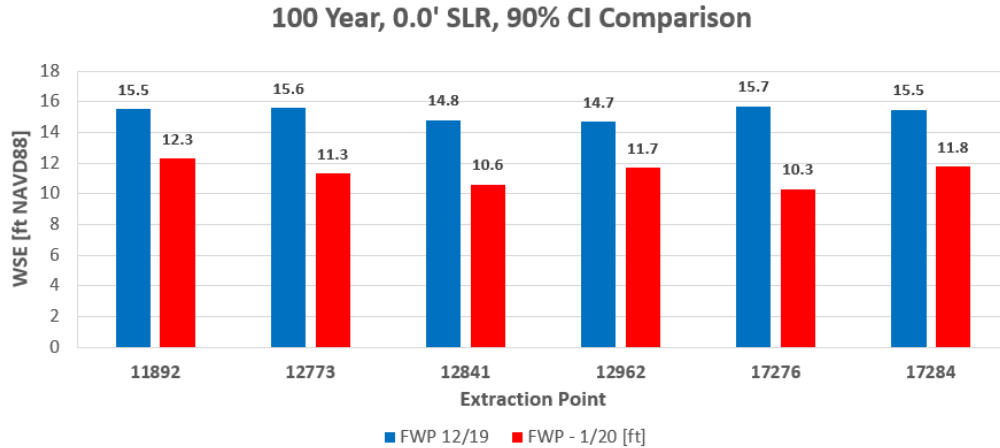
**Figure 2. Comparison of initial and revised 100-year, 0.0' SLR, 90% Confidence Interval results provided by USACE.**

The USACE modeled 170 storms comprising the Joint Probability with Optimal Sampling (JPM-OS) storm suite using a coupled ADCIRC-STWAVE model. The USACE used these storms to develop extremal wave and water surface elevation statistics. These statistics erroneously showed high-water surface elevations along the backside of Galveston Island. To correct for this error, the USACE supplied revised water surface elevations at selected points for use in this analysis. A comparison of the initial results (blue) and revised results (red) is shown in Figure 2.

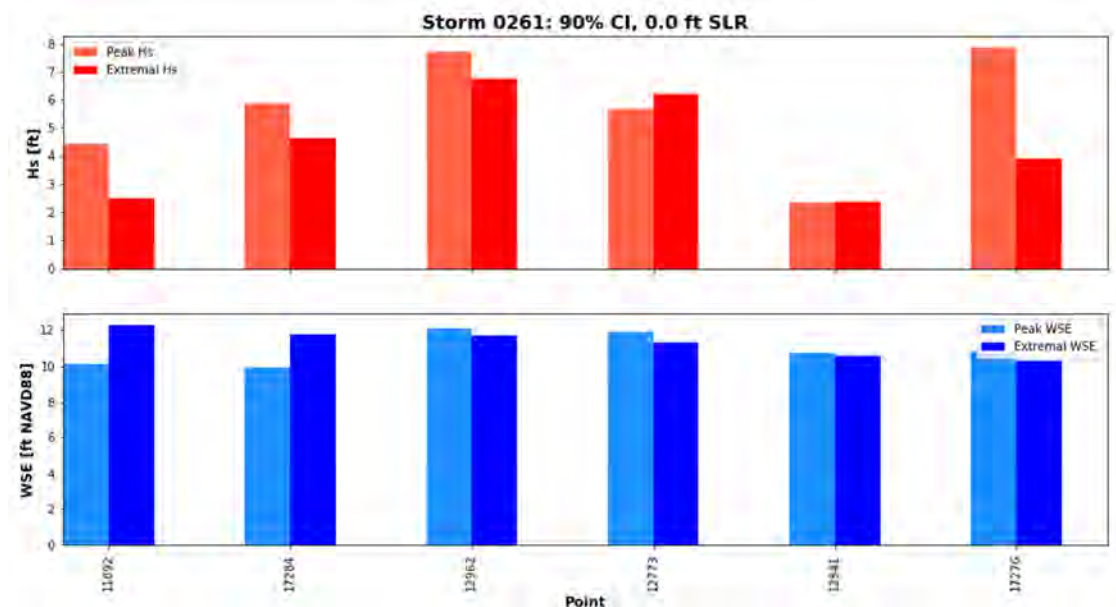
**Figure 3. Comparison of peak wave and water surface elevations to 100-year, 0.0' SLR, 90% CI values.**

As shown in Table 2, Storm 0261 minimized the average absolute error when compared to the extremal values. In addition, the wave heights were close to the 100-year value, however the absolute error is higher than the other 4 storms shown. However, the wave heights are slightly above the 100-year values. Therefore, to maintain a slightly conservative estimate at this stage of planning, Storm 0261 was selected as the representative storm for the 100-year, 0.0' SLR, 90% CI scenario. Figure 3 shows a comparison of the peak values for Storm 0261, and the extremal values at each extraction point.

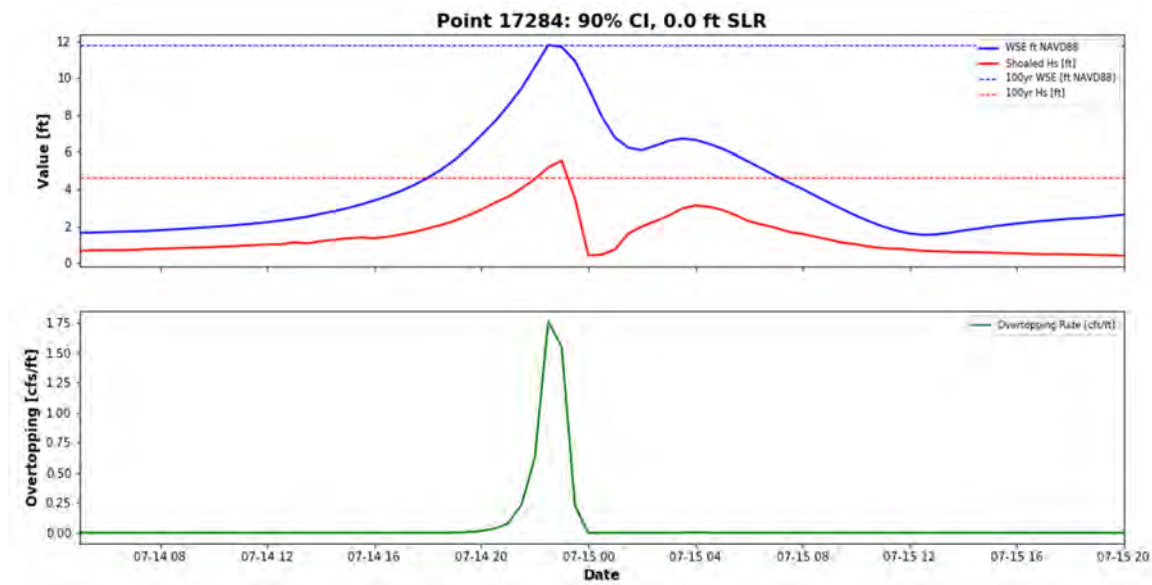
**Figure 4. Timeseries of water surface elevation and wave heights (top) compared to overtopping rates (bottom).**

As described in the previous section, Storm 0261 was selected as the representative storm, and the wave and water surface elevation timeseries were developed for all extraction points. Then the overtopping rates were calculated using the shoaled wave heights, and the scaled water surface elevations. Vertical wall overtopping equations from the Eurotop, 2018 manual were used to calculate an overtopping timeseries along the proposed ring barrier improvements for the selected storm. A timeseries showing the scaled water surface elevation and wave heights at point 17824 is shown below in Figure 4. Note that point 17824 was adjacent to the proposed gate structure, so no shoaling or transformation was conducted.

Overtopping timeseries similar to Figure 4 were produced at all extraction points, and applied to the hydrologic model as described in Section 3. A summary of the peak overtopping rates for the design condition agreed upon with the USACE (100-year, 90% CI, 0.0' SLR) are shown below in Table 3.

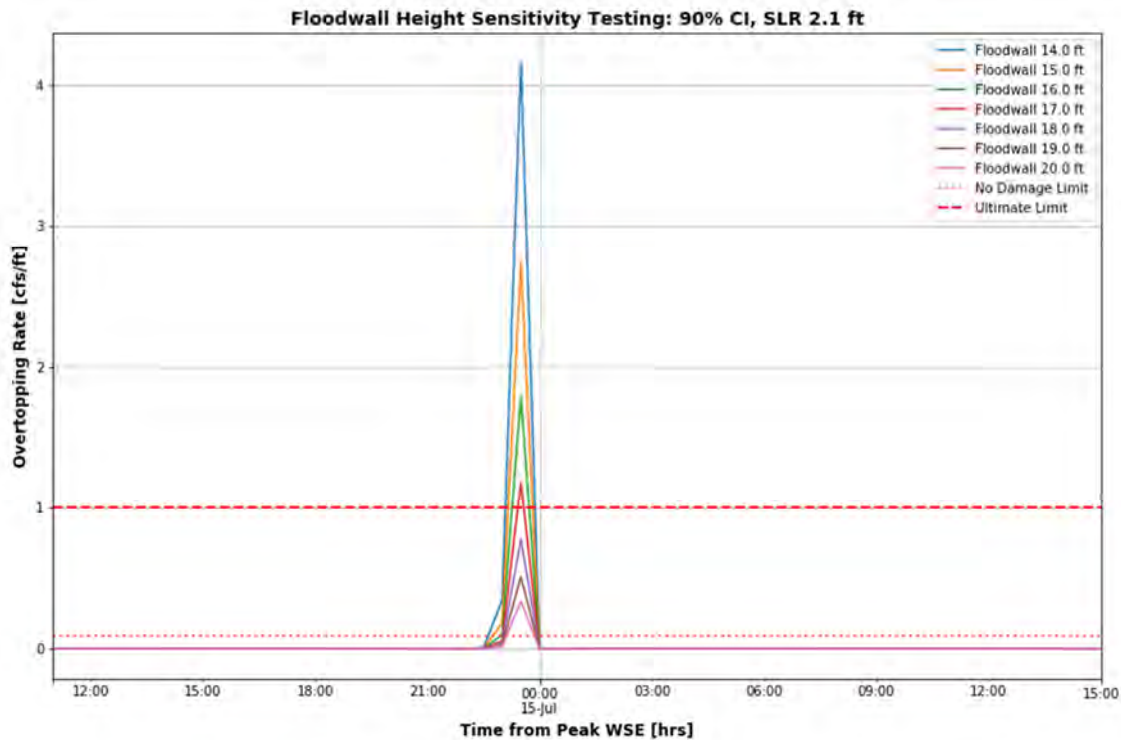
**Figure 5. Floodwall height sensitivity testing for 100-year, 90% CI, 2.1' SLR scenario.**

Table 4 shows that the with SLR condition causes large increases in peak overtopping rates. For the 90%, with SLR scenario, most extraction points show peak rates above the ‘ultimate limit’, with the highest value of 4.17 cfs/ft at extraction point 12962. To mitigate these large overtopping rates in the future, it is recommended that the floodwall elevation be raised in the future to combat SLR and mitigate any future increases in overtopping. Figure 5 shows

sensitivity testing for different floodwall heights, comparing the peak overtopping rate for the 100-year, 90%CI, 2.1' SLR scenario to the 'ultimate' and 'no damage' limits.

As shown in Figure 5, in order to reduce the peak overtopping rate below the ultimate limit for the 100-year, 90% CI, 2.1' SLR scenario, the floodwall would need to be raised to +18.0' NAVD88. Note that the with SLR scenario included a linear addition of SLR to the extremal WSE. In addition, the wave shoaling accounted for the increase in WSE due to SLR, however the data at the offshore extraction point was unaltered from the without SLR scenario due to lack of sufficient extremal data for the with SLR condition. Therefore, it is highly recommended that in future phases of the study, overtopping requirements for the with SLR condition be investigated further. The results and recommendations for the with SLR condition shown in this Section are for study planning only, and further analysis is required in future phases of the study.

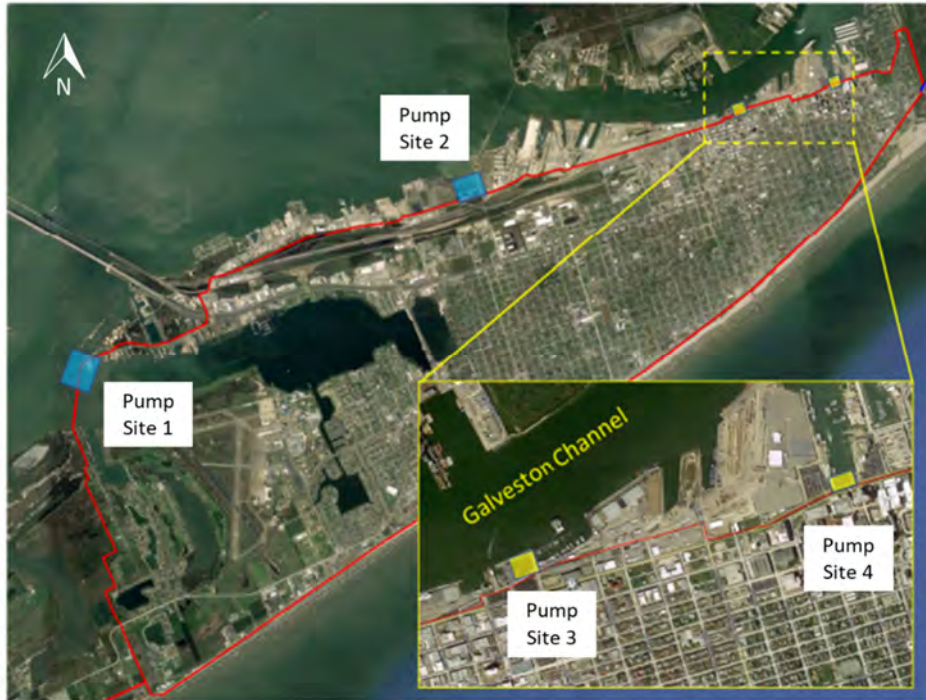
Figure 6. Overview of original pump site locations at Galveston.

An aerial showing the general location of these pump sites is provided in Figure 6. Detailed figures showing the proposed pump site and conduit layout locations from the original analysis are provided in Figure 7 through Figure 10.

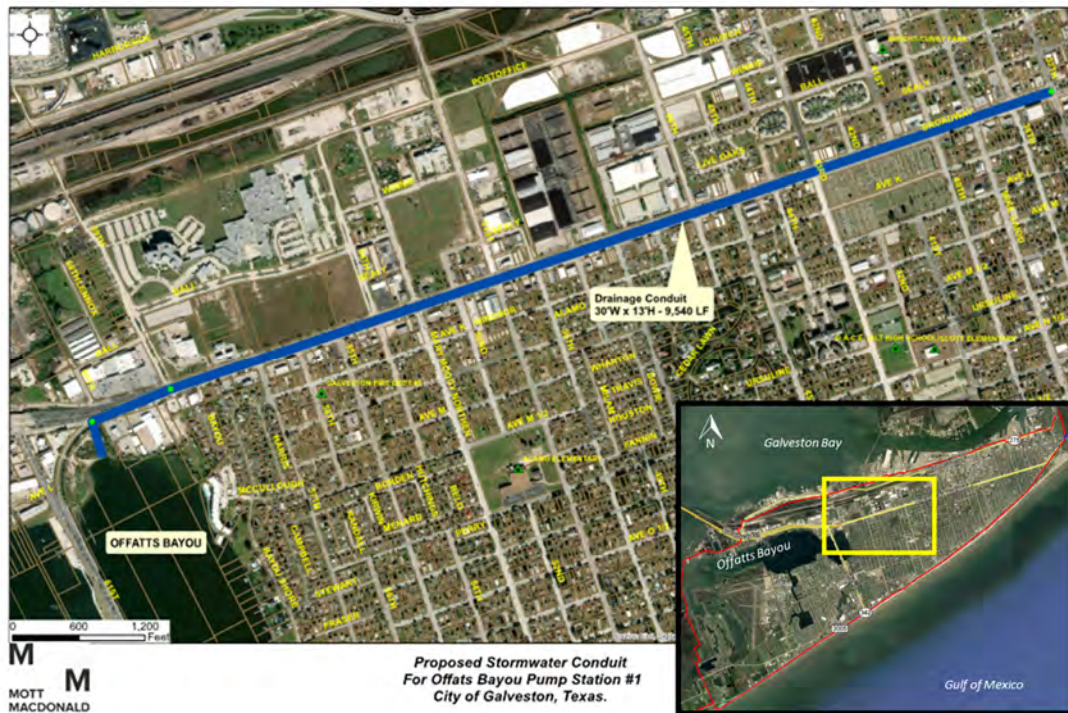
Figure 7. Original proposed stormwater conduit location and size into Offatts Bayou for Pump Site 1.

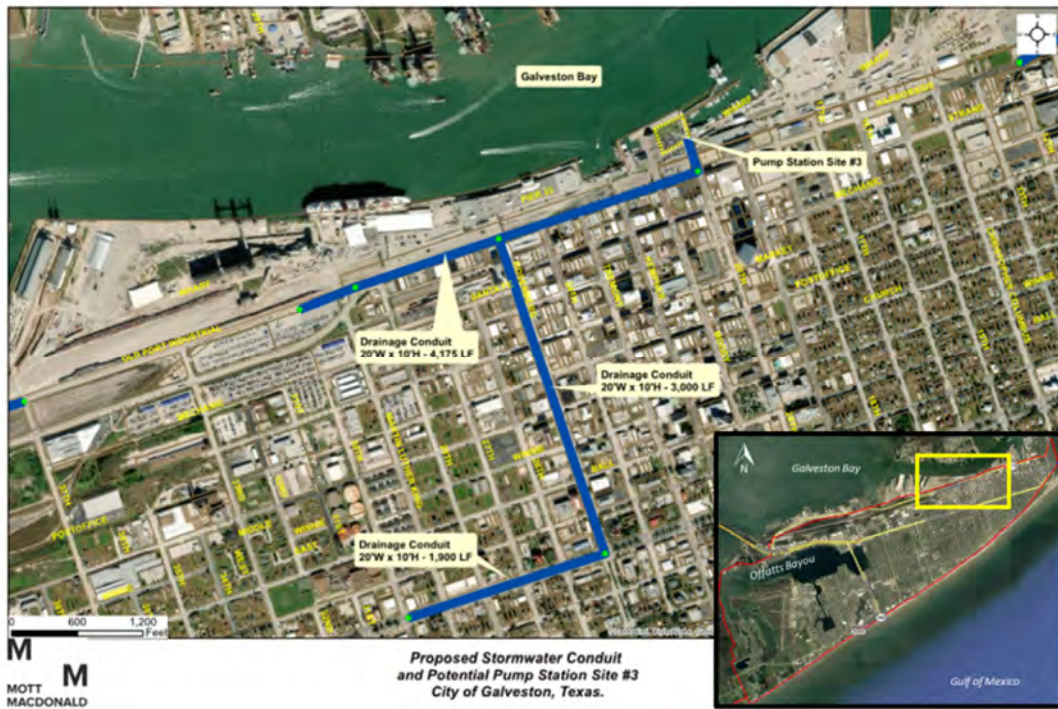
Figure 9. Original proposed stormwater conduit into Pump Site 3.

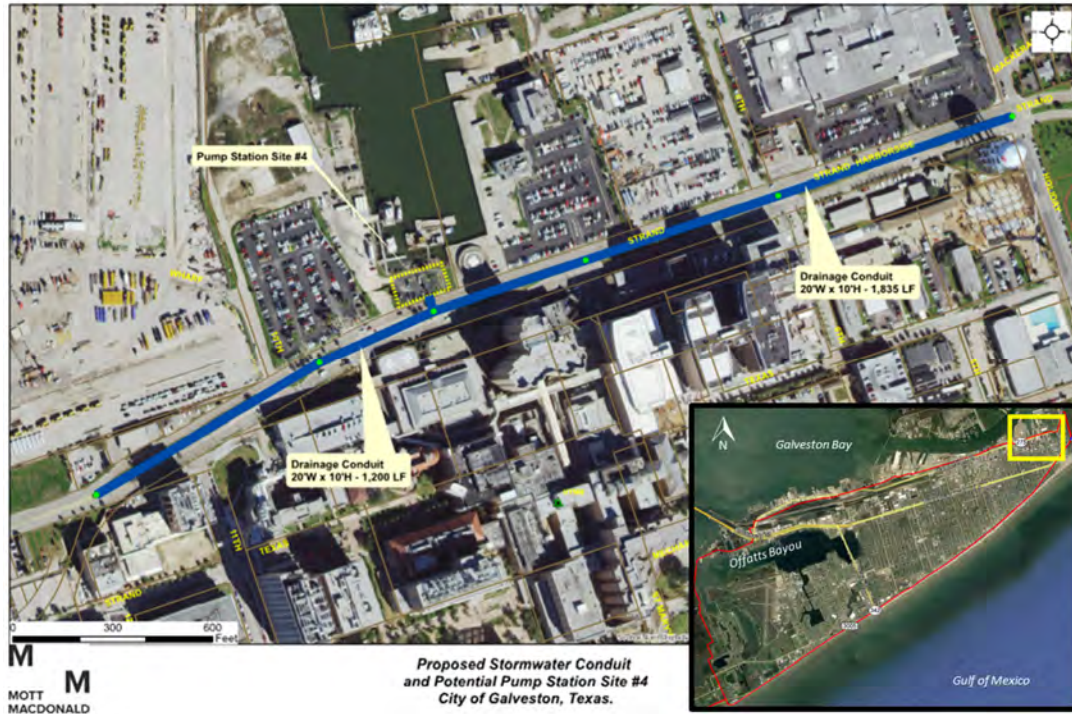
**Figure 10. Original proposed stormwater conduit into Pump Site 4.**

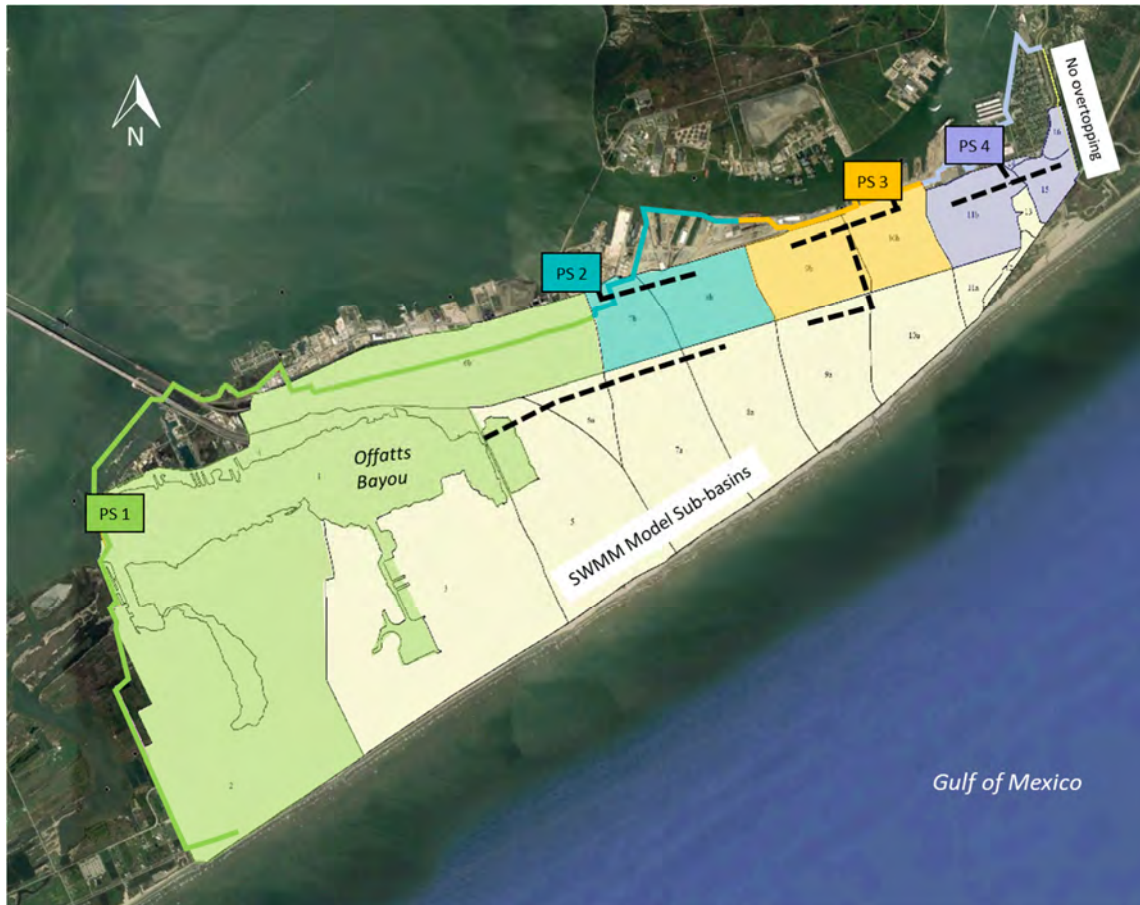
Figure 12. Schematic of the SWMM model sub-basins with the revised alignment. The sections of alignment, sub-basins, and Pump Sites (PS) are color coordinated to show where overtopping contributes to each pump site. No overtopping was observed along the northeastern section of alignment. Note that pump sites and conduit channels (dashed lines) are for visual representations only and do not accurately portray the proposed physical locations of the facilities.

- Overtopping rates were applied to the pump site and conduit systems using the overtopping rate (cfs/ft) multiplied by the section length (ft) of the new alignment that is located adjacent to each existing sub-basin. This results in a new inflow timeseries of volumetric overtopping (cfs) per pump site system. A list the sub-basins and the associated pump systems which they flow into is provided below, and a sketch showing the sub-basins and the associated sections of floodwall is provided in Figure 12.

- The revised alignment causes an increase in surface area within several areas the watershed. This can be seen in Figure 12, where the revised alignment extends outside the model domain footprint. This analysis does not account for the additional rainfall runoff over the new areas created by the new alignment. Thus, it is possible that the additional rainfall runoff would require another increase in pump site facilities and conduit sizes. Furthermore, the location of the conduit channels may need to be modified or extended in order to properly collect surface runoff from the additional areas within the floodwall alignment.

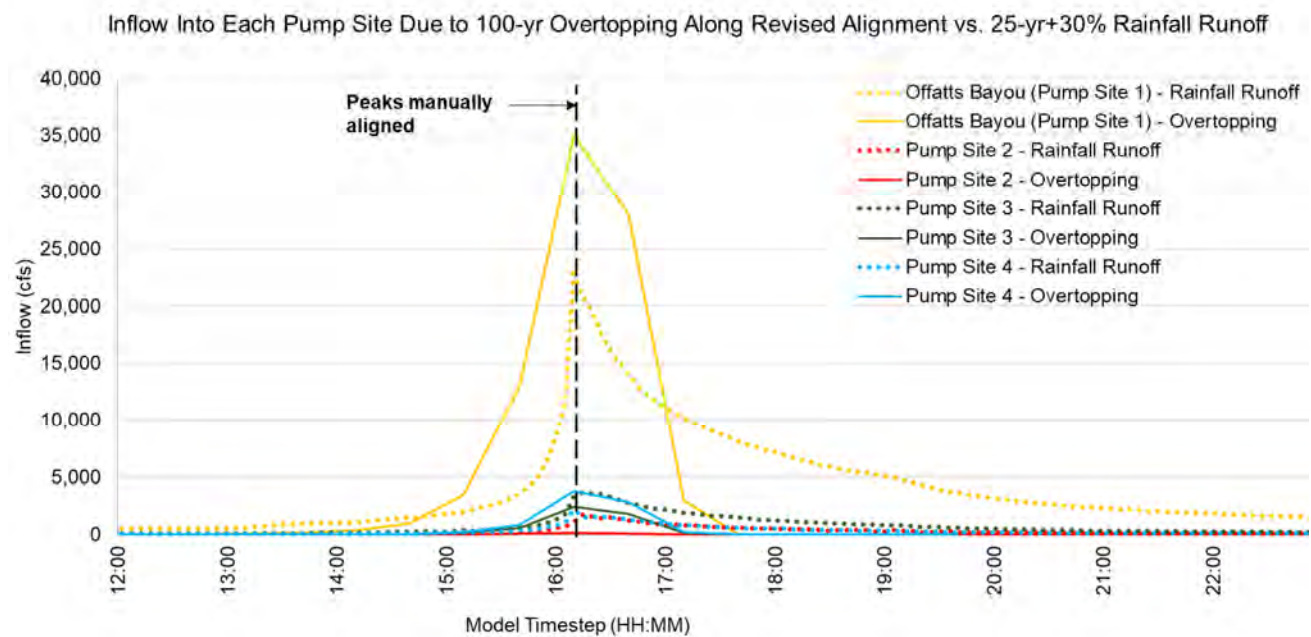
**Figure 13. Comparison of input timeseries for the overtopping and rainfall runoff inflows per pump site.**

The timeseries of inflow from rainfall runoff compared to overtopping per pump site is displayed in Figure 13. In this plot, the rainfall runoff inflows are represented by the dotted lines, and the overtopping inflows are represented by the solid lines. The x-axis, which represents model timestep was trimmed for ease of visibility; the full input timeseries extends a 24-hr period. The following observations are made from this plot:

- For Pump Site 1, inflow quantities from overtopping is significantly greater than inflow quantities from rainfall runoff over multiple timesteps. The large overtopping volume is due to the large wave conditions present at these sections of floodwall.

- For Pump Site 3, the overtopping inflow quantities do not appear to substantially surpass the rainfall runoff inflows. However, it will still cause an increase in total inflow volume, and thus it is expected that facilities at this pump site will likely need to be increased.

- For Pump Site 4, the overtopping inflows are approximately twice that of rainfall runoff inflow over multiple timesteps. This indicates that the facility sizes for Pump Site 4 will likely need to be increased in order to accommodate the additional volume.

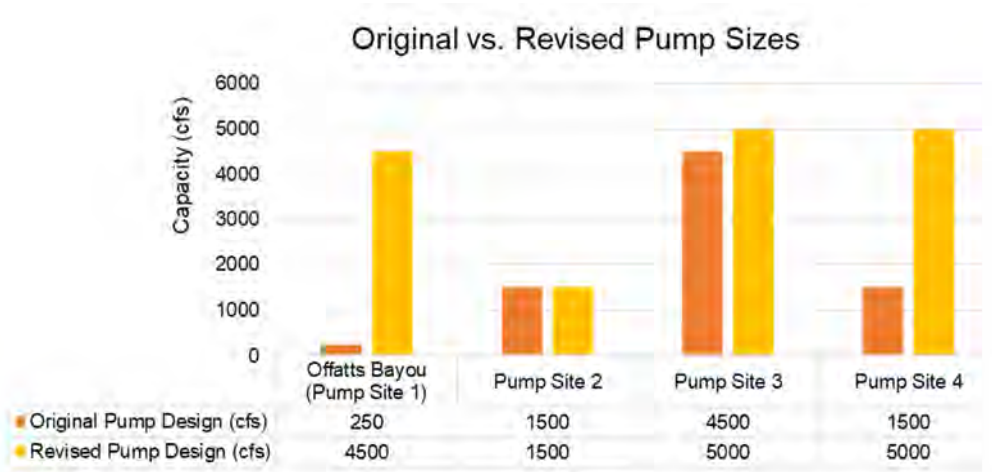
**Figure 14. Comparison of original (orange) and revised (yellow) designed pump size capacities.**

A comparison of these revised facility sizes to those of the original analysis are provided in the following figures, where Figure 14 compares pump size capacity, Figure 15 compares cross section area of the conduit channels, and Figure 16 compares the resulting maximum water surface elevation in Offatts Bayou experienced over the duration of the simulated storm.

Figure 14 shows that Pump Sites 1 and 4 require the greatest increase to pump capacities, Pump Site 3 requires a relatively minor increase to pump capacity, and Pump Site 2 requires no change to pump capacity. For conduit channel cross section sizes (Figure 15), the channels for Pump Sites 1, 3 and 4 increased; the channel size for Pump Site 2 did not change. See Appendix B for detailed plan-view layouts of the revised conduit channels.

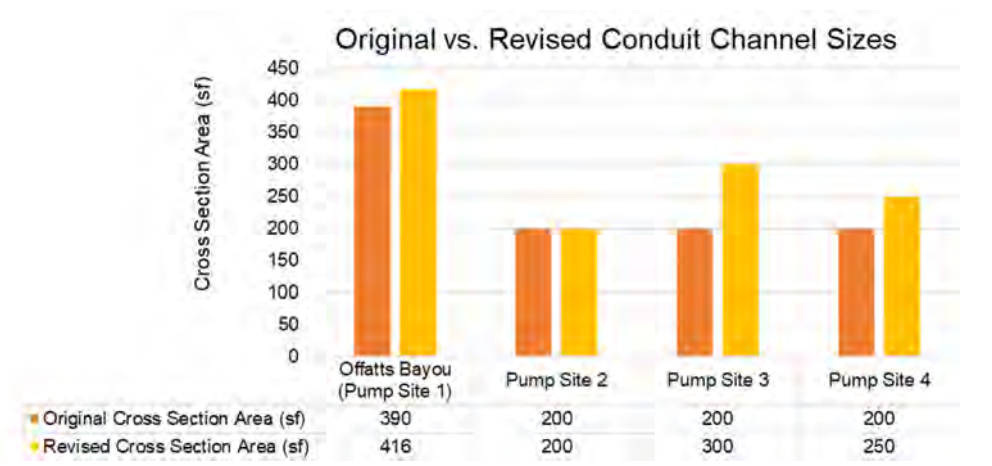
**Figure 15. Comparison of original (orange) and revised (yellow) designed conduit channel cross section areas.**

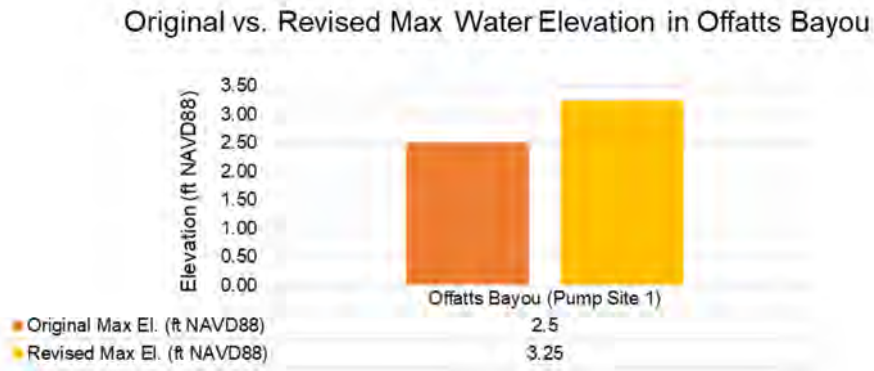
**Figure 16. Comparison of original (orange) and revised (yellow) maximum water surface elevations in Offatts Bayou over the simulated storm duration.**

Lastly, the resulting maximum water surface elevation in Offatts Bayou (Figure 16) that was experienced over the duration of the simulated storm increased from 2.5 ft NAVD88 (per the original Pump Site 1 system design) to 3.25 ft NAVD88 (per the revised Pump Site 1 system design). Considering the maximum allowable water surface elevation of 4.0 ft NAVD88 as stated in the performance criteria, this indicates that the resulting freeboard (the vertical clearance between the water surface and the maximum allowable elevation) decreased from 1.5 ft (per the original Pump Site 1 system design) to 0.75 ft (per the revised Pump Site 1 system design).

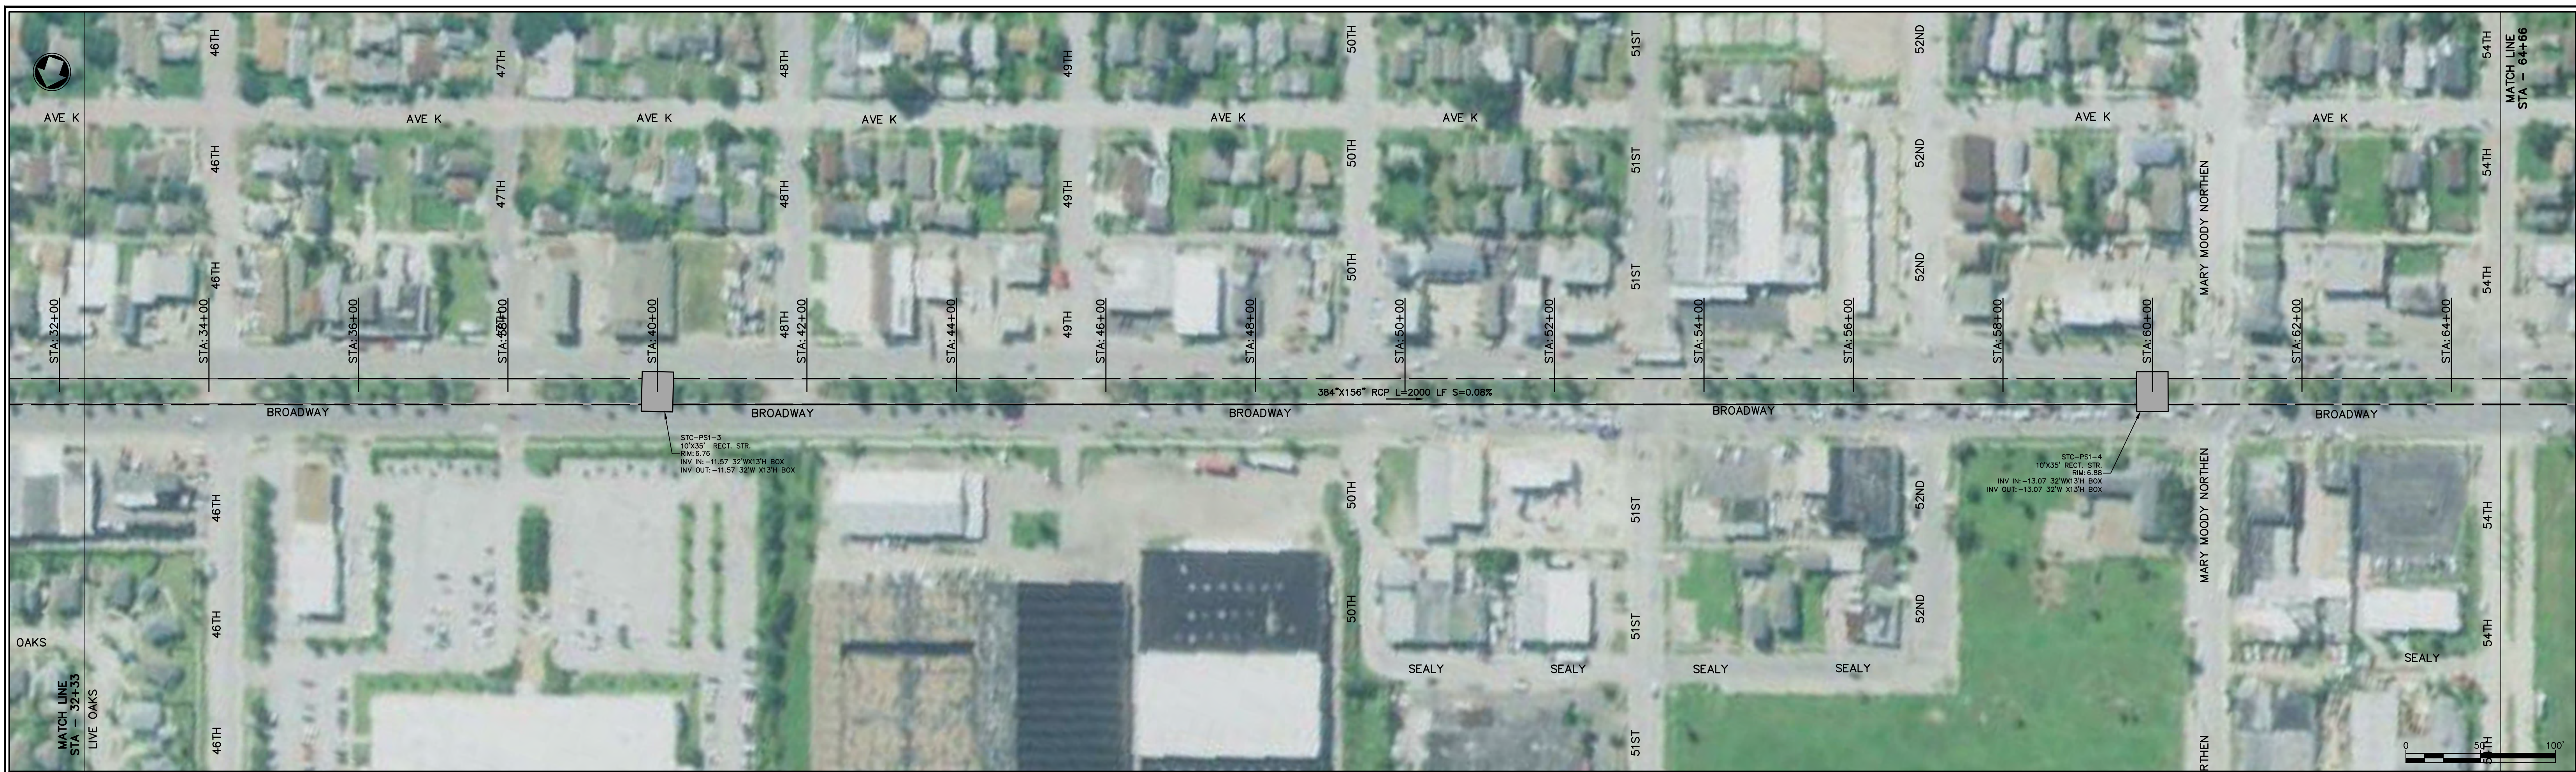
Title  
**TEXAS COASTAL PROTECTION AND RESTORATION PROJECT  
INTERIOR DRAINAGE AND HYDROLOGY  
COLLECTION SYSTEM FOR PUMP STATION#1  
SHEET 2 OF 3**

PLAN VIEW  
SCALE 1"=100'

Pump Station #1 Collection Conduits  
STA 32+33 TO 64+66

PROFILE VIEW  
H. SCALE 1"=100'  
V. SCALE 1"=10'

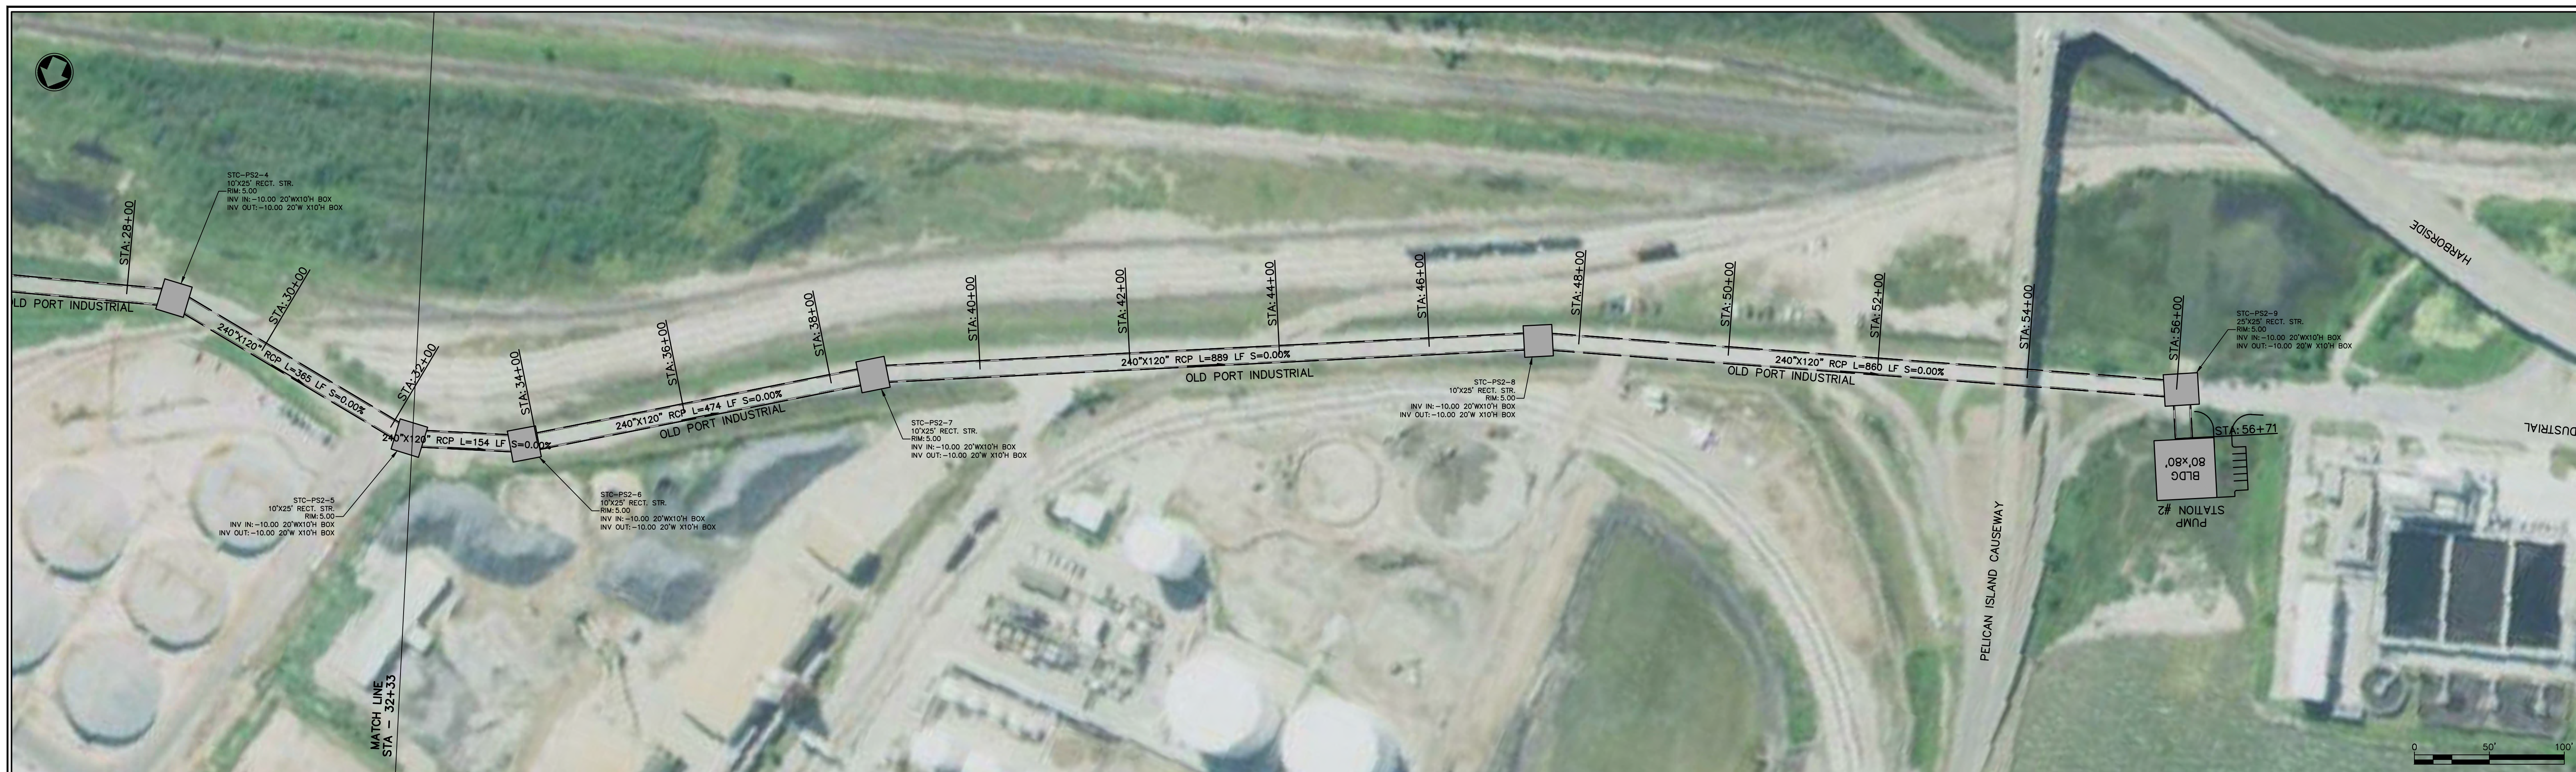
TEXAS COASTAL PROTECTION AND RESTORATION PROJECT  
INTERIOR DRAINAGE AND HYDROLOGY  
COLLECTION SYSTEM FOR PUMP STATION#2  
SHEET 2 OF 2

PLAN VIEW  
SCALE 1"=100'

Pump Station #2 Collection Conduits  
STA 32+33 TO 56+71

PROFILE VIEW  
H. SCALE 1"=100'  
V. SCALE 1"=10'

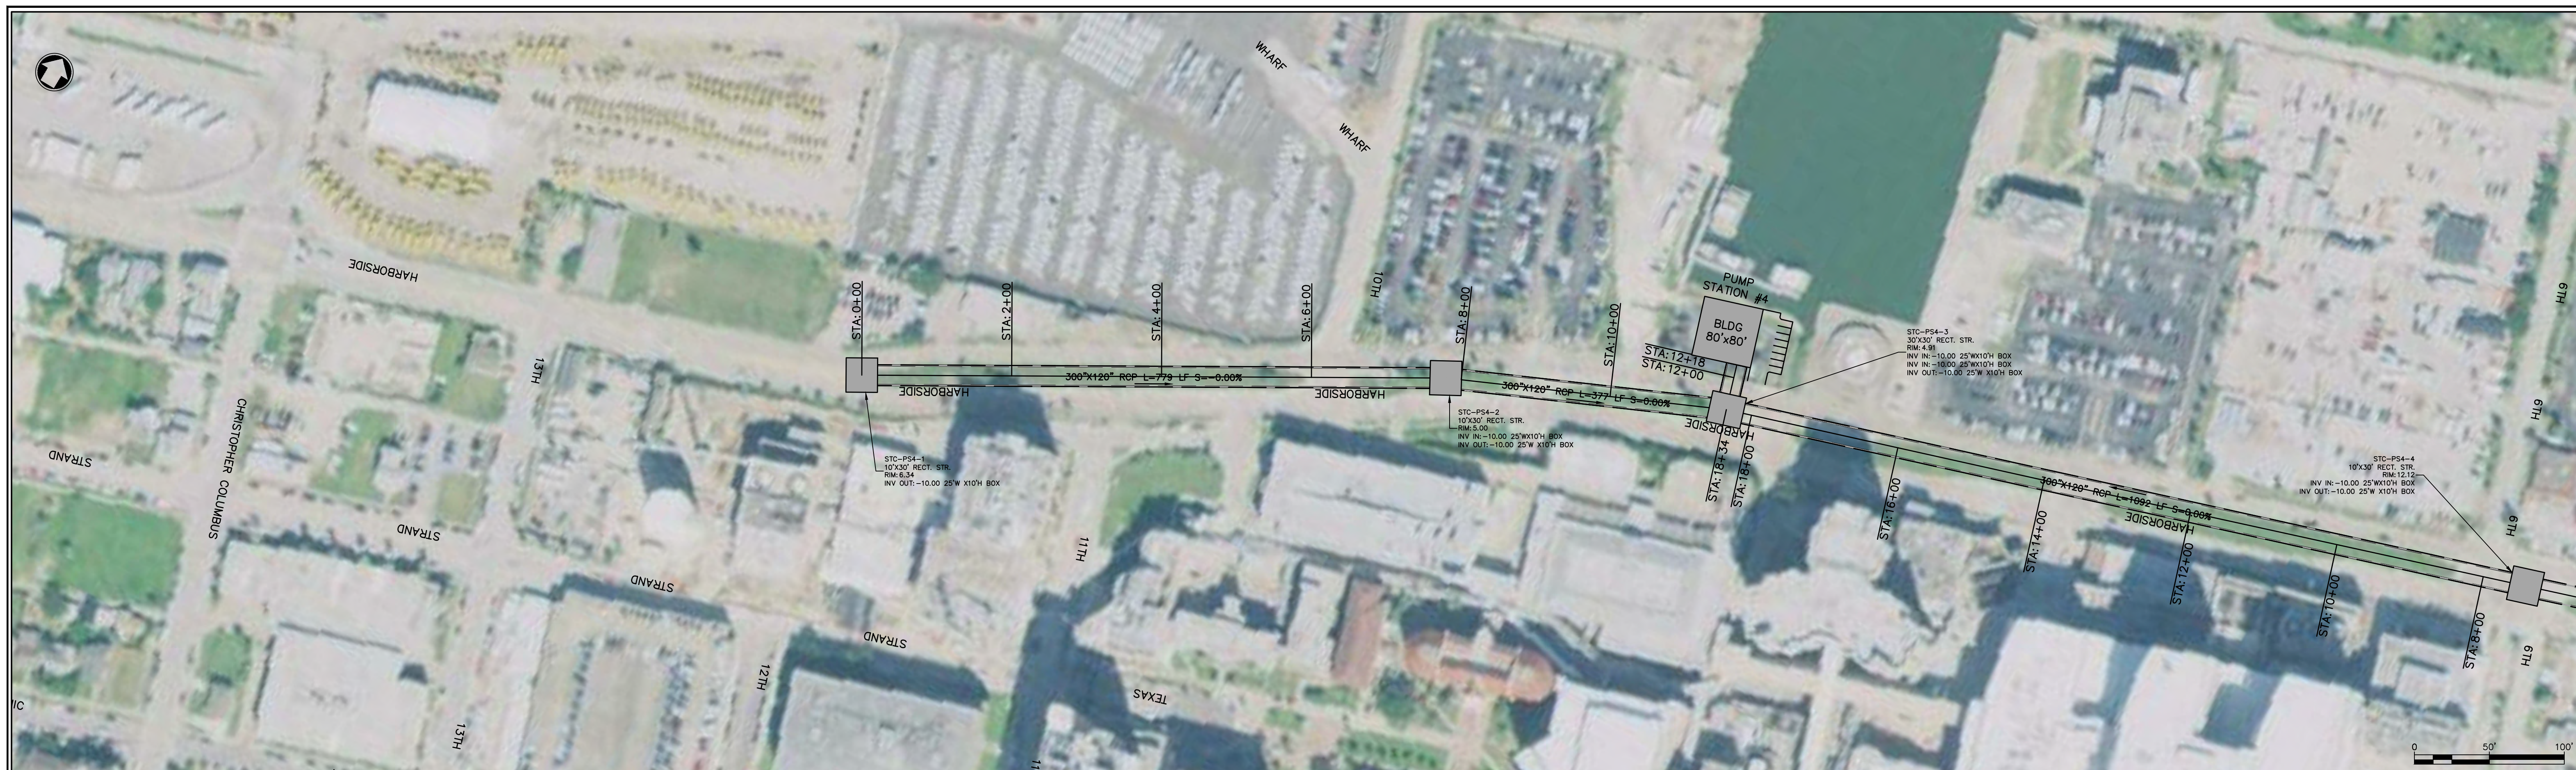
PLAN VIEW  
SCALE 1"=100'

Pump Station #4 Collection Conduits East Side  
STA 0+00 TO 12+04  
PROFILE VIEW  
H. SCALE 1"=100'  
V. SCALE 1"=10'
