SABINE PASS TO GALVESTON BAY, TEXAS
MEASURE 5-10
INFORMATION SHEET

DESCRIPTION OF MEASURE: 5-10 Closing of Rollover Pass, Galveston County

Sabine Pass to Galveston Bay Texas, Coastal Storm Risk Management and Ecosystem Restoration Feasibility Study

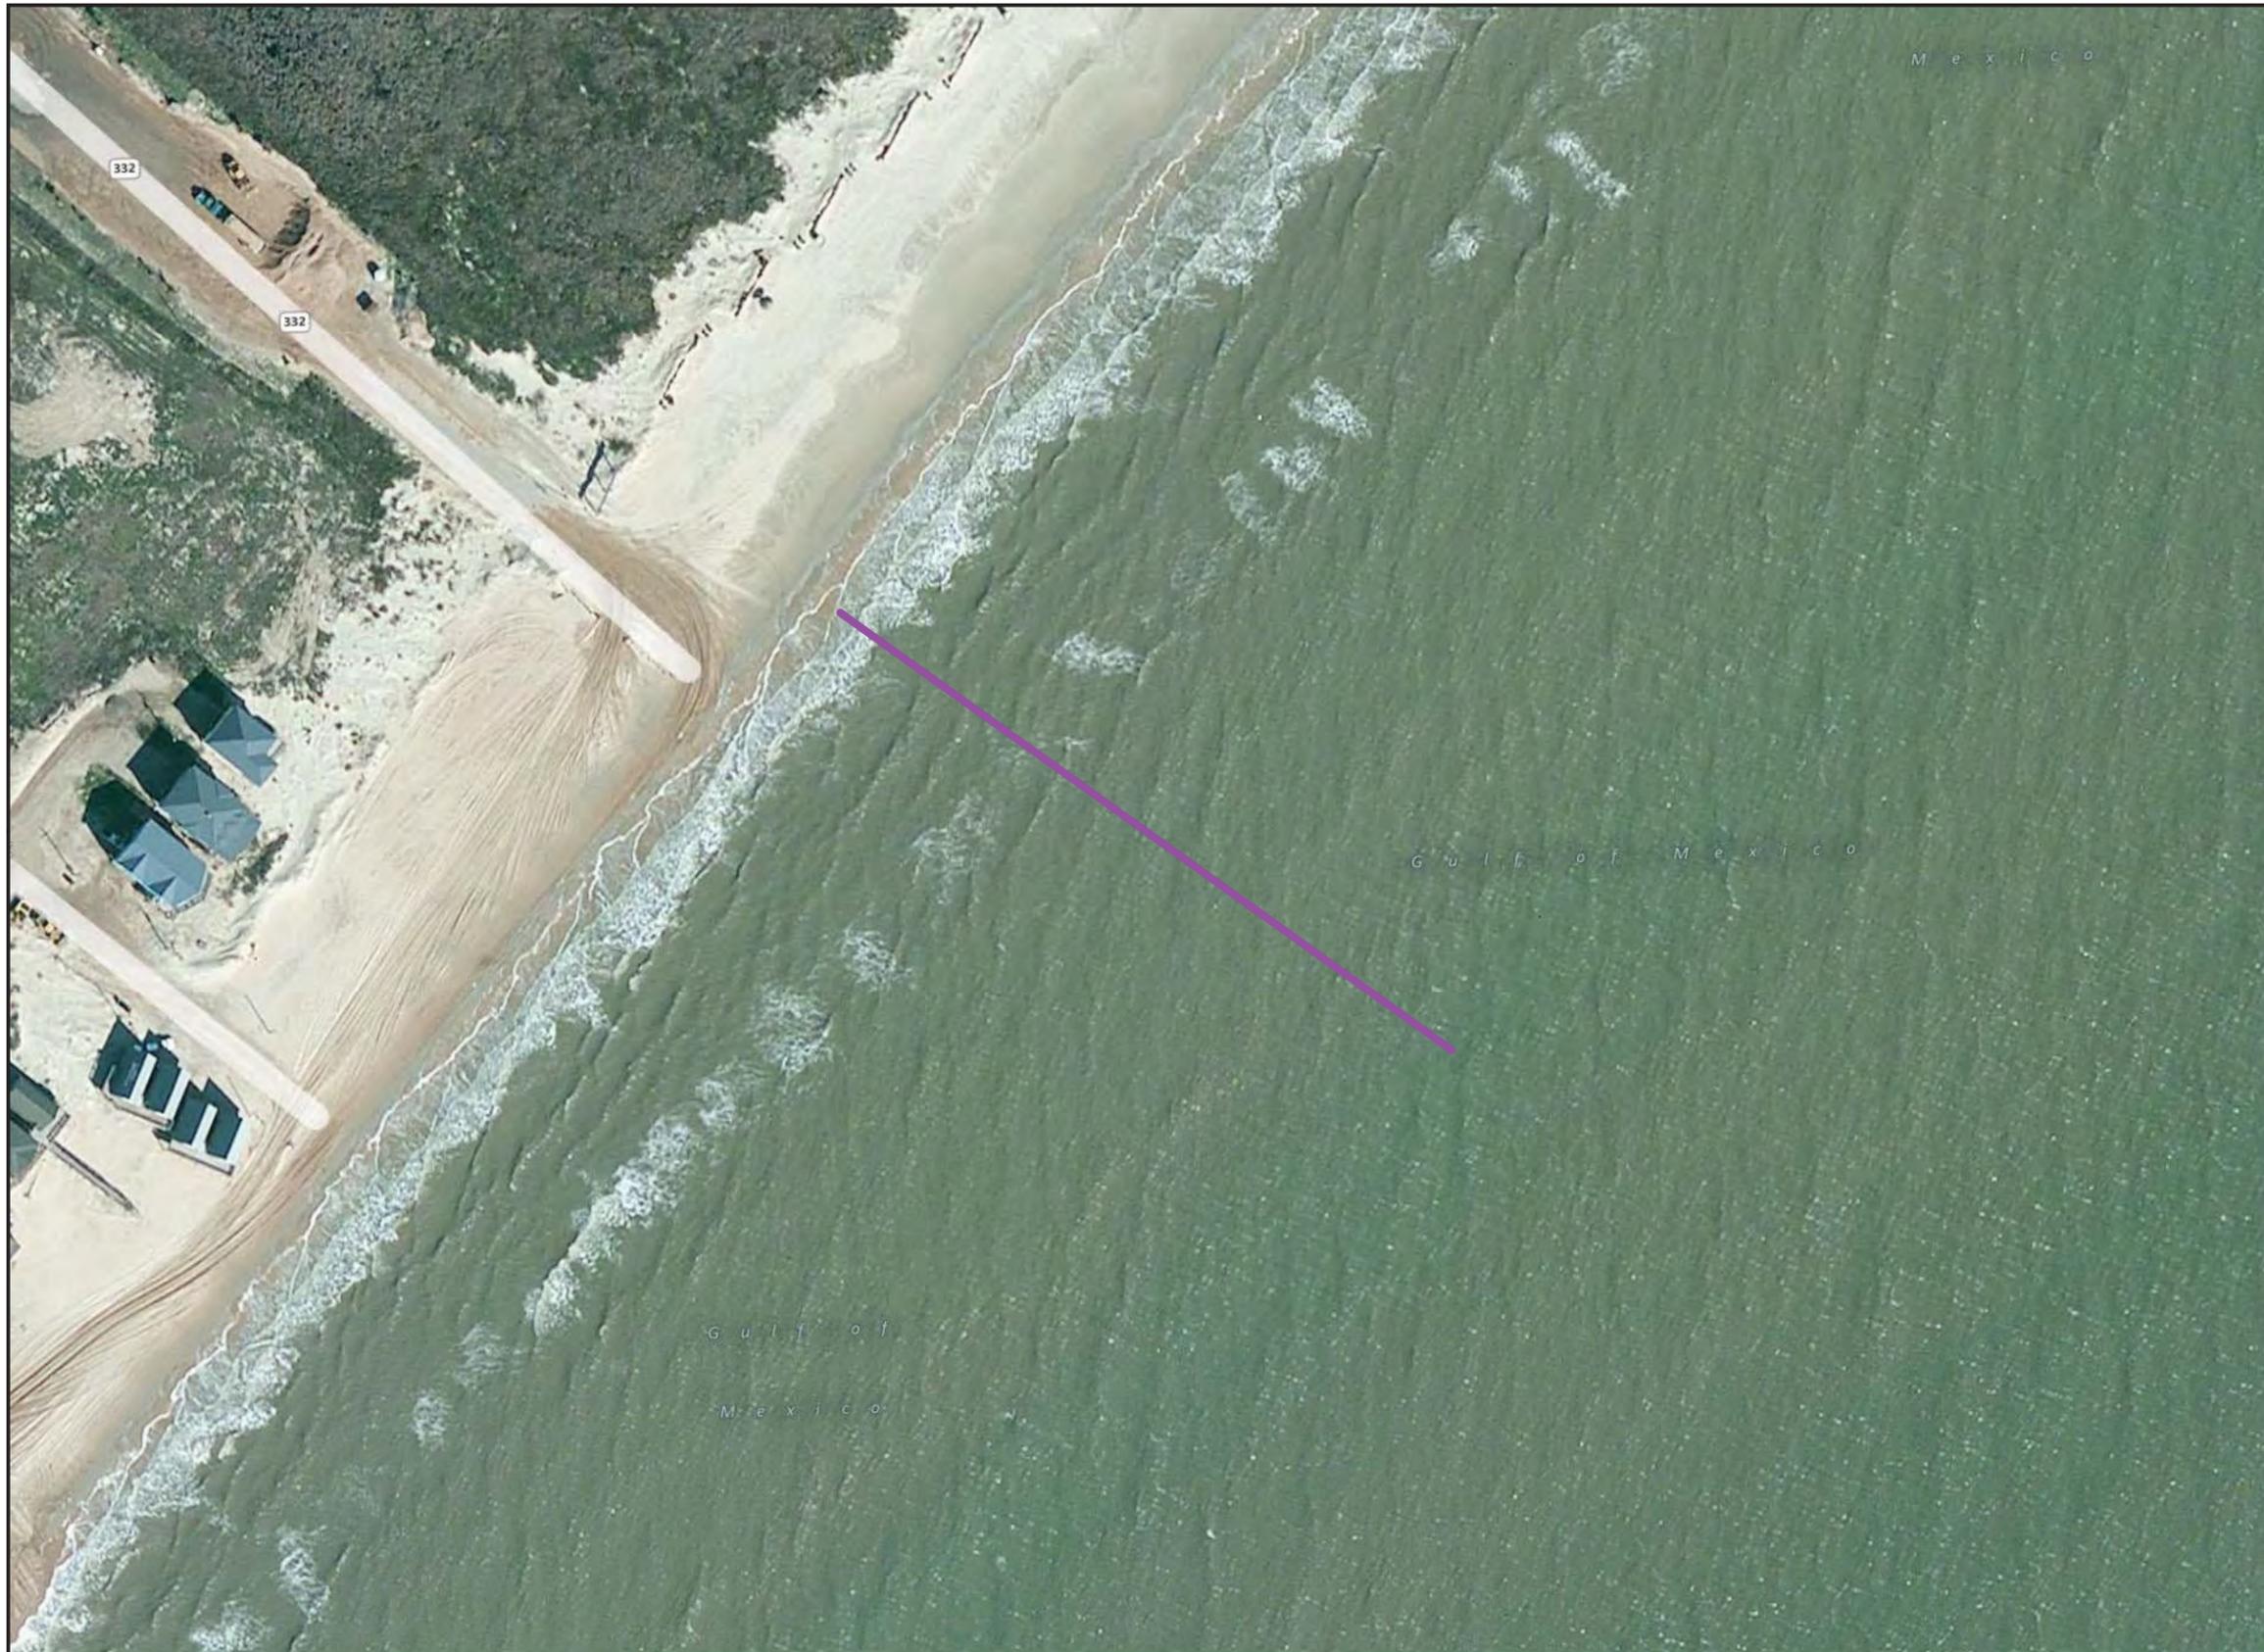
Measure 5-16: Groin at State Highway 332, Brazoria County

Groin

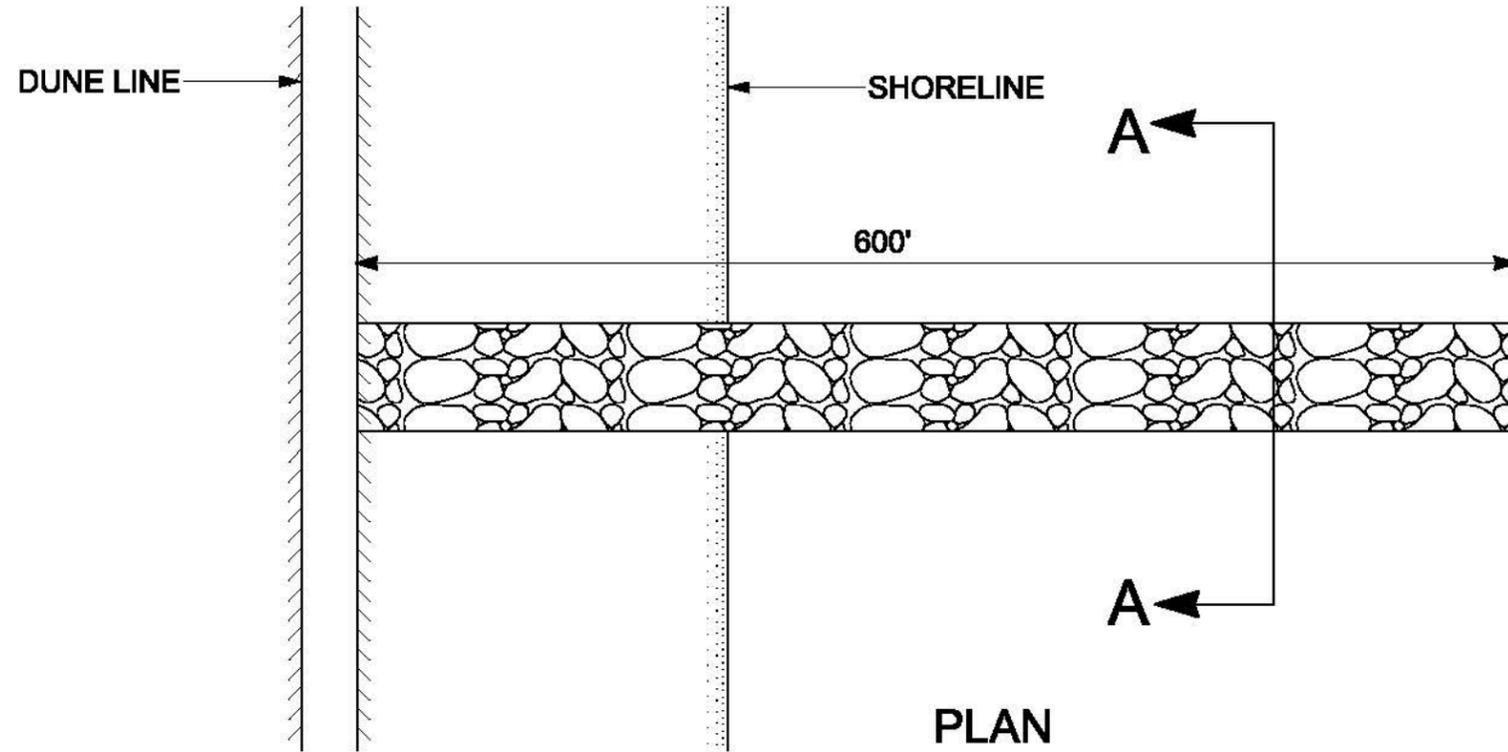
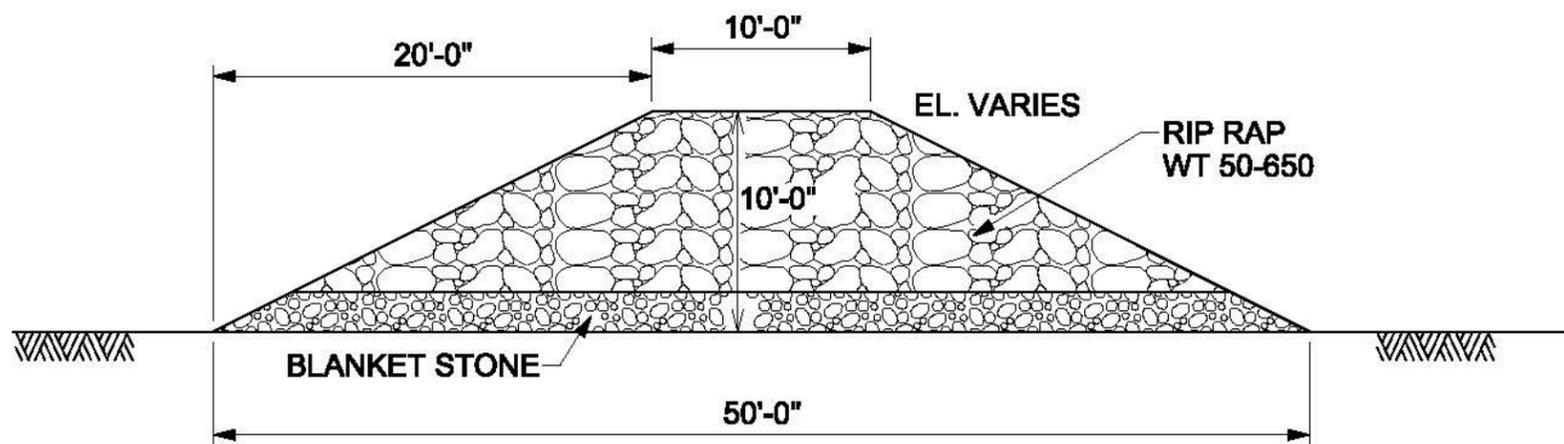
Typical Section S-12: Groin at SH-332, Brazoria County

PLAN
N.T.S.

RIP RAP END AREA = 300 FT²

GROIN
N.T.S.

- 1: GROIN IS 600 FT LONG
- 2: GROIN SECTION IS CONSTANT
- 3: VOLUME IS BASED ON CROSS SECTION AREA MULTIPLIED BY LENGTH

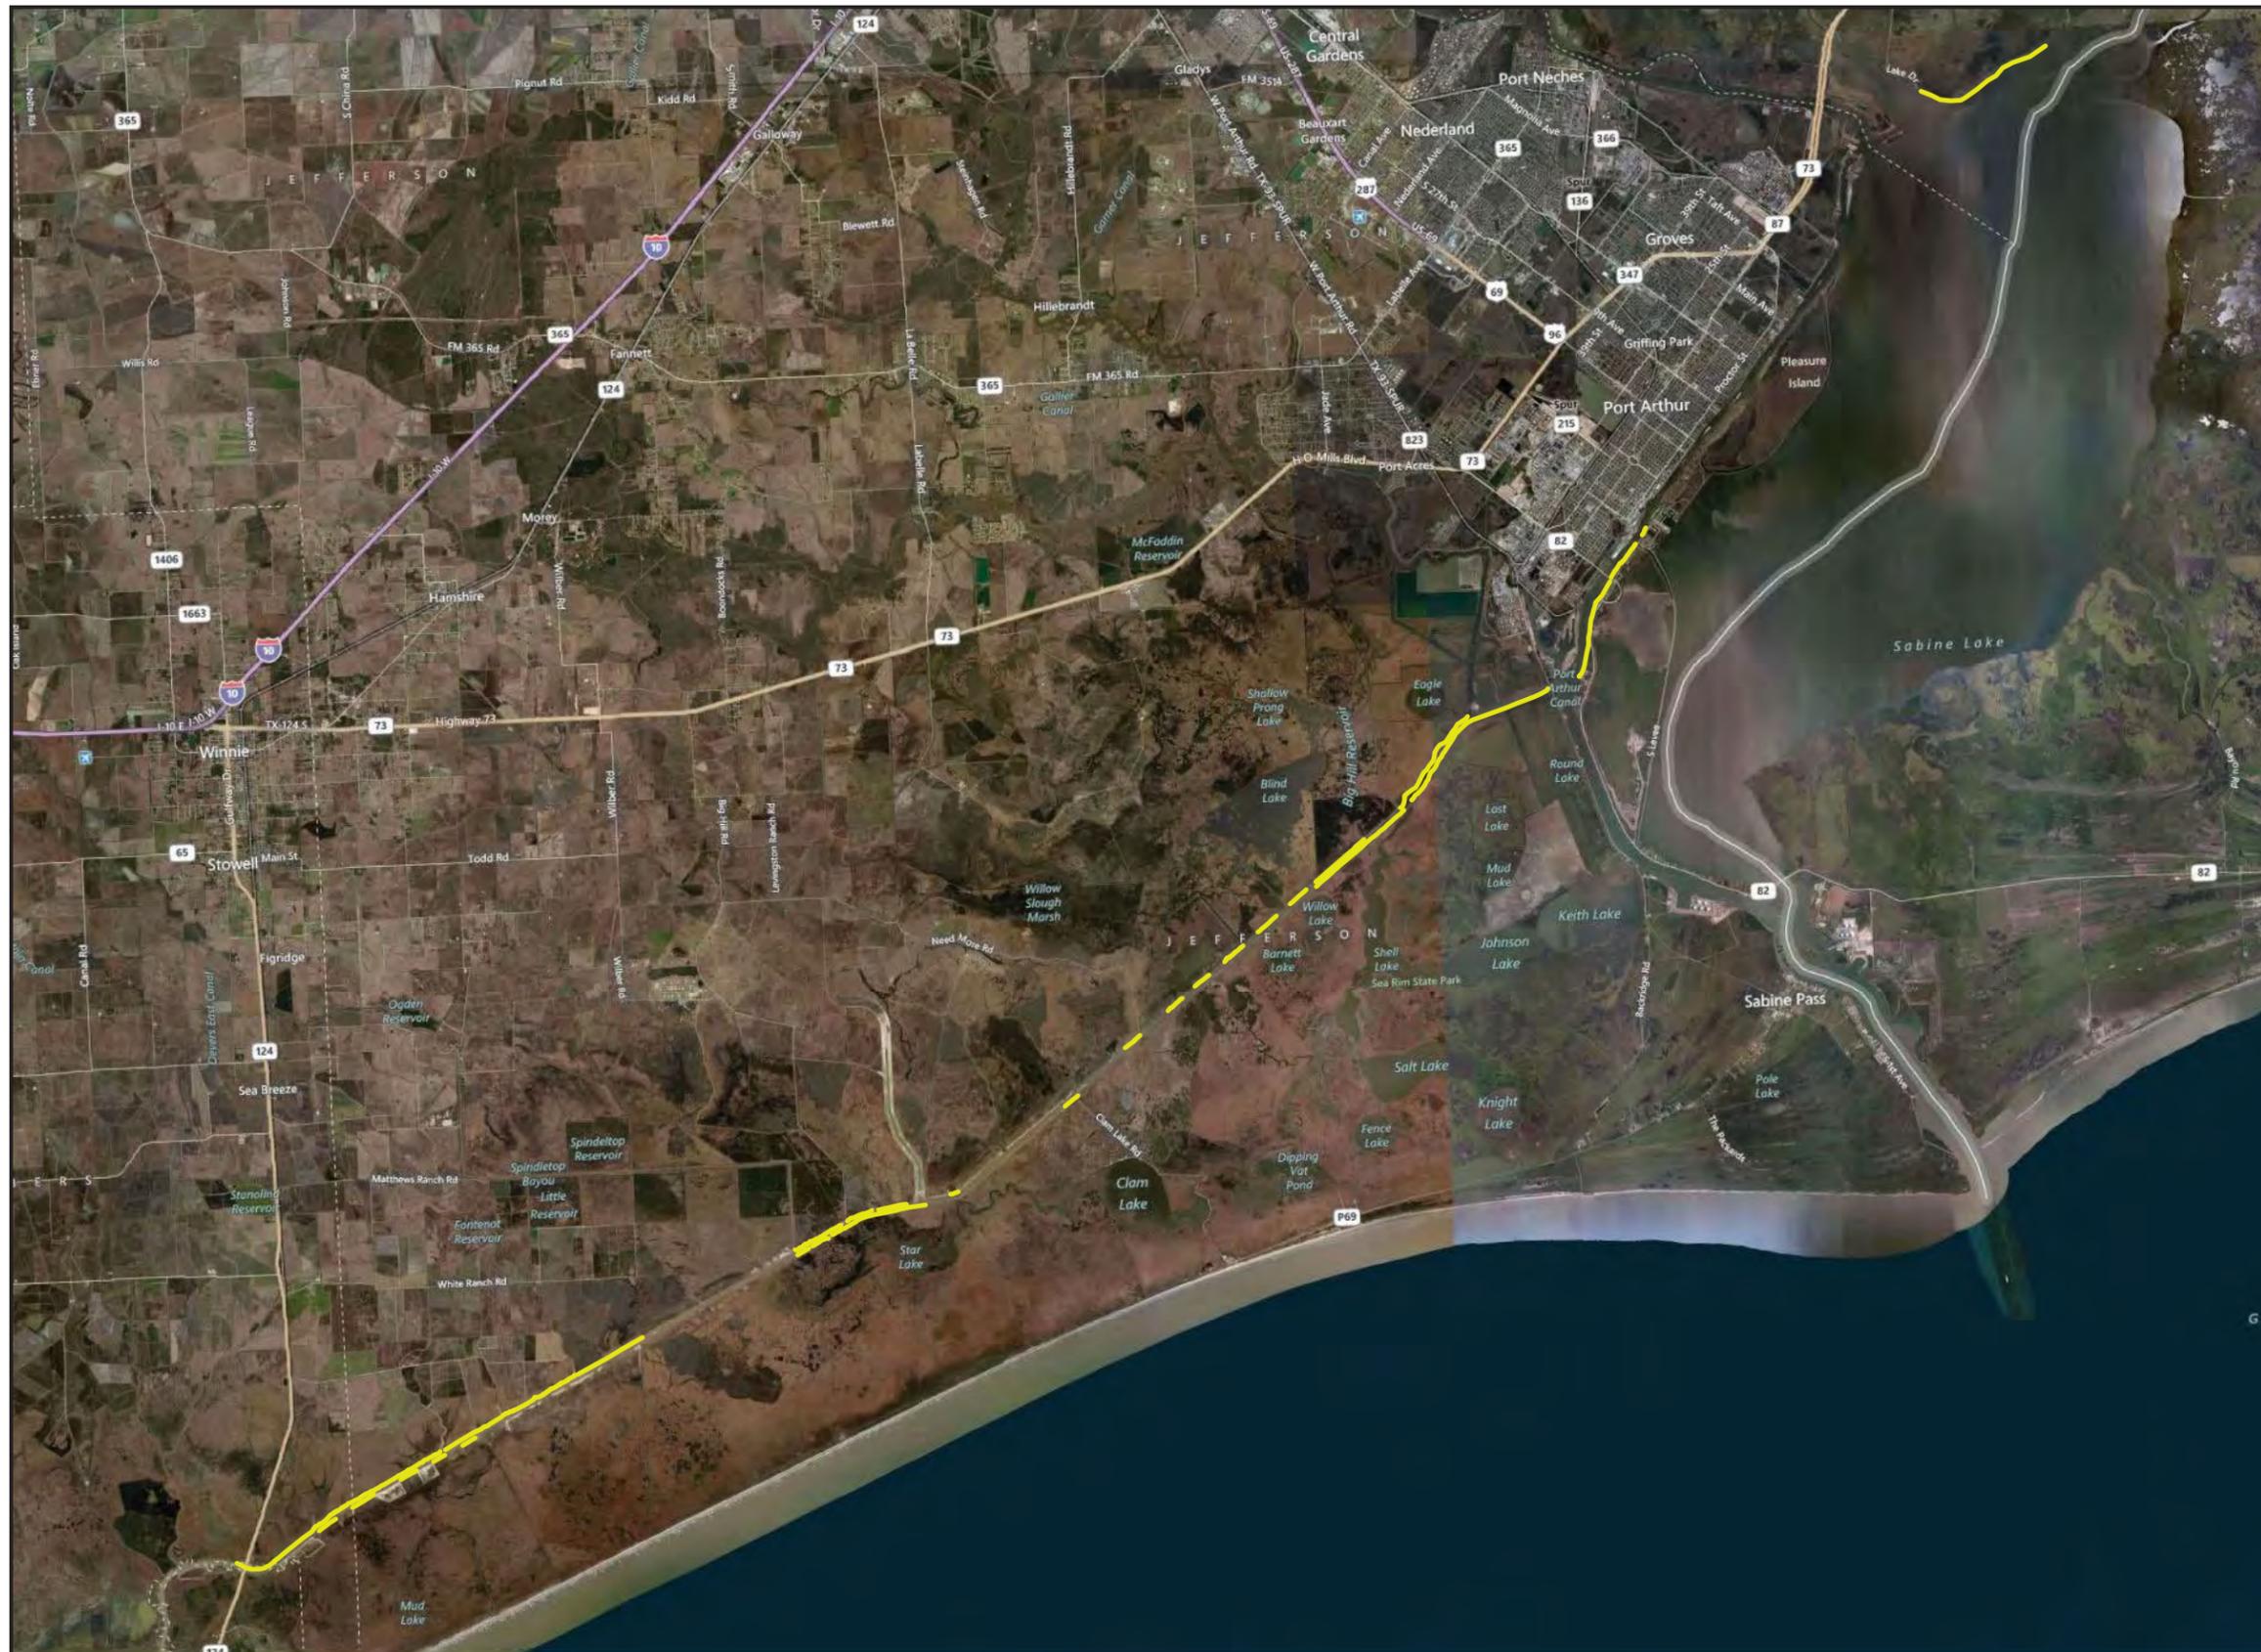
Measure 6-2 - GIWW Breakwaters, Neches River to High Island, Jefferson County

GIWW Breakwaters

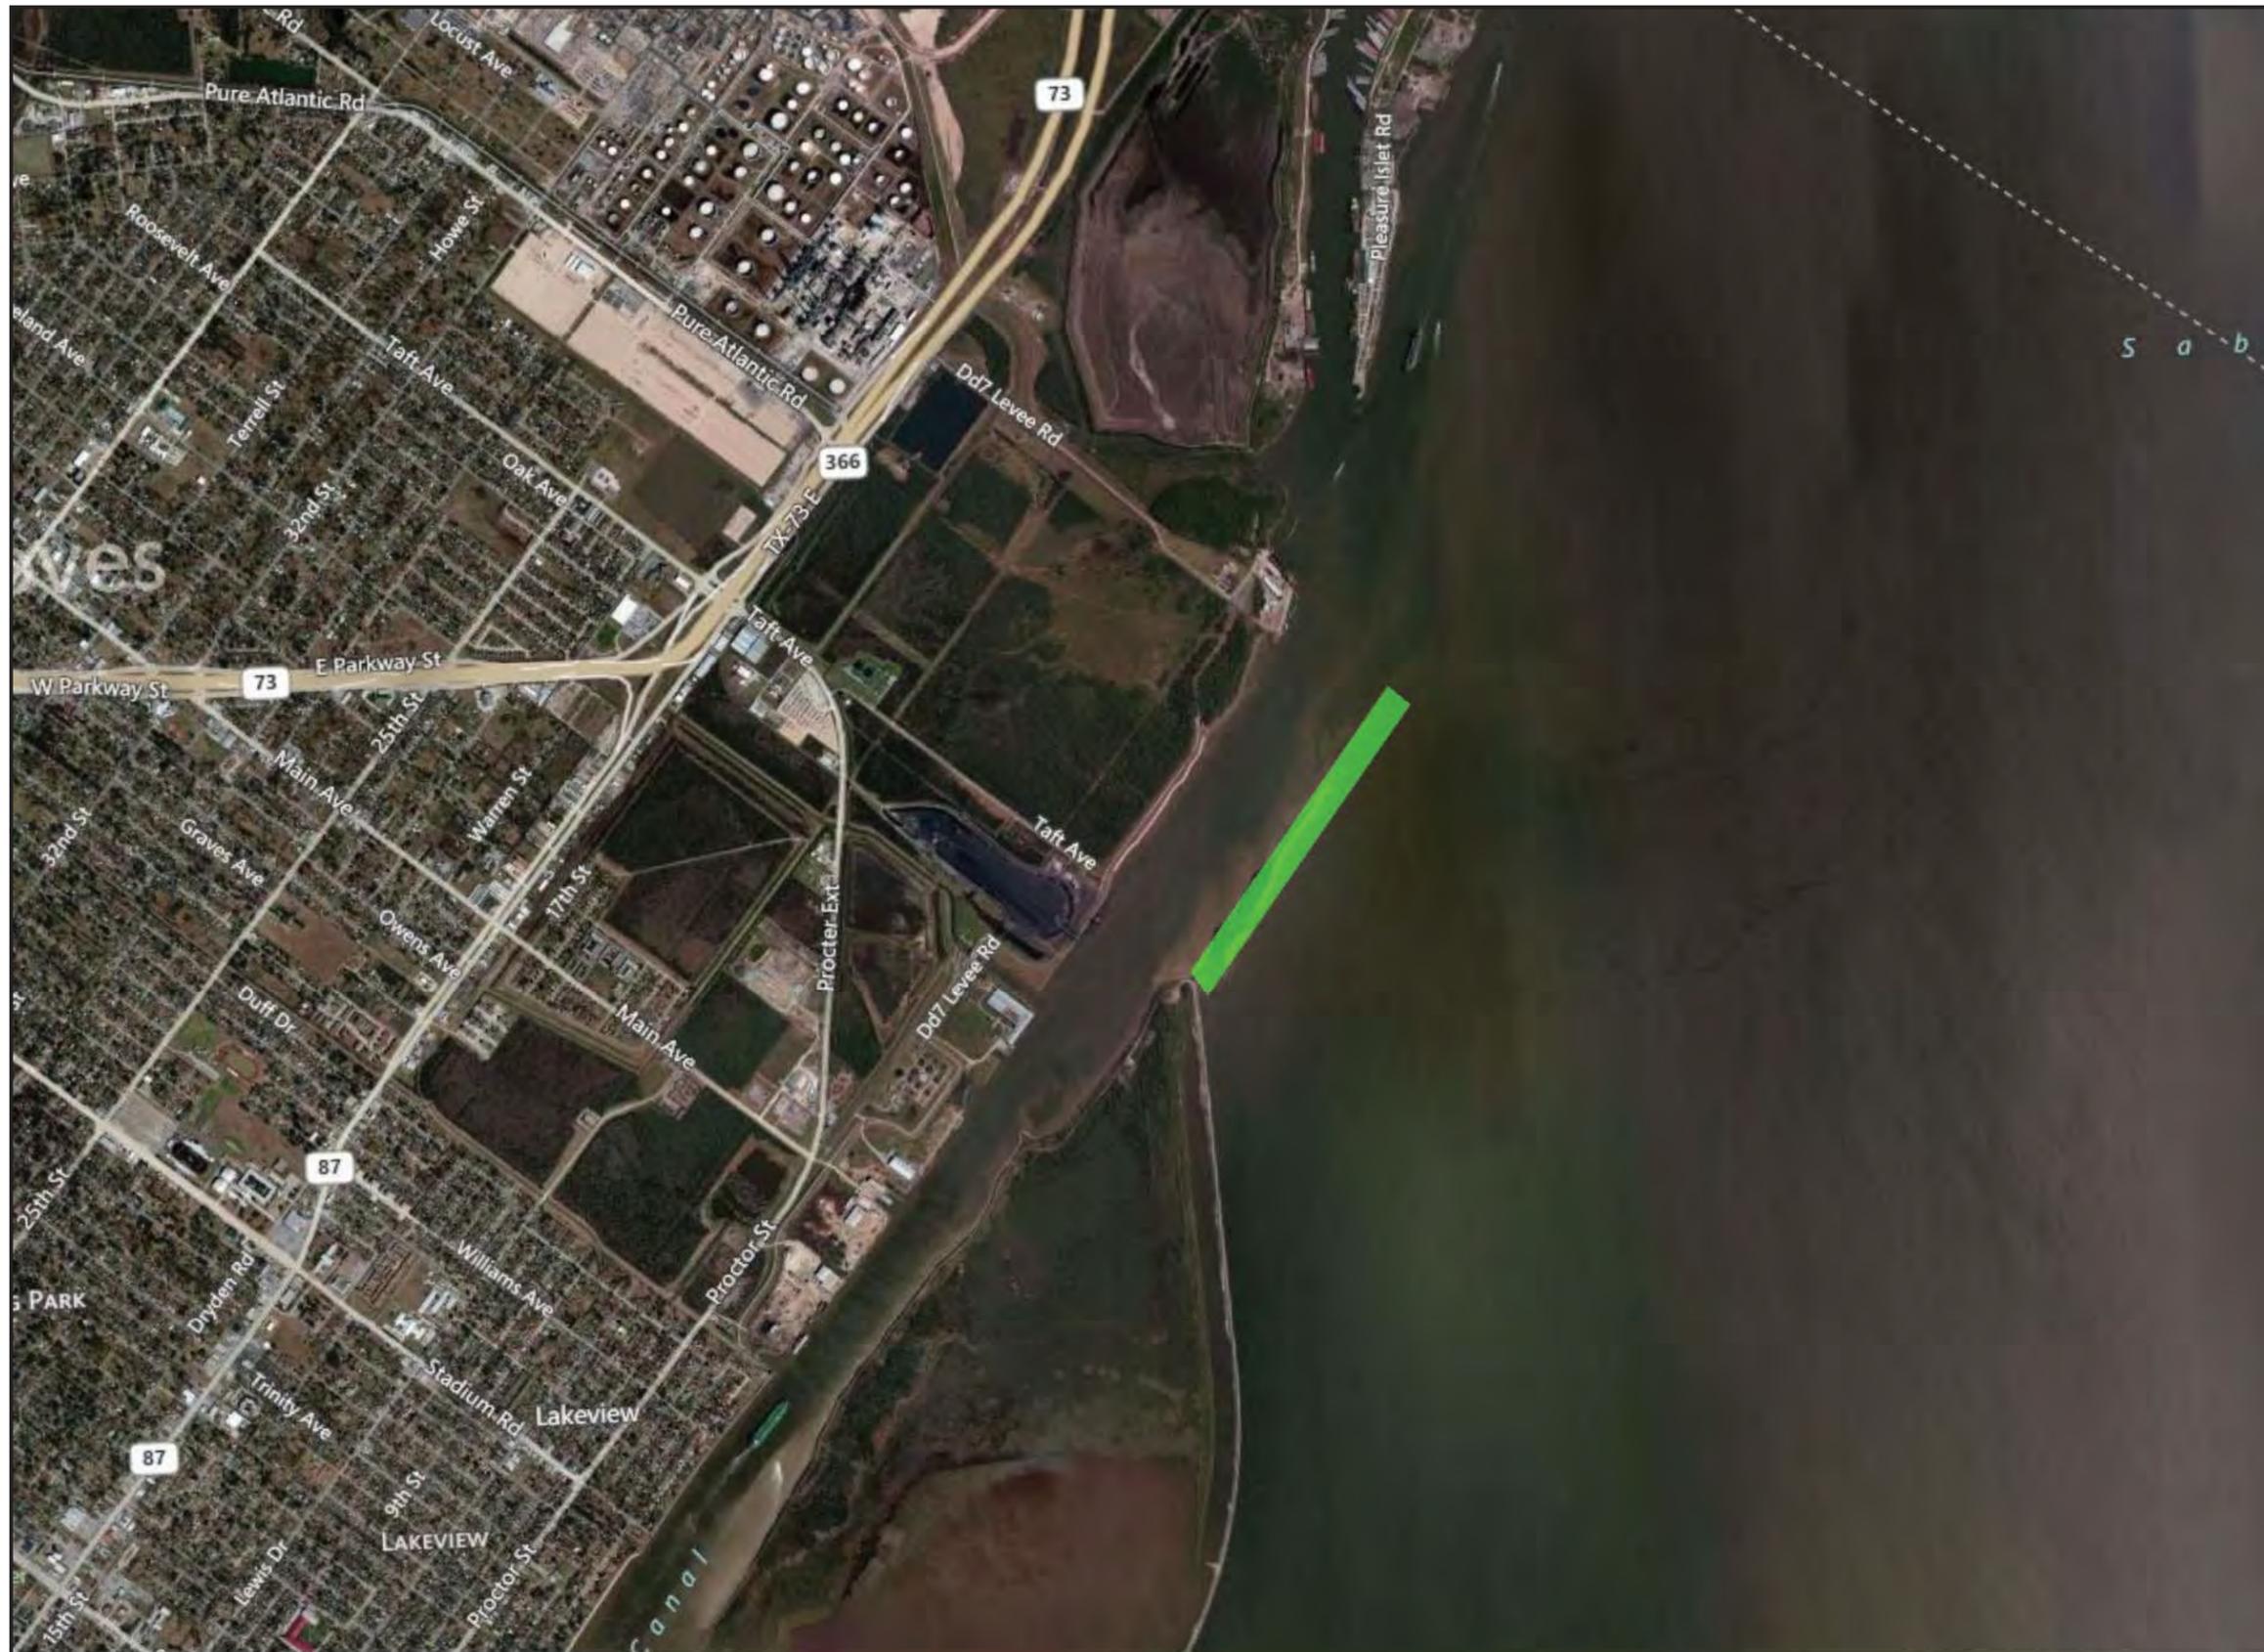
Measure 6-3 - GIWW Barrier Island Restoration, North Pleasure Island, Jefferson County

Barrier Island Restoration

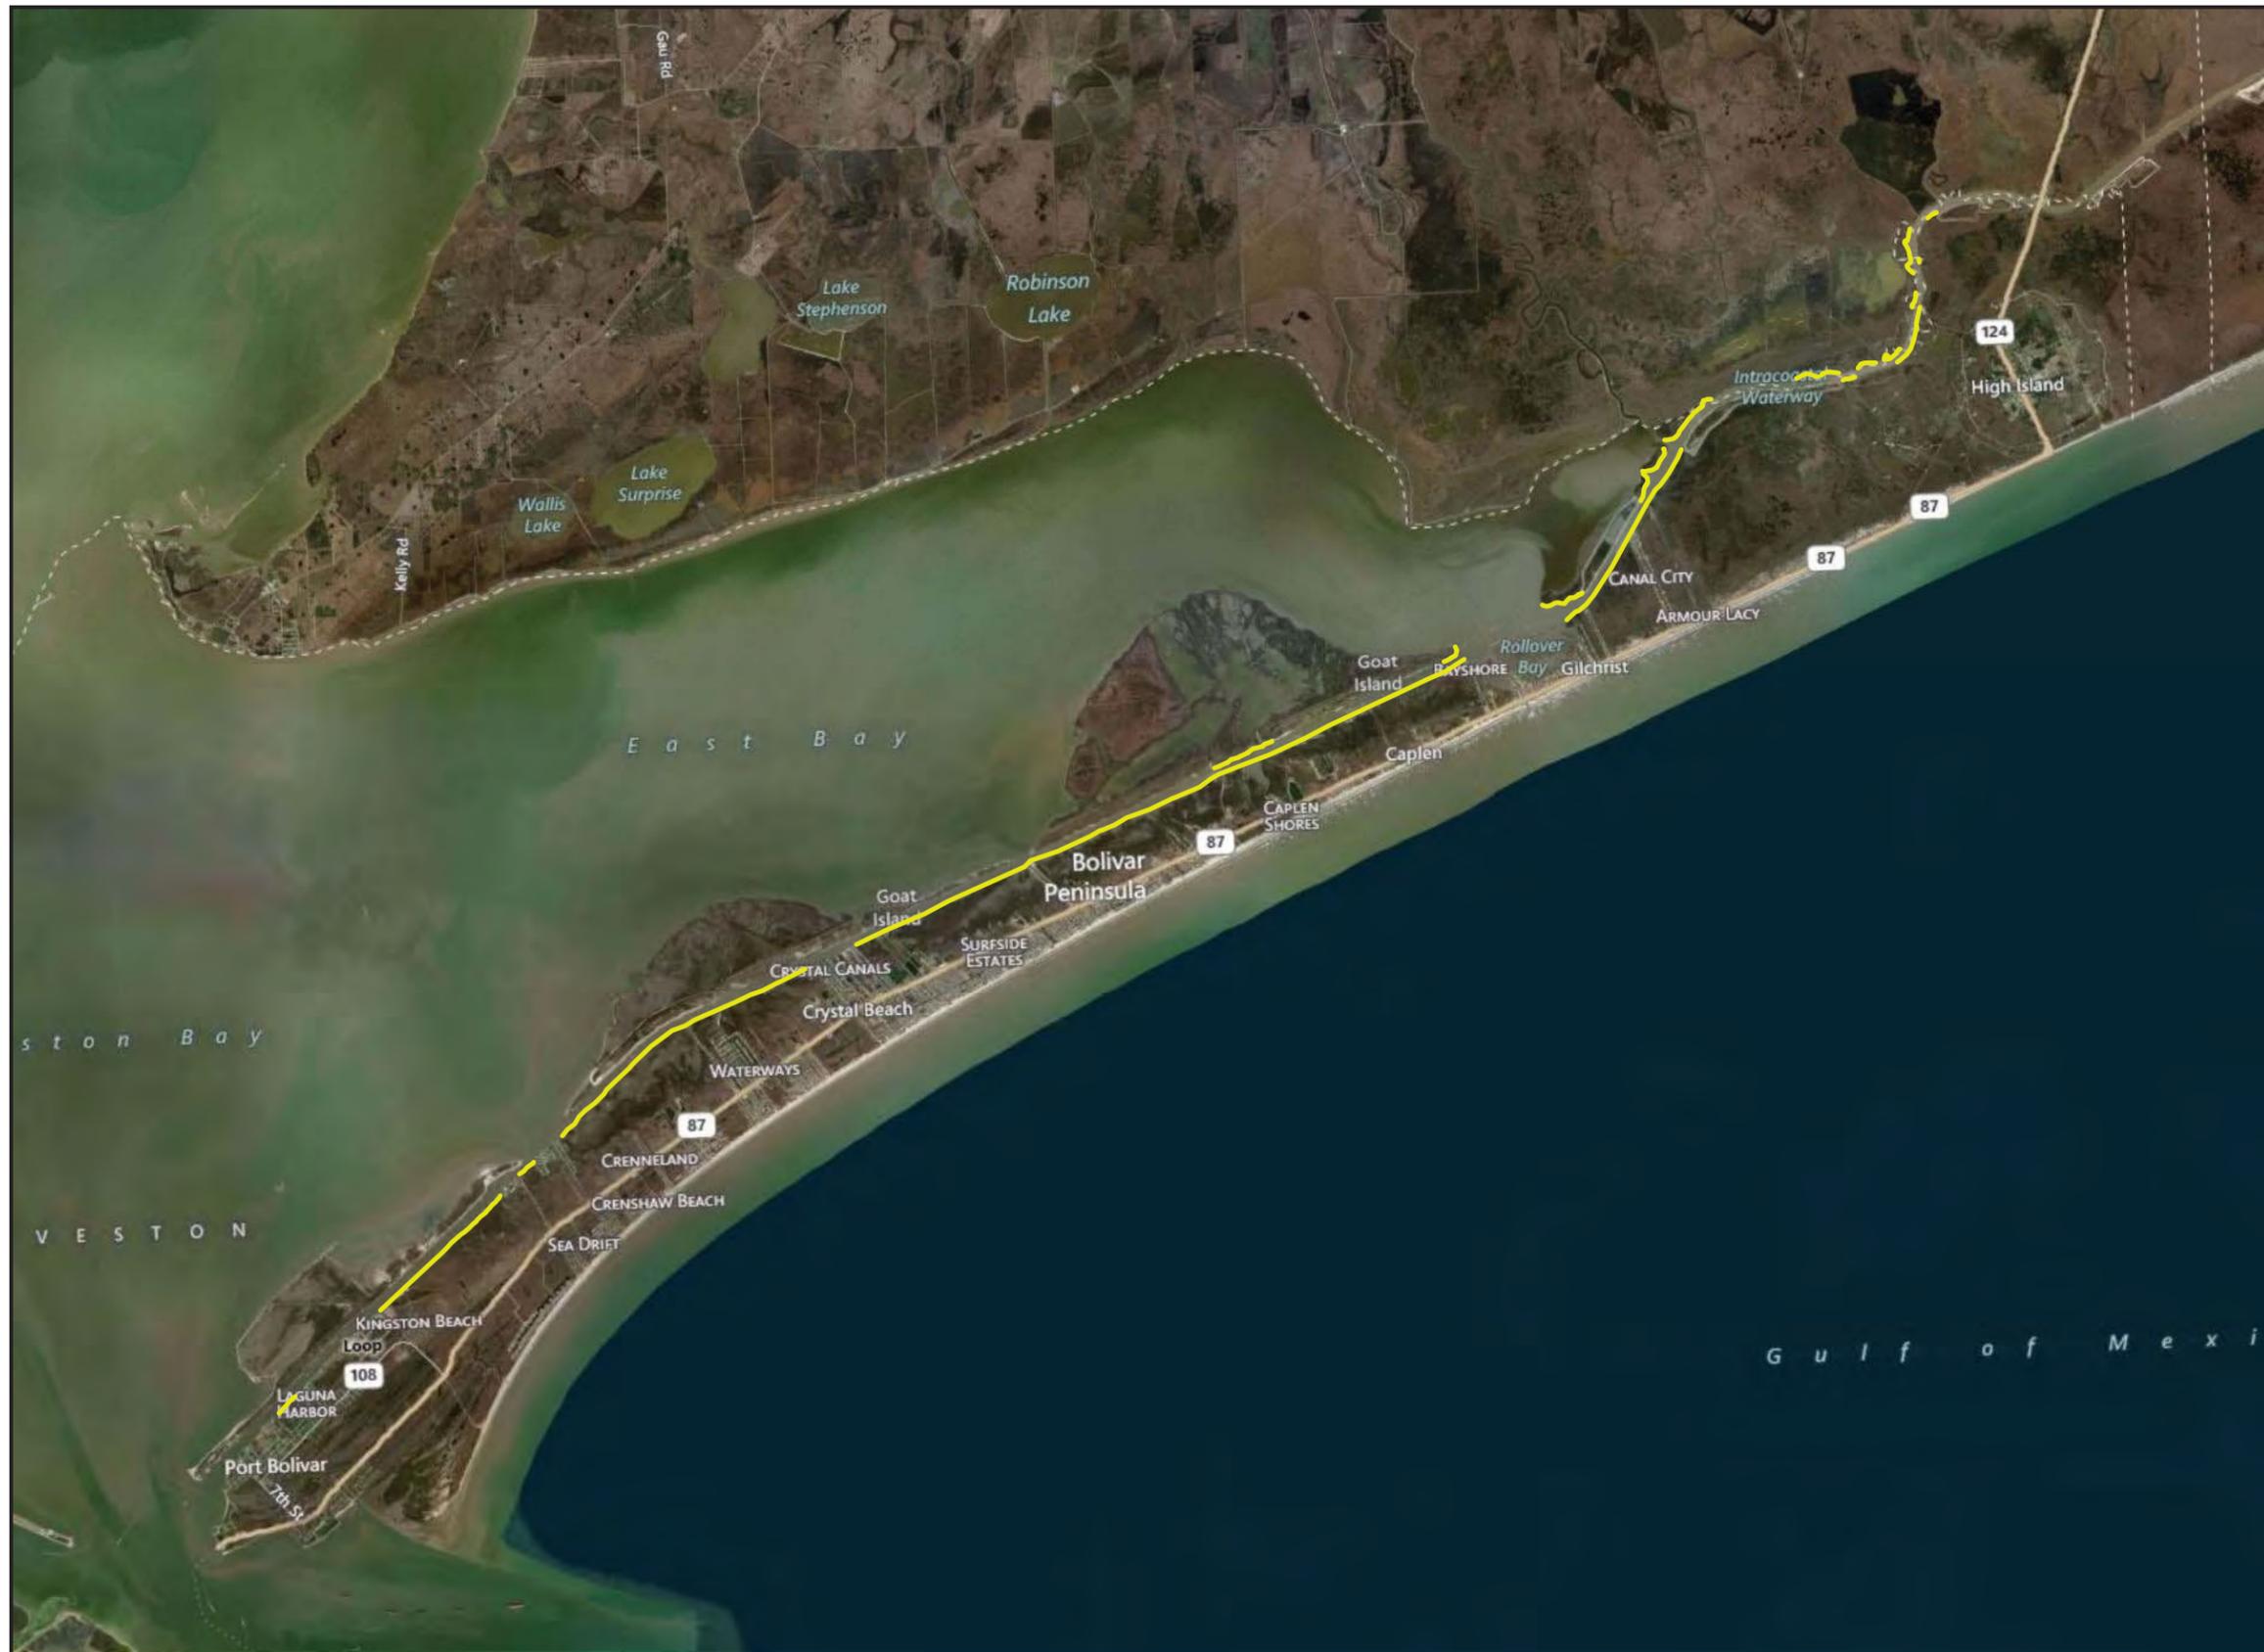
Measure 6-4.1 - GIWW Breakwaters, Bolivar Peninsula, Galveston County

- GIWW Breakwaters

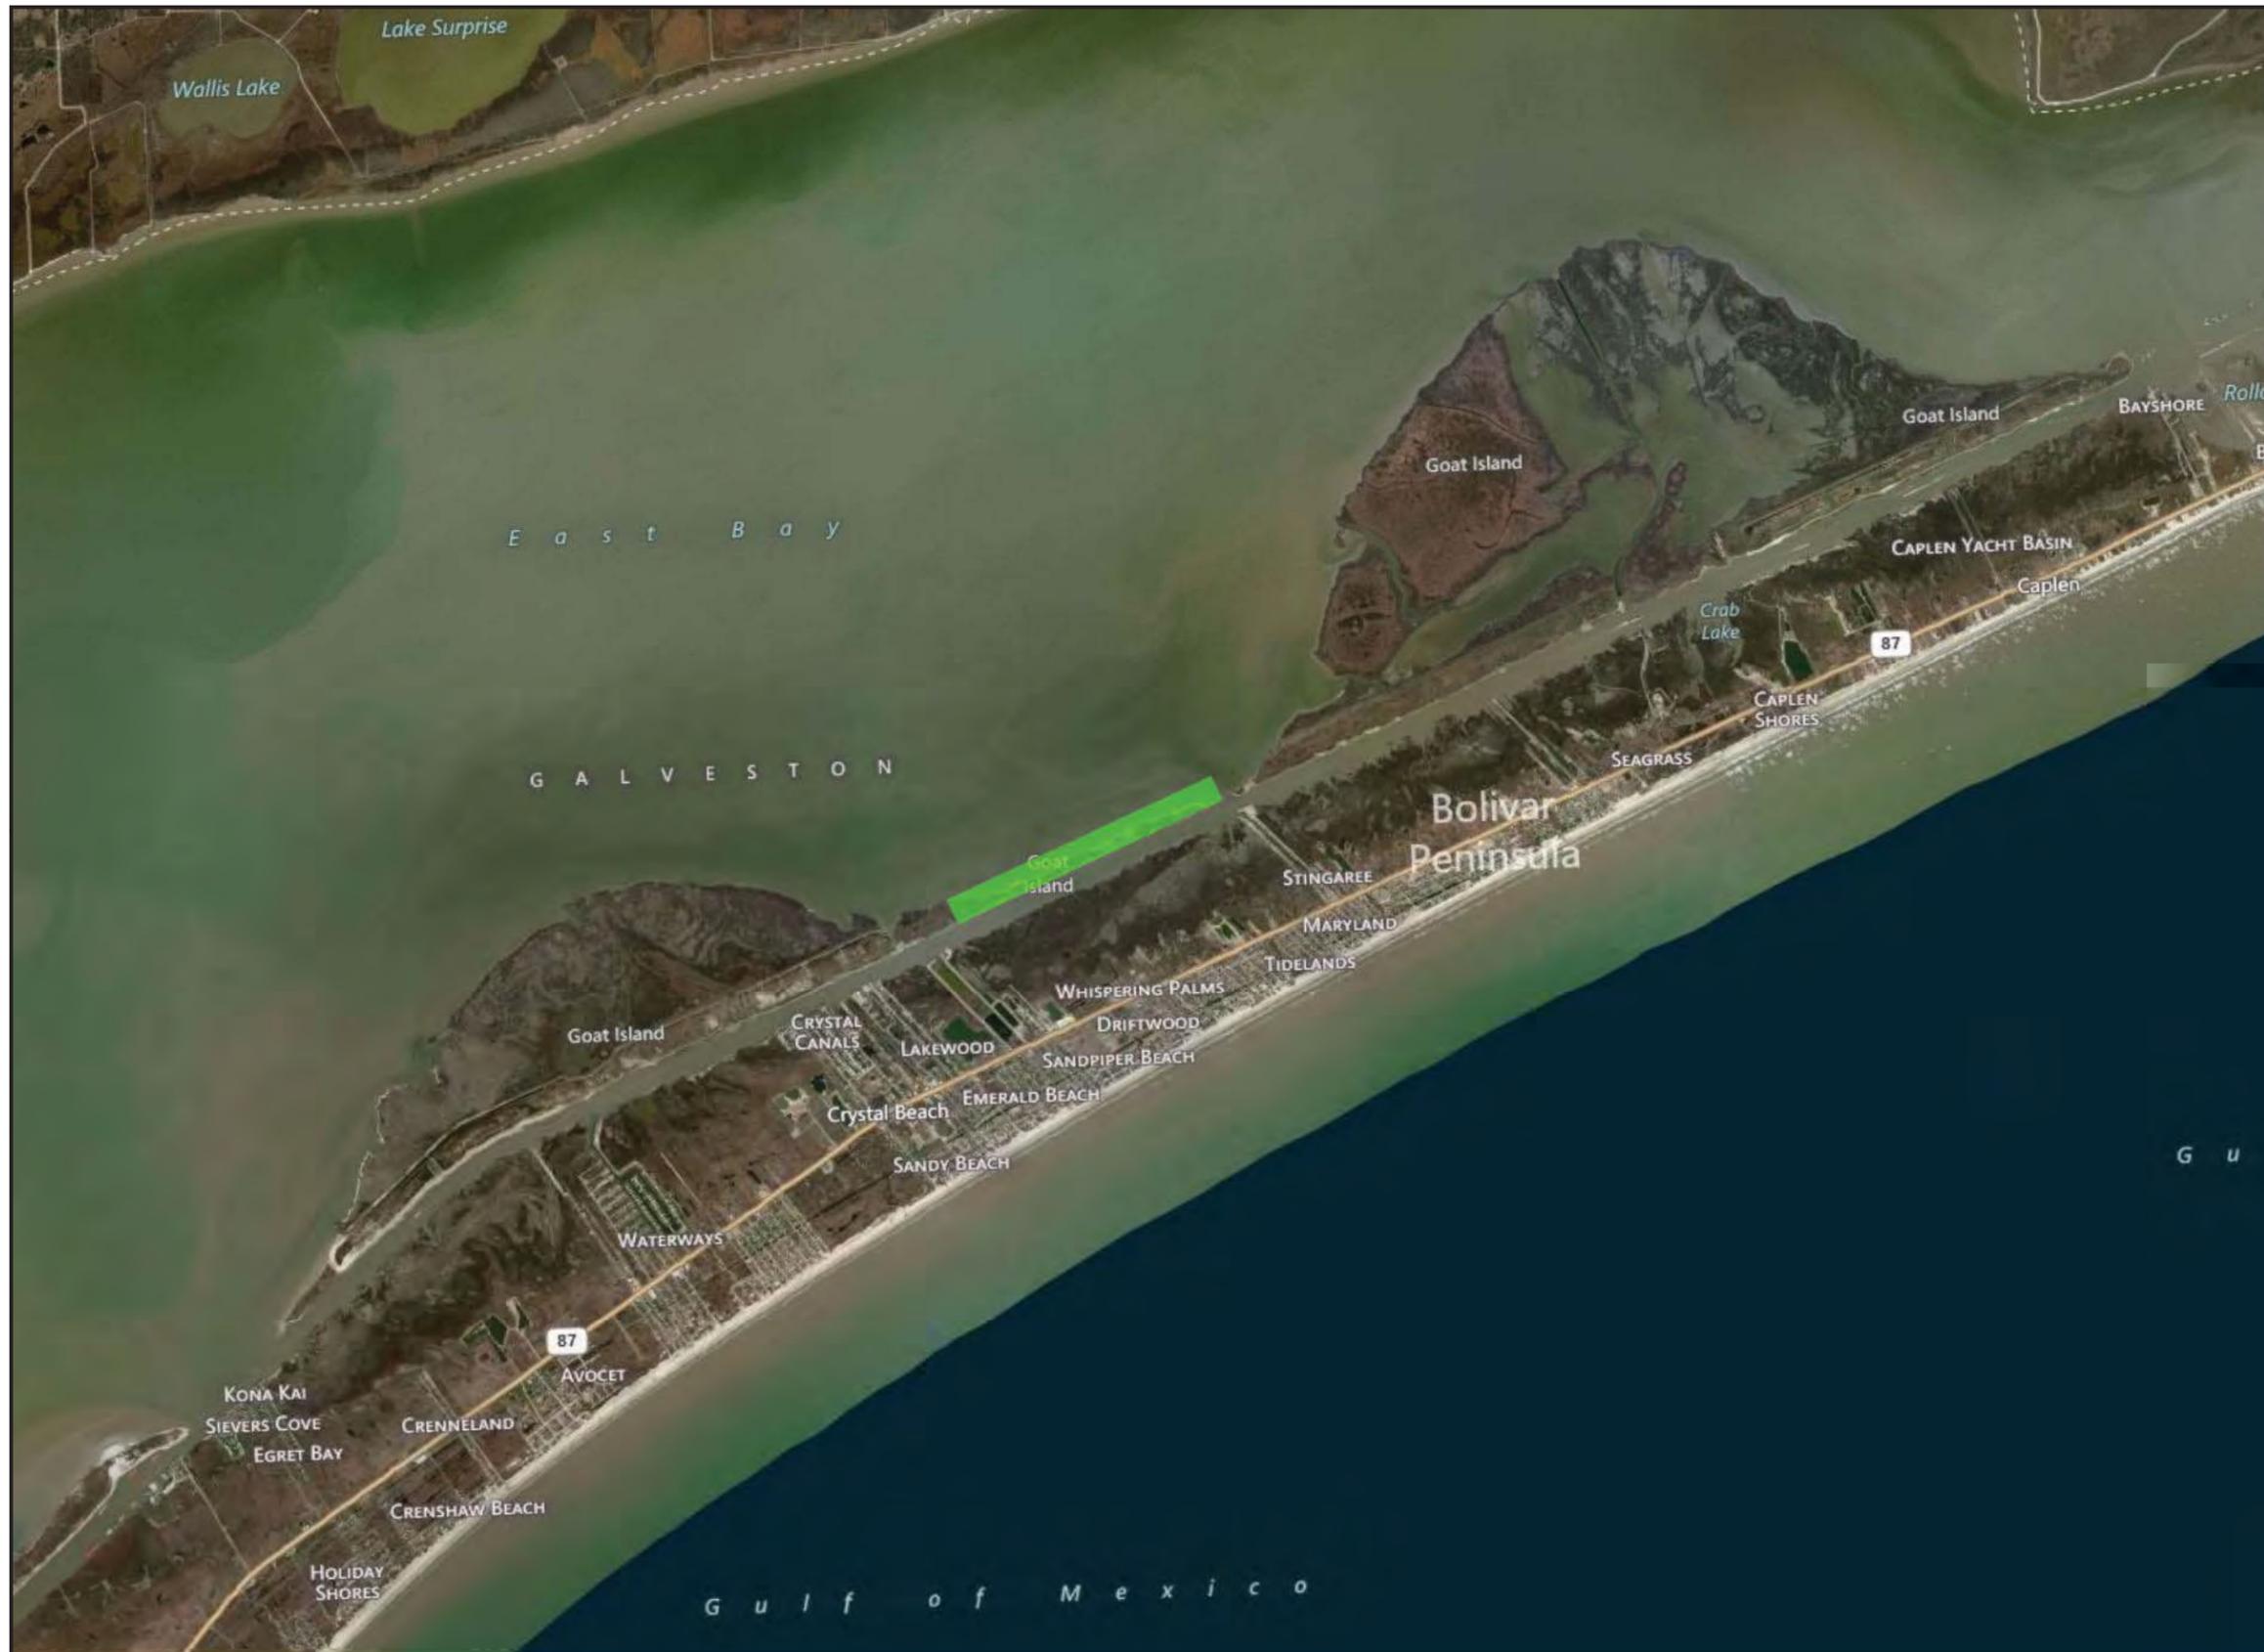
Measure 6-4.2 - GIWW Barrier Island Restoration, Bolivar Peninsula, Galveston County

Barrier Island Restoration
