SABINE PASS TO GALVESTON BAY, TEXAS
MEASURE 5-10
INFORMATION SHEET

DESCRIPTION OF MEASURE: 5-10 Closing of Rollover Pass, Galveston County

Sabine Pass to Galveston Bay Texas, Coastal Storm Risk Management and Ecosystem Restoration Feasibility Study

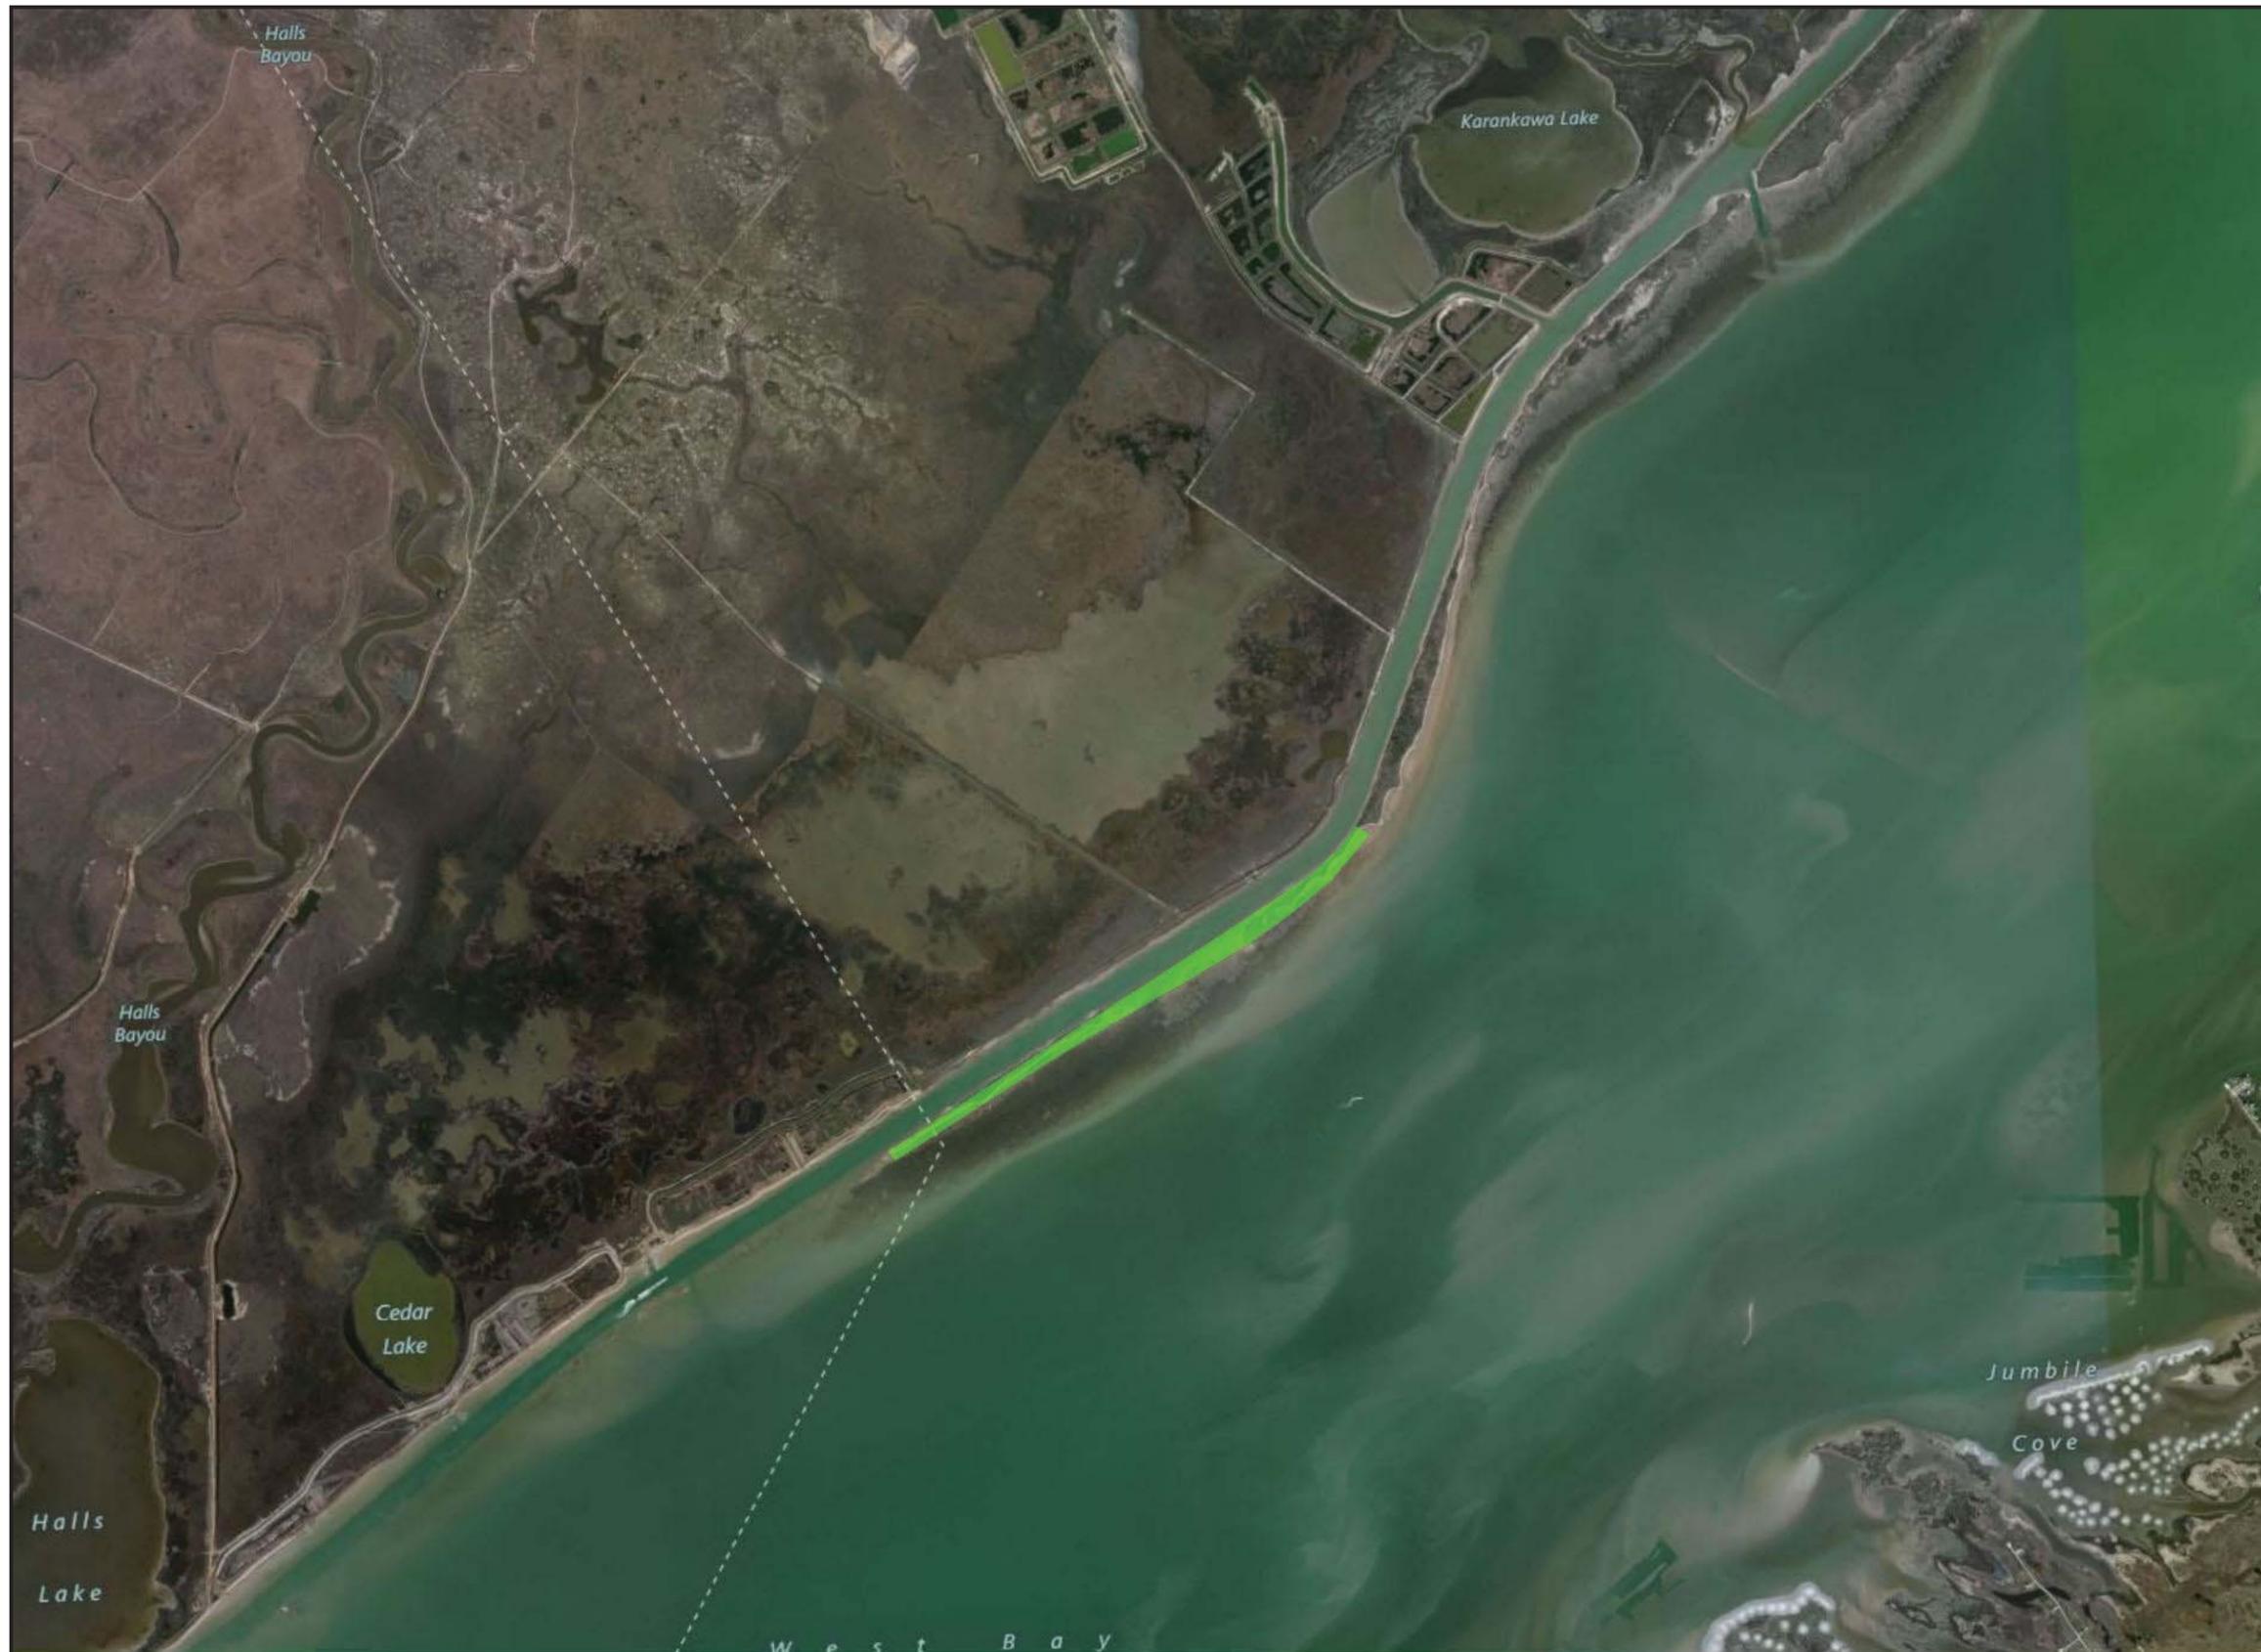
Measure 6-5.2 - GIWW Barrier Island Restoration, West Bay 1, Galveston County

Barrier Island Restoration

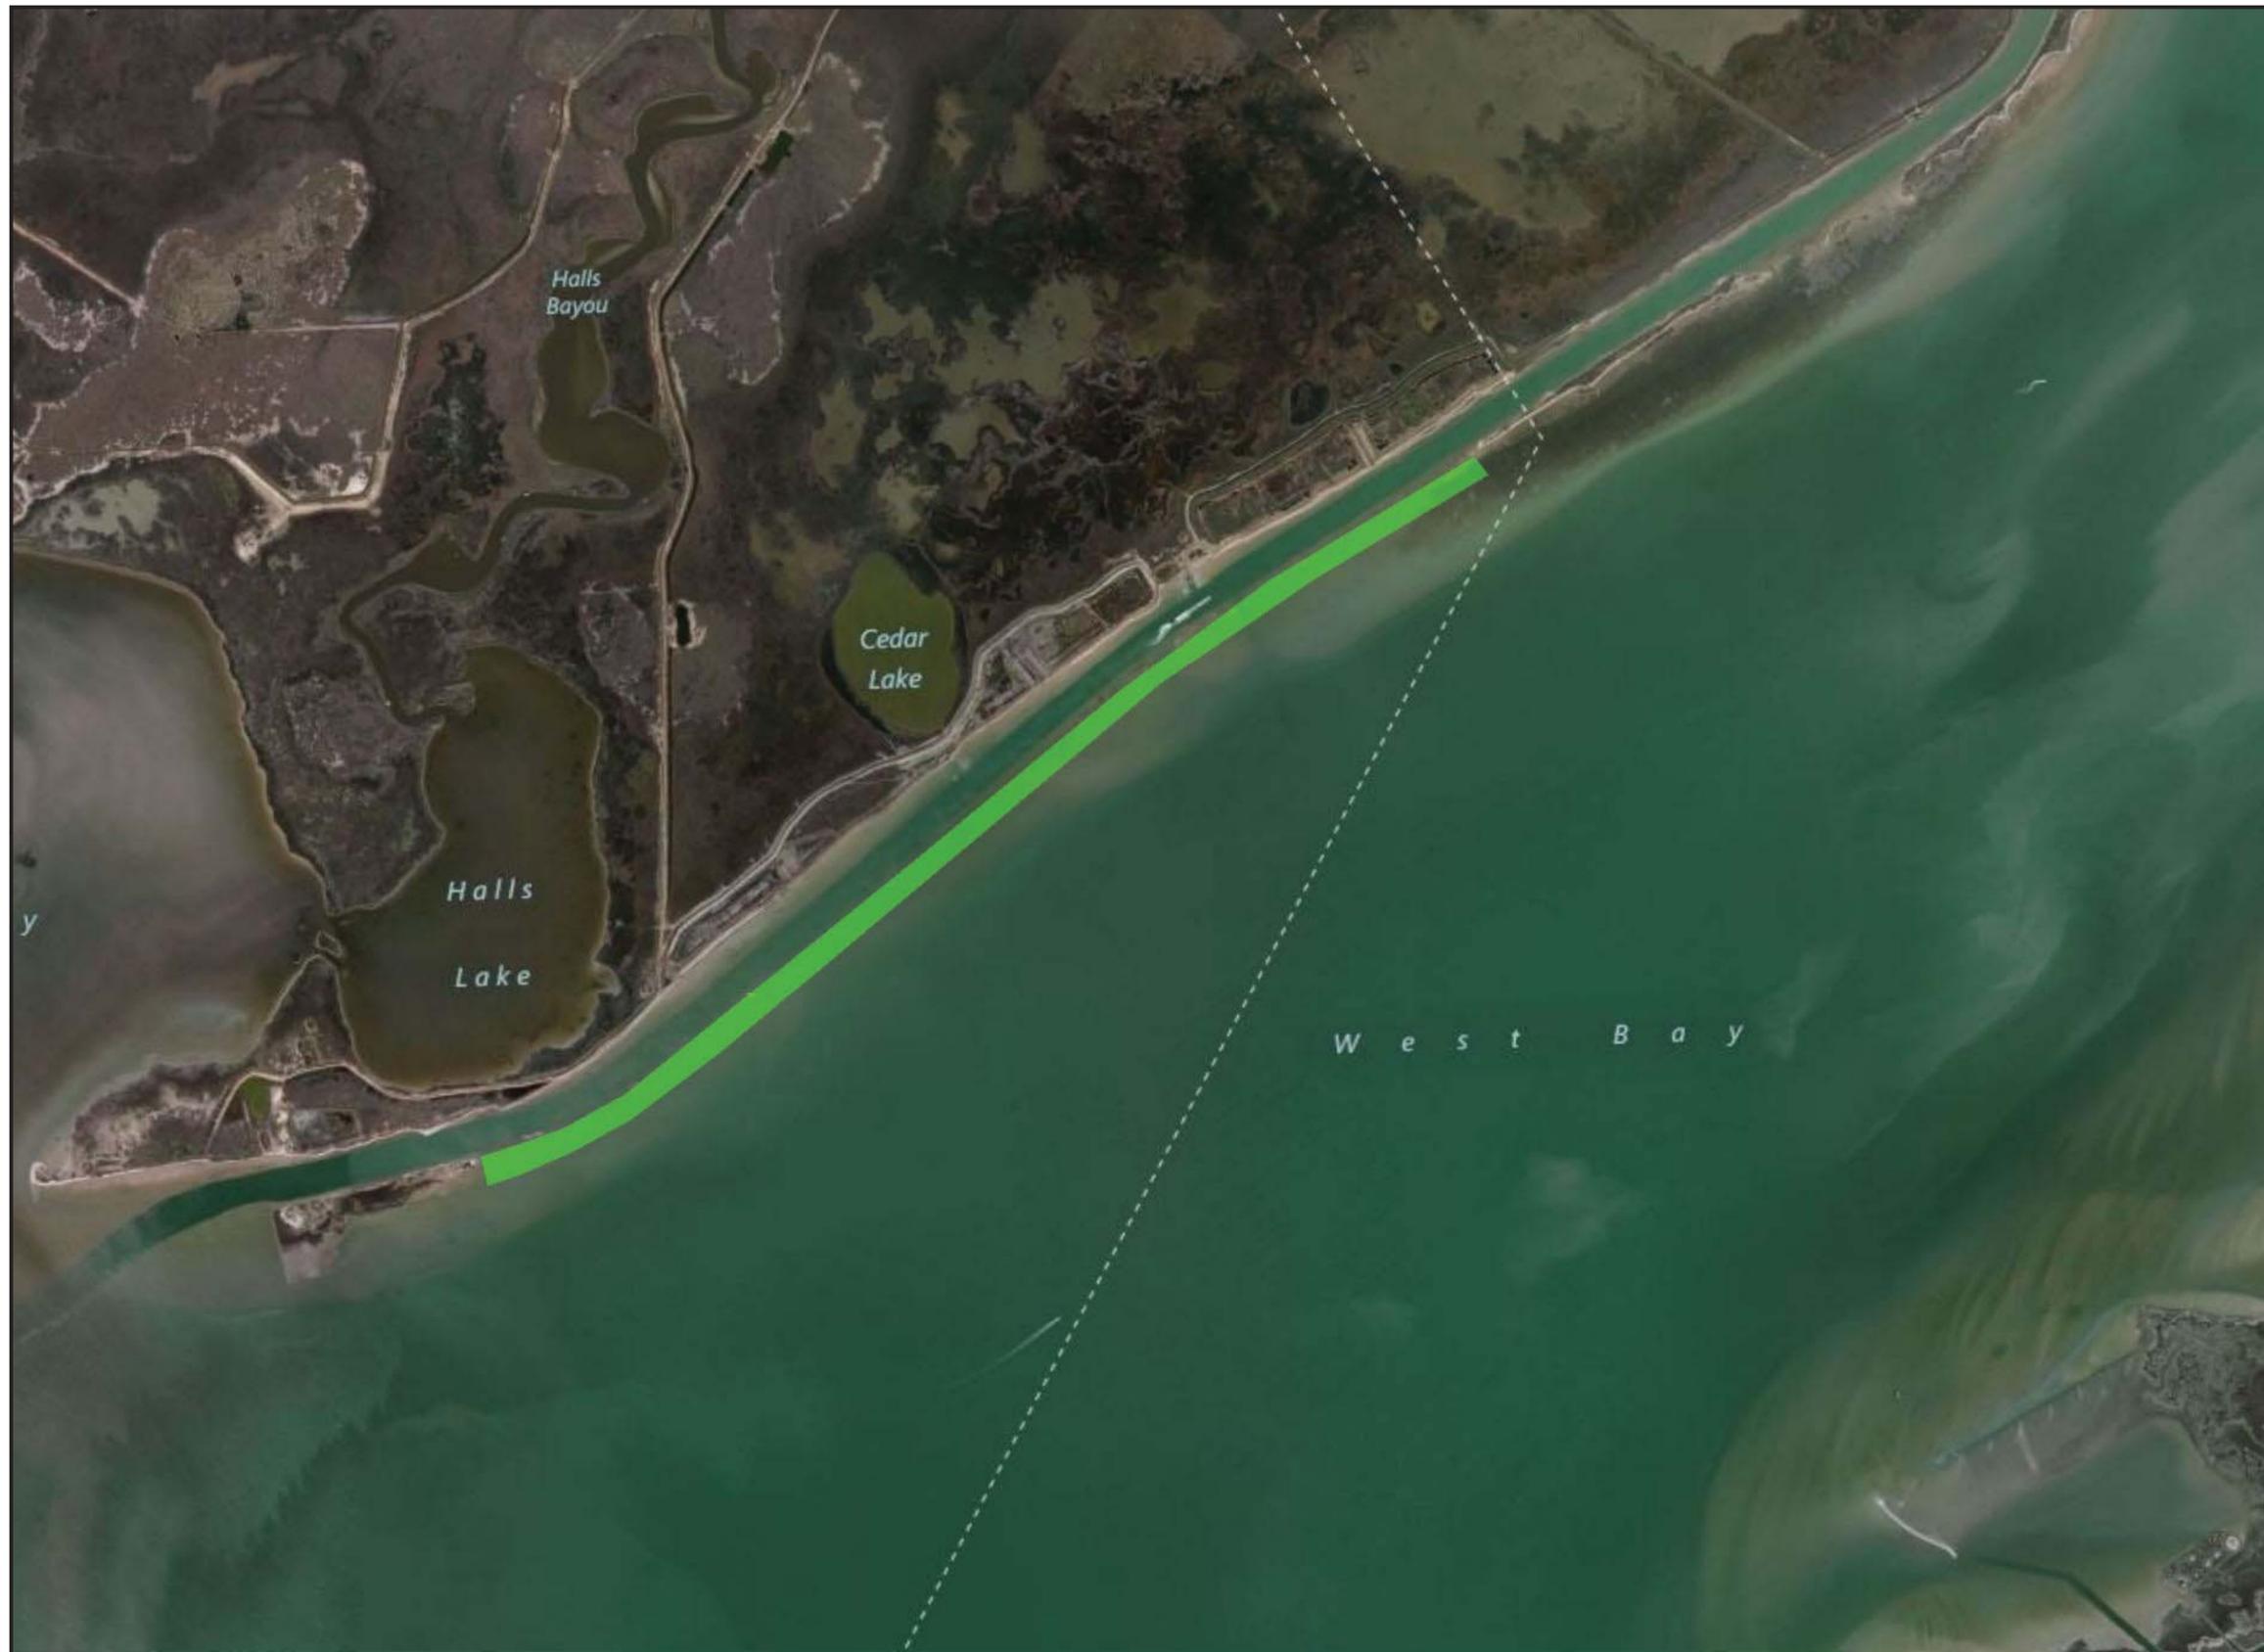
Measure 6-6.2 - GIWW Barrier Island Restoration, West Bay, Brazoria County

Barrier Island Restoration

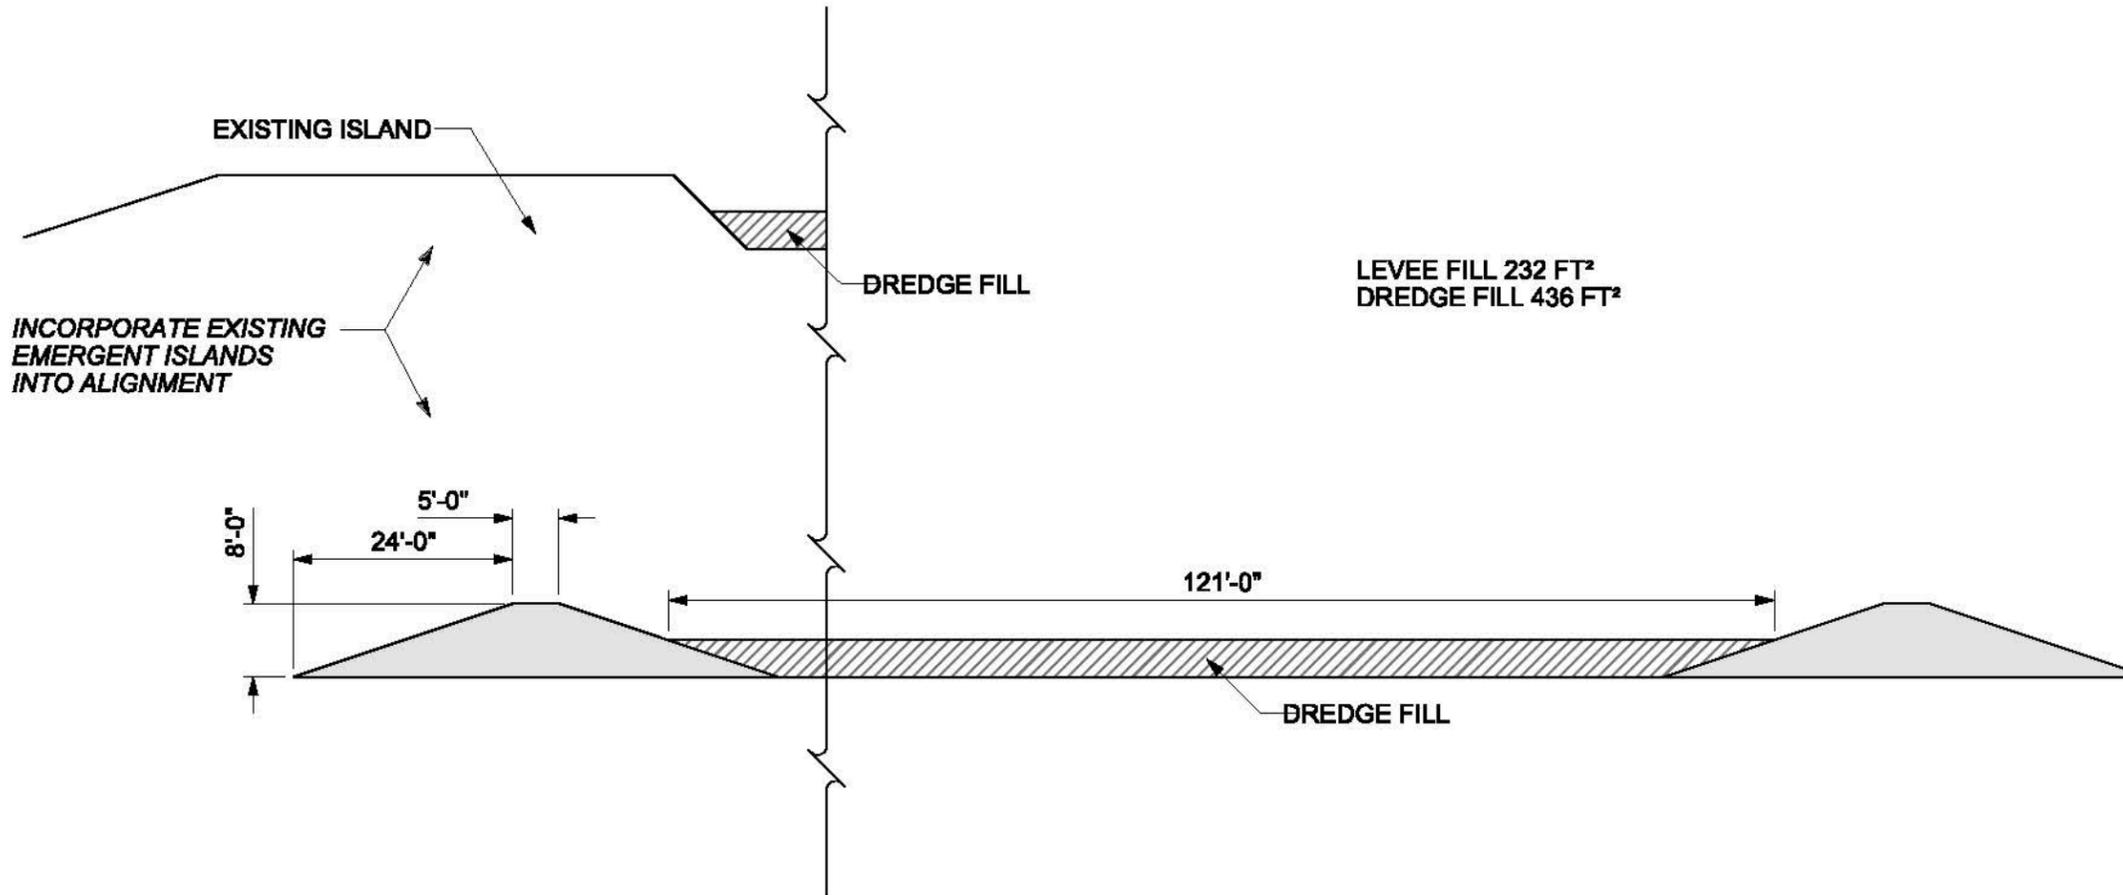
Typical Section S-13: GIWW Shore Protection Island Restoration

- Measure:
- 6-1.2
 - 6-3
 - 6-4.2
 - 6-5.2 (Existing Islands)
 - 6-5.3 (Existing Islands)
 - 6-6.2
 - 7-3 (Existing Islands)

- ASSUMPTIONS:**
- 1: LEVEE FILL IS LOOSELY PLACED NON COMPACTED
 - 2: LEVEE FILL IS SIDE CAST FROM ACCESS CHANNEL CONSTRUCTION
 - 3: LEVEE TEMPLATE IS FOUNDED ON THE -4FT CONTOUR
 - 4: DREDGE FILL IS A UNIFORM 4FT THICKNESS
 - 5: VOLUME IS BASED ON CROSS SECTION AREA MULTIPLIED BY LENGTH
 - 6: INCORPORATE EXISTING EMERGENT ISLANDS INTO ALIGNMENT

- Levee fill is side cast from access channel construction and loosely placed non-compacted shaped to levee template.
- Levee template is founded on the -4 foot contour. Length = 33,400 ft.
- Levee volume is based on cross sectional area multiplied by total length. Volume = 286,993 CY.
- Quantities are neat line, settlement not accounted for.
- Access channel is 9 feet deep and 50 feet wide with 1:1 side slopes, excavated material used for levee template.
- Containment levee can tie into existing islands.
- Island area is 27 and interior dredge fill is 4 feet deep. The area fill volume is 332,037 CY.
- Island dredge fill from maintenance material from Channel to Liberty along side of island and 12,000 LF on each side.
- No erosion protection applied to outside of levees.

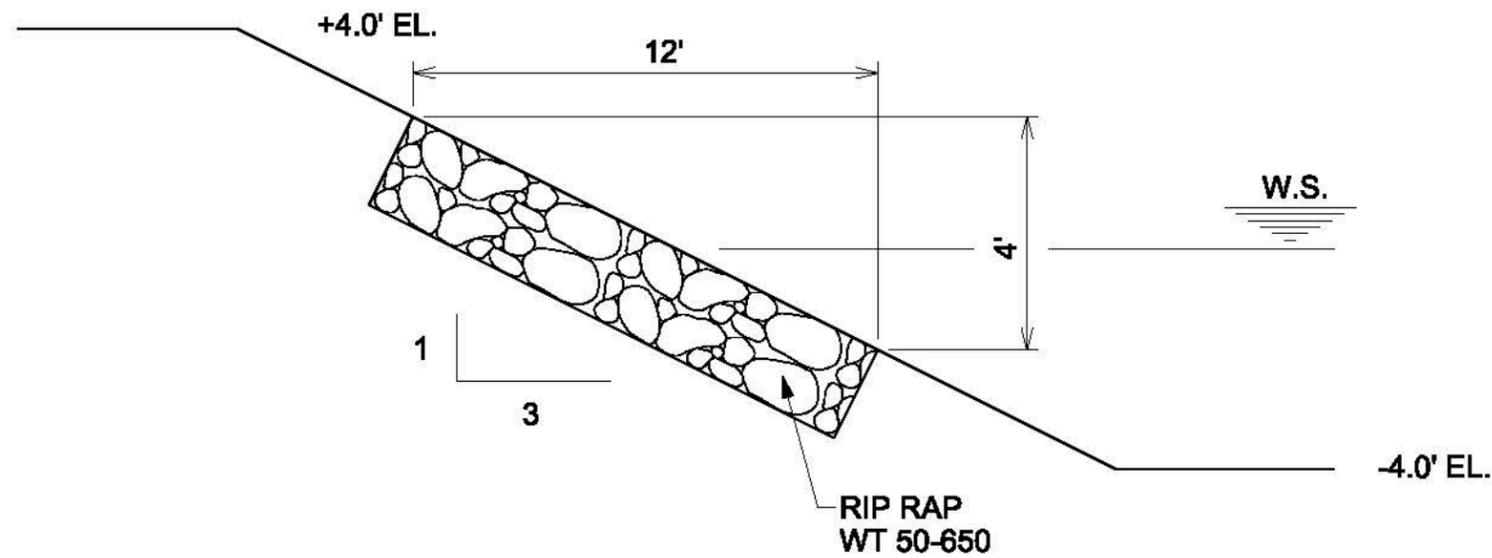
Typical Section S-14: Levee Armor

- Measures:
6-5.2
6-5.3
6-6.2

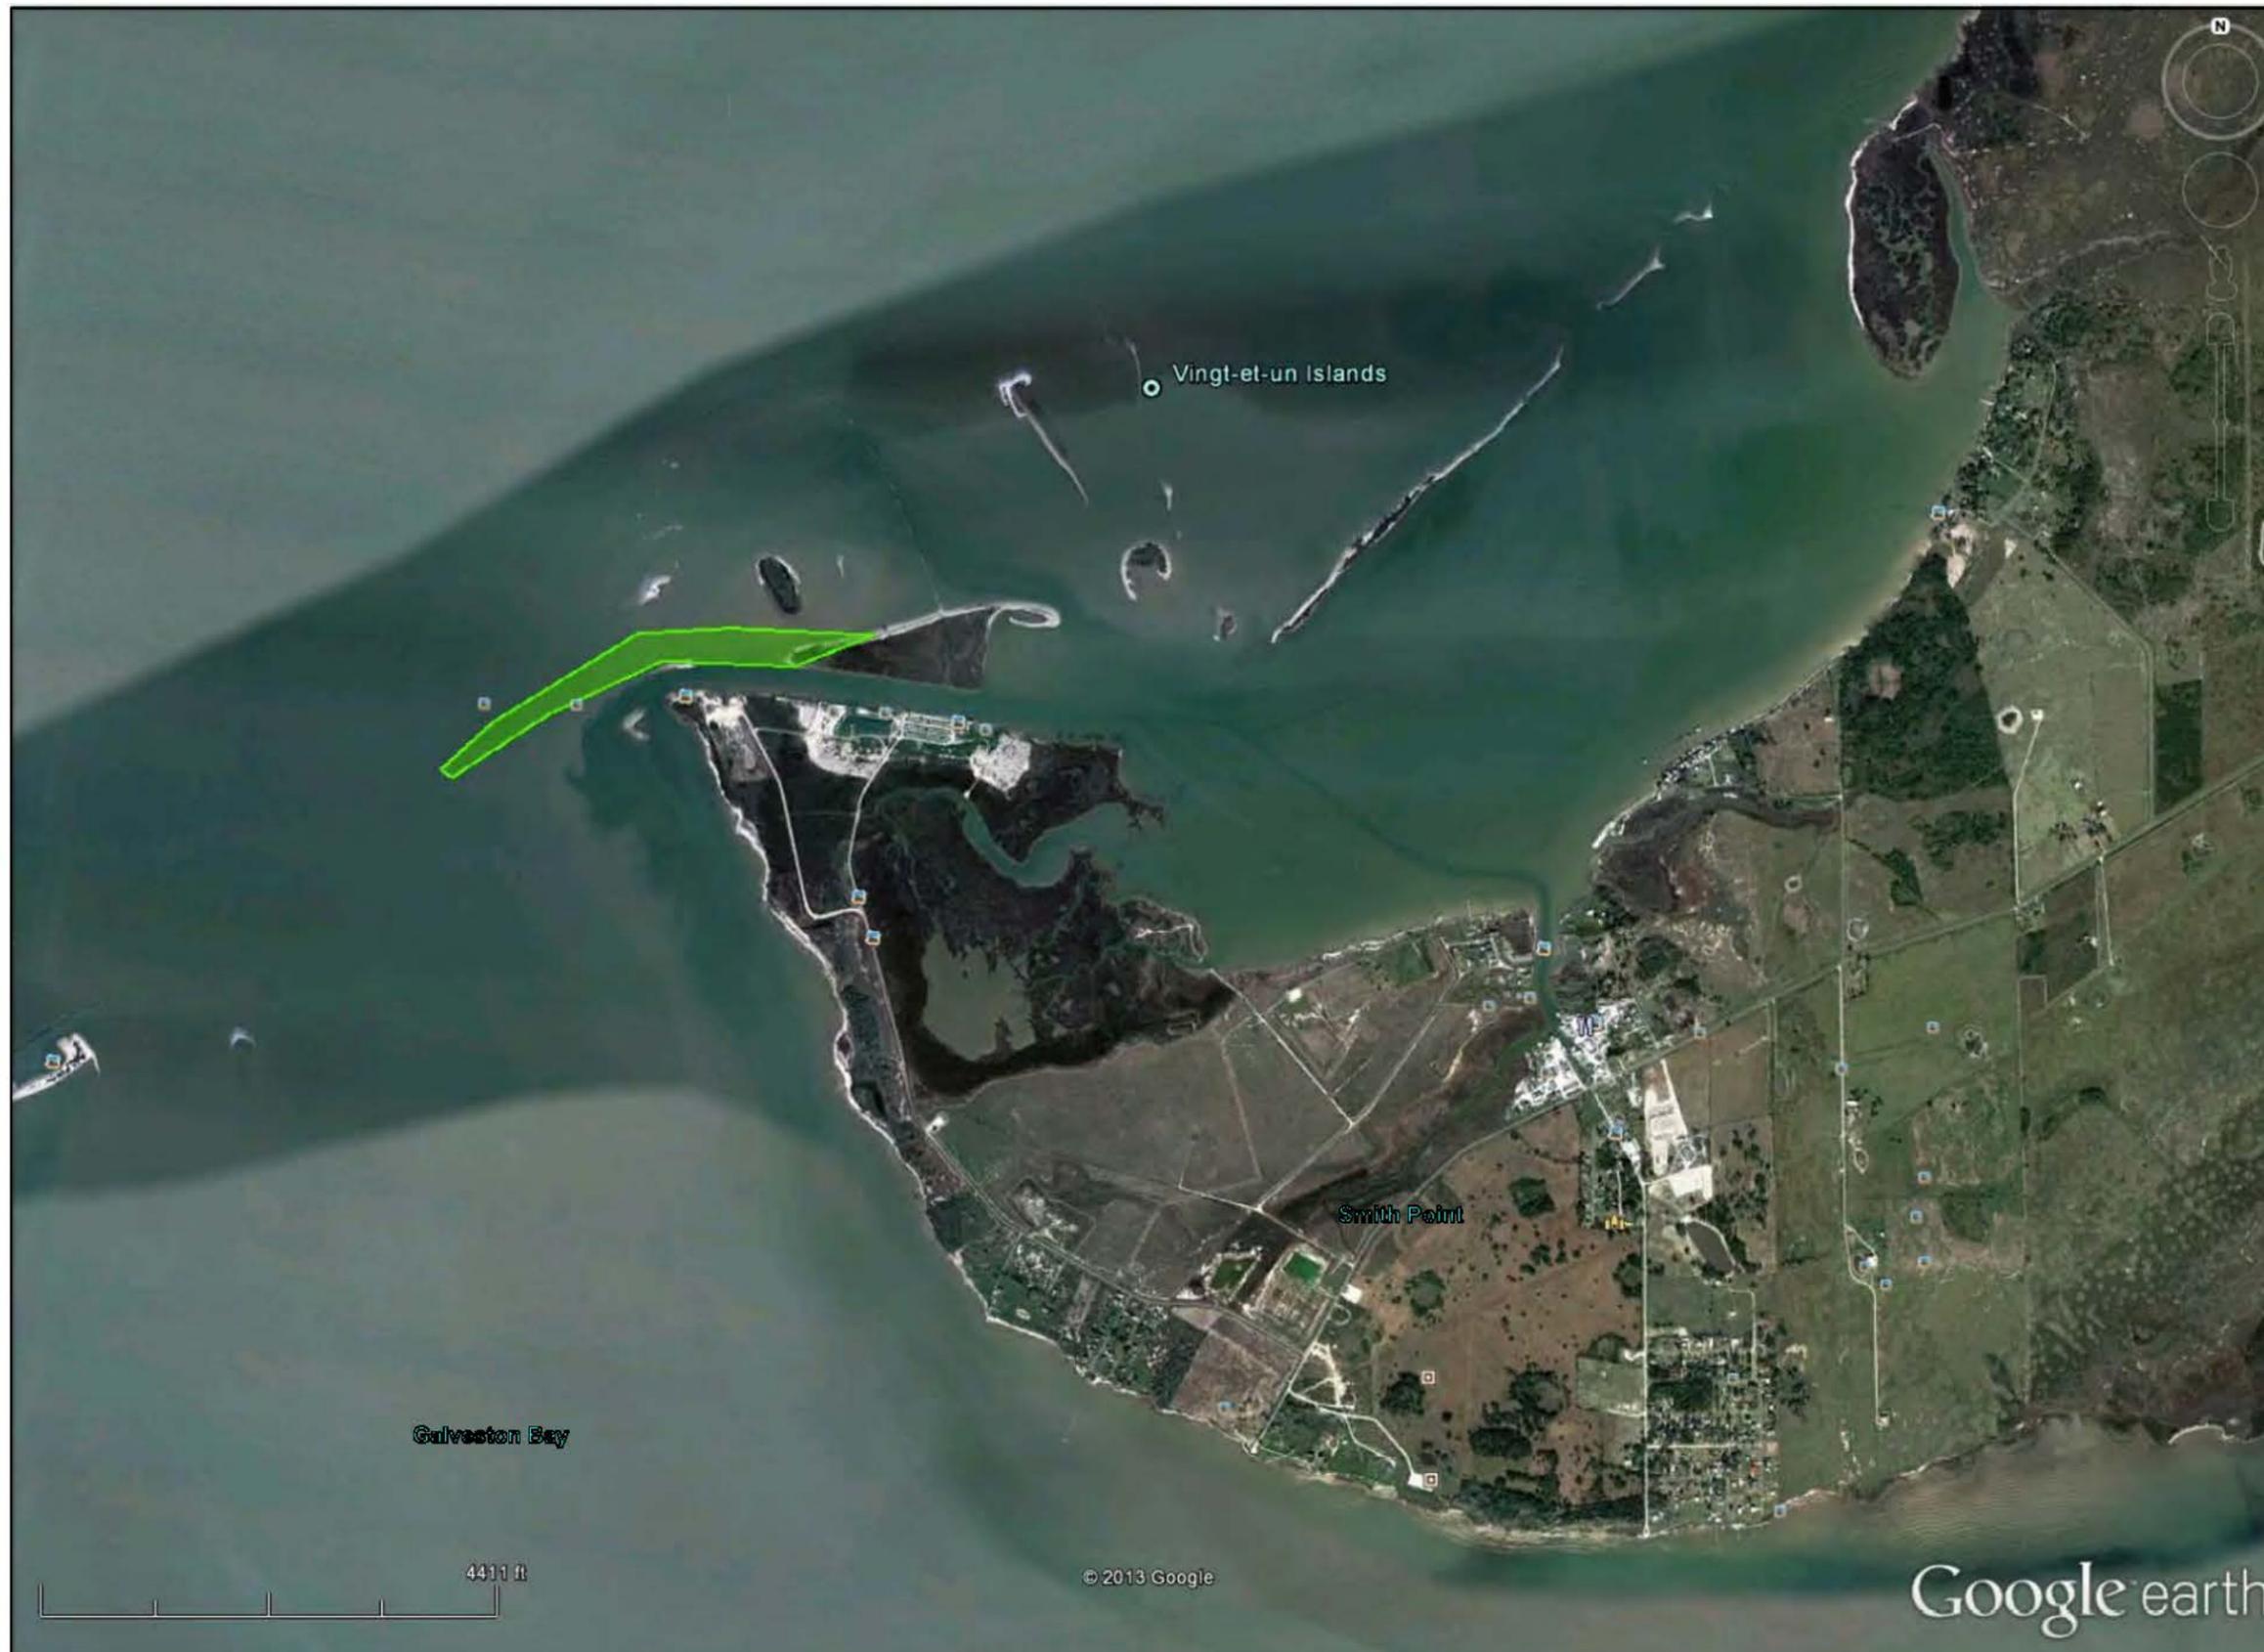
Measure 7-3: Island Restoration, Vingt-et-un, Chambers County

- ASSUMPTIONS:**
- 1: LEVEE FILL IS LOOSELY PLACED NON COMPACTED
 - 2: LEVEE FILL IS SIDE CAST FROM ACCESS CHANNEL CONSTRUCTION
 - 3: LEVEE TEMPLATE IS FOUNDED ON THE -4FT CONTOUR
 - 4: DREDGE FILL IS A UNIFORM 4FT THICKNESS
 - 5: VOLUME IS BASED ON CROSS SECTION AREA MULTIPLIED BY LENGTH
 - 6: INCORPORATE EXISTING EMERGENT ISLANDS INTO ALIGNMENT

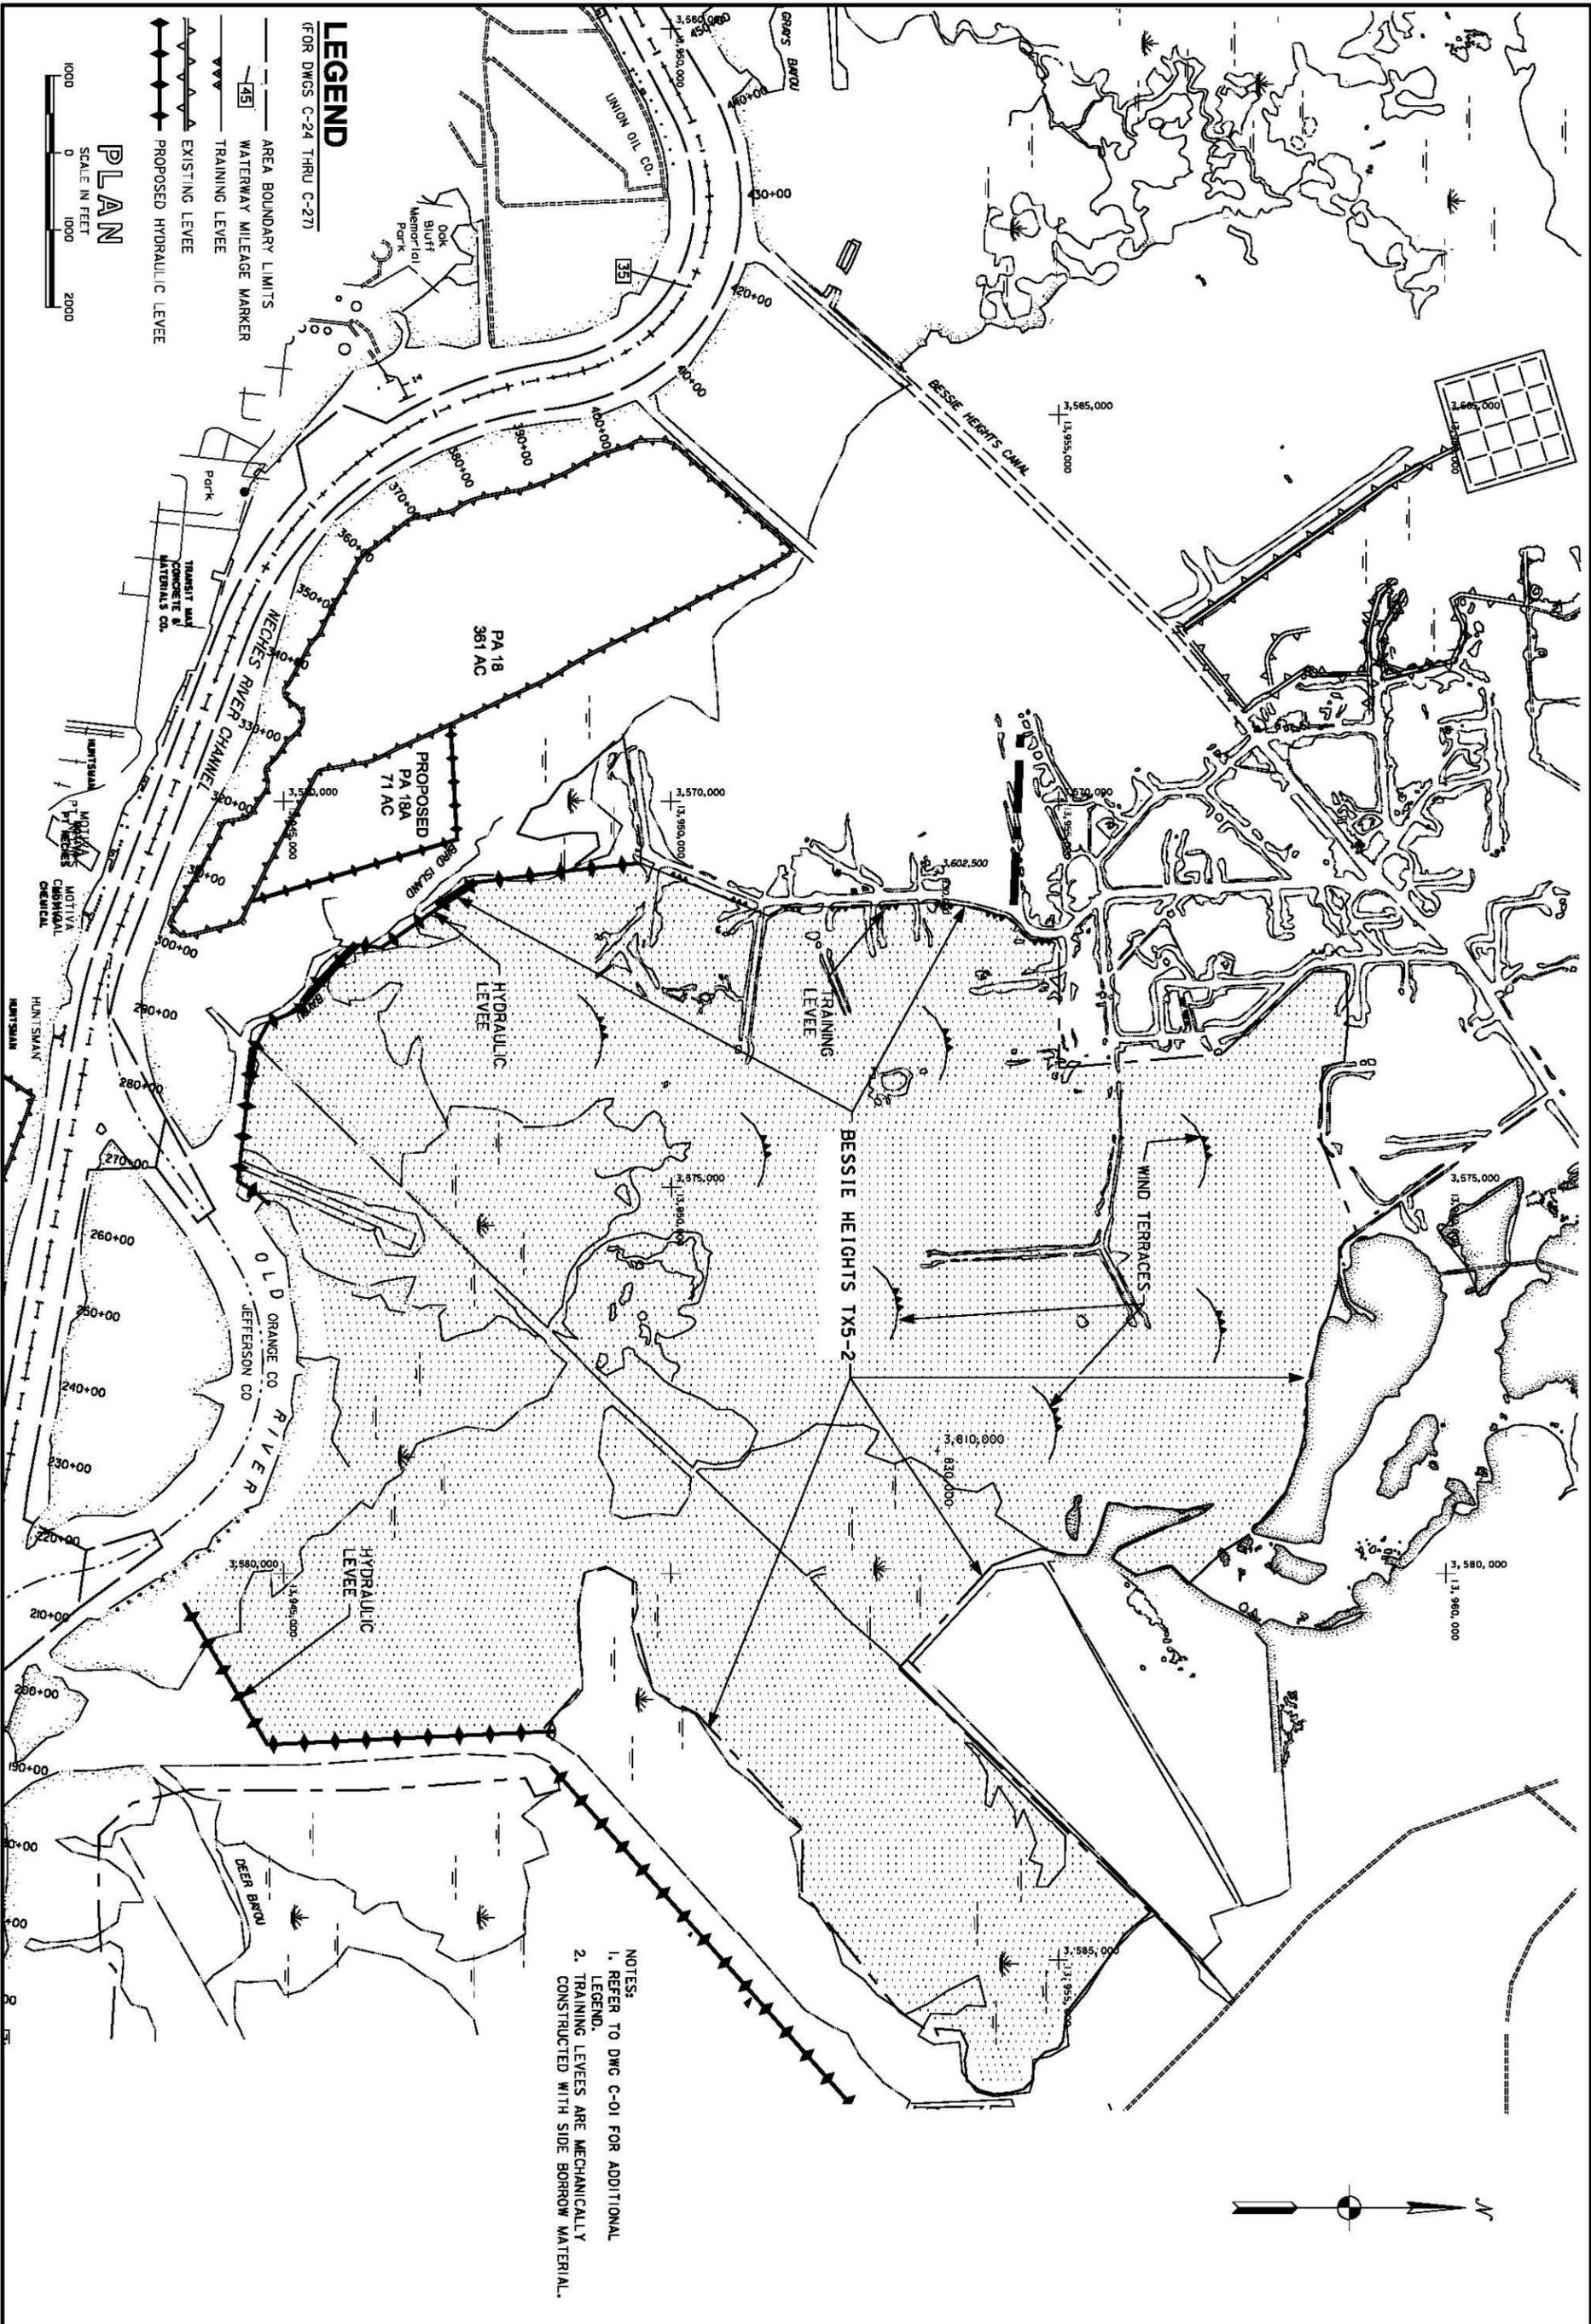
- (FOR DWGS C-24 THRU C-27)
- AREA BOUNDARY LIMITS
- WATERWAY MILEAGE MARKER
- TRAINING LEVEE
- EXISTING LEVEE
- PROPOSED HYDRAULIC LEVEE

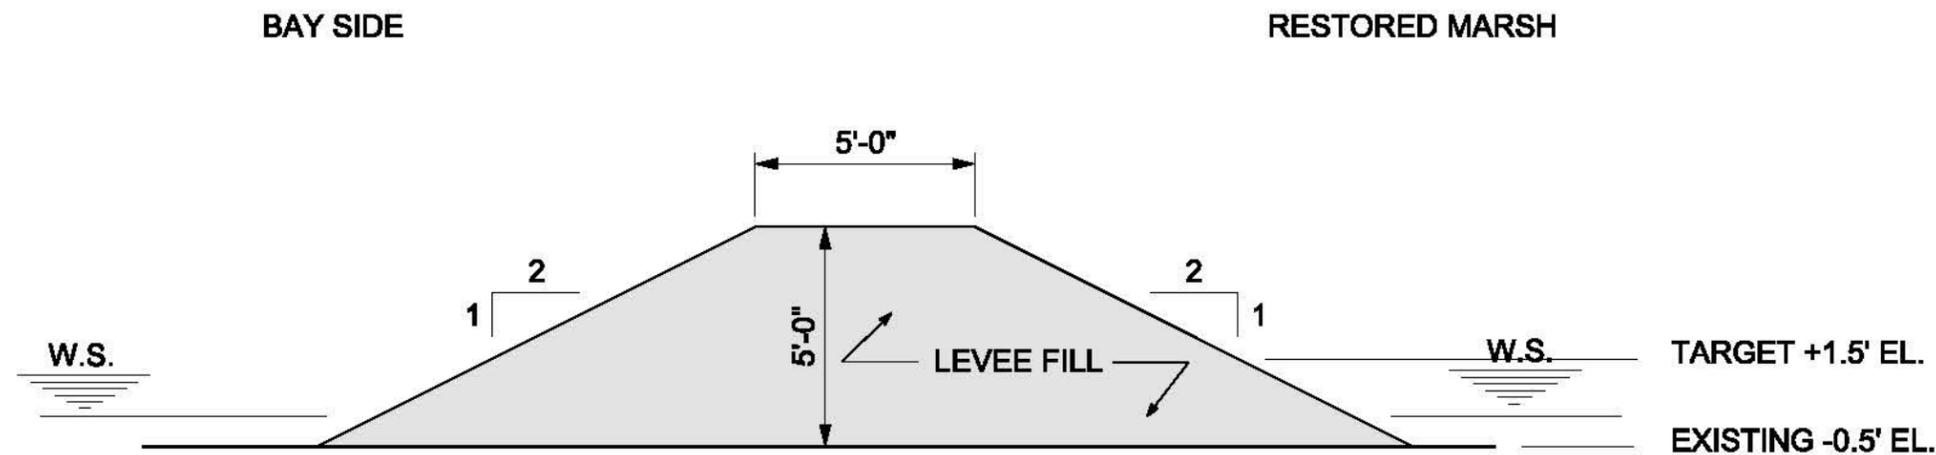
Typical Section S-16: Marsh Restoration Containment Levee

- 1: CONTAINMENT LEVEE FILL OBTAINED FROM ONSITE BORROW AREA
- 2: RESTORED MARSH FILL HYDRAULICALLY PUMPED
- 3: CONTAINMENT LEVEE FOUNDED ON -0.5' CONTOUR

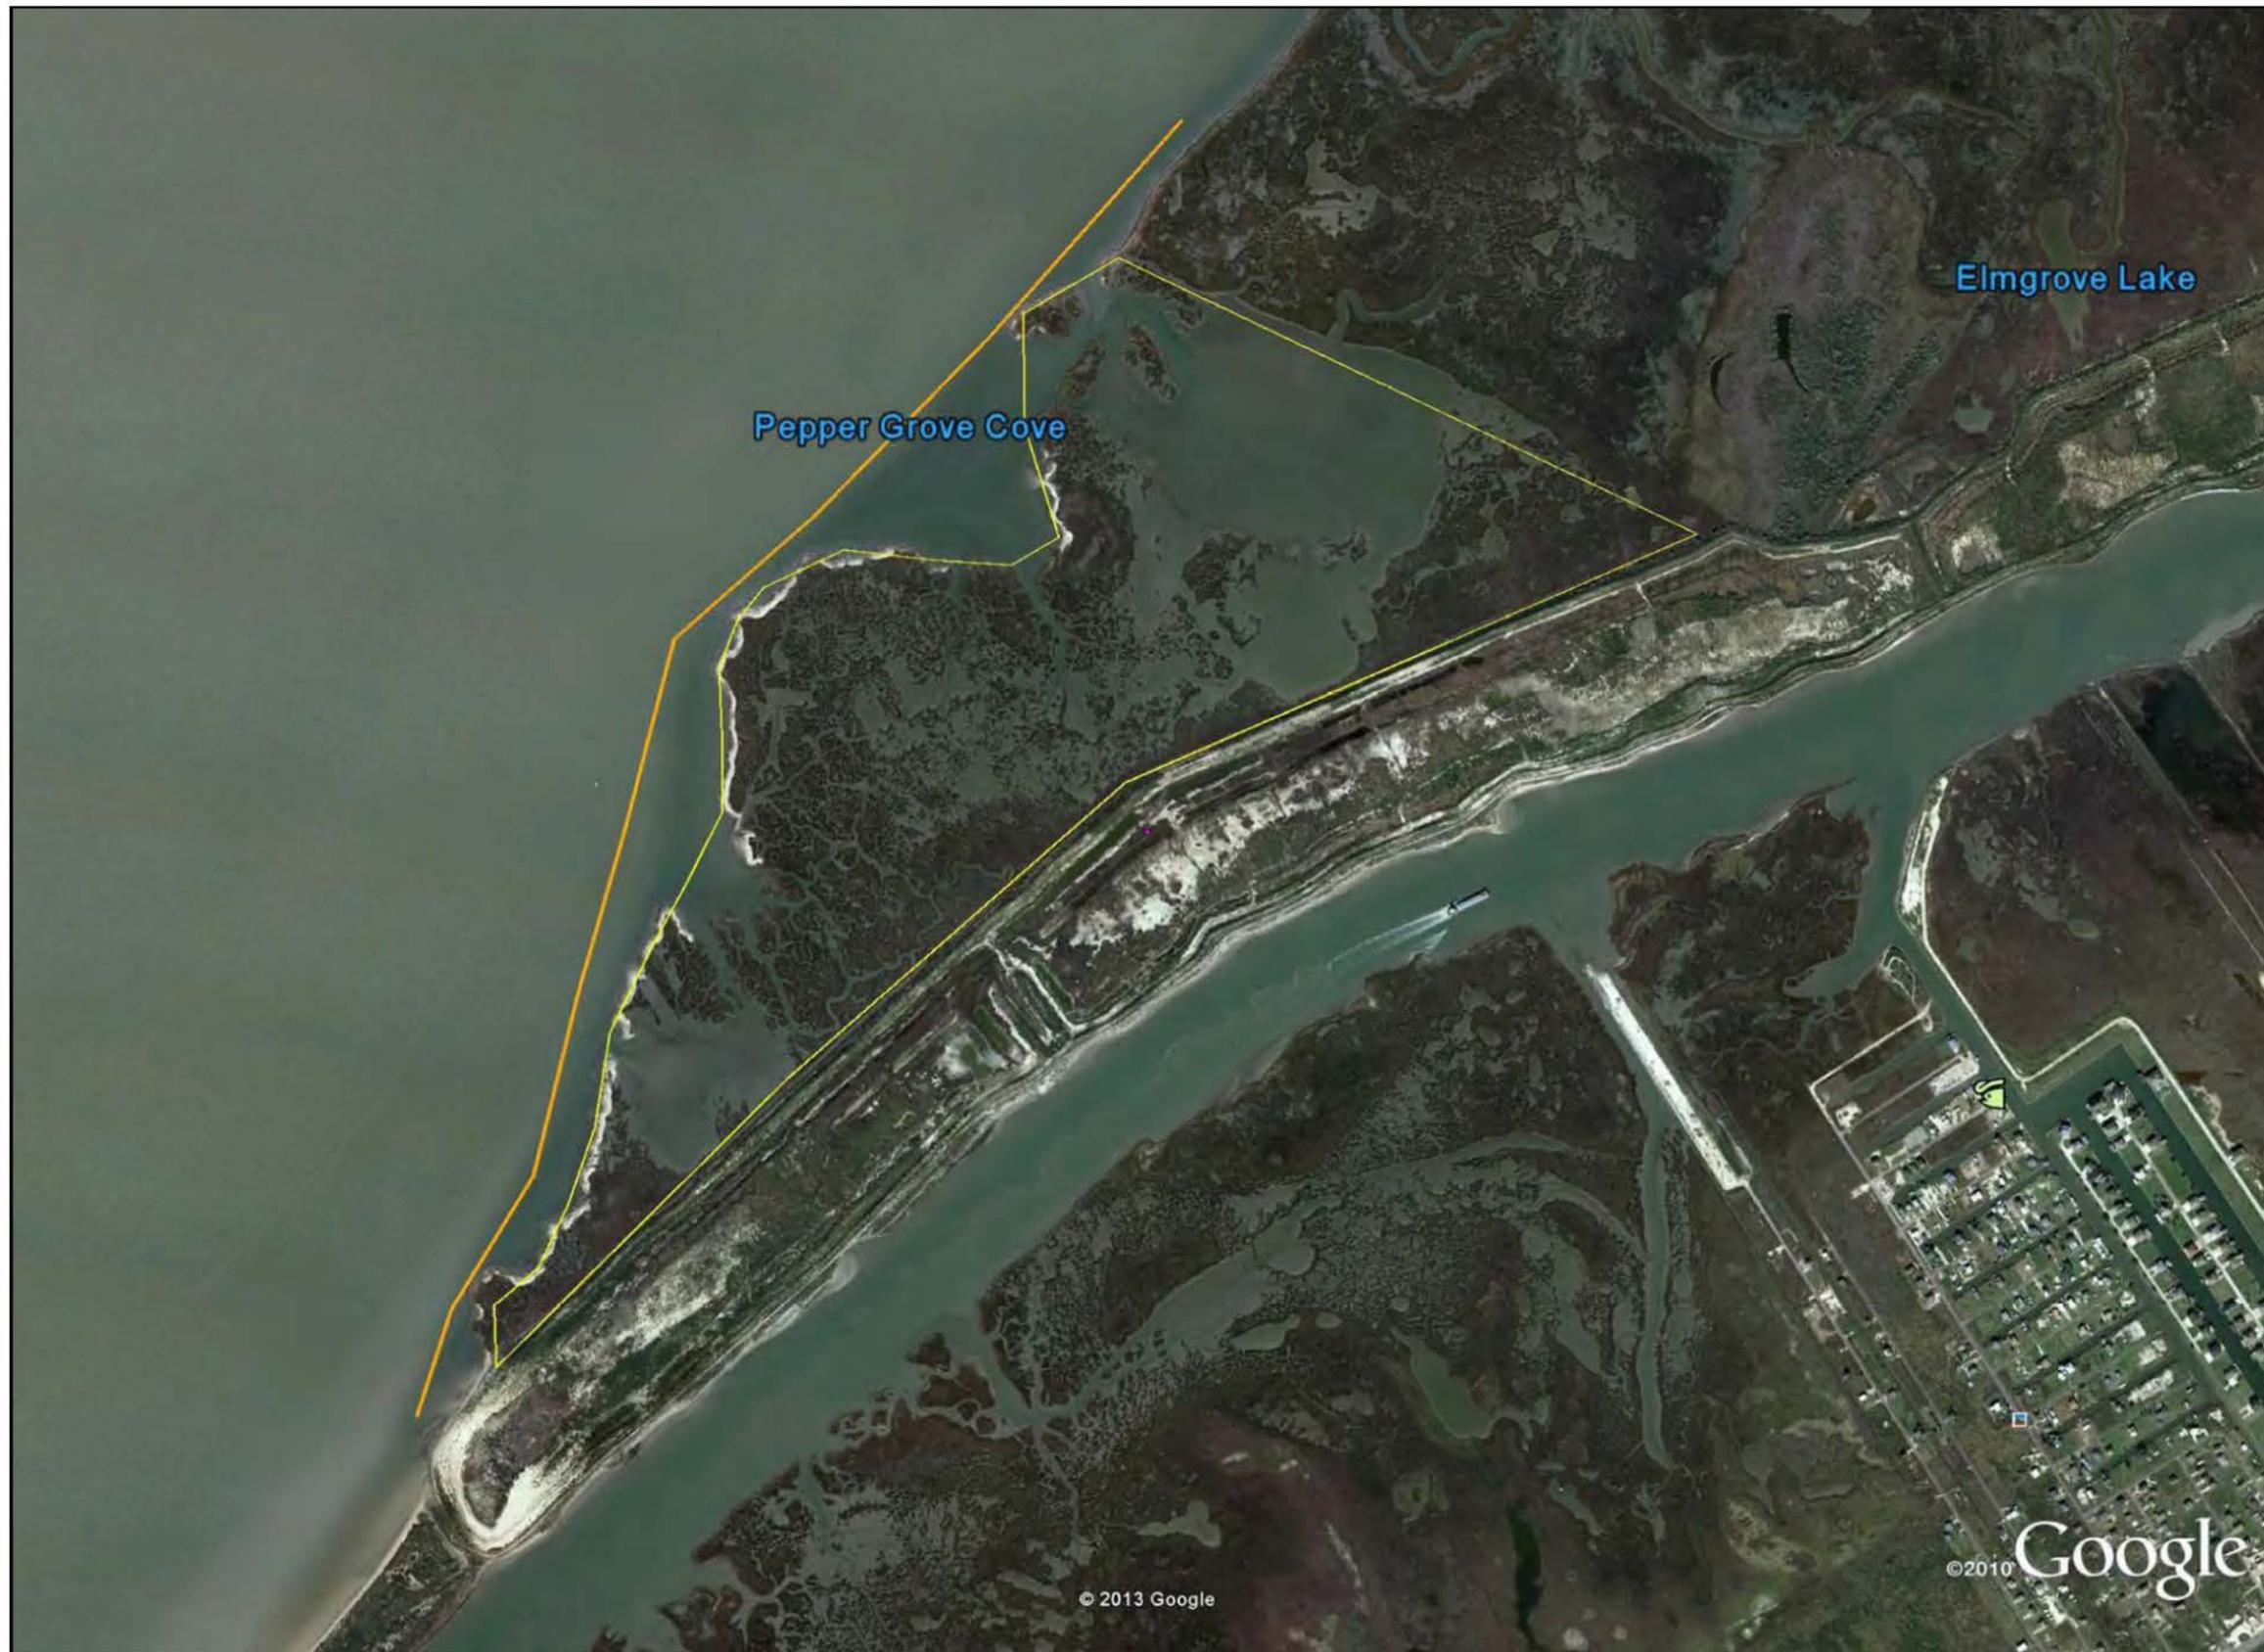
Measure 8-4.1: Marsh Restoration, Pepper Grove Cove, Galveston County

- Marsh Restoration
- Shoreline Protection
