SABINE PASS TO GALVESTON BAY, TEXAS
MEASURE 5-10
INFORMATION SHEET

DESCRIPTION OF MEASURE: 5-10 Closing of Rollover Pass, Galveston County

Sabine Pass to Galveston Bay Texas, Coastal Storm Risk Management and Ecosystem Restoration Feasibility Study

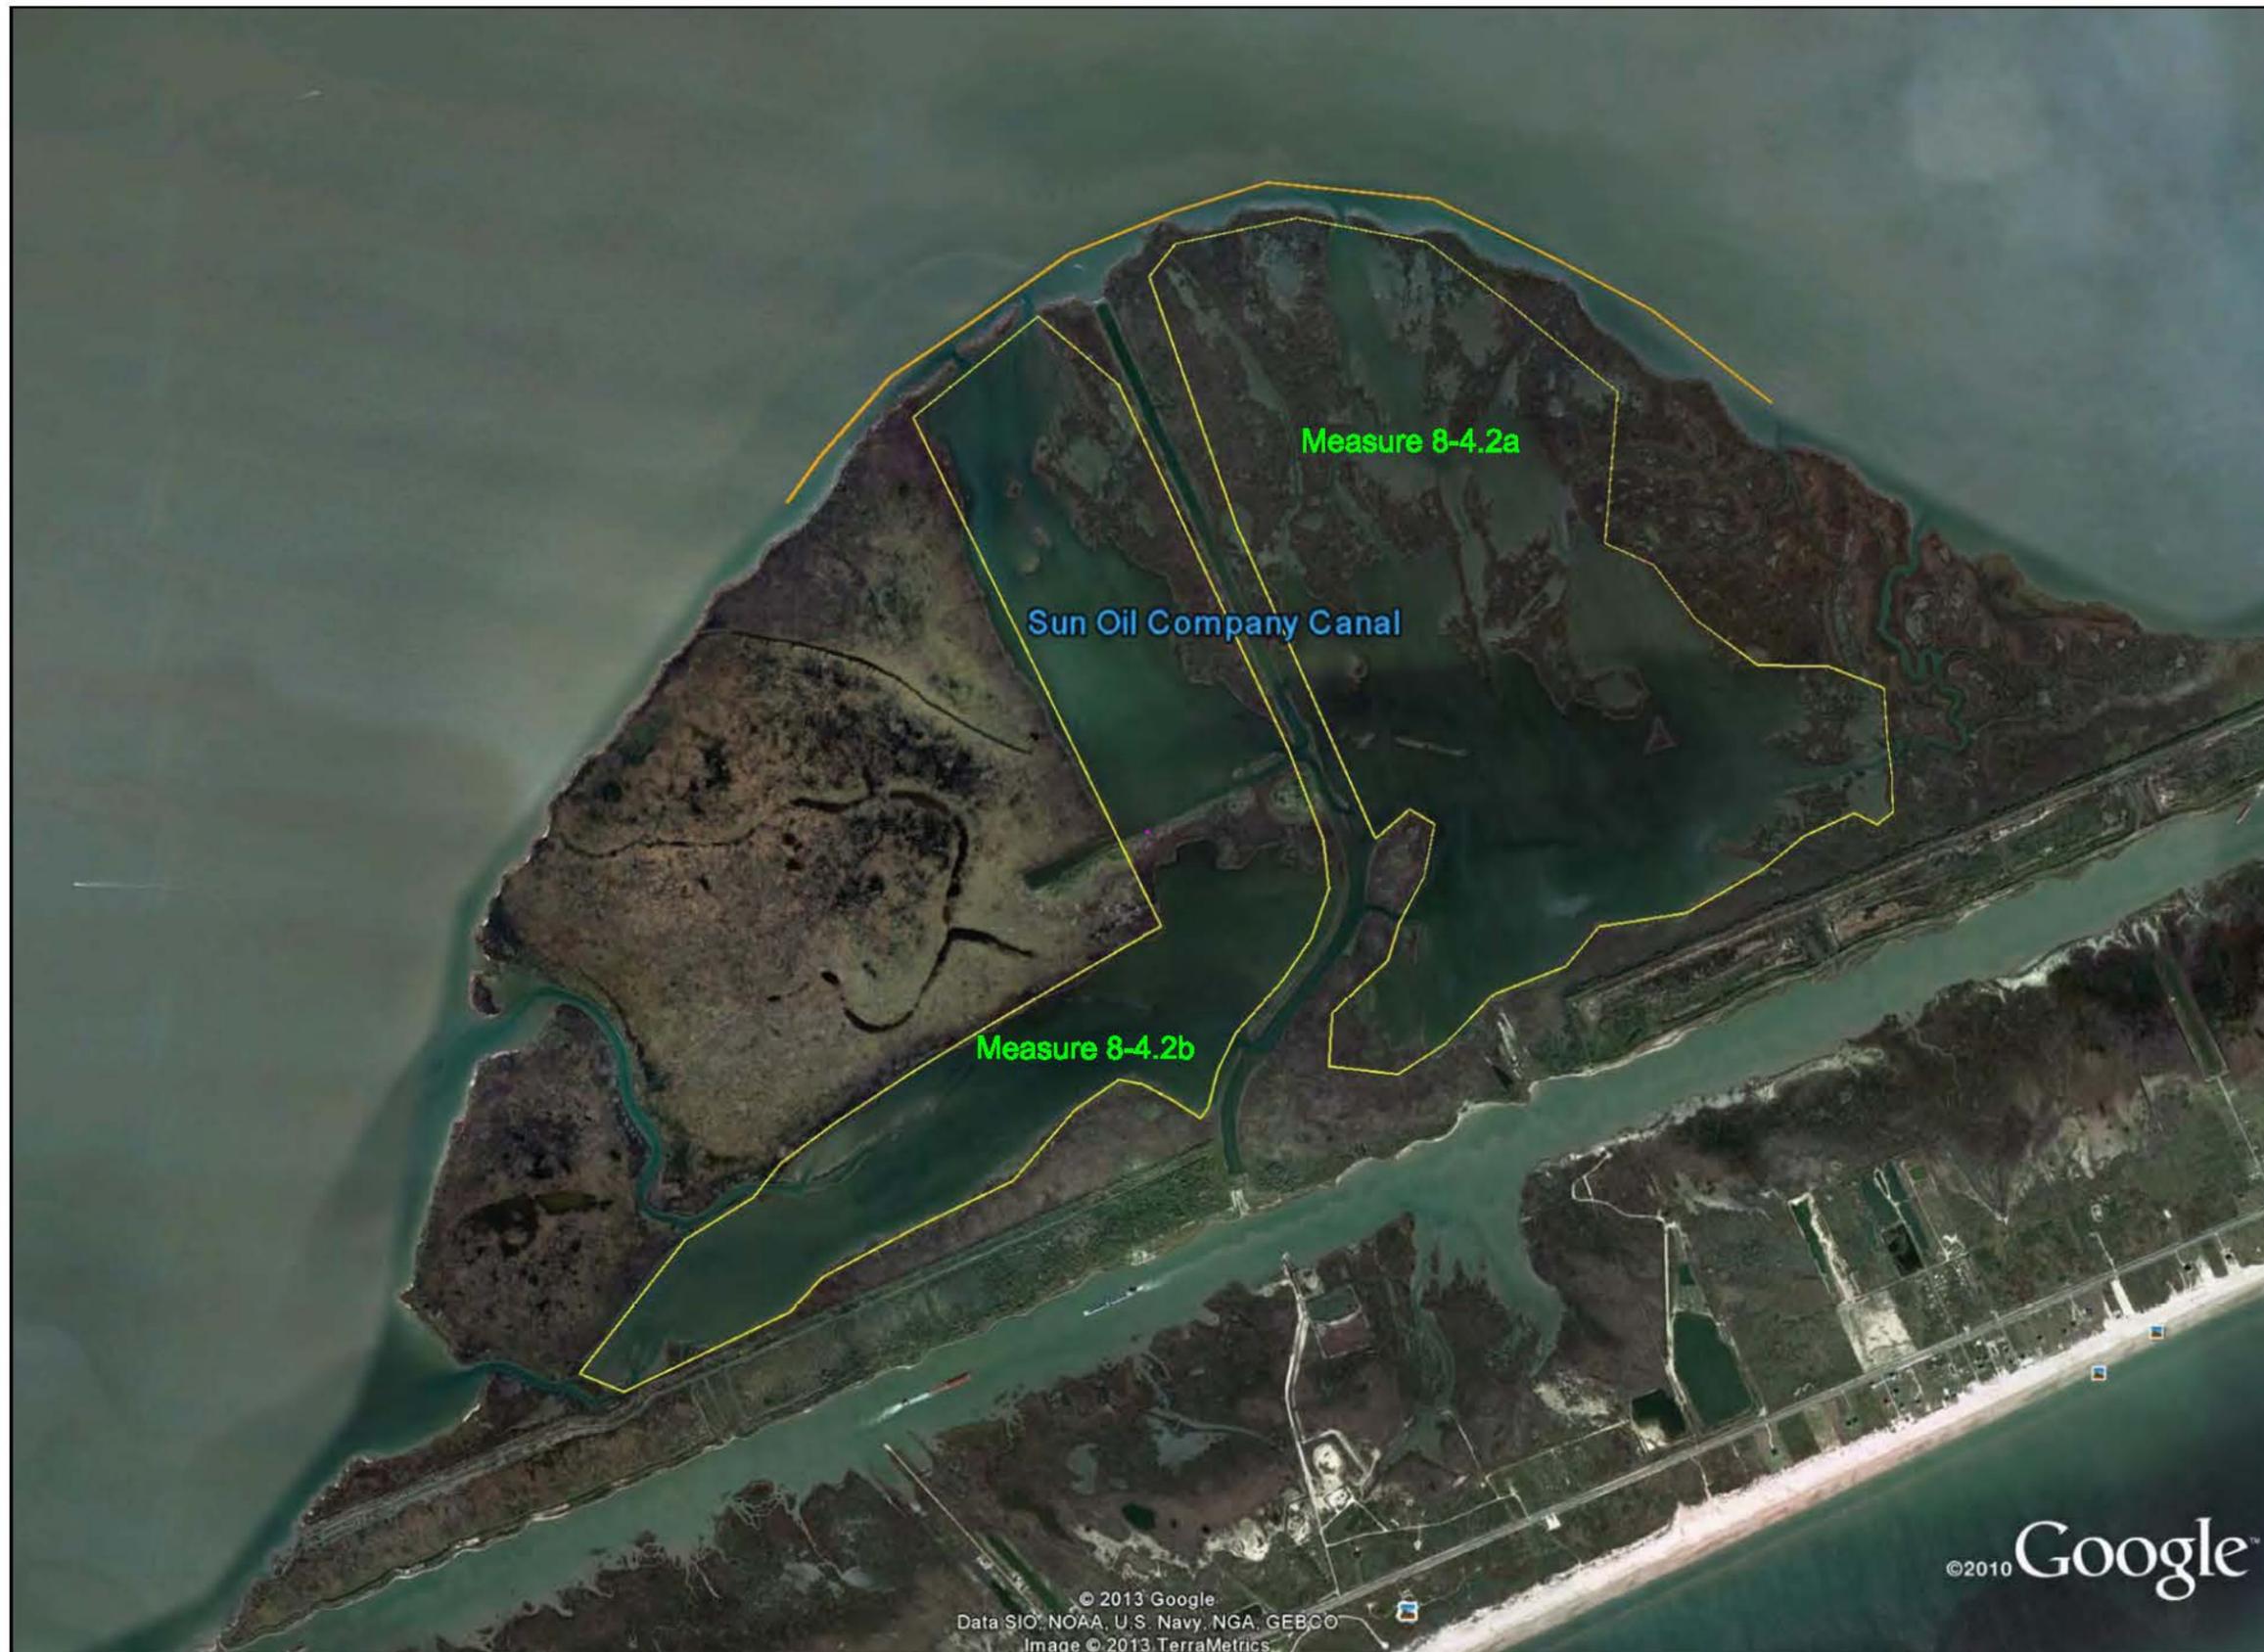
Measure 8-4.2: Marsh Restoration, Long Point Marsh, Galveston County

- Marsh Restoration
- Shoreline Protection

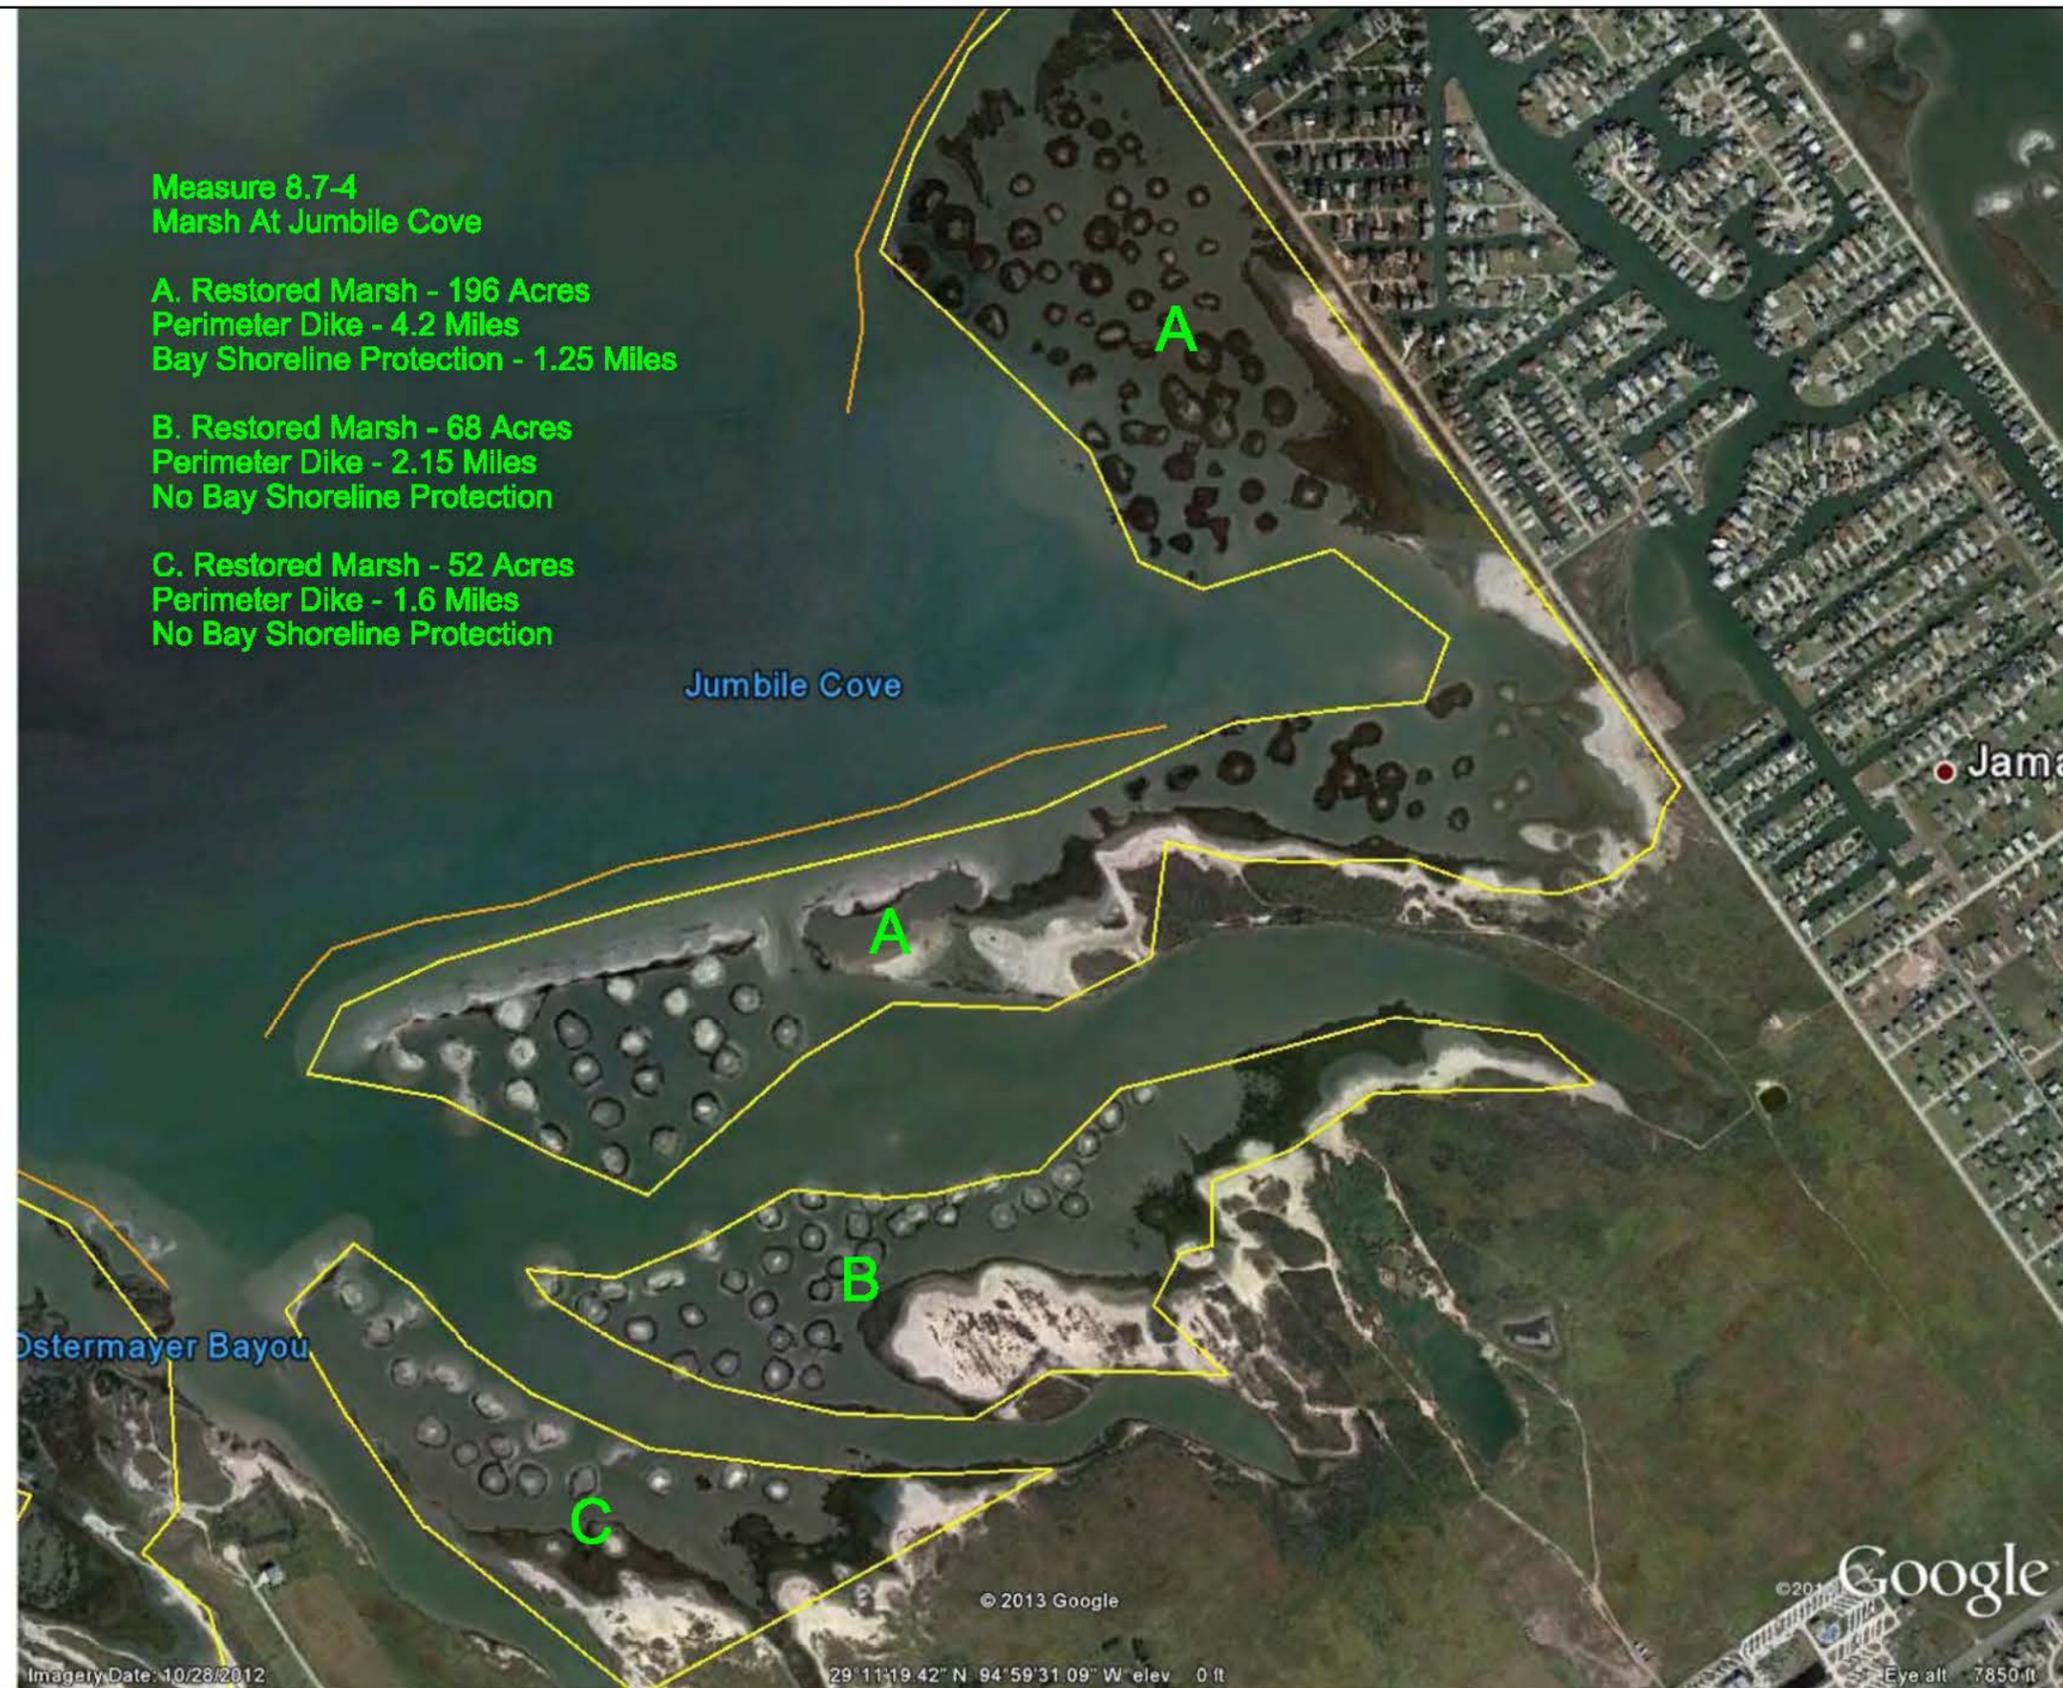
Measure 8-7.4: Marsh Restoration, Jumbile Cove, Galveston County

- Measure 8-7-4**
Marsh At Jumbile Cove
- A. Restored Marsh - 196 Acres**
Perimeter Dike - 4.2 Miles
Bay Shoreline Protection - 1.25 Miles
 - B. Restored Marsh - 68 Acres**
Perimeter Dike - 2.15 Miles
No Bay Shoreline Protection
 - C. Restored Marsh - 52 Acres**
Perimeter Dike - 1.6 Miles
No Bay Shoreline Protection

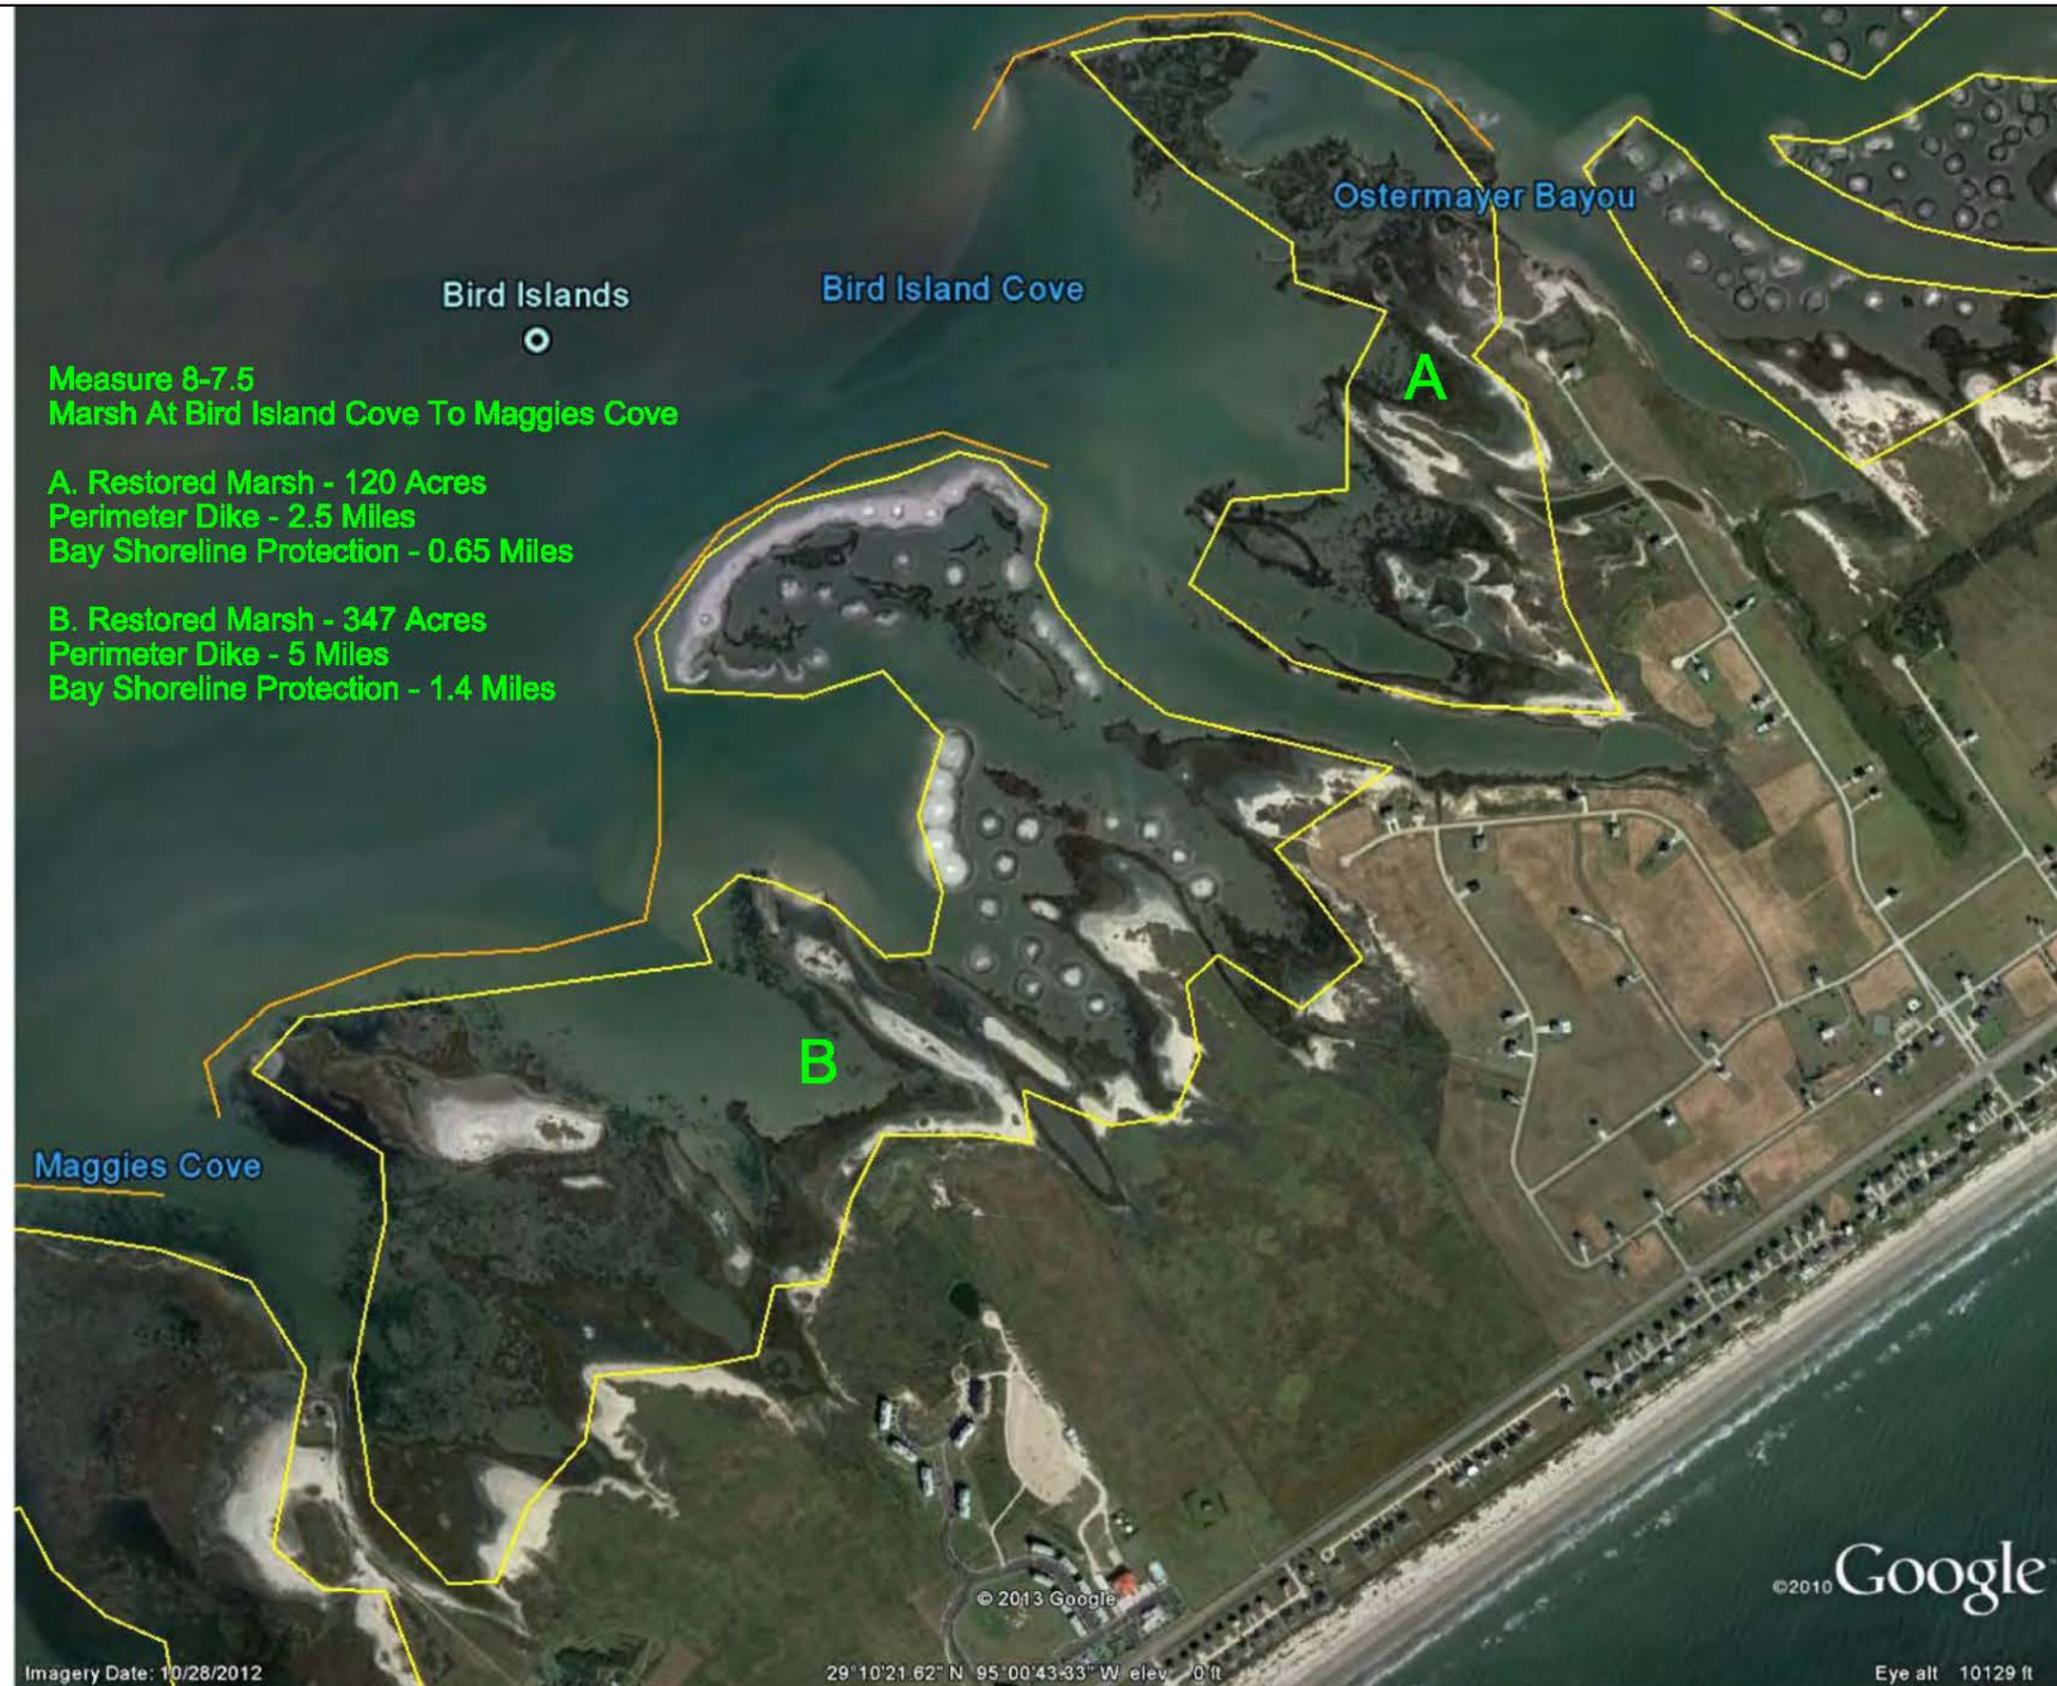
Measure 8-7.5: Marsh Restoration, Bird Island to Maggies Cove, Galveston County

Measure 8-7.5
Marsh At Bird Island Cove To Maggies Cove

A. Restored Marsh - 120 Acres
Perimeter Dike - 2.5 Miles
Bay Shoreline Protection - 0.65 Miles

B. Restored Marsh - 347 Acres
Perimeter Dike - 5 Miles
Bay Shoreline Protection - 1.4 Miles

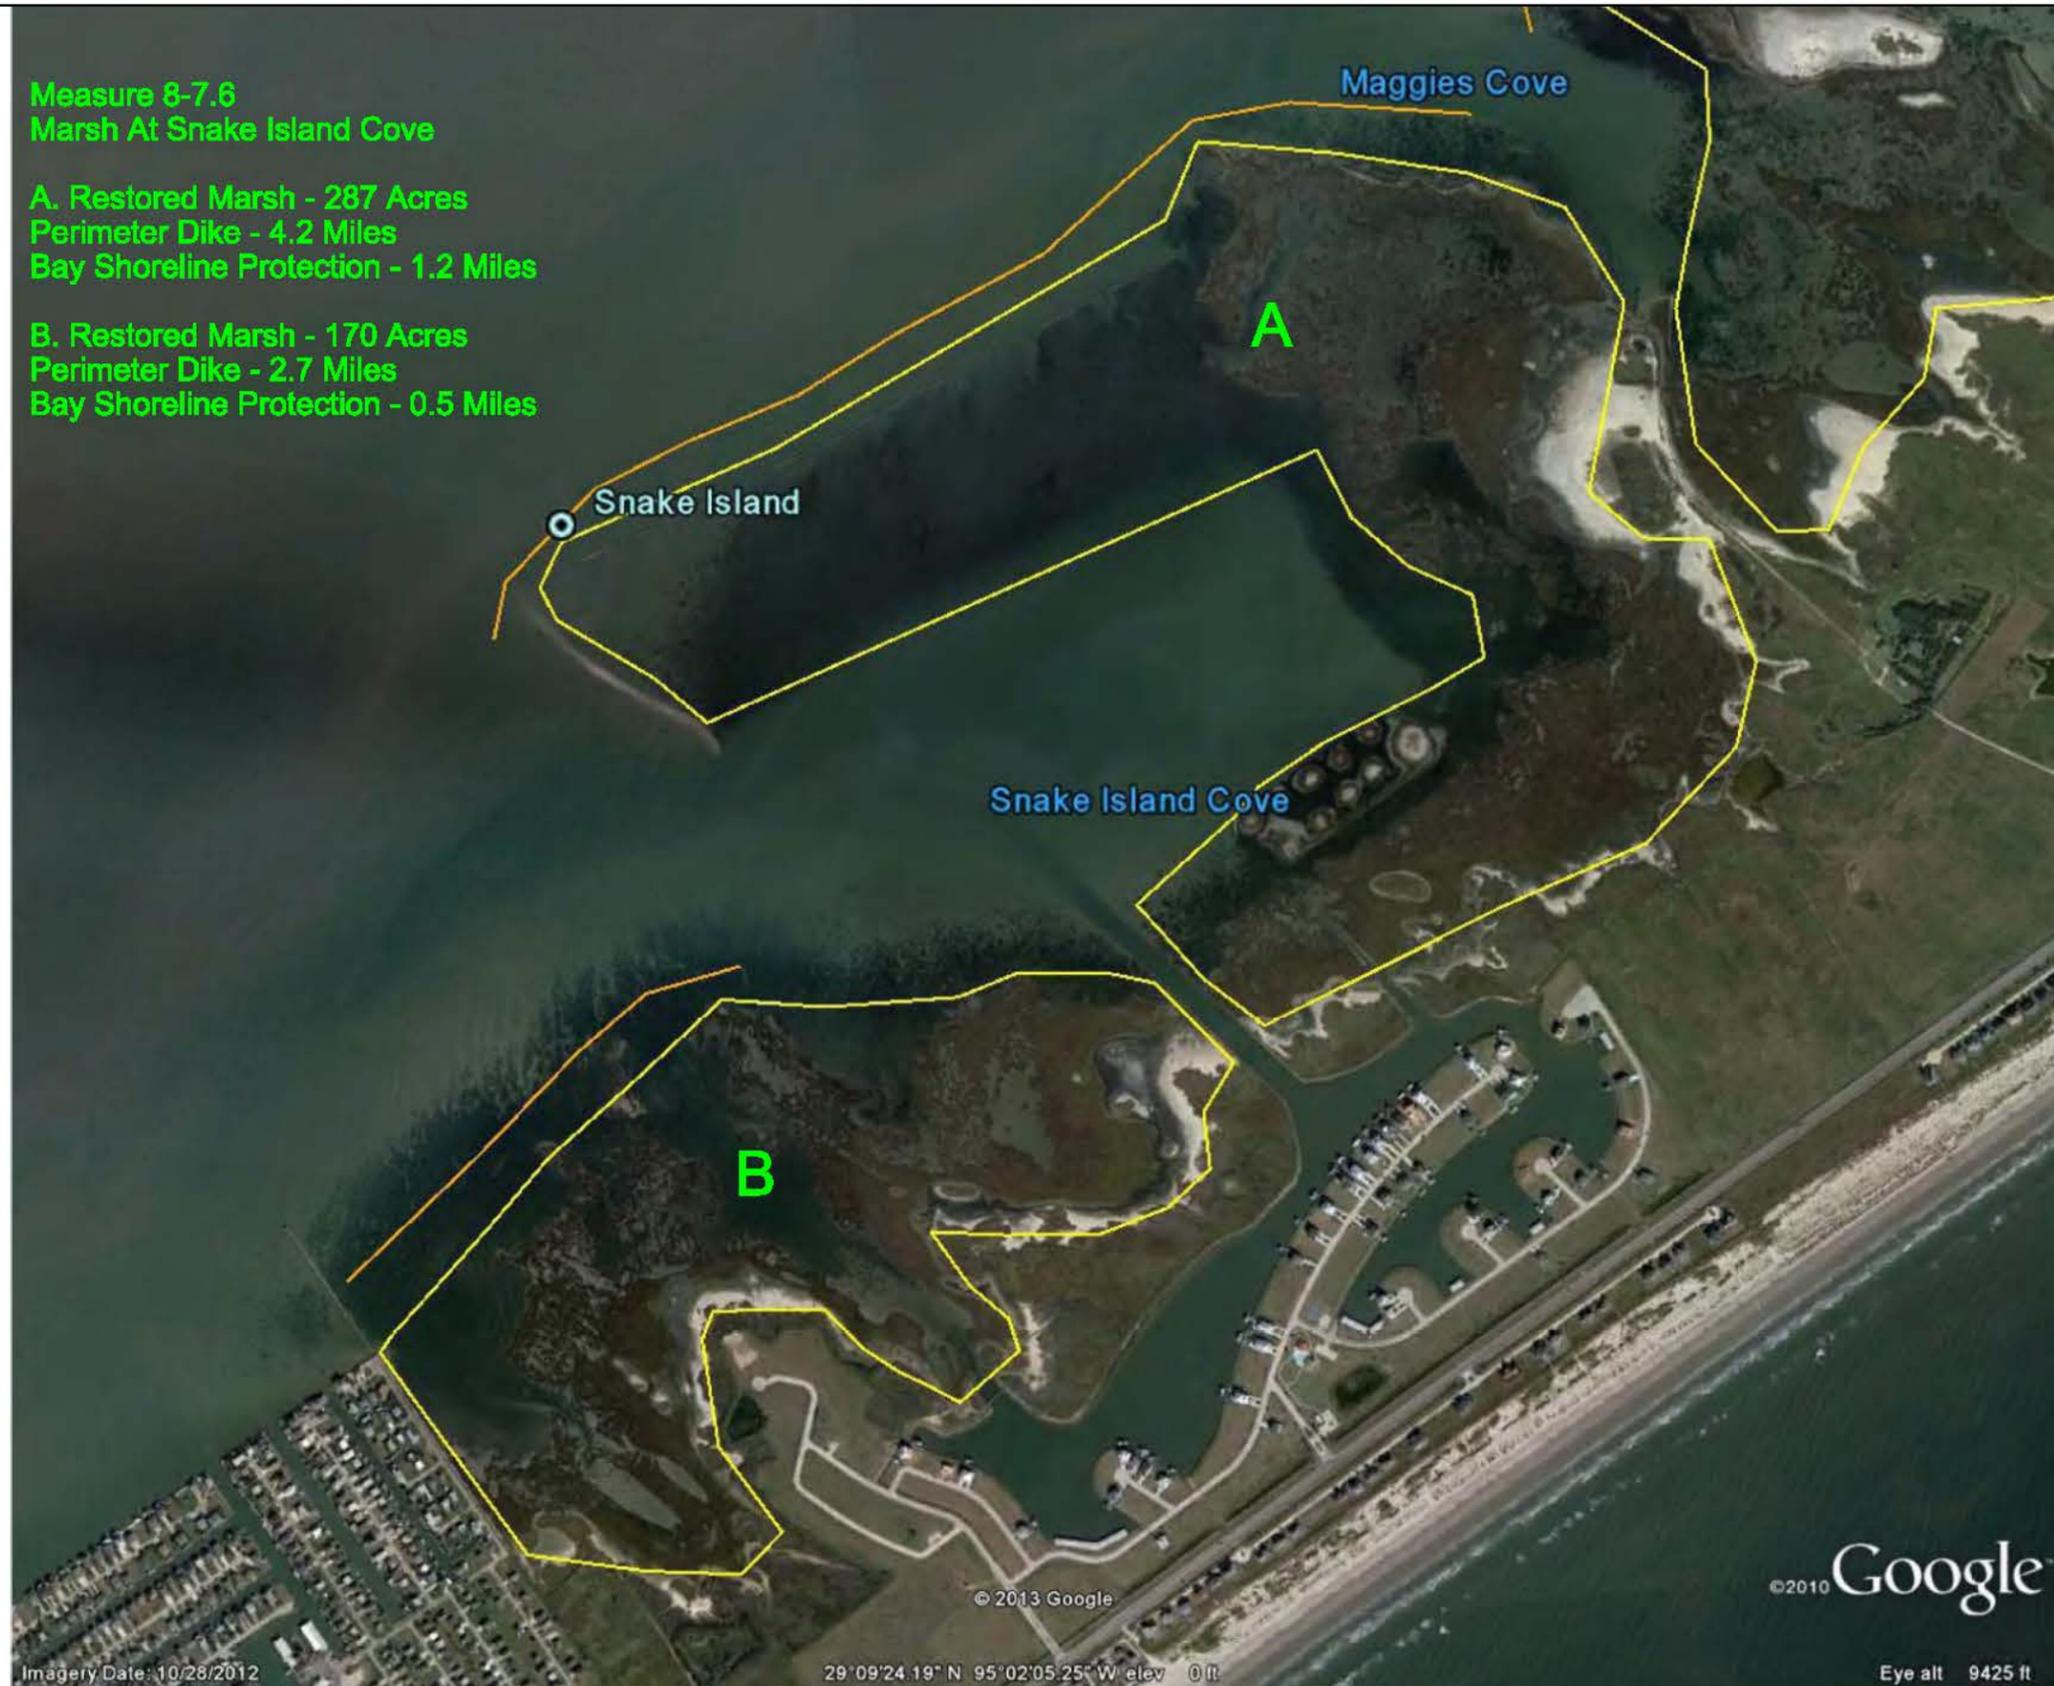
A. Restored Marsh - 287 Acres
Perimeter Dike - 4.2 Miles
Bay Shoreline Protection - 1.2 Miles

B. Restored Marsh - 170 Acres
Perimeter Dike - 2.7 Miles
Bay Shoreline Protection - 0.5 Miles

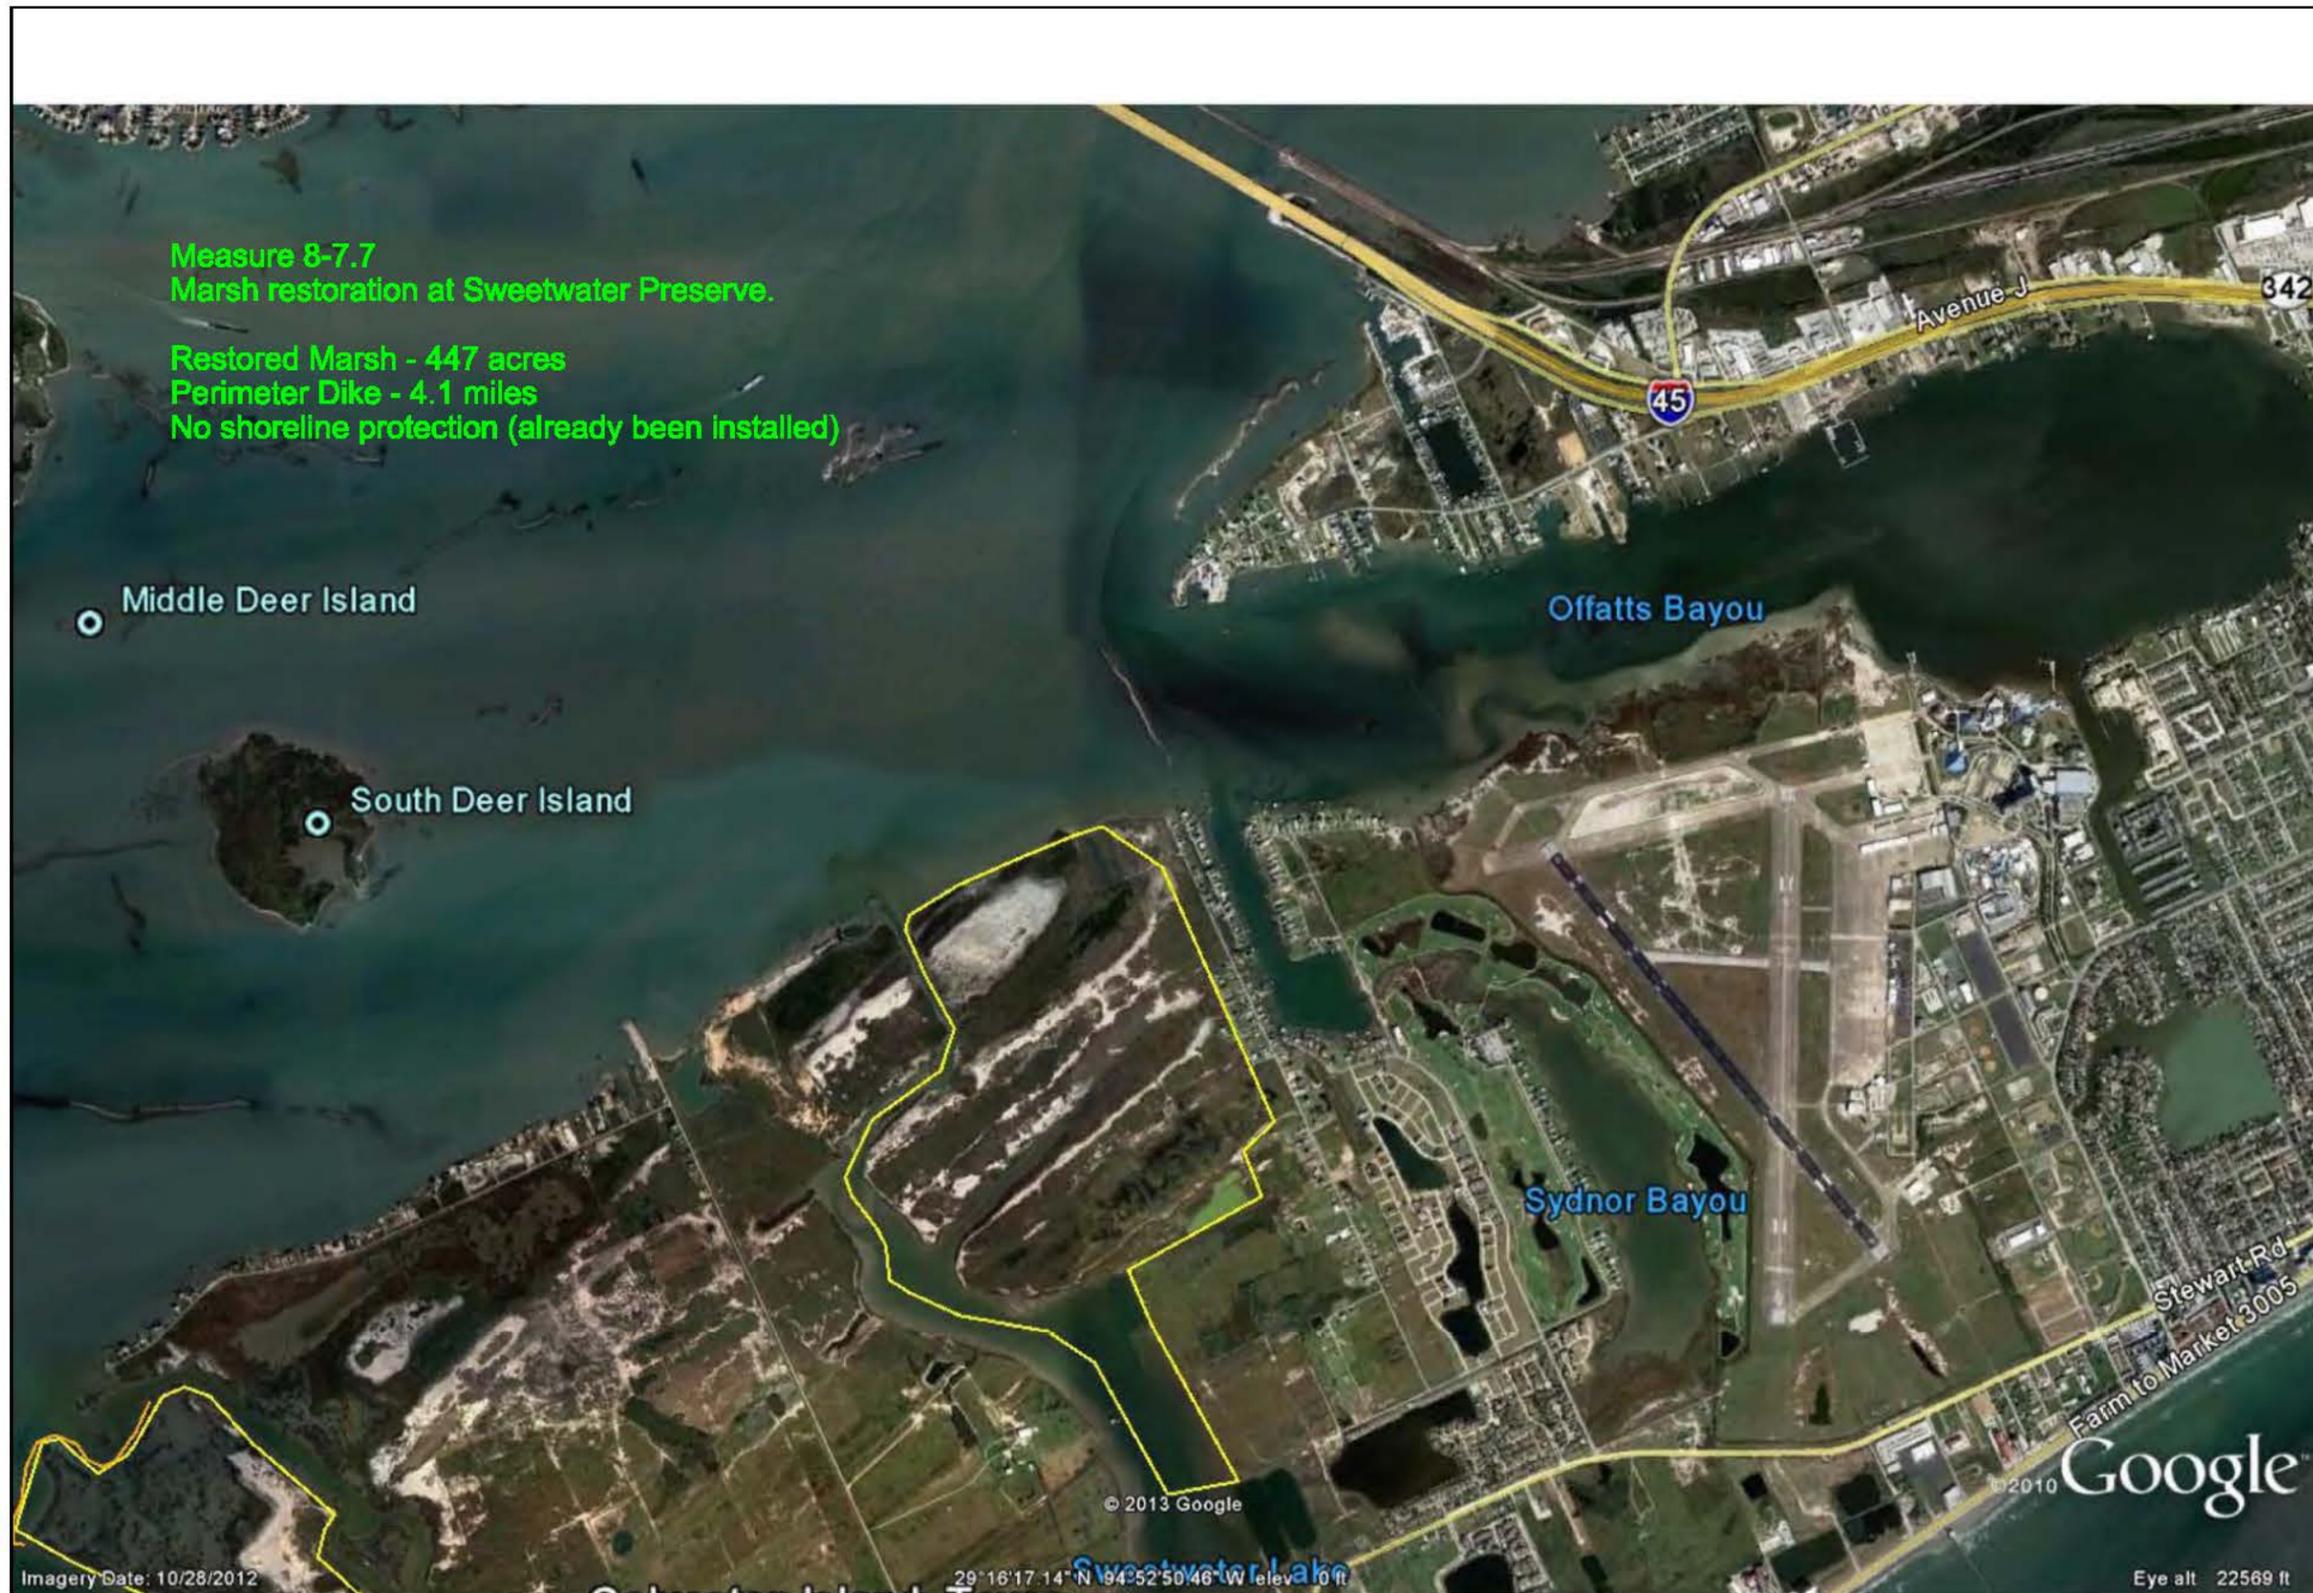
Measure 8-7.7: Marsh and Bayou Restoration, Sweetwater Preserve, Galveston County

Measure 8-7.7
Marsh restoration at Sweetwater Preserve.
Restored Marsh - 447 acres
Perimeter Dike - 4.1 miles
No shoreline protection (already been installed)

- Total area 447 acres, of which 323 acres needs to be degraded an average of two feet to meet target elevation of 1.5' MSL.
- The volume of excavated material is 1,042,300 CY.
- Excavated material moved to remaining portions of work area and used to reduce width of bayou connecting Sweetwater Lake to West Bay.
- Access via local roads, bulldozers and dump trucks can be used to complete work.
- No additional maintenance work will need to be performed for the 50 year.

- The existing area will be degraded using a dozer to move the existing material around to the required elevation,
- reduce the width of the bayou connecting Sweetwater Lake and West Bay.
- A standard 25% contingency, E&D of 8%, and CM of 6% was used with the cost

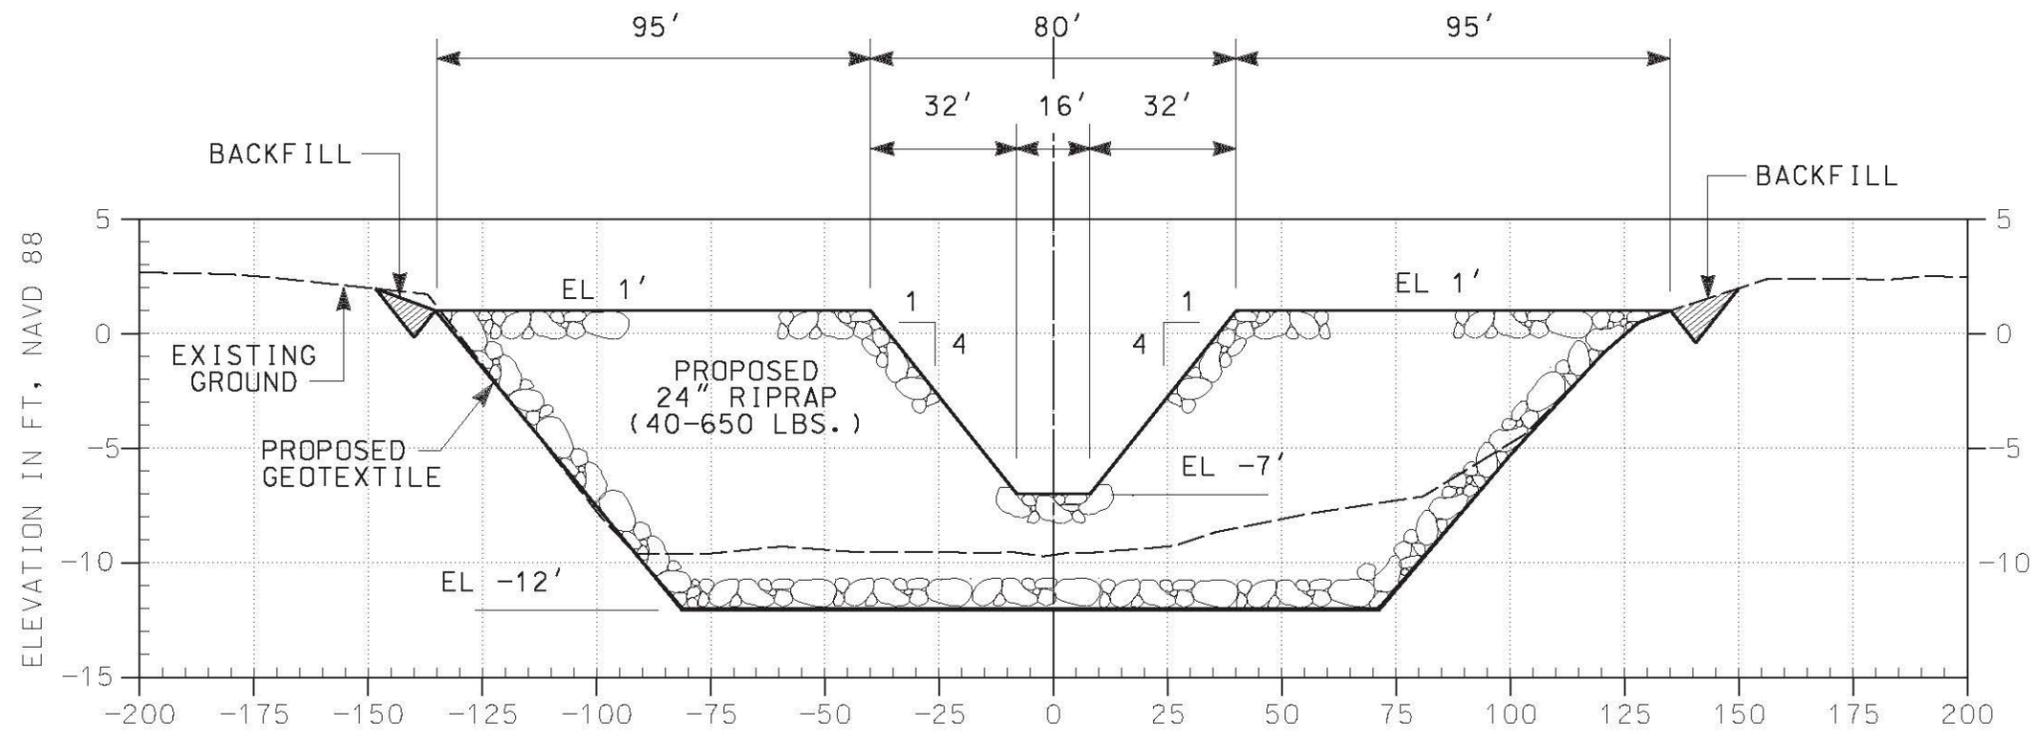
SECTION B-B
SCALE: AS SHOWN

DATUM	
NAVD 88	MLLW
0'	0.42'
-7.0'	-7.42'

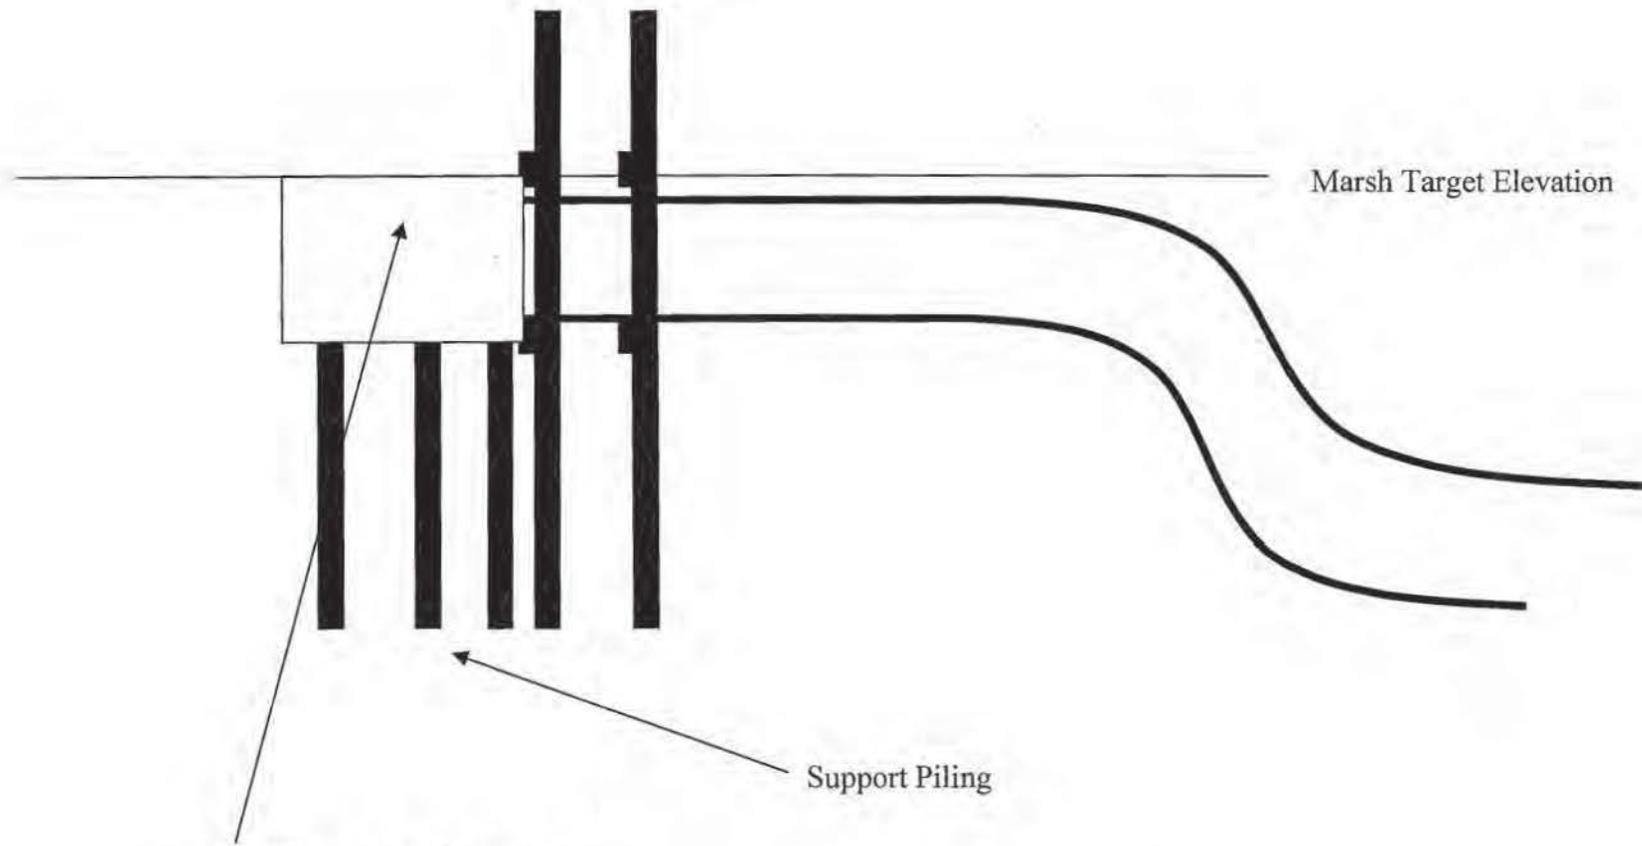
North End of Siphons – Box intake

Aluminum box with open top
Top elevation set to marsh elevation.
Box will be 10 feet long and 10 feet wide with aluminum grate covering the top
