SABINE PASS TO GALVESTON BAY, TEXAS
MEASURE 5-10
INFORMATION SHEET

DESCRIPTION OF MEASURE: 5-10 Closing of Rollover Pass, Galveston County

Sabine Pass to Galveston Bay Texas, Coastal Storm Risk Management and Ecosystem Restoration Feasibility Study

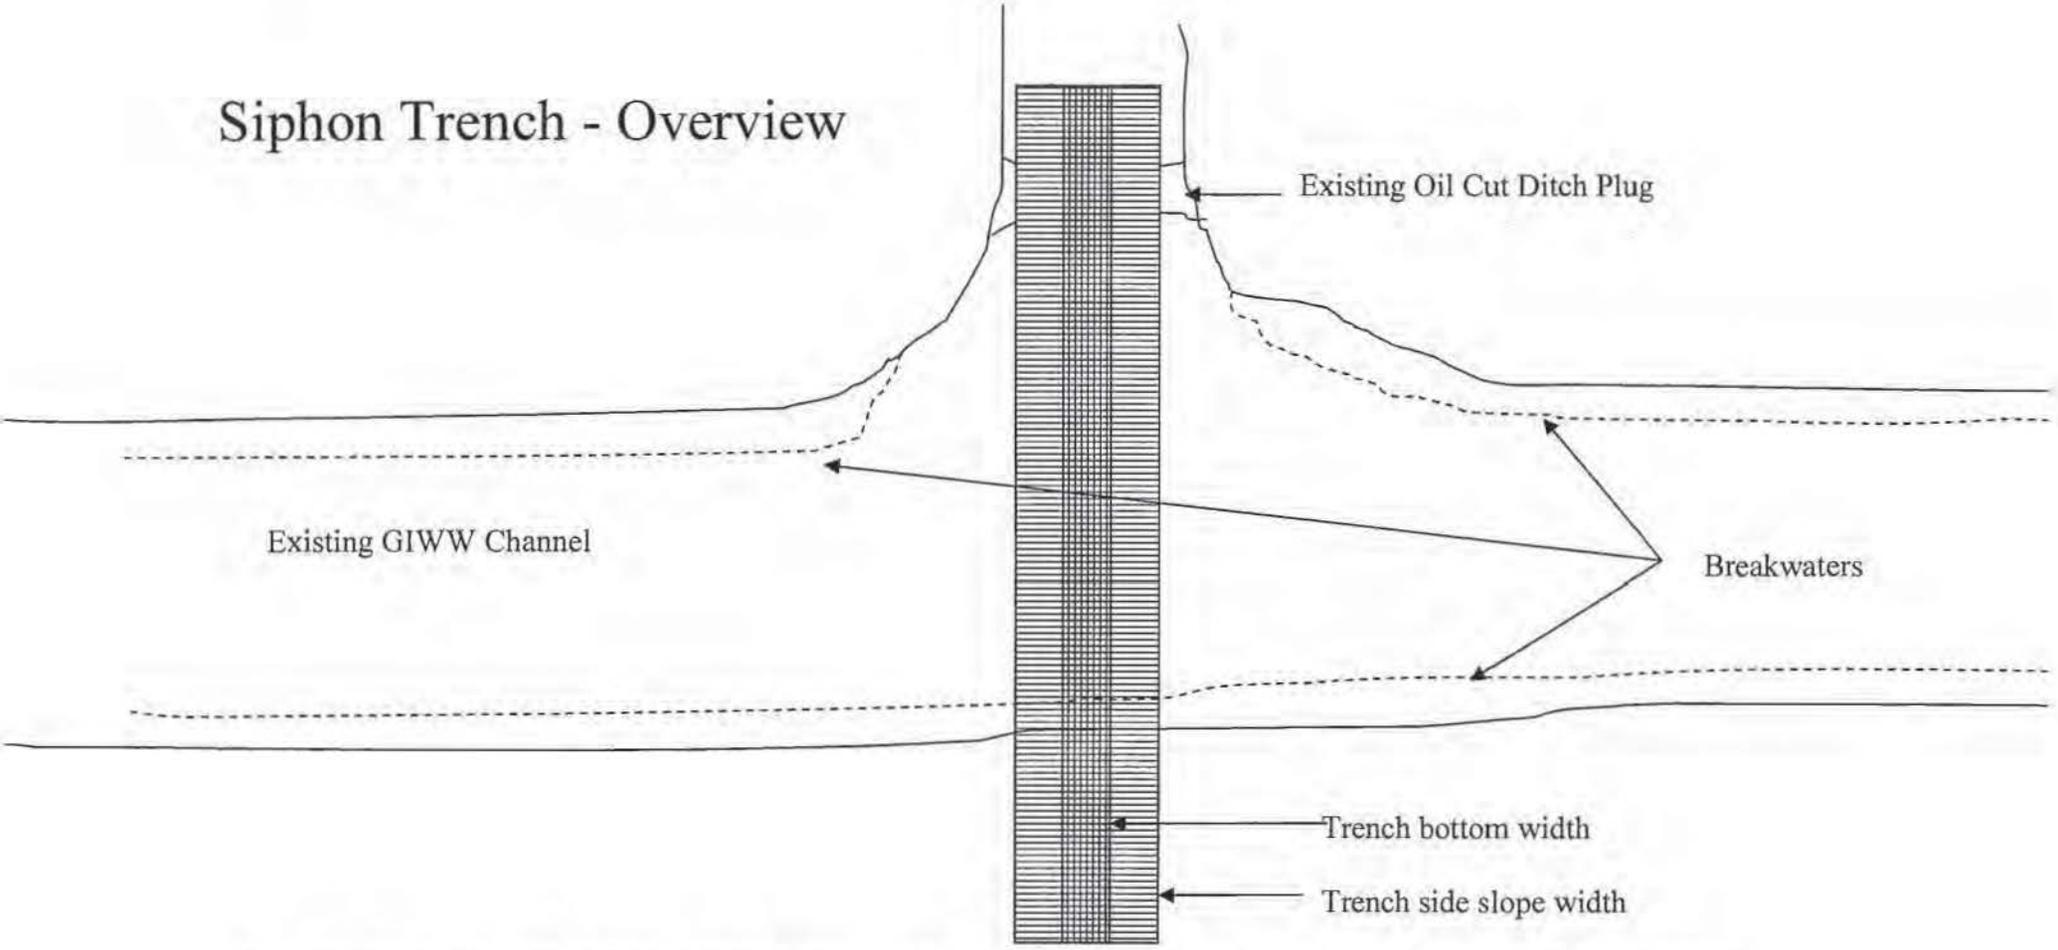
Siphon Trench - Overview

Trench will have a depth of 33 feet (6' for pipe + 15' below channel depth + 12' channel) and bottom width of 18 feet. Trench side slope with will be a 1:1 ratio and extend 21 feet either side of center of trench. Total Trench width will be 60 feet wide.

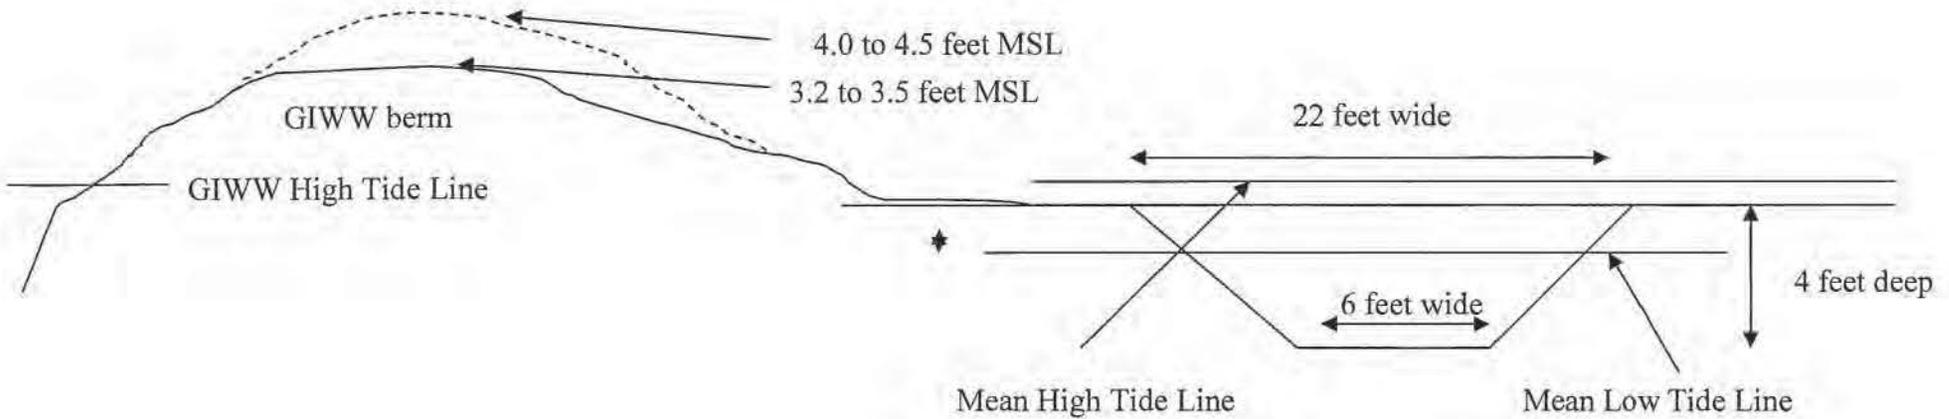
Cross Section View of Diversion Channel

- Water depth at mean high tide is 2 inches above marsh elevation.
- Water depth at mean low tide is 6 inches above marsh elevation.
- Tidal exchange limited to sheet flow across the marsh from Barnett Lake located over 2200 feet away.
- Channel construction will require 4646 cubic yards of spoil to be removed from ditch, to be placed on the existing GIWW spoil shoreline
- Diversion channel moves water to the west into the Wild Cow Bayou marsh then through structures into the marsh surrounding Barnett Lake.
- GIWW shoreline will be elevated between 1 to 2 feet with spoil material to help stop salt water intrusion from the GIWW.

Notice: These water levels are inside a structurally controlled area.

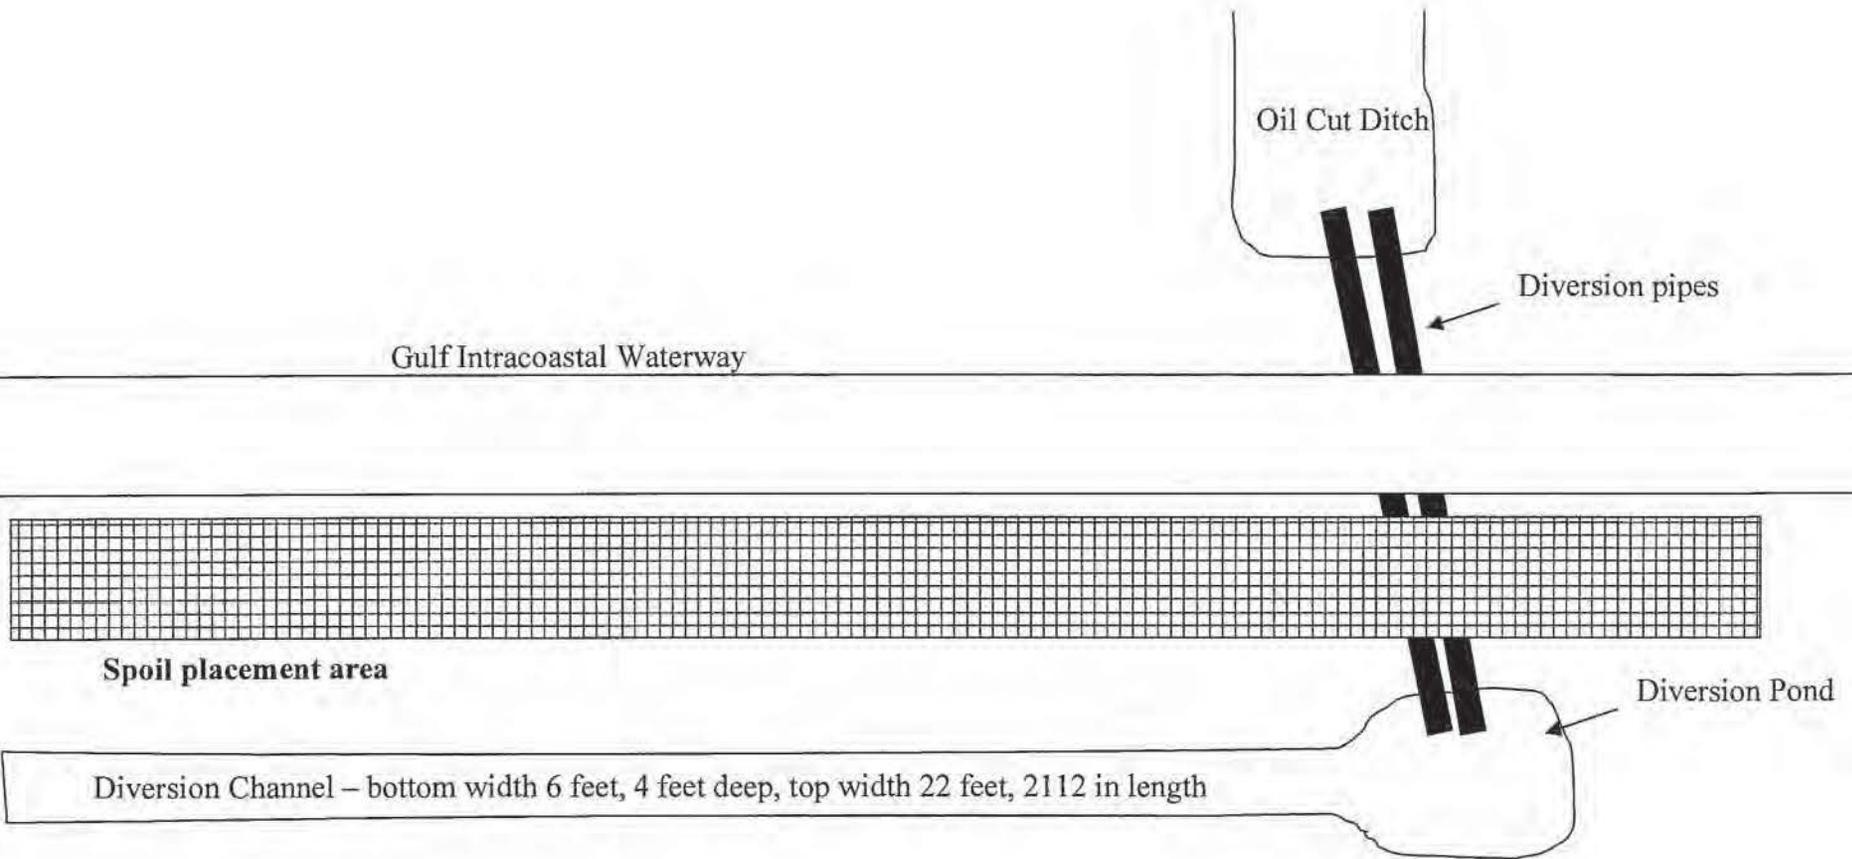
Aerial View of Siphon and Diversion Channel

Diversion Channel's spoil material will be placed on the existing shoreline to increase GIWW elevation to stop salt water intrusion. Diversion channel will create 4646 cubic yards of material from the ditch will be placed on the existing shoreline berm. Pond will be 30 feet diameter with a depth of 8 feet. Spoil material to be placed on GIWW shoreline berm. Pond will create 267 cubic yards of material from the pond site which will be placed on the existing shoreline berm.
