# **Waters of the U.S./Wetlands Conditional and Functional Assessment & Mitigation Plan**

US 59 from Fostoria Road to State  
Loop 573  
(CSJ 0177-03-096)

Prepared by: Spirit Environmental, LLC  
Date: December 2018

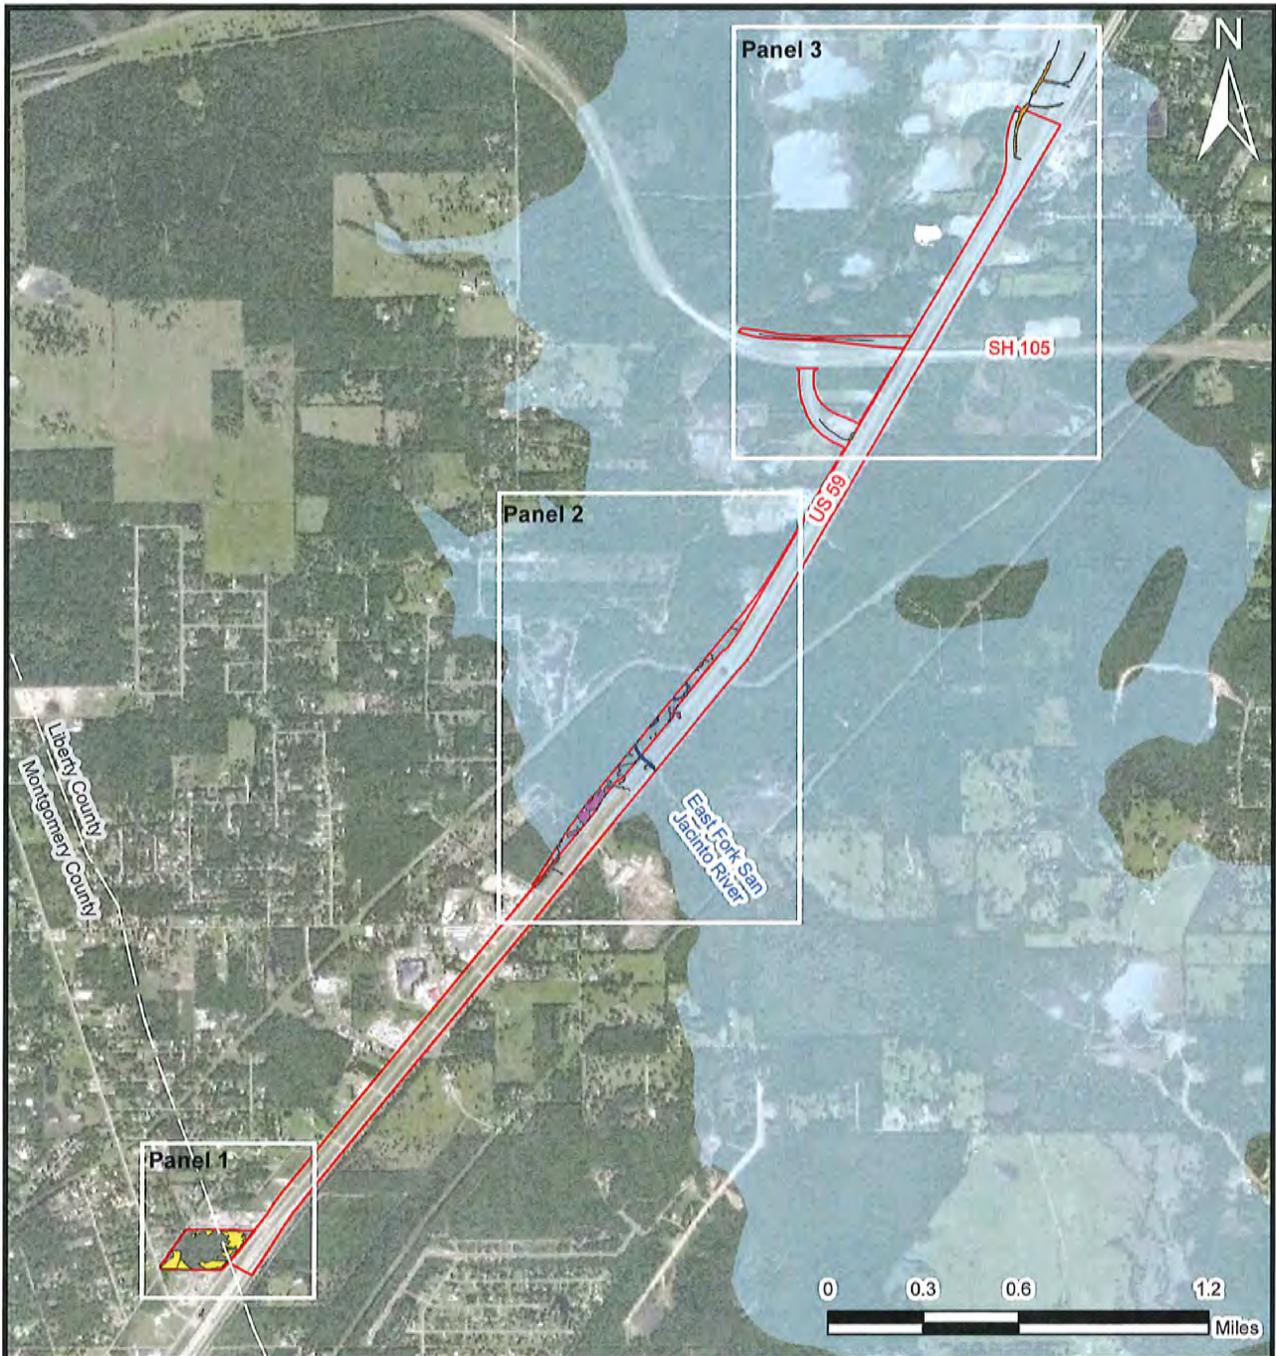
Figure No.: 2
Date: 9/24/2018
Project No.: 17465.00N
Drawn By: JPrescott
Revision No.: 1
<i>Note: This is not a Property Boundary Survey</i>
<i>Service Layer Credits: Source: Esri, DigitalGlobe, GeoEye, Earthstar Geographics, CNES/Airbus DS, USDA, USGS, AeroGRID, IGN, and the GIS User Community</i>

**US 59 (CSJ 0177-03-096)  
 AQUATIC FEATURES MAP  
 TEXAS DEPARTMENT OF  
 TRANSPORTATION  
 MONTGOMERY AND LIBERTY  
 COUNTIES, TEXAS**

Four (4) wetland delineation reports were compiled for the overall project area and utilized for this conditional and functional assessment. A map of the delineated aquatic features within the project area is presented in Attachment 1.

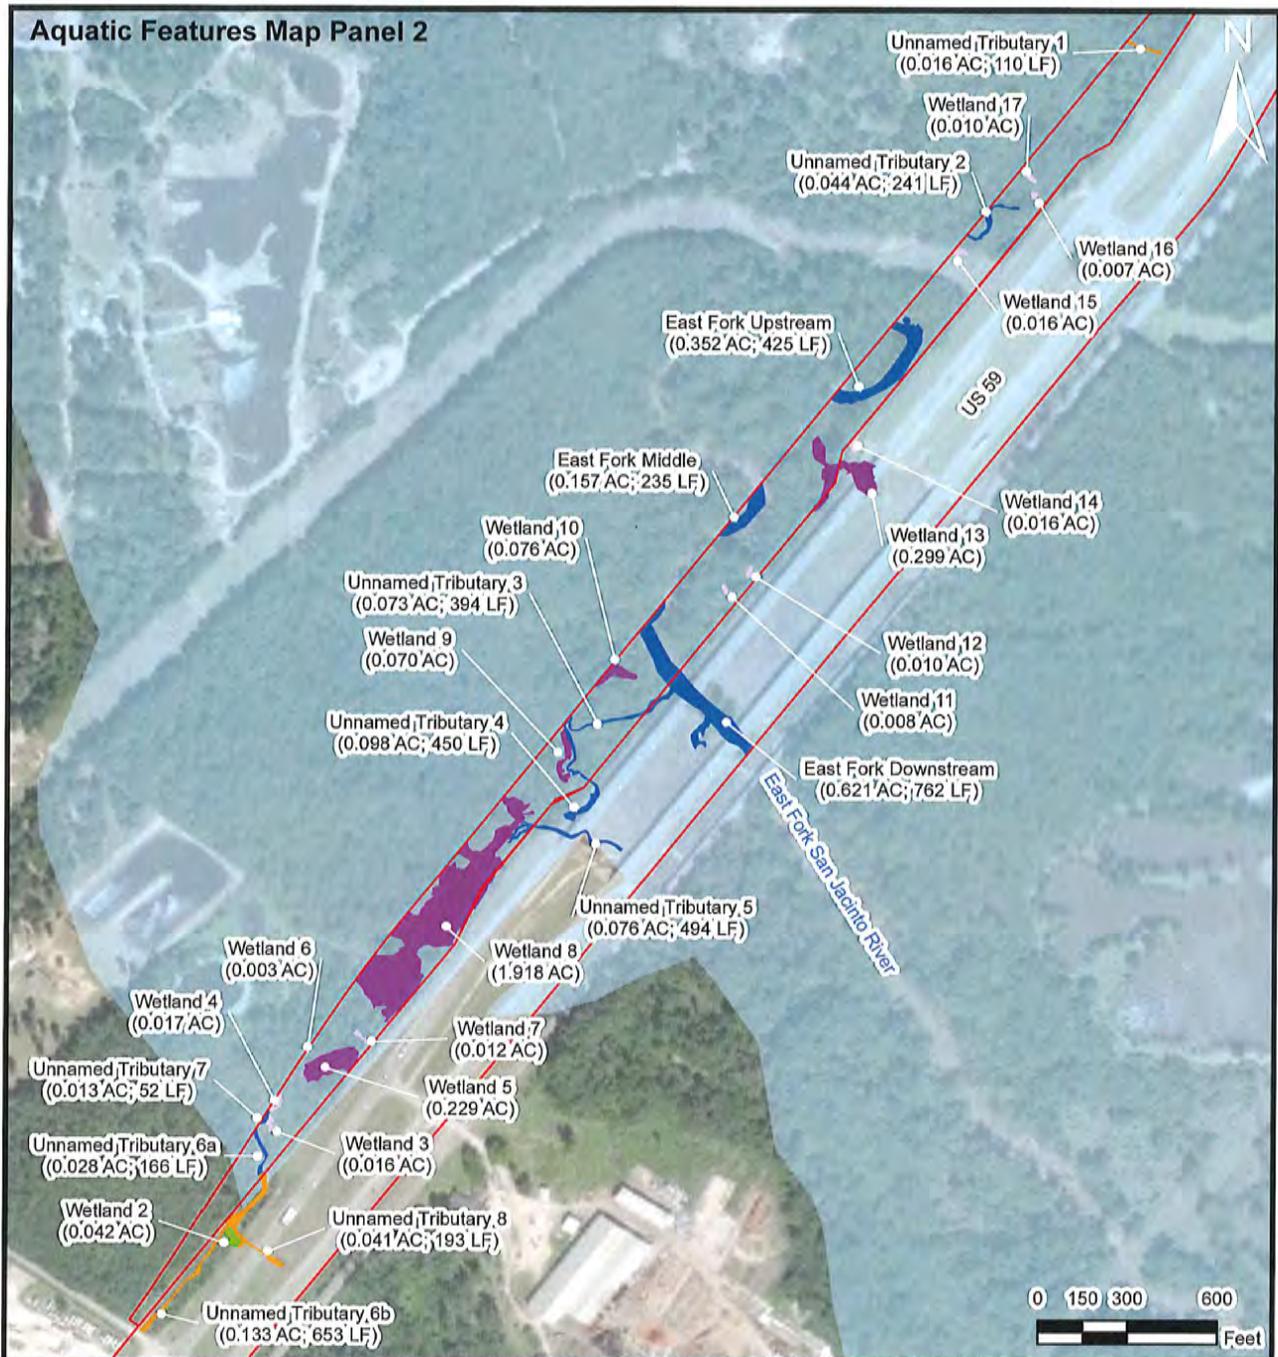
<b>Legend</b> 		<p><b>US 59 (CSJ 0177-03-096)</b>  <b>AQUATIC FEATURES MAP</b>  <b>PANEL 2</b>  <b>TEXAS DEPARTMENT OF</b>  <b>TRANSPORTATION</b>  <b>MONTGOMERY AND LIBERTY</b>  <b>COUNTIES, TEXAS</b></p>	Figure No.: 2-2 Date: 9/25/2018 Project No.: 17465.00N Drawn By: JPrescott Revision No.: 1
<p><b>Legend</b></p> <ul style="list-style-type: none"> <li> Project Area</li> <li> FEMA 100-YR Floodplain</li> <li><b>PJD</b></li> <li> Forested Wetlands</li> <li><b>AJD</b></li> <li> Potentially Jurisdictional Forested Wetlands</li> <li> Potentially Jurisdictional Herbaceous Wetlands</li> <li> Potentially Jurisdictional WOTUS</li> <li> Potentially Non-Jurisdictional Drainage Ditches</li> <li> Potentially Non-Jurisdictional Herbaceous Wetlands</li> </ul>			<p><b>SPiRiT</b>                  ENVIRONMENTAL</p> <p>20465 State Highway 249, Suite 300                  Houston, TX 77070</p>

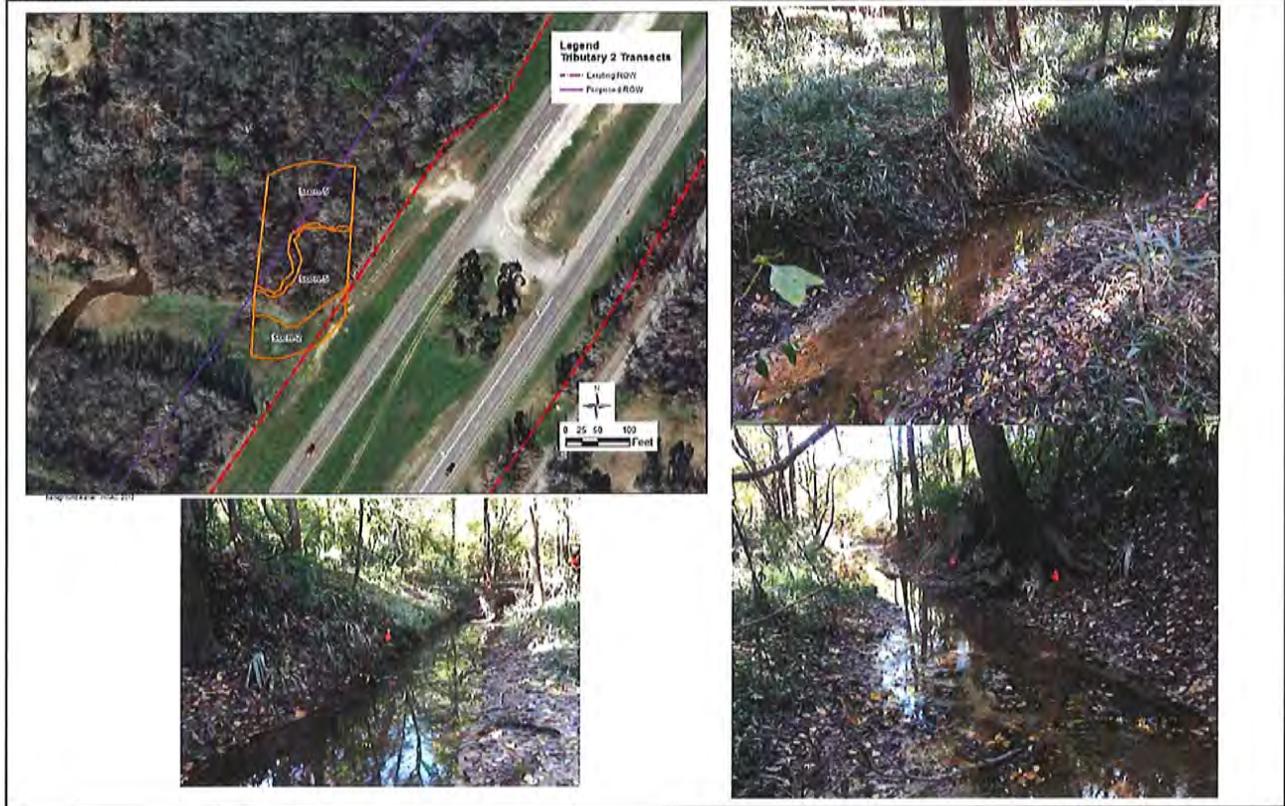
INSERT PHOTOS:

<b>SCORE</b>	<b>5</b>	<b>4</b>	<b>3</b>	<b>2</b>	<b>1</b>	<b>AV</b> <b>5.00</b>	
<b>Notes:</b> No channeling or alterations are present; therefore, the channel alteration is optimal.							
<b>REACH CONDITION INDEX and STREAM CONDITION UNITS FOR THIS REACH</b>							
<b>THE CONDITION INDEX (CI) &gt;&gt;</b>							<b>3.11</b>

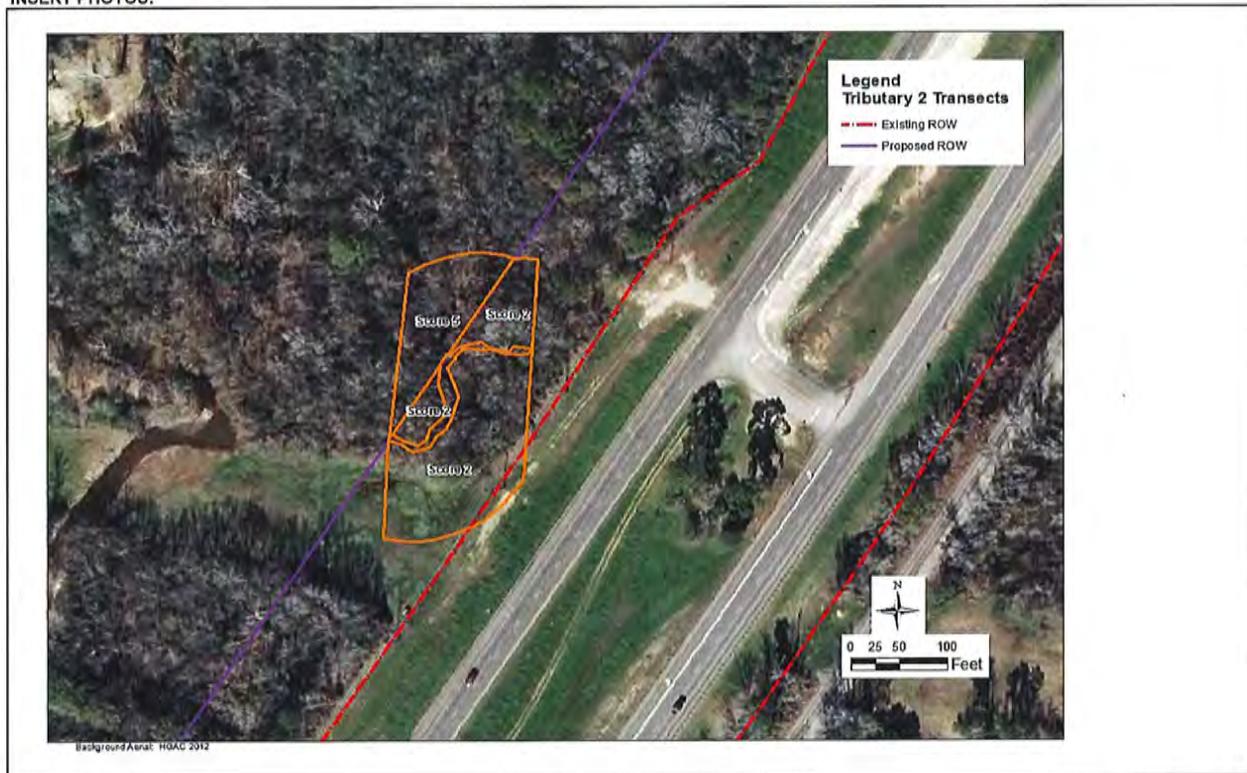
INSERT PHOTOS:

<b>SCORE</b>	5	4	3	2	1	<b>AV</b> 0.00
<b>Notes:</b> This stream has not been assessed TCEQ and is an intermittent stream.							
<b>REACH CONDITION INDEX and STREAM CONDITION UNITS FOR THIS REACH</b>							
<b>THE CONDITION INDEX (CI) &gt;&gt;</b>							0.00

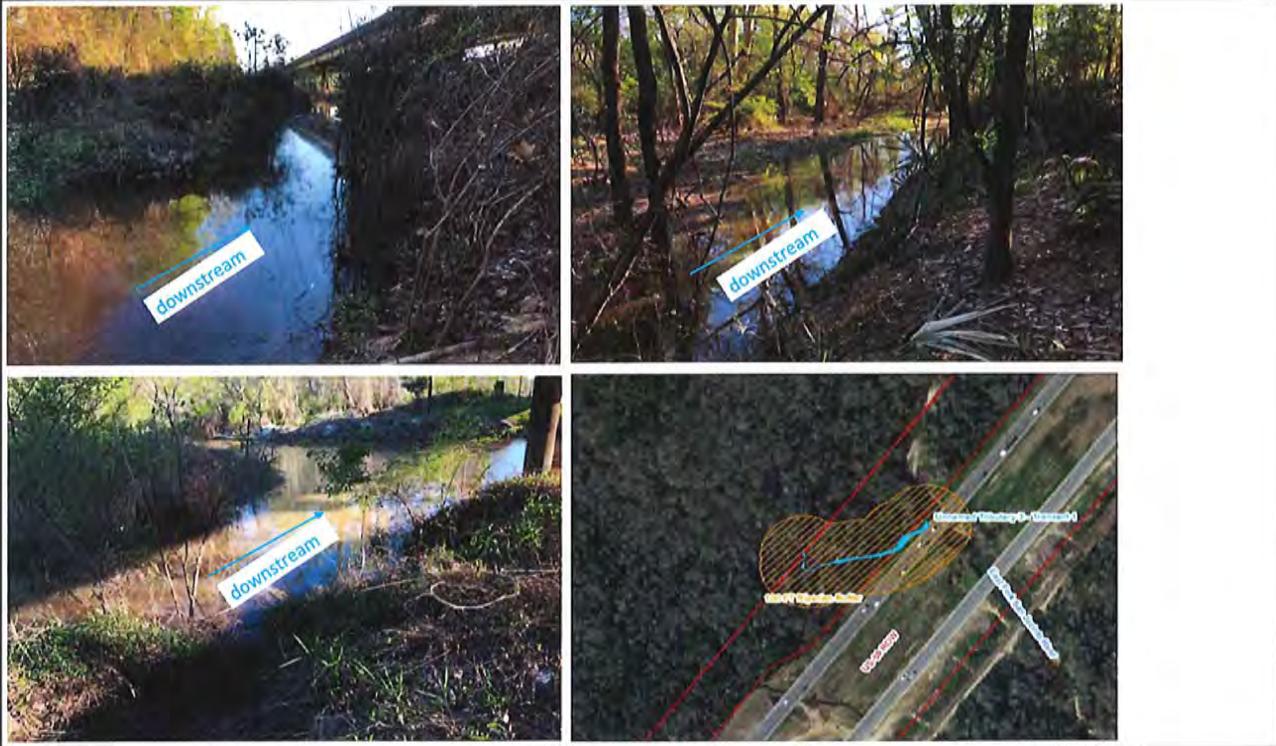
INSERT PHOTOS:

<b>SCORE</b>	5	4	3	2	1	AV <b>4.00</b>	
<b>Notes:</b> Evidence of past alterations and recovery.							
<b>REACH CONDITION INDEX and STREAM CONDITION UNITS FOR THIS REACH</b>							
						THE CONDITION INDEX (CI) >>	<b>3.05</b>

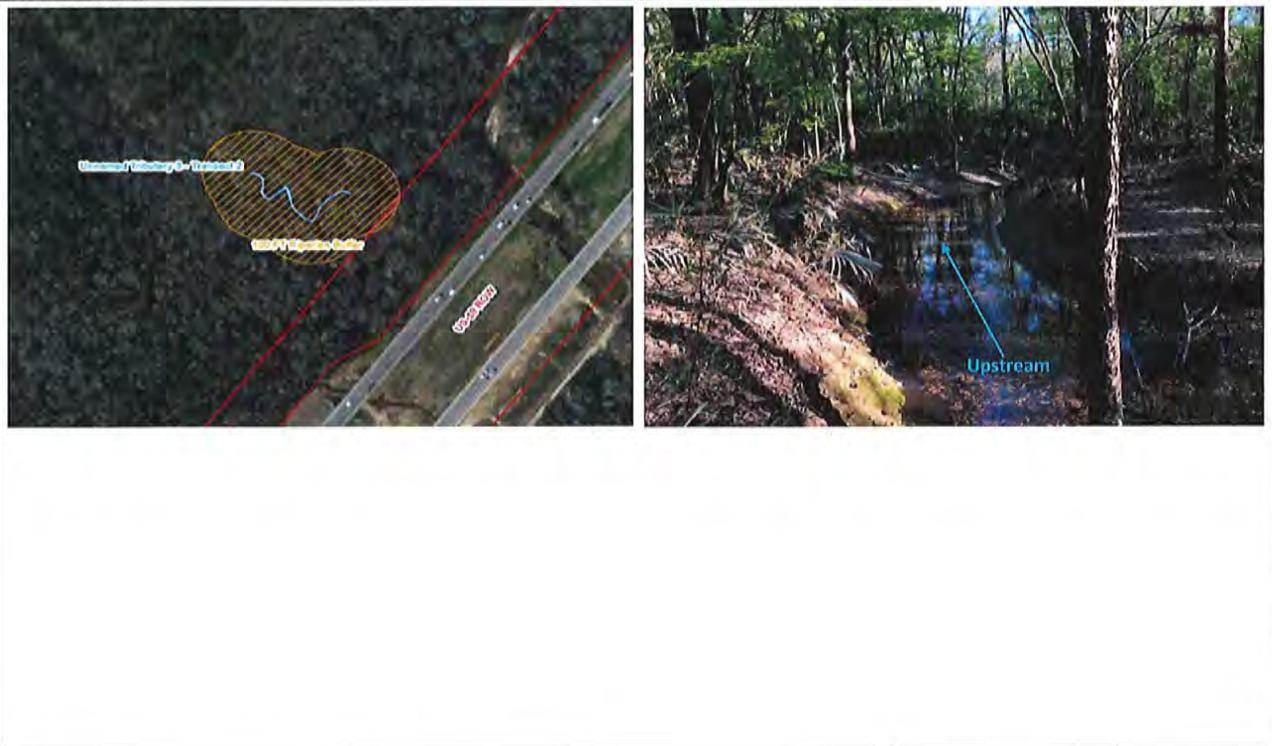
INSERT PHOTOS:

<b>SCORE</b>	5	4	3	2	1	<b>AV</b> 5.00	
<b>Notes:</b> No man-made channel alterations along this reach. Pooling occurs when low surface runoff due to intermittent nature.							
<b>REACH CONDITION INDEX and STREAM CONDITION UNITS FOR THIS REACH</b>							
						THE CONDITION INDEX (CI) >>	3.55

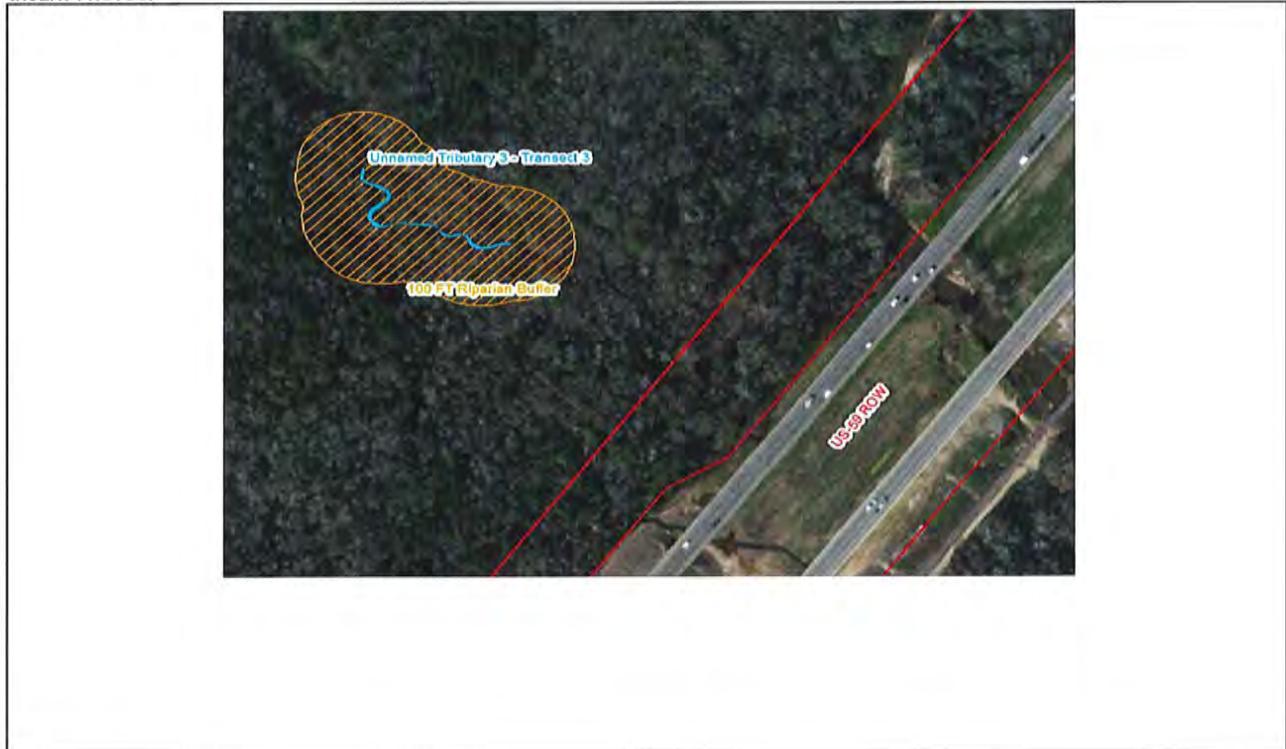
INSERT PHOTOS:

<b>SCORE</b>	5	4	3	2	1	AV <b>5.00</b>	
Notes: No man-made channel alterations along this reach. Pooling occurs when low surface runoff due to intermittent nature.							
<b>REACH CONDITION INDEX and STREAM CONDITION UNITS FOR THIS REACH</b>							
						<b>THE CONDITION INDEX (CI) &gt;&gt;</b>	<b>3.86</b>

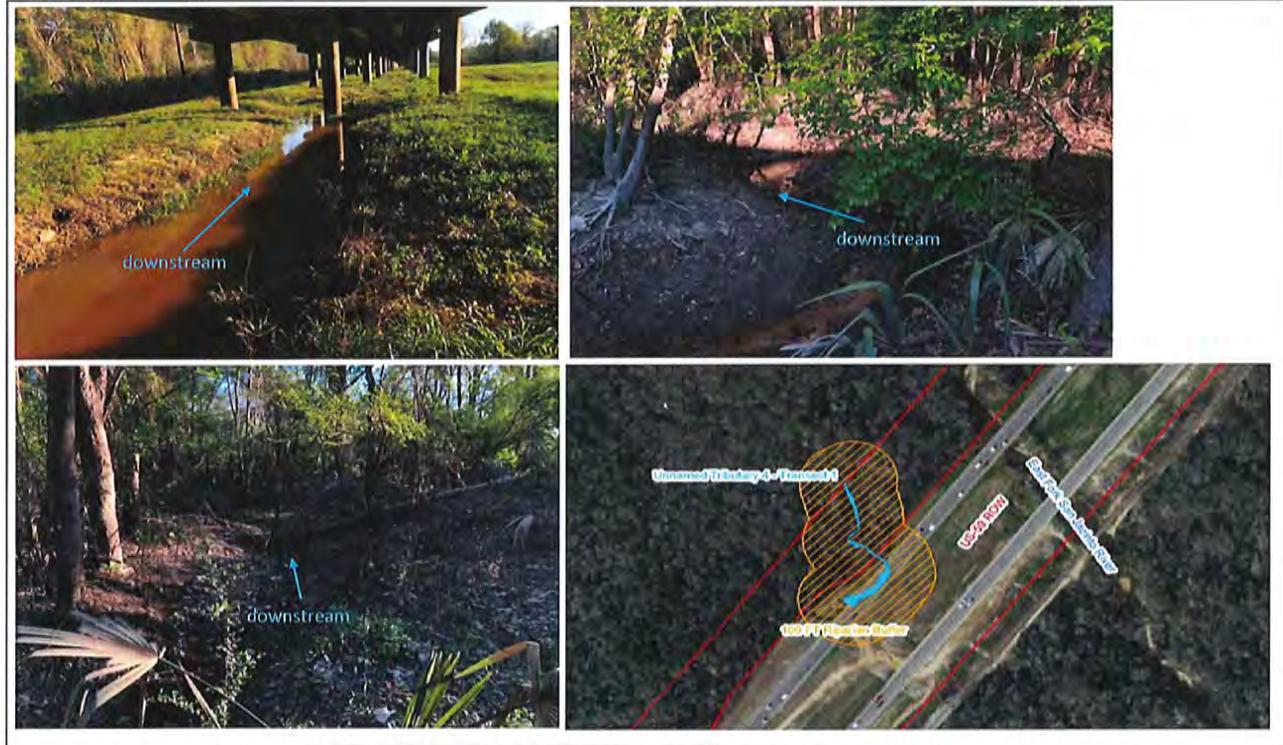
INSERT PHOTOS:

SCORE	5	4	3	2	1	AV	4.00
Notes: Impacted by pilings of US-59 bridge.							
REACH CONDITION INDEX and STREAM CONDITION UNITS FOR THIS REACH							
THE CONDITION INDEX (CI) >>							3.06

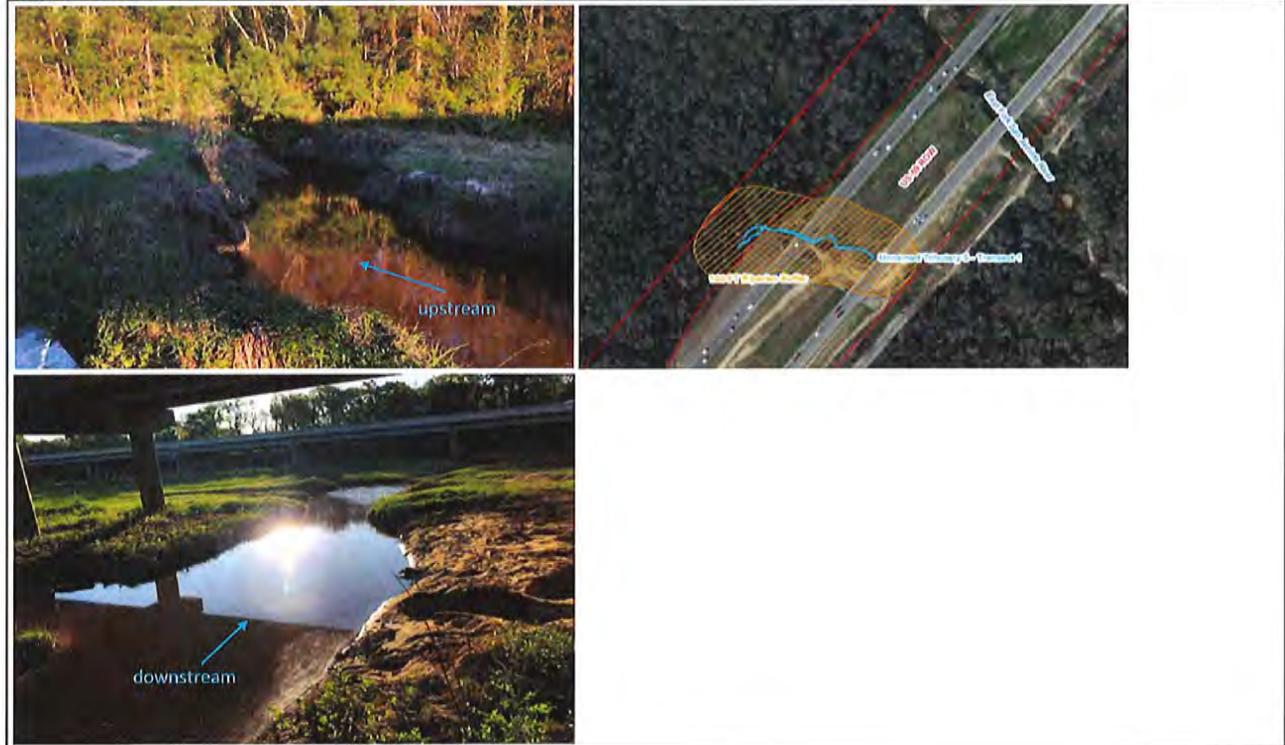
INSERT PHOTOS:

SCORE	5	4	3	2	1	AV
Notes: Only a portion of the stream is affected by the US-59 bridge ramp (a portion of the left bank is concreted/filled for the bridge ramp skirt)							
REACH CONDITION INDEX and STREAM CONDITION UNITS FOR THIS REACH							
THE CONDITION INDEX (CI) >>							2.50

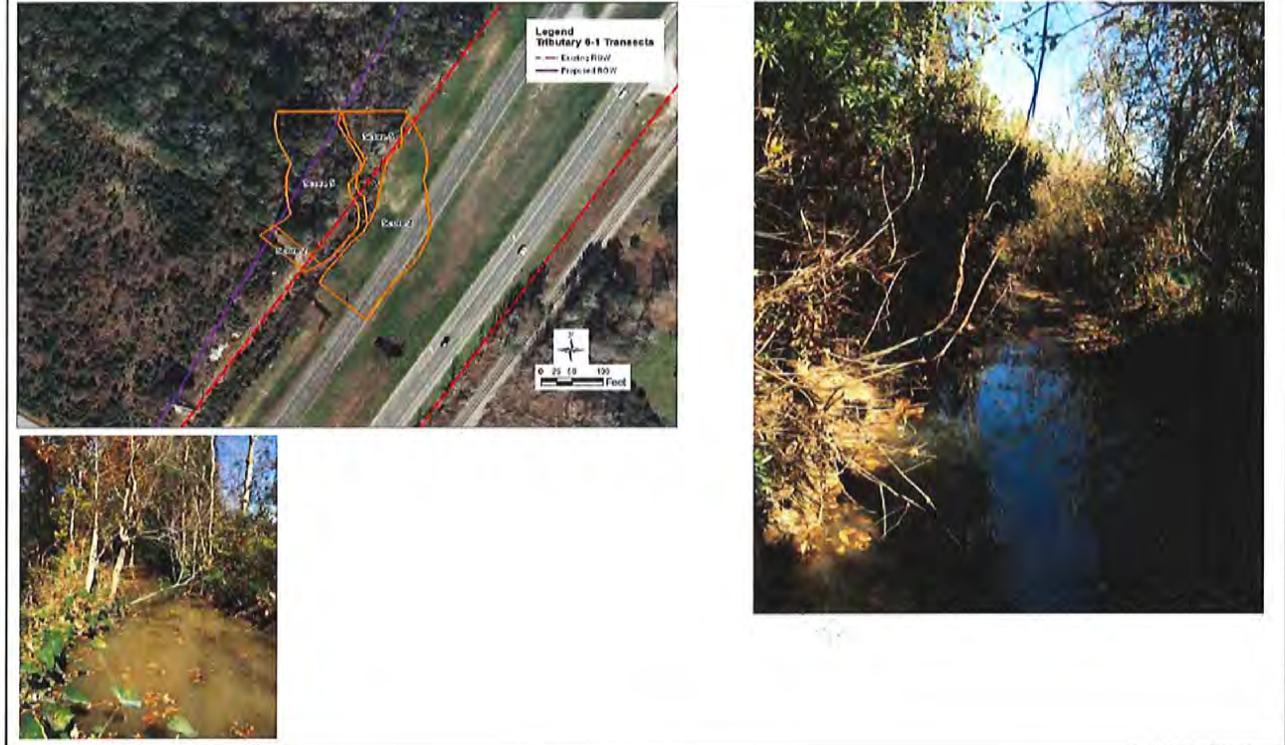
INSERT PHOTOS:

<b>SCORE</b>	<b>5</b>	<b>4</b>	<b>3</b>	<b>2</b>	<b>1</b>		
						<b>AV</b>	<b>2.00</b>
<b>Notes:</b> Impacted by drainage structures. Evidence of past alteration is present.							
<b>REACH CONDITION INDEX and STREAM CONDITION UNITS FOR THIS REACH</b>							
						<b>THE CONDITION INDEX (CI) &gt;&gt;</b>	<b>2.69</b>

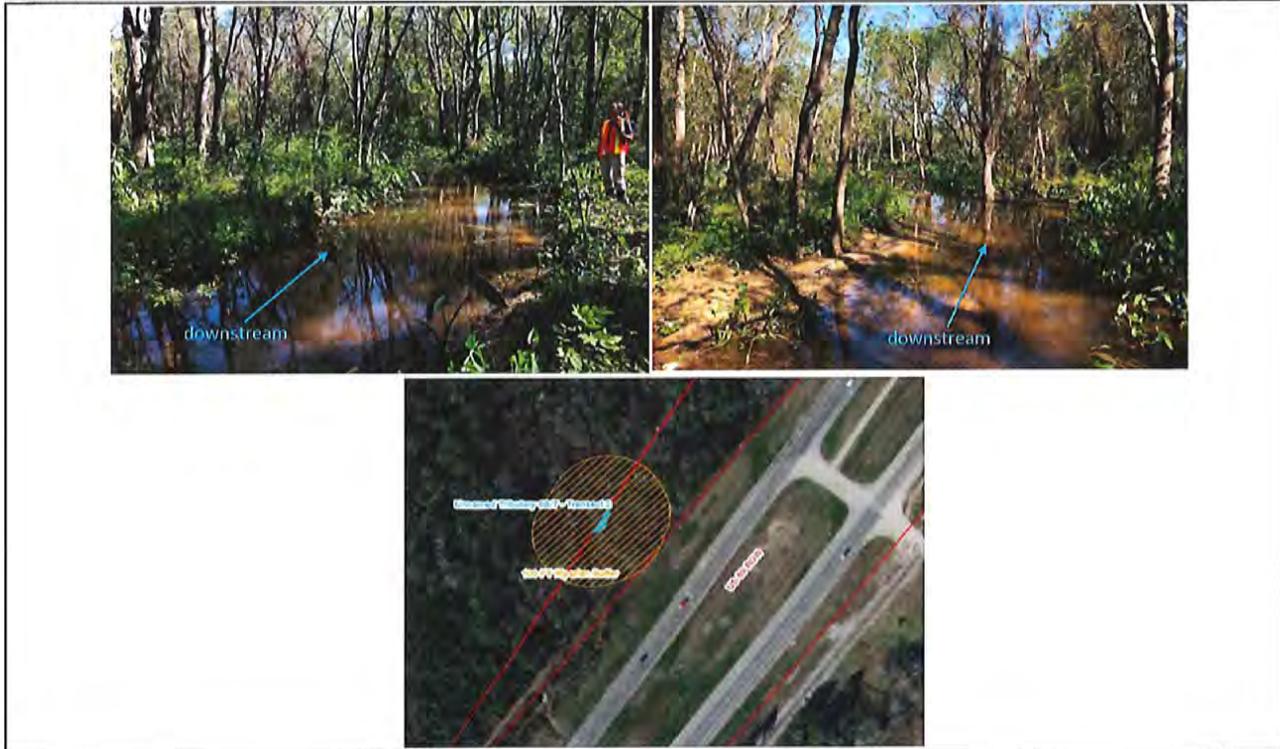
INSERT PHOTOS:

SCORE	5	4	3	2	1	AV	4.00
Notes: Ephemeral stream is ponded in some areas; however, the obstructions are not man-made.							
REACH CONDITION INDEX and STREAM CONDITION UNITS FOR THIS REACH							
THE CONDITION INDEX (CI) >>							3.00

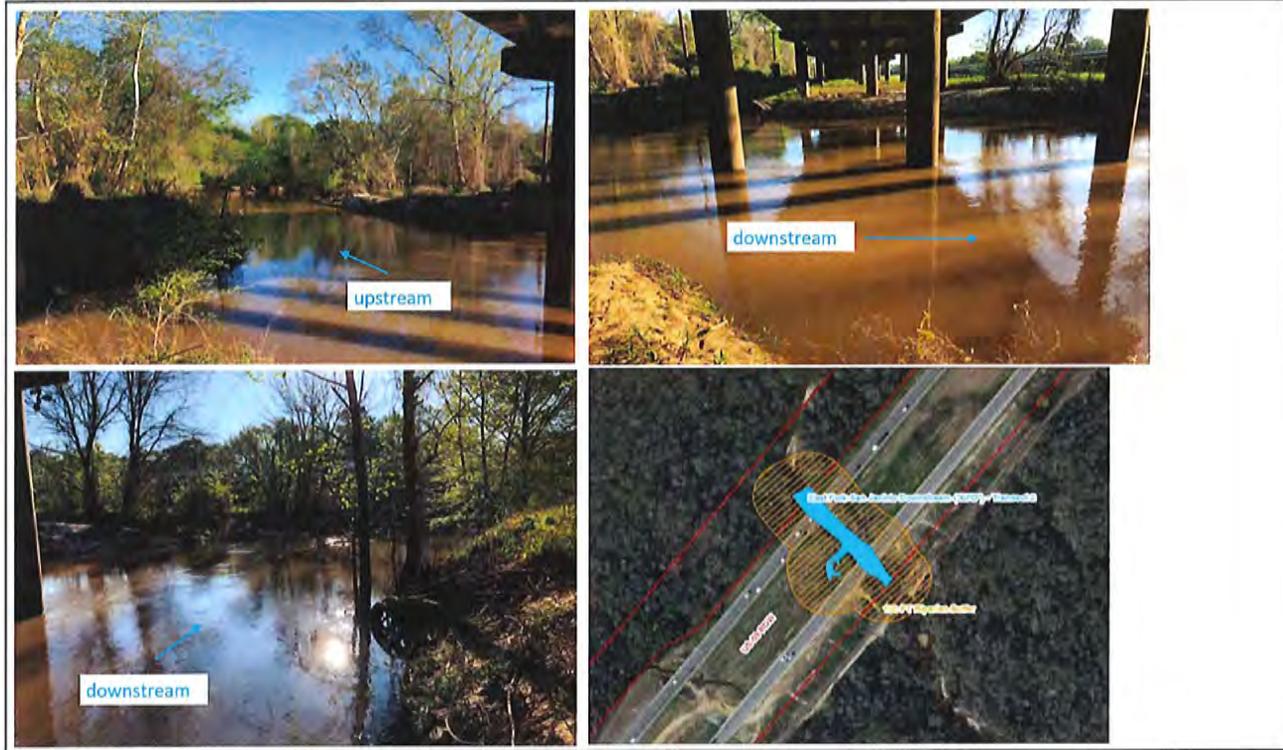
SCORE	5	4	3	2	1	AV 2.00	
Notes: Impacted by existing pilings of the US-59 bridge.							
REACH CONDITION INDEX and STREAM CONDITION UNITS FOR THIS REACH							
THE CONDITION INDEX (CI) >>							2.53

INSERT PHOTOS:

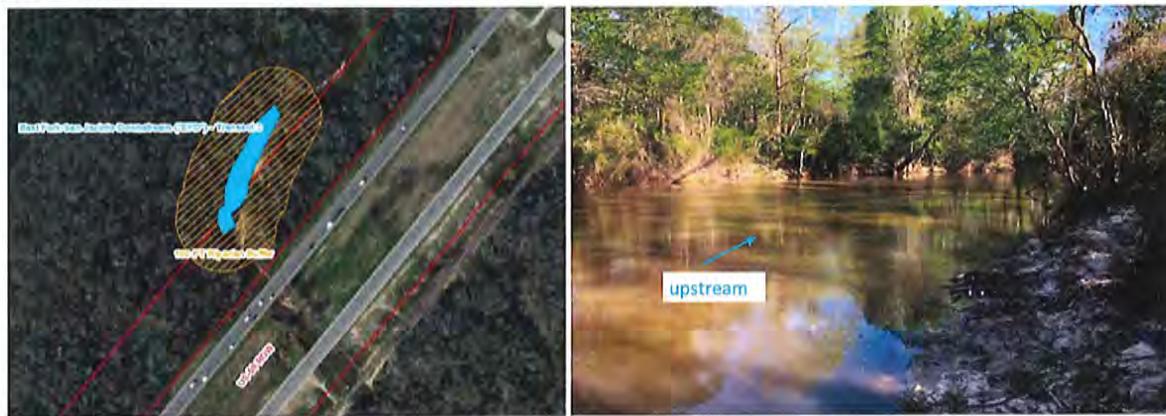
SCORE	5	4	3	2	1	AV	4.00
Notes: Downstream is altered by US-59 bridge but this reach is not impacted by man-made alterations.							
REACH CONDITION INDEX and STREAM CONDITION UNITS FOR THIS REACH							
THE CONDITION INDEX (CI) >>							4.00

INSERT PHOTOS:

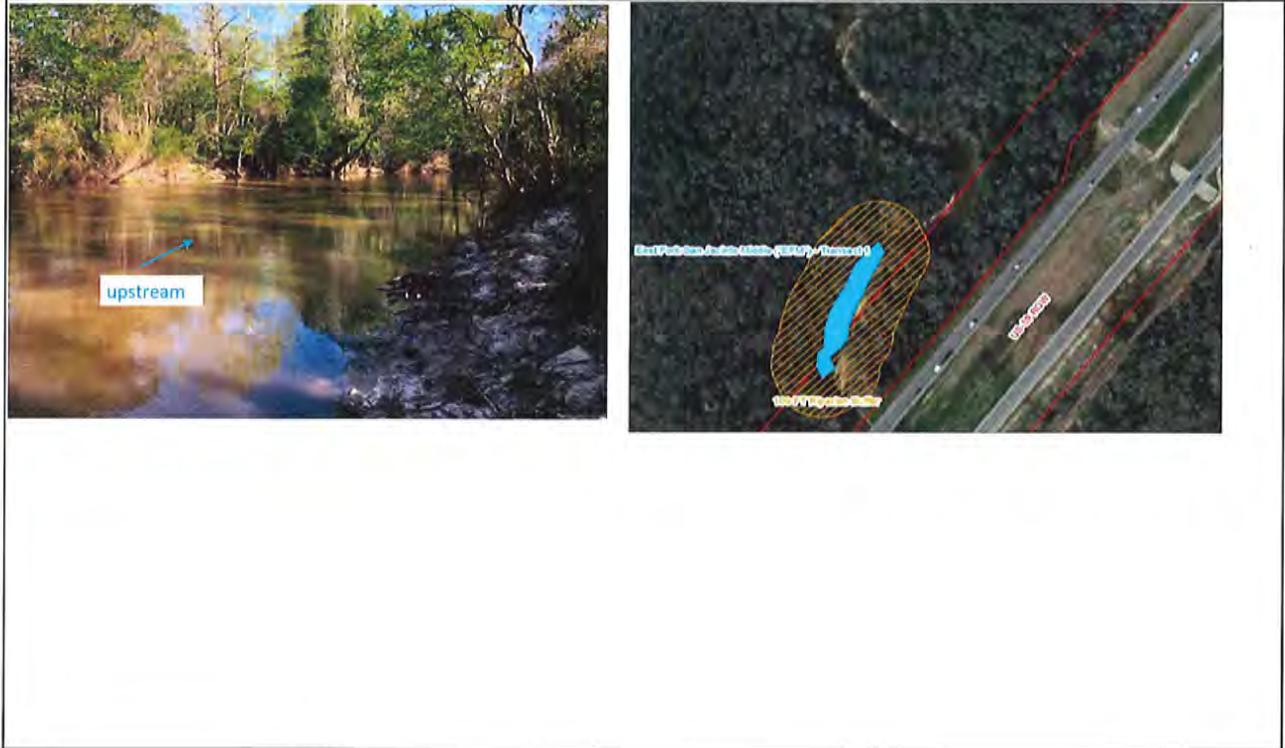
SCORE	5	4	3	2	1	AV	4.00
Notes: Downstream is altered by US-59 bridge but this reach is not impacted by man-made alterations.							
REACH CONDITION INDEX and STREAM CONDITION UNITS FOR THIS REACH							
THE CONDITION INDEX (CI) >>							4.00

INSERT PHOTOS:

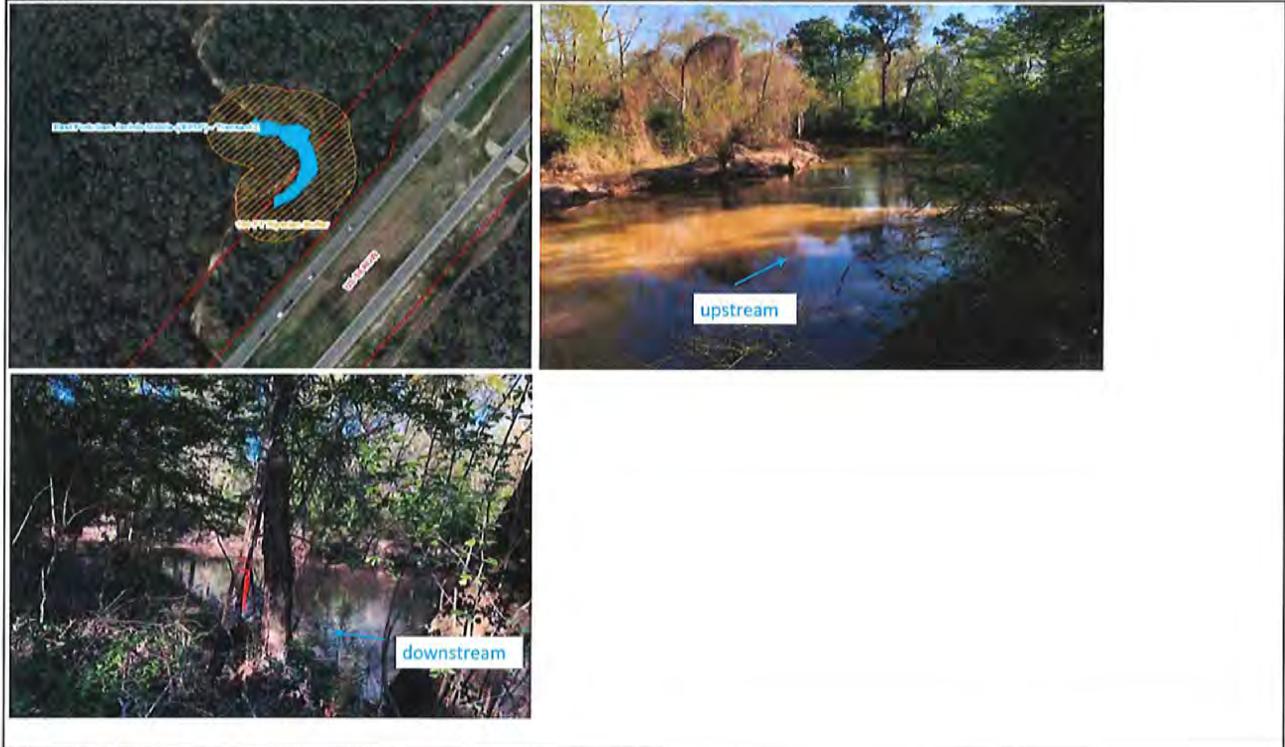
SCORE	5	4	3	2	1	AV 4.00	
Notes: Not impacted by man-made structures. Stream pattern is stable.							
REACH CONDITION INDEX and STREAM CONDITION UNITS FOR THIS REACH							
THE CONDITION INDEX (CI) >>							4.06

INSERT PHOTOS:

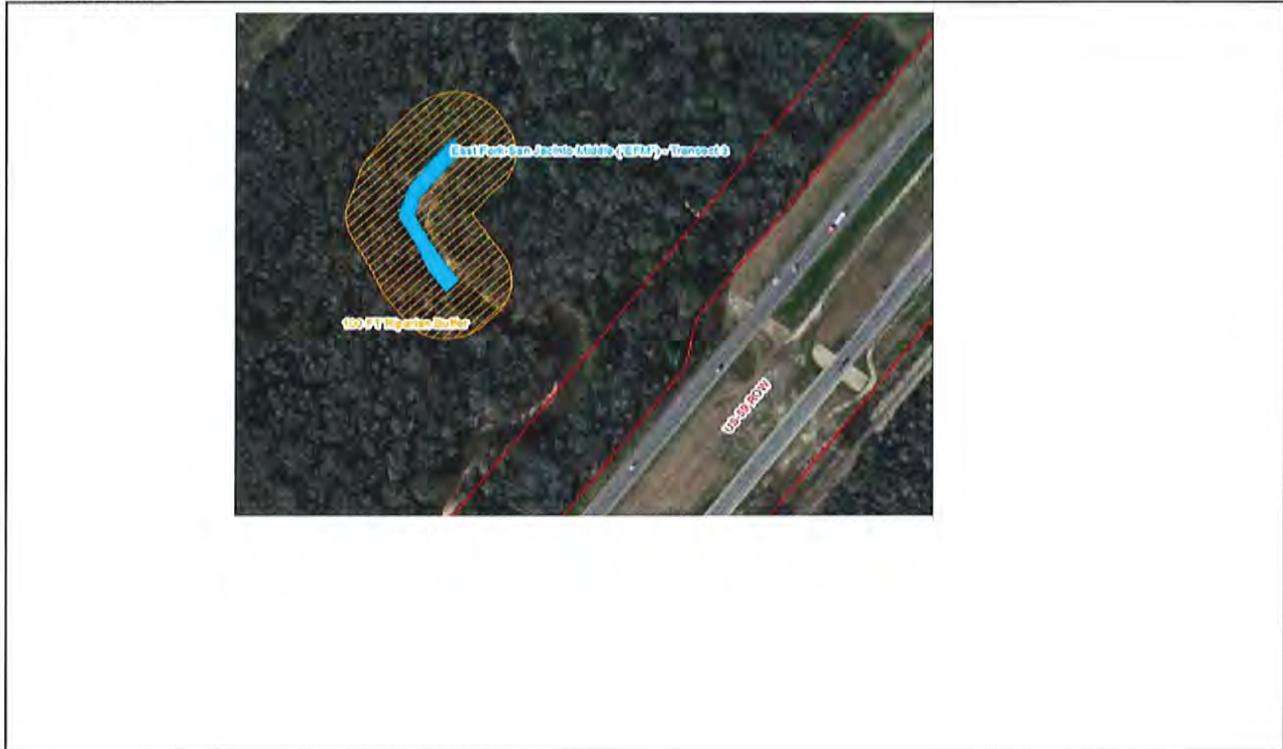
SCORE	5	4	3	2	1	AV	4.00
Notes: Not impacted by man-made structures. Stream pattern is stable.							
REACH CONDITION INDEX and STREAM CONDITION UNITS FOR THIS REACH							
THE CONDITION INDEX (CI) >>							4.13

INSERT PHOTOS:

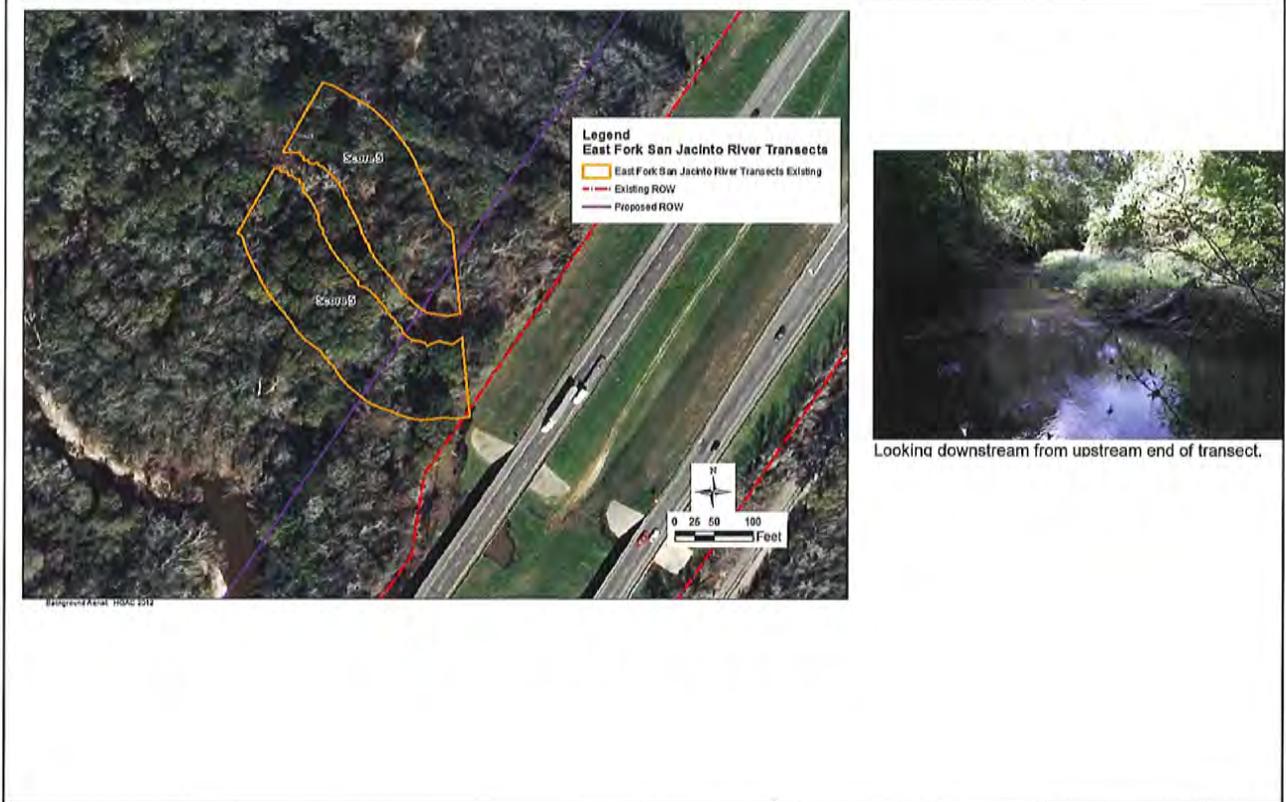
SCORE	5	4	3	2	1	AV	5.00
<b>Notes</b> No channelization or man-made alterations.								
<b>REACH CONDITION INDEX and STREAM CONDITION UNITS FOR THIS REACH</b>								
THE CONDITION INDEX (CI) >>								4.50

INSERT PHOTOS:

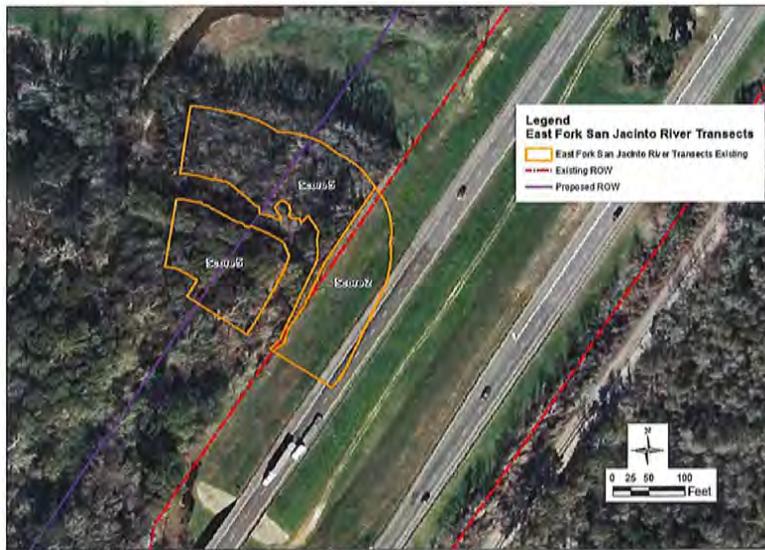
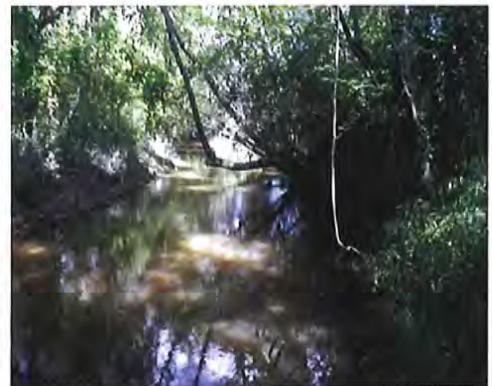
SCORE	5	4	3	2	1	AV	5.00
<b>Notes</b> Channel has not been altered. No dams, dikes, or rip-rap within teh stream.							
<b>REACH CONDITION INDEX and STREAM CONDITION UNITS FOR THIS REACH</b>							
THE CONDITION INDEX (CI) >>							4.09

Looking upstream from downstream end of transect.

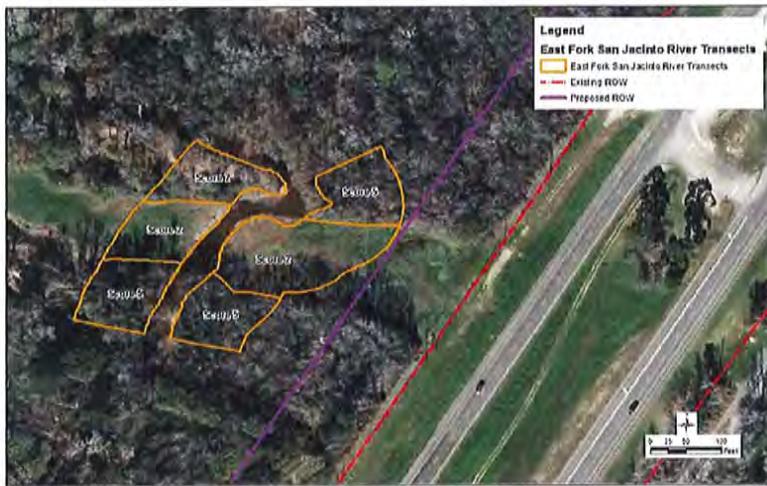
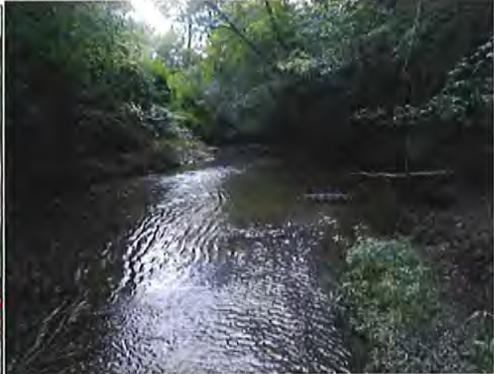
<b>SCORE</b>	<b>5</b>	<b>4</b>	<b>3</b>	<b>2</b>	<b>1</b>	<b>AV</b>
<b>Notes</b> Contains man-made alterations within maintained ROW.							
<b>REACH CONDITION INDEX and STREAM CONDITION UNITS FOR THIS REACH</b>							
<b>THE CONDITION INDEX (CI) &gt;&gt;</b>							<b>3.57</b>

Looking downstream from middle of transect.
