MARATHON PETROLEUM CORPORATION

GALVESTON BAY REFINERY

DOCK SHORELINE RESTORATION PROJECT PHASE II
TEXAS CITY SHIP CANAL/GALVESTON BAY
EROSION AND SEDIMENT CONTROL DETAIL 1

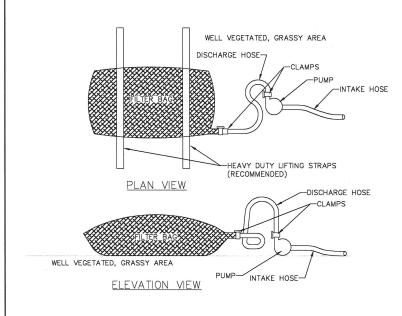
STANDARD CONSTRUCTION DETAIL PUMPED WATER FILTER BAG

LOW VOLUME FILTER BAGS SHALL BE MADE FROM NON-WOVEN GEOTEXTILE MATERIAL SEWN WITH HIGH STRENGTH, DOUBLE STITCHED "J" TYPE SEAMS. THEY SHALL BE CAPABLE OF TRAPPING PARTICLES LARGER THAN 150 MICRONS. HIGH VOLUME FILTER BAGS SHALL BE MADE FROM WOVEN GEOTEXTILES THAT MEET THE FOLLOWING STANDARDS:

A SUITABLE MEANS OF ACCESSING THE BAG WITH MACHINERY REQUIRED FOR DISPOSAL PURPOSES SHALL BE PROVIDED. FILTER BAGS SHALL BE REPLACED WHEN THEY BECOME 1/2 FULL OF SEDIMENT. SPARE BAGS SHALL BE KEPT AVAILABLE FOR REPLACEMENT OF THOSE THAT HAVE FAILED OR ARE FILLED. BAGS SHALL BE PLACED ON STRAPS TO FACILITATE REMOVAL UNLESS BAGS COME WITH LIFTING STRAPS ALREADY ATTACHED.

BAGS SHALL BE LOCATED IN WELL—VEGETATED (GRASSY) AREA, AND DISCHARGE ONTO STABLE, EROSION RESISTANT AREAS. WHERE THIS IS NOT POSSIBLE, A GEOTEXTILE UNDERLAYMENT AND FLOW PATH SHALL BE PROVIDED. BAGS MAY BE PLACED ON FILTER STONE TO INCREASE DISCHARGE CAPACITY. BAGS SHALL NOT BE PLACED ON SLOPES GREATER THAN 5%. FOR SLOPES EXCEEDING 5%, CLEAN ROCK OR OTHER NON-ERODIBLE AND NON-POLLUTING MATERIAL MAY BE PLACED UNDER THE BAG TO REDUCE SLOPE STEEPNESS.

THE PUMP DISCHARGE HOSE SHALL BE INSERTED INTO THE BAGS IN THE MANNER SPECIFIED BY THE MANUFACTURER AND SECURELY CLAMPED. A PIECE OF PVC PIPE IS RECOMMENDED FOR THIS PURPOSE.

THE PUMPING RATE SHALL BE NO GREATER THAN 750 GPM OR 1/2 THE MAXIMUM SPECIFIED BY THE MANUFACTURER, WHICHEVER IS LESS. PUMP INTAKES SHALL BE FLOATING AND SCREENED.

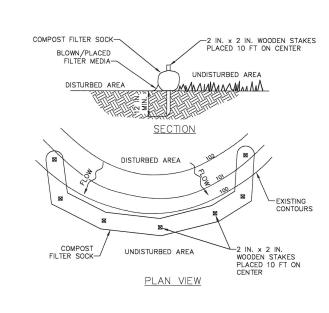
STANDARD CONSTRUCTION DETAIL COMPOST FILTER SOCK

SOCK FABRIC SHALL MEET THE STANDARDS FOR THE TEXAS COMMISSION ON ENVIRONMENTAL QUALITY AND ALL LOCAL JURISDICTIONS. THE COMPOST FILTER SOCK WILL SHALL BE INSTALLED FOLLOWING THE LATEST BMP's METHODS.

COMPOST FILTER SOCK SHALL BE PLACED AT EXISTING LEVEL GRADE. BOTH ENDS OF THE BARRIER SHALL BE EXTENDED AT LEAST 8 FEET UP SLOPE AT 45 DEGREES TO THE MAIN BARRIER ALIGNMENT. MAXIMUM SLOPE LENGTH ABOVE ANY BARRIER SHALL NOT EXCEED THAT SPECIFIED FOR THE SIZE OF THE SOCK AND THE SLOPE OF ITS TRIBUTARY AREA.

UPON STABILIZATION OF THE AREA TRIBUTARY TO THE SOCK, STAKES SHALL BE REMOVED. THE SOCK MAY BE LEFT IN PLACE AND VEGETATED OR REMOVED. IN THE LATTER CASE, THE MESH SHALL BE CUT OPEN AND THE MULCH SPREAD AS A SOIL SUPPLIFIENT.

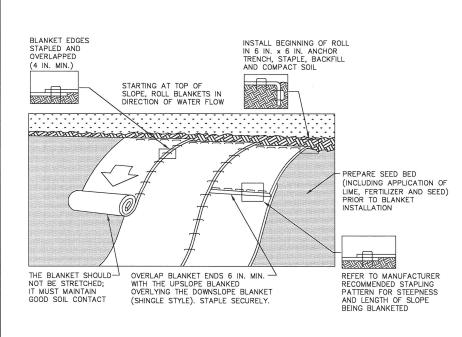
STANDARD CONSTRUCTION DETAIL EROSION CONTROL BLANKET INSTALLATION

SEED AND SOIL AMENDMENTS SHALL BE APPLIED ACCORDING TO THE RATES IN THE PLAN DRAWINGS PRIOR TO INSTALLING THE BLANKET.

PROVIDE ANCHOR TRENCH AT TOE OF SLOPE IN SIMILAR FASHION AS AT TOP OF SLOPE.

BLANKET SHALL HAVE GOOD CONTINUOUS CONTACT WITH UNDERLYING SOIL THROUGHOUT ENTIRE LENGTH. LAY BLANKET LOOSELY AND STAKE OR STAPLE TO MAINTAIN DIRECT CONTACT WITH SOIL. DO NOT STRETCH BLANKET.

THE BLANKET SHALL BE STAPLED IN ACCORDANCE WITH THE MANUFACTURER'S RECOMMENDATIONS.

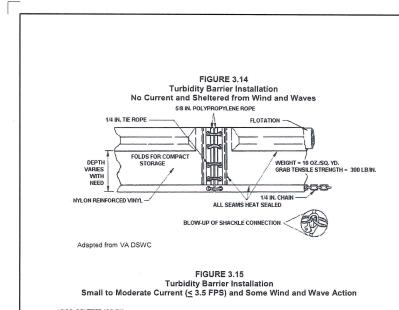
FIGURE 3.16
Turbidity Barrier Installation
Considerable Current (3.5 - 5 FPS) and Potential Tidal, Wind, and Wave Action

Installation - Follow the manufacturer's guidelines for proper installation. Make sure all obstacles, impediments, and potentially damaging objects have been removed from the installation area prior to beginning the installation. Figures 3.14 through 3.17 illustrate typical installations. However, manufacturer's details should be used for actual installation.
