**Applicant: Harris County Improvement District No. 1**  
**Memorial Park Central Connector Project**  
**Mitigation Plan**

The project area is located within Memorial Park, southeast of I-10 and I-610 in Harris County, Texas. The USGS Quad reference map is *Houston Heights* and the center of the project area is located approximately at NAD 83 UTM Zone 15 coordinates UTM 263,836 E; 3,294,962 N (WGS84/NAD83).

**LEVEL 1 STREAM ASSESSMENT - EXISTING CONDITIONS  
 SITE MAP**

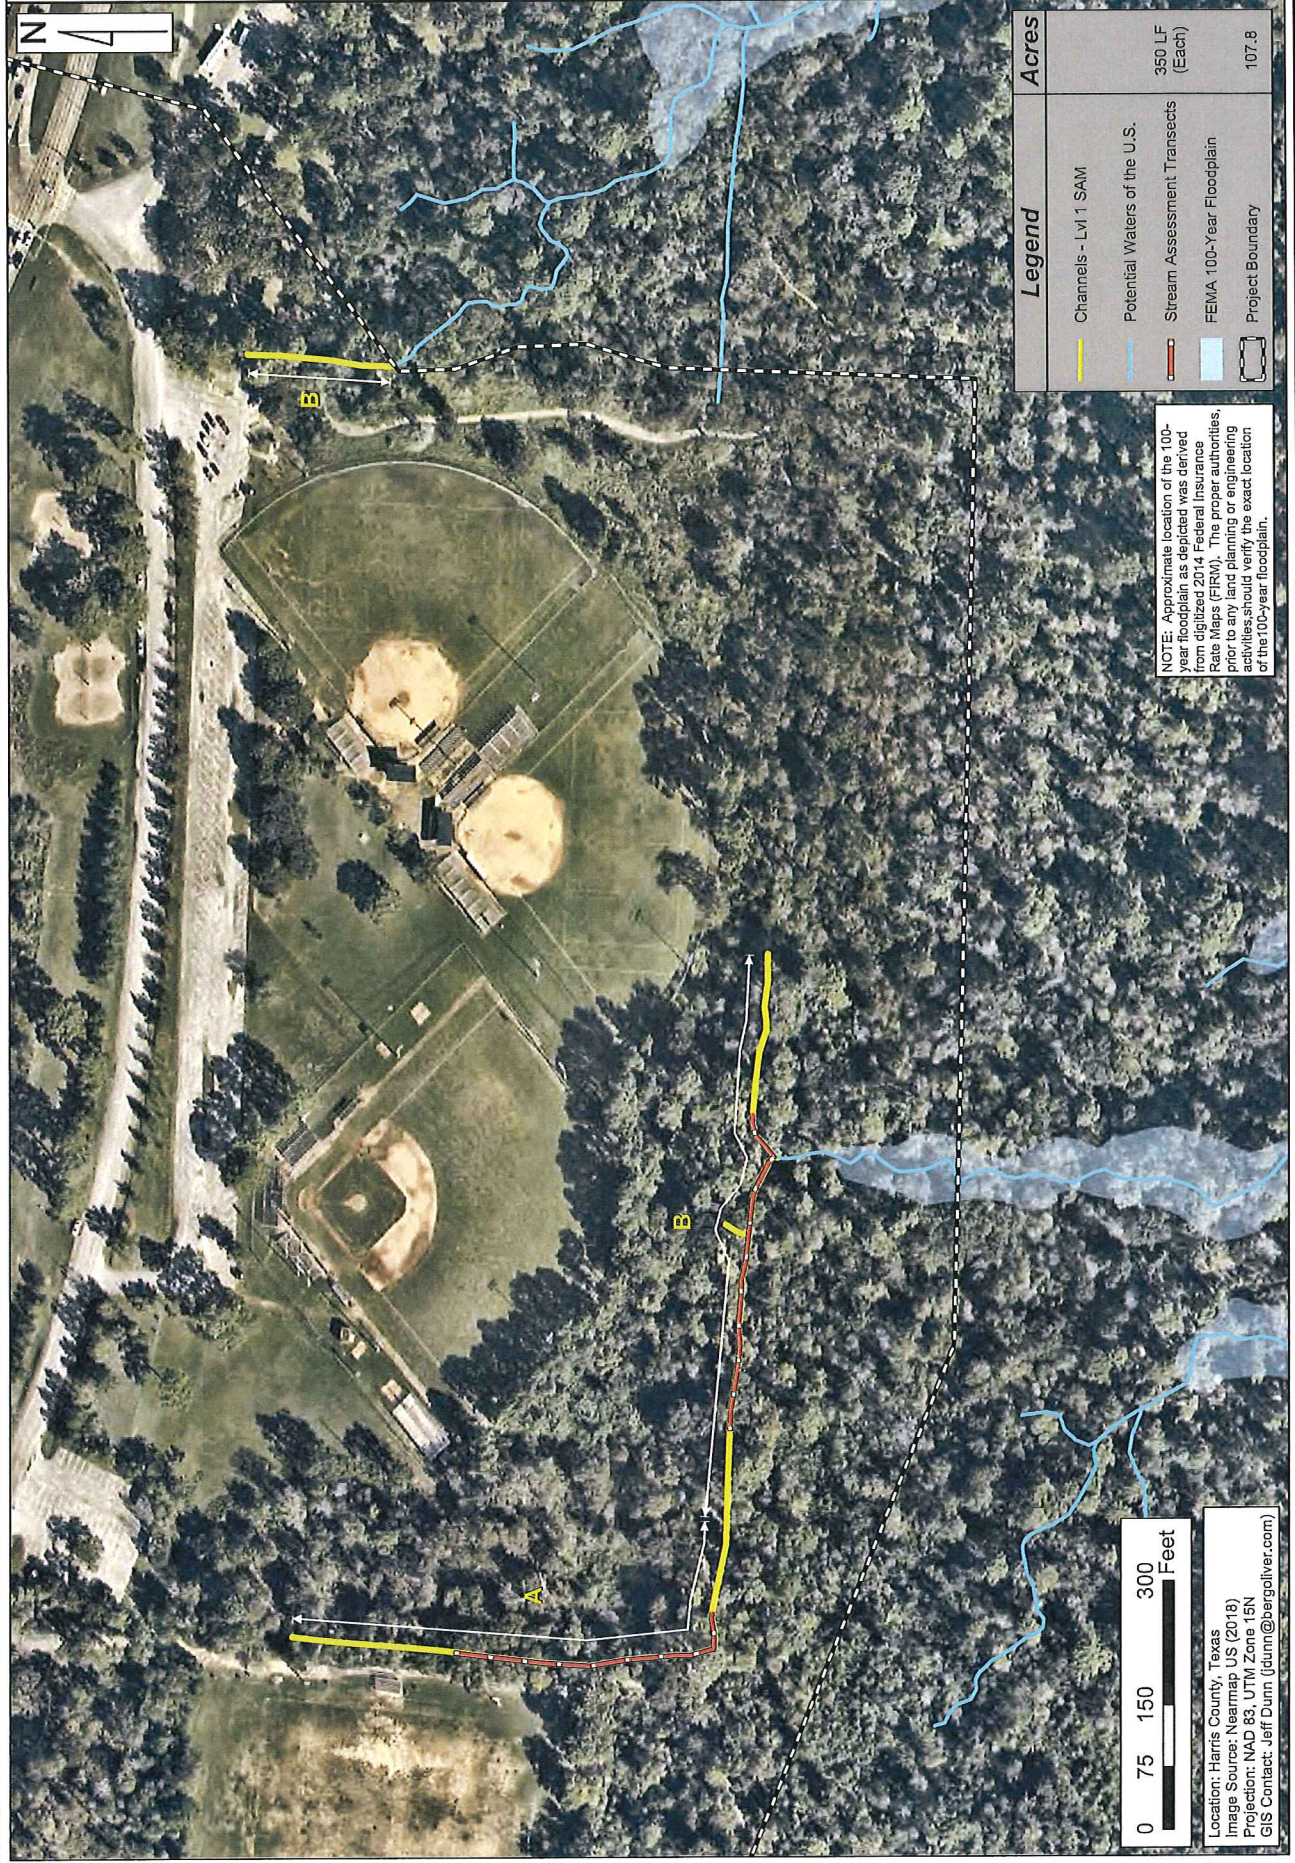
Legend	Acres
Channels - Lvl 1 SAM	350 LF (Each)
Potential Waters of the U.S.	107.8
Stream Assessment Transects	
FEWA 100-Year Floodplain	
Project Boundary

NOTE: Approximate location of the 100-year floodplain as depicted was derived from digitized 2014 Federal Insurance Rate Maps (FIRM). The proper authorities, prior to any land planning or engineering activities, should verify the exact location of the 100-year floodplain.

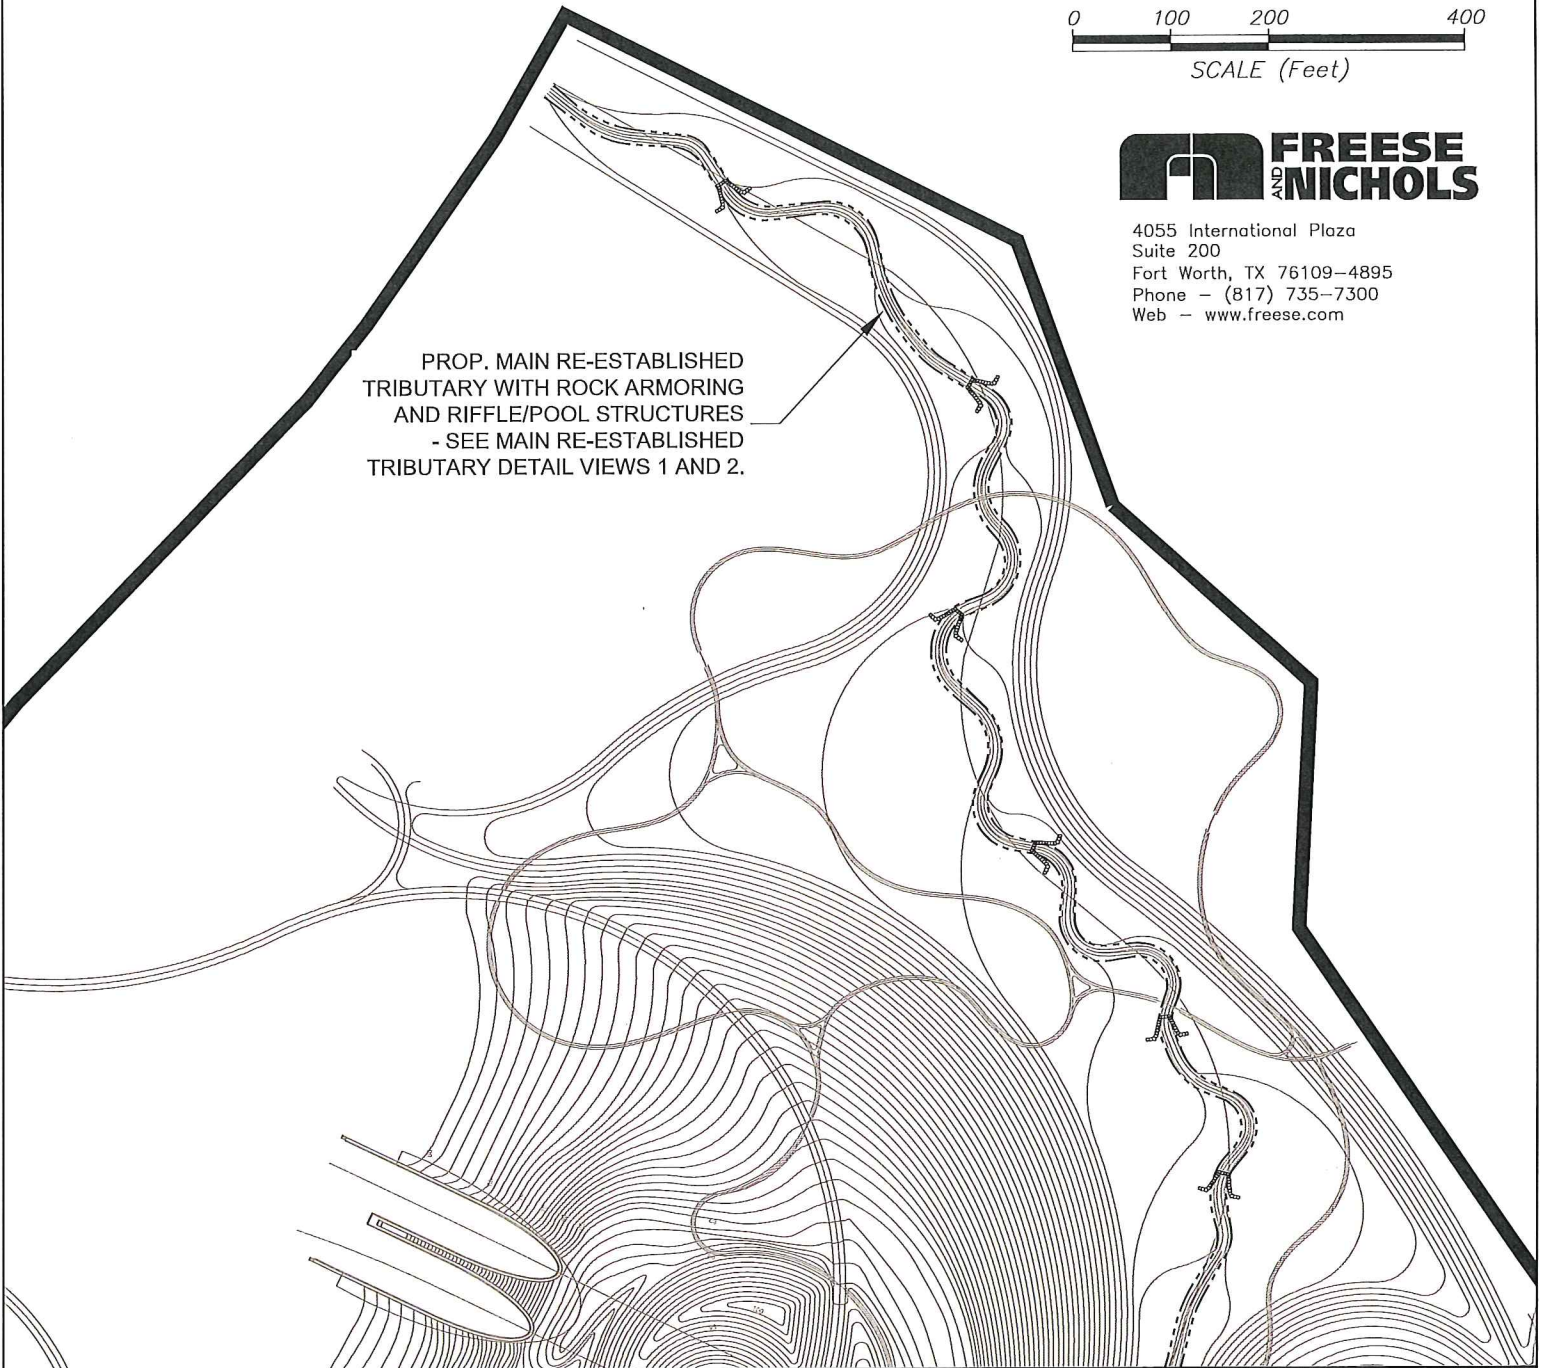
**MEMORIAL PARK CENTRAL CONNCECTOR PROJECT  
SHEET 1**

PROP. MAIN RE-ESTABLISHED  
 TRIBUTARY WITH ROCK ARMORING  
 AND RIFFLE/POOL STRUCTURES  
 - SEE MAIN RE-ESTABLISHED  
 TRIBUTARY DETAIL VIEWS 1 AND 2.
