**Harris County Water Control and Improvement District 96**

**P133-00-00 Maintenance & Erosion Repairs  
Harris County, Texas**

**Mitigation and Monitoring Plan**

June 2016

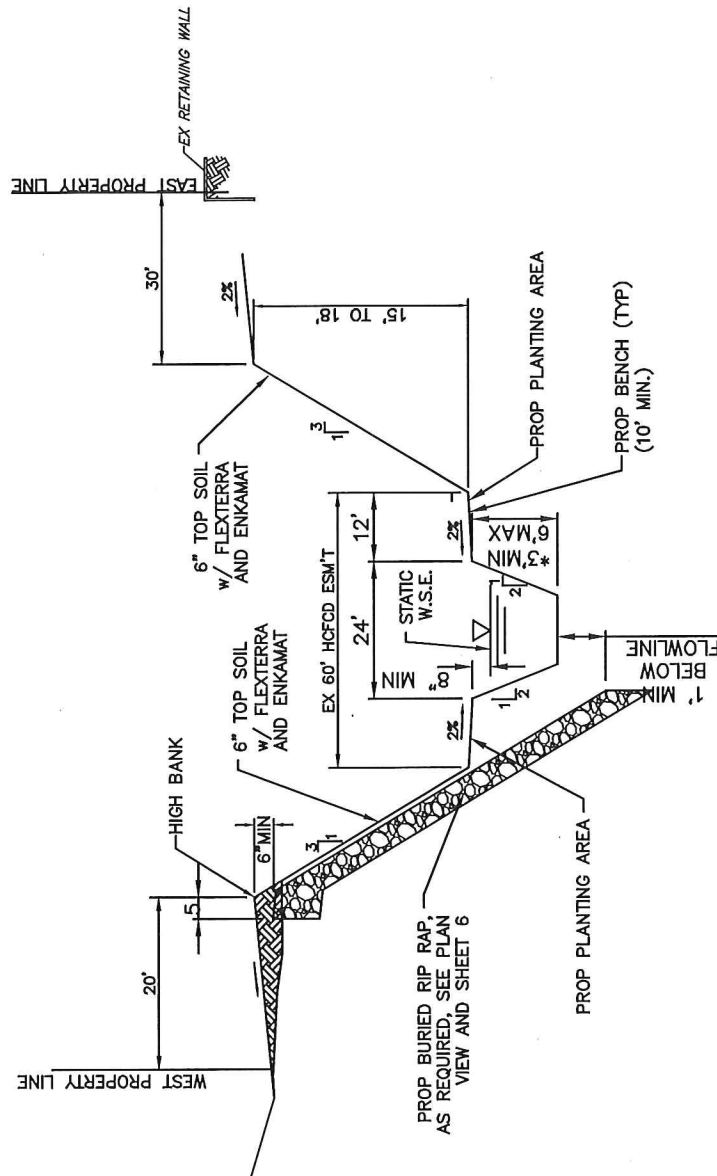
TYPICAL CROSS SECTION

N.T.S.

Scale:	Job No.:	Date:	Exhibit:
N.T.S.	96108-61	JUNE, 2016	2C

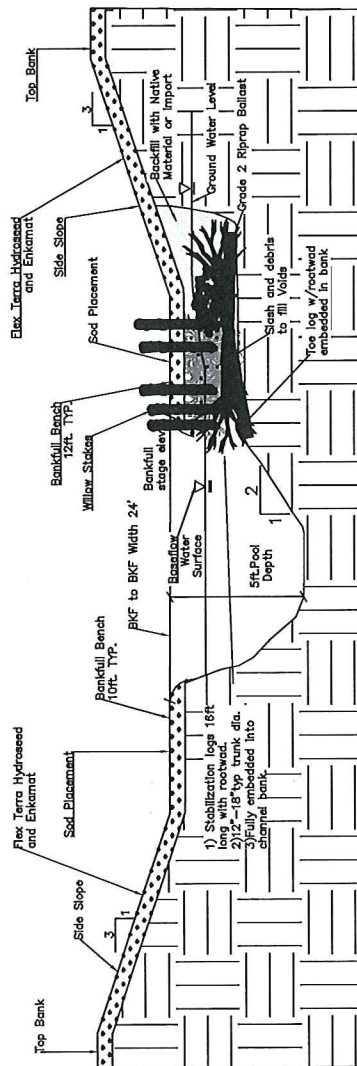
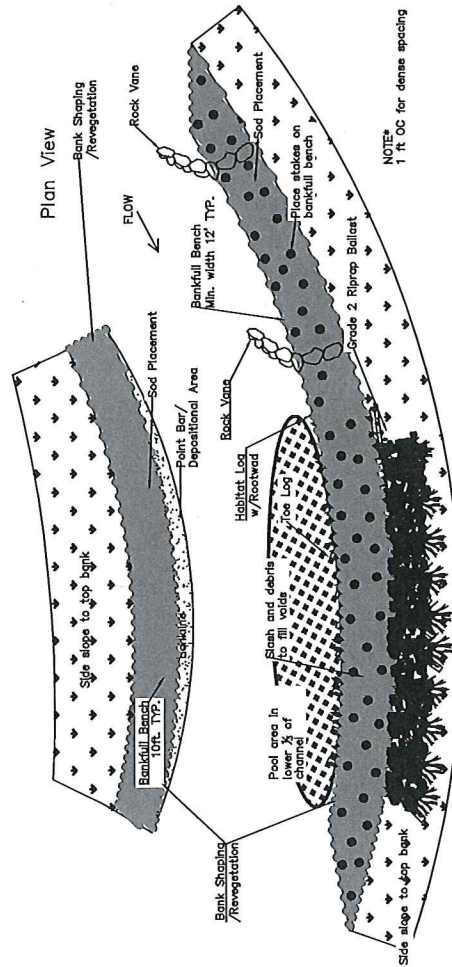
## TOE WOOD DETAIL

## Section View

SCALE: NTS

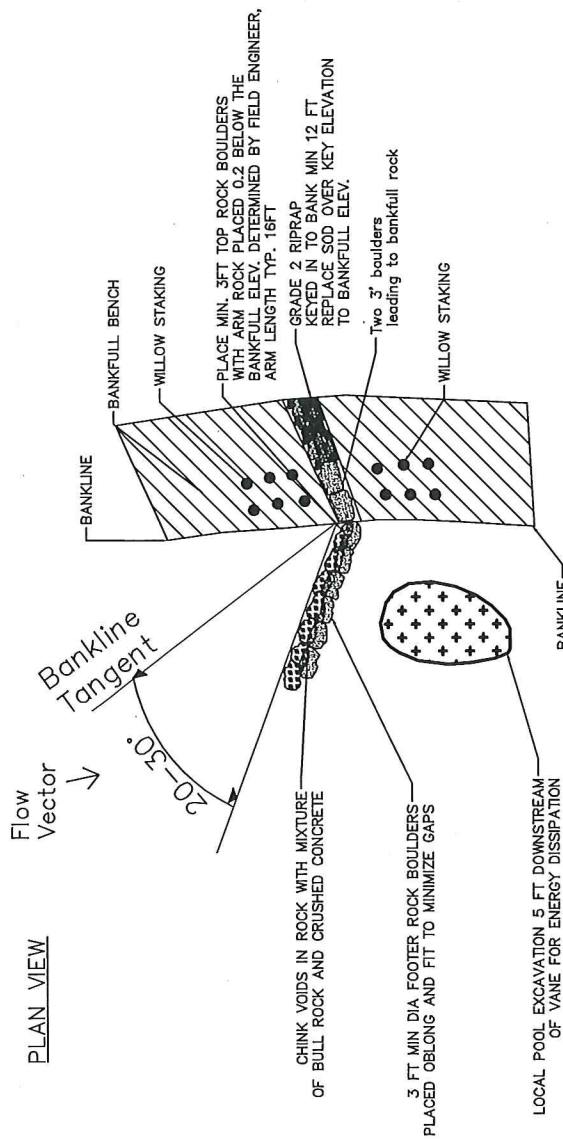
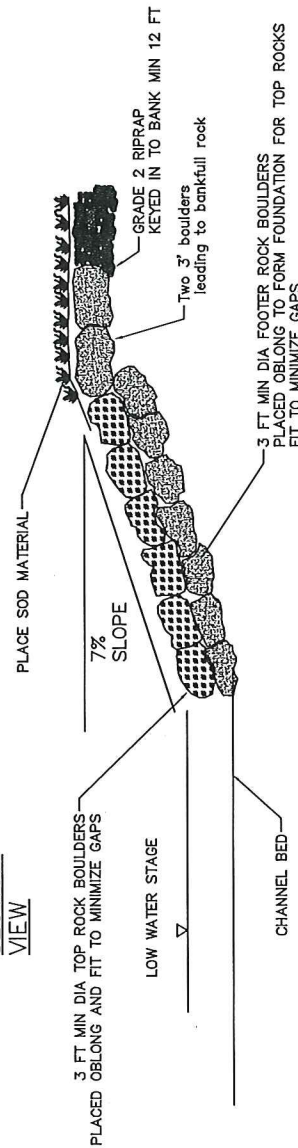
PLAN VIEW

SECTION VIEW

BOULDER VANE DETAIL

SCALE: NTS

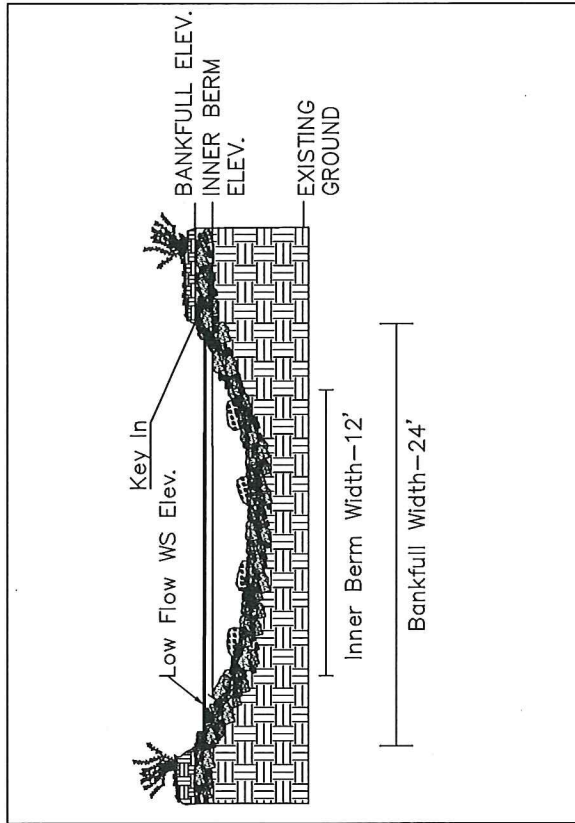
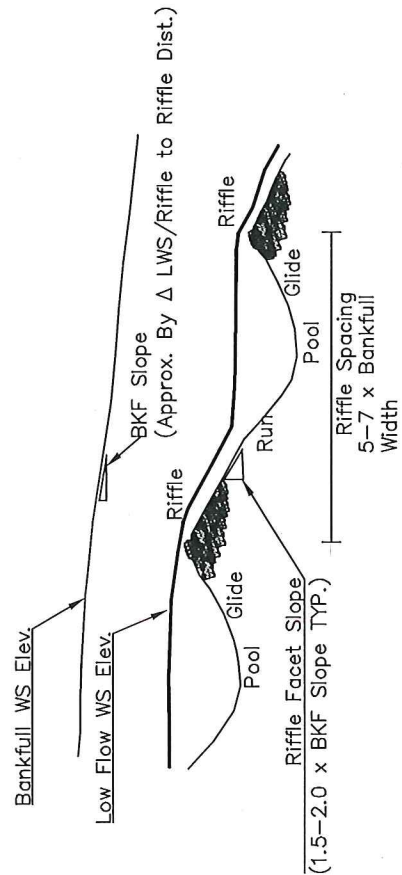
# RIFFLE AND POOL DETAIL

# Cross-Section View

# Plan View

# PROFILE TOP RIFFLE (TR)

SCALE: NTS

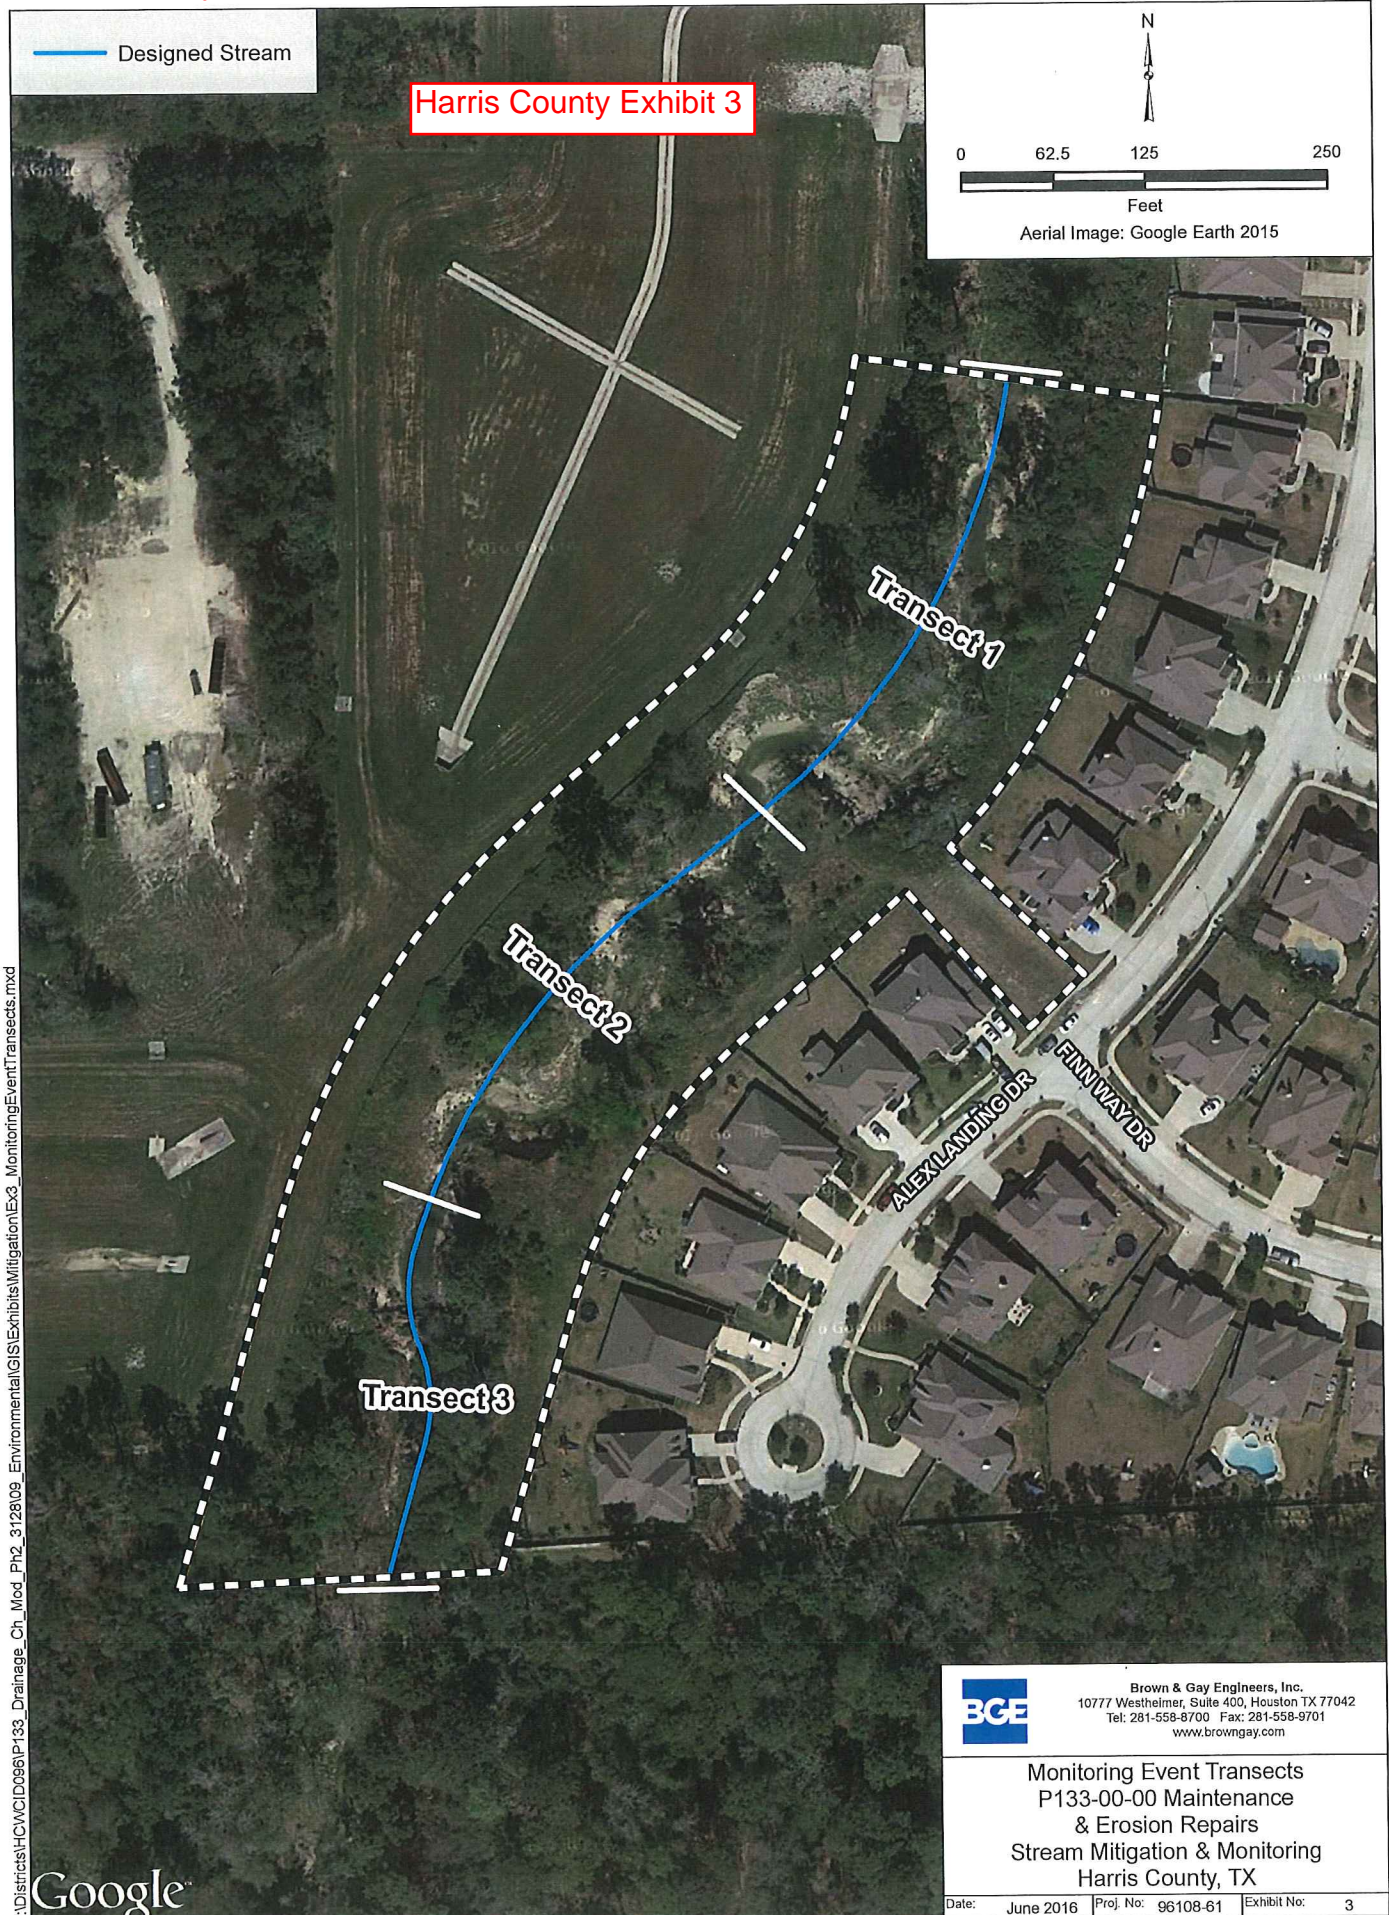
X:\Districts\HCWCID096\P133\_Drainage\_Ch\_Mod\_Ph2\_3128109\_Environmental\GIS\Exhibits\Mitigation\Ex3\_MonitoringEvent\Transects.mxd
