# WETLAND MITIGATION BANK PROSPECTUS

BASFORD BAYOU MITIGATION BANK  
SWG-2017-00718  
Galveston County, Texas

Prepared for Submittal to:  
U.S. Army Corps of Engineers, Galveston District

Prepared By:  
Wildwood Environmental Credit Company, LLC

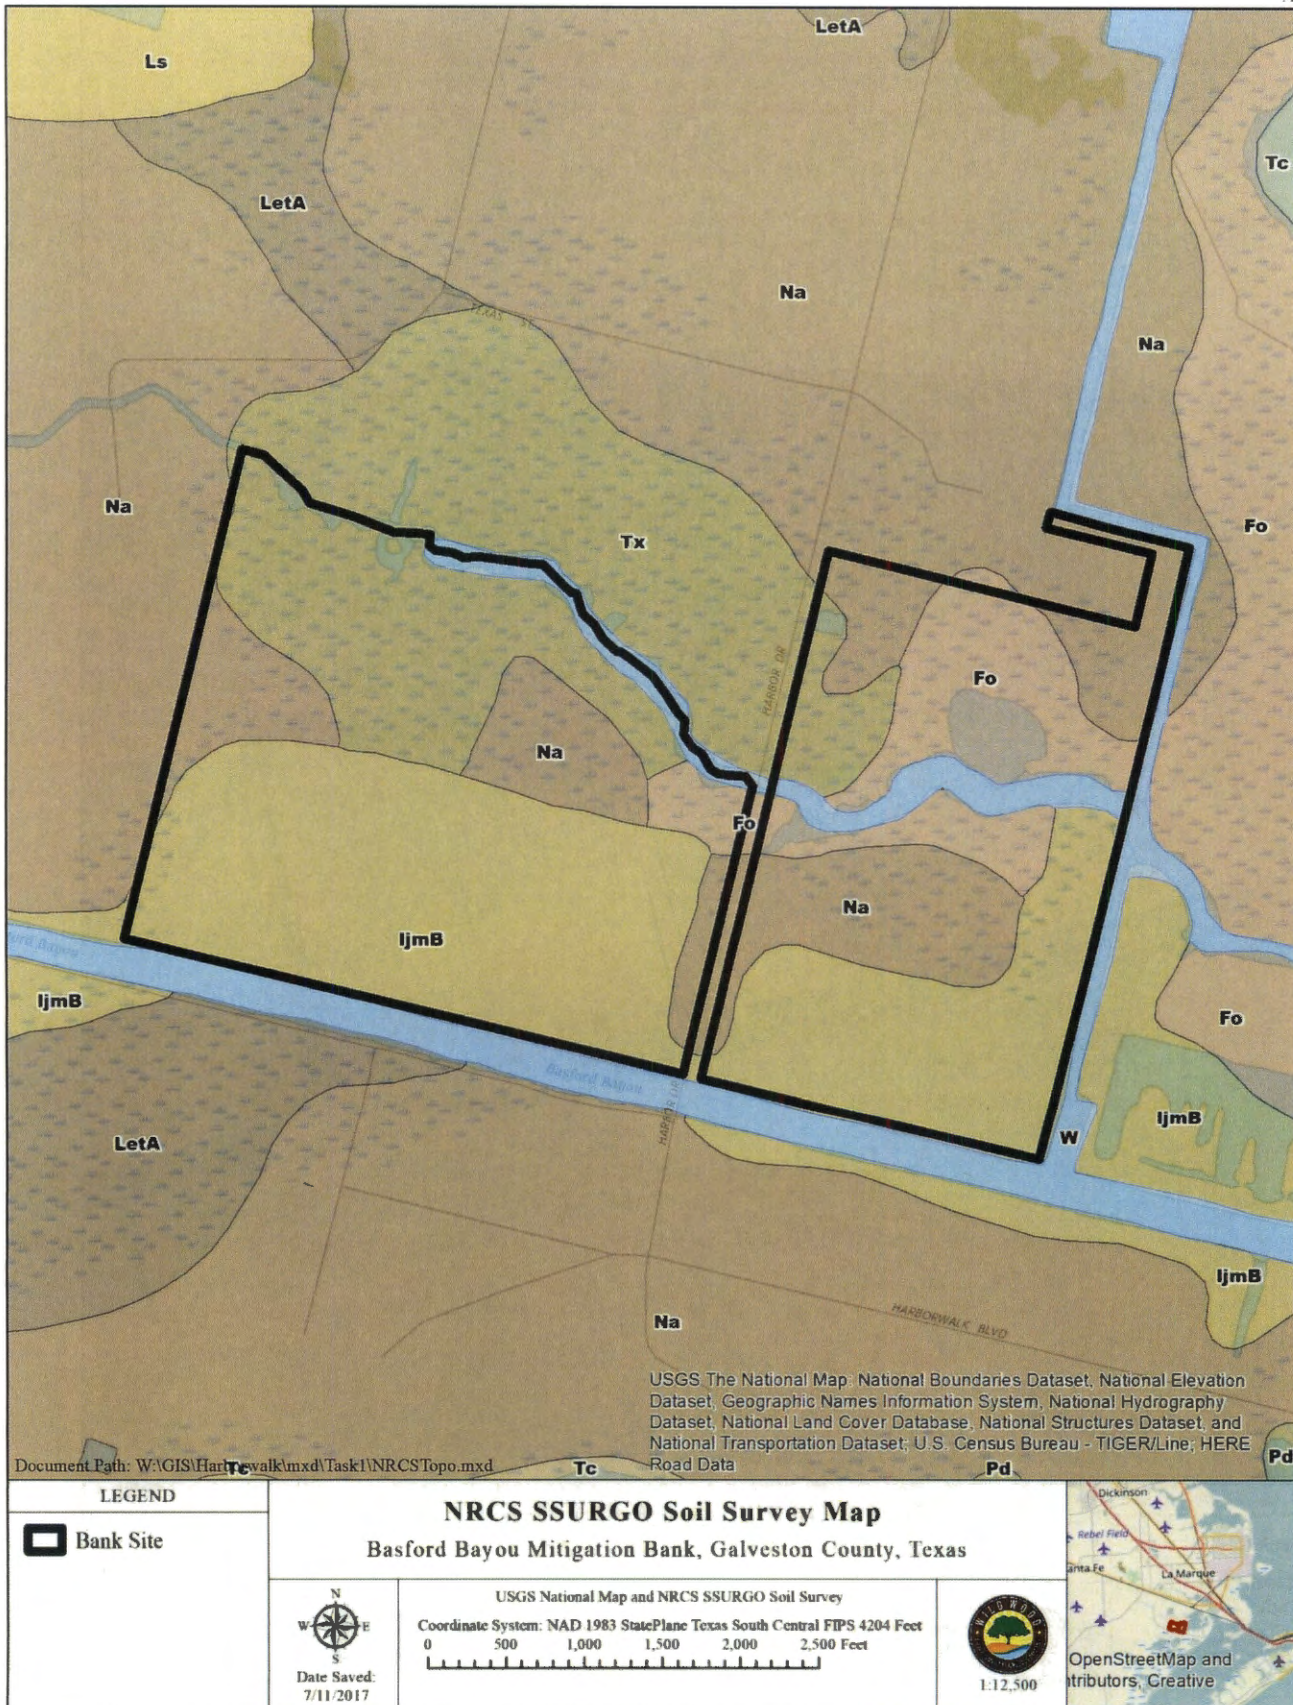
Figure 12. NRCS SSURGO Soil survey map of the site over the National Map baselayer.

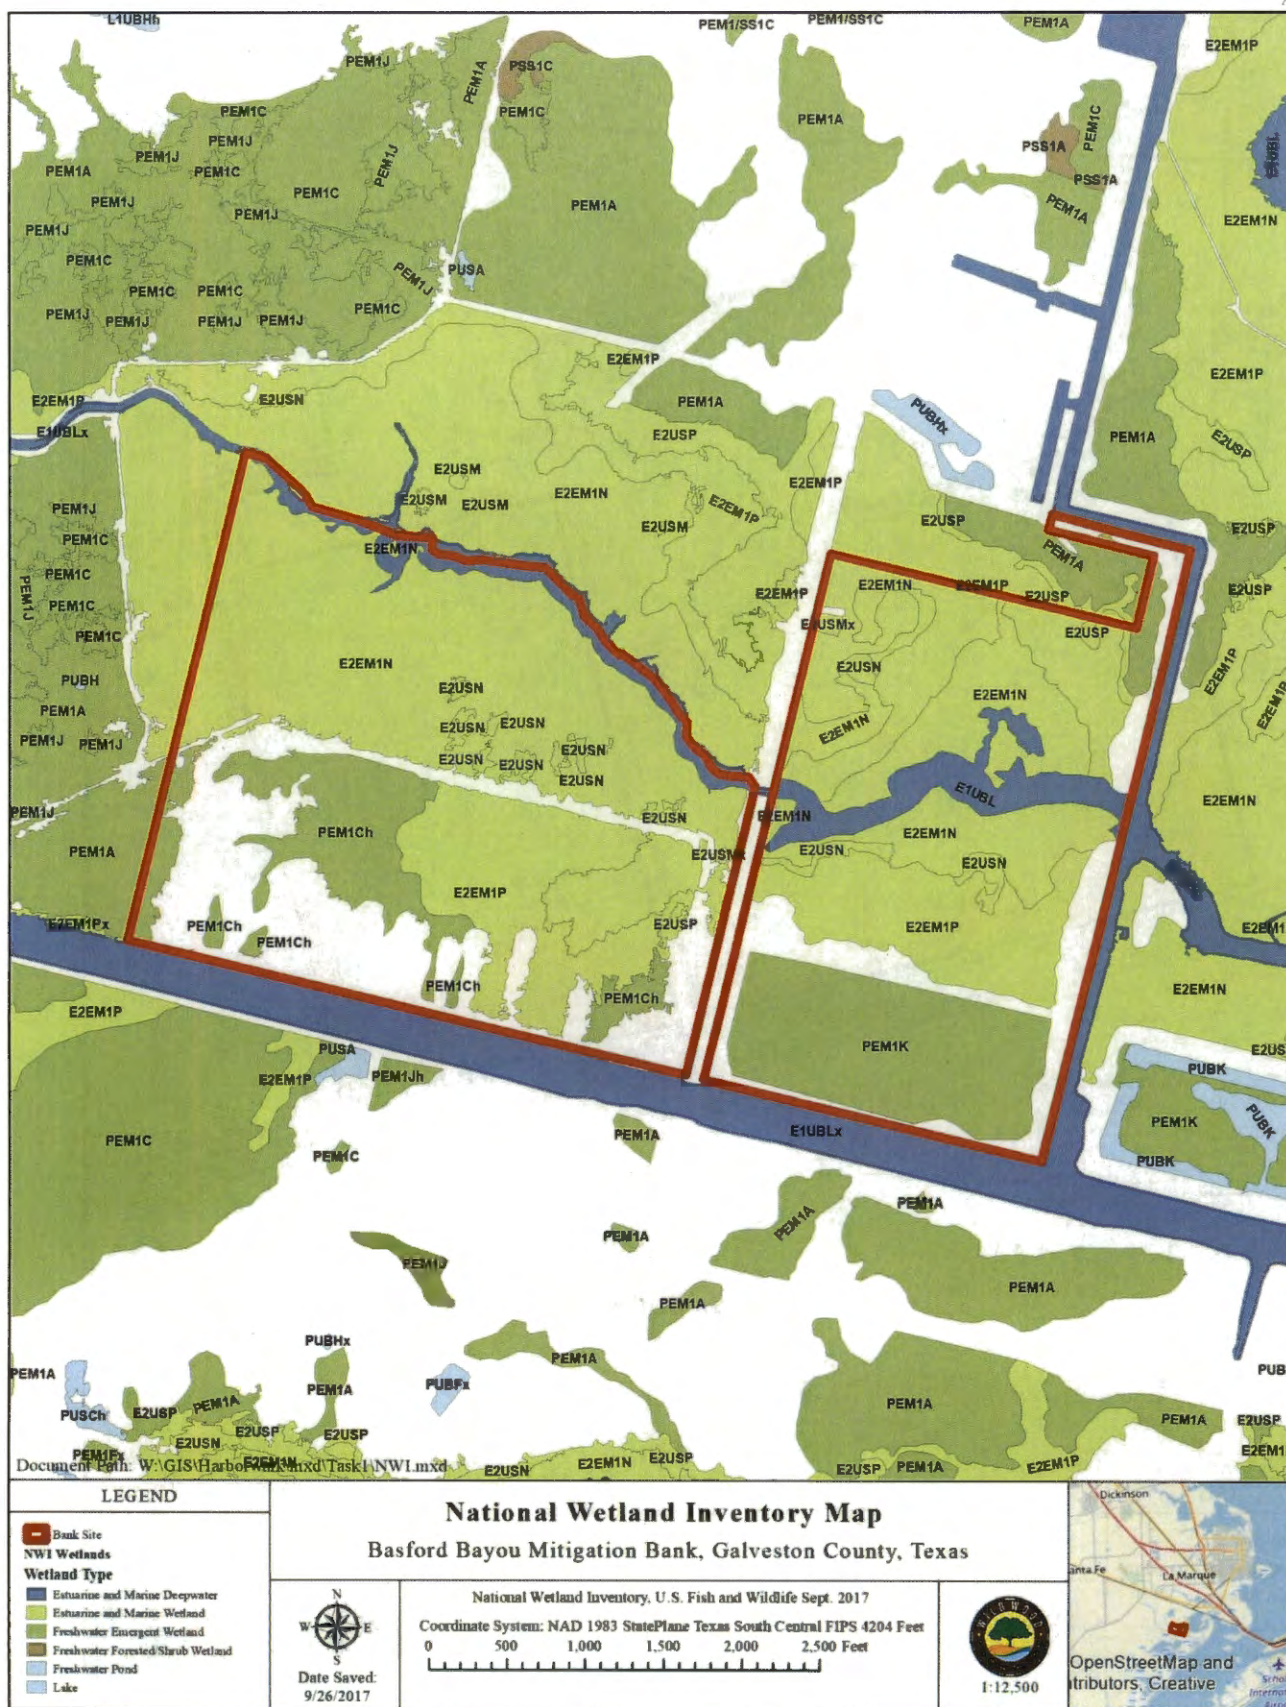
Figure 13. National Wetland Inventory classification of the site.

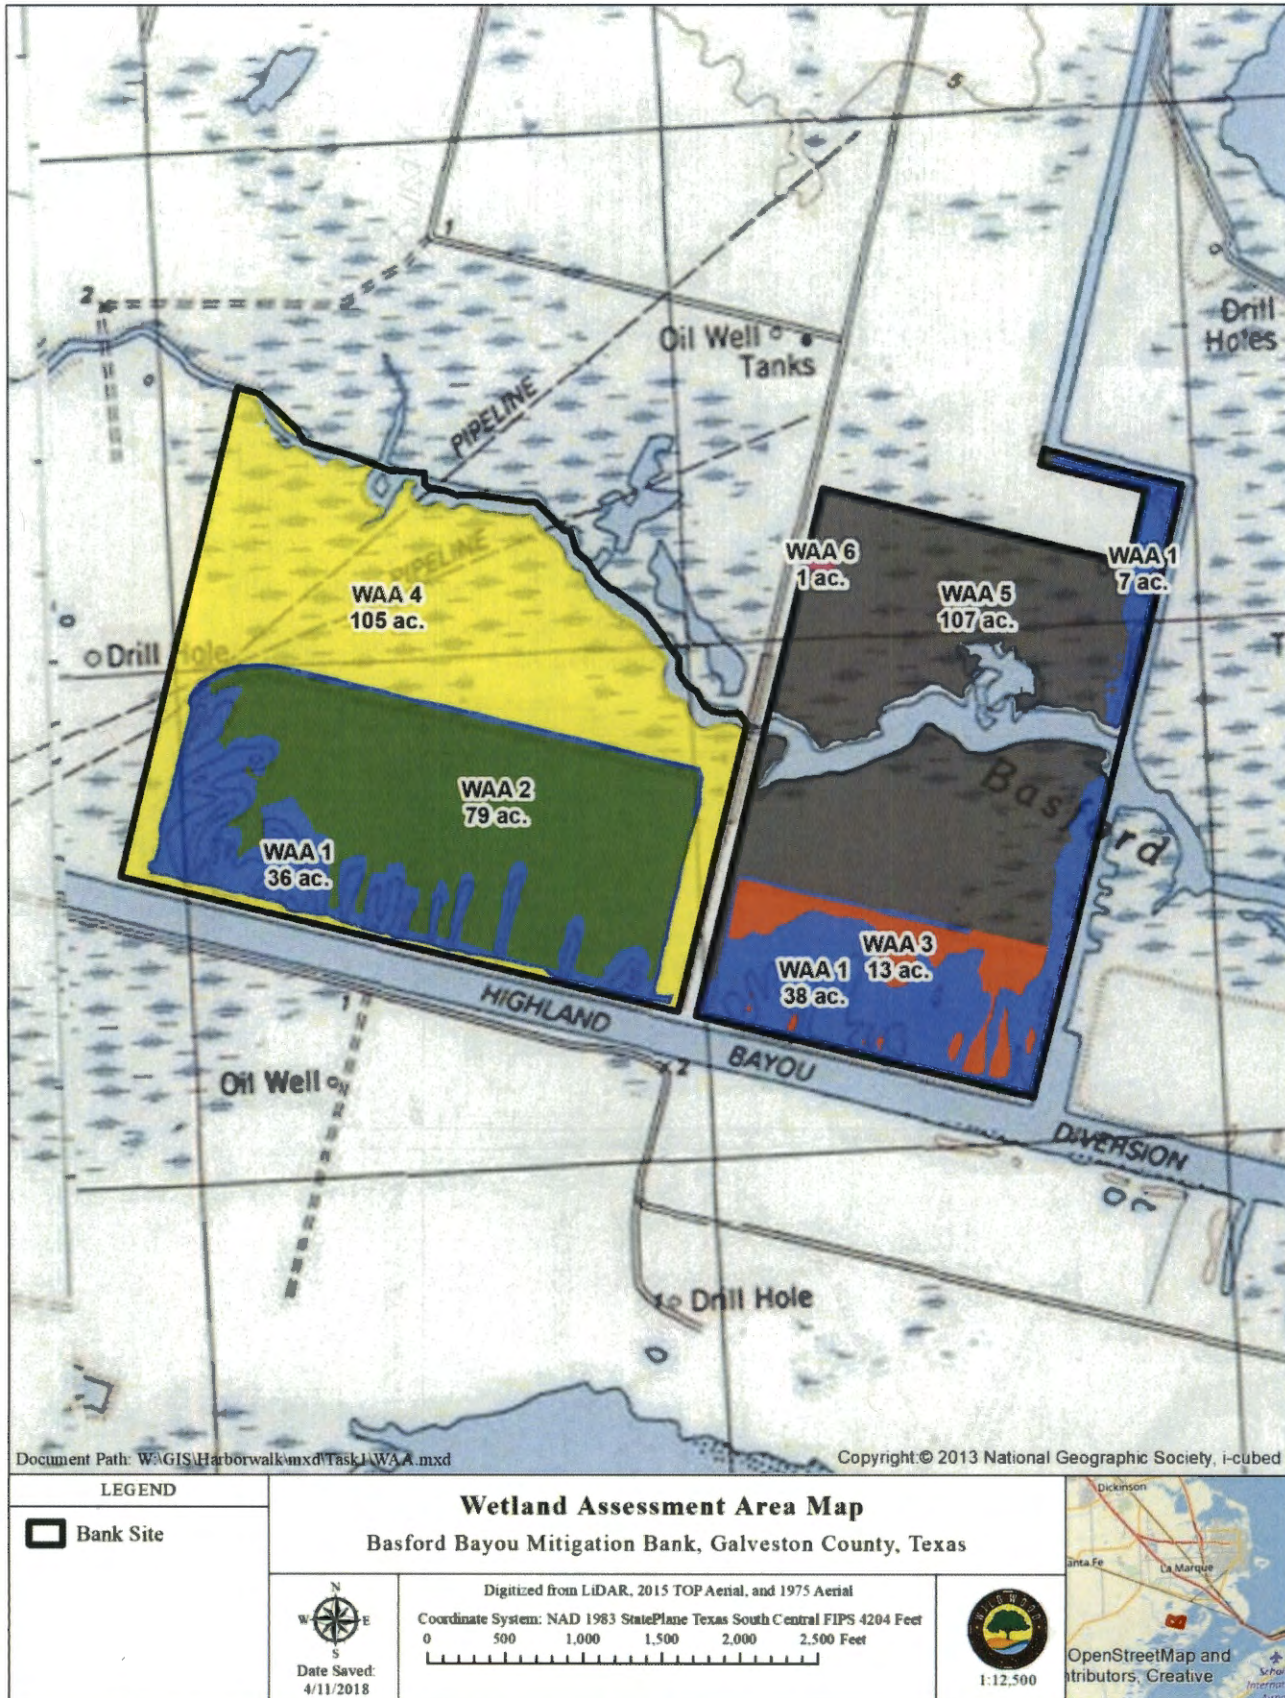
Figure 15. Map of wetland assessment areas used for discussion and credit calculation.

The tract has been separated into six Wetland Assessment Areas (WAAs): 1) non-wetland spoil areas; 2) wetlands west of Harbor Drive and within the former containment levee; 3) wetlands east of Harbor Drive and within the former containment levee; 4) wetlands west of Harbor Drive and outside of the former containment levee; 5) wetlands east of Harbor Drive, and 6) the former borrow pit east of Harbor Drive. A map of the WAAs may be found as **Figure 15**. The following discussions are based on the general ability of the wetlands onsite to function relative to the U.S. Army Corps of Engineer's Tidal Fringe iHGM assessment method.<sup>6</sup> **Appendix C** contains a desktop iHGM assessment for each WAA showing the current baseline and projected subindex scores 1, 3, 5, and 7 years' post-construction and revegetation.

The tract has been separated into six Wetland Assessment Areas (WAAs): 1) non-wetland spoil areas; 2) wetlands west of Harbor Drive and within the former containment levee; 3) wetlands east of Harbor Drive and within the former containment levee; 4) wetlands west of Harbor Drive and outside of the former containment levee; 5) wetlands east of Harbor Drive, and 6) the former borrow pit east of Harbor Drive. A map of the WAAs may be found as **Figure 15**. The following discussions are based on the general ability of the wetlands onsite to function relative to the U.S. Army Corps of Engineer's iHGM assessment methods.<sup>8</sup>

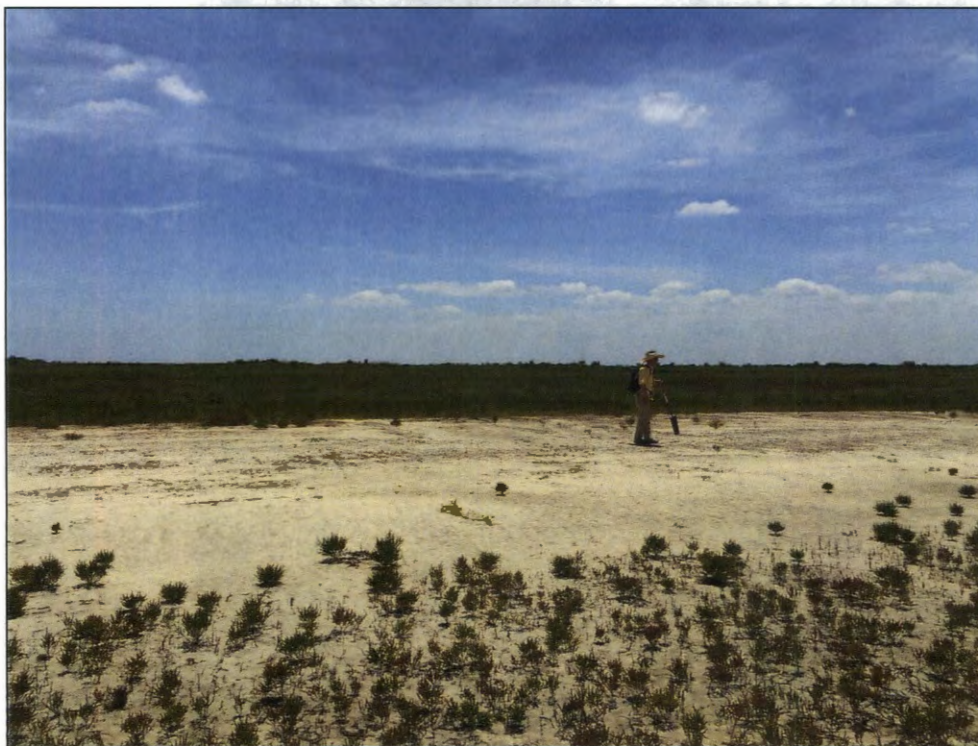
Photo 4. Former containment levee that is 0.9 feet higher than adjacent marsh surface (7/31/2017).

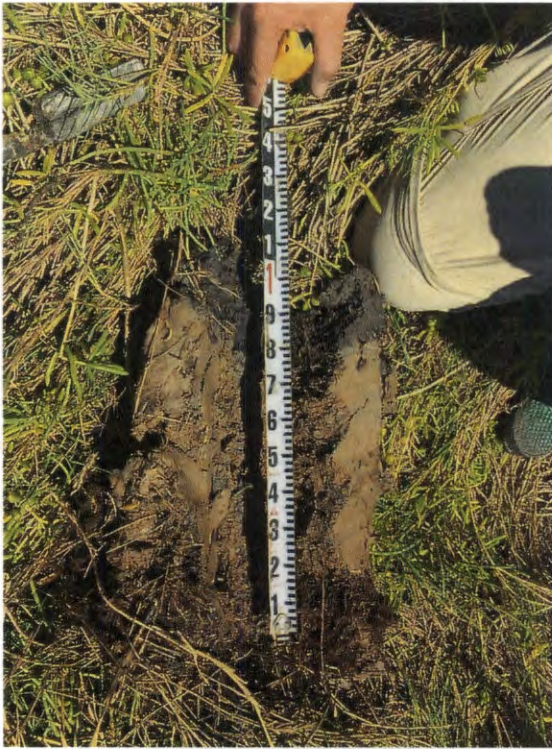
Photo 5. Typical soil profile in spoil covered area showing underlying wetland soil (7/31/2017).

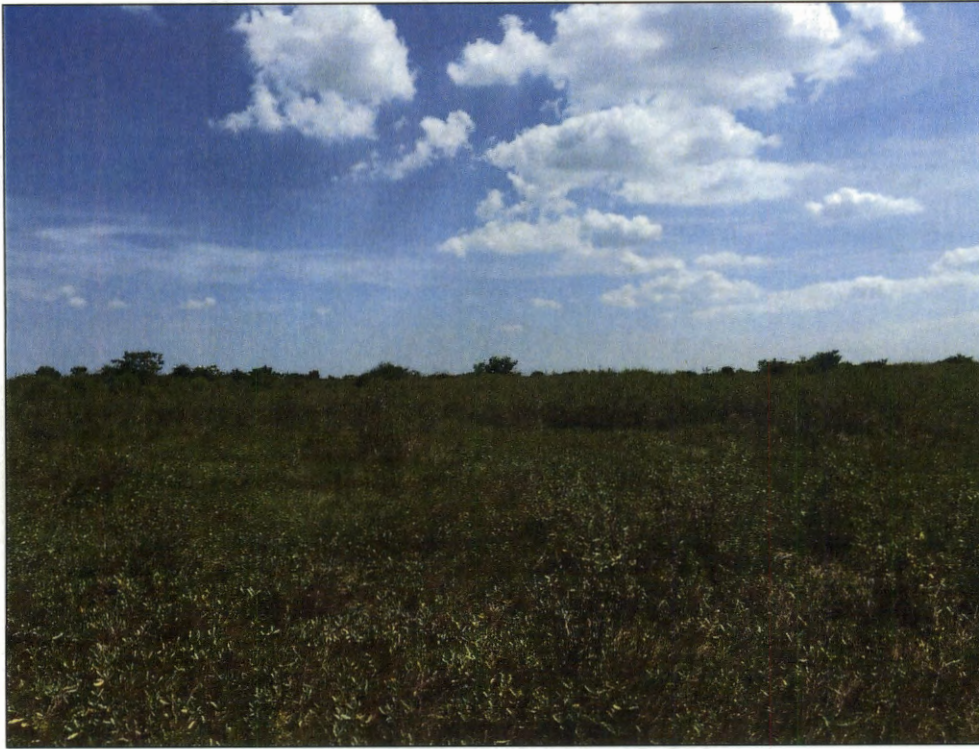
Photo 7. Toe of spoil pile in non-wetland area (7/31/2017).

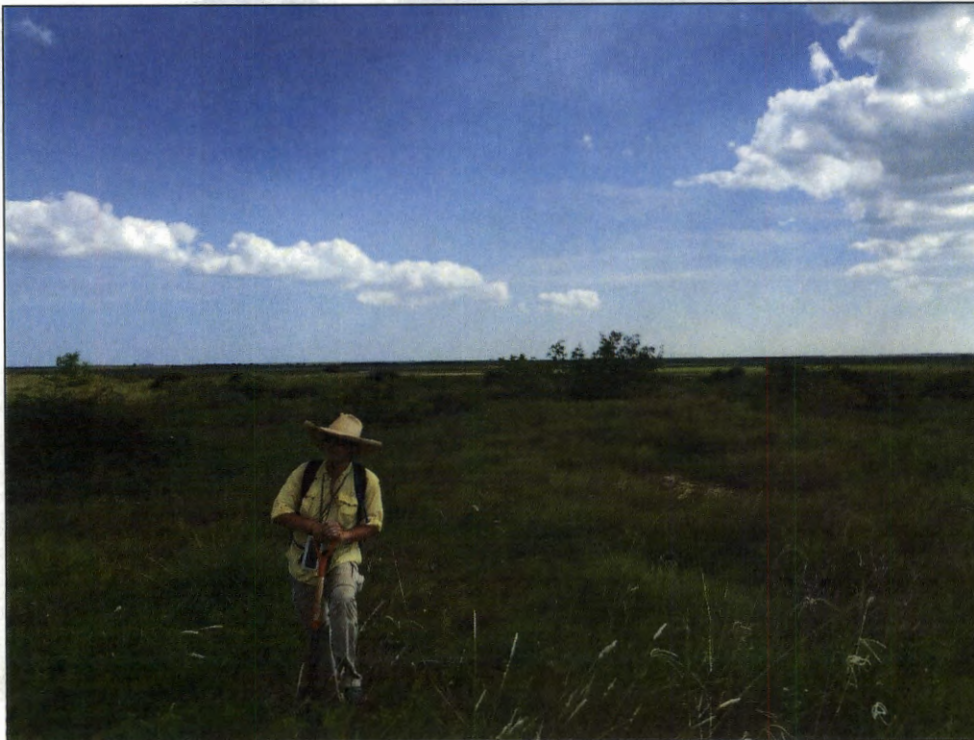
Photo 8. Top of spoil pile (7/31/2017).

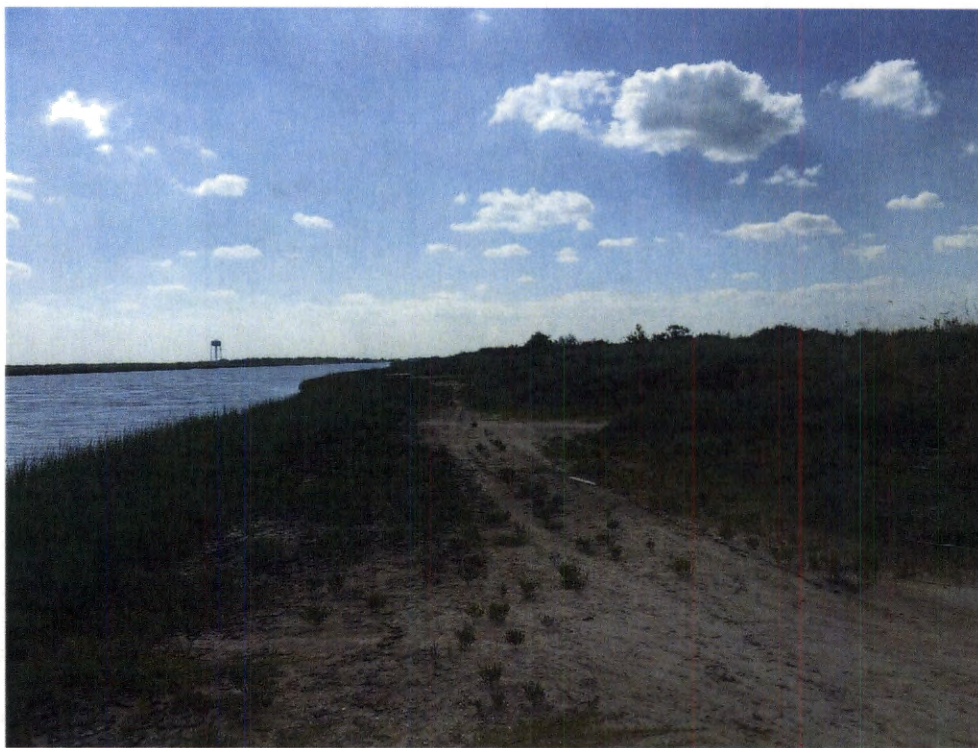
Photo 9. North side of Highland Bayou Diversion Canal looking west (7/31/2017).

Lateral erosion can be mitigated by leaving a spoil terrace or constructing a bench along the fronts of both canals. No recent lateral erosion was observed along Highland Bayou Diversion Canal during the July/August site visit and it appeared stable. This was because a bench has already formed along the canal (**Photo 9**).

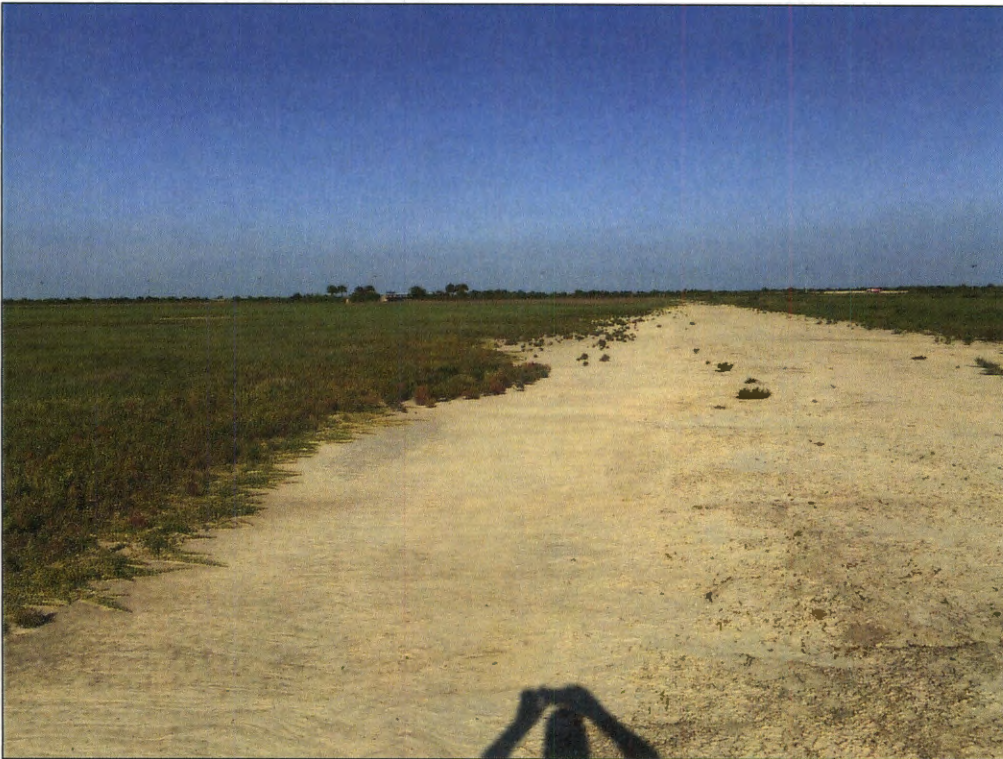
Photo 18. Containment levee looking east (7/31/2017).

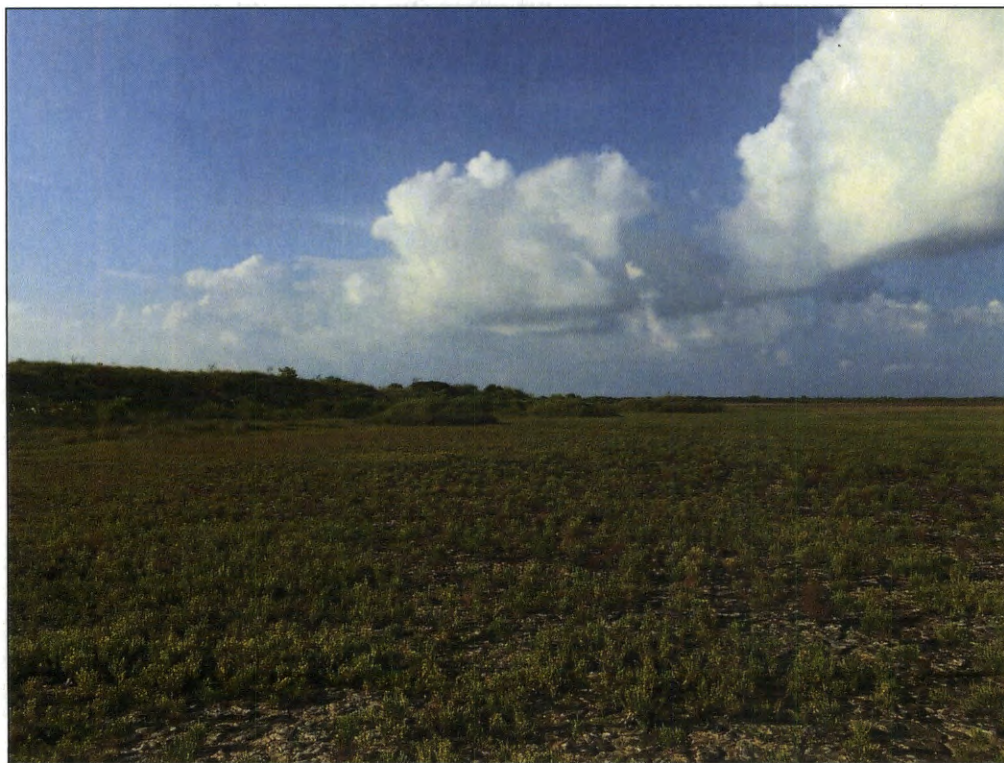
Photo 20. Toe of spoil bank on east boundary of the east tract (8/1/2017).

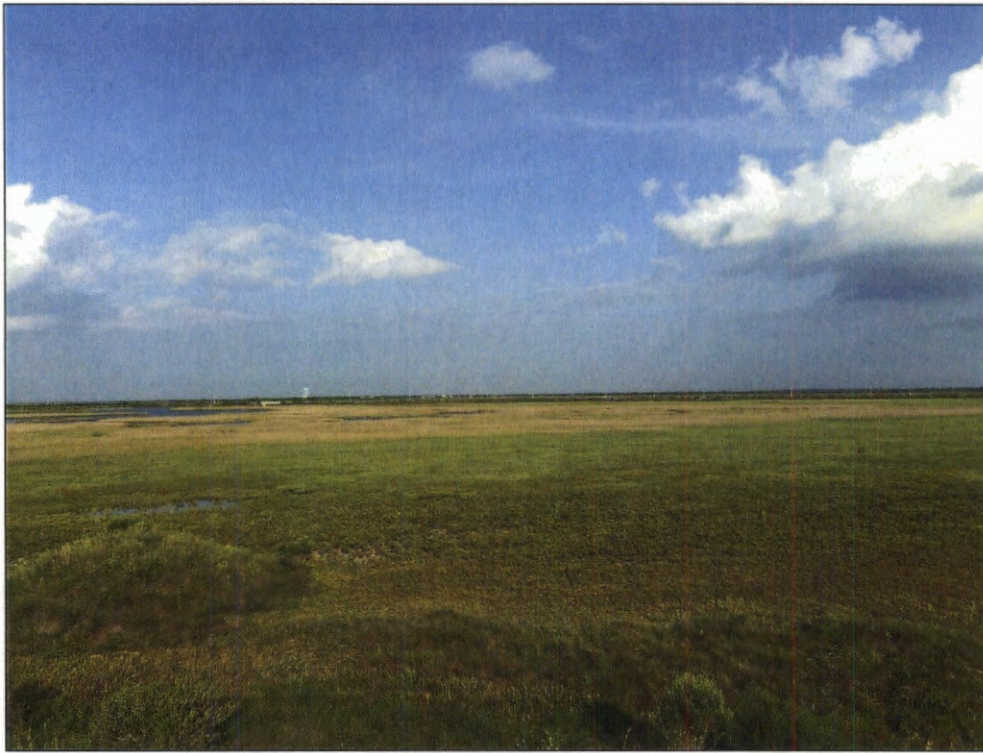
Photo 21. Top of spoil pile on east tract looking west (8/1/2017).

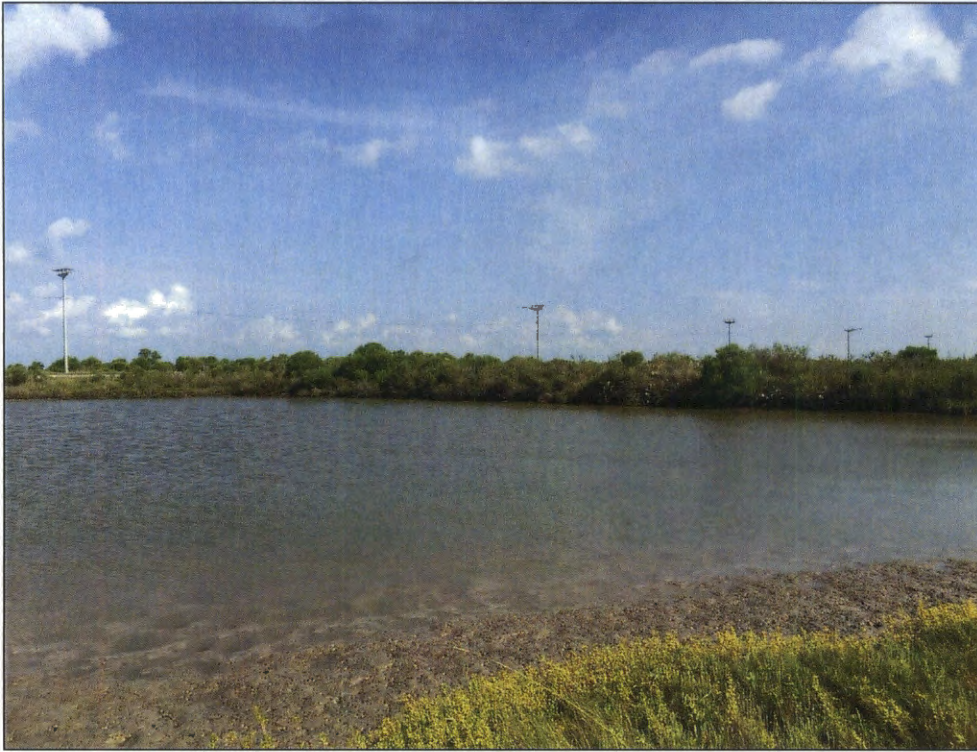
Photo 23. Former borrow pit on east tract (8/1/2017).

| Photo 23. Former borrow pit on east tract (8/1/2017). .... | 31 |

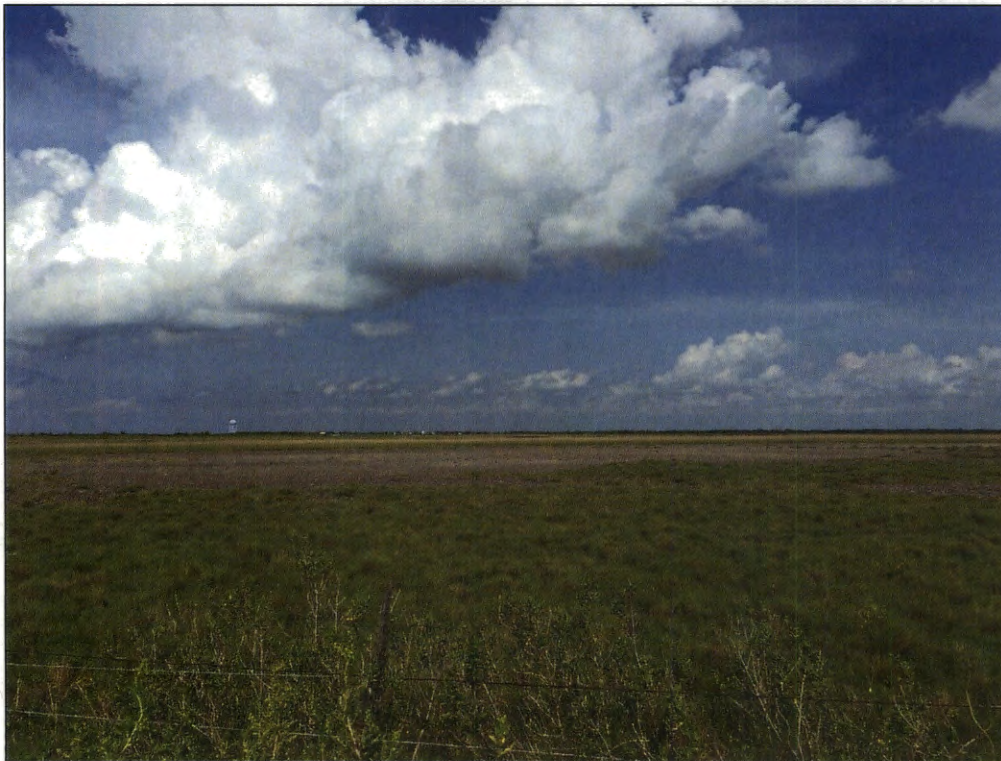
Photo 24. Heavily grazed pasture adjacent to West Tract (8/1/2017).

| Photo 24. Heavily grazed pasture adjacent to West Tract (8/1/2017). .... | 31 |

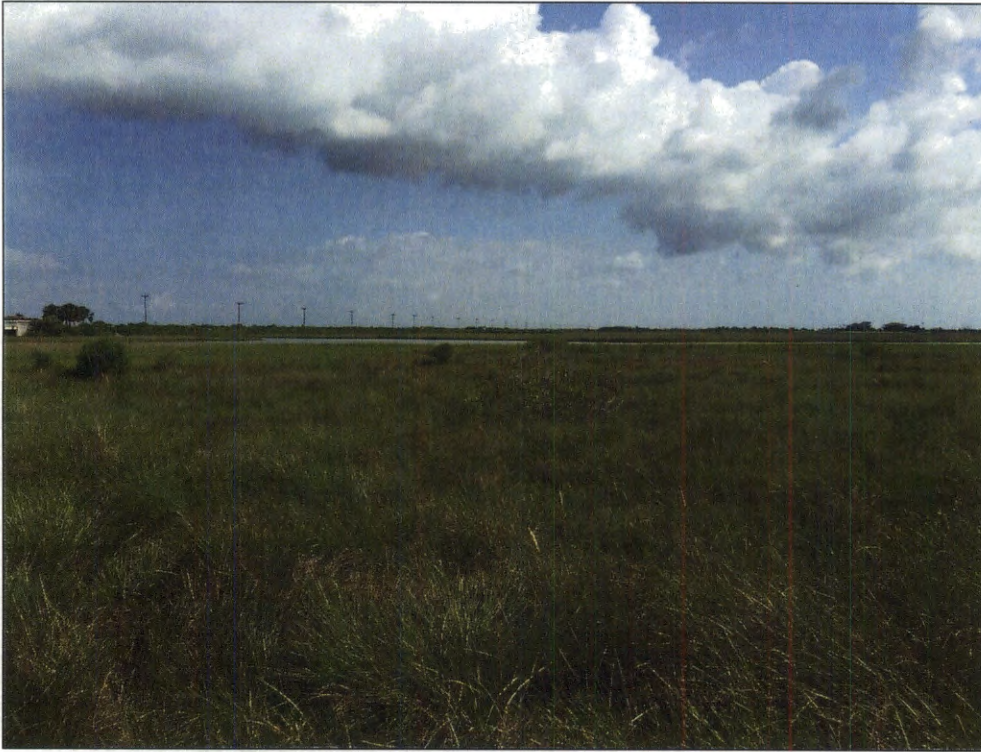
Photo 25. Gulf cordgrass dominated flat on east tract (8/1/2017).

| Photo 25. Gulf cordgrass dominated flat on east tract (8/1/2017). .... | 32 |

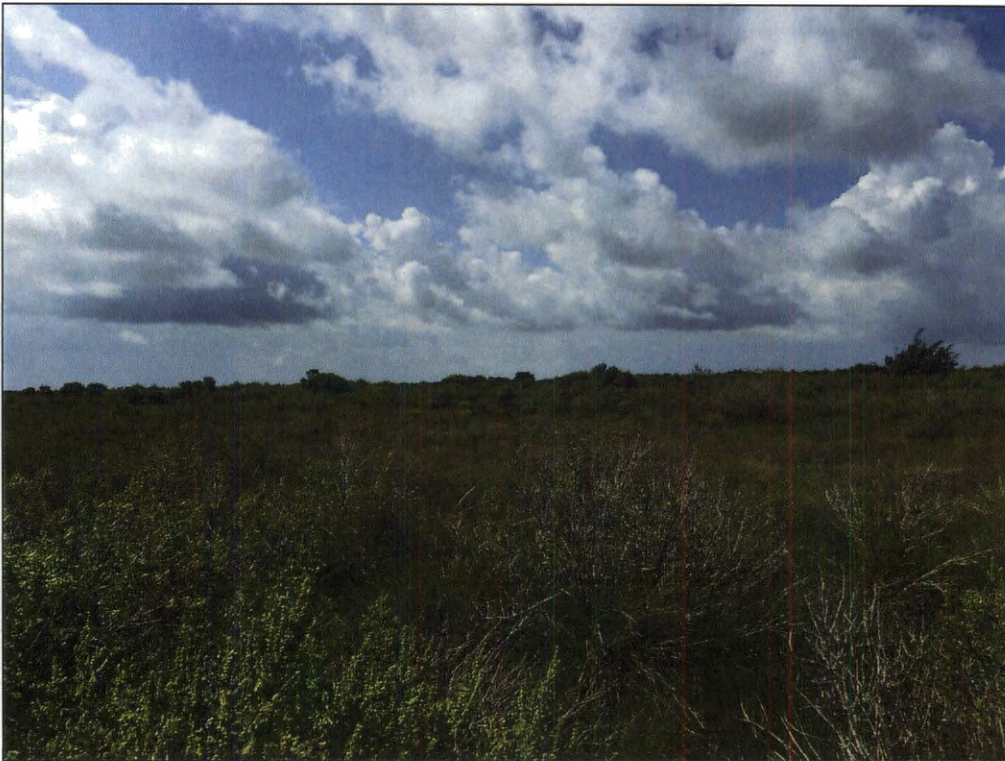
Photo 26. Scrub-shrub wetland on east tract (8/1/2017).

| Photo 26. Scrub-shrub wetland on east tract (8/1/2017). .... | 32 |

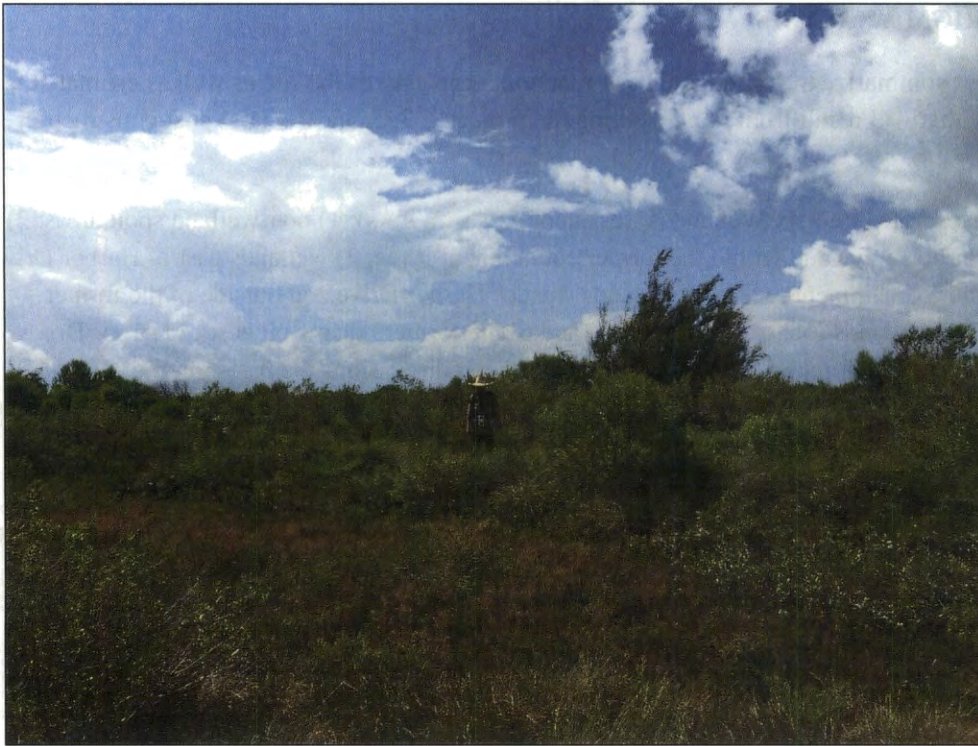
Photo 27. View of someone standing on the retention levee on the east tract (8/1/2017).

| Photo 27. View of someone standing on the retention levee on the east tract (8/1/2017). .... | 33 |

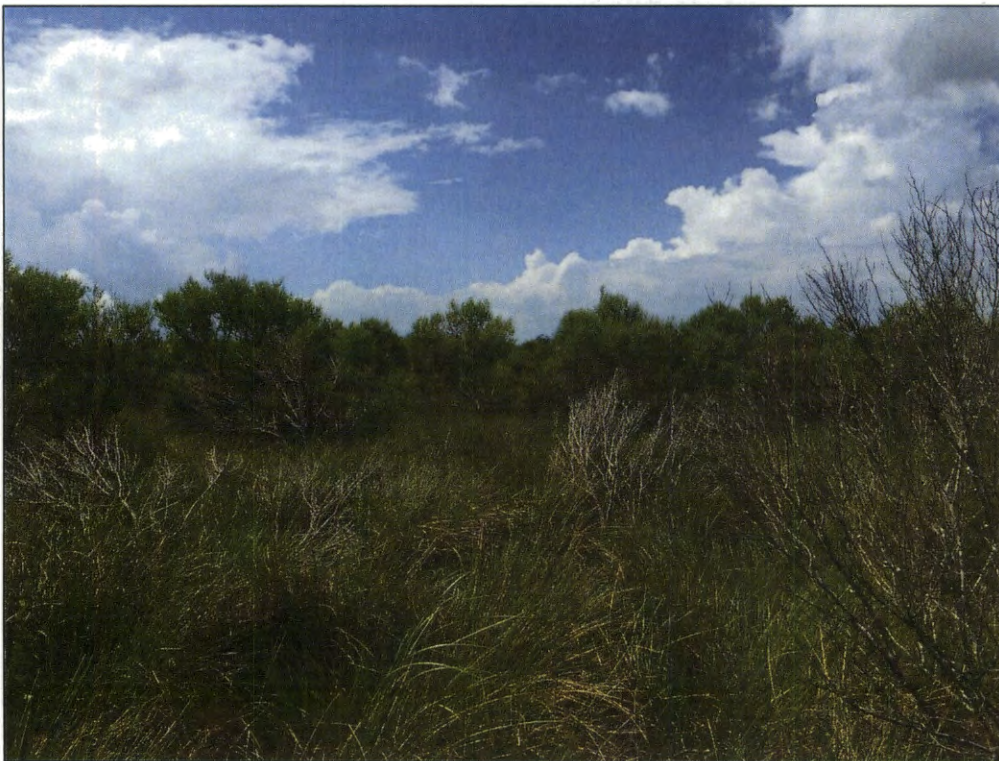
Photo 28. Heavily disturbed scrub-shrub wetland (potentially not-wetland) area within retention levee (8/1/2017).

| Photo 28. Heavily disturbed scrub-shrub wetland (potentially not-wetland) area within retention levee<br>(8/1/2017)..... | 33 |
