**Cape Velero Estates
Home Owners
Association**

**SWG-2005-00696
Project Vicinity Map
Boating Improvement Project
Aransas County, Texas**

**SWG-2005-00696
 Project Overview Aerial
 Boating Improvement Project
 Aransas County, Texas**
 Source: Google Earth Satellite Photography; 2022
 Scale: 1:222

SWG-2005-00696
Living Shoreline Mitigation Structure
Double Row of 36-Inch Reef Balls
3-Foot Edge to Edge Offset

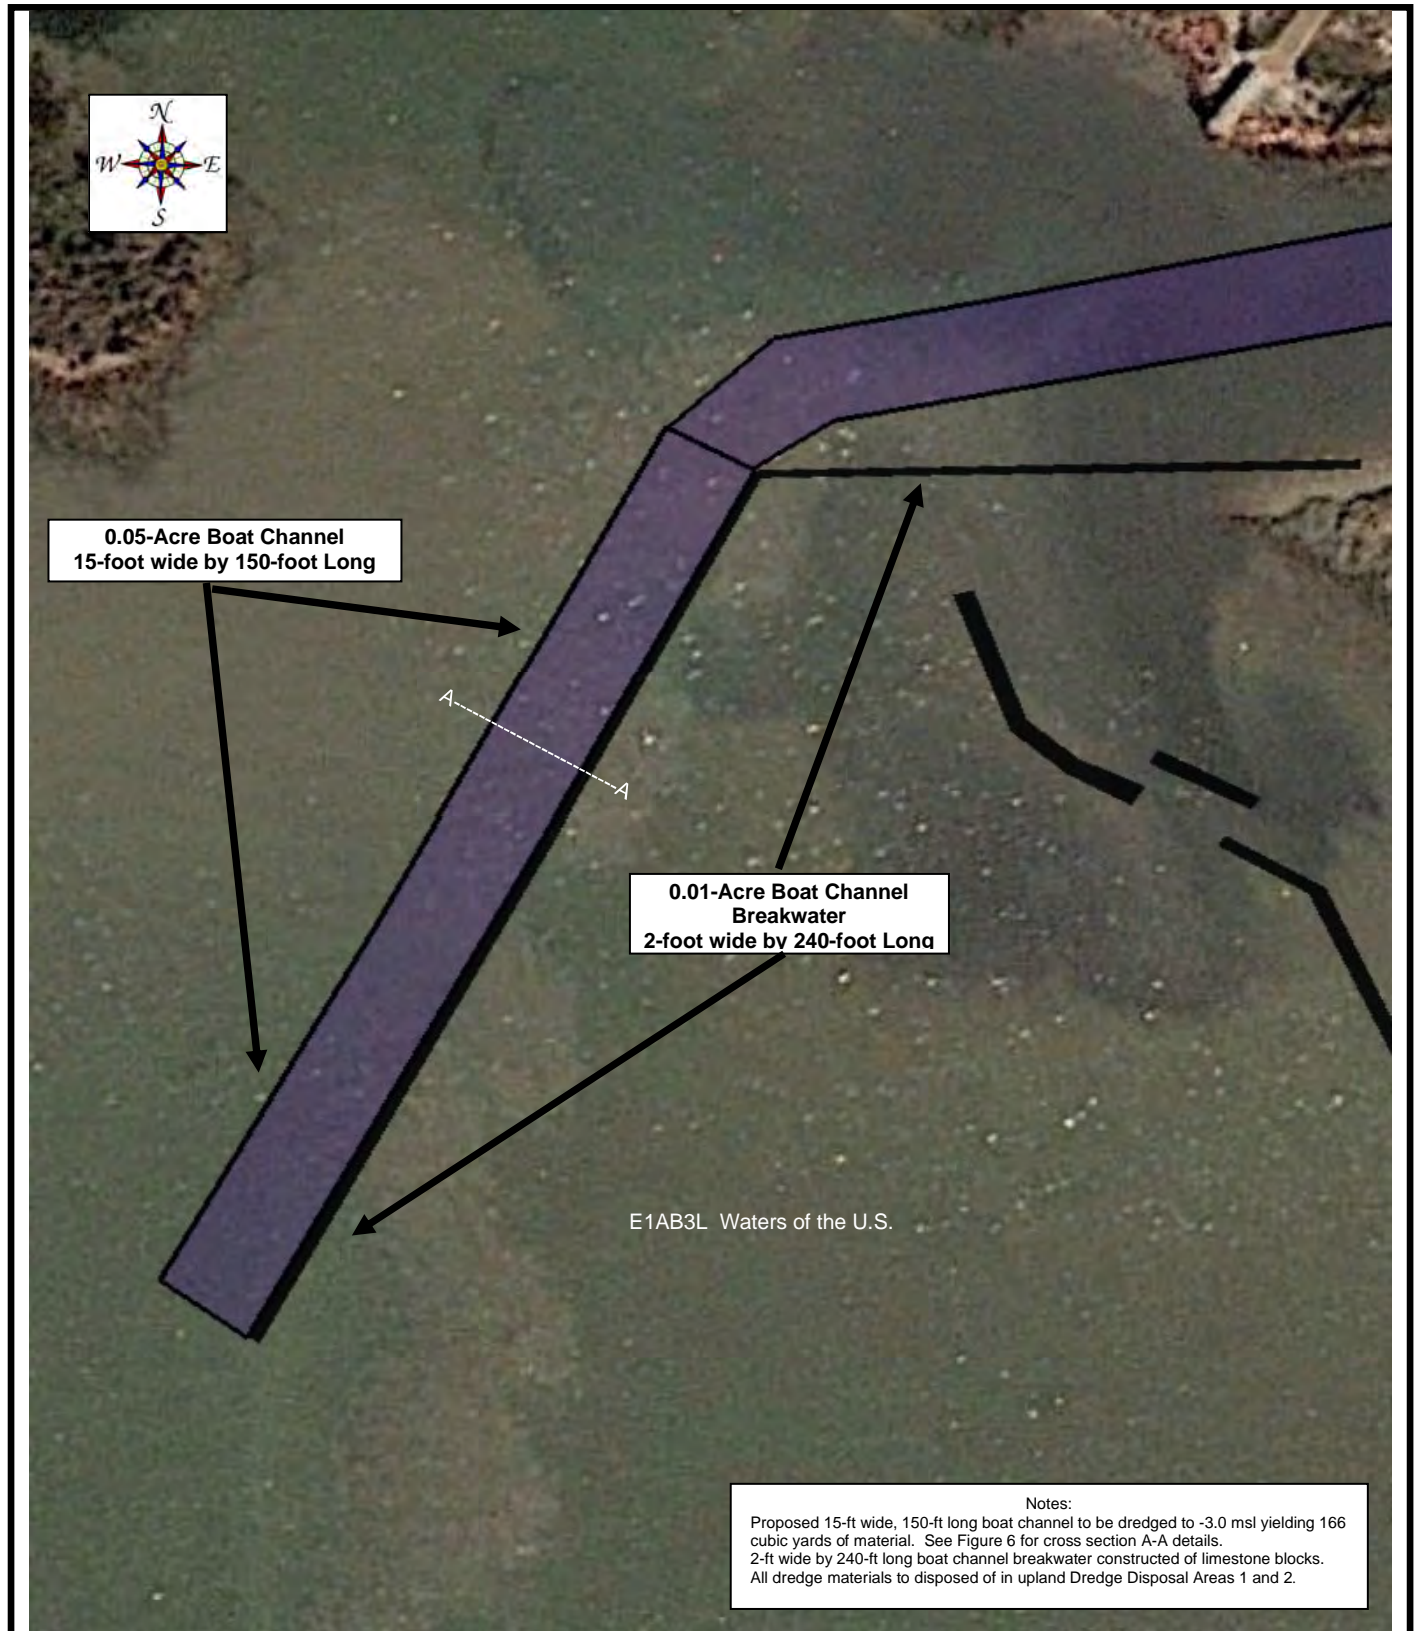
FIGURE 5

**SWG-2005-00696
Boat Channel Detail Aerial
Boating Improvement Project
Aransas County, Texas**

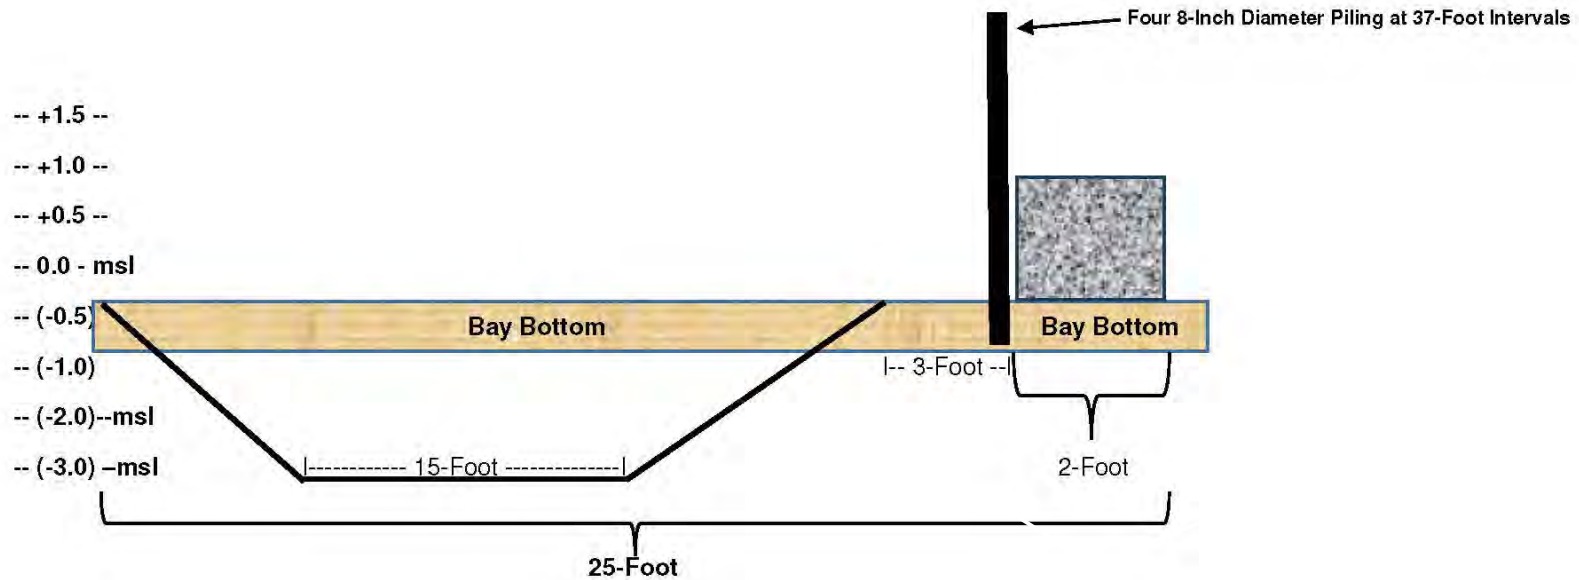
The permittee is proposing to fill 0.01 acres of bay bottom below the average high tide line for a breakwater to decrease sedimentation of the proposed channel and to place substrate for establishment of oysters and create fish habitat.

The permittee will install a turbidity curtain around the construction area until excavation and material placement is finished and turbidity has settled to protect adjacent resources.

Breakwater material will consist of one (1) row of limestone blocks 2-foot square by 5-foot in length.

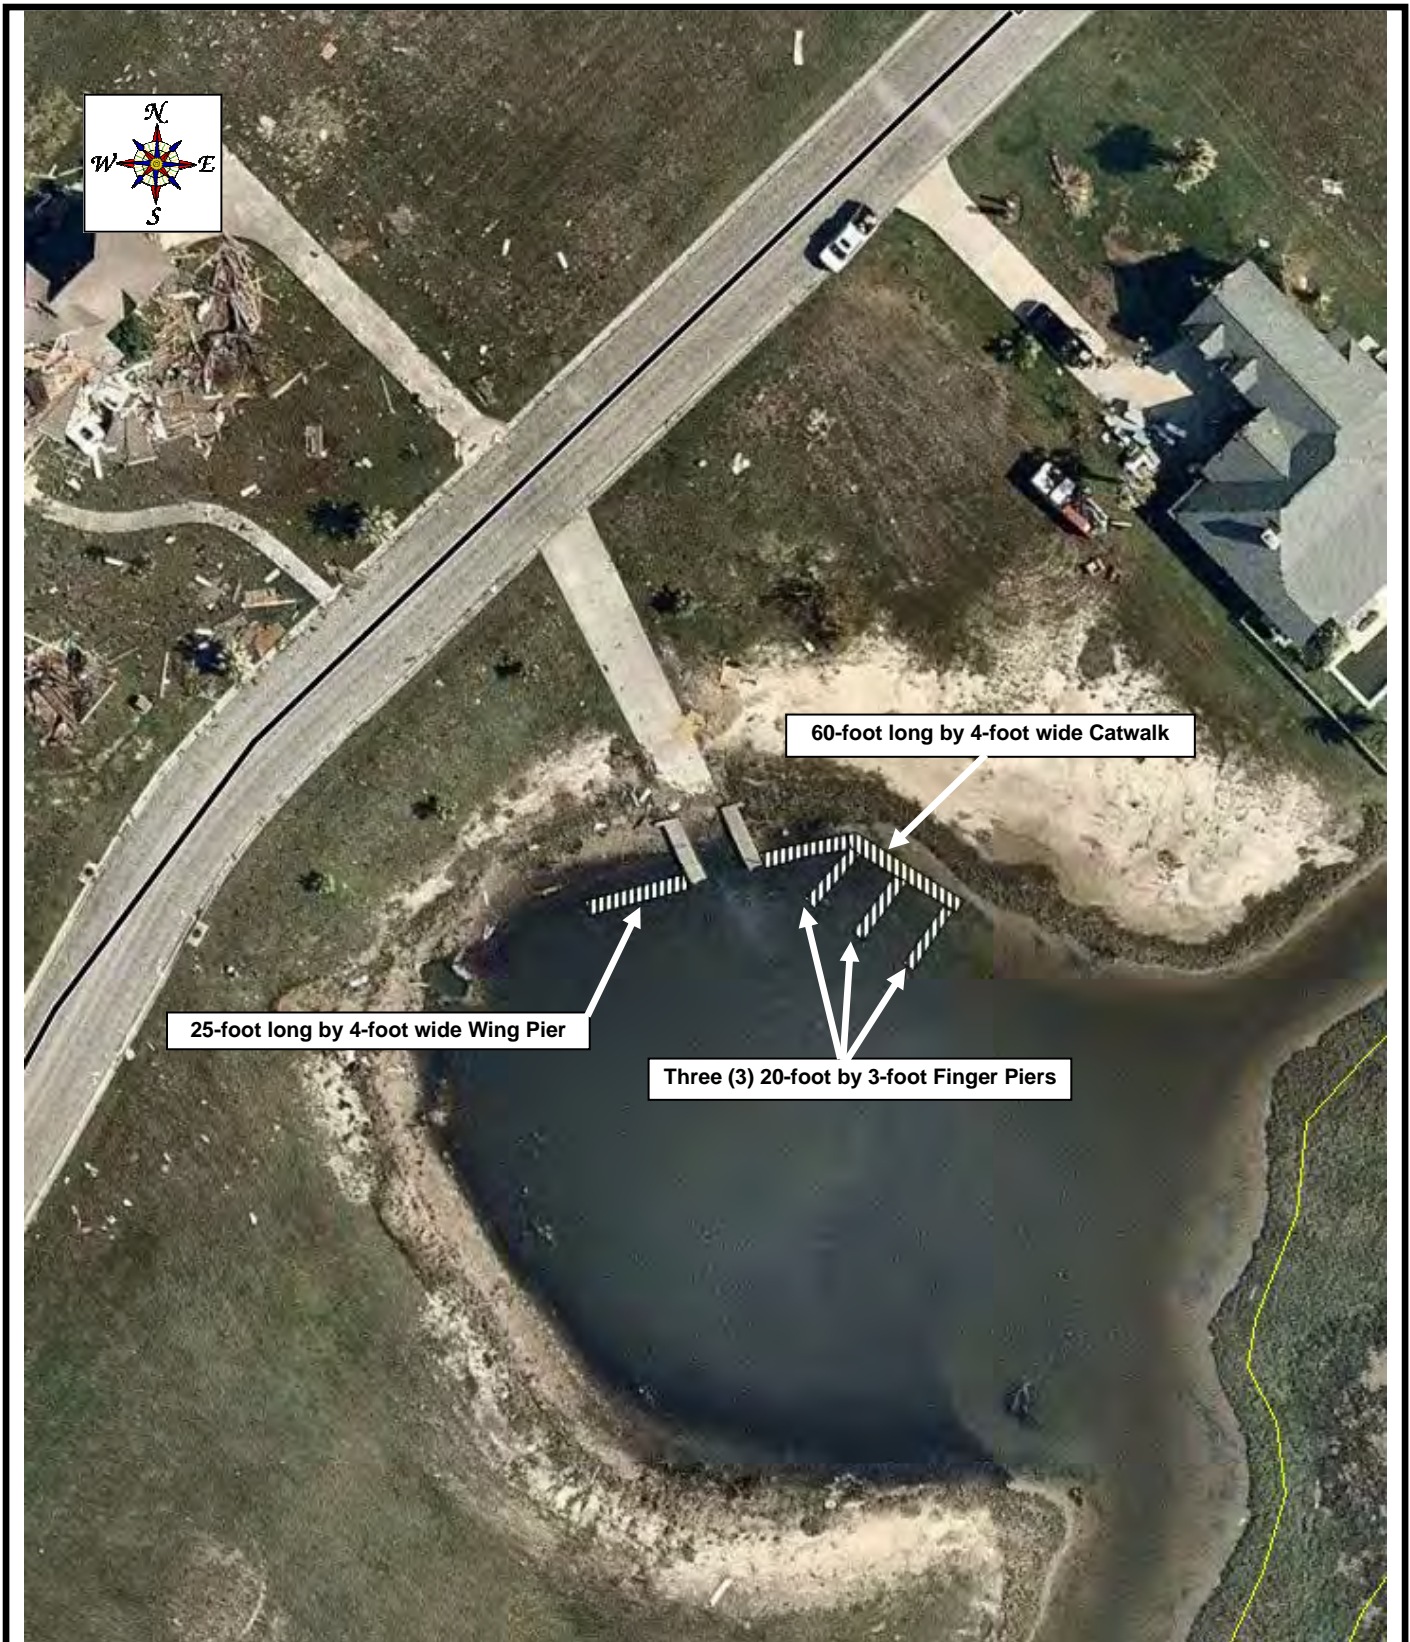
**SWG-2005-00696
Boat Launch Pier Additions
Boating Improvement Project
Aransas County, Texas**

8-Inch Diameter Treated Piles set on Four Foot Centers
 2x10 Treated Stringers, with 2x6 Treated Deck Boards

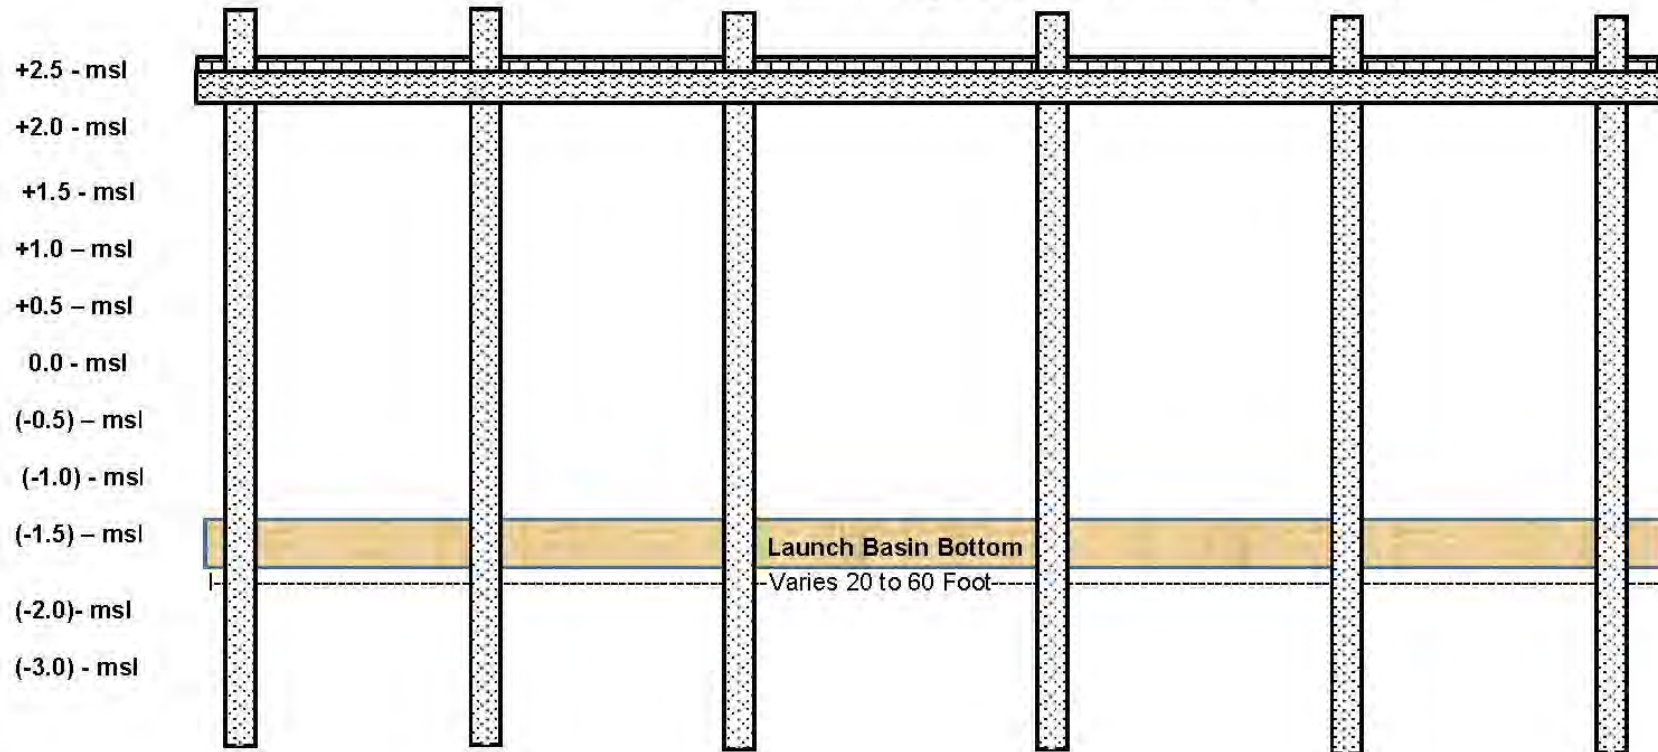
- Notes:
- For planning and permitting purposes only.
 - msl: elevation in mean sea level
 - Support piling will be driven by a drop weight operated off a small barge
 - Piling set 4-Foot into mud line
 - 1-Inch Gap Left between Deck Boards, or Flow-Thru Decking will be used.
 - Minor variances could occur during construction.

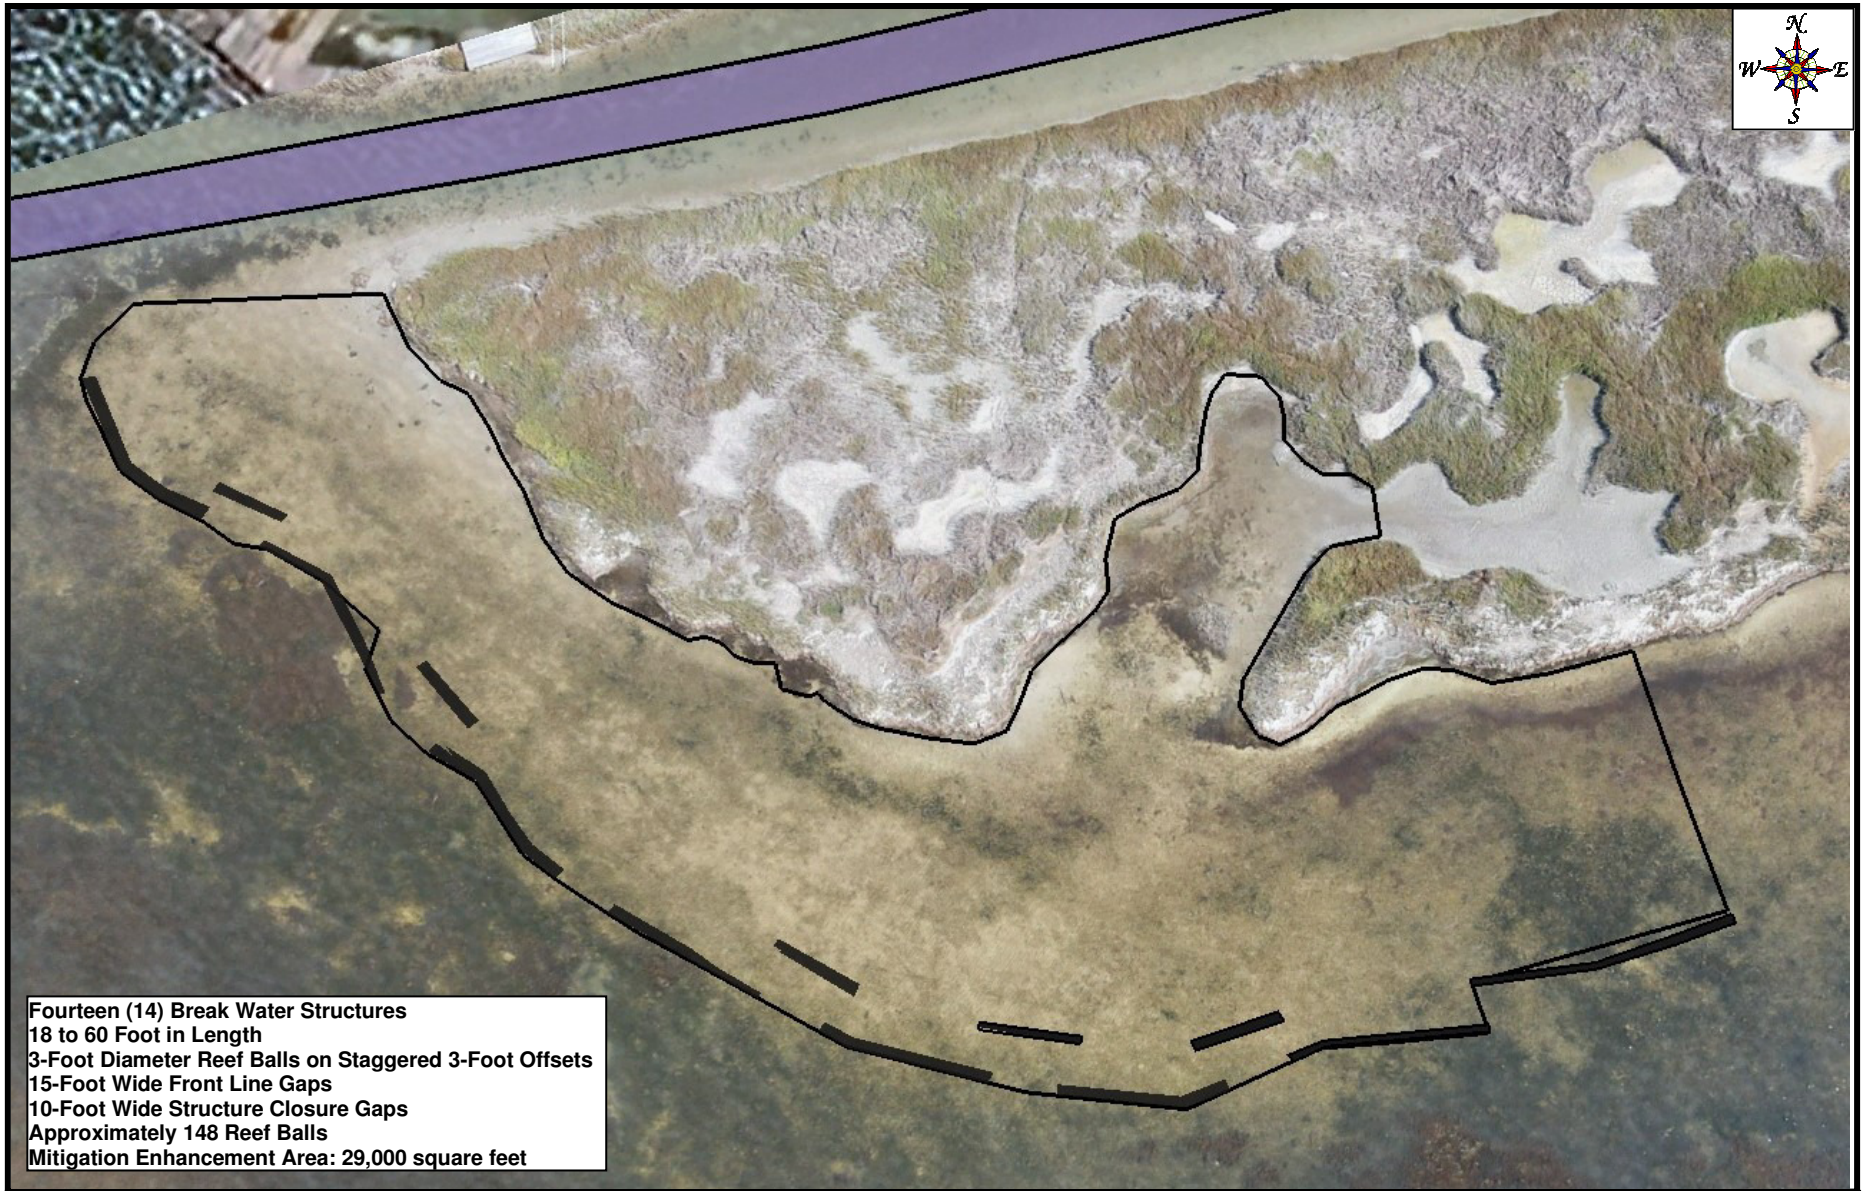
FIGURE 1

Fourteen (14) Break Water Structures
18 to 60 Foot in Length
3-Foot Diameter Reef Balls on Staggered 3-Foot Offsets
15-Foot Wide Front Line Gaps
10-Foot Wide Structure Closure Gaps
Approximately 148 Reef Balls
Mitigation Enhancement Area: 29,000 square feet

The project's proposed mitigation action is at an area of bay bottoms that are immediately east of the proposed community boat channel into Port Bay. Figure 1 (attached) illustrates the proposed location relative to the community boating improvement project.

As shown on Figure 1, the intent is to install the reef balls where areas of bare bay bottom interface with existing submerged aquatic vegetation. The installation will be a double row of 36-inch diameter reef balls installed on a staggered 4-ft offset, using approximately 148 reef balls.

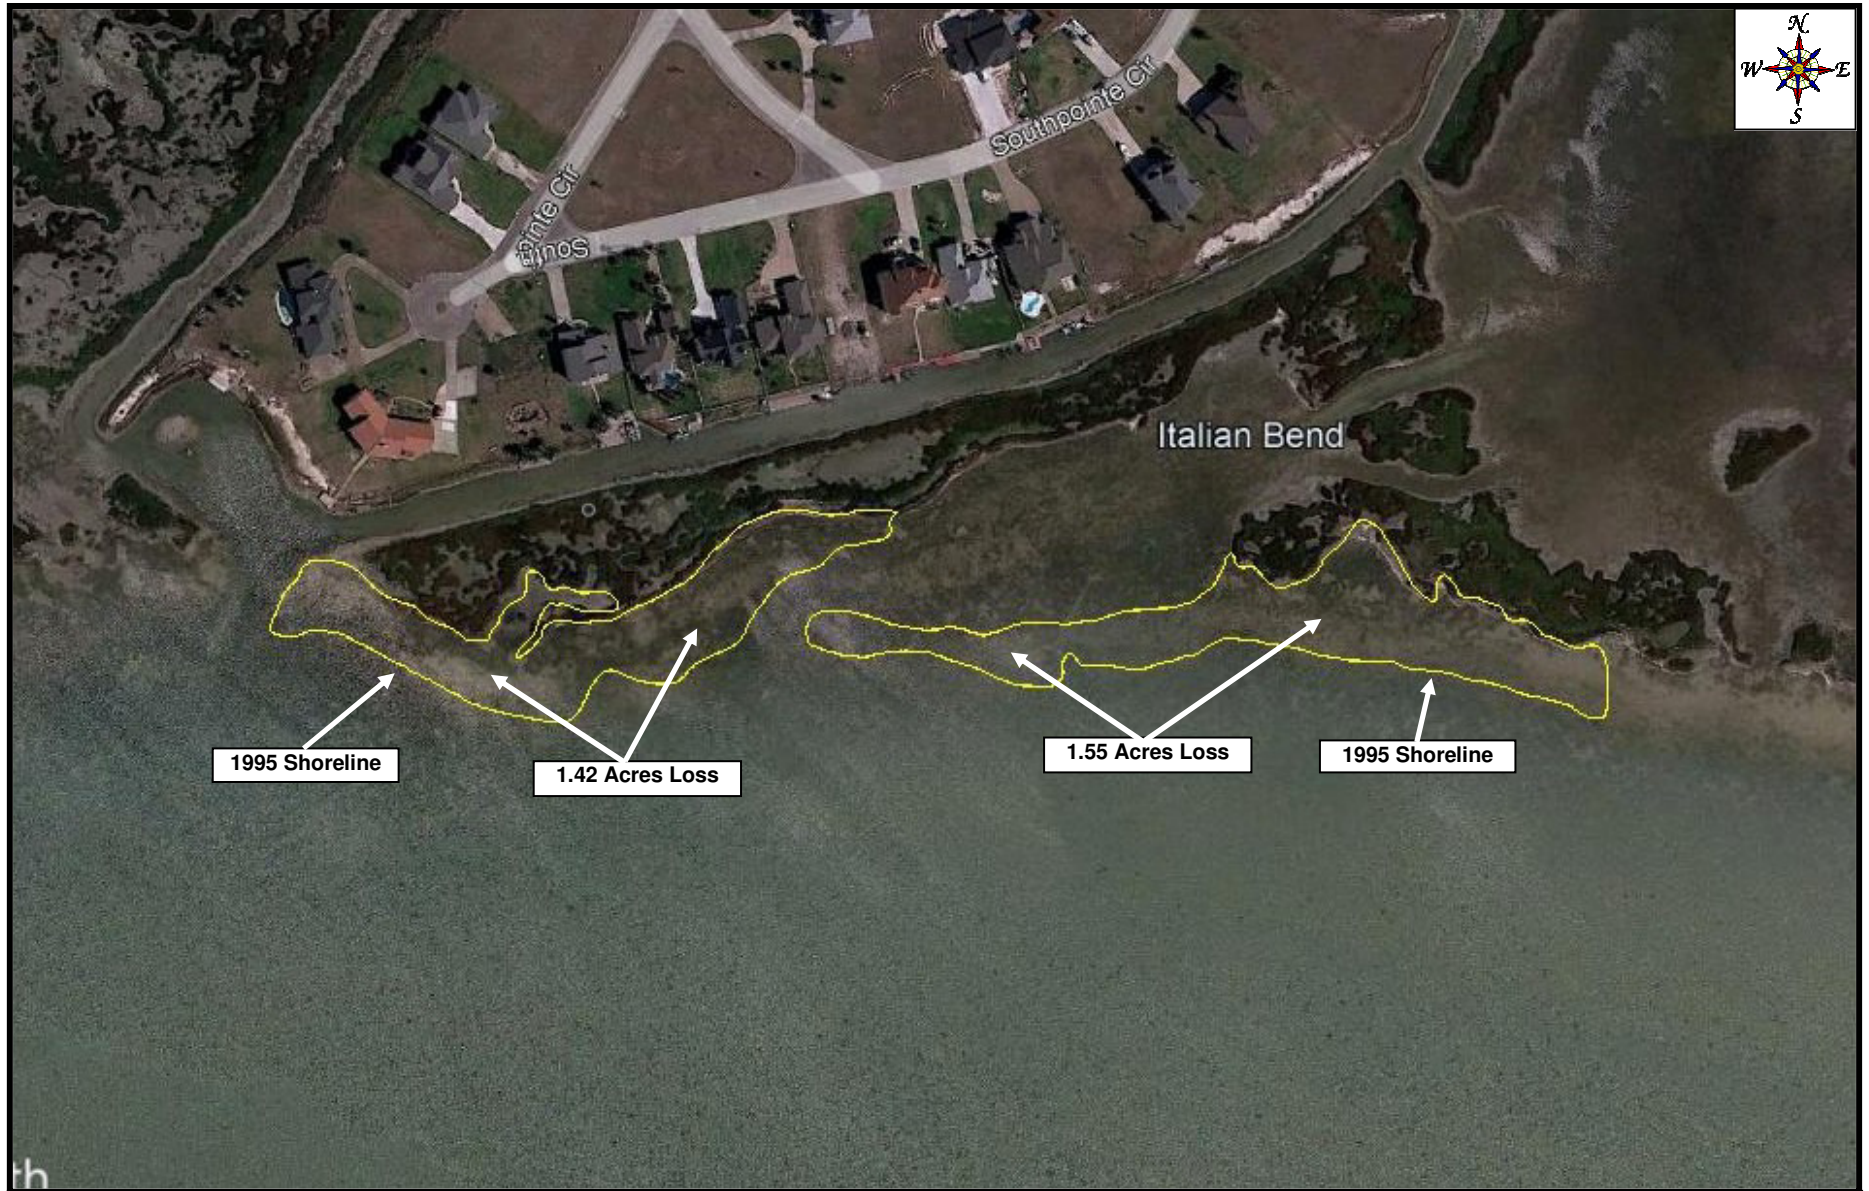
Emergent Wetland Loss-Shoreline Retreat 1995-2017
SWG-2005-00696
Boating Improvement Project
Port Bay
Aransas County, Texas
Source: Google Earth Aerial Photography
