Appendix C

Dredged Material Management Plan

PCCA Dredged Material Management Plan, February 2024

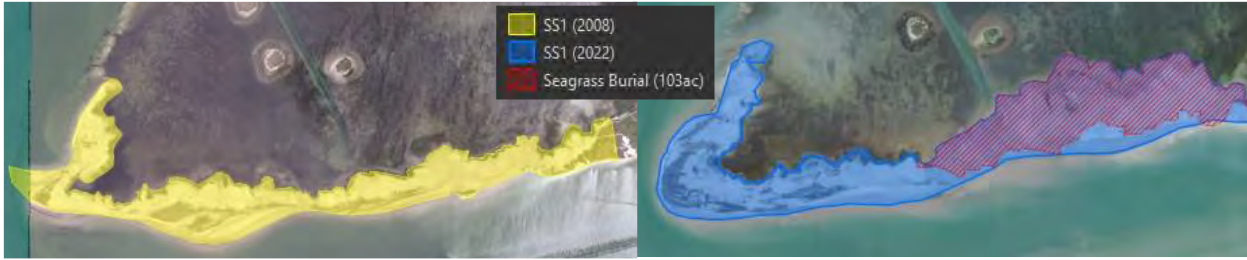
Figure 1: Historical and Recent Aerial Imagery Demonstrating Significant Erosion and Deposition of SS1, resulting in approximately 103ac seagrass burial.

The original landmass near SS1 was formed by placing dredge material from the original construction of the CCSC. SS1 is located along the northern shoreline of the CCSC and southeast of Redfish Bay. Redfish Bay has approximately 14,000ac of seagrass beds that contribute to improved water quality and provide habitat for larvae and juvenile fish. Significant erosion and sediment deposition to the southern shoreline and interior portions of the site is present due to the increased frequency of vessel traffic through the CCSC as well as the recent hurricane storm surge. While the original land mass at SS1 served to protect the seagrass of Brown and Root flats, the continual erosion and overwash resulted in the deposition of sand, inward into the flats. Port Corpus Christi compared aerial imagery from 2008 to 2022 and estimated the current shoreline and seagrass edge. Based on these estimates, the erosion and overwashing, Port Corpus Christi estimates approximately 103ac of seagrass have been buried in the past 14 years, see Figure 1 below:

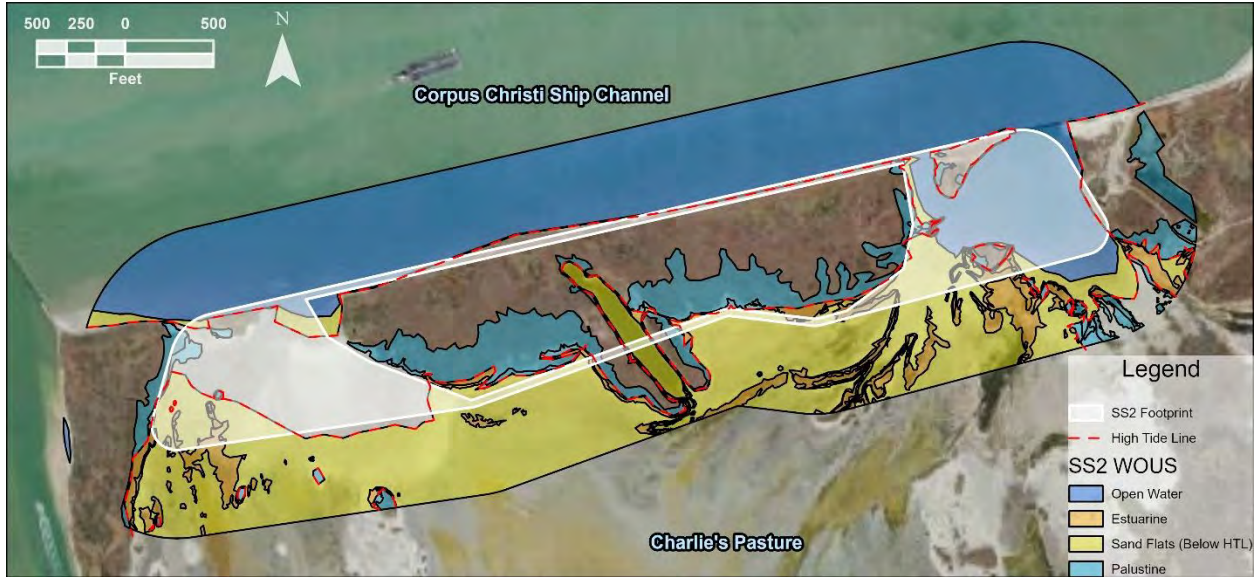
Figure 3: SS2 Existing Wetlands and Aquatic Resources (WOUS). Refer to Table 2 for additional information.

SS2 has an approximate 45.21ac footprint. The shoreline exhibits severe erosion due to wave energy from large passing vessels and two large breaches in the shoreline created by Hurricane Harvey. The construction of SS2 will impact 13.74ac of open water, 24.20ac of sand flats below HTL, 1.25ac of estuarine wetlands, and 11.25ac of palustrine wetlands. See Figure 3 below:

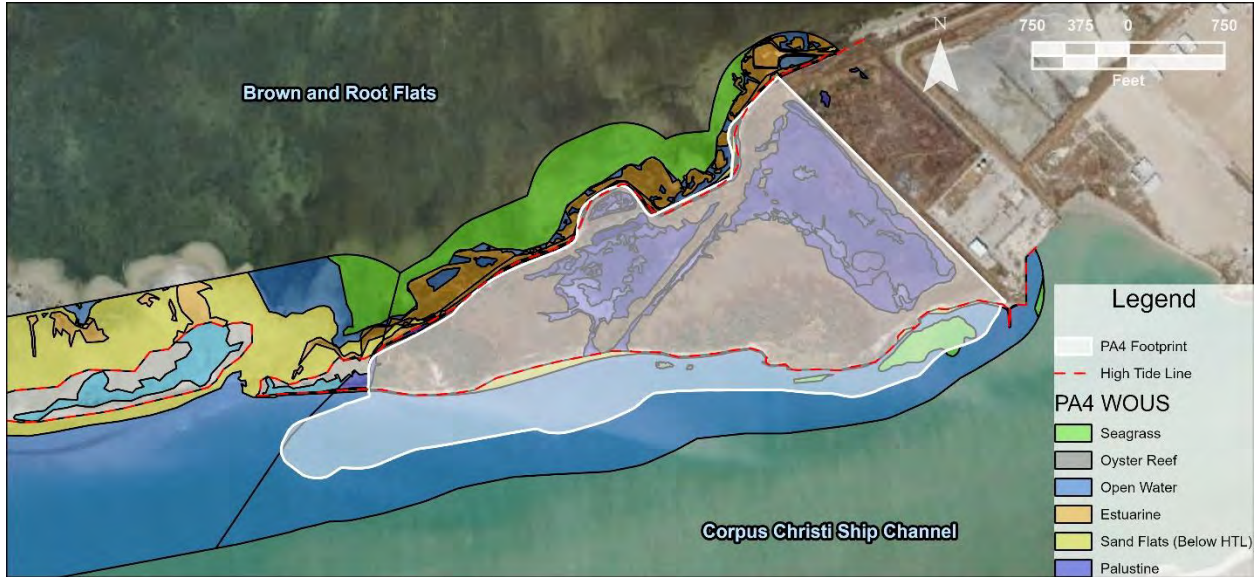
Figure 4: PA4 Existing Wetlands and Aquatic Resources (WOUS). Refer to Table 2 for additional information.

PA4 has an approximate 170.79ac footprint. Severe erosion occurring along the southern shoreline is due to the increased frequency of larger vessels passing. The construction of PA4 will impact 42.14ac of open water, 2.80ac of flats/beach, 0.75ac of estuarine wetlands, 41.75ac of palustrine wetlands, and 3.46ac of seagrass (DEIS 2022). See Figure 4 below:

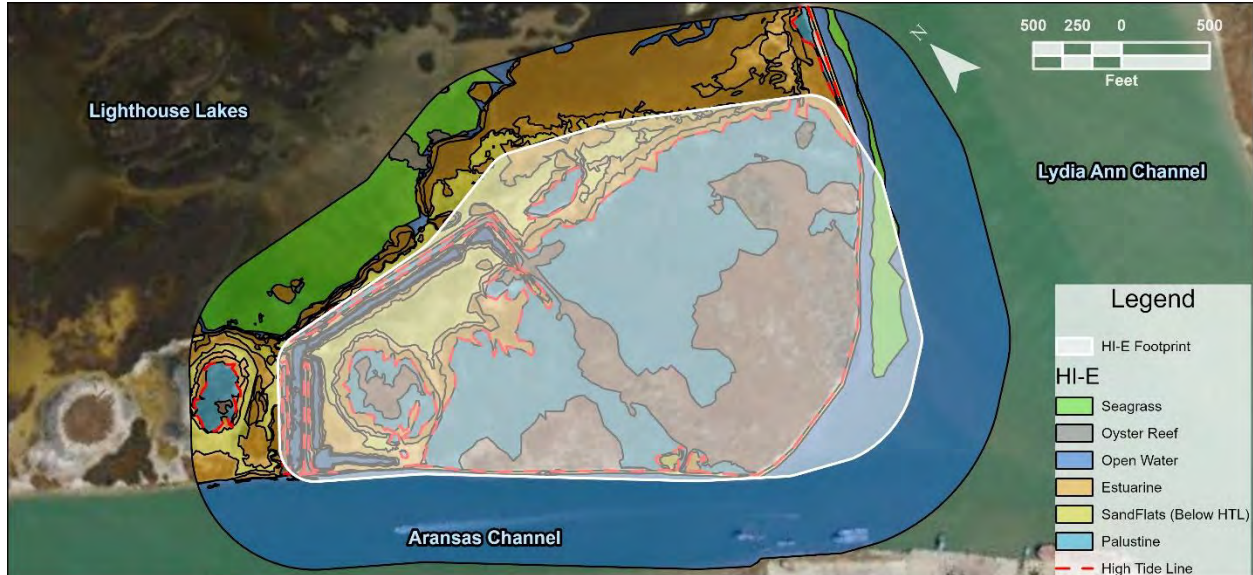
Figure 5: HI-E Existing Wetlands and Aquatic Resources WOUS. Refer to Table 2 for additional information.

HI-E has an approximate 138.73ac footprint. Severe erosion and land mass loss along channel shorelines are due to the increased frequency of larger vessels passing. The construction of HI-E will impact 13.12ac of open water, 23.21ac of sand flats below HTL, 10.69ac estuarine wetlands, 48.42ac of palustrine wetlands, 3.41ac of seagrass and 0.10ac of oysters. See Figure 5 below:

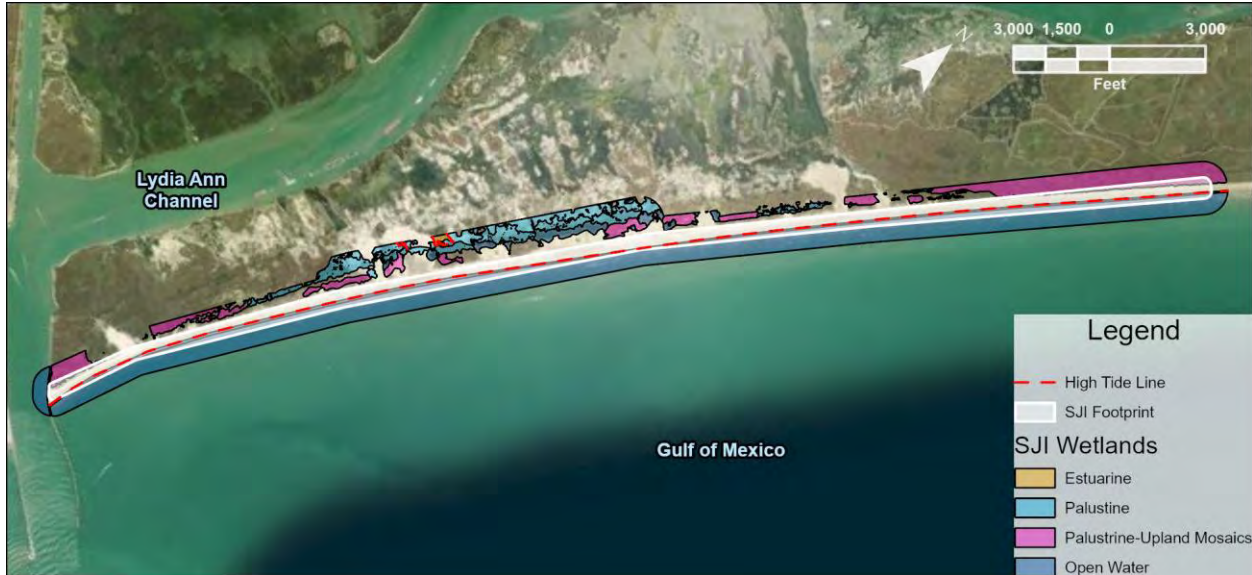
Figure 6: SJI Existing Wetlands and Aquatic Resources (WOUS). Refer to Table 2 for additional information.

SJI has an approximate 441.2ac footprint. Hurricane Harvey significantly altered several locations within the footprint. Impacts include shoreline breaches resulting in unvegetated shallow ponded areas within and behind the foredune ridge. The construction of SJI will only impact open water and beach. The SJI footprint will be adjusted in final design to conclude at the waterward toe of the existing sand dune; this will account for any natural changes to the beach profile and avoid wetlands identified landward of the dune system. See Figure 6 below:

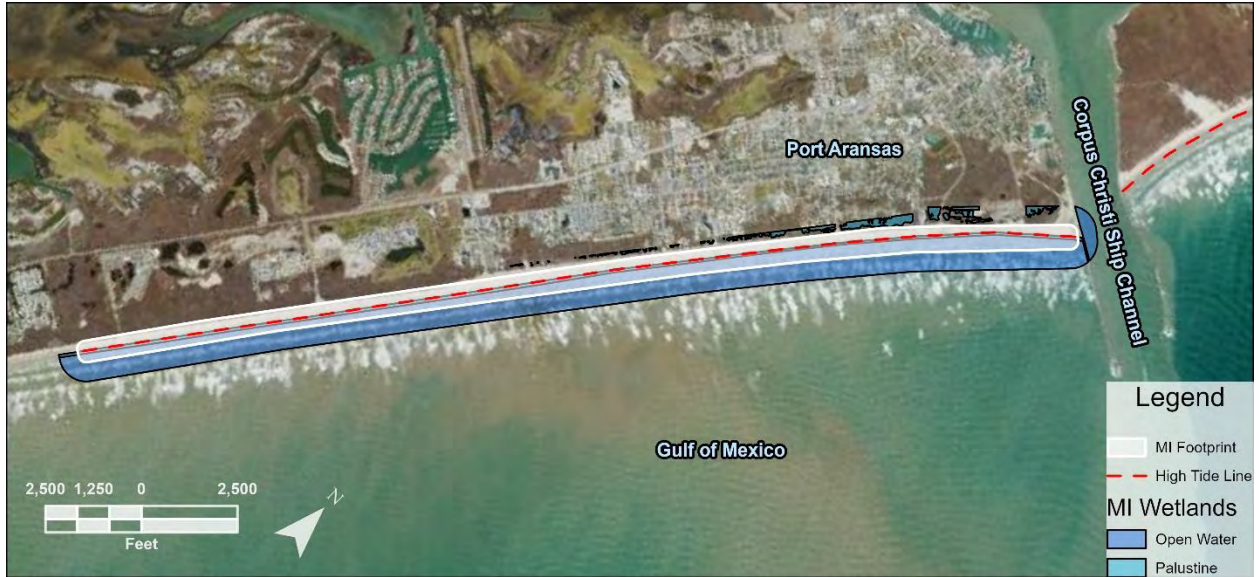
Figure 7: MI Existing Wetlands and Aquatic Resources. Refer to Table 2 for additional information.

MI has an approximate 362.2ac footprint. Sea level rise and storm events have significantly eroded beach width along this shoreline. The construction of MI will impact 205.58ac of open water and 124.11ac of flats/beach. See Figure 7 below:

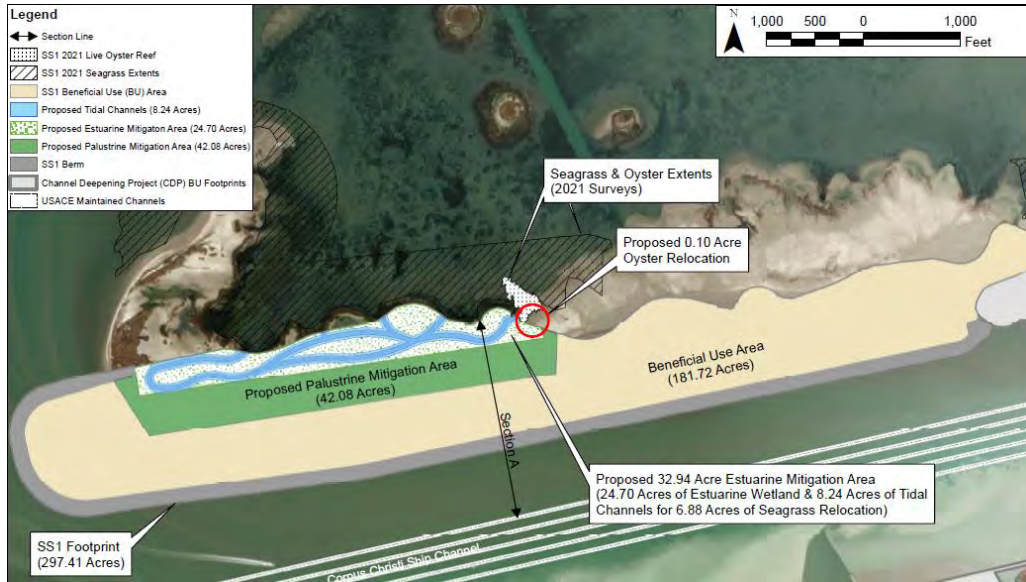
Figure 9: Proposed BU Placement at SS1. This plan excludes discussion on the acreage identified for mitigation. For additional information on the mitigation, see the 12-Step Permittee Responsible Compensatory Mitigation Plan.

Following the construction of the berm, stone or similar revetment will armor the channel-facing slope. The site will be hydraulically backfilled with sands or clays to +3.8ft MLLW and graded to suitable elevations that sustain vegetation. Sandy material will be hydraulically placed and dewatered within the footprint of SS1, using the existing land mass as containment. Sand is the primary grain size for the CDP dredging and can be sourced from most of the channel (BH-12 – BH-38). Since the BU placement at SS1 will create wetland and upland habitats, some clays are acceptable for placement between the berm and the existing landmass. Following the placement of sand behind the berm, heavy machinery will shape the dredge material to the specified slope and elevation. Heavy machinery will mobilize from State Highway 361 (HWY 361) and drive to SS1 via an existing levee road on the north side of PA4. Should equipment be mobilized via barge, the barge will approach the site from the channel. All equipment staging will occur above HTL and within the footprint of SS1 or PA4.

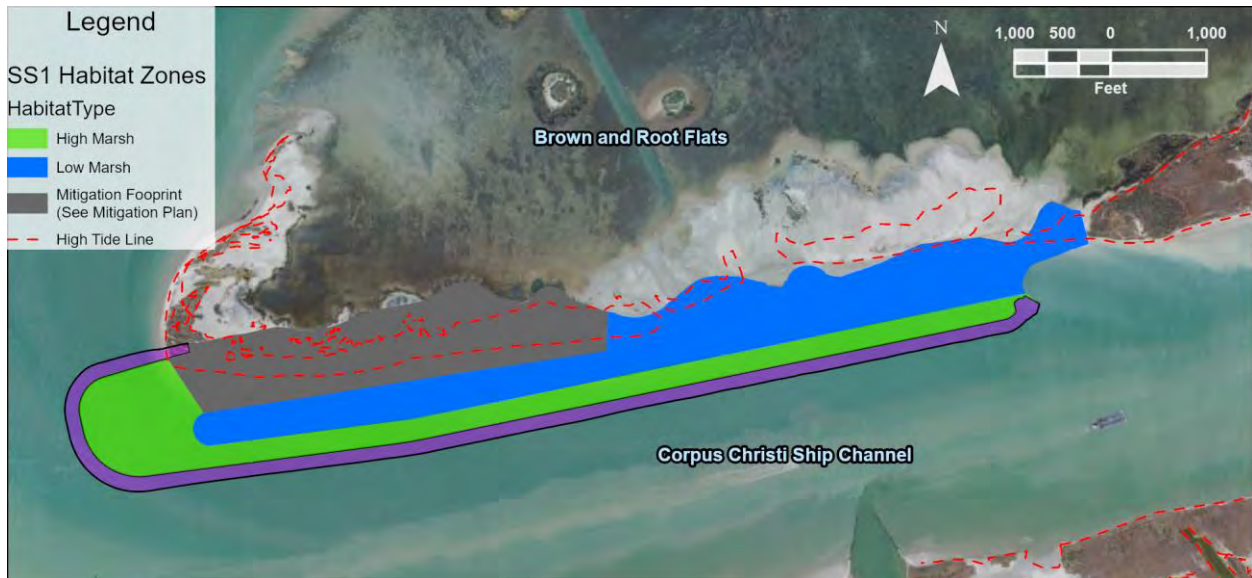
Figure 10: SS1 Proposed BU and Habitat Planting Zones. For additional information on the mitigation, see the 12-Step Permittee Responsible Compensatory Mitigation Plan.

All planting will occur on 5ft centers during spring or fall following the construction of SS1 to take advantage of seasonal rainfall. The various habitat zones will be staked to provide visual demarcation for planting efforts. Transplants will likely be sourced from the adjacent PA4, given the proximity to the site. While natural recruitment is expected to occur due to the proximity of the naturally occurring vegetation on the existing landmass, a survival survey will be conducted to ensure the success of transplanting vegetation.

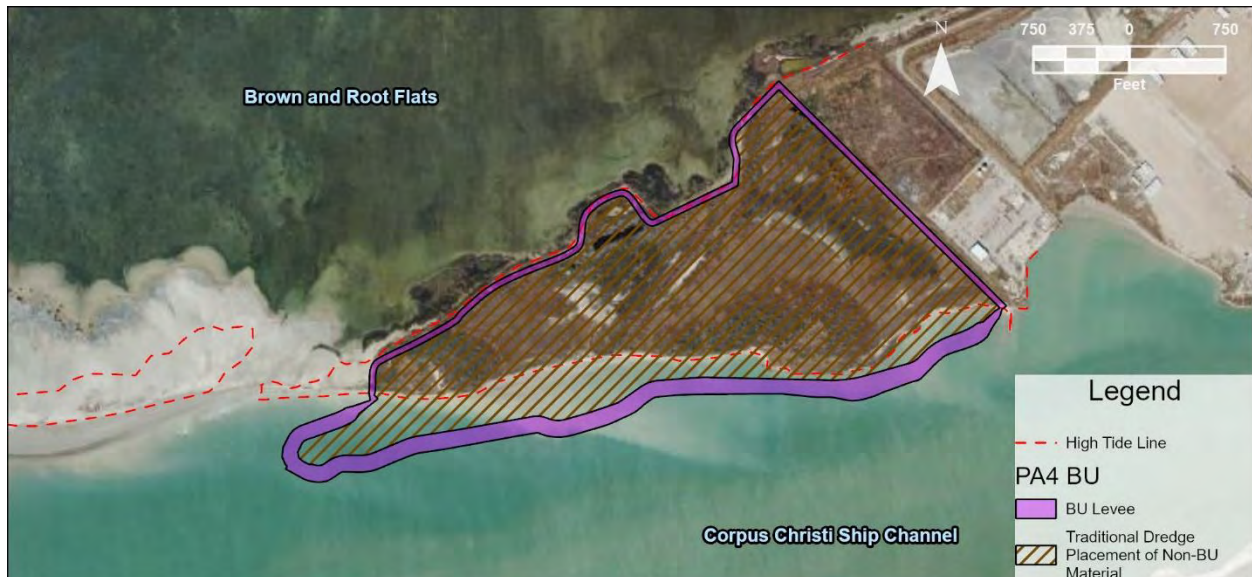
Figure 12: Proposed BU Placement at PA4.

Approximately 4,320,400cy of dredged material will be placed to construct PA4. The channel side will be constructed from the existing bay bottom to an elevation of +24ft MLLW at a 4:1 slope. The top of the levee width will be approximately 10ft, and the interior levee will match existing interior elevations at a 4:1 slope. The 2018 Geotech Report identified suitable clay deposits for levee construction near the westernmost portion (BH-38, BH-36, and BH-22) of the CDP as well as significant amounts of suitable clays in the easternmost extent of the CDP (BH-01 – BH-12). Clays will likely be mechanically dredged and placed on a barge to transport to PA4. The levees may also be constructed mechanically with in-situ material from PA4. Since the berms will be constructed mechanically, temporary berms for dewatering dredge material will not be required. Following the construction and restoration of the PA4 levees, unsuitable material for BU (approximately 2,861,400cy) will be hydraulically placed in a traditional confined placement area.

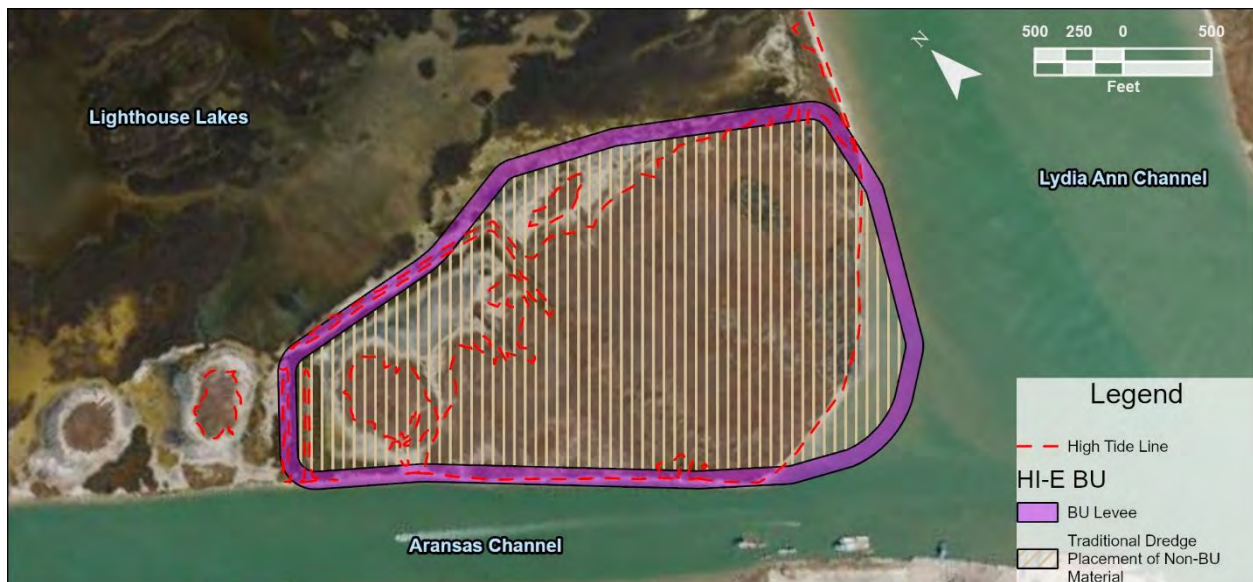
Figure 13: Proposed BU Placement at HI-E.

Approximately 1,825,000cy of dredged material will be placed to construct the site. The existing eroded bluff will be raised using stiff clay. The exterior berm will be constructed from existing bay bottom elevations to varying heights of +8 MLLW to +15 MLLW at a 4:1 slope. The top of the berm width will be 15ft, and the interior berm will be constructed to match interior elevations at a 10:1 slope. The 2018 Geotech Report identified suitable clay deposits for levee construction near the westernmost portion (BH-38, BH-36, and BH- 22) of the CDP as well as significant amounts of suitable clays in the easternmost extent of the CDP (BH-01 – BH-12). Clays will likely be mechanically dredged and placed on a barge to transport to HI-E. The levees may also be constructed mechanically with in-situ material from HI-E. Since the berms will be constructed mechanically, temporary berms for dewatering dredge material will not be required. Rip rap placement will occur along both channel sides after completing the berm construction. Unsuitable material for BU (approximately 1,647,200cy of total dredged material) will be hydraulically pumped within raised levees.

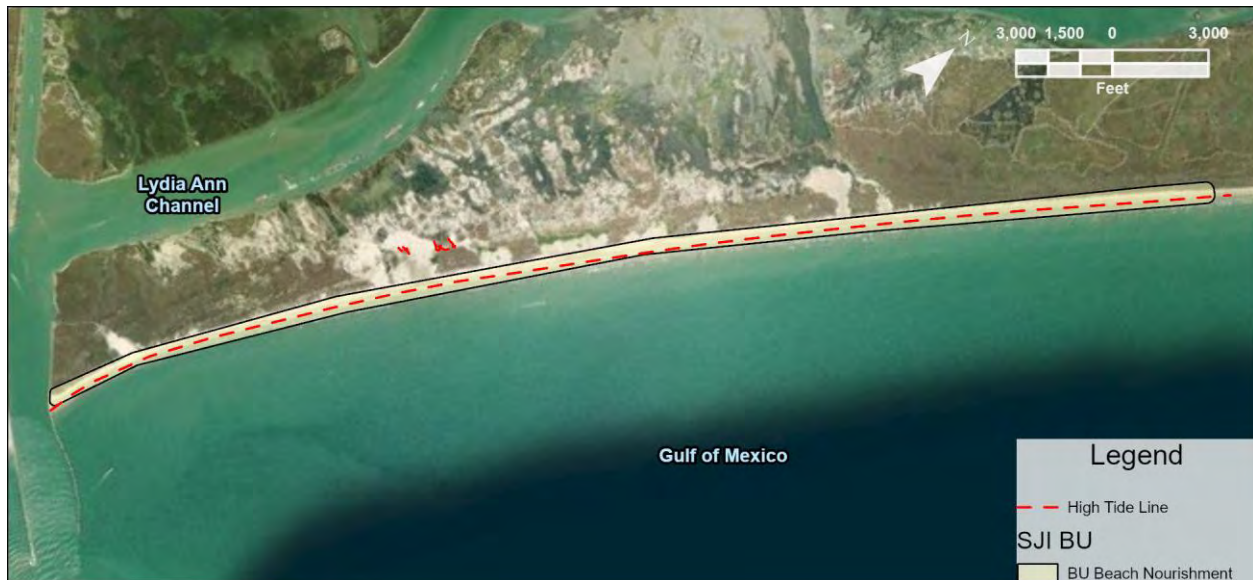
Figure 14: Proposed BU Placement at SJI.

Beach fill (sand) will be directly placed on the existing foreshore to +6ft MLLW and advance the beach seaward. The beach profile will be extended 200ft at a slope of 50:1 to match the existing bottom of GoM. Fill (sand to silty sand) will be graded seaward of the existing foredune from an elevation of +6ft to extend the beach profile into the GoM.

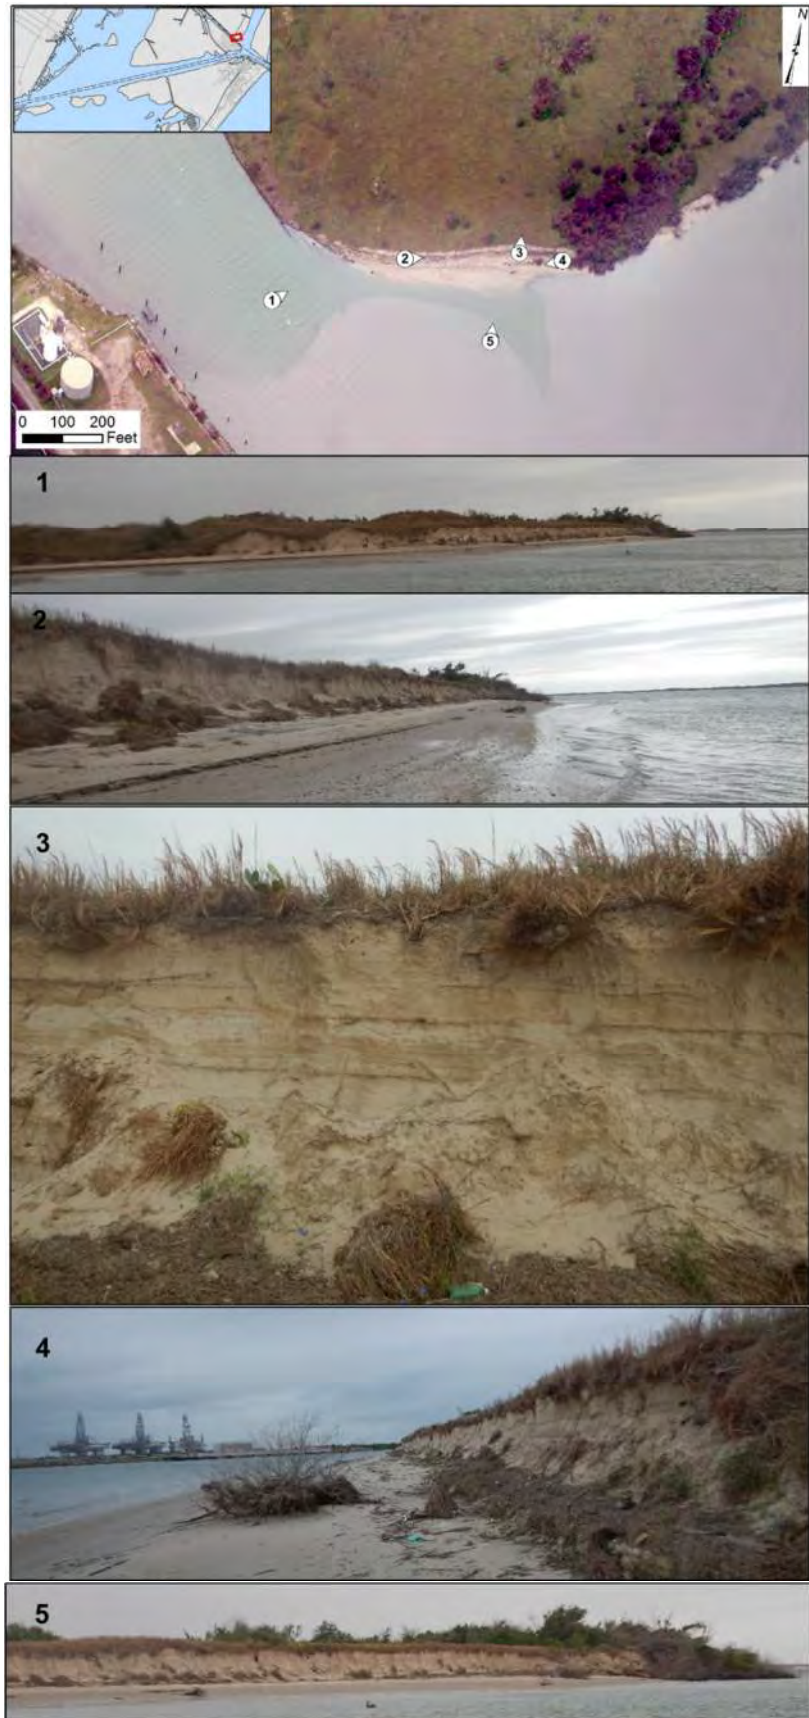
Figure 1. East Harbor Island Point

This area is located at the point where the Aransas and Lydia Ann Channels intersect just east of Port Aransas as shown in Figure 1. The desktop analysis showed erosion rates in excess of 30' at this location due to Hurricane Harvey. An escarpment was visible along the shoreline which was approximately 7' tall and 750' long. Based on the observed long-term erosion rates in this area, continual erosion is expected. If allowed to continue unmitigated, this erosion will lead to additional loss of PCCA property as well as potential sedimentation of the adjacent Lydia Ann and Aransas channels.

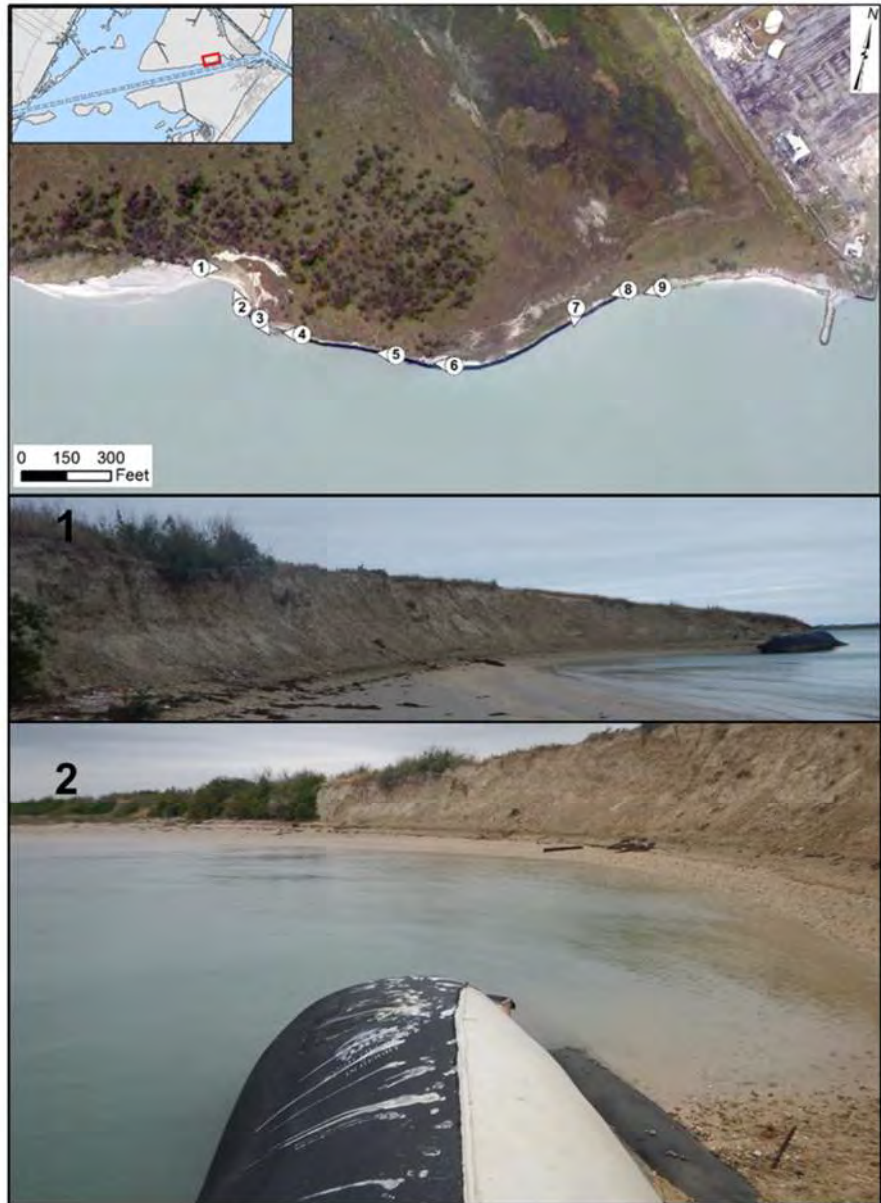
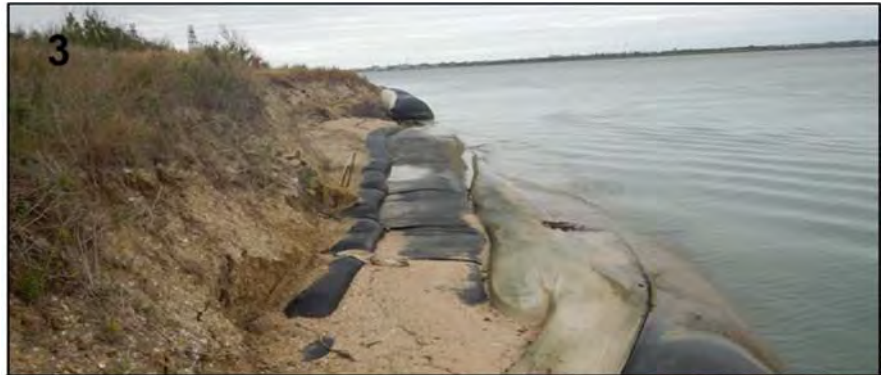
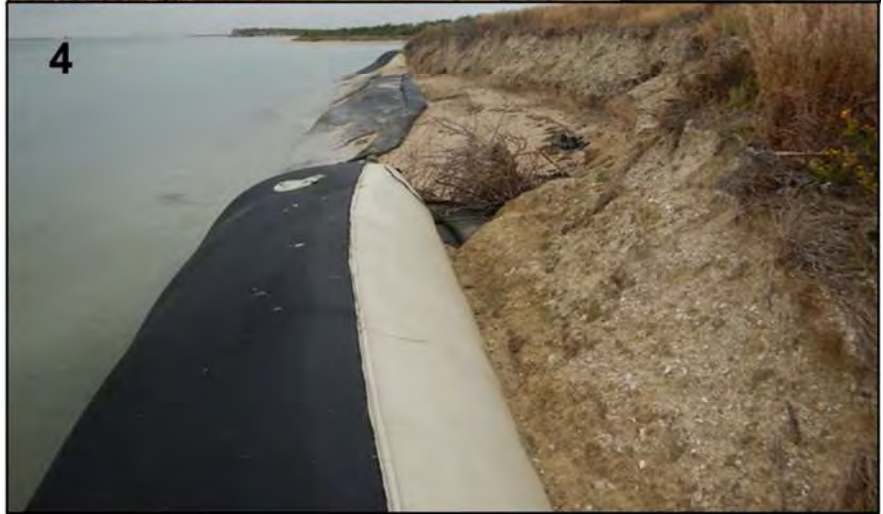
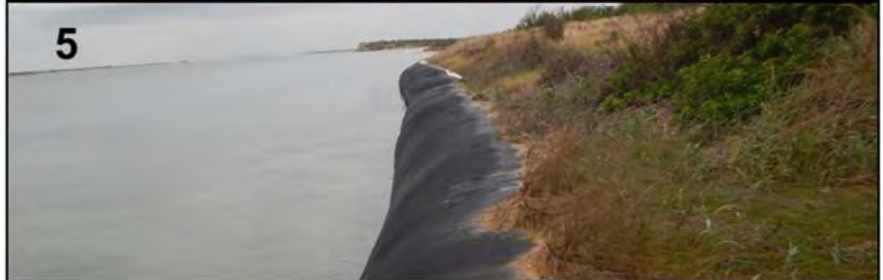
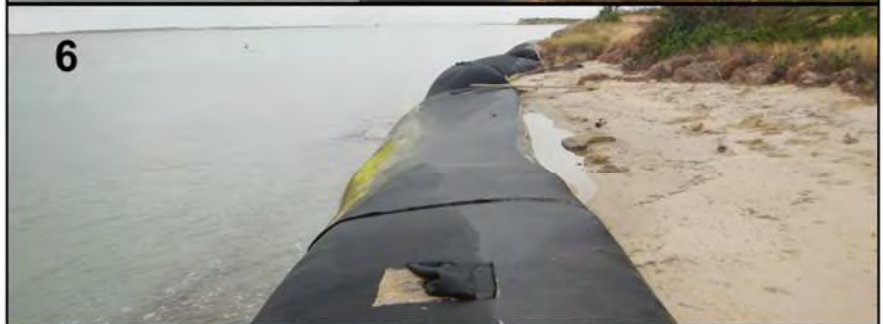
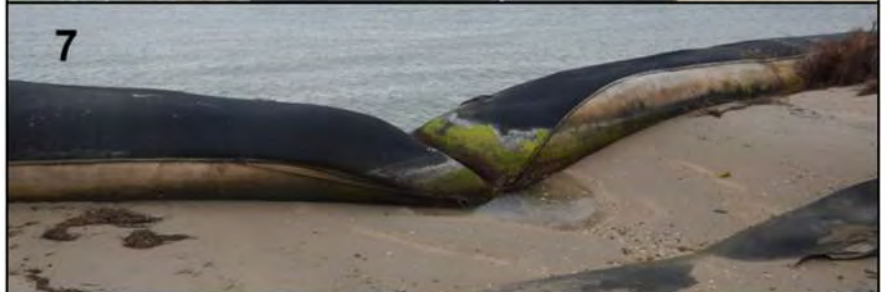
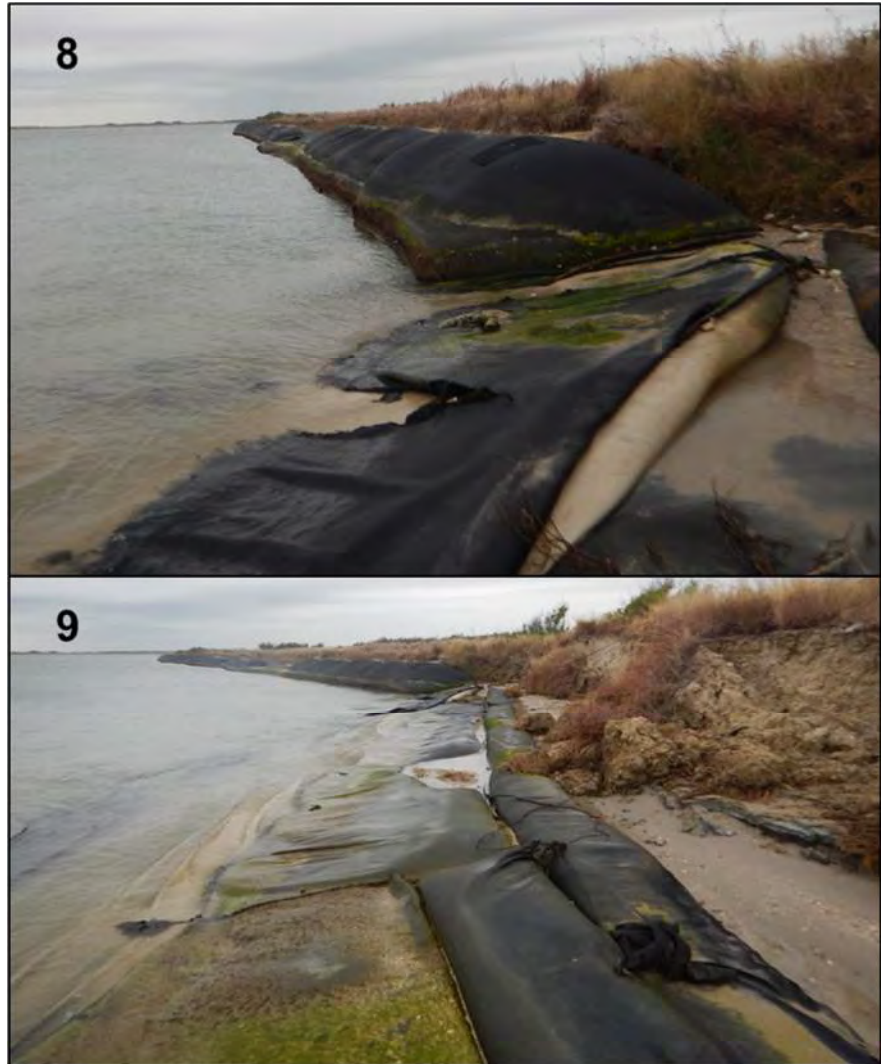
Figure 2. Harbor Island geotextile tube

There is approximately 1,800 feet of geotextile tube along harbor island, just northwest of Port Aransas. Figure 2 shows sections of the geotextile tube had been damaged prior to Hurricane Harvey, but some areas have sustained further damage due to the storm. Along the east end of this area, the geotextile tube was no longer intact and only the scour apron remained (photos 1-4 in Figure 2). The shoreline at this location had begun to erode and an escarpment is clearly visible. Although the remainder of the geotextile tube was mostly intact, some visible damage to the geotextile fabric is present. The area seaward of the tube appears to have eroded since its installation because there was a significant elevation difference from the land behind the tube and the seaward edge of the scour apron (approximately 12 feet to 15 feet). Signs that the tube has started to collapse seaward where the tube has rolled seaward slightly to the point where the sections not covered by the UV shroud are visible. There was also localized erosion at the locations where adjacent tubes met as material could wash out through the gaps in the joints (Photo 7 of Figure 2). There were some areas where the tube had failed and had lost fill material, evidenced by the observed loss in crest elevation.

A section of geotextile tube (approximately 100 feet long) at the eastern end of the structure, where the tube had failed and had rolled into the water (photos 8 and 9 in Figure 2). The scour apron was exposed and the land behind had begun to erode. Even though this occurred prior to the hurricane, additional erosion at the shoreline in this location was observed. The land adjacent to the east terminus of the tube had also

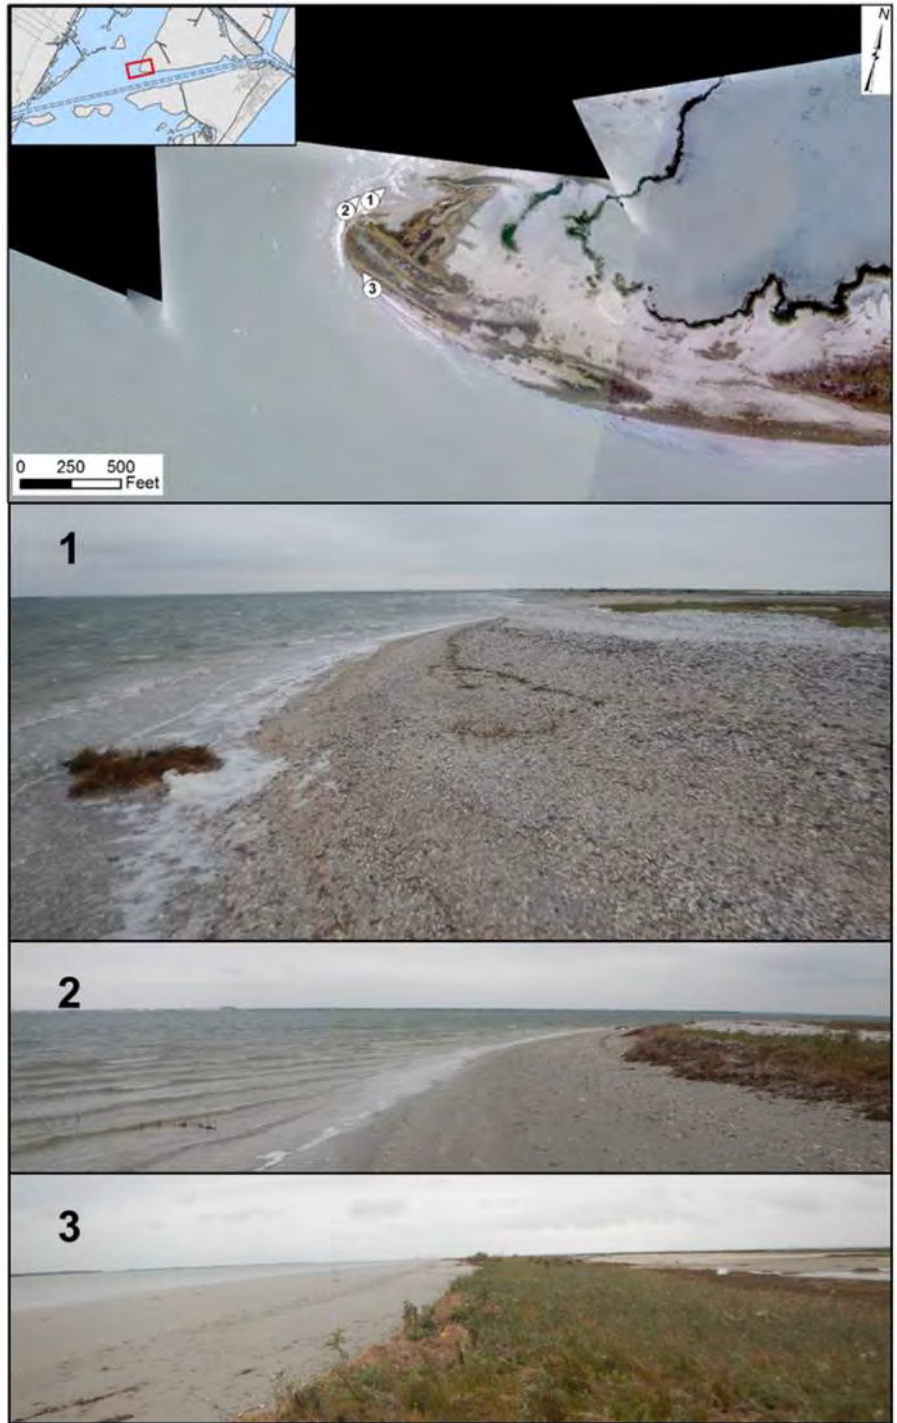
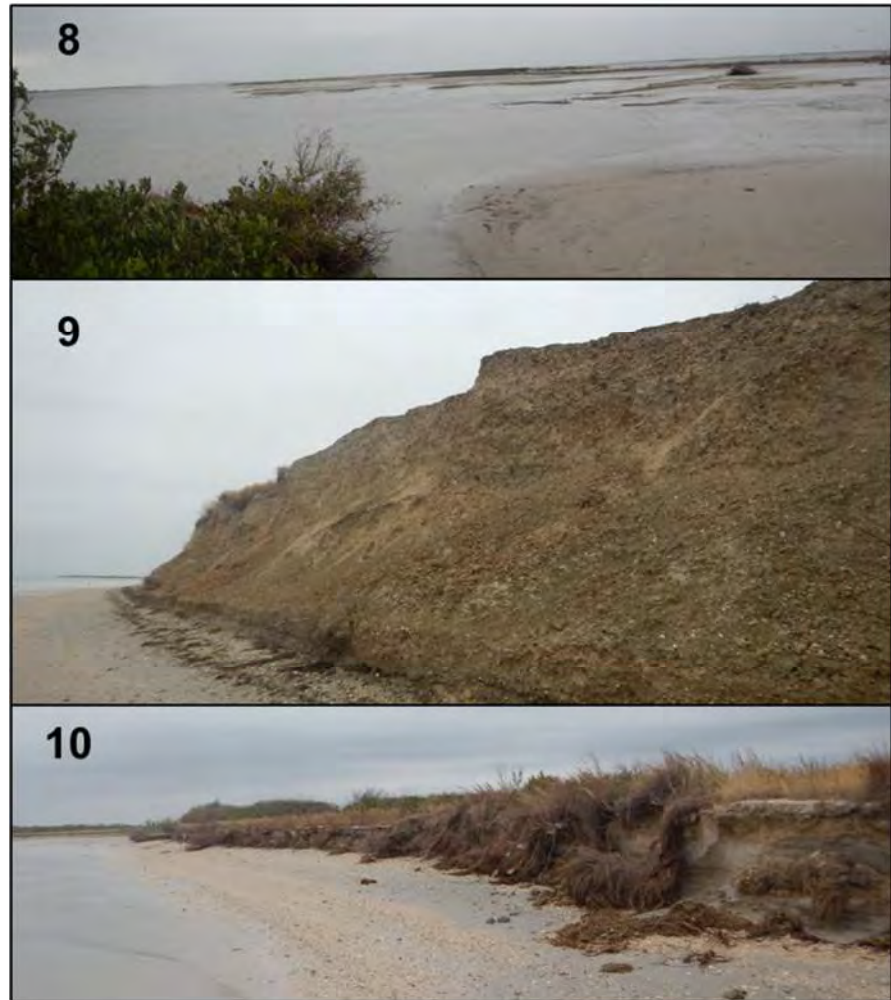
Figure 3. West Harbor Island

The shoreline along the western end of Harbor Island also experienced additional erosion due to Hurricane Harvey as indicated in Figure 3. The land in this area is at a much lower elevation than the other adjacent areas within Port Aransas which make it more susceptible to storm surge. The storm surge from Hurricane Harvey caused several breaches to form, connecting Redfish Bay to the Corpus Christi Ship Channel. Some existing breaches had also expanded due to the hurricane.

At the time of the site visit, the tide was low enough that the breach locations were not submerged however, there was evidence that the land was submerged because water had ponded during higher tides in several locations as noted in picture 4-8 of Figure 3. The breaching and low elevation also led to severe erosion of the shoreline from the storm which was estimated to range on average between 50 and 100 feet and up to a maximum of approximately 200 feet along the western point of harbor island.

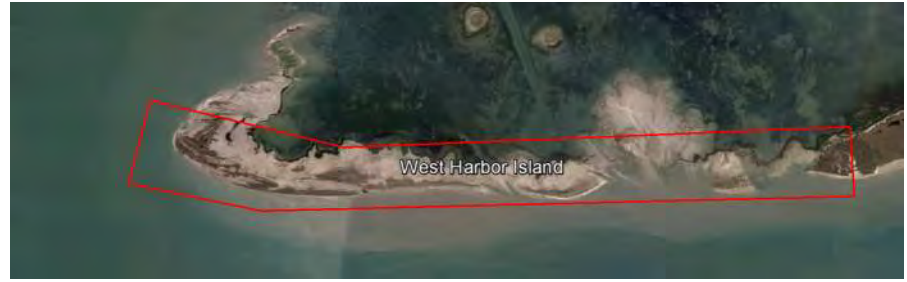
Figure 4. West harbor island shoreline stabilization area

Two options are presented for the stabilization and restoration of the western Harbor Island shoreline. The first would be to install approximately 12,000 linear feet of geotextile tube along the shoreline of Harbor Island, covering the area shown in Figure 4. The tube is assumed to have an approximate circumference of 32 feet based on observations of similar structures in the area.

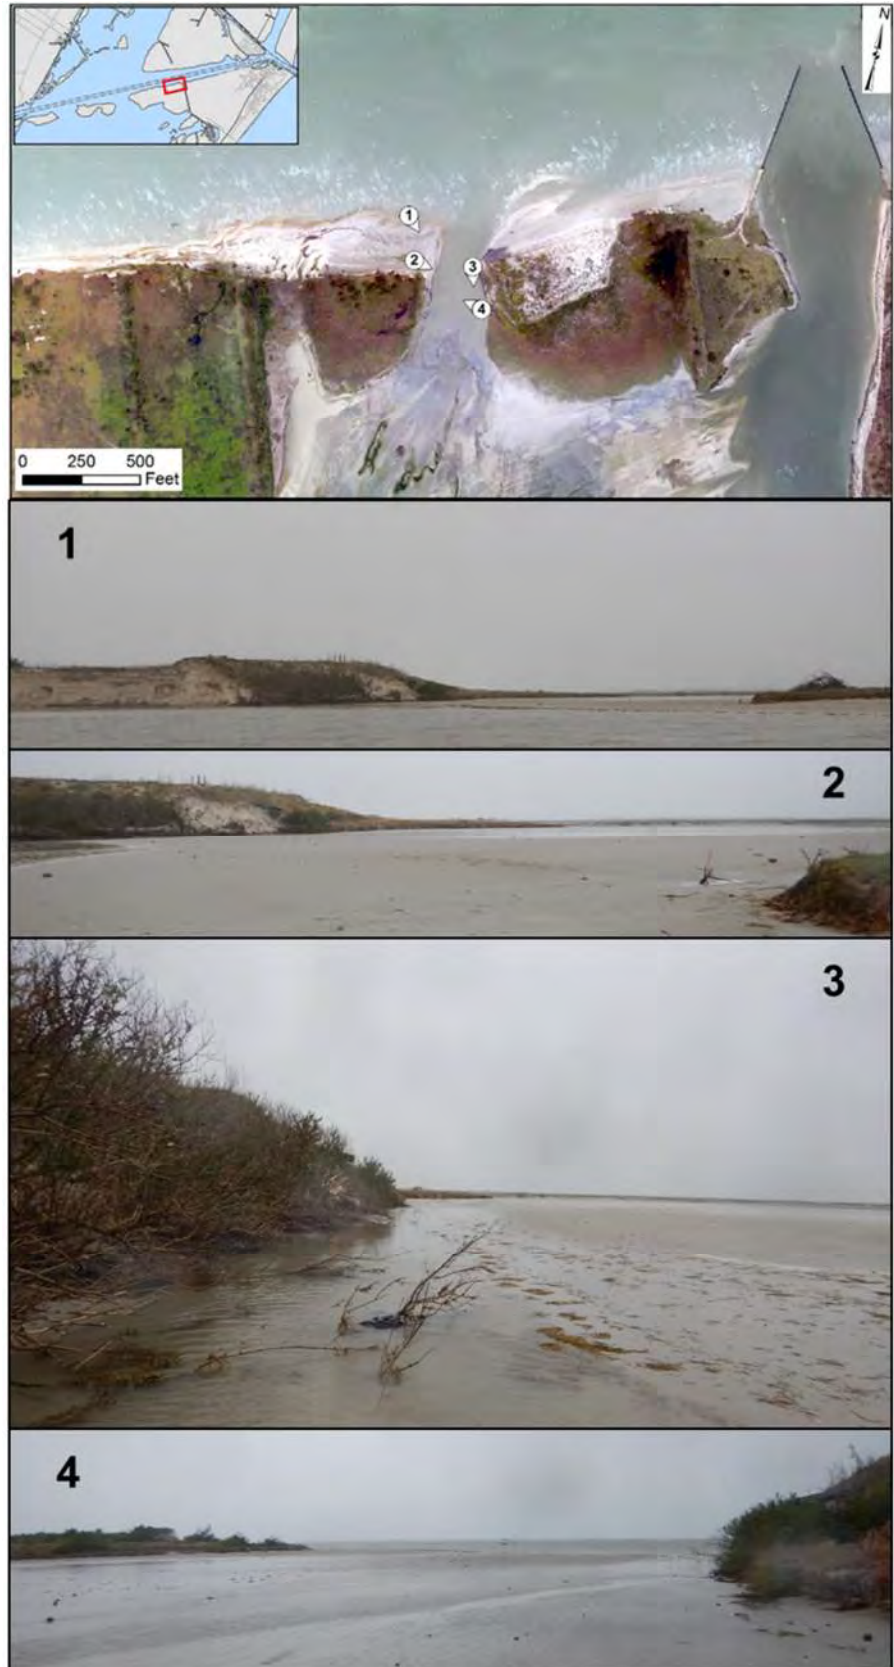
Figure 5. West of Piper Channel Breach

A breach approximately 300 feet wide has formed along the shoreline just west of Piper Channel (Figure 5). A large escarpment had formed just east of the breach where a large dune prevents breaching in that location. At the time of the site visit, the breach area was not submerged, but the elevation along this area remains low enough to allow flooding of this area during higher tides. The presence of flotsam and jetsam in the area gave further evidence that the breach was partially submerged recently. If no action is taken, it is likely that this breach will continue to deepen due to erosion caused by hydraulic conductivity through the area.

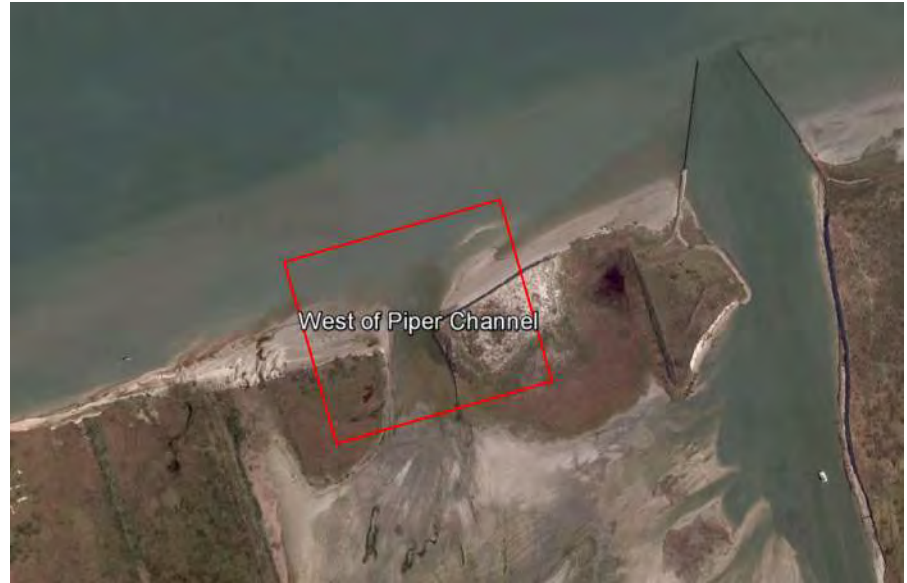
Figure 6. West of Piper Channel breach

Two alternatives were considered to close the breach just west of Piper Channel. The first alternative involves installation of a geotextile tube along the shoreline. Based on visual estimates, the tube would need to be a minimum of 500 feet long to stabilize the area shown in Figure 6. It was assumed that a 32-foot circumference geotextile tube with scour apron will be required.

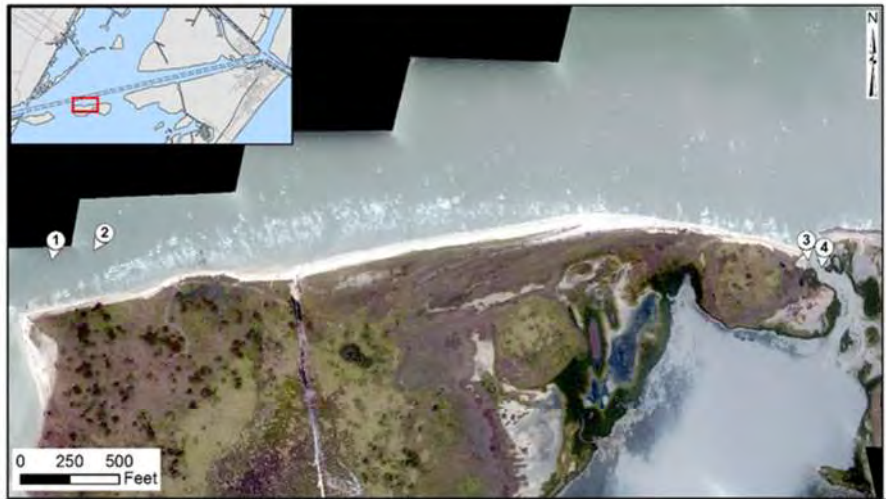
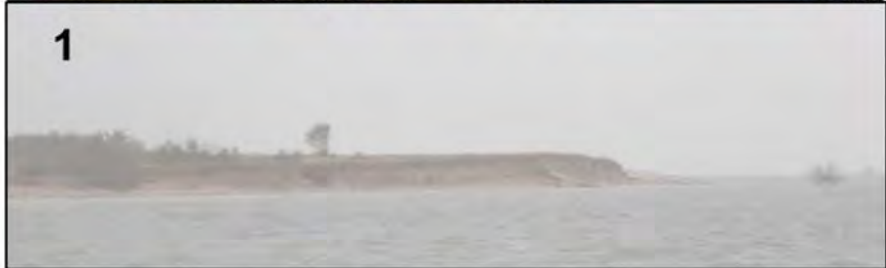
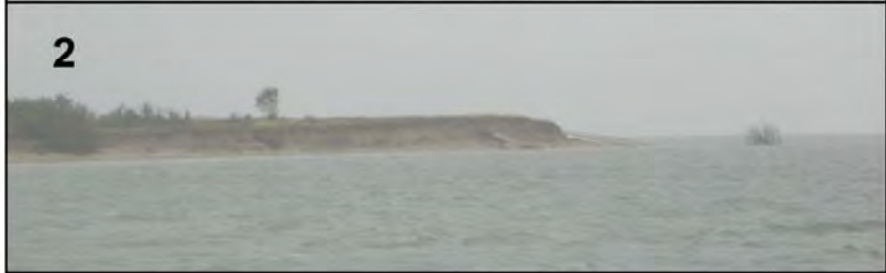
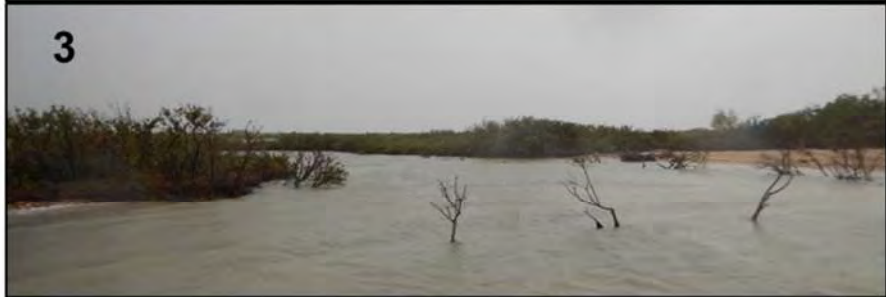
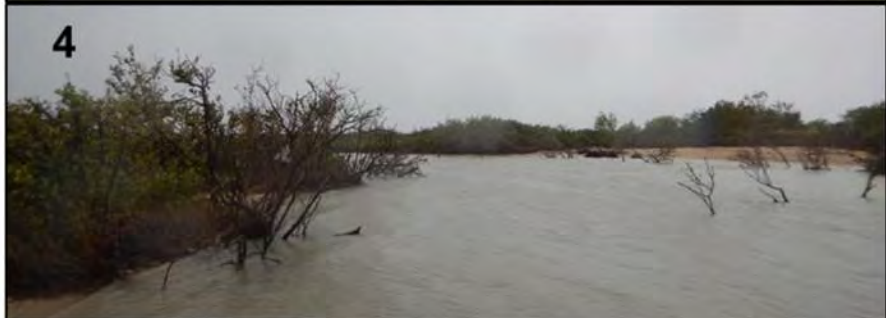
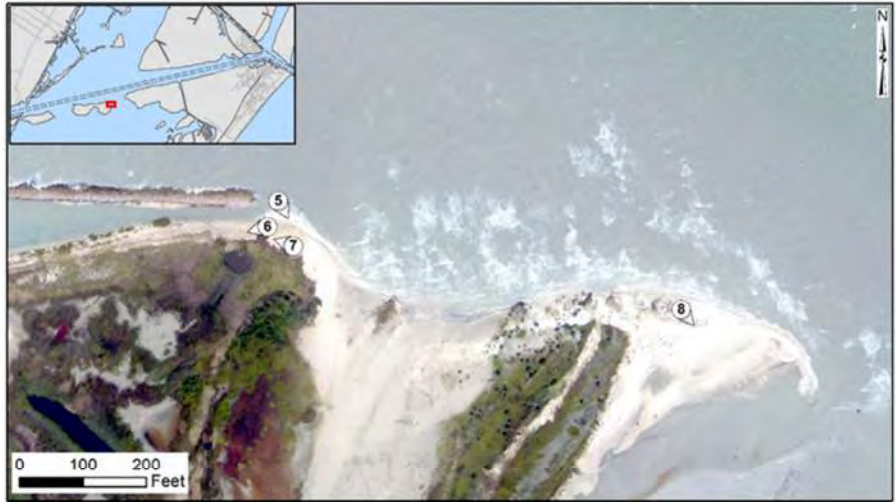
Figure 7. Pelican Island

As previously mentioned in our letter sent on October 30, 2017, Pelican Island sustained excessive erosion in the wake of Hurricane Harvey. Although damage to the existing breakwater was no observed, there were signs of excessive erosion to the unprotected shoreline adjacent to the structure (Figure 7). The east end of Pelican Island suffered erosion greater than 100 feet; while a large breach formed on the western end of the existing breakwater as shown in pictures 3 and 4 of Figure 7). The desktop analysis also showed excessive erosion along the western and southwestern shorelines. Due to the low elevation of Pelican Island, few escarpments were observed on the east end. However, there were obvious signs of erosion such as submerged vegetation that were previously in the uplands and the observed breach.

Pictures 6 and 7 of Figure 7 indicate a large escarpment had formed on the western end of the island where the shoreline was also significantly eroded due to Hurricane Harvey. In fact, the desktop shoreline analysis has shown consistent erosion all around Pelican Island. If allowed to continue unabated, the exposed shoreline along Pelican Island will continue to erode and the island will continue to reduce in size.
