Appendix C

Dredged Material Management Plan

PCCA Dredged Material Management Plan, February 2024

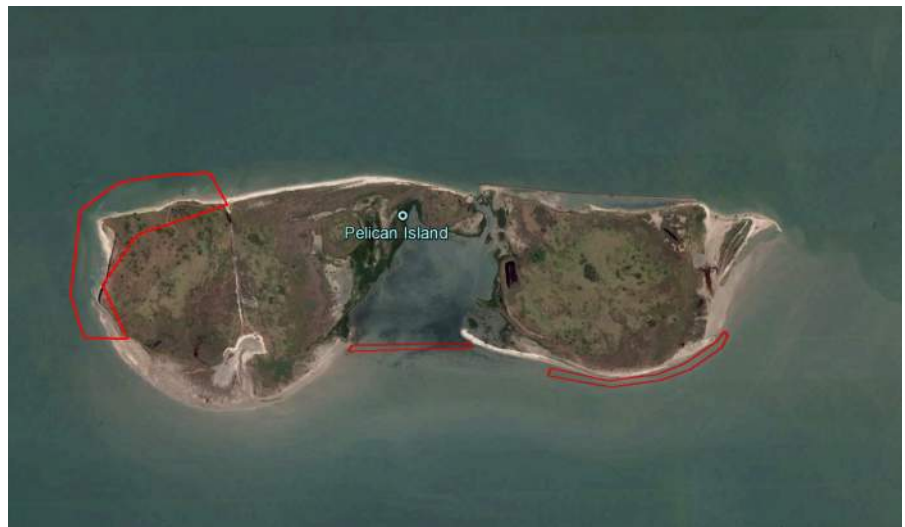
Figure 8. Pelican Island additional breakwater locations

Results from this analysis showed three main locations, apart from the locations discussed in our previous letter, where the shoreline has been eroding at a significant rate. These areas have been delineated in Figure 8. Stabilization of these areas will require construction of riprap breakwater sections spanning a total length of 6,100 feet. We assume that the breakwater design for these areas will be similar to the existing breakwater along the north-east end of Pelican Island.

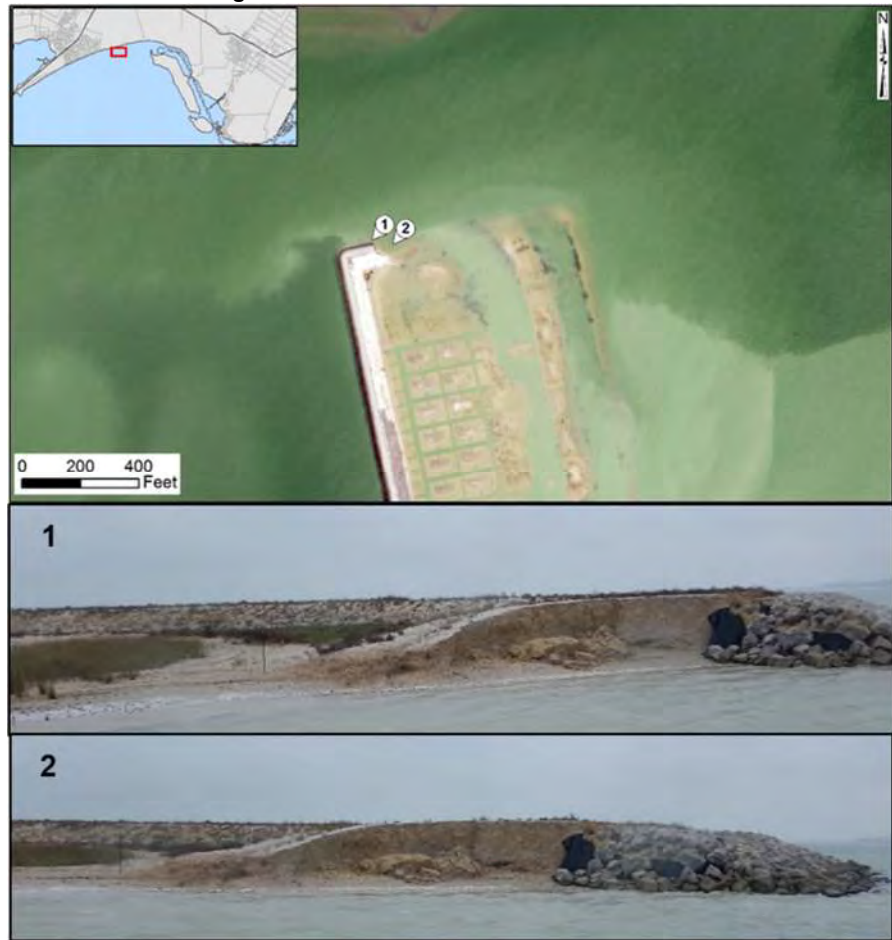
Figure 10. BUS6 Offshore Emergent Levee

As shown in Figure 10, the terminal end of the offshore emergent levee within Cell F of BUS6 has suffered damage due to erosion. This area was damaged prior to the storm due to erosion of the adjacent shoreline. This erosion is likely caused by waves refracting around the structure, creating a focal point for wave energy adjacent to the structure. Typically, armored structures incorporate radial ends in their design to avoid this kind of failure, but the levee in this location did not include that in the design. Hurricane Harvey resulted in additional erosion, which has caused the armor stone to collapse into the adjacent channel and geotextile to become exposed. If a remedy is not constructed, erosion will continue to cause the collapse of the levee which will expose the adjacent mitigation area to sustain damage from increased wave energy reaching the site.

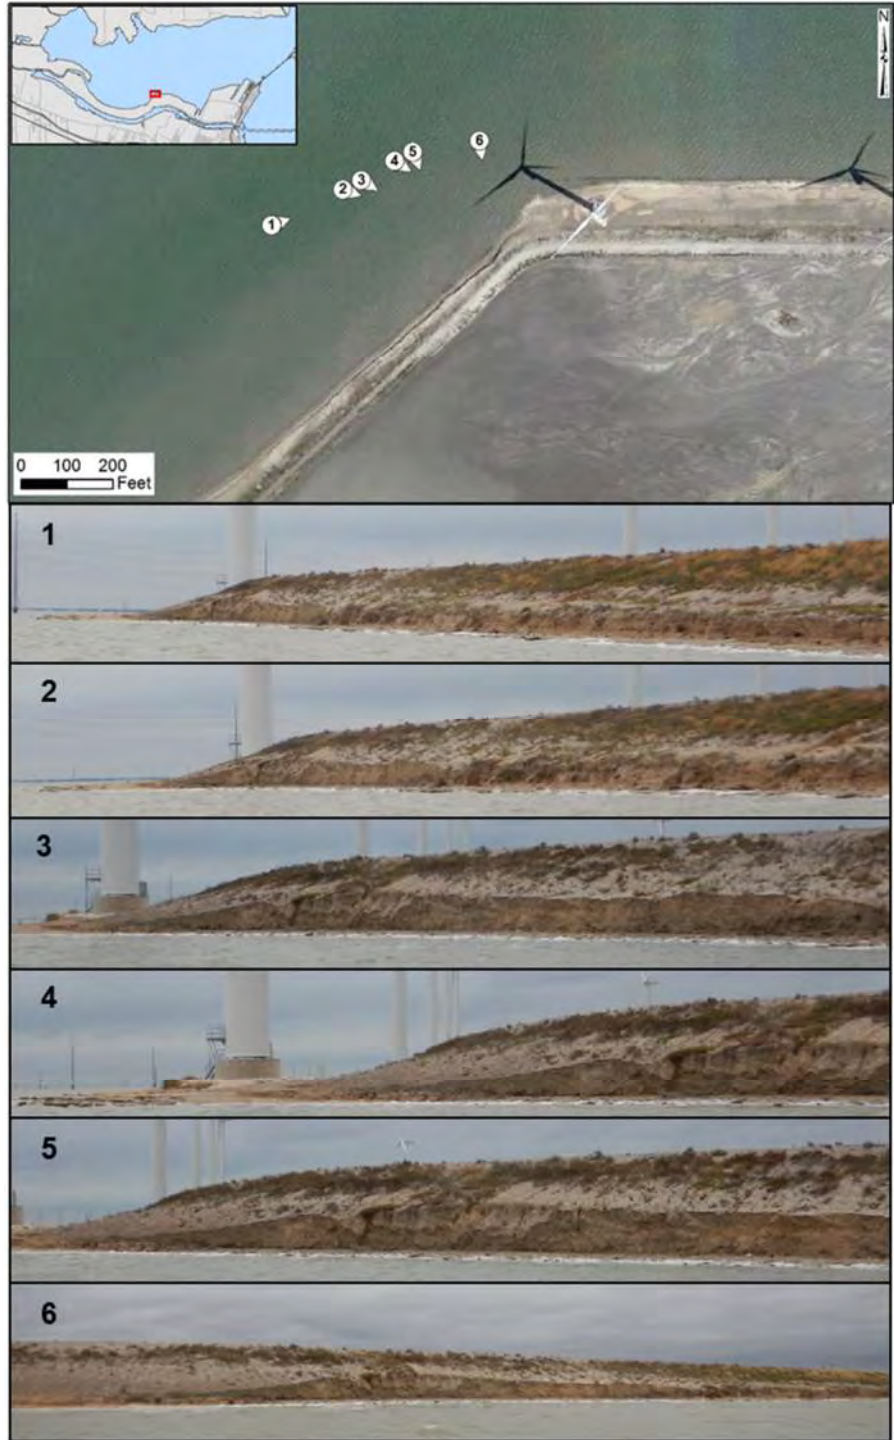
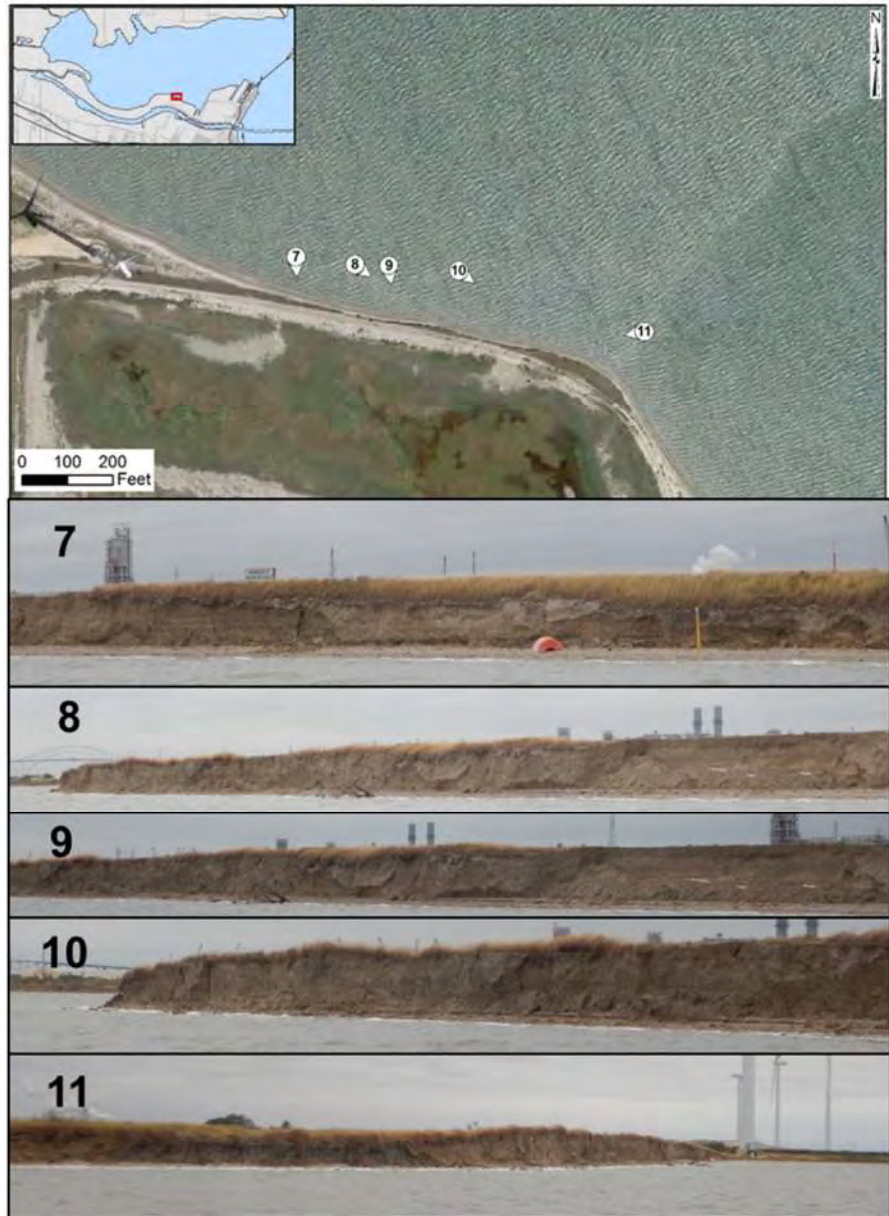
Figure 13. South Shore DMPA Cell B Shoreline

The shoreline along the west and east corners of South Shore DMPA Cell B suffered considerable erosion due to Hurricane Harvey. An escarpment spanning approximately 900 feet at the northwest corner of this DMPA was observed where erosion of the adjacent levee has begun as shown in pictures 1-6 of Figure 13. If erosion in this area is not mitigated, the levee may become compromised and will require repair prior to placing of dredged material in the DMPA.

A similar escarpment was observed at the northeast corner of the DMPA spanning approximately 900 feet (pictures 7-11 in Figure 13). Significant erosion of the levee was observed in this area and is currently at risk of further damage due to shoreline erosion.

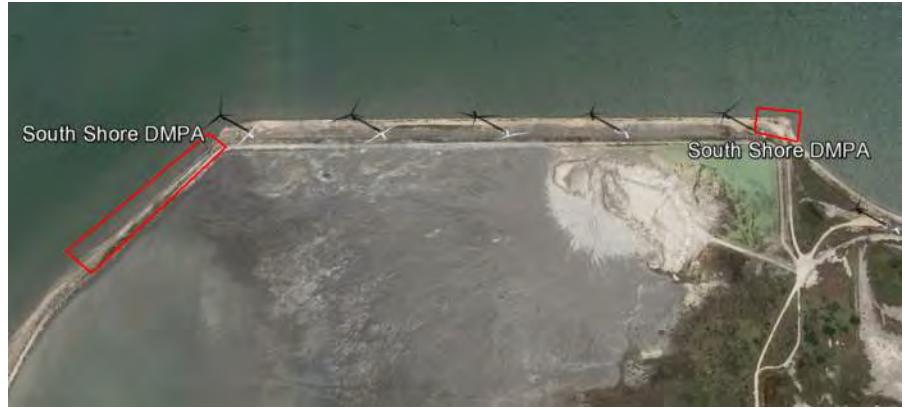
Figure 14. DMPA Cell B proposed revetment areas

The recommended alternative for stabilization of the shoreline in this area would be to install a riprap revetment similar to those previously installed throughout the Nueces Bay shoreline. Approximately 1,800 feet of revetment will need to be installed to stabilize the areas shown in Figure 14.

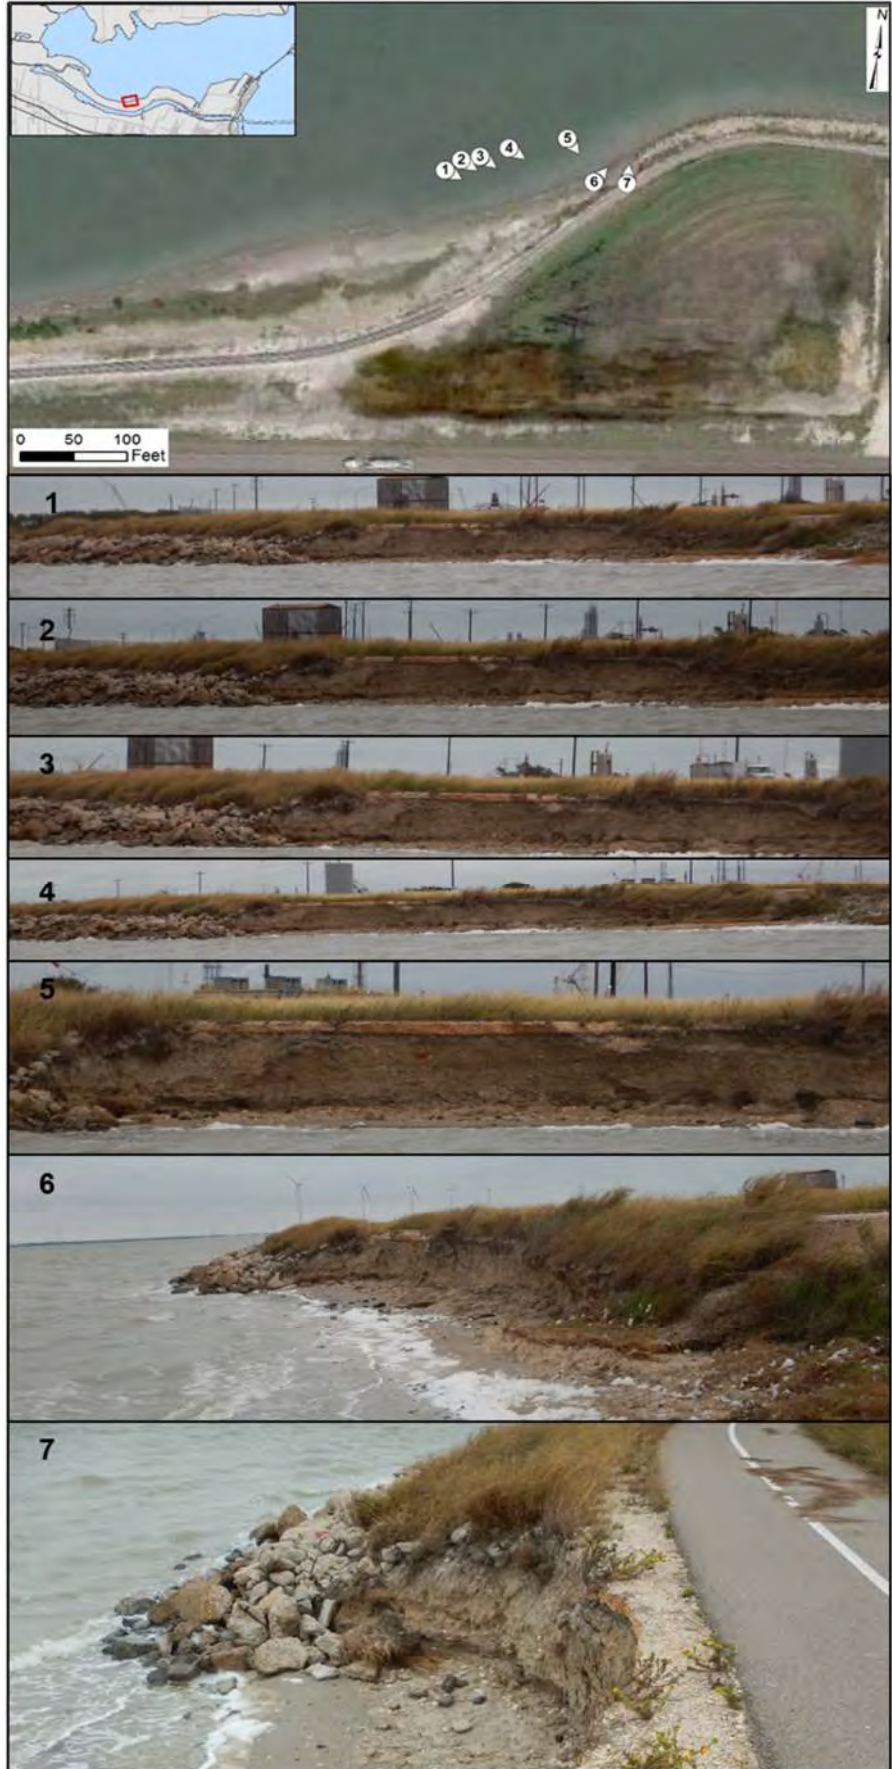
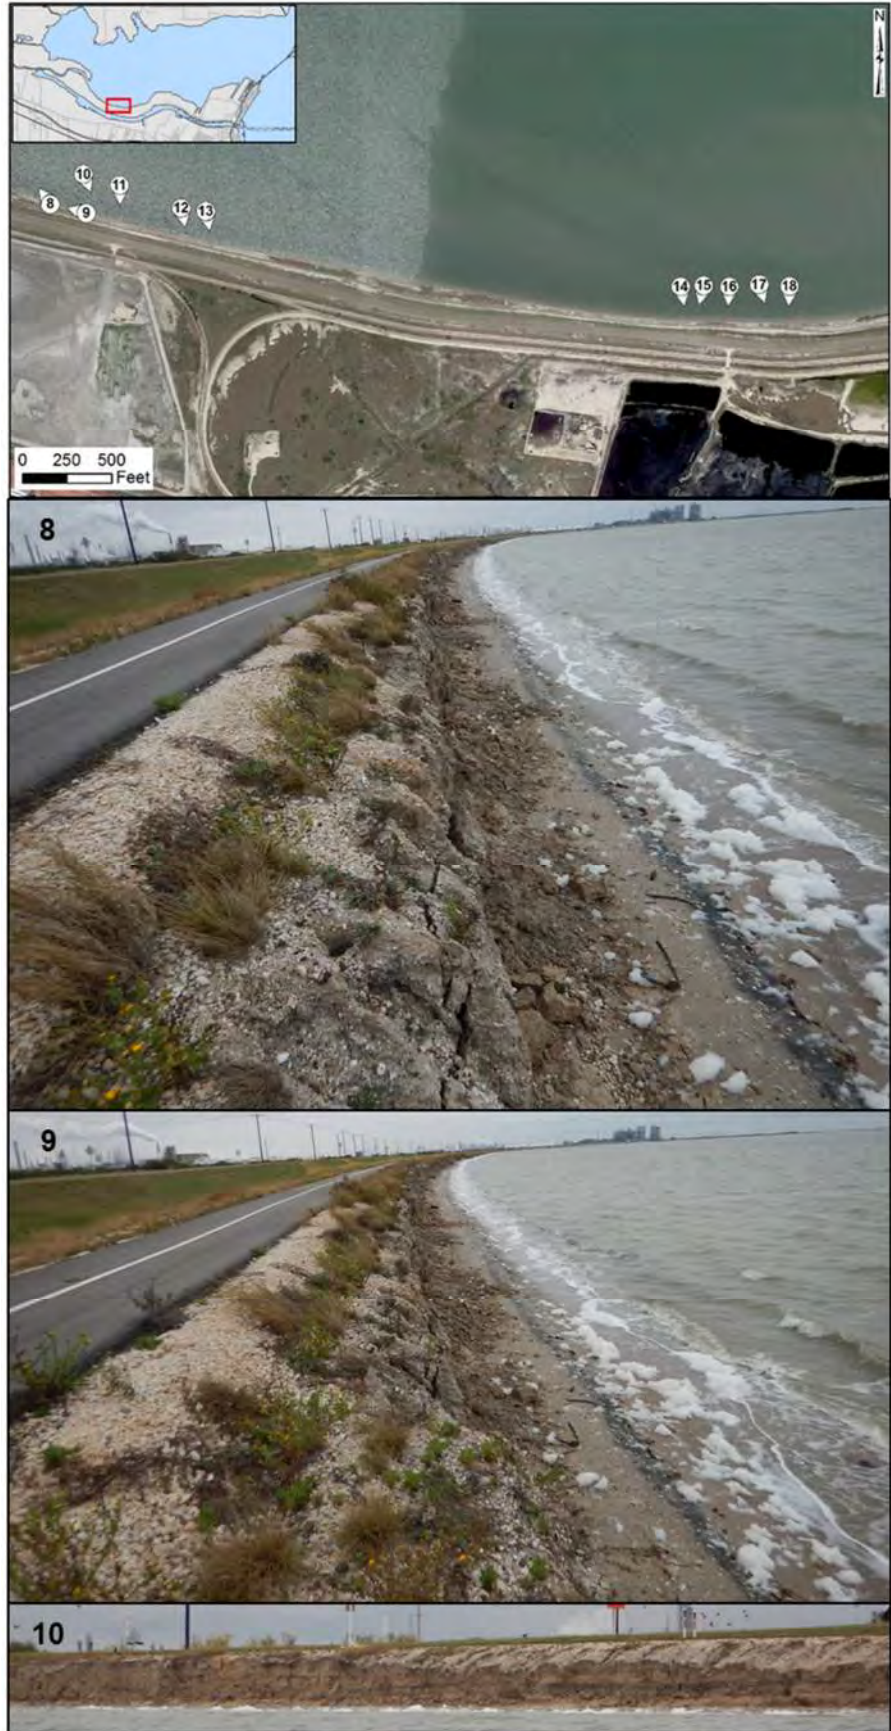
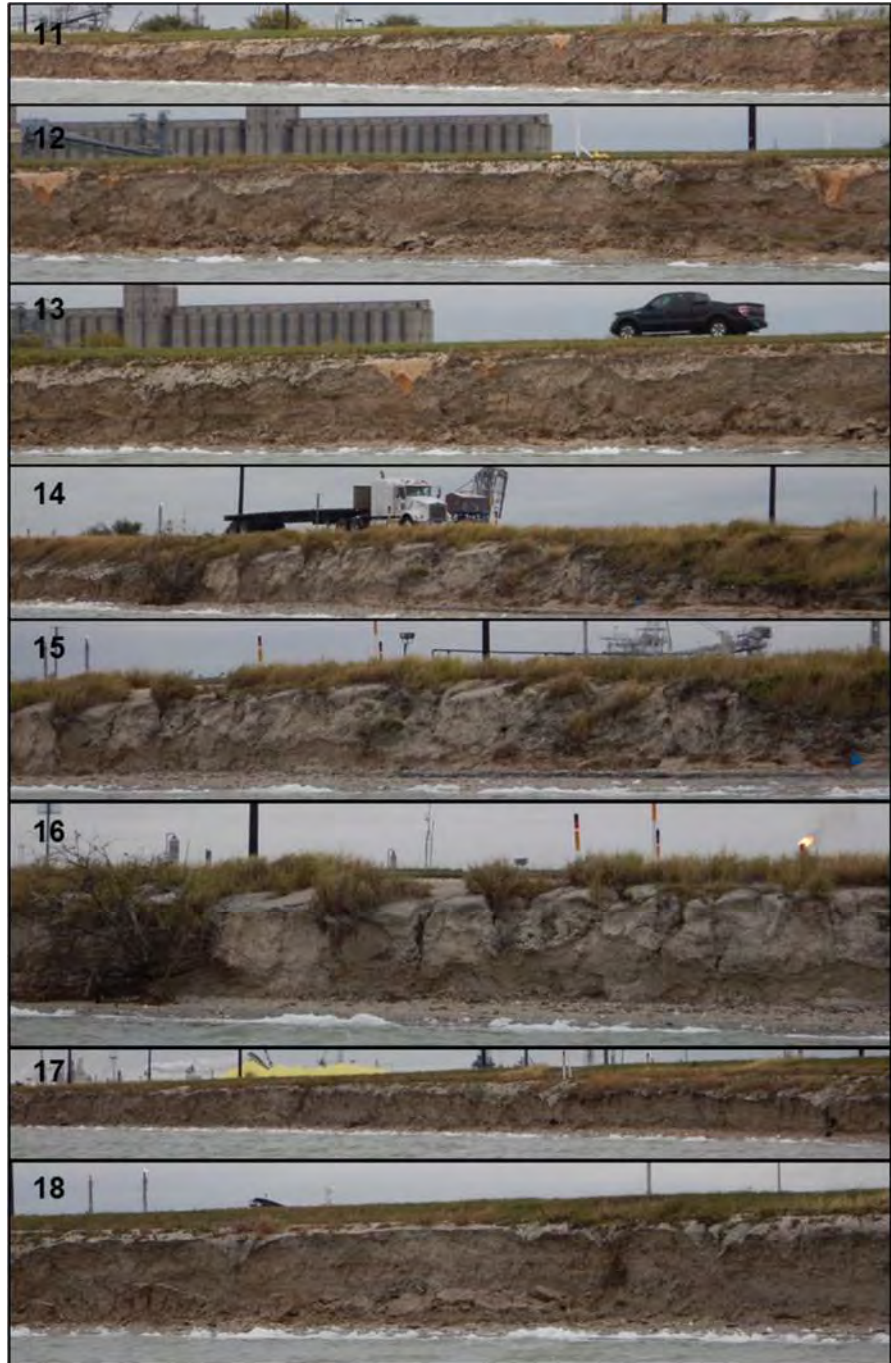
Figure 15. Nueces Bay shoreline

Figure 15 shows three areas along Nueces Bay adjacent to the Joe Fulton Corridor which had experienced noticeable erosion due to Hurricane Harvey. The three areas spanned a total length of 3,200 feet. The first and worst area was just west of the existing riprap revetment along the existing bike path as depicted in pictures 1-7 of Figure 15. Localized erosion in the lee of the structure led to the formation of a large escarpment and the exposure of the subgrade under the adjacent bike path. If erosion continues, the path will collapse into Nueces Bay at this location.

The second location is approximately 1200 feet west of the existing riprap revetment and is approximately 1500 feet long (pictures 8-13 of Figure 15). A large escarpment has formed in this area which is immediately adjacent to the bike path. Although the erosion has not yet reached the path, if allowed to continue, the subgrade will be eroded and the path will collapse into Nueces Bay.

The third location is approximately 1200 feet west of the second location and is also approximately 1500 feet long (pictures 14-18 in Figure 15). Similar to the second location, an escarpment has formed near to the existing path which, if not addressed, may eventually result in the undermining and collapse of the asphalt into Nueces Bay.

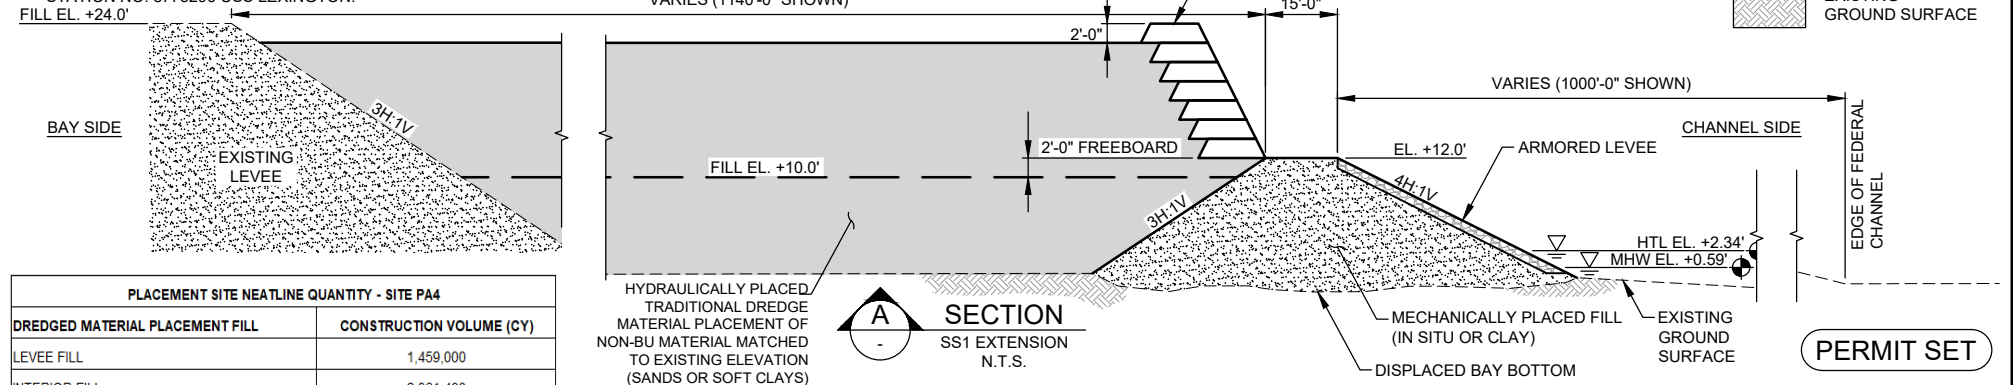
- PLACED DREDGE MATERIAL
- PLACED BERM MATERIAL
- EXISTING GROUND SURFACE

PLACEMENT SITE NEATLINE QUANTITY - SITE PA4	
DREDGED MATERIAL PLACEMENT FILL	CONSTRUCTION VOLUME (CY)
LEVEE FILL	1,459,000
INTERIOR FILL	2,861,400
TOTAL DREDGED MATERIAL FILL	4,320,400
ADDITIONAL (NON-DREDGE) FILL	CONSTRUCTION VOLUME (CY)
ARMORING	217,000

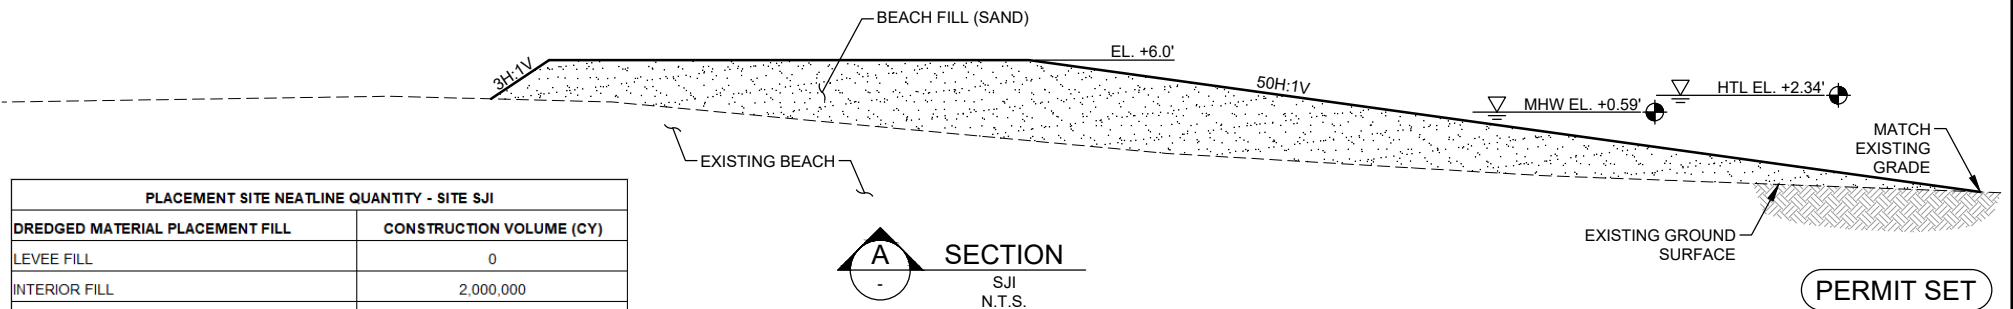
SECTION A-A
SJI
N.T.S.

PLACEMENT SITE NEATLINE QUANTITY - SITE SJI	
DREDGED MATERIAL PLACEMENT FILL	CONSTRUCTION VOLUME (CY)
LEVEE FILL	0
INTERIOR FILL	2,000,000
TOTAL DREDGED MATERIAL FILL	2,000,000
ADDITIONAL (NON-DREDGE) FILL	CONSTRUCTION VOLUME (CY)
ARMORING	0

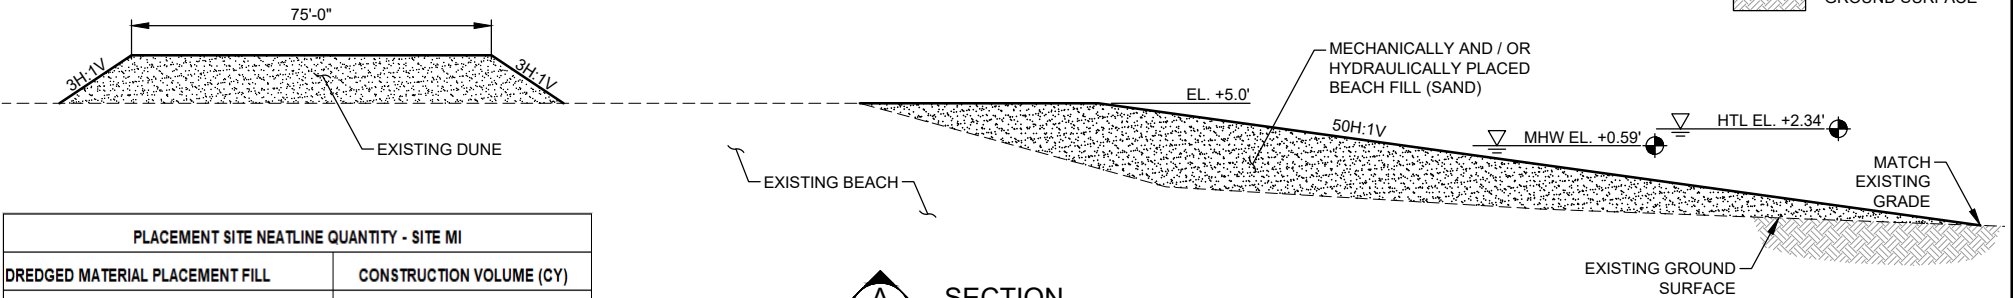
SECTION A
MI
N.T.S.

- PLACED DUNE FILL
- PLACED BEACH FILL
- EXISTING GROUND SURFACE

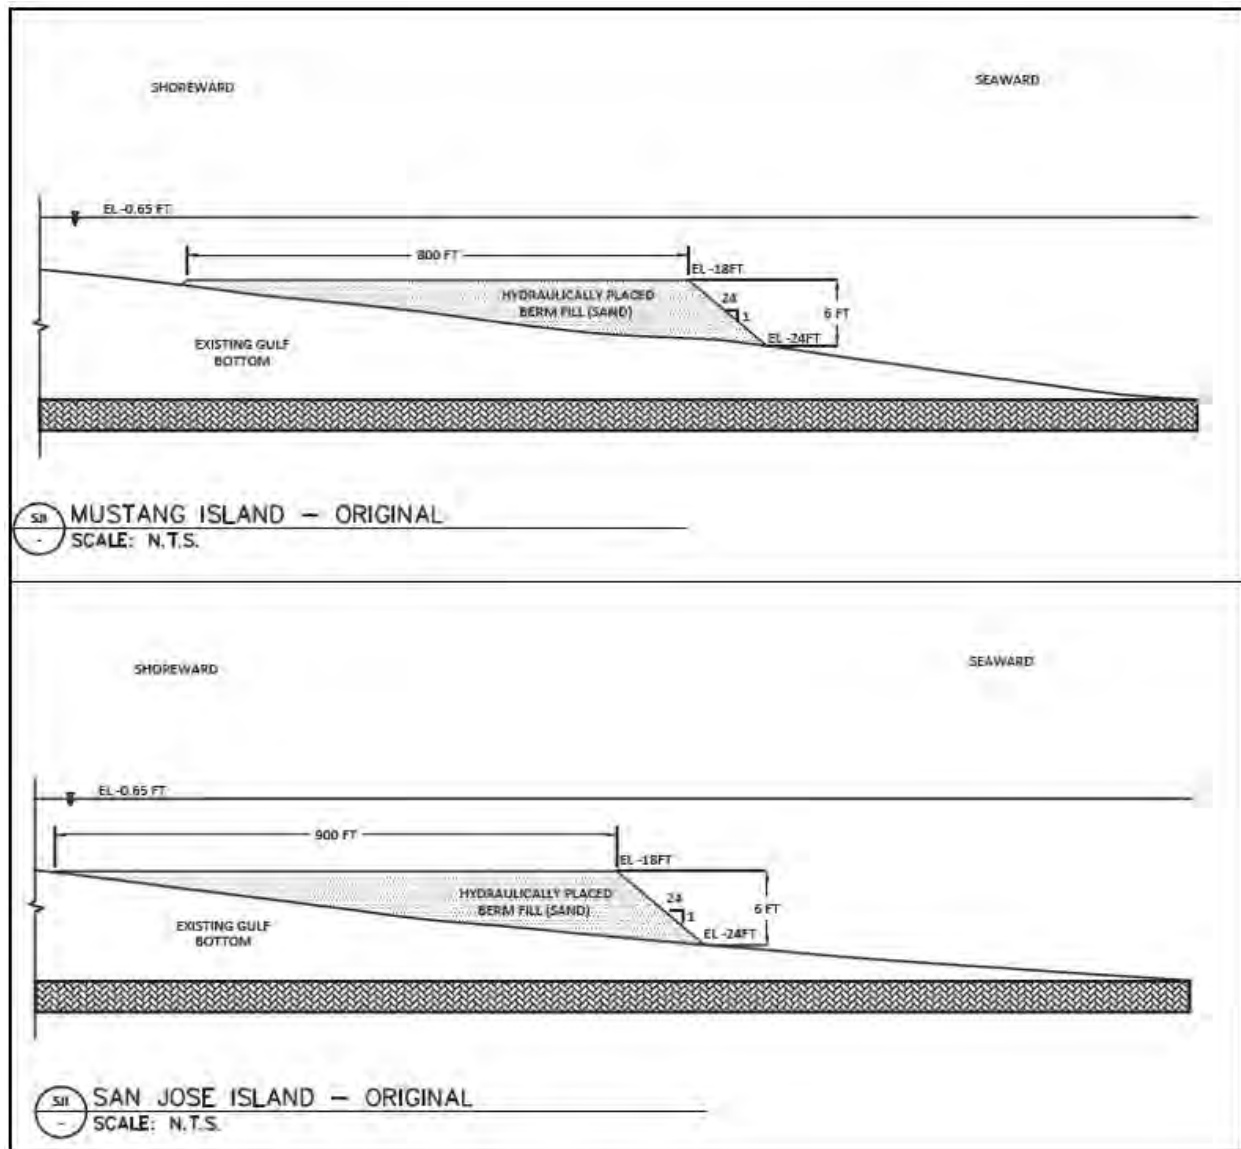
Figure 5. San José Island and Mustang Islands Nearshore Feeder Berm Bathymetry Overlay Profiles at the -24-ft Depth Contour (Elevations are Referenced to NAVD88)

Figure 5 displays the profile of the typical feeder berm cross-sectional geometry when overlaid on the latest nearshore bathymetry at San José Island and Mustang Island, with the seaward toe of the berms located at the 24-ft depth contour. Because of the reduction in the cross-sectional area of the berm geometry, these capacities are much less than the proposed in-situ volume of dredged sediments to be placed in the nearshore.

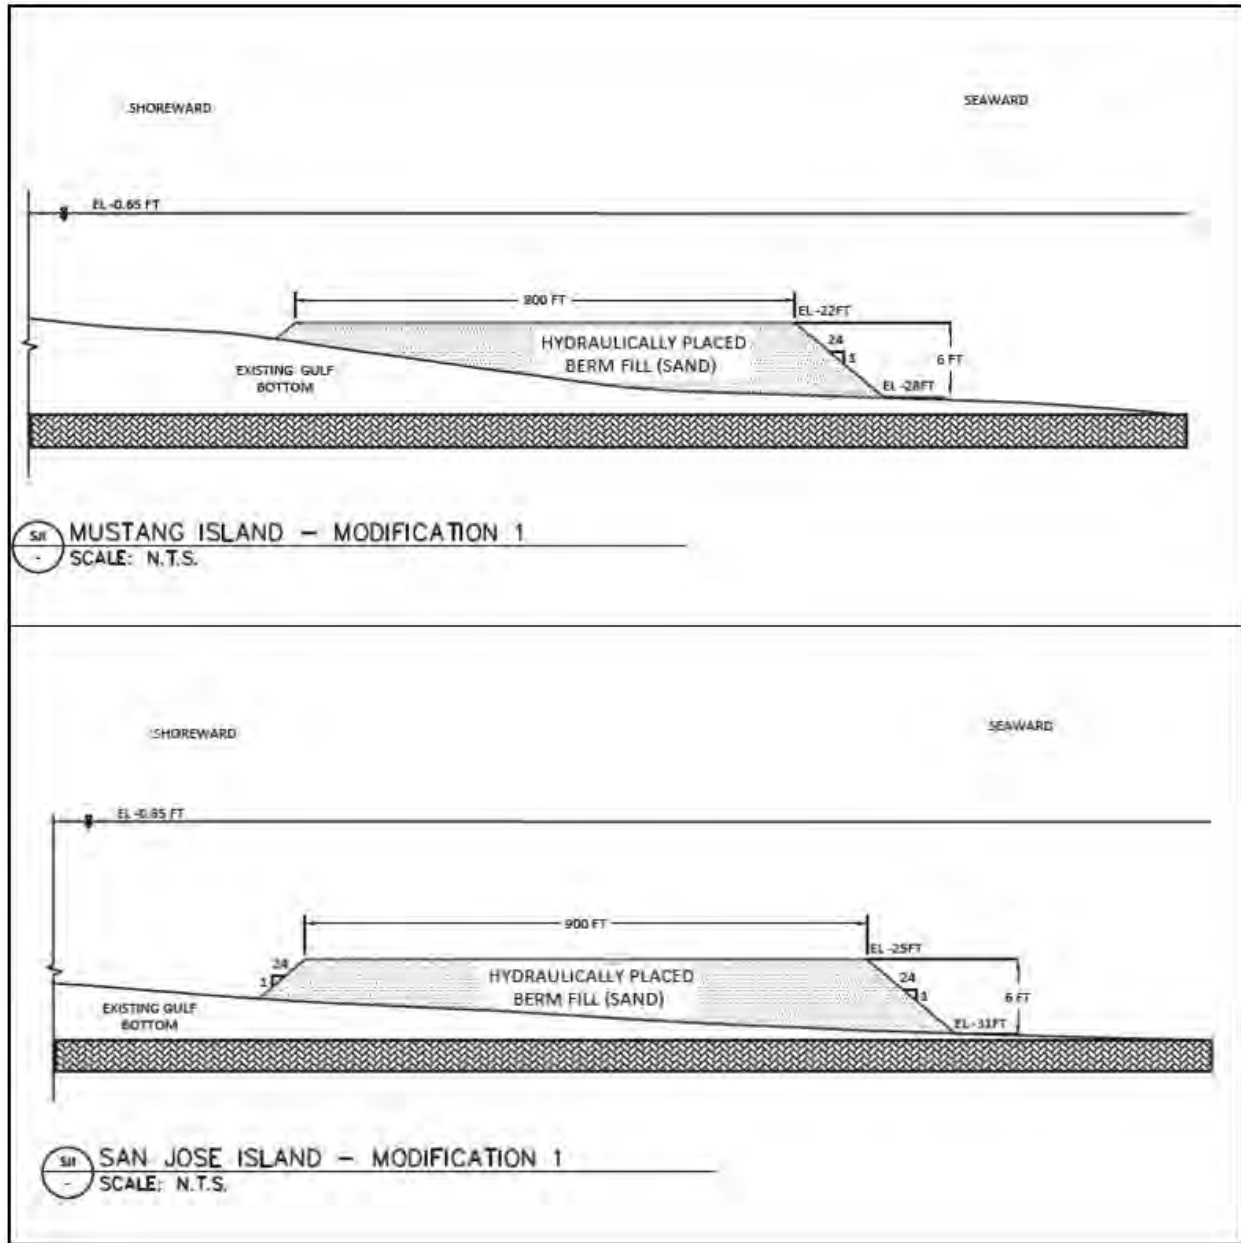
Figure 8. San José Island and Mustang Islands Nearshore Feeder Berm Bathymetry Overlay Profiles at the Alternative Depth Contours (Elevations are Referenced to NAVD88)

The resulting alternative configuration attributes for each nearshore feeder berm are listed in Table 15 (San José Island) and Table 16 (Mustang Island) with the plan views shown in Figure 6 (San José Island) and Figure 7 (Mustang Island). Profile views of the typical cross-sections for the alternative configurations overlaid on the latest bathymetry are shown in Figure 8.

Attachment B shows the comparative nearshore feeder berm profile differences at San José Island and Mustang Island between the originally proposed berm depth (at 24-ft) and the alternative berm depths (at 28- and 31-ft).
