Lake Houston Mitigation Bank Prospectus swg-2019-00077

1 INTRODUCTION

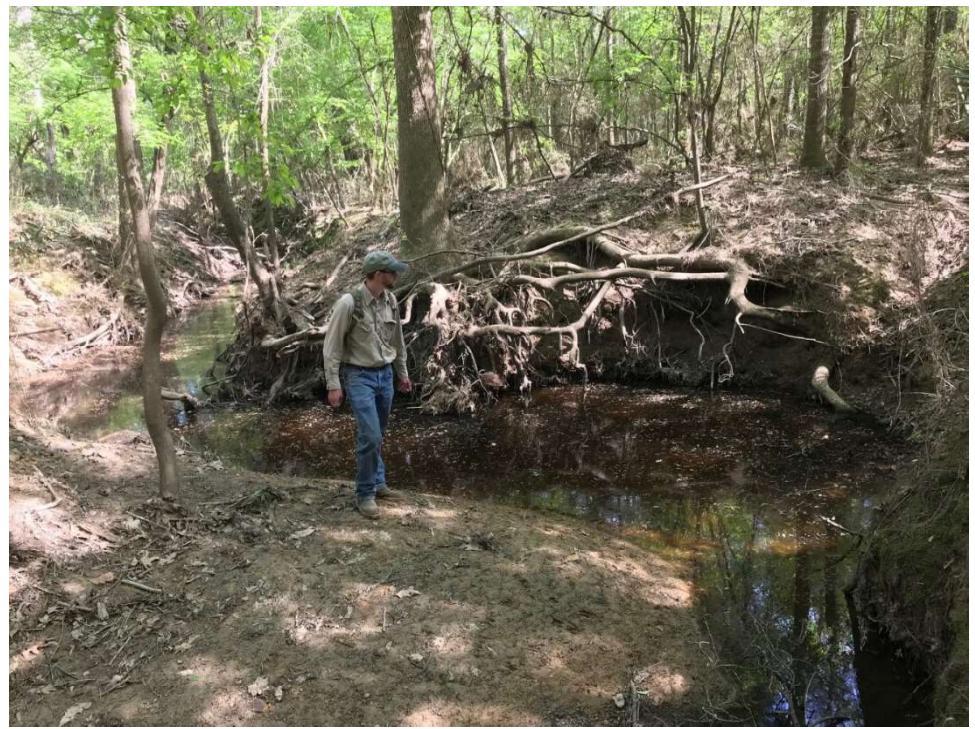
Camp Branch and associated tributaries (Camp Branch East Fork, Camp Branch West Fork, and multiple unnamed tributaries) were observed to be severely entrenched and lacking access to the historic floodplain (Figure 1 and Figure 2). Substantial, active erosion was also observed along these reaches. This was further confirmed by evaluations by Brian King (Engineering 303) and Dave Rosgen. **Based on preliminary calculations and measurements, it's estimated that streams within the bank erode 4,000 – 6,000 tons of sediment per year into the East Fork of the San Jacinto River or Luce Bayou and ultimately into Lake Houston. The streams observed were severely entrenched with highly erosive streambanks ranging in heights from 5 feet to 15 feet. The middle section of the East Fork of Camp Branch is the most deeply entrenched and unstable. The streams observed were either type "G5" or "F5" as described by Rosgen Classification of Natural Rivers (Rosgen, 1994). These sand bed streams are currently considered to be highly unstable erosive systems with little to no connection to their floodplains. It is E303 and Rosgen's opinion that by stabilizing these streams they will transition to gravel bed systems as the streambank erosion is reduced. Remnant gravel bed substrate can be observed in multiple locations along Camp Branch.**

Figure 1 – View of severely entrenched, actively eroding Camp Branch.

Engineering 303's recommended design approach will be to abandon most of the existing streams and build new streams (Priority 1) at the original and proper level of the valley floors. This approach has many advantages.

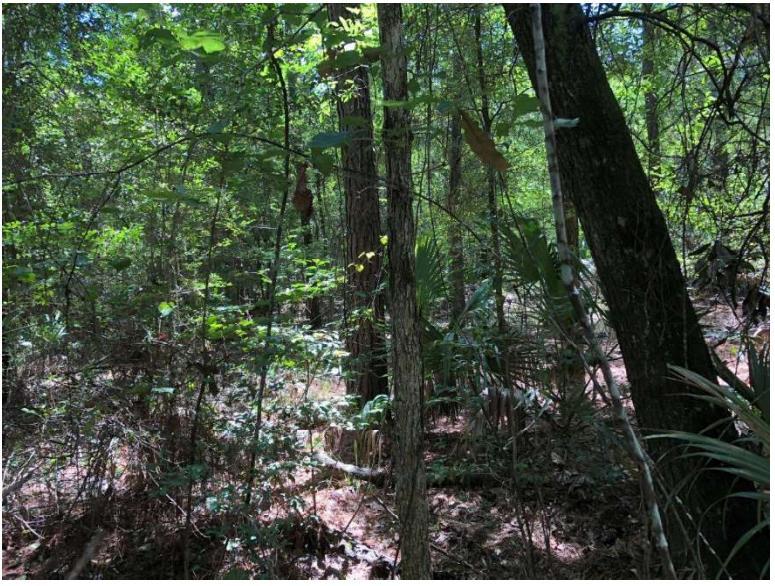
The site is predominately a mixed pine/hardwood stand (Figure 3). Based on historical and recent aerial photographs (Appendix A – Exhibits 10-15), the site appears to have been in a similar state since the 1930's and likely before. Although the historical conditions appeared to have a much heavier component of hardwood and could be best characterized as hardwood/pine. The site has experienced some selective timber harvesting but no clear-cutting and no conversion to loblolly pine plantations. As reported in the Block 1 and Block 2 wetland delineations within the site included loblolly pine (Pinus taeda), sweetgum (Liquidambar

dominant vegetation within uplands *Figure 3. Representative view of upland mixed pine/hardwood found within the tract.*

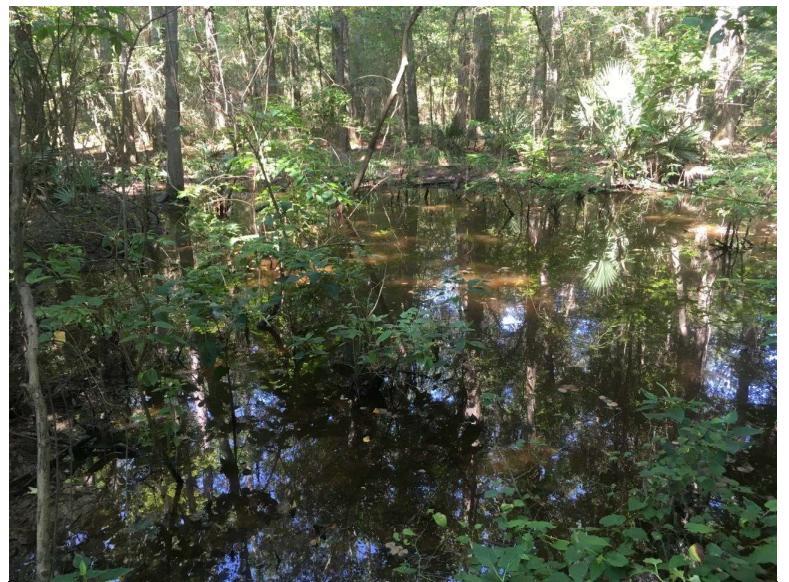
Figure 4. Representative view of small wetland area near East Fork San Jacinto River.

Dominant vegetation observed within wetland areas (Figure 4) included laurel oak (Quercus laurifolia), willow oak (Quercus phellos), water oak (Quercus nigra), bottom-land post oak (Quercus similis), blackgum (Nyssa sylvatica), sweetgum (Liquidambar styraciflua), loblolly pine (Pinus taeda), Chinese tallow (Triadica sebifera), red maple (Acer rubrum), yaupon (*Ilex vomitoria*), common buttonbush (Cephalanthus occidentalis), maidencane (Panicum hemitomon), coastal plain yelloweyed grass (Xyris ambigua), southern waxy sedge (Carex glaucescens), Louisiana sedge (Carex louisianica), dwarf palmetto (Sabal minor), long-leaf

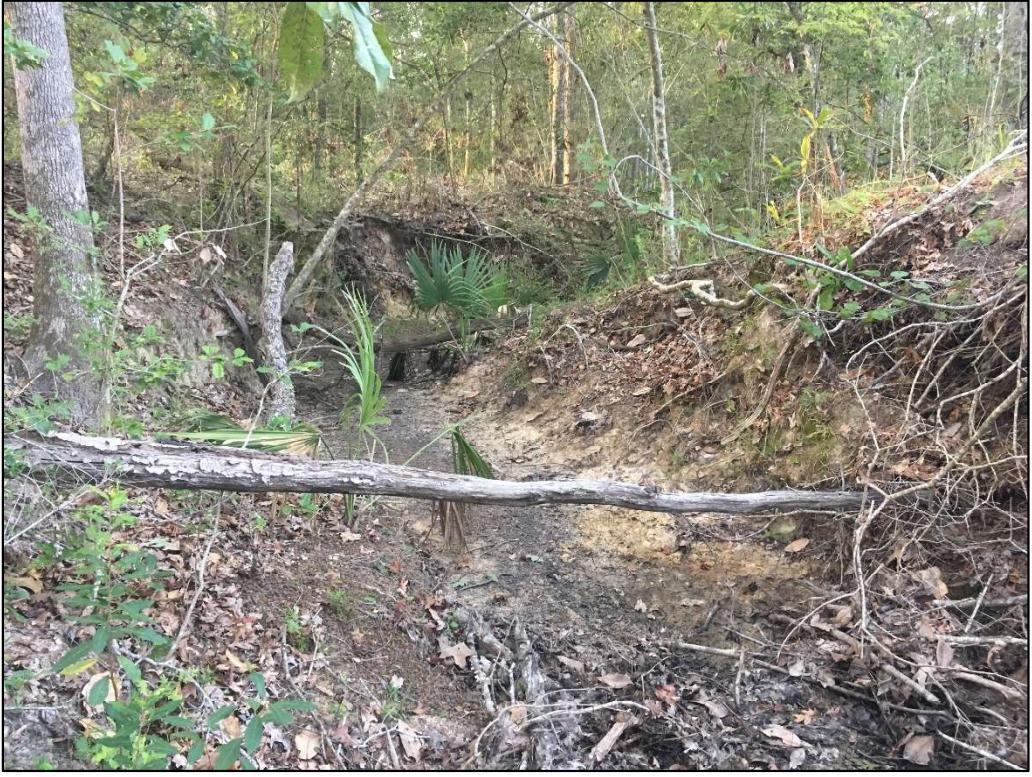
West Fork spans 7,551 Lf. from the confluence with East Fork north to the Block 1 Delineation Boundary and has an average OHWM width of 9.6 ft. and depth of 1.4 ft. Camp Branch East Fork spans 5,624 Lf. from the confluence of Camp Branch West Fork north the Block 1 Delineation Boundary and has an average OHWM width of 9.1 ft. and depth of 1.4 ft. These streams were flowing at the time of investigation and did appear to receive seasonal groundwater influence. However, these streams were observed dry during portions of the summer, even though the area experience a wetter than average summer (see Table 2 and Figure 1).

Figure 1. Portion of Camp Branch System dry during summer (July 2018).

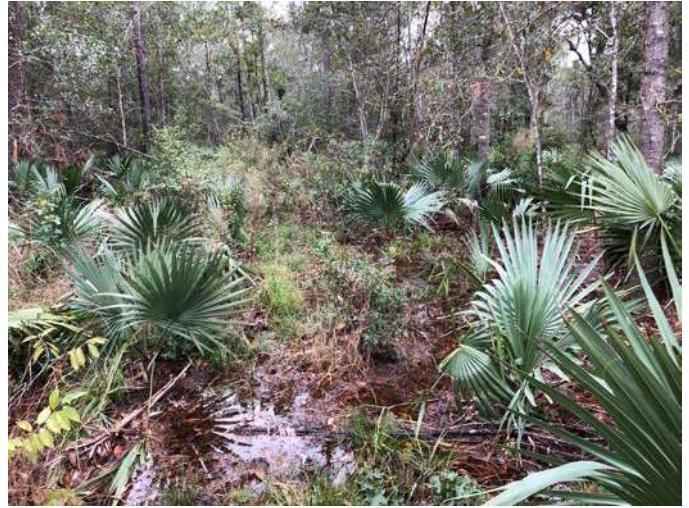
DP 03 Vegetation. Wetland depression (Wetland 1) near Camp Branch West. Predominantly hardwood stand with pine on mounds

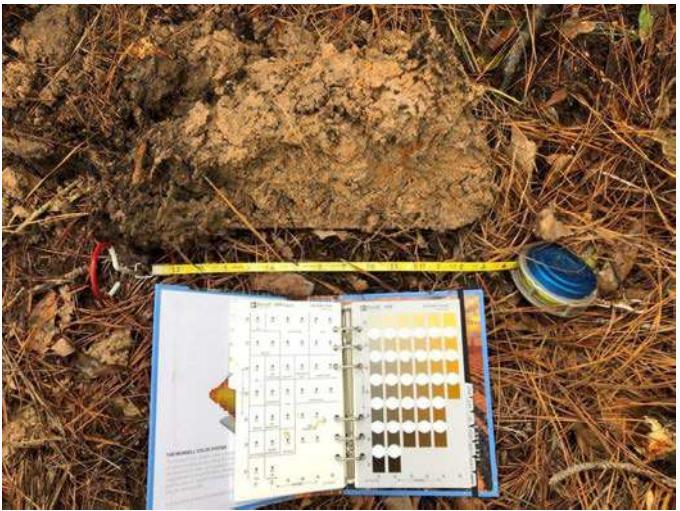
DP 04 soils. No hydric soil indicators observed.

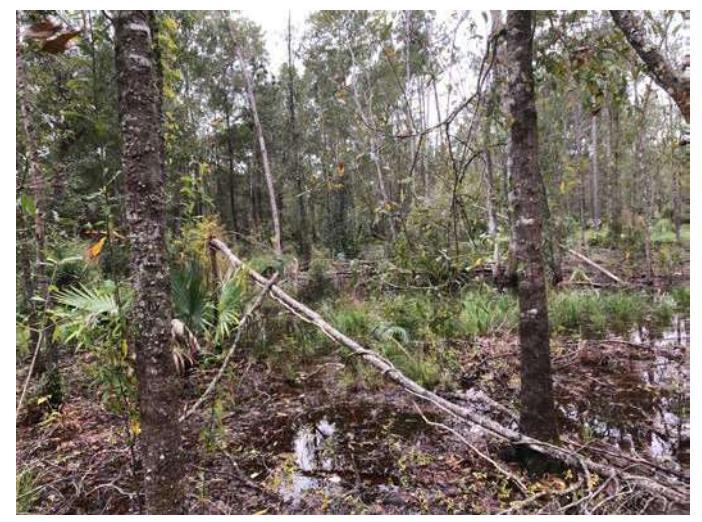
DP 05 vegetation facing south. Eastern extent of hardwood dominated depressional wetland (Wetland 1).

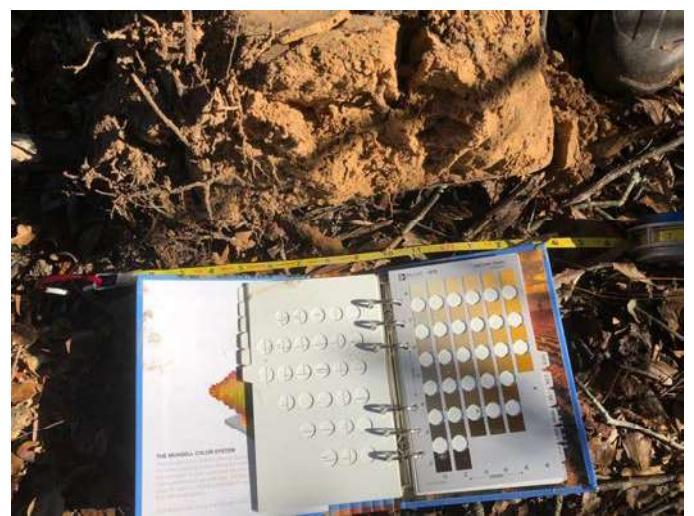
DP 10 soils. No hydric soil indicators observed.

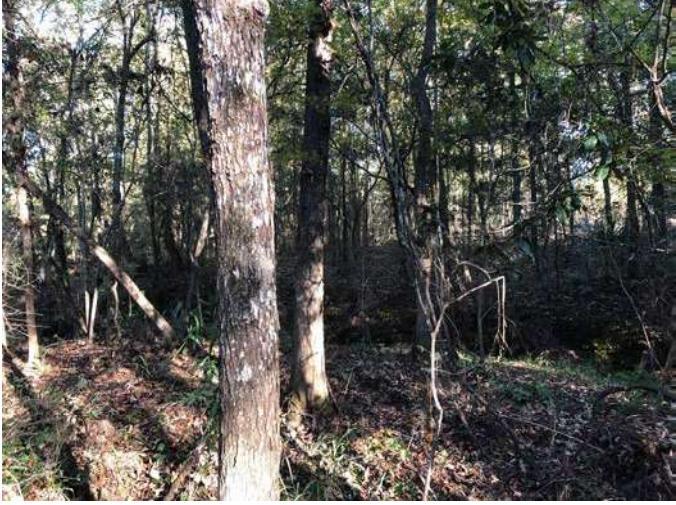
DP11 vegetation facing north. Hardwood stand adjacent to Camp Branch West Fork.

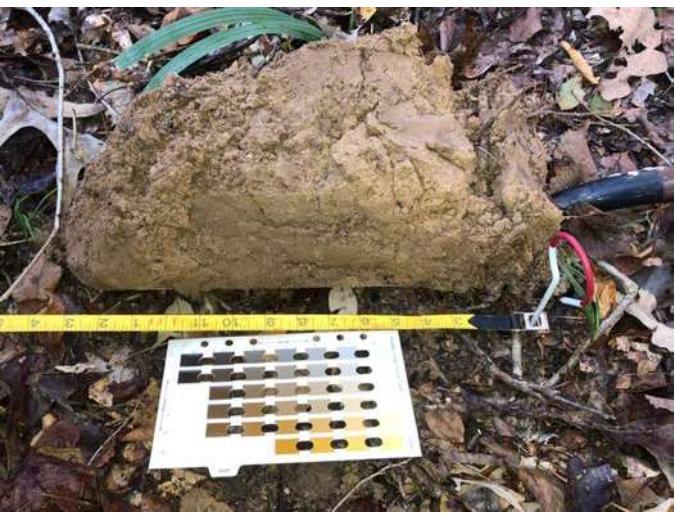
DP11 soils. No hydric soil indicators observed.

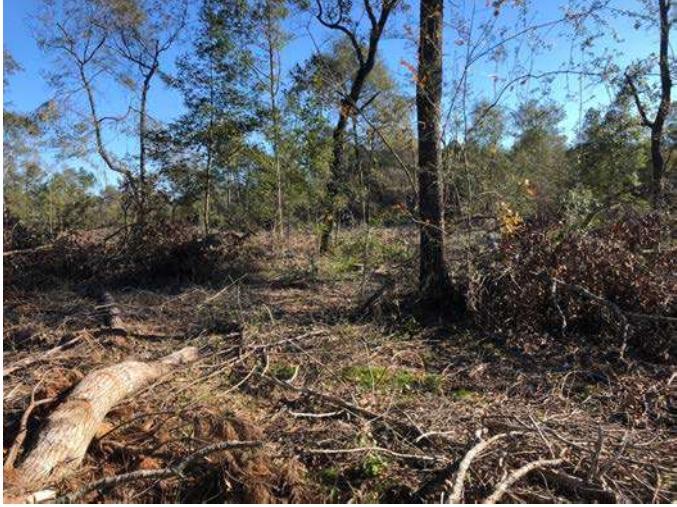
DP 12 vegetation facing east. Recently thinned mixed hardwood non-wetland flat.
